ERA23LA310

## INVESTIGATION PHOTOGRAPHS

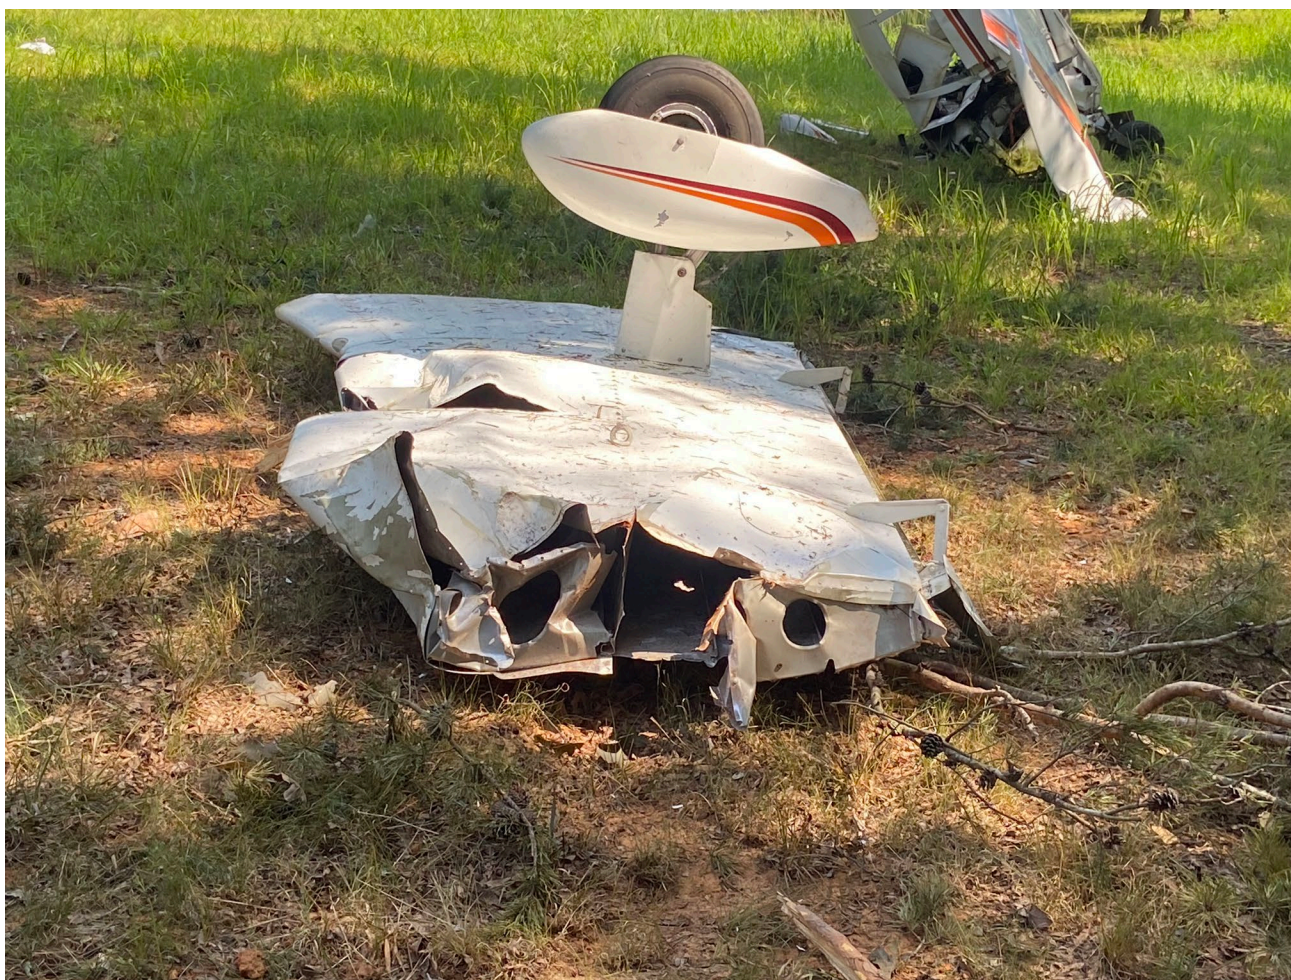
**Photograph 1 - Impact separated right wing with main wreckage in background. (Courtesy of FAA)**

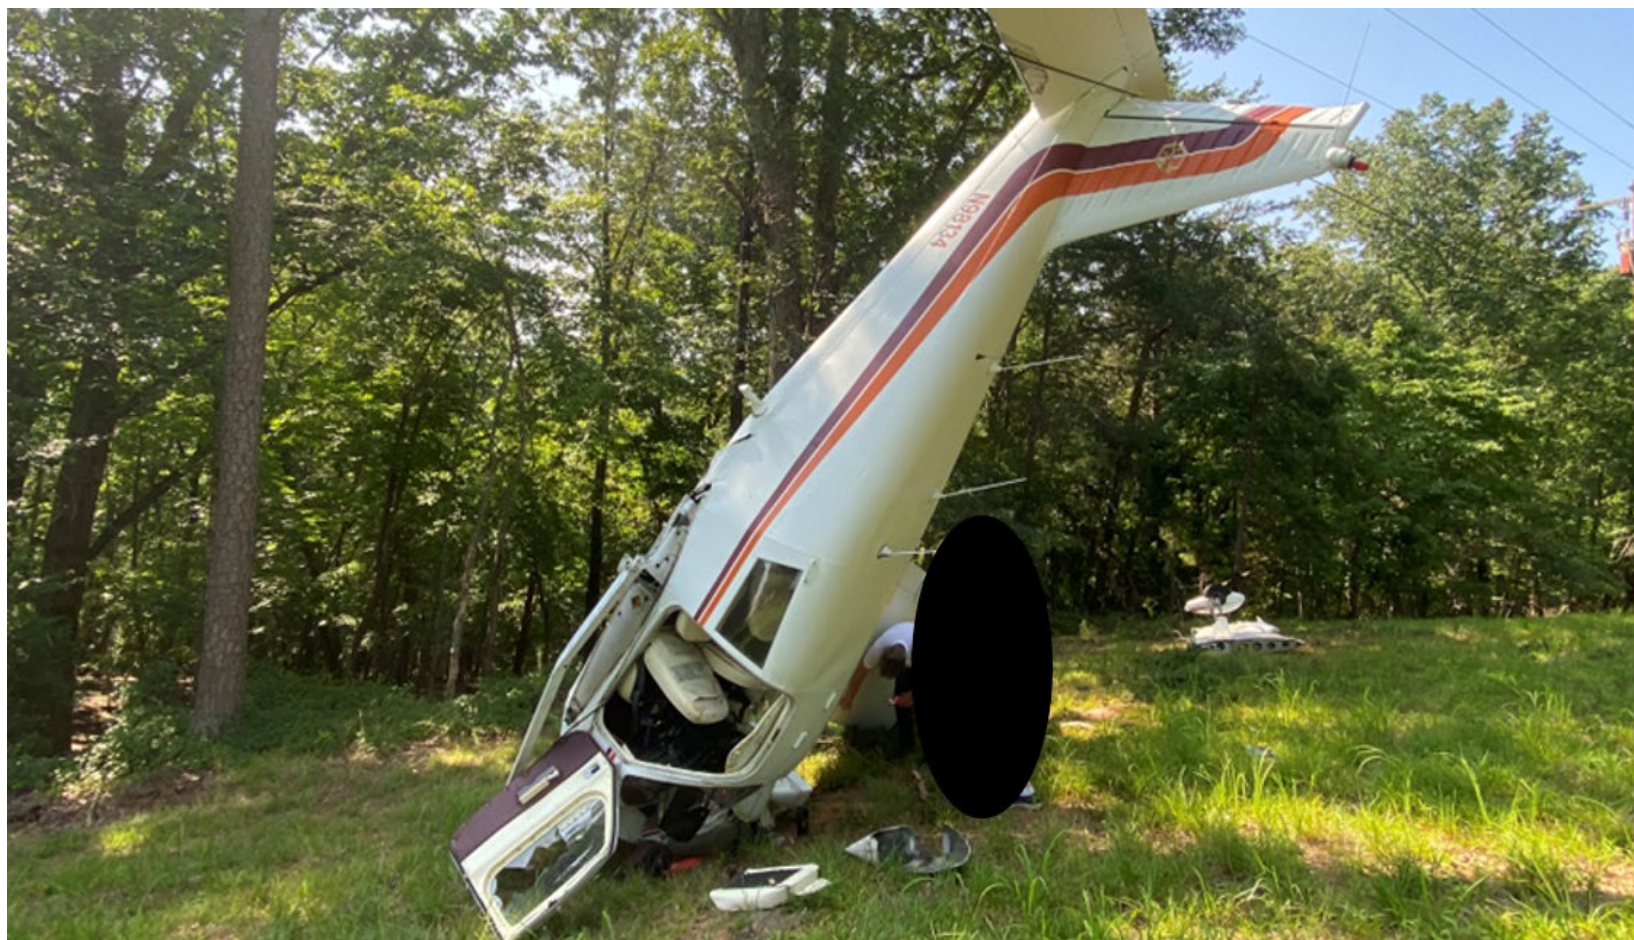
**Photograph 3 - View of wreckage as discovered. (Courtesy of FAA)**

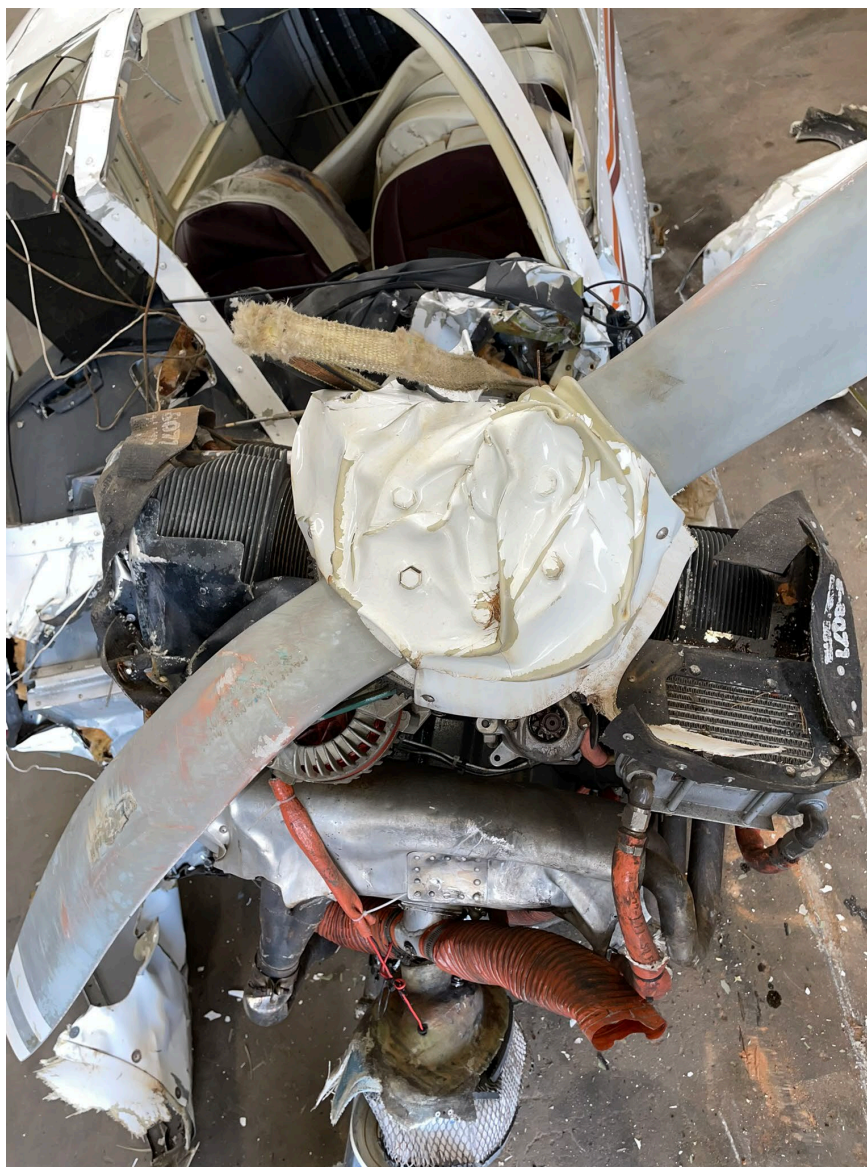
**Photograph 4 - View of propeller and spinner. (NTSB)**

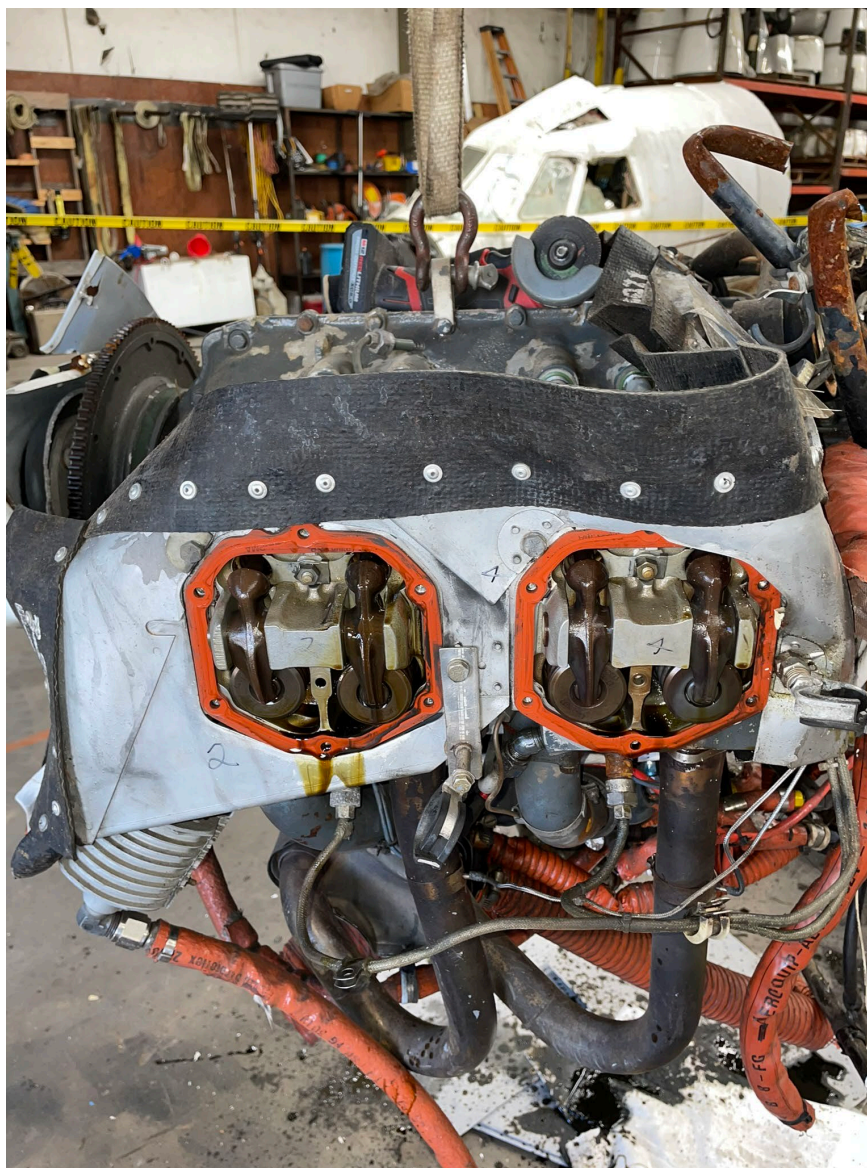
**Photograph 5 - View of Nos. 2 and 4 side with valve covers removed. (NTSB)**
