ERA23LA311

## INVESTIGATION PHOTOGRAPHS

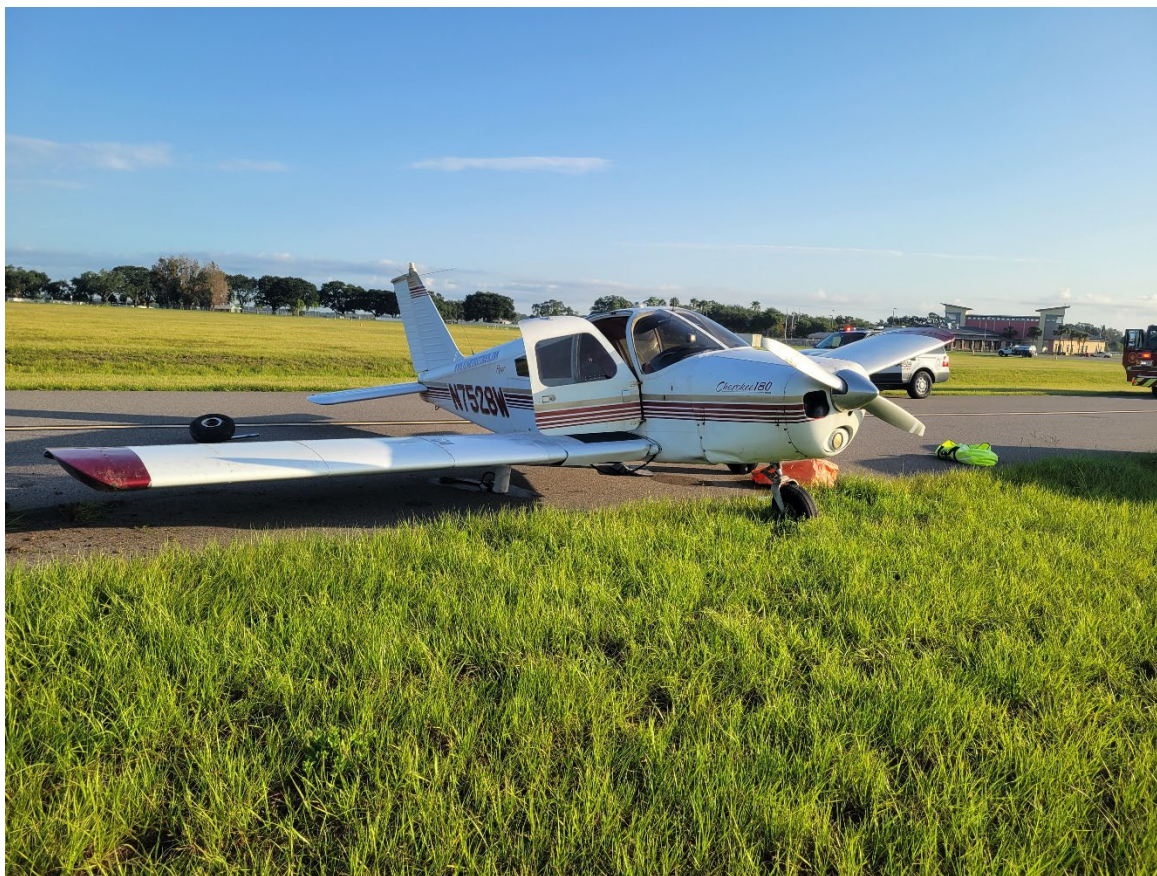
**Photograph 1 - Right side of airplane (Courtesy of FAA)**

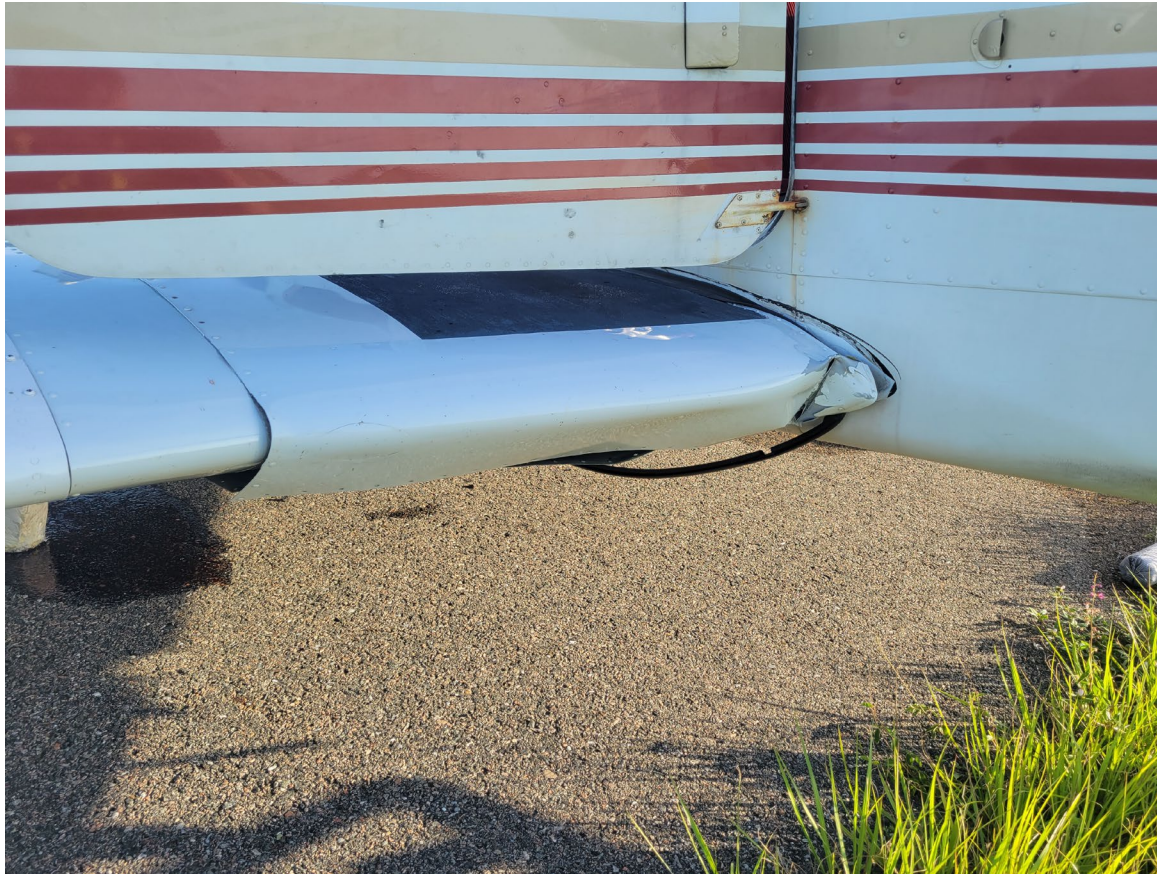
**Photograph 2 - Right wing root showing damage (Courtesy of FAA)**
