ERA23LA319

## INVESTIGATION PHOTOGRAPHS

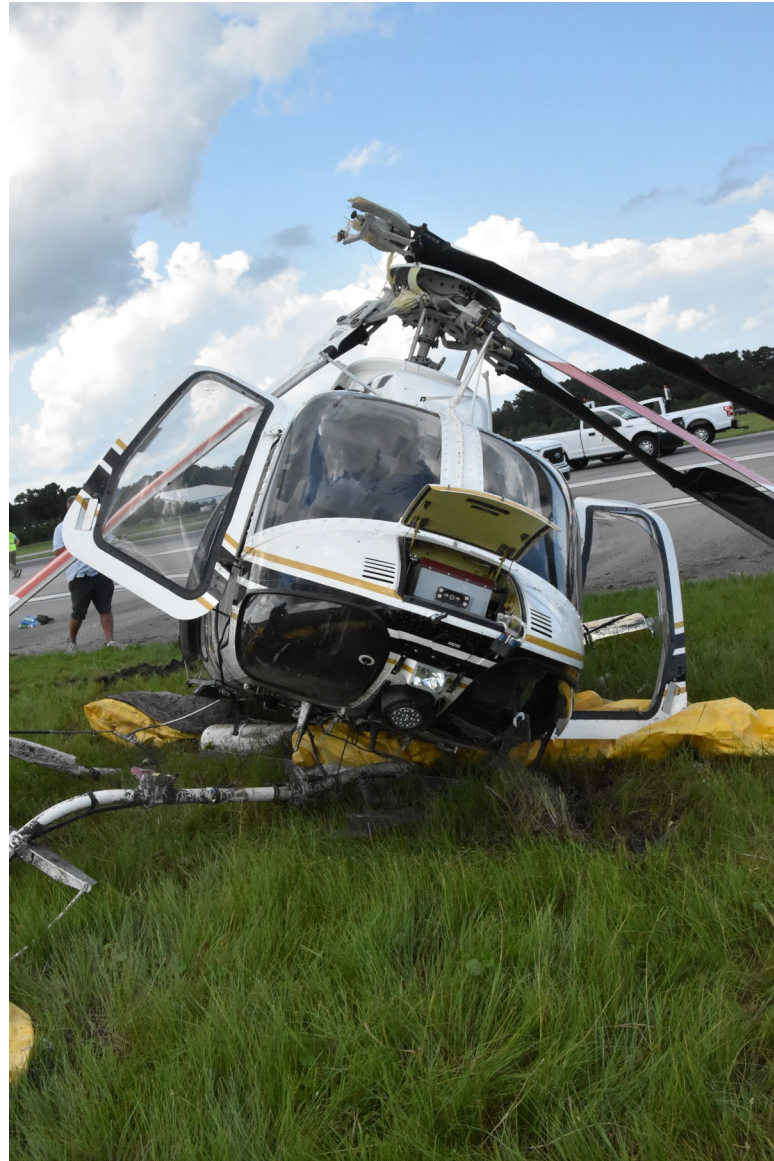
**Photograph 1 - Main Wreckage (Courtesy of FAA)**

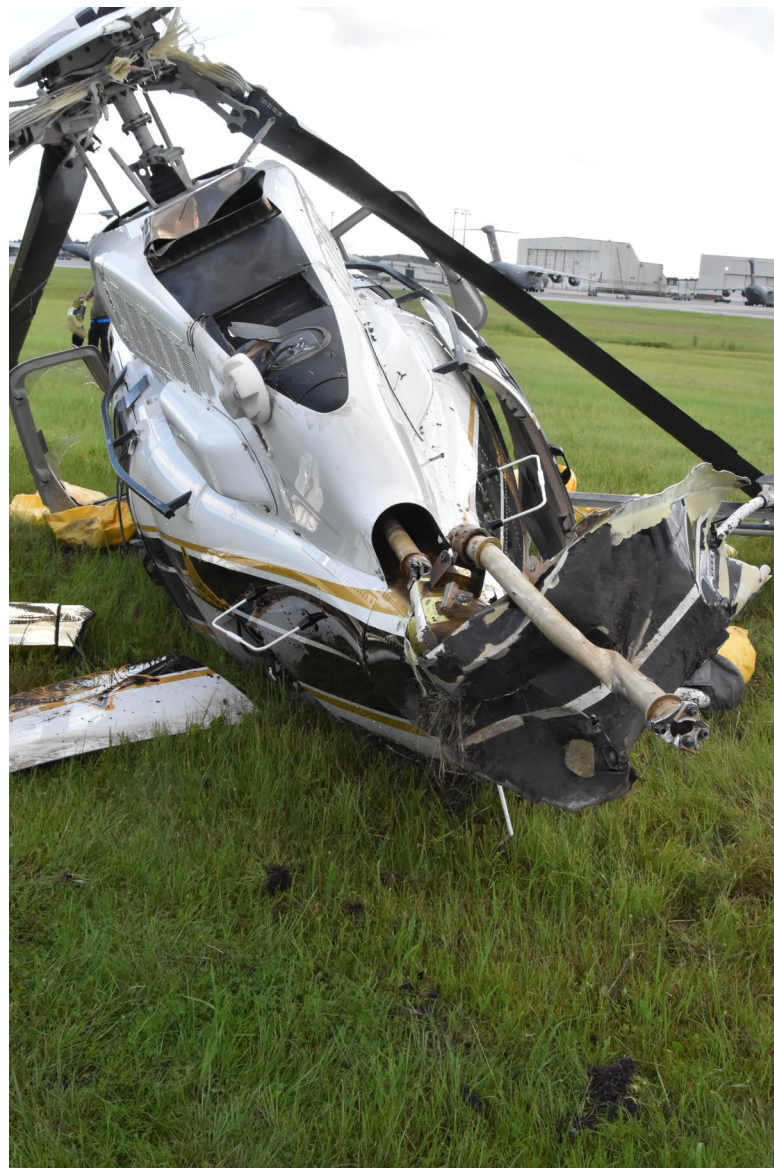
**Photograph 2 - Main Wreckage (Courtesy of FAA)**

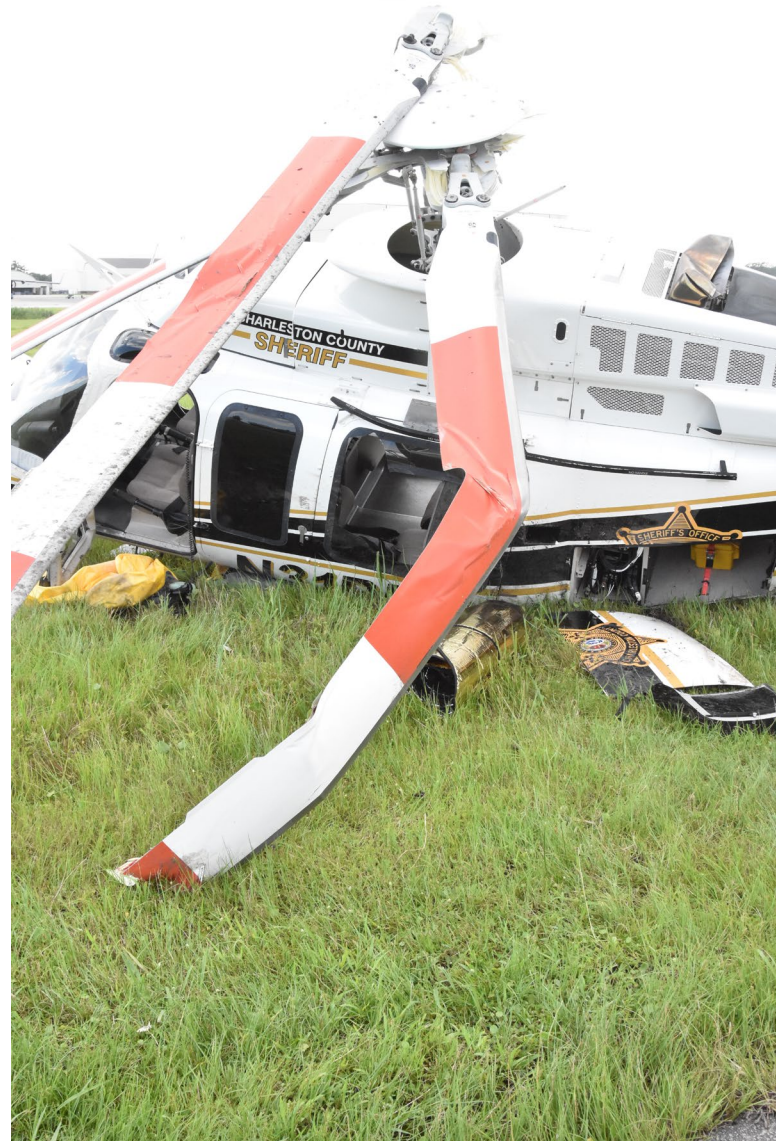
**Photograph 3 - Main Wreckage (Courtesy of FAA)**

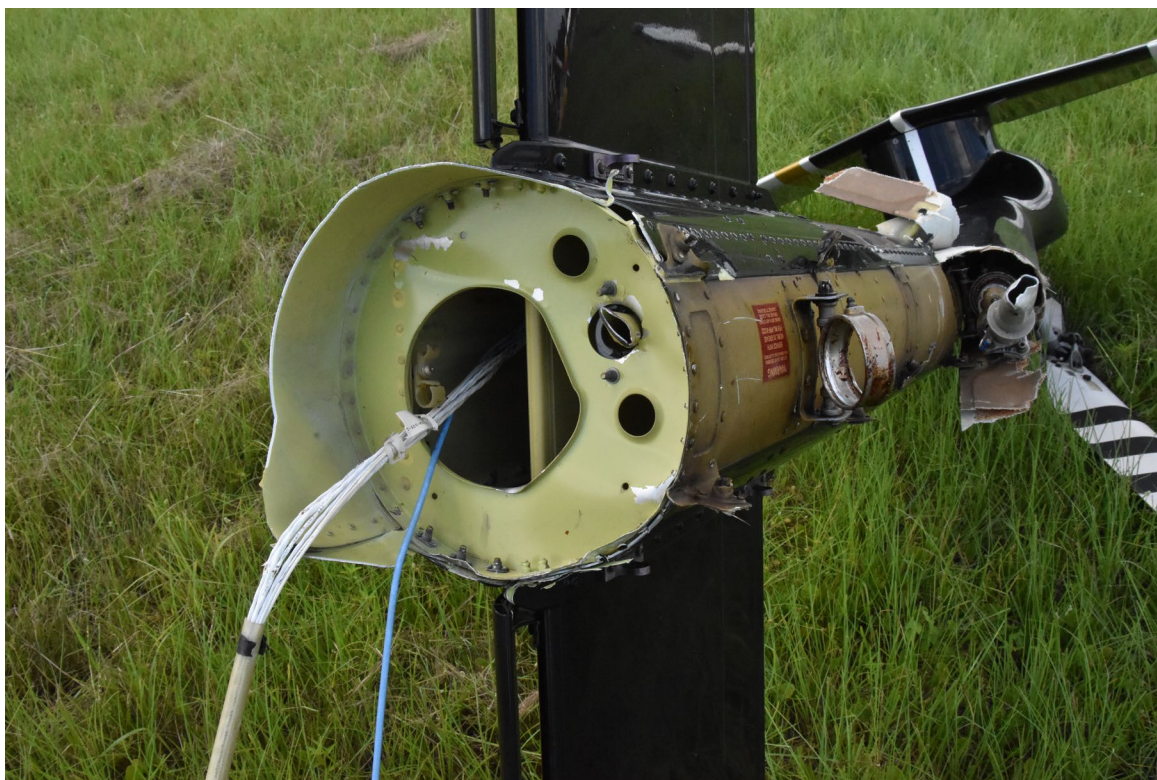
**Photograph 4 - Empennage and Tail Rotor (Courtesy of FAA)**

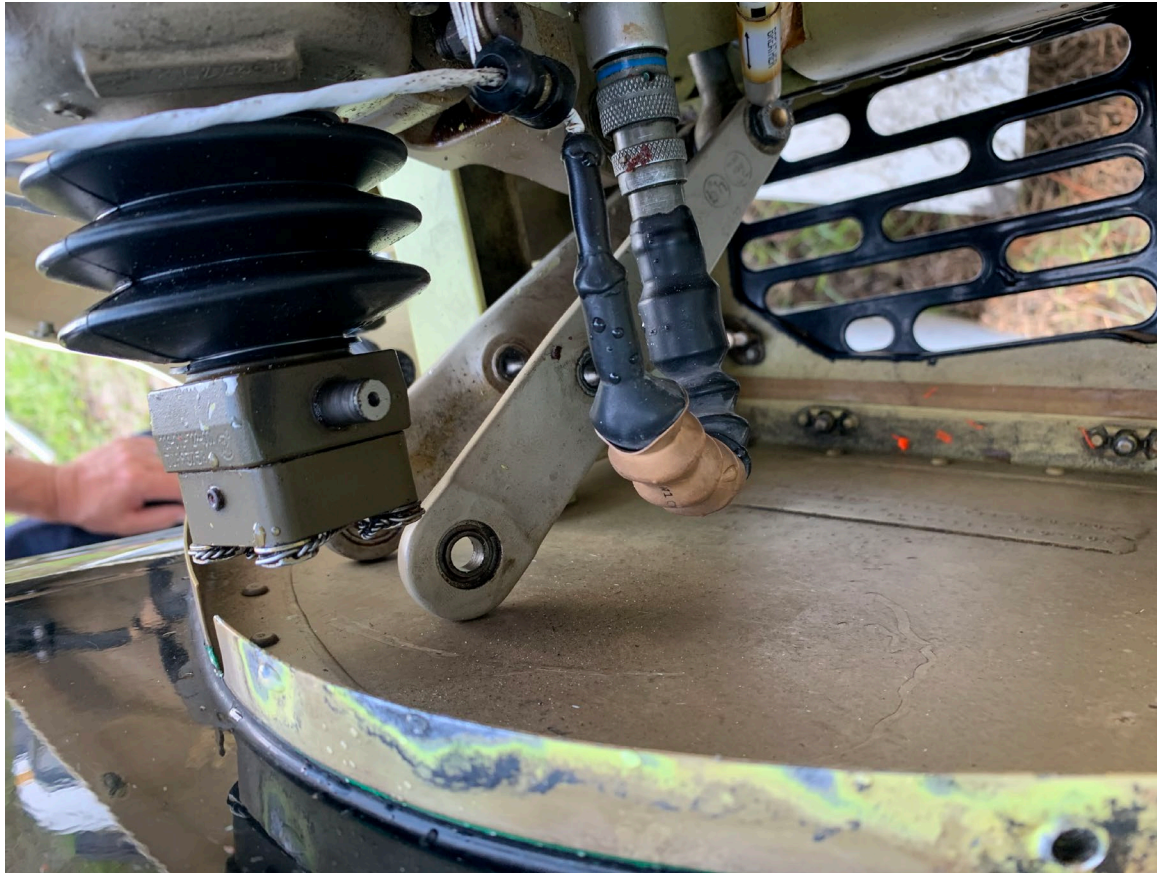
**Photograph 5 - Tail Rotor Pitch Change Trunnion and Lever Assemblies (Courtesy of FAA)**

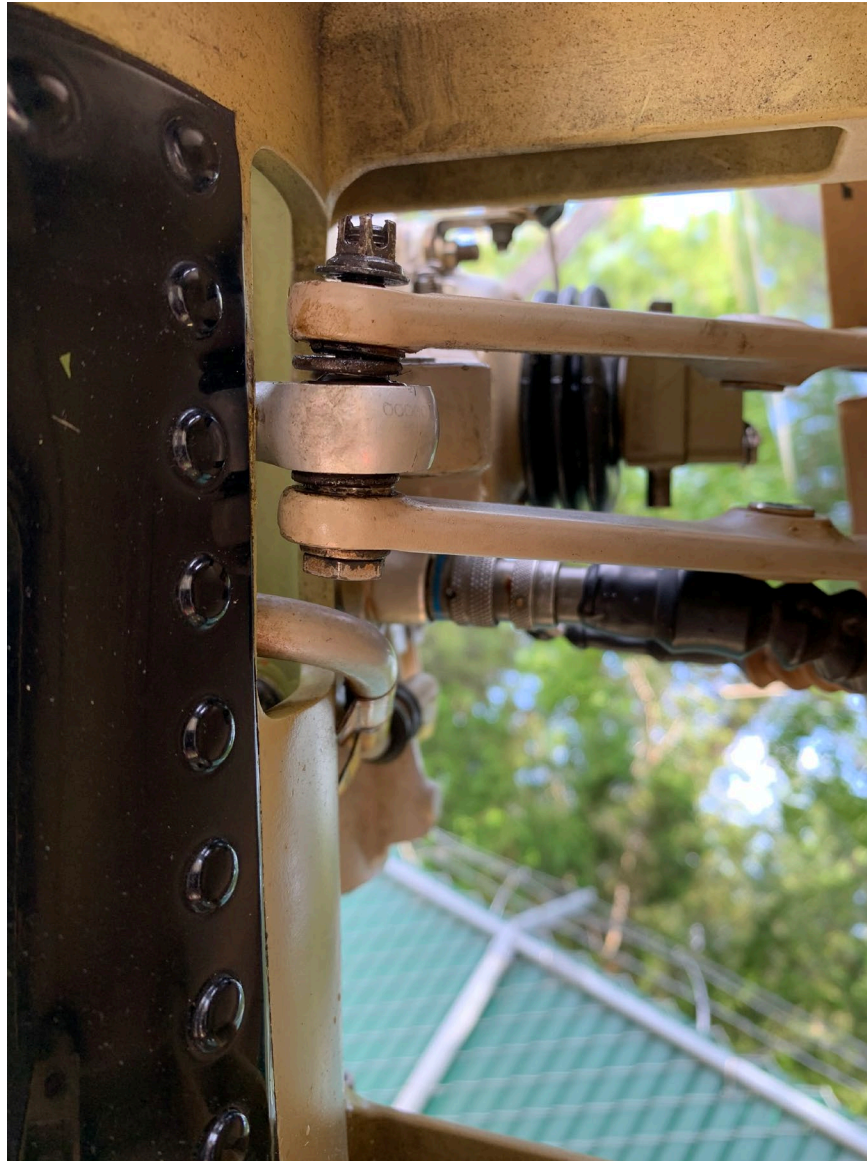
**Photograph 6 - Tail Rotor Pitch Change Trunnion and Lever Assemblies (Courtesy of FAA)**
