ERA23LA235

## INVESTIGATION PHOTOGRAPHS

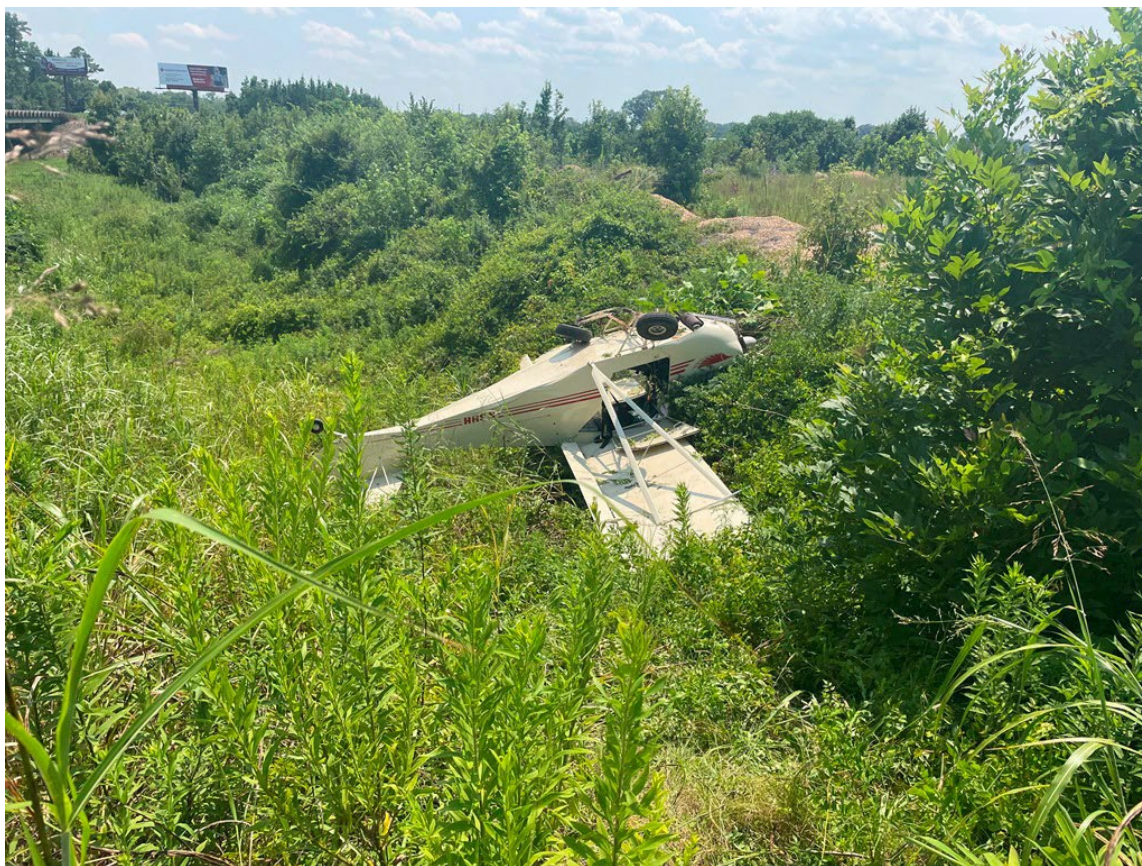
**Photograph 1 –Airplane at Accident Site Inverted (Courtesy of Tyler Hodge)**

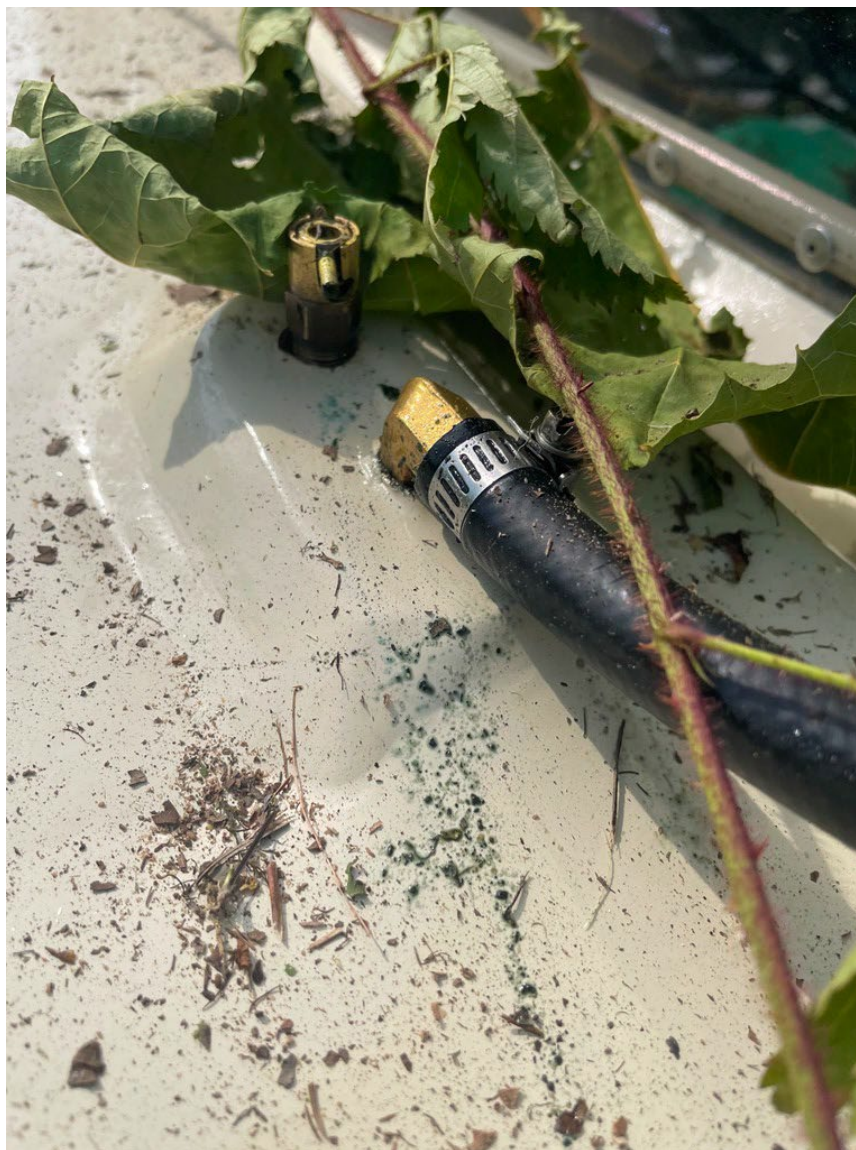
**Photograph 2 – Fuel Staining Around Fuel Drain Valve on Right Wing  
(Courtesy of Tyler Hodge)**

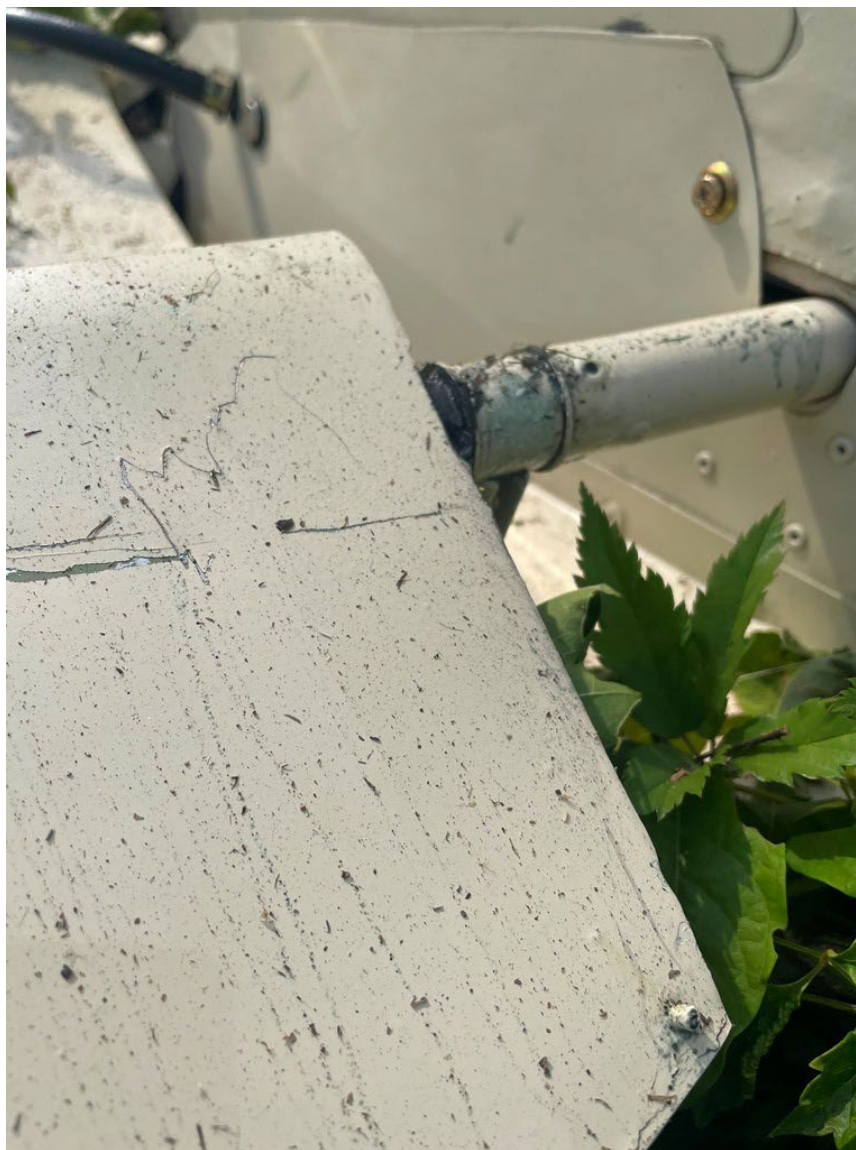
**Photograph 3 – Fuel Staining on RH Flaperon (Courtesy of Tyler Hodge)**
