# PT6A SERIES BORESCOPE REPORT

| Customer:<br>Ruhe Ag | | Work Order #<br>23-1215 | Order/Task:<br>Borescope | Date:<br>8/16/2023 | Tech:<br>Geoffrey Lance |

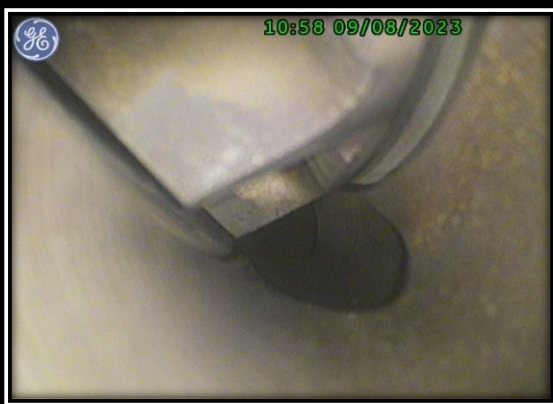
9. Centrifugal Compressor Disc. No signs of damage.

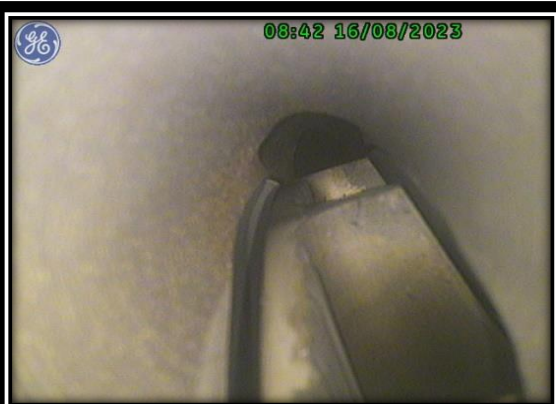
10. Centrifugal Compressor Disc. No signs of damage.

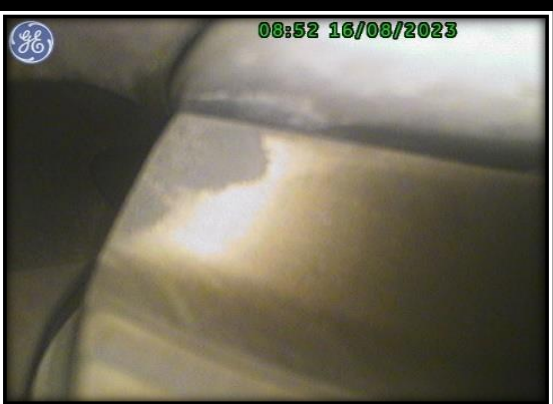
11. Centrifugal Compressor

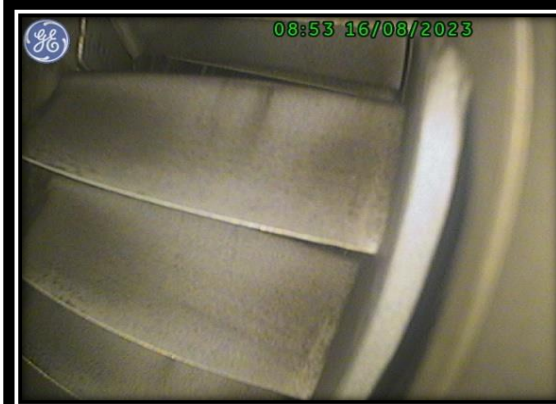
12. Centrifugal Compressor Guide Vanes

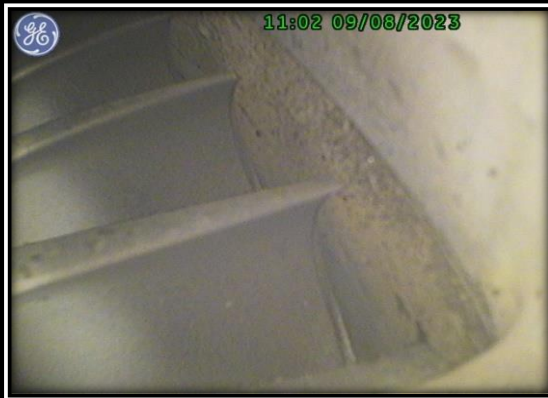
13. Compressor Turbine Blades. No signs of damage.

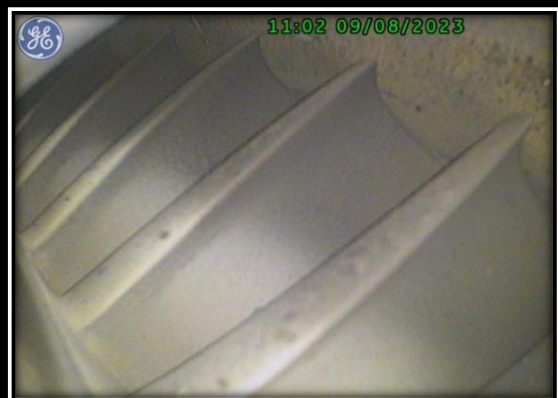
14. Compressor Turbine Blades. No signs of damage.

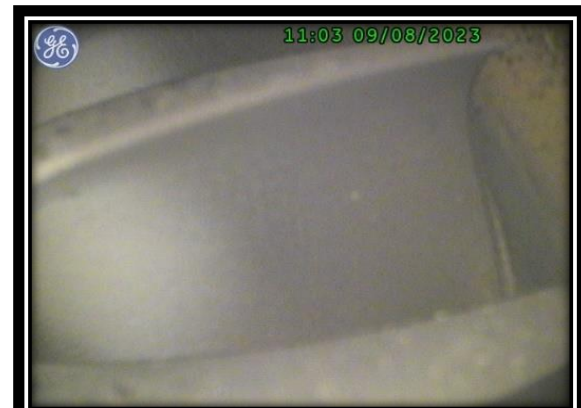
15. Compressor Turbine Blades. Bottom side of engine. Showing little to no radial tip clearance.

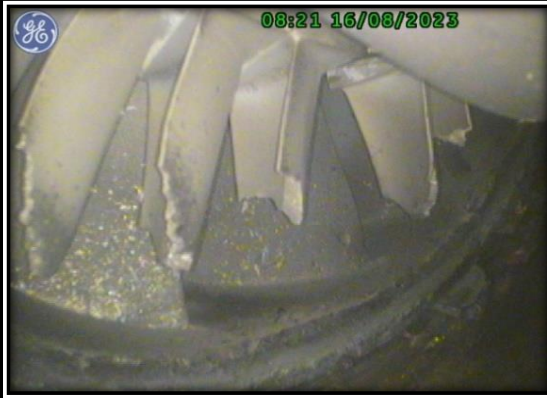
21. Power turbine blades. Heavily damaged, with breakage.

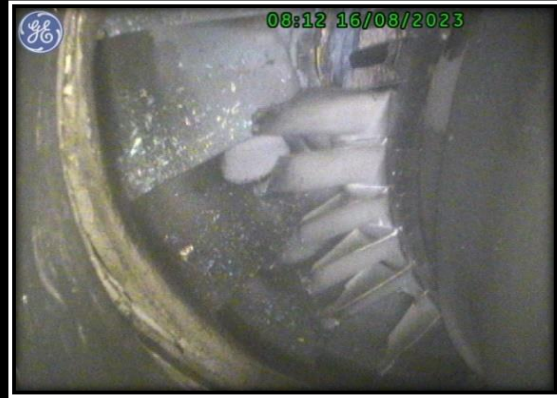
22. Power Turbine Blades. Heavily damaged, with breakage.

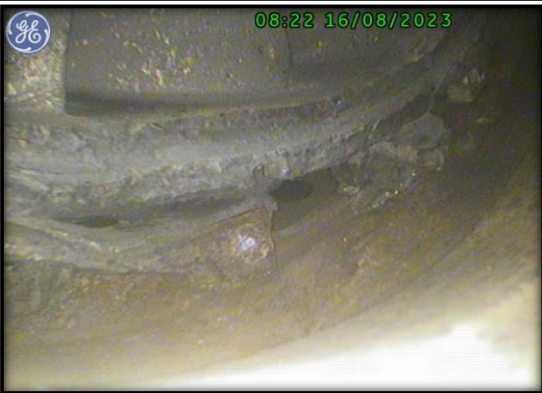
23. Power Turbine Stator and Housing. Damaged from Blade failure.

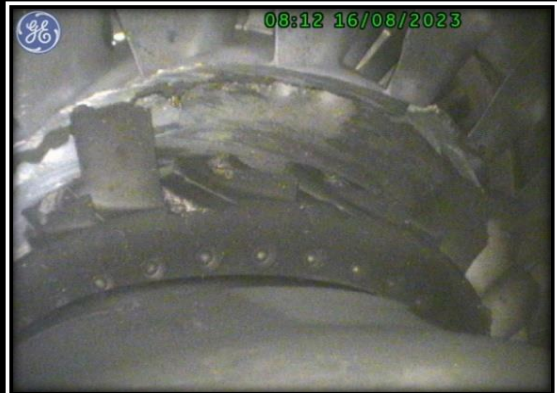
24. Power Turbine Blades and Disc. Complete Blade failure at the root/fir tree.

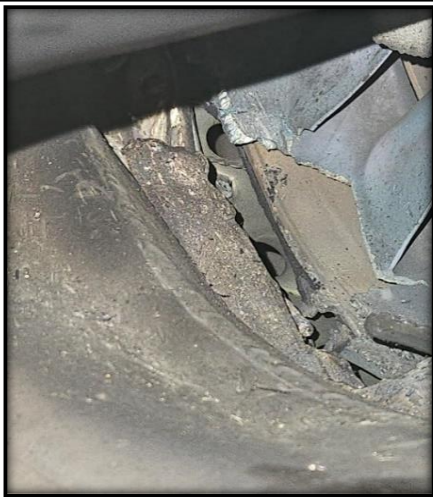
27. Damage to Exhaust Duct, PT Guide Vanes and Stator Housing.

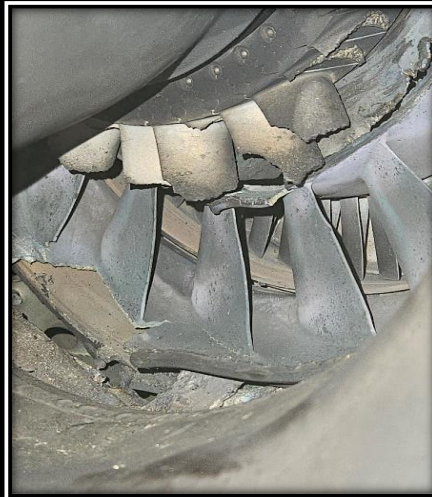
28. Damage to Exhaust Duct, PT Guide Vanes and Stator Housing.

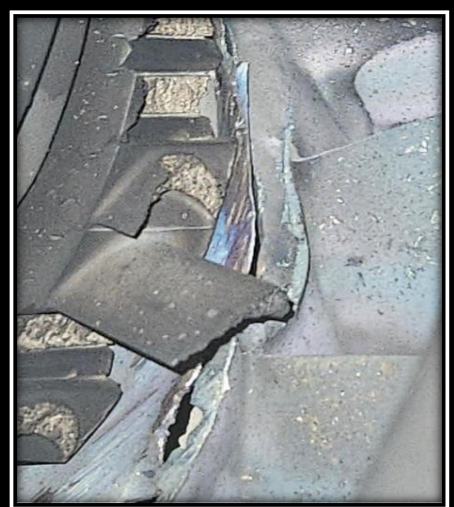
29. Close up view of Power Turbine Disc with Blades broken at root.

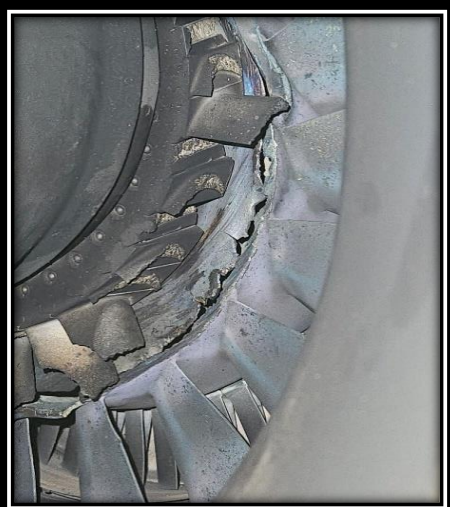
30. Close up view of Power Turbine Disc with Blades broken at root.

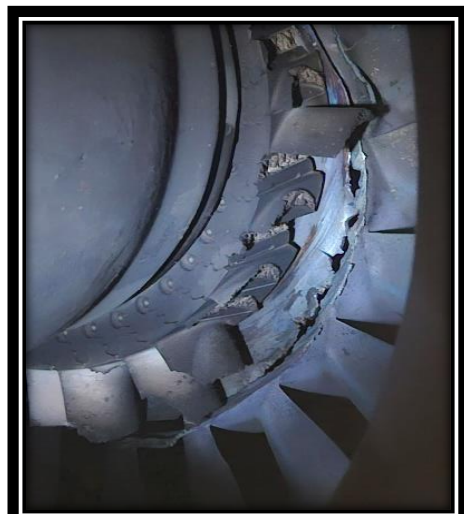
31. Broken Power Turbine Blades.

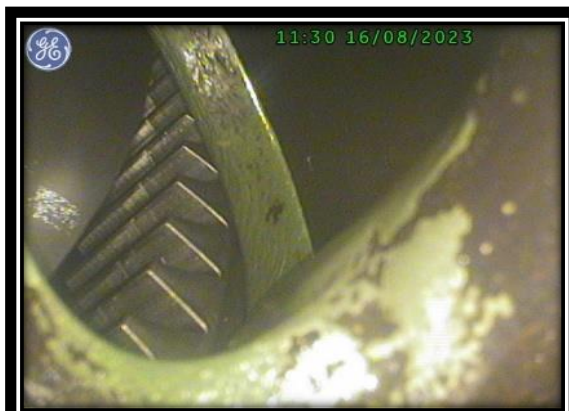
32. Second Stage Reduction Ring Gear.  
Note: At this stage in the inspection the gear box siezed and would no longer turn for the remainder of the inspection.

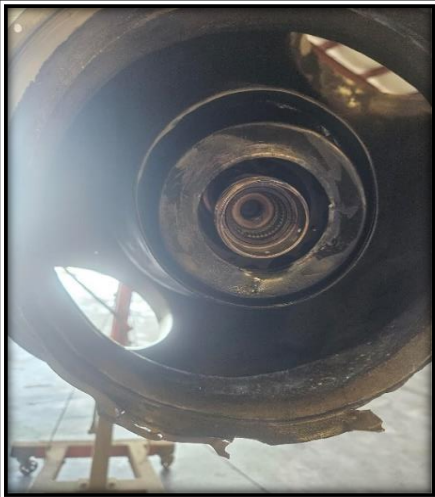
33. Picture of the 3/4 Bearing Housing. Note: in particular, a missing #3 bearing.

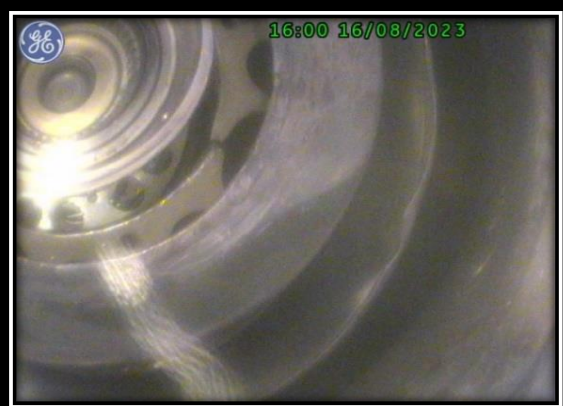
34. Damaged #3 Bearing support webbing.

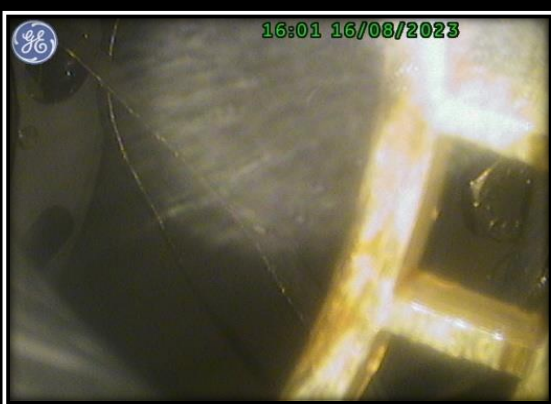
35. #3 Bearing Cage.

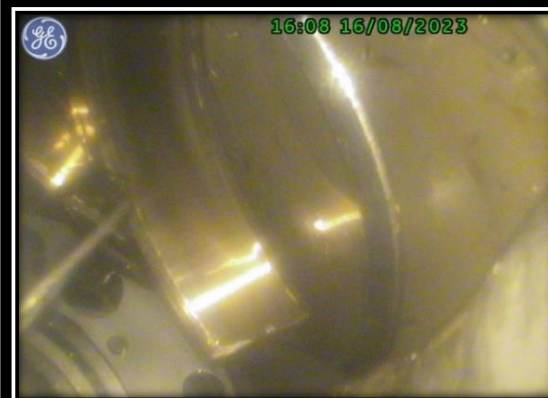
40. #3 Bearing Race. Note: Broken in half.

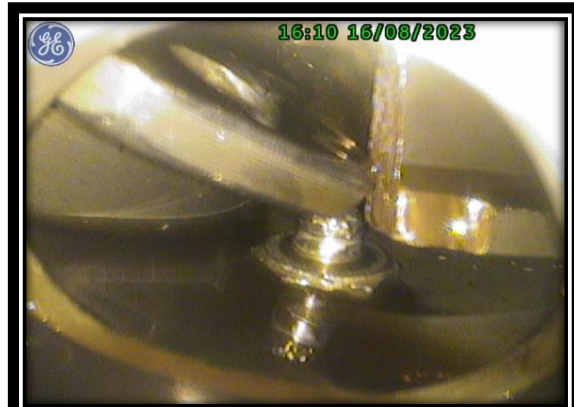
42. #3 Bearing Bolt, sheared, and broken Race.

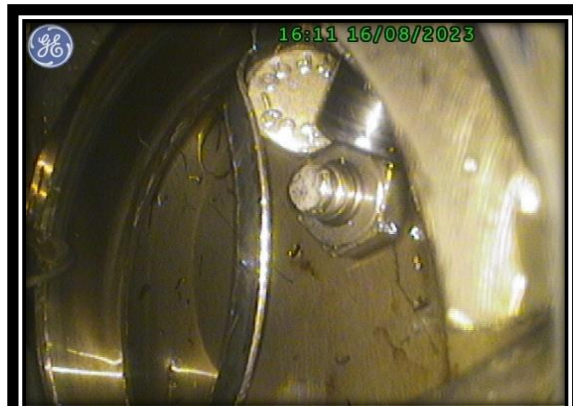
43. #3 Bearing Race. Sheared bolts. Roller Bearing and possible Retaining Ring from Flex Coupling.  
Note: Images of #3 Bearing Roller and Race does not show indication of oil starvation type bearing failure.

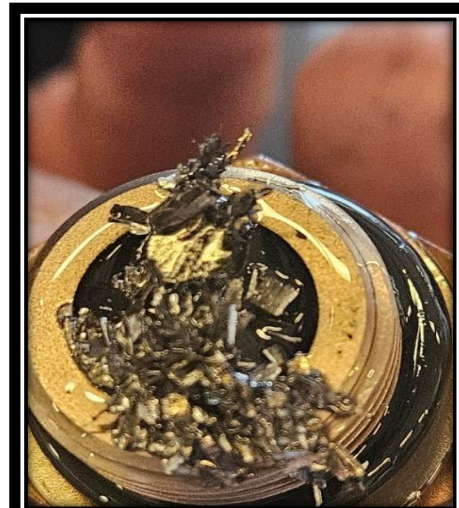
44. Reduction Gear Box chip detector.

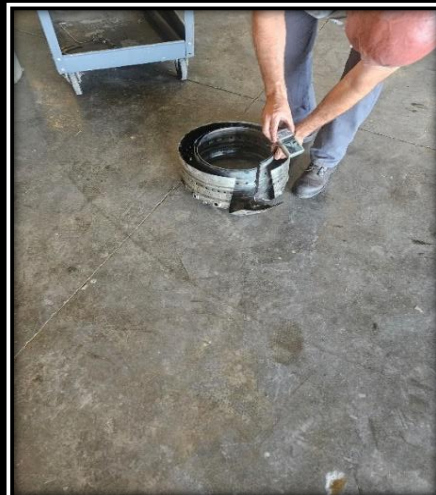
46. Steve Vilimonovic inspecting  
the Combustion Liner. Liner had  
to be cut off with saw due to  
heavy damage and warping  
encountered as a result of blade

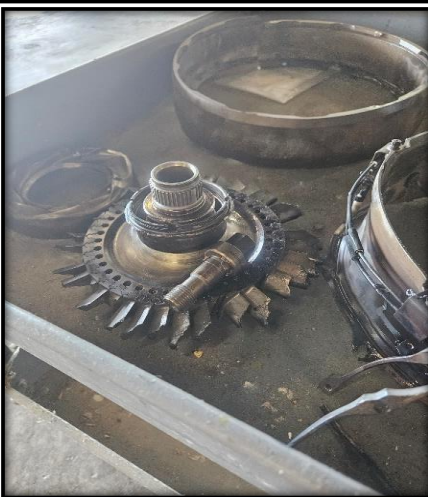
47. Power Turbine Disc and  
Blades, as removed.  
Note: Retaining Bolt was properly  
crimped at time of removal and all  
Blade retaining rivets were  
installed and tight.
