# Investigator notes

USA (Leipsic, OH) Air Tractor AT502B N5048S engine fire 04 August 2023. 1954 eastern daylight time, an Air Tractor AT-502B, N5048S, was substantially damaged when it was involved in an accident near Leipsic, Ohio. The pilot was not injured. The flight was operated as a Title 14 Code of Federal Regulations Part 137 aerial application flight. The pilot had been applying fungicide to several fields, during which he noted no engine performance anomalies. Shortly after starting the second spray run in a field, he heard a pop sound. He saw flames coming out of the engine exhaust stacks and the engine stopped producing power. He performed a forced landing to a neighboring field and the airplane ground-looped in the high crops. Examination of the wreckage by a Federal Aviation Administration inspector revealed that the airplane came to rest upright with substantial damage to the left wing. The NTSB is investigating.

WO 23-1215 reviewed

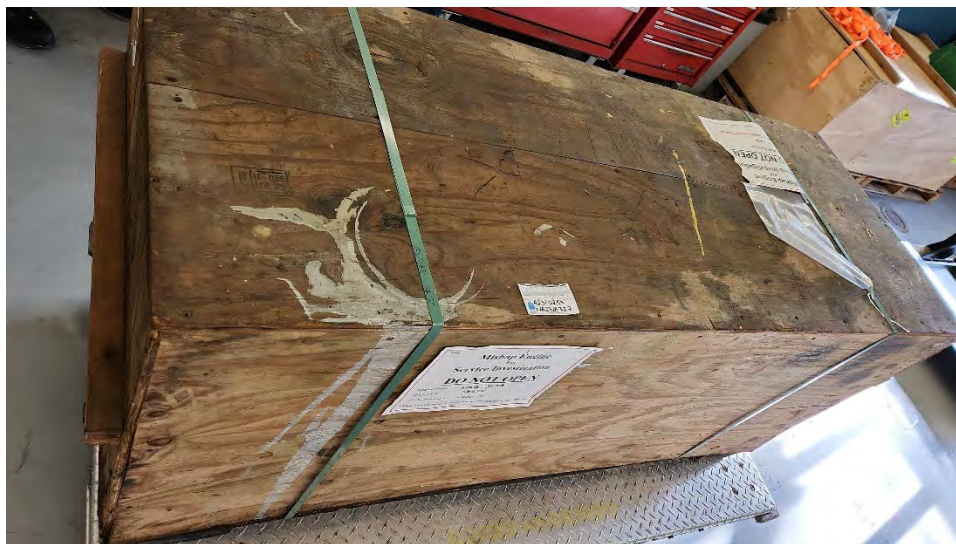
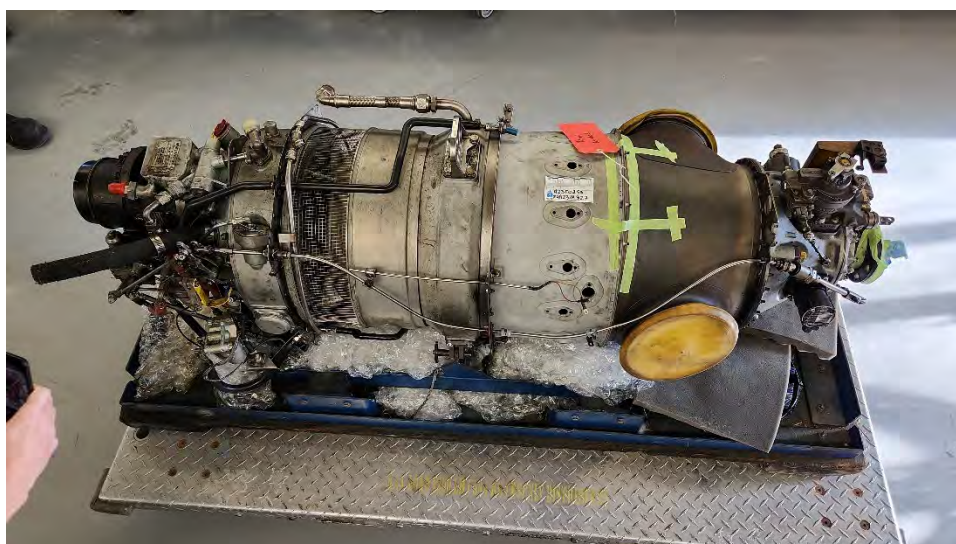
Casing split on c flange. Combustion can liner found missing from shipment

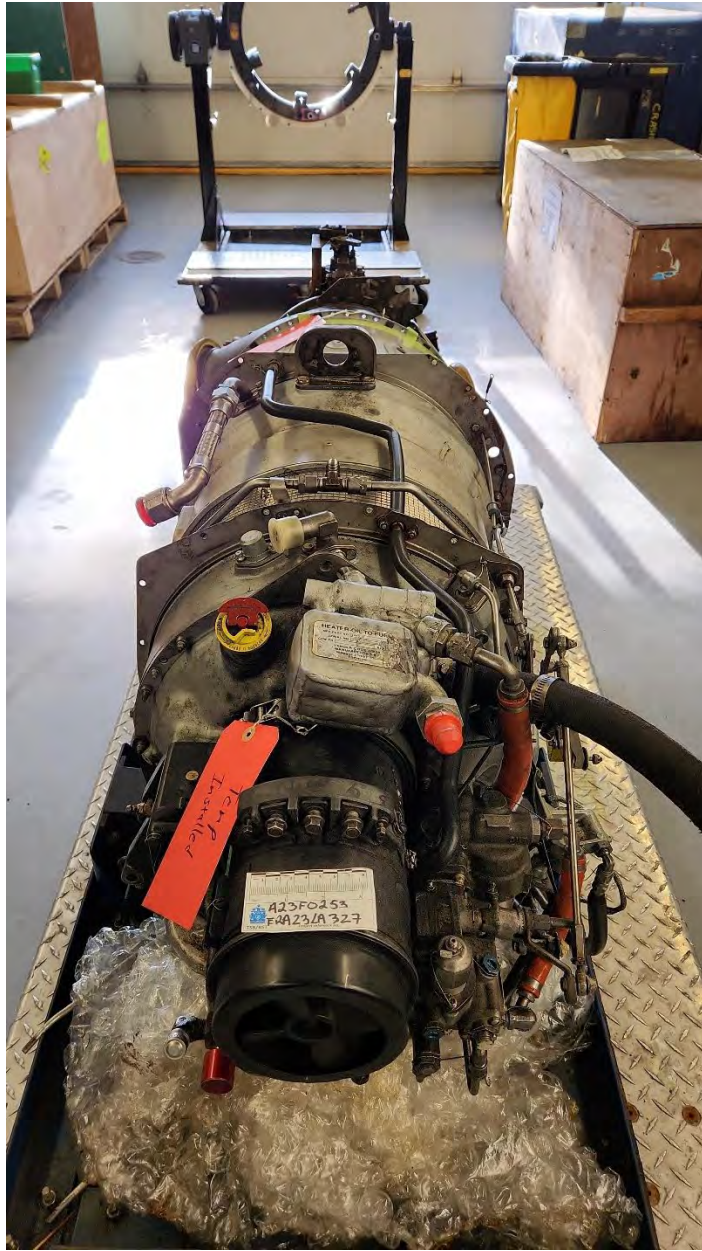
Group picture of all parts received

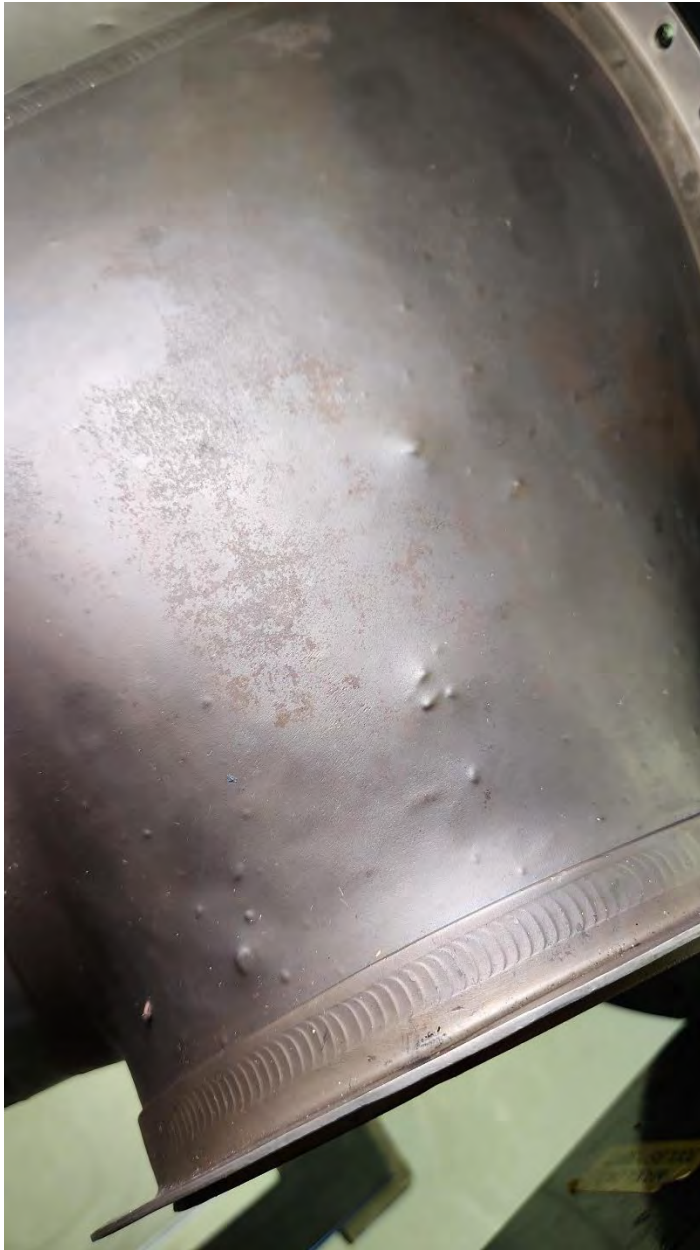
Dimple damages from departing PT blades

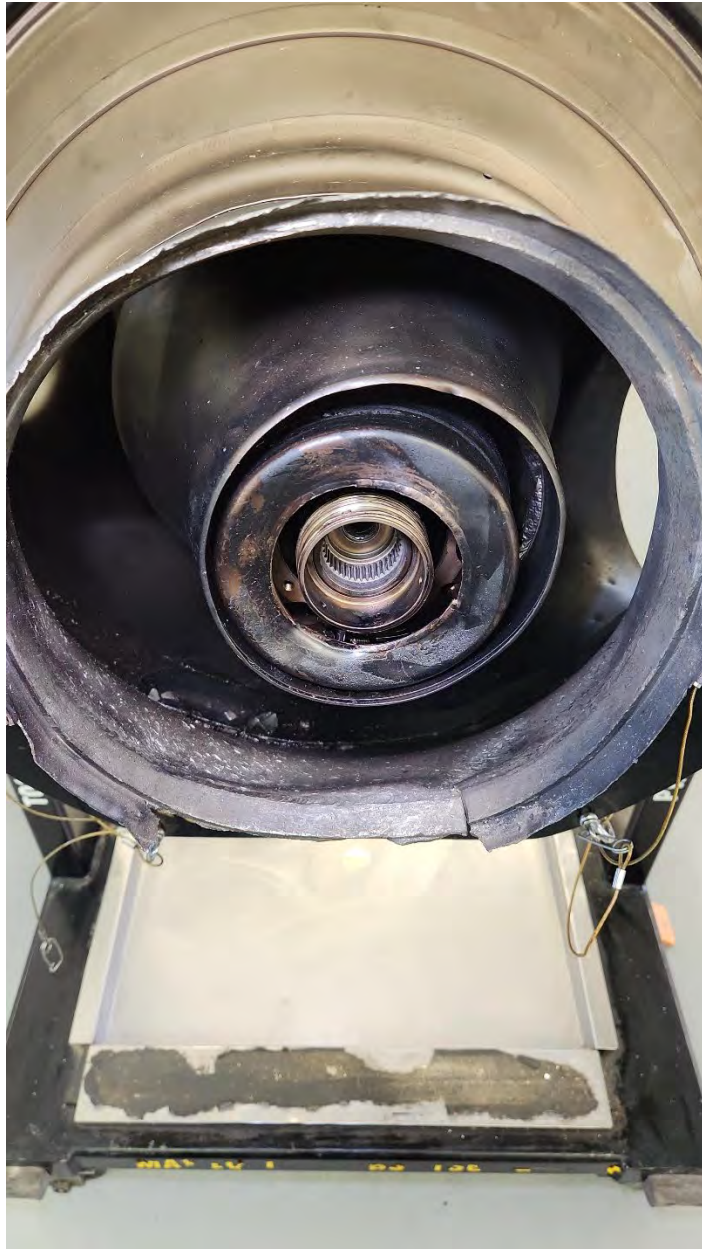
PT shaft forward looking

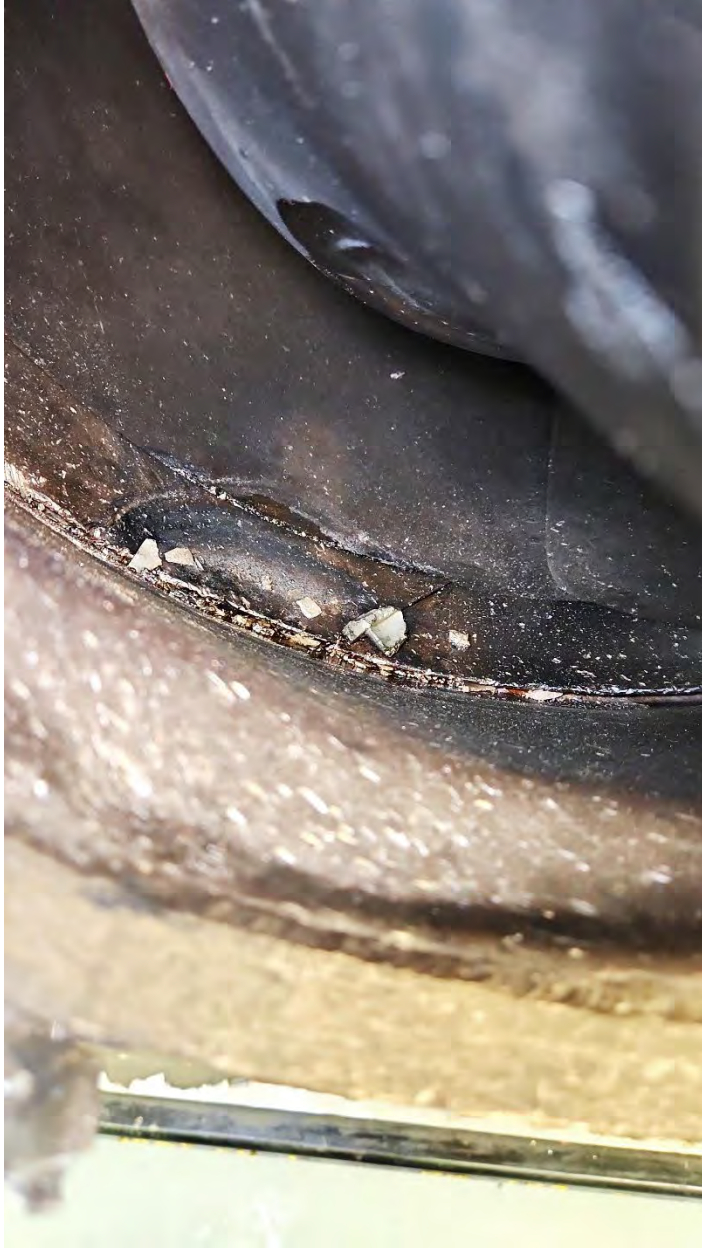
FOD in exhaust

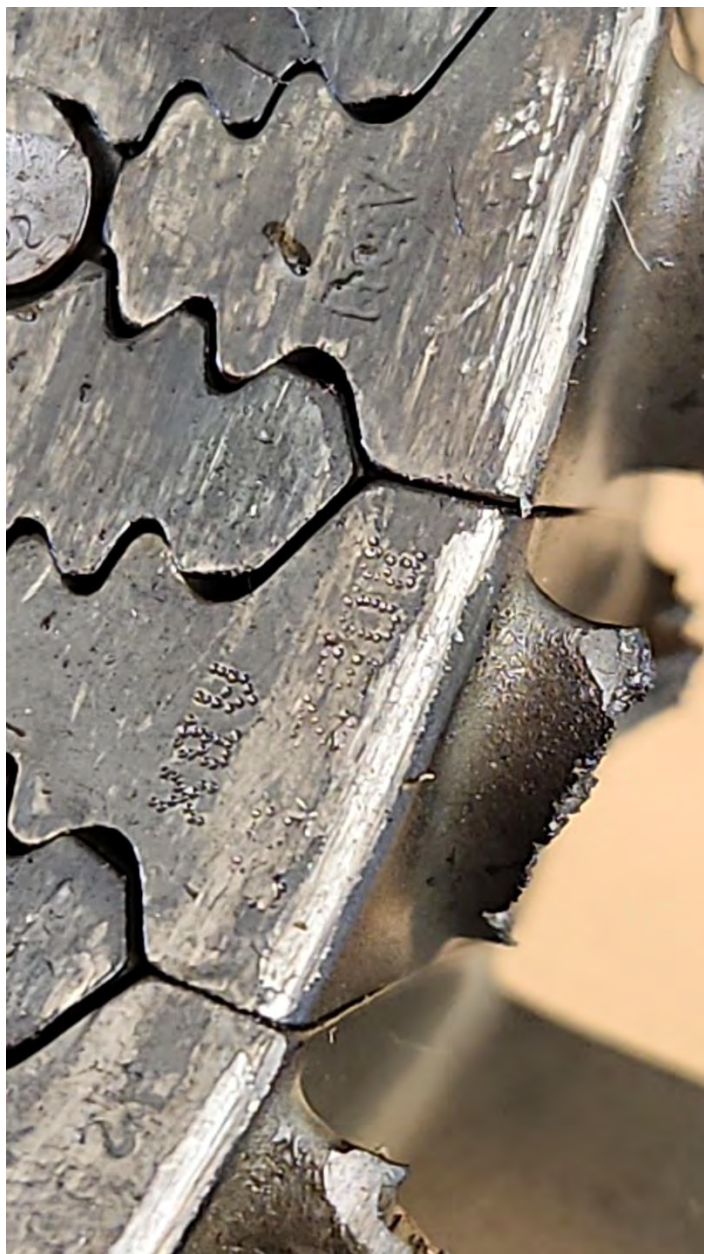
Casting number on PT blades

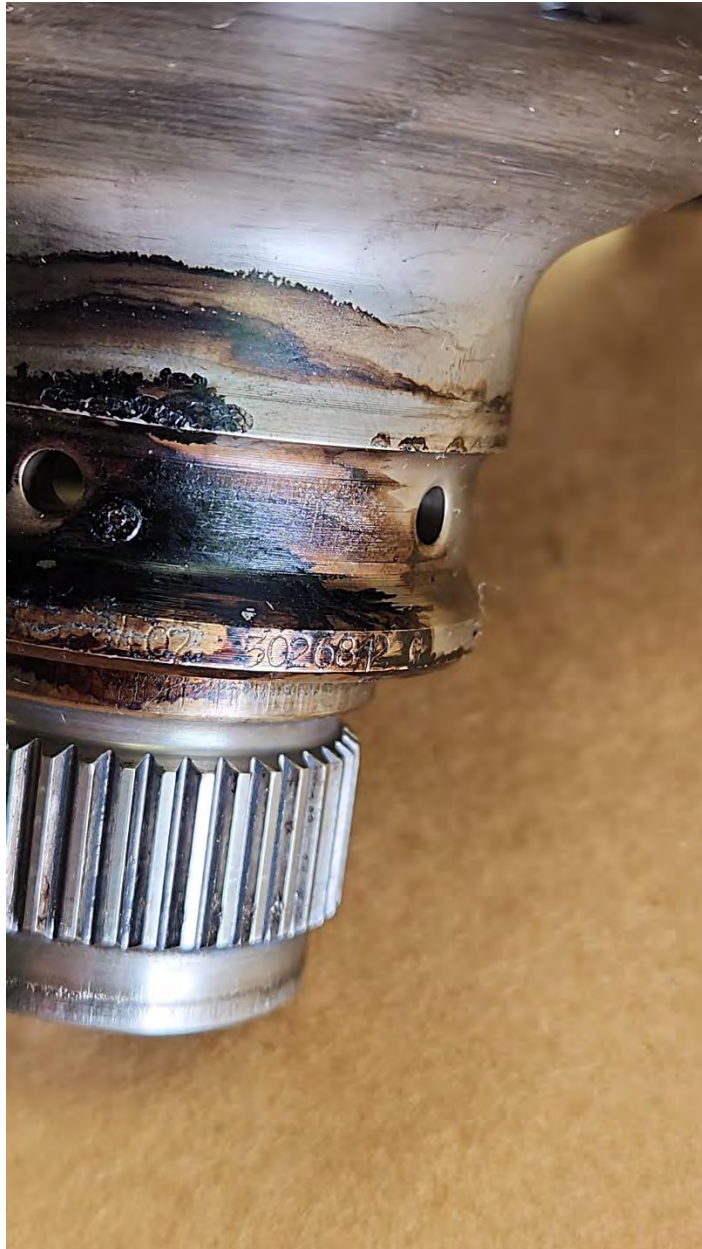
PT wheel part number

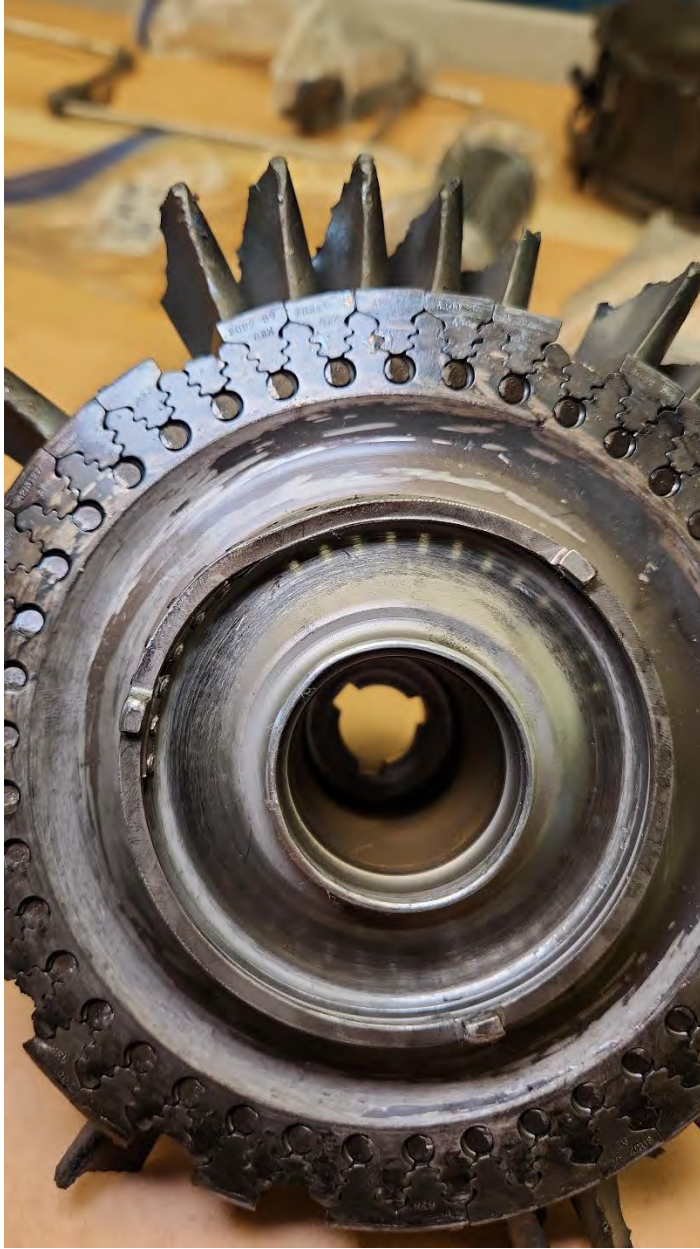
PT Wheel deformation

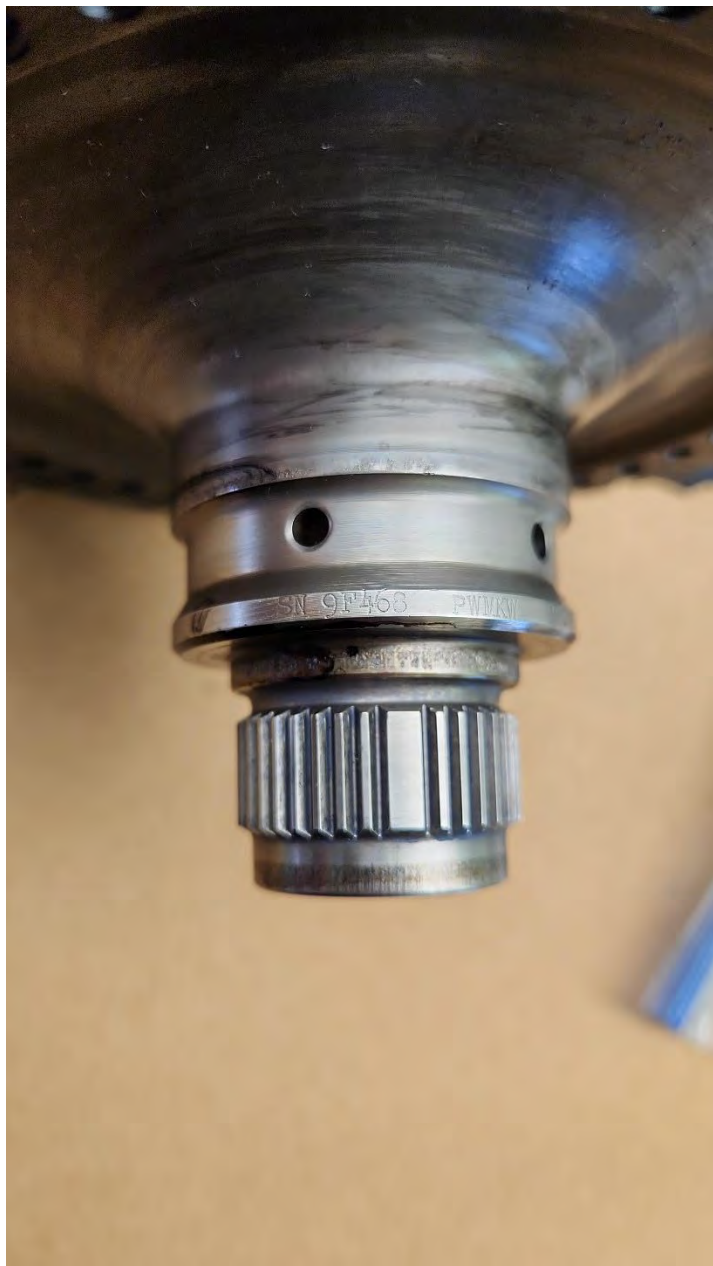
PT wheel SN

Blade part number AE 3013102T. All blades will need to be removed from disk, analyzed and PN verified

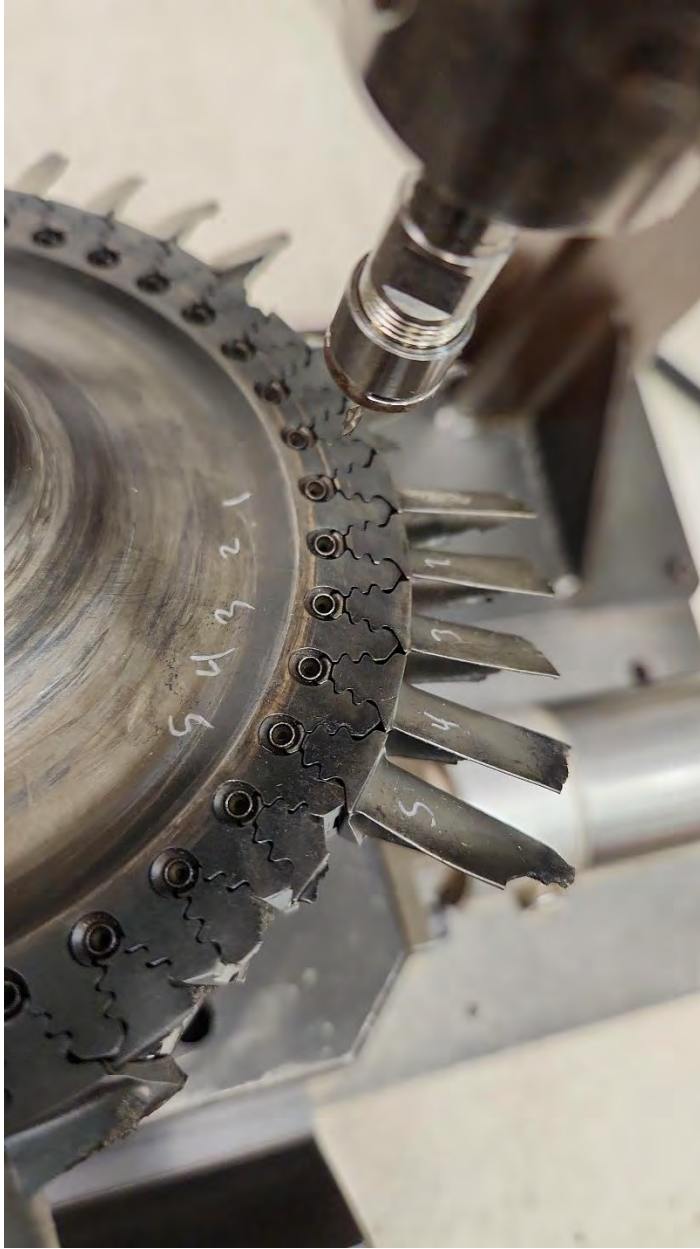
5 blades were removed to confirm part numbers. Blades were identified.

Information from blade provenance. The prefixes AE means it comes from an approved PWC vendor in UK

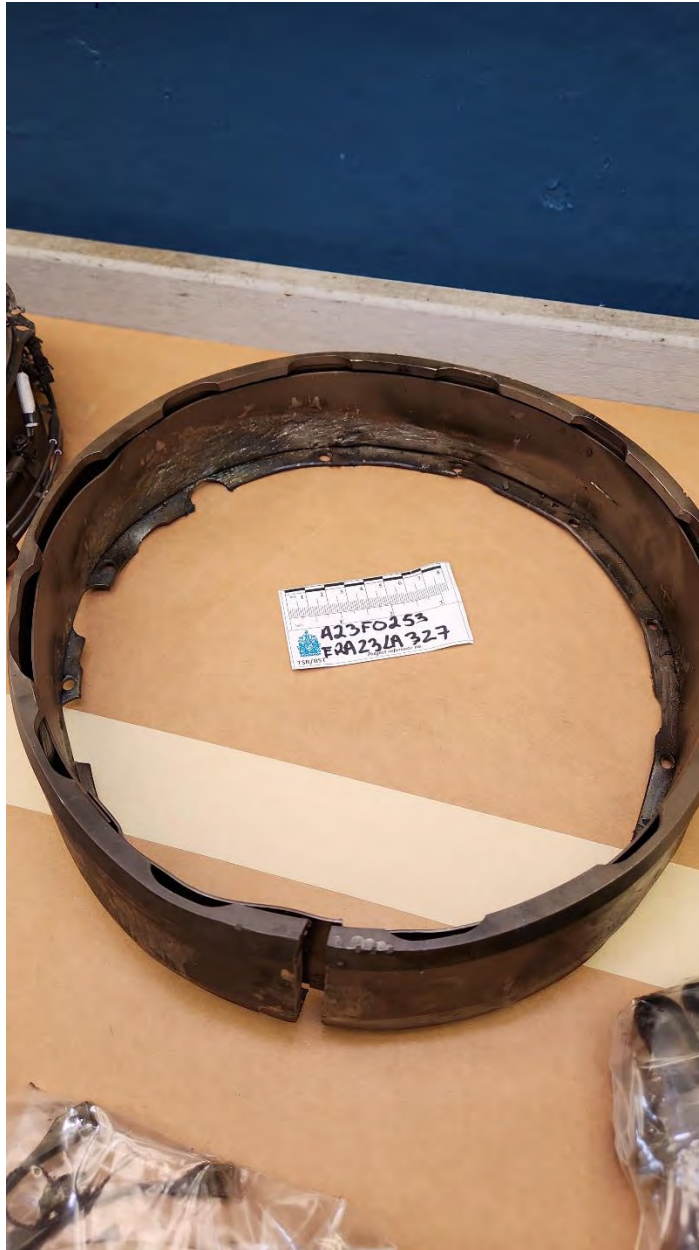
Departing blades impact marks

Ovalized shape of PT shroud

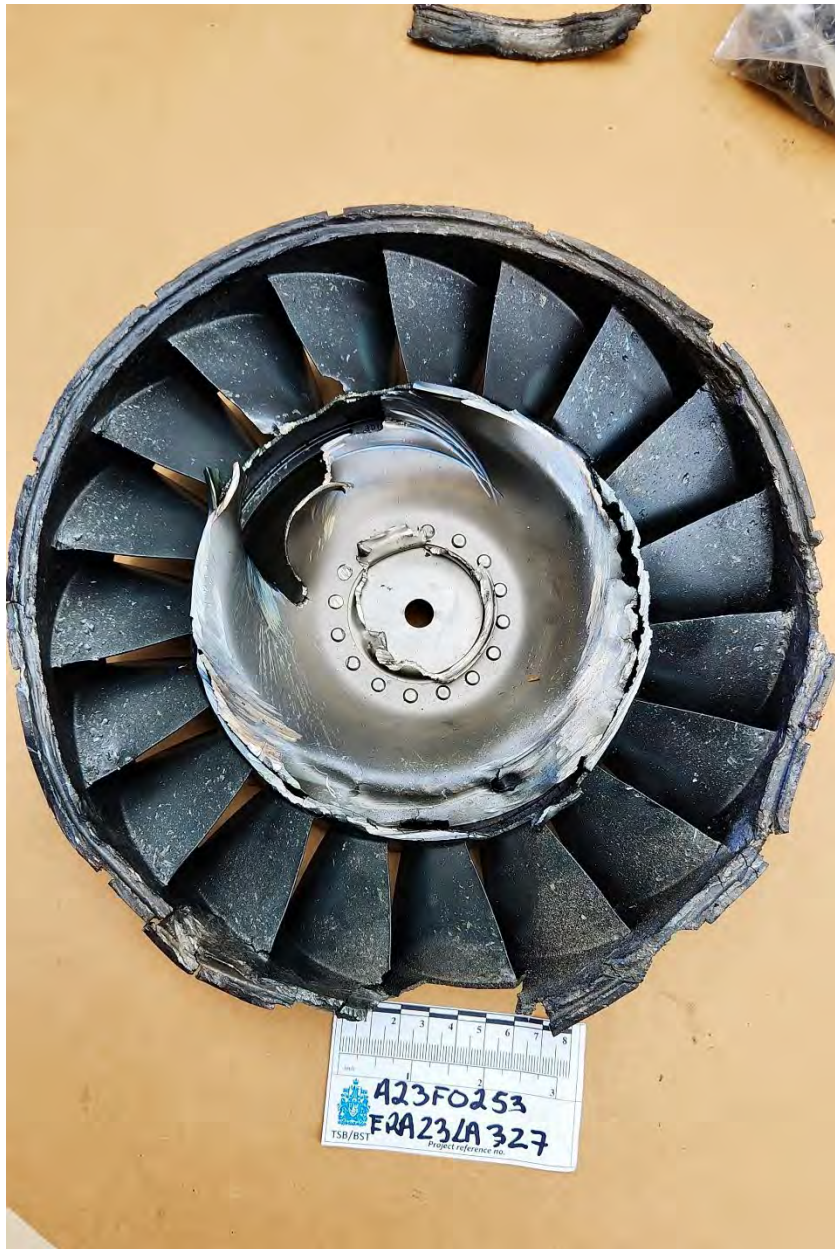
Stator vanes between CT and PT seen from trailing edge with damages on PT side

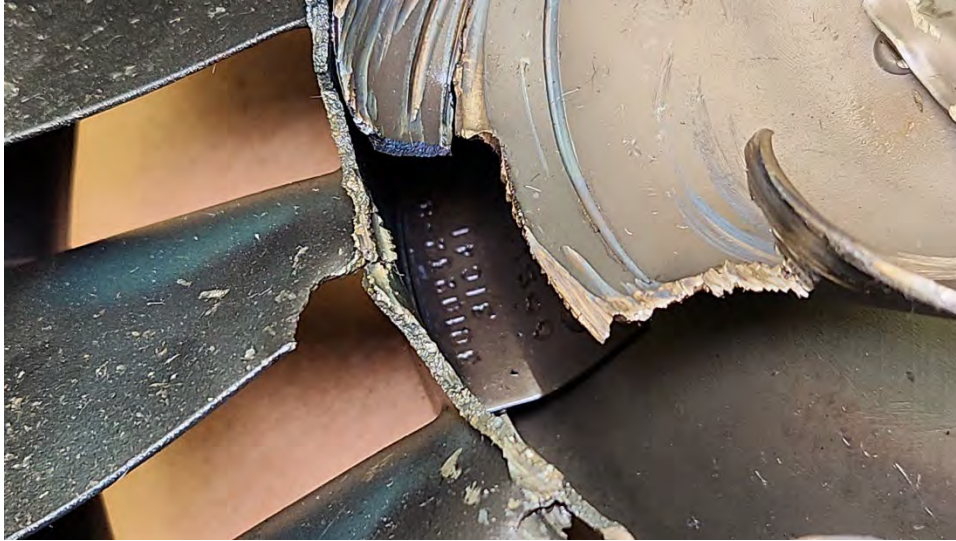
Interstage baffle inner part number

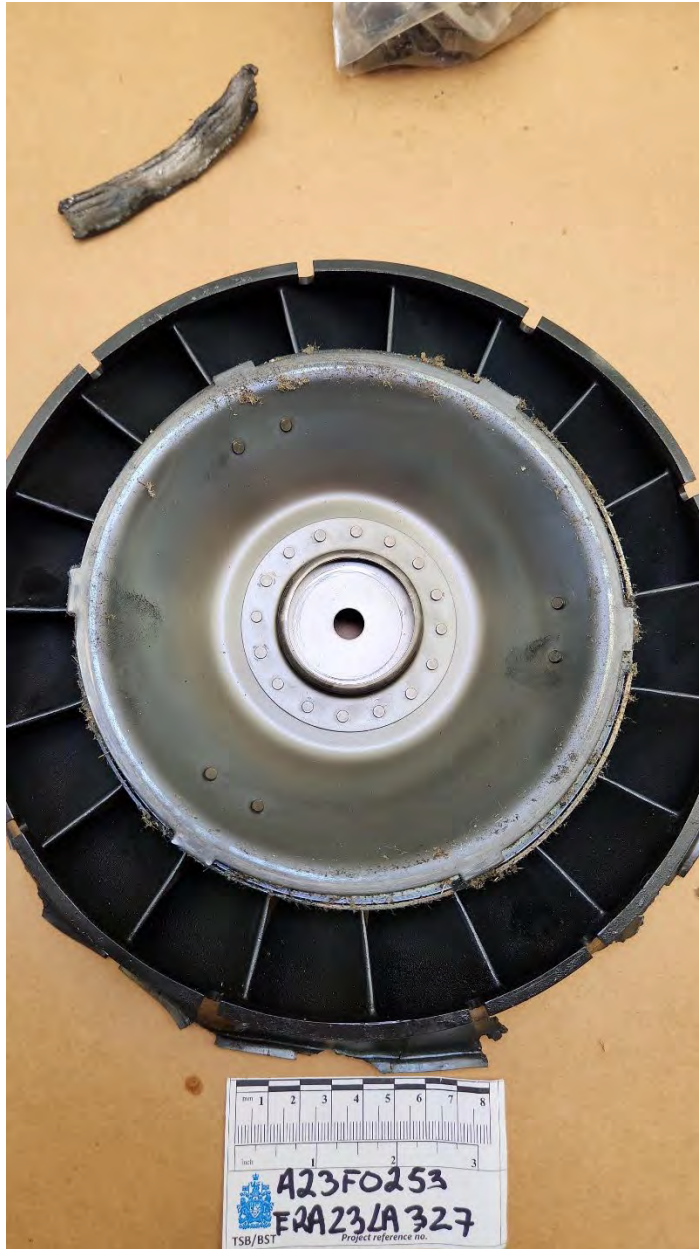
Leading edge's view (center part show evidence of rotational signature with CT disk due to rubbing evidence)

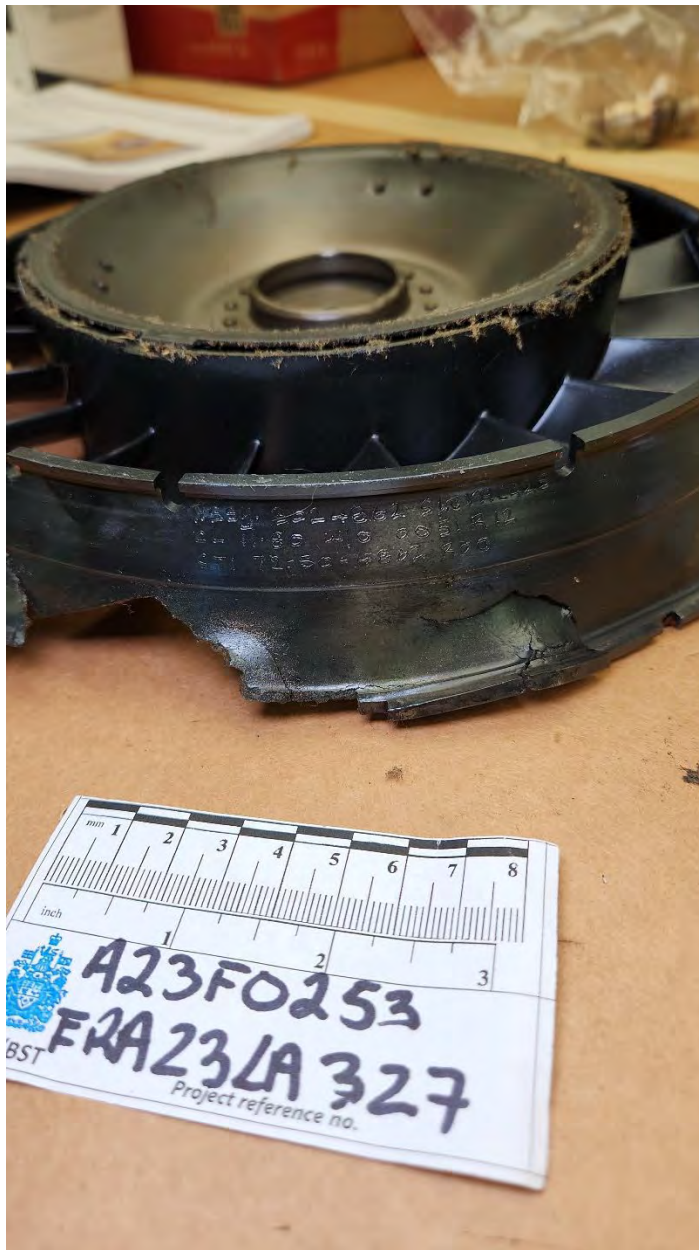
STI 72-50-4802 ROO part number therefore not PWC number

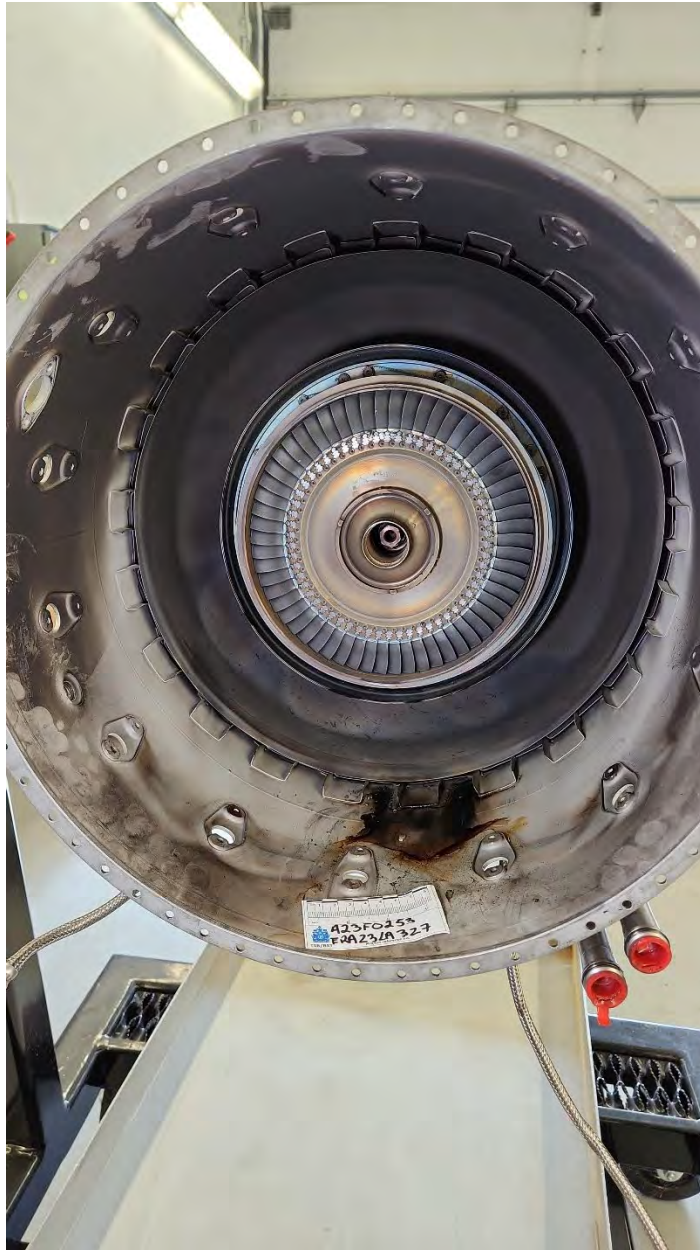
CT wheel Trailing edge looking aft

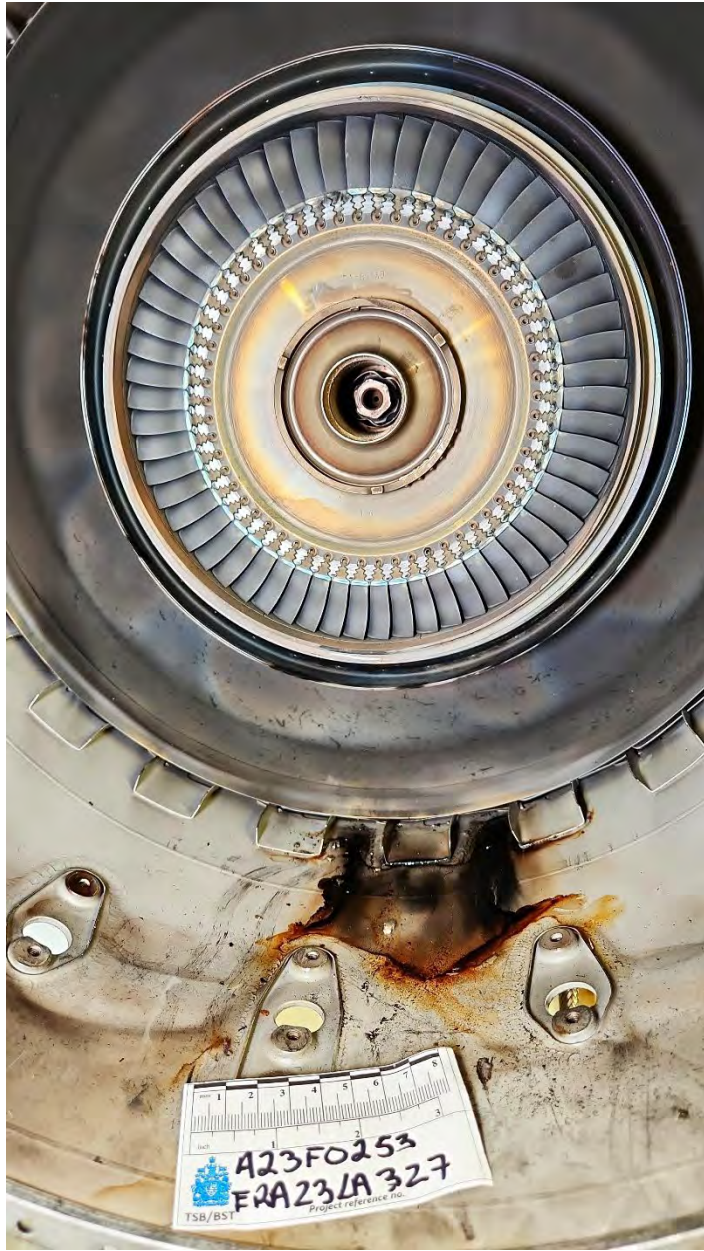
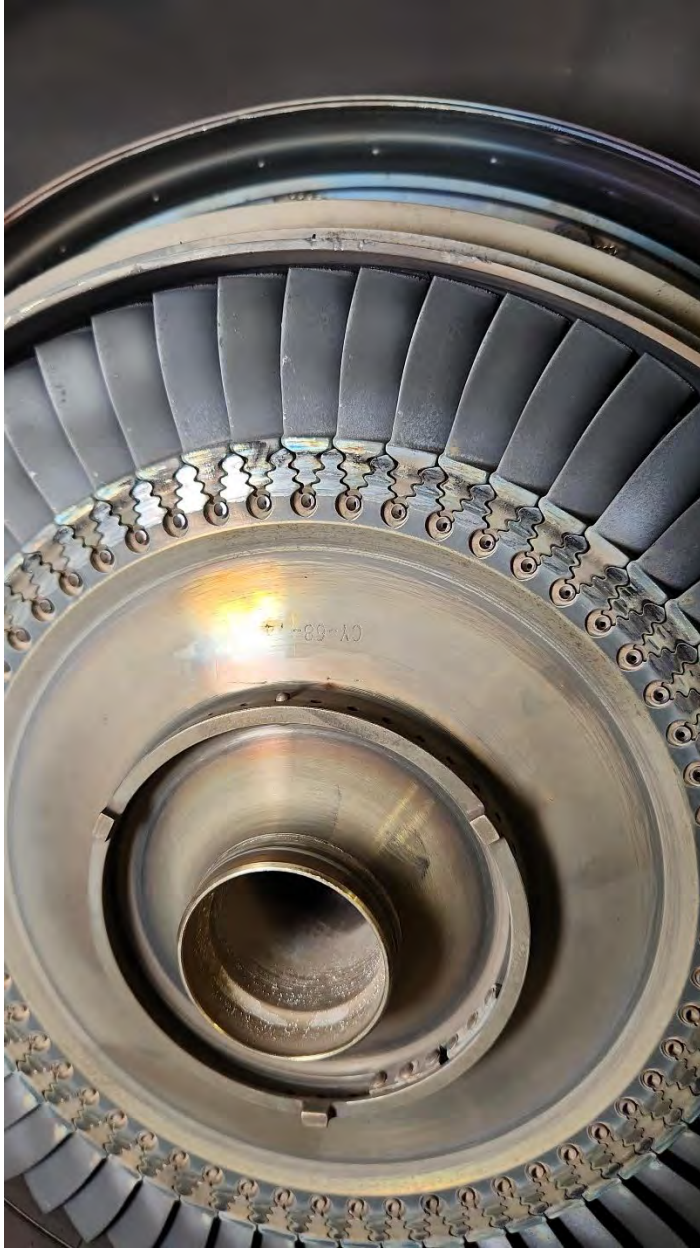
CT blades were turned with starter gen outlet and free to spin no rubbing or noises.  
Back of CT blades show evidence of rubbing on inter baffle section vane

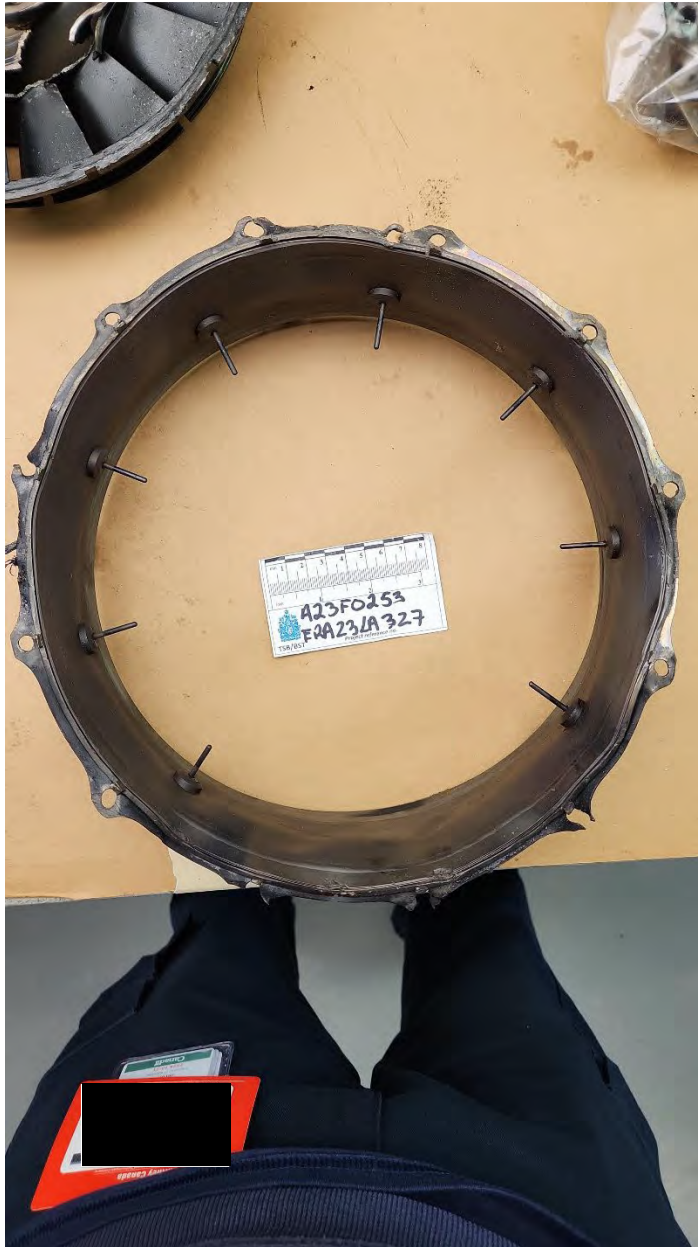
T5 casing with damages

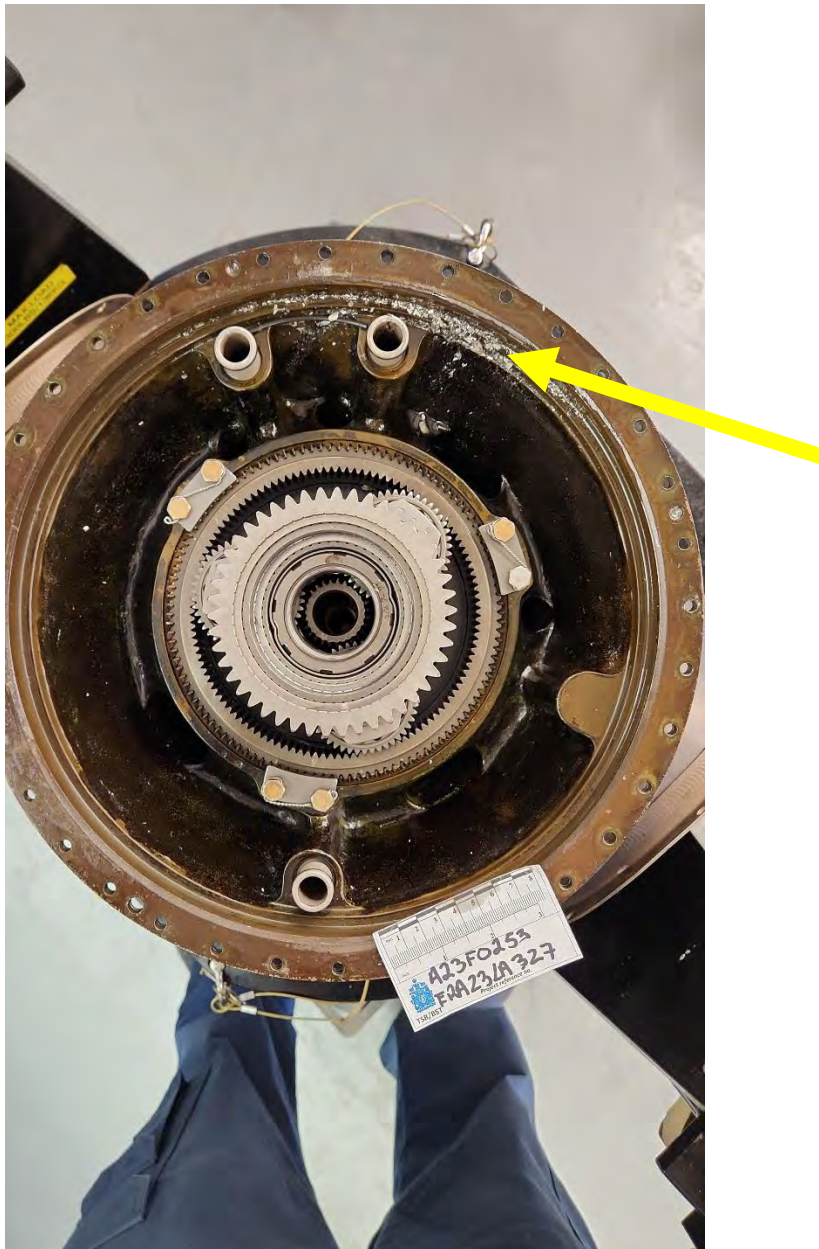
First stage gears with debris

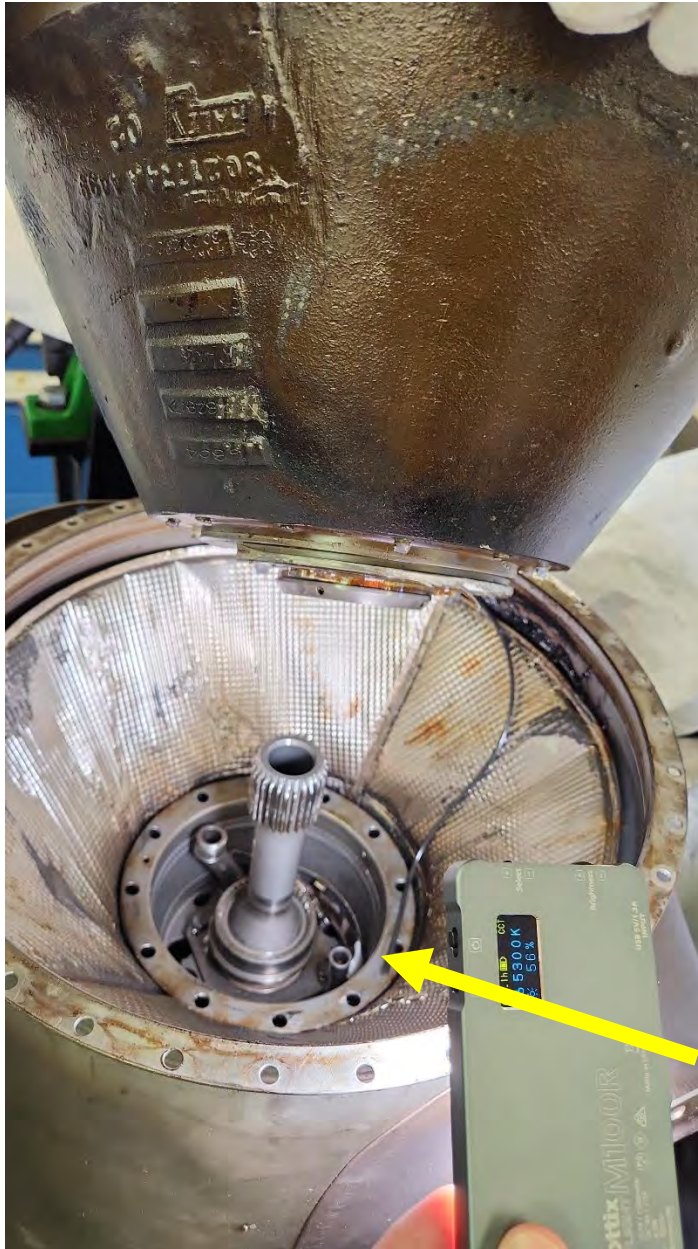
All bolts on gear RGB rear case found sheared and #3 roller bearing at bottom (please do not mind the light...)

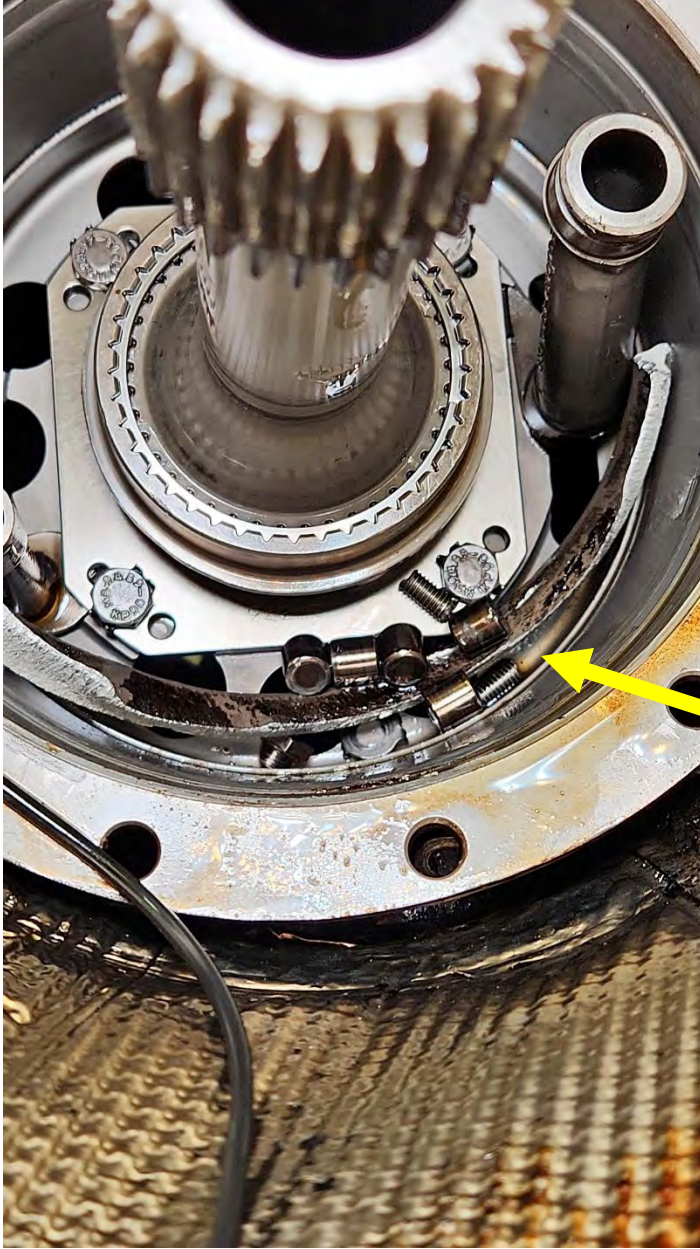
Bearing 3 roller found loose at bottom of case. Bearing #3 race attachment bolts found sheared with part found at bottom of the case. Bearing #4 race bolts were found secured but damaged (bent)

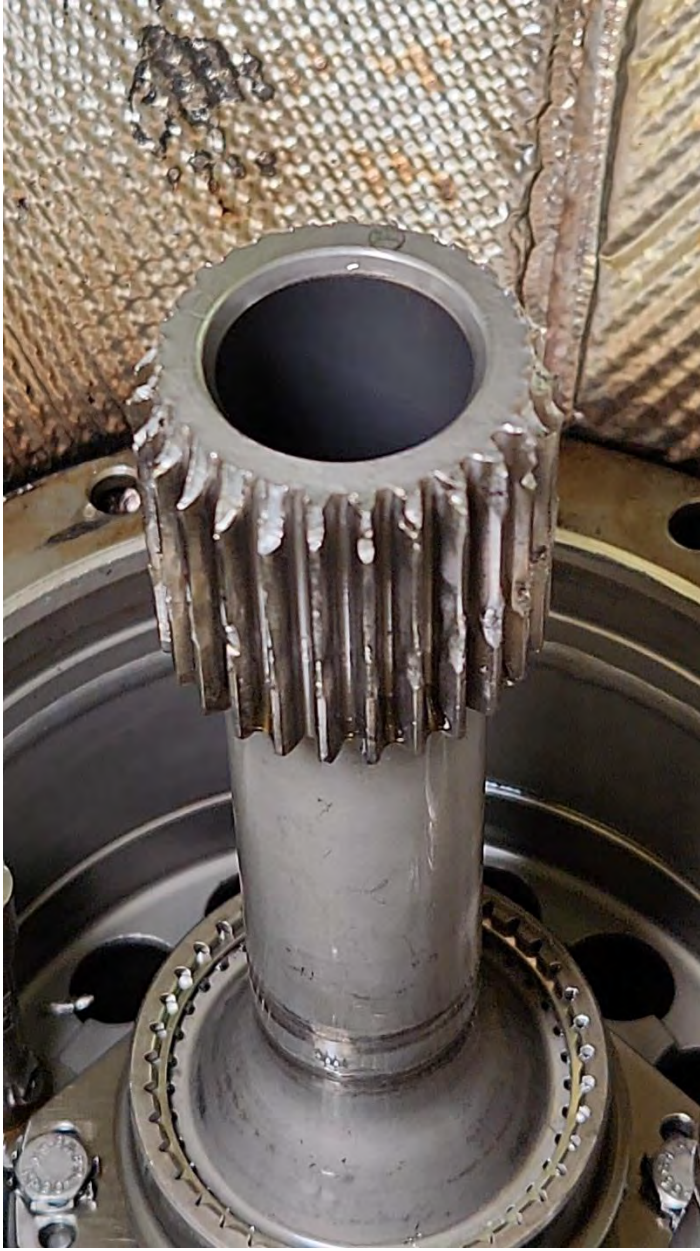
PT Shaft with damage

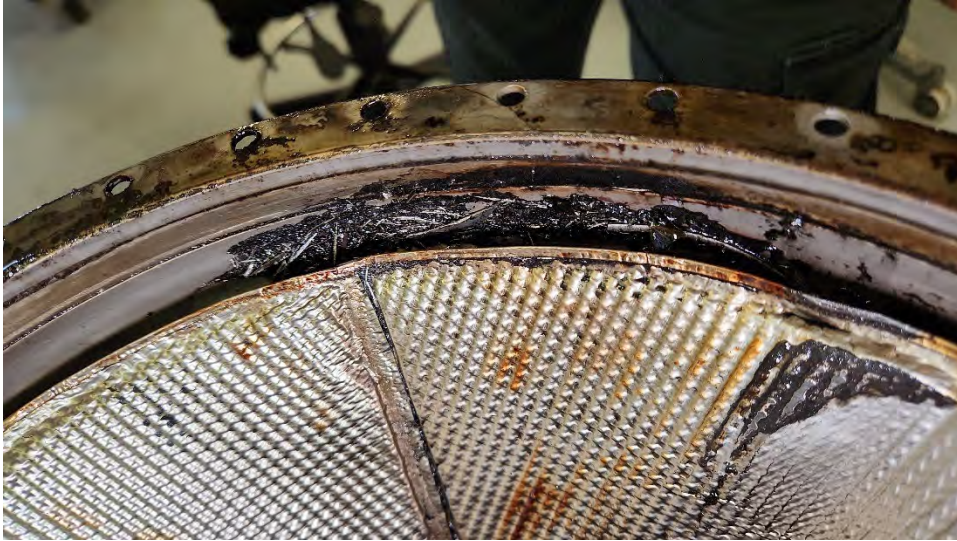
Bottom of RGB rear casing with debris

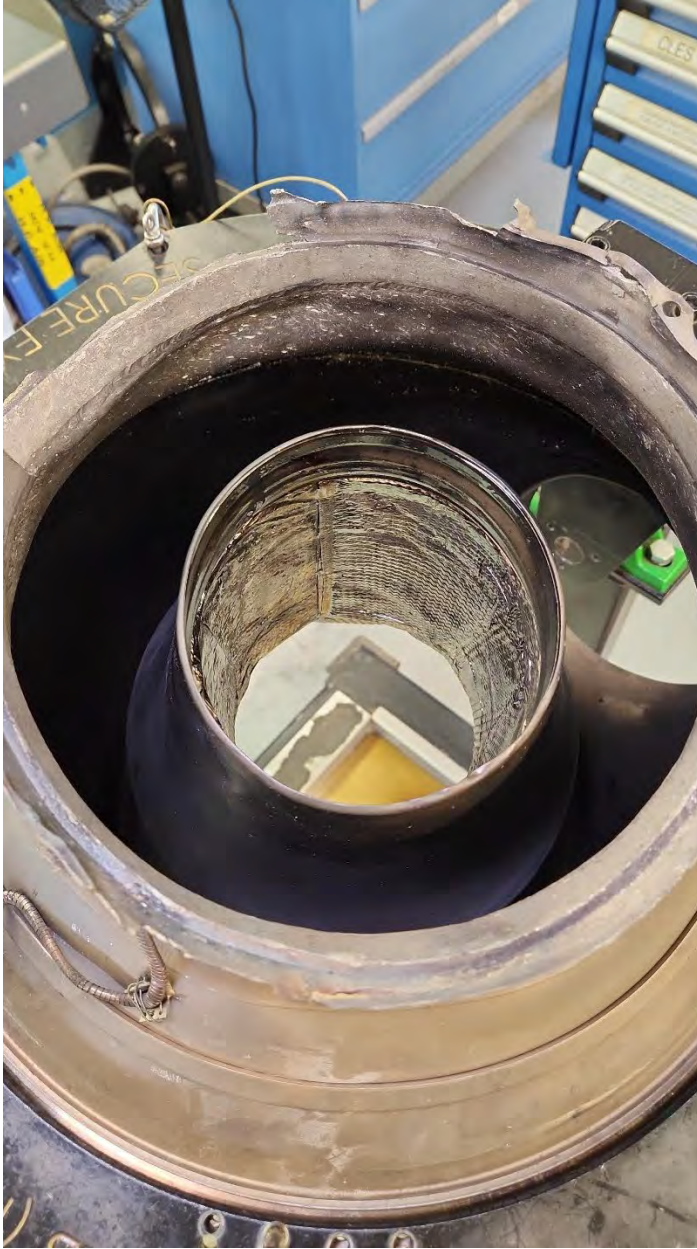
Exhaust Casing liner found offset

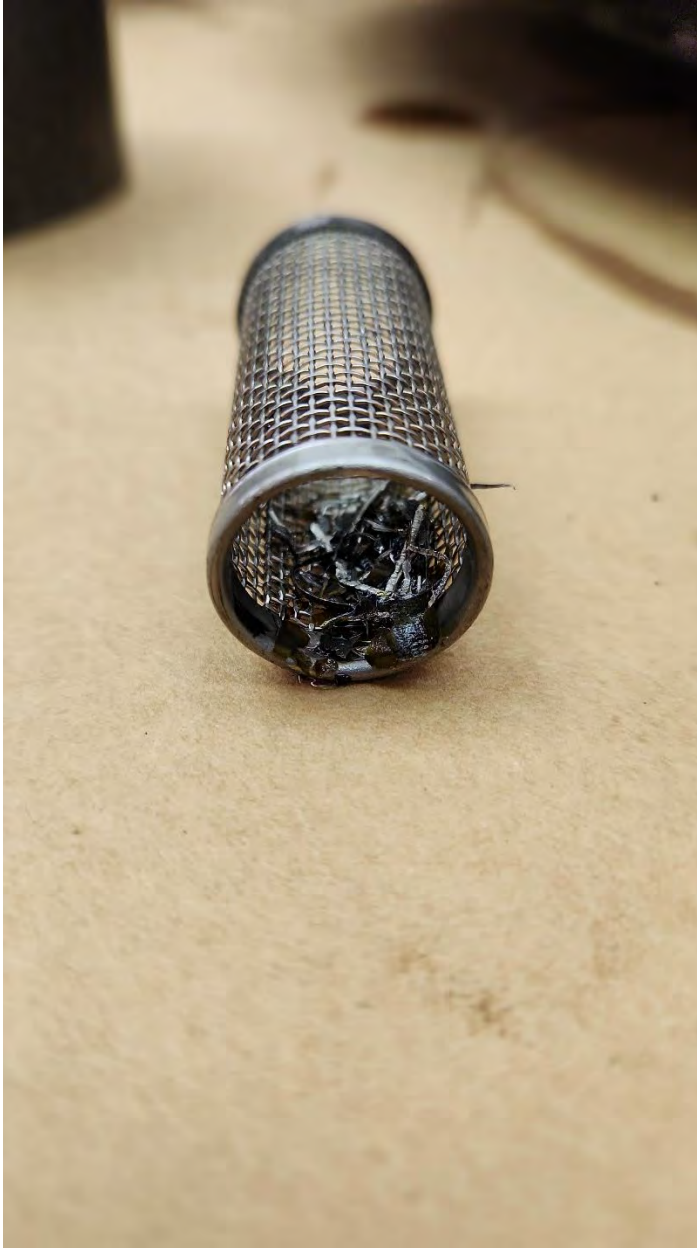
RGB strainer with debris
