# Investigator notes

USA (Leipsic, OH) Air Tractor AT502B N5048S engine fire 04 August 2023. 1954 eastern daylight time, an Air Tractor AT-502B, N5048S, was substantially damaged when it was involved in an accident near Leipsic, Ohio. The pilot was not injured. The flight was operated as a Title 14 Code of Federal Regulations Part 137 aerial application flight. The pilot had been applying fungicide to several fields, during which he noted no engine performance anomalies. Shortly after starting the second spray run in a field, he heard a pop sound. He saw flames coming out of the engine exhaust stacks and the engine stopped producing power. He performed a forced landing to a neighboring field and the airplane ground-looped in the high crops. Examination of the wreckage by a Federal Aviation Administration inspector revealed that the airplane came to rest upright with substantial damage to the left wing. The NTSB is investigating.

WO 23-1215 reviewed

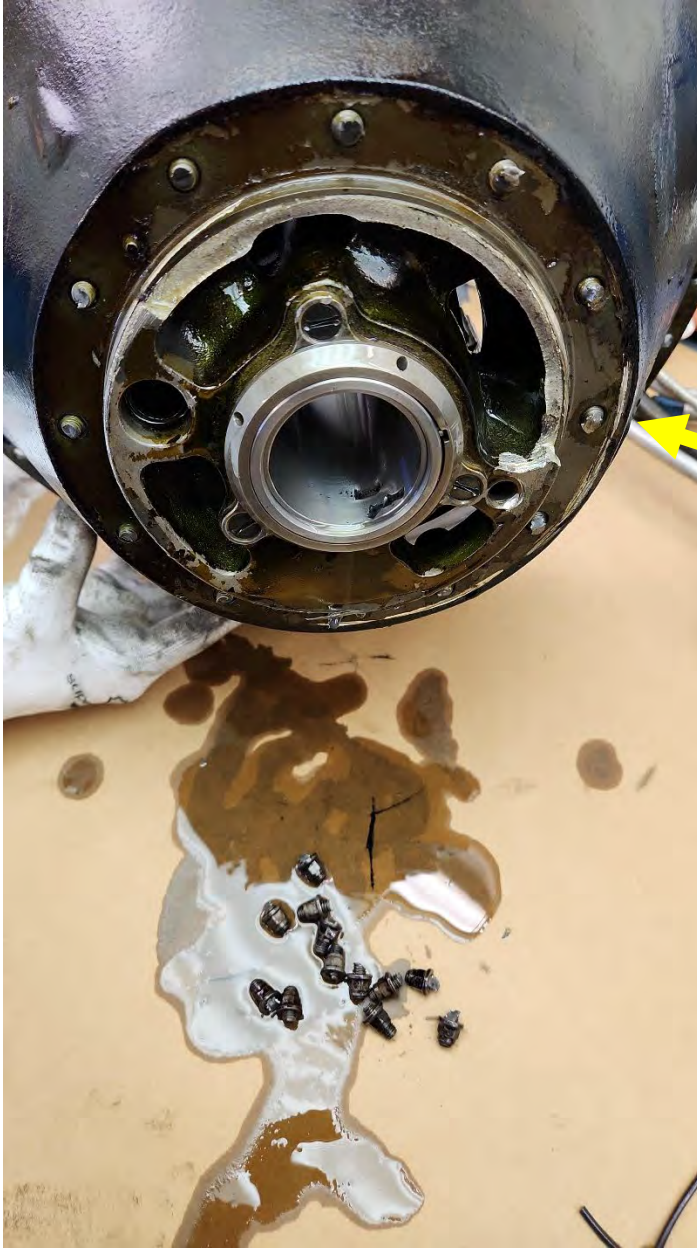
RGB rear case all bolts found sheared

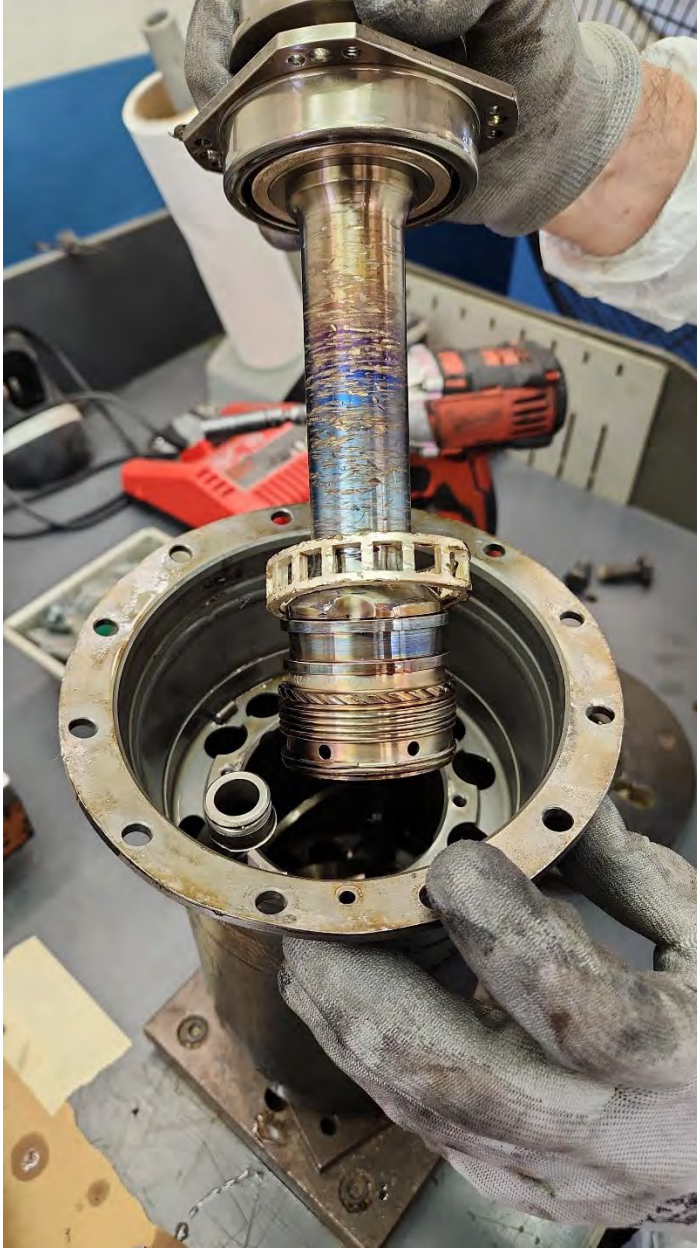
PT Shaft between bearing 3 and 4 found with heat damage evidence and impact damage most likely from bearing cage spinning around after release of the rollers

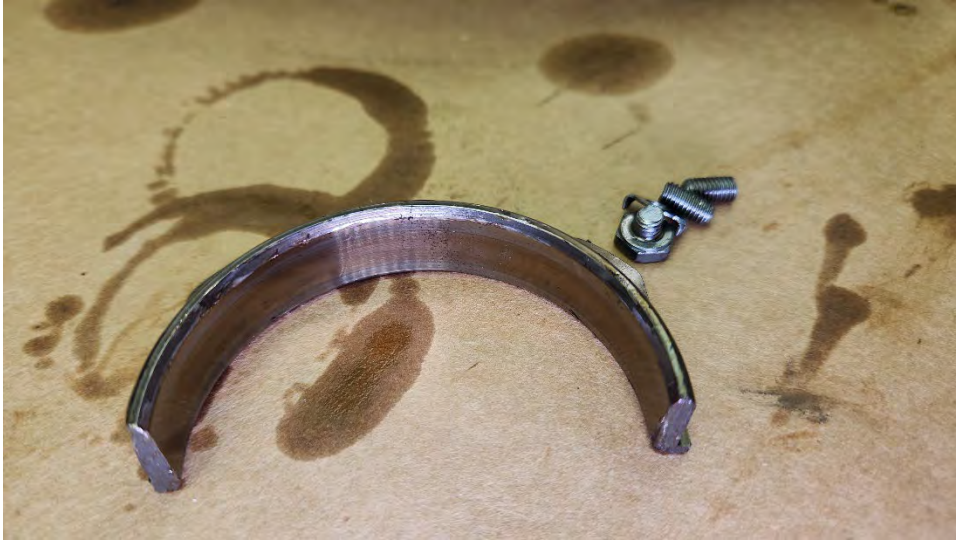
Bearing #3 race found in 2 separate parts no evident signs of scraping or overheat on the race  
All 4 bolts holding the race found sheared

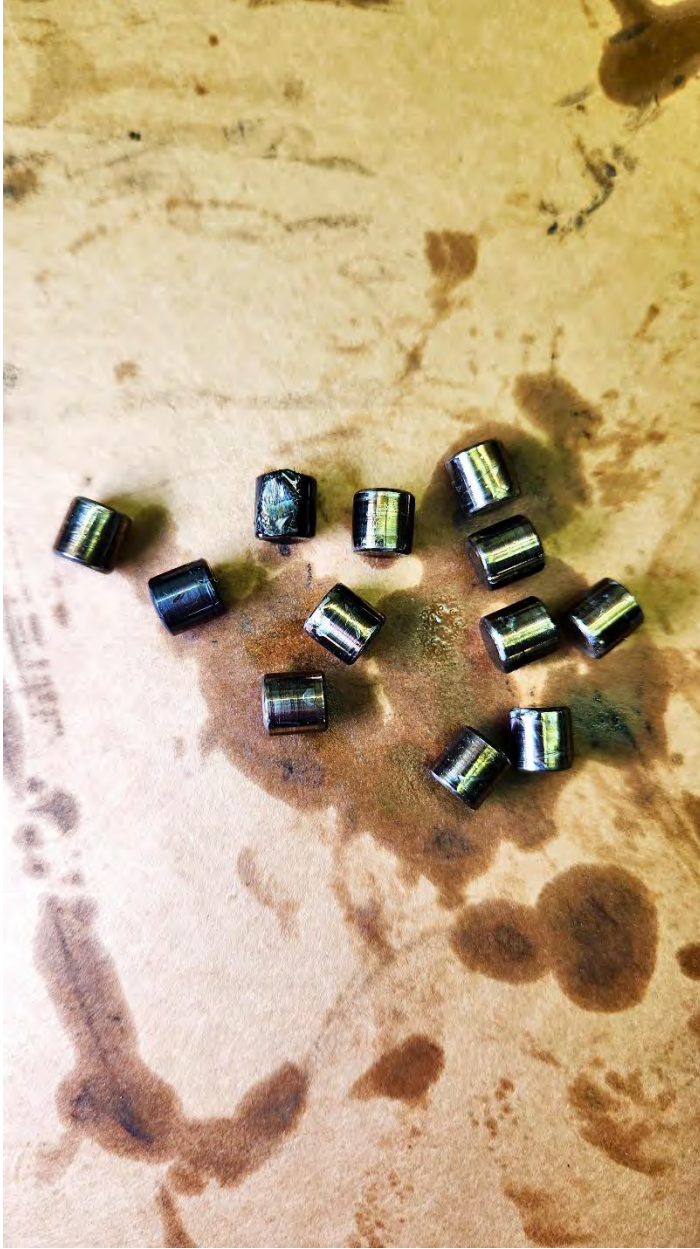
Bearing roller found with heat damage and rubbing

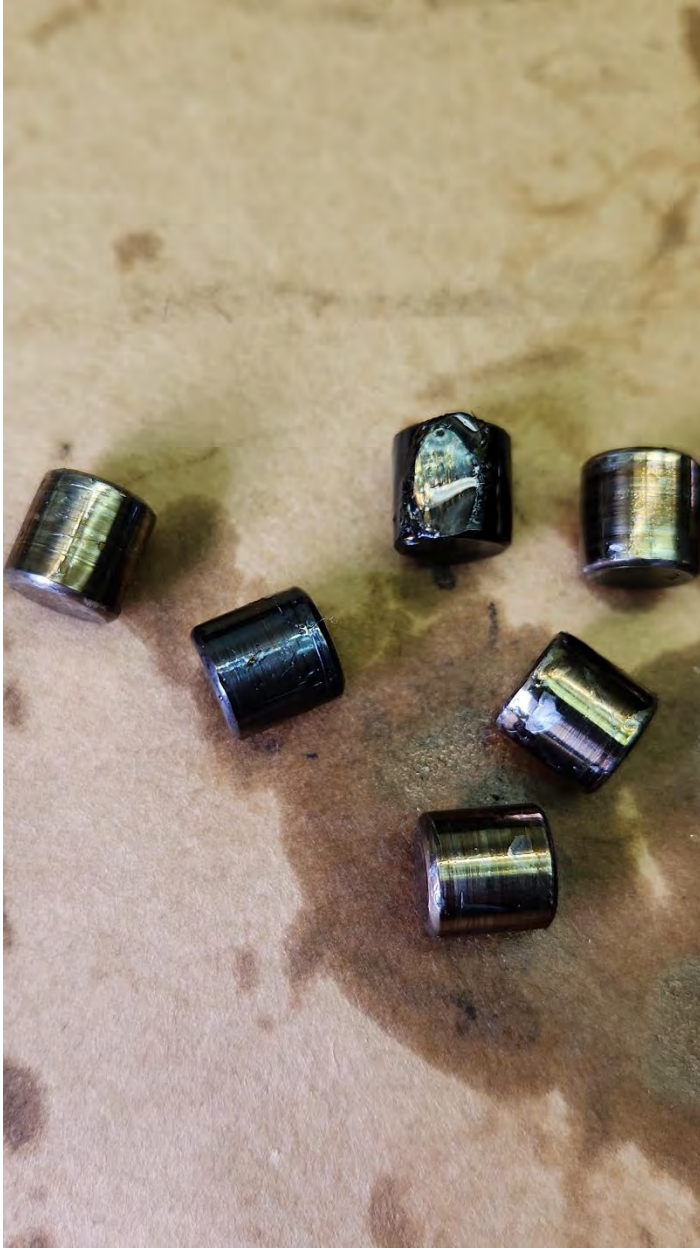
2 bearing roller indicated signs of rubbing and overheat signatures

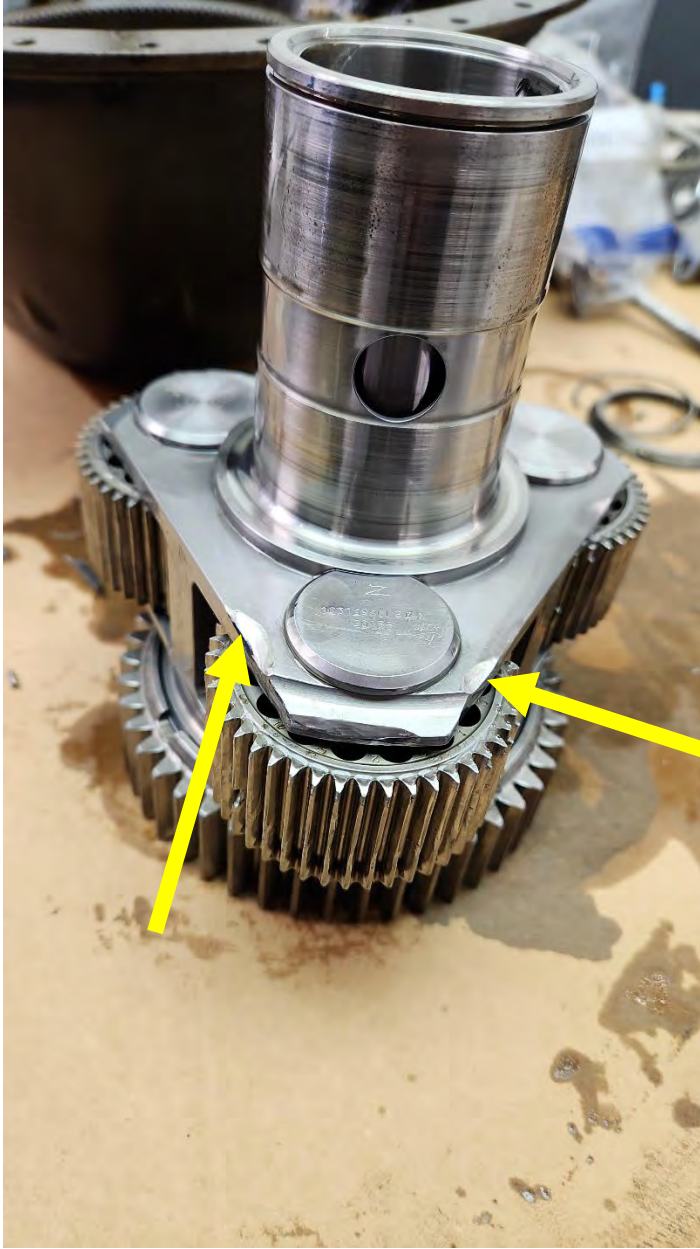
First stage planetary gears balancing (metal removed from triangular plate)

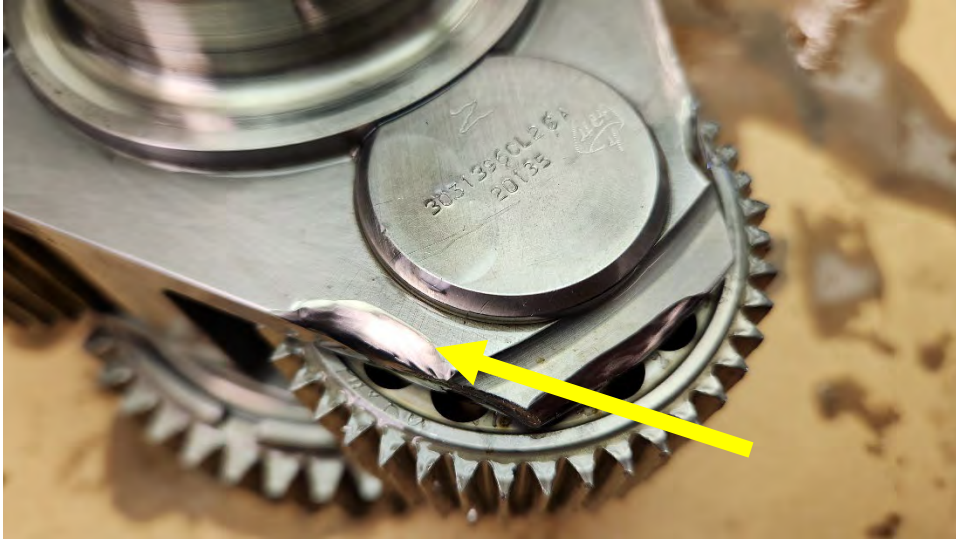
All sun/planetary gears turned without issues. Material missing is part of balancing process but need verification from PWC

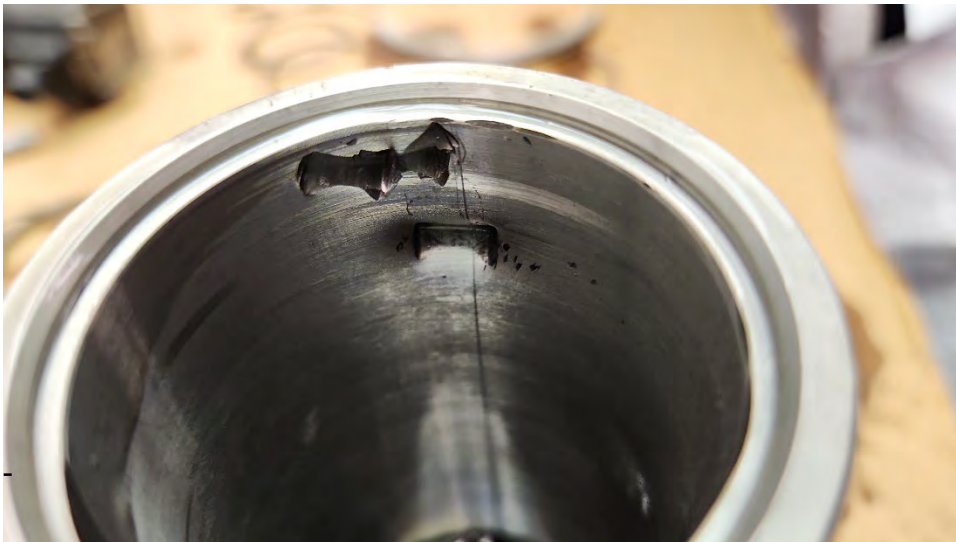
Two imprints inside tube FWD of bearing #4

Imprint inside tube that enclose shaft forward to 3-4 showed an exact imprint of a roller bearing. Most likely one roller got stuck, rubbed and overheat. Shaft shows also sign of rubbing

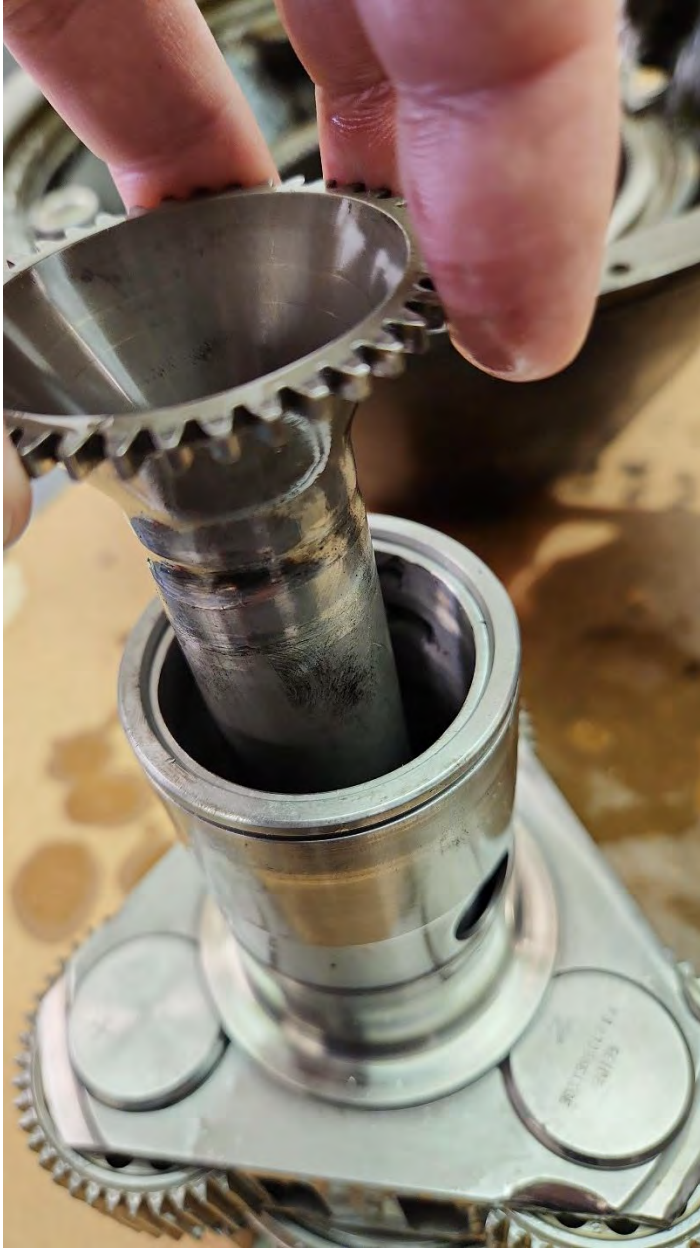
Scoring/rubbing on PT shaft

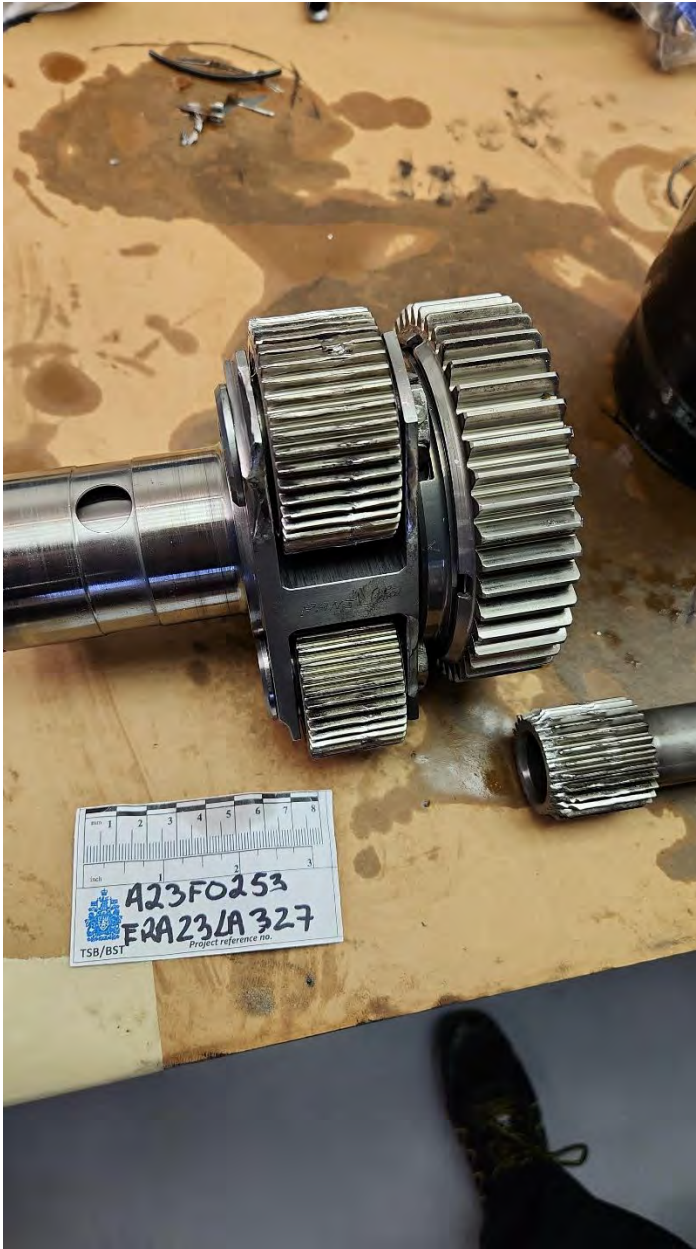
Damages found on first stage planetary gears

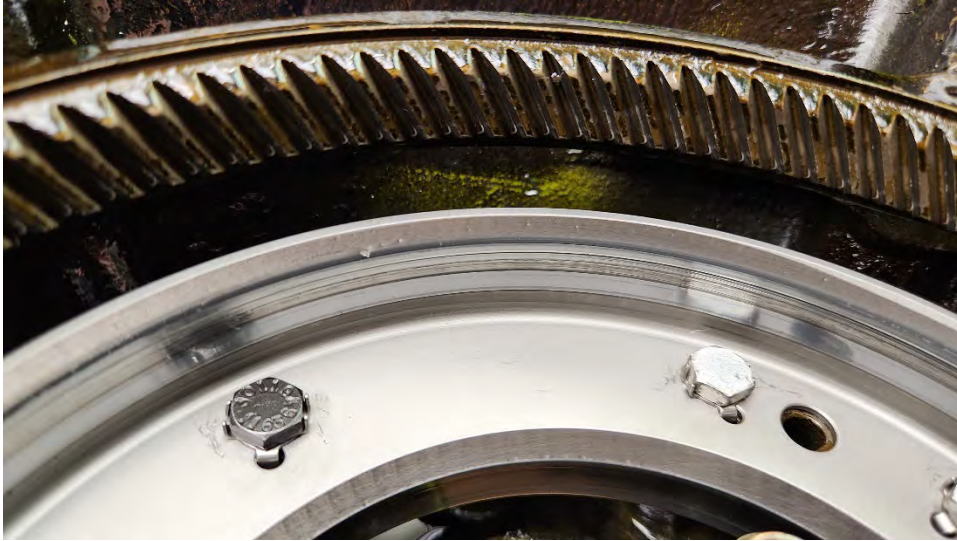
Torque plate scoring. No visible damage found on ring gear

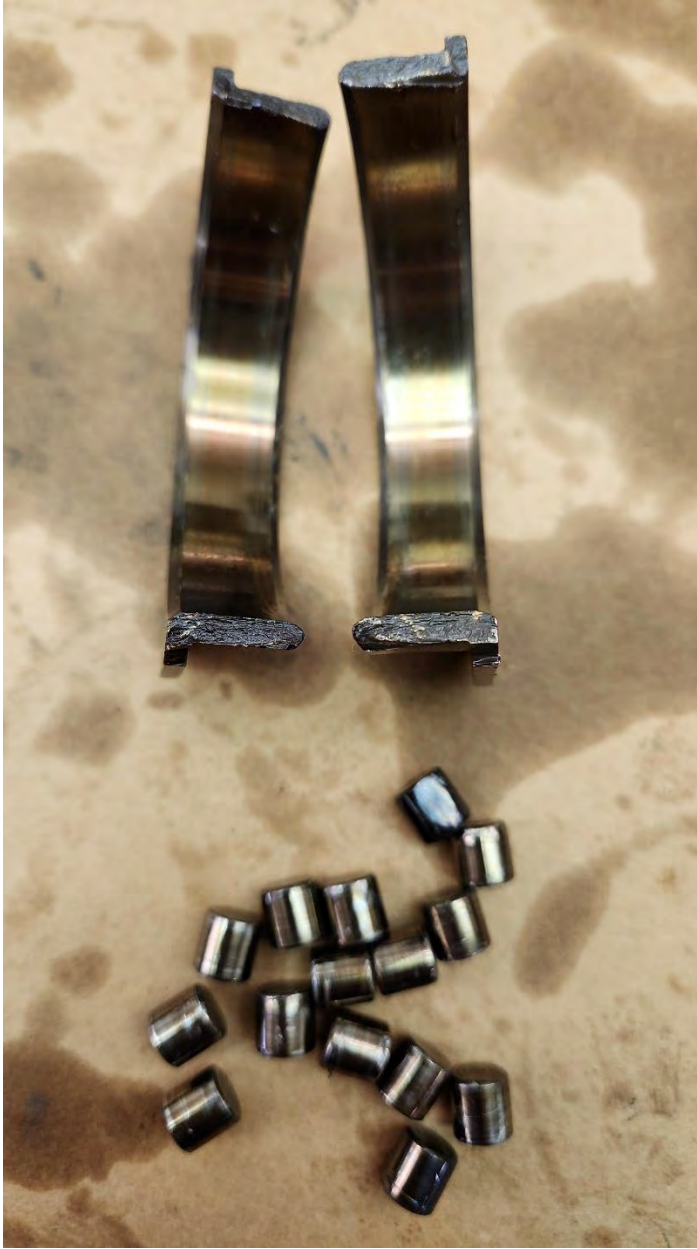
Bearing 3 race and found roller (One roller was not found). #3 bearing race did not exhibit sign of overheat or heavy scoring

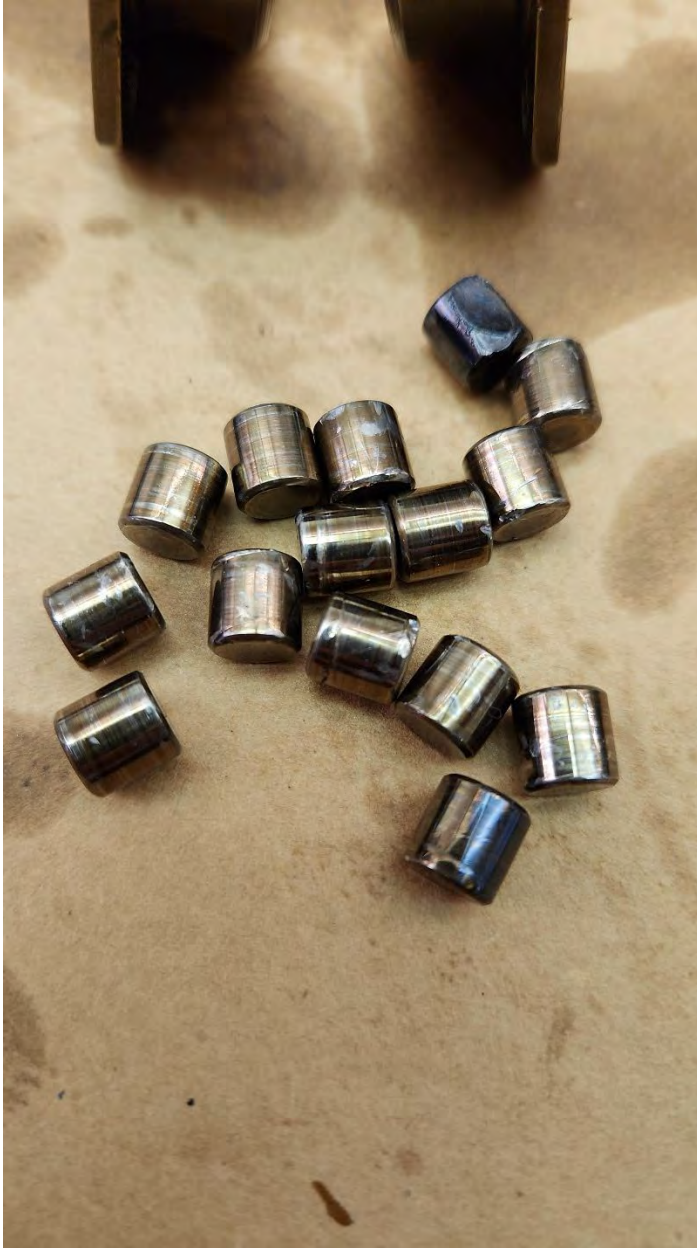
Bearing #3 rollers

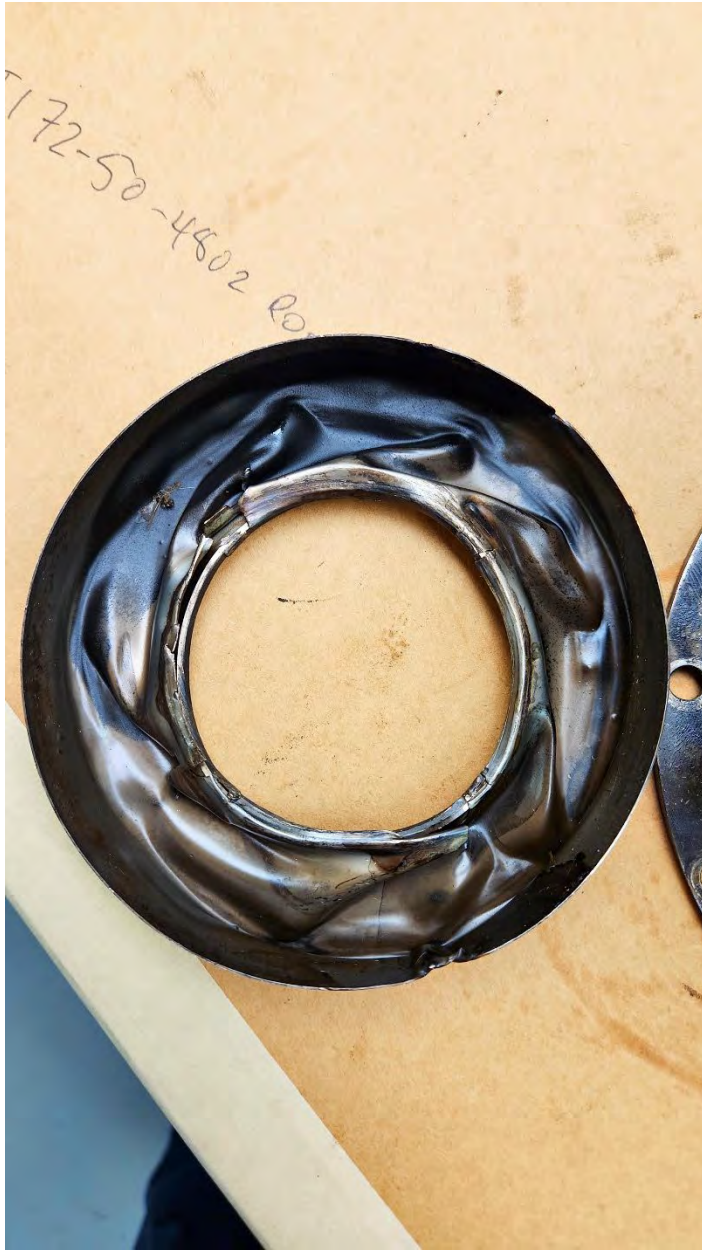
Power turbine shaft cap between PT shaft housing and PT wheel exhibit evidence of crushing and torsional force

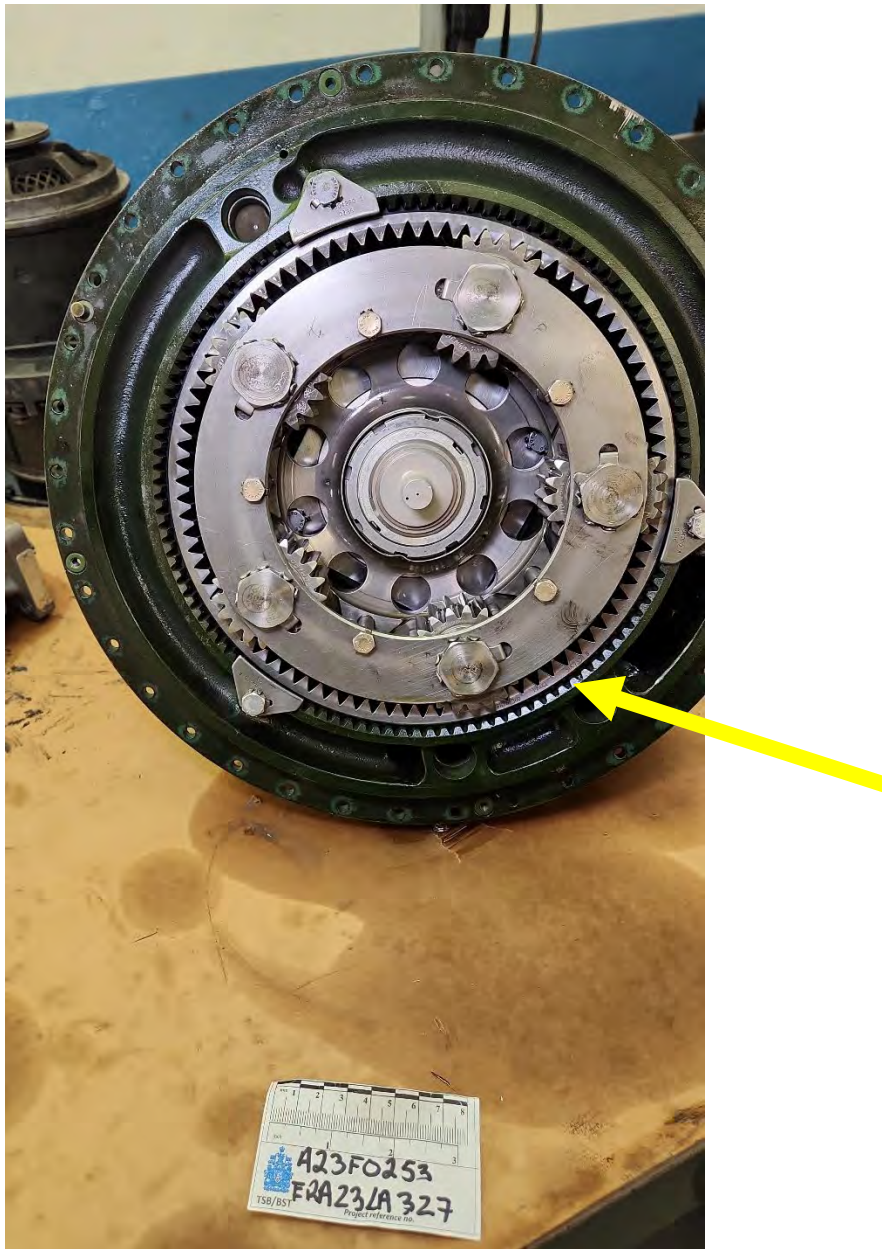
Forward RGB behind looking forward. The part number and serial number visible on the ring gear (5 o'clock) is indicative that the ring gear is installed the right way. Note that the 3 tabs are not engaged in the ring gear groove therefore not preventing axial play forward.

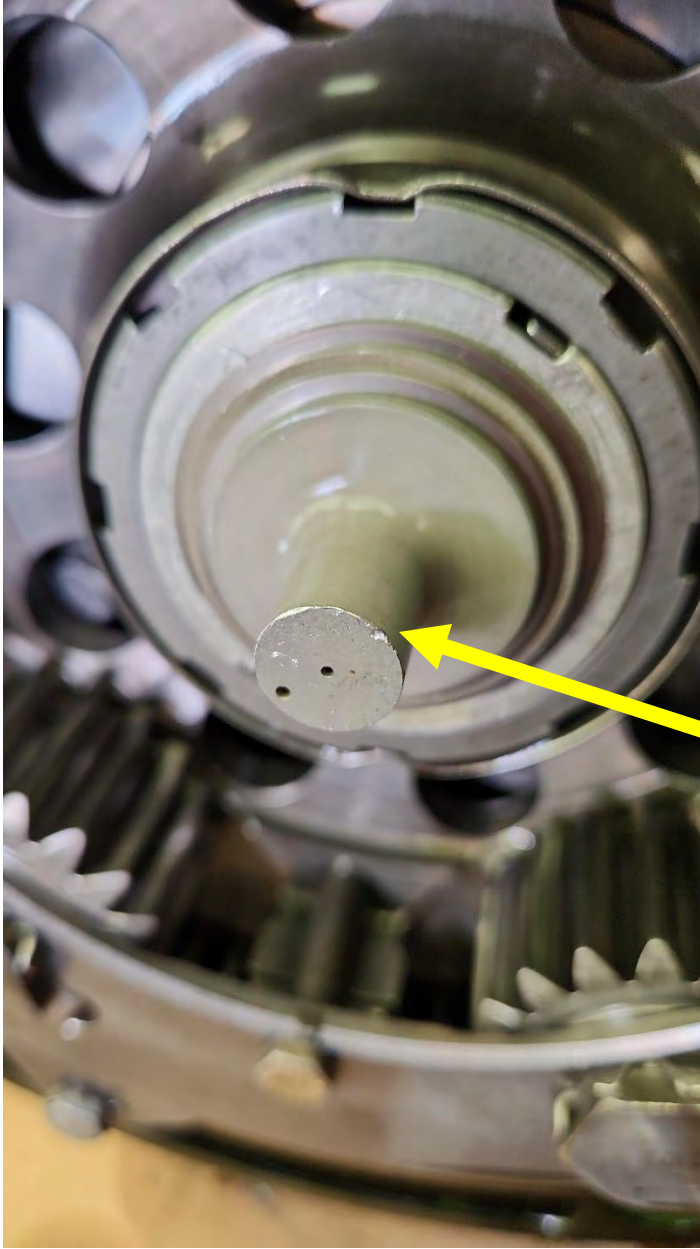
Oil nozzle with damages

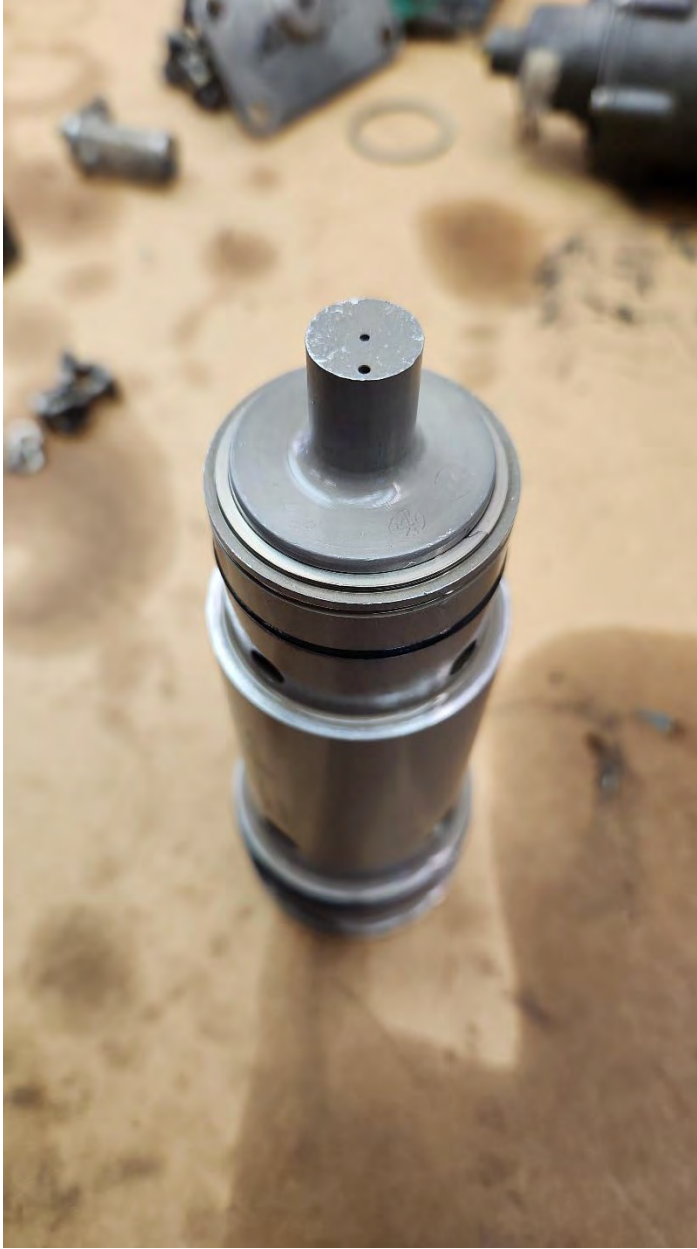
Inner core with damages

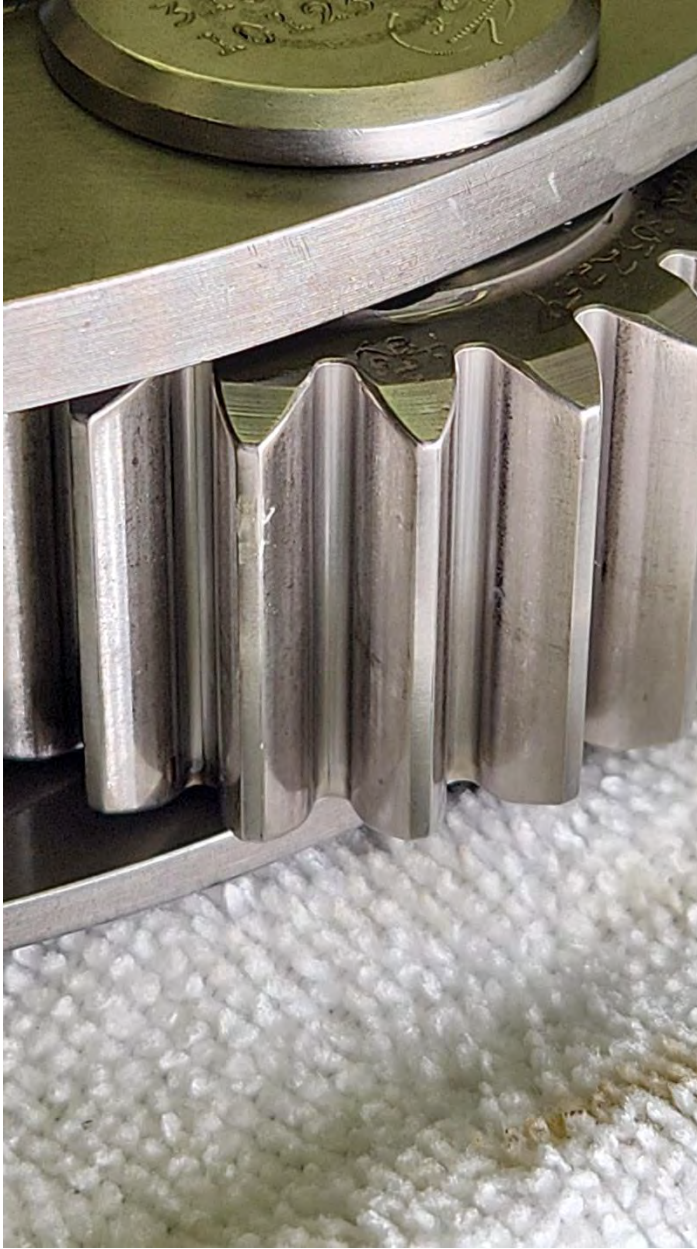
Second stage planetary gear with damages

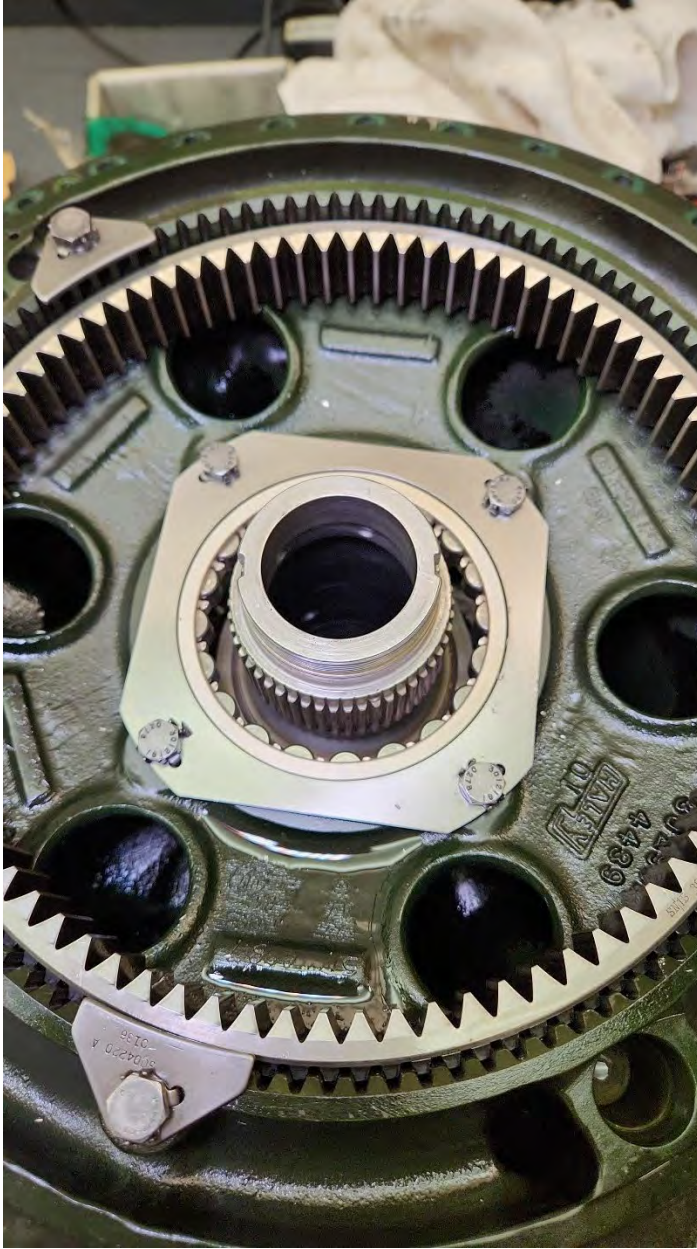
Bearing 5 no visible issues. Note Ring gear not installed correctly (tab no in grooves)

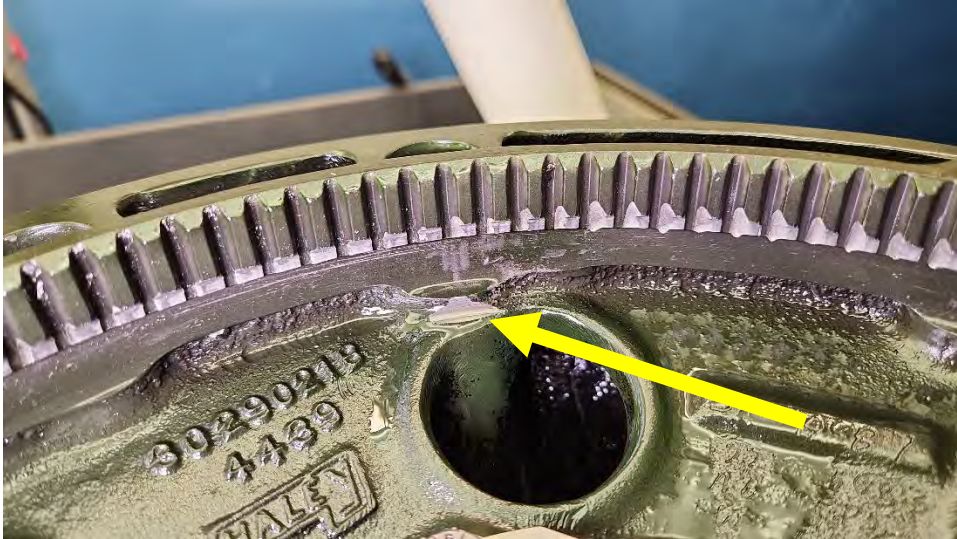
Bottom FWD RGB casing ring gear insert damaged

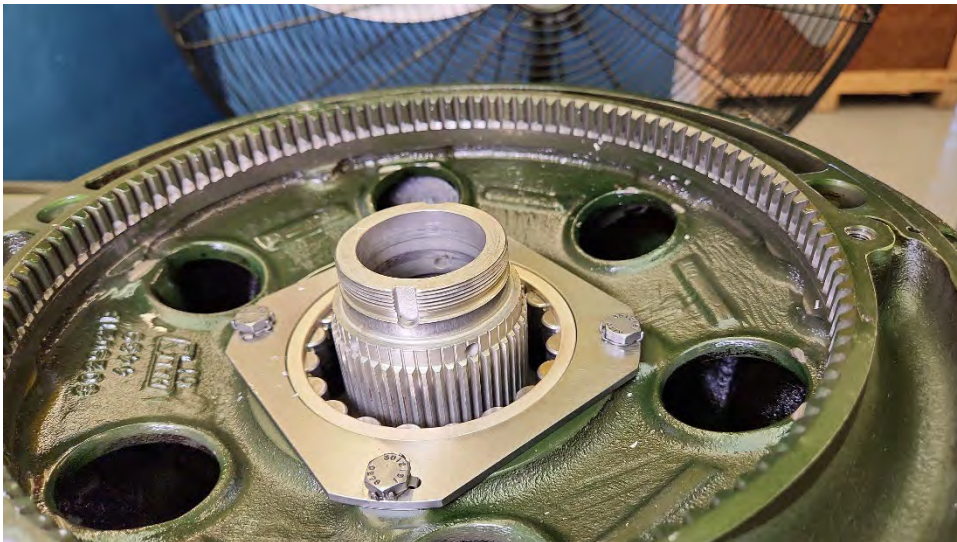
Damage on RGB ring gear most likely due to ring gear migrating FWD.

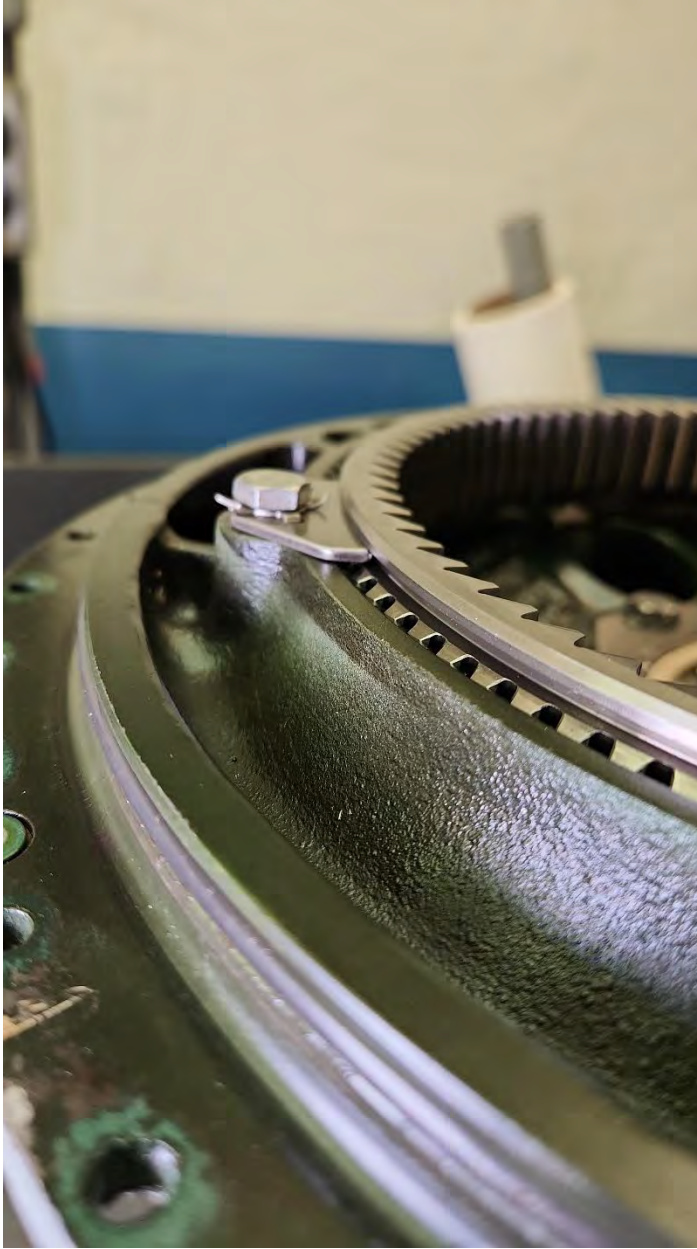
For demonstration ONLY- Ring gear correctly installed in groove to prevent axial play. With ring installed incorrectly the ring would migrate forward until such point that the planetary gear would have spun the ring gear and damage the casing. At this point the theory would be that no power would be transferred to the prop and PT wheel would overspeed.

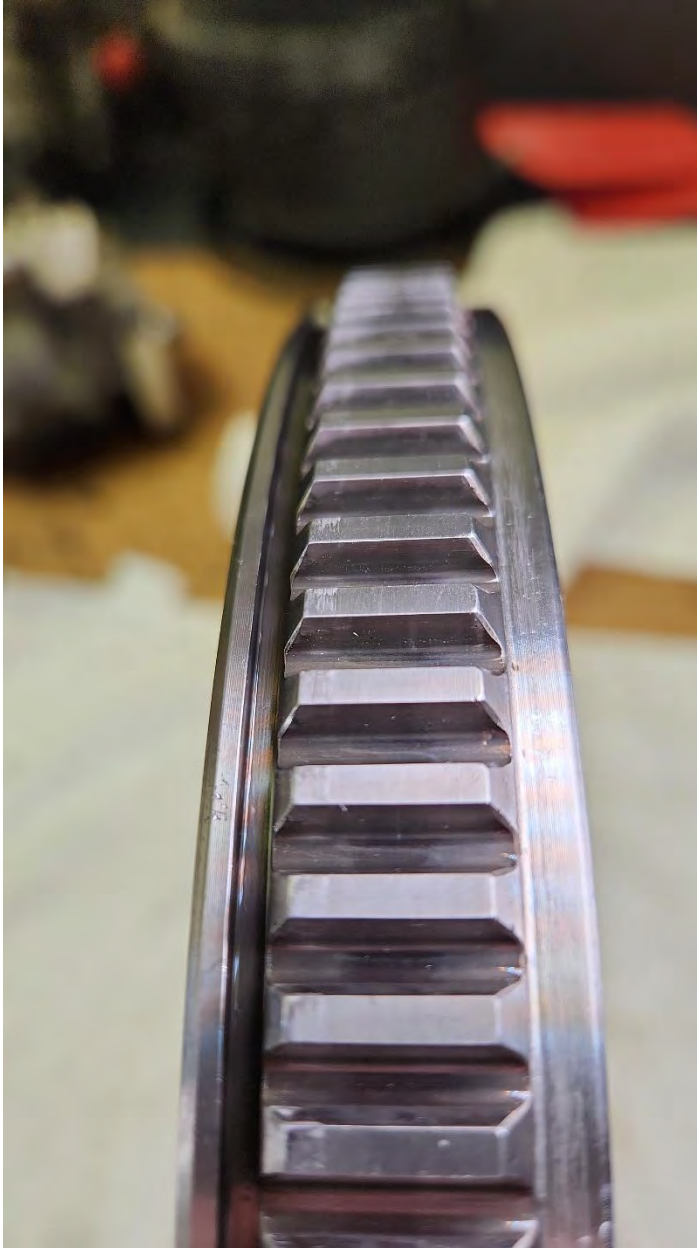
When the gear went forward it wear the bottom casing ring gear. Damage on the ring gear is indicative of that

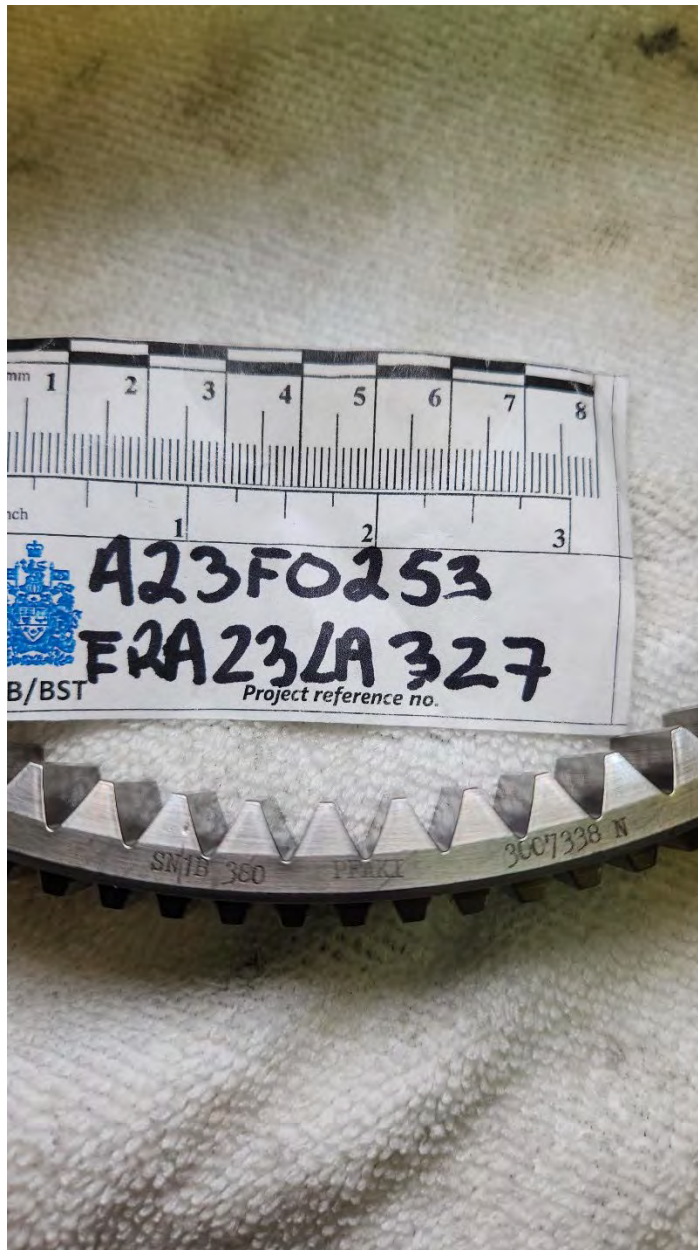
Ring gear part number. PN and SN were visible and therefore the groove on the ring gear was installed the right way (aft)

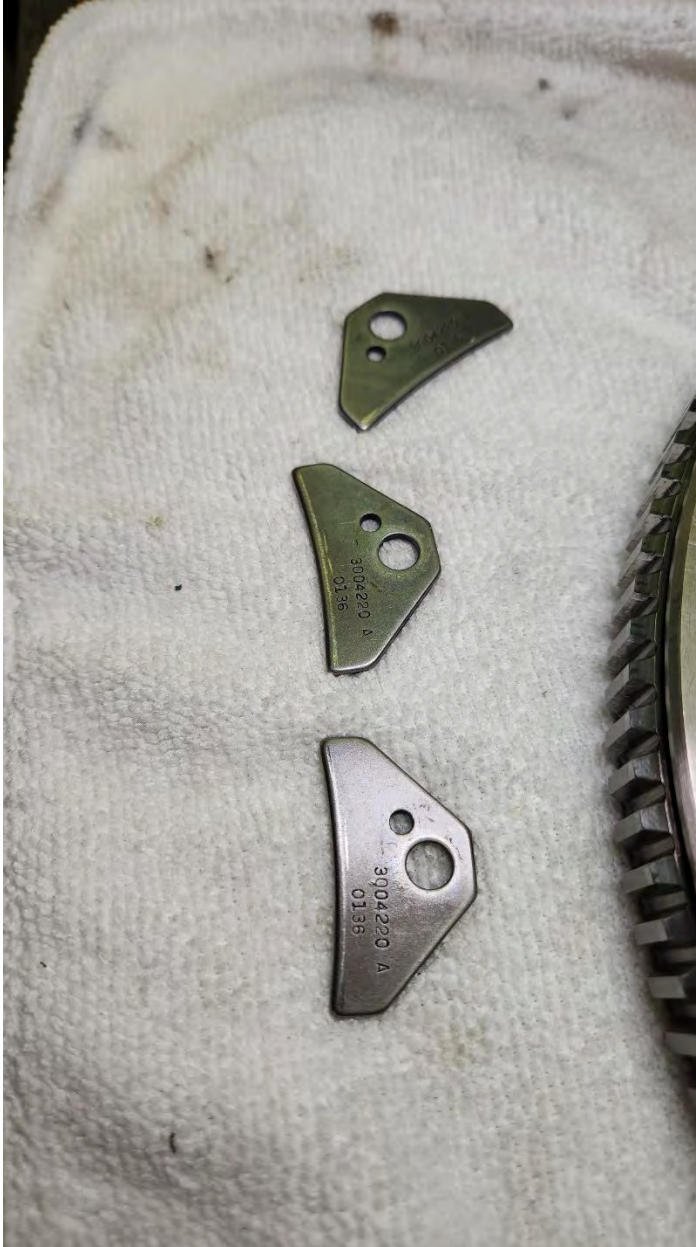
Wear on top of brackets may indicate it was installed properly at some point during the life of the ring gear/tabs

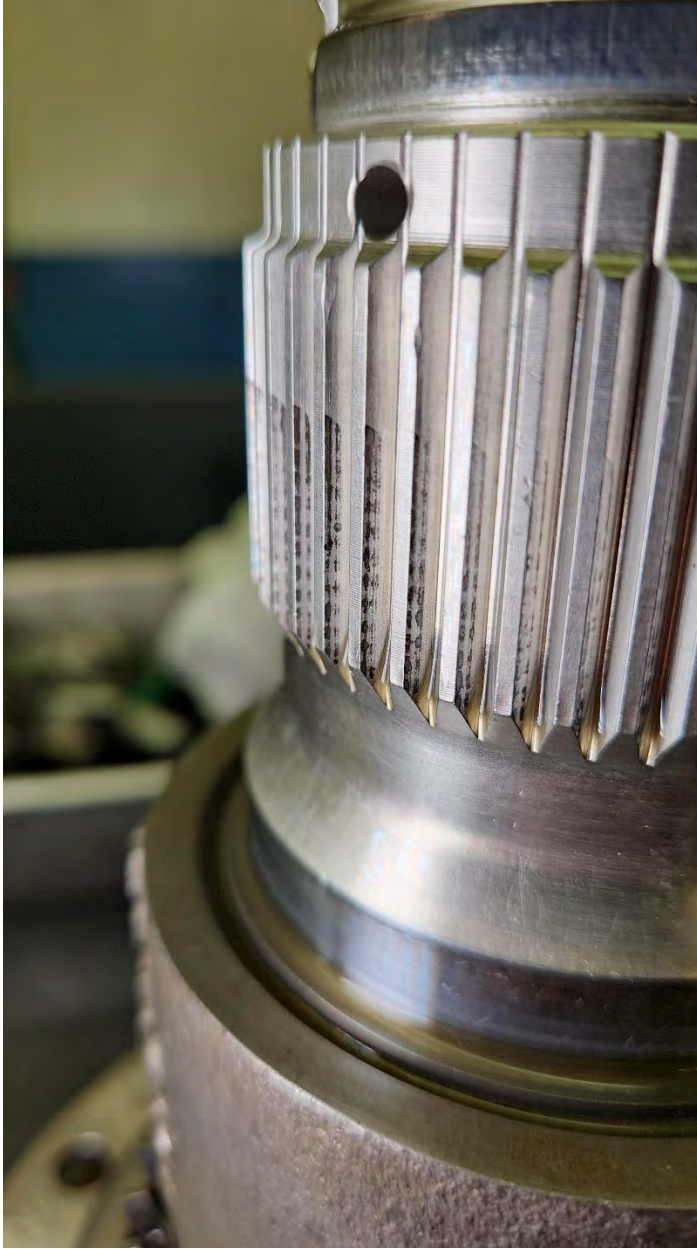
Prop shaft gear teeth damage
