Service Investigation  
**Accident / Incident Report**  
P&WC 8114 (2020-10)

**Report No.: 23-125**

**Bob Ruhe AG Service LLC  
Air Tractor AT-502B, N5048S  
Leipsic, Ohio, USA  
04 August 2023  
PT6A-34AG, S/N: 56520**

**NTSB Identification:** ERA23LA237  
**TSB Identification:** A23F0253  
**P&WC File No.:** 23-125  
**RFA No.:** 23SIE00219

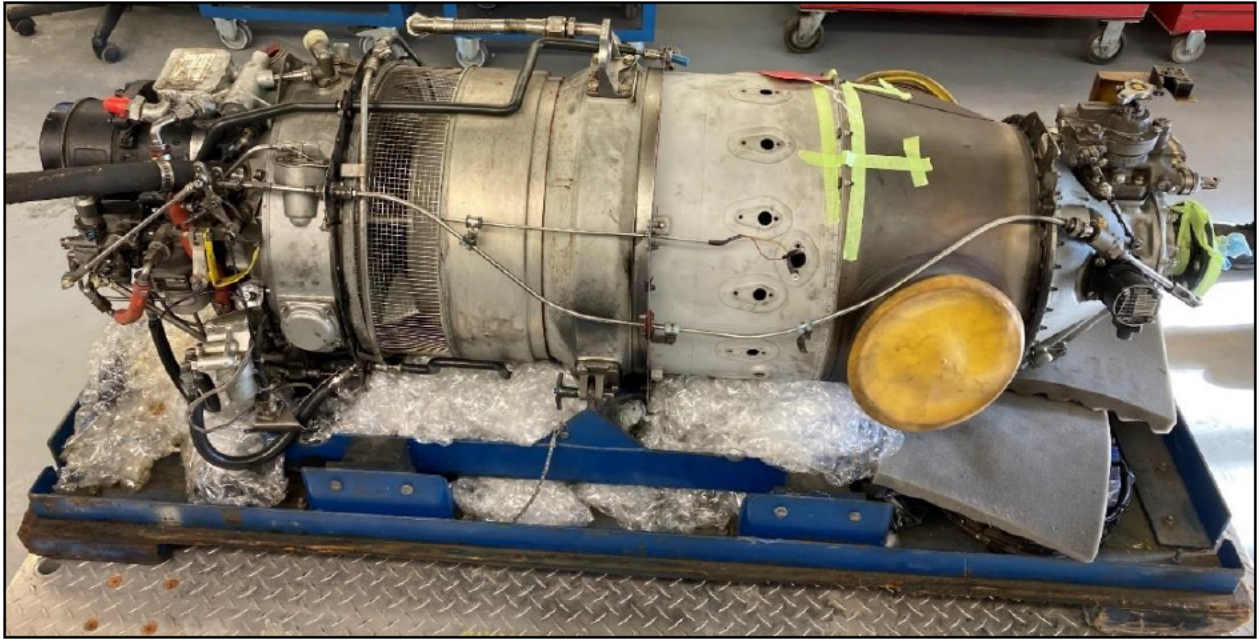
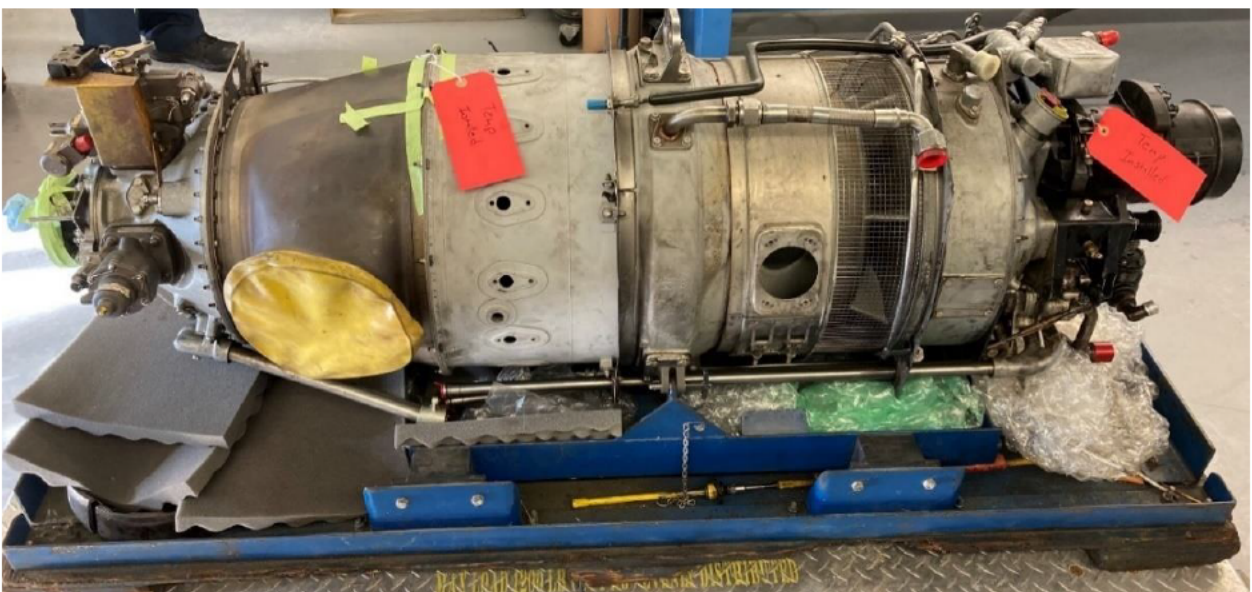
The engine was received assembled with tags and indications that it had been previously disassembled post accident. Engine parts sealed in plastic bags and wrapped in bubble wrap were packed underneath the engine directly on the wooden pallet (Photo No. 1 & 2). Engine components were unwrapped and placed on a work bench for evaluation (Photo No. 3). The engine data plate confirmed the engine model to be a PT6A-34AG and engine SN PC-E 56520 (Photo No. 4).

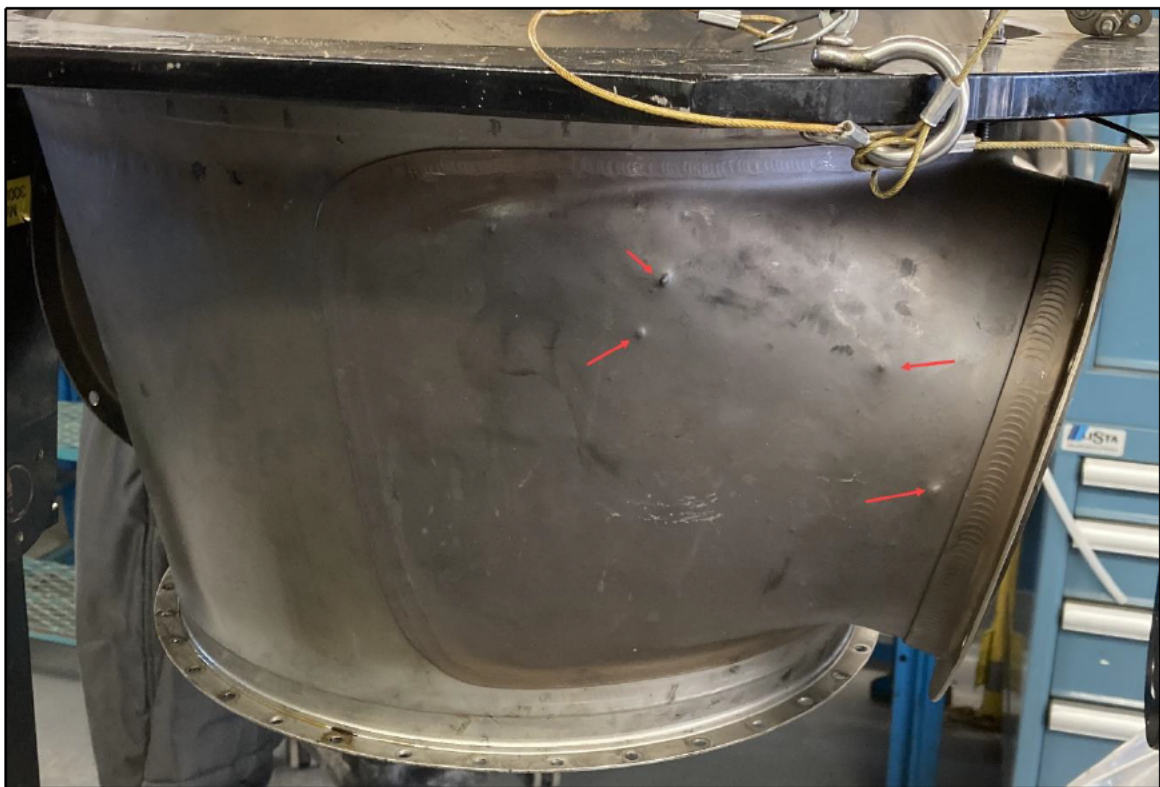
Photo No. 5, Exhaust Duct

**Exhaust Duct:** The exhaust duct exhibited dimples on its exterior surface indicative of PT blade distress damage, (Photo No. 5). T-Bolts at the “C” flange were missing and a red tag was attached through one of the holes, indicating it was accessed post-accident and temporarily re-installed.

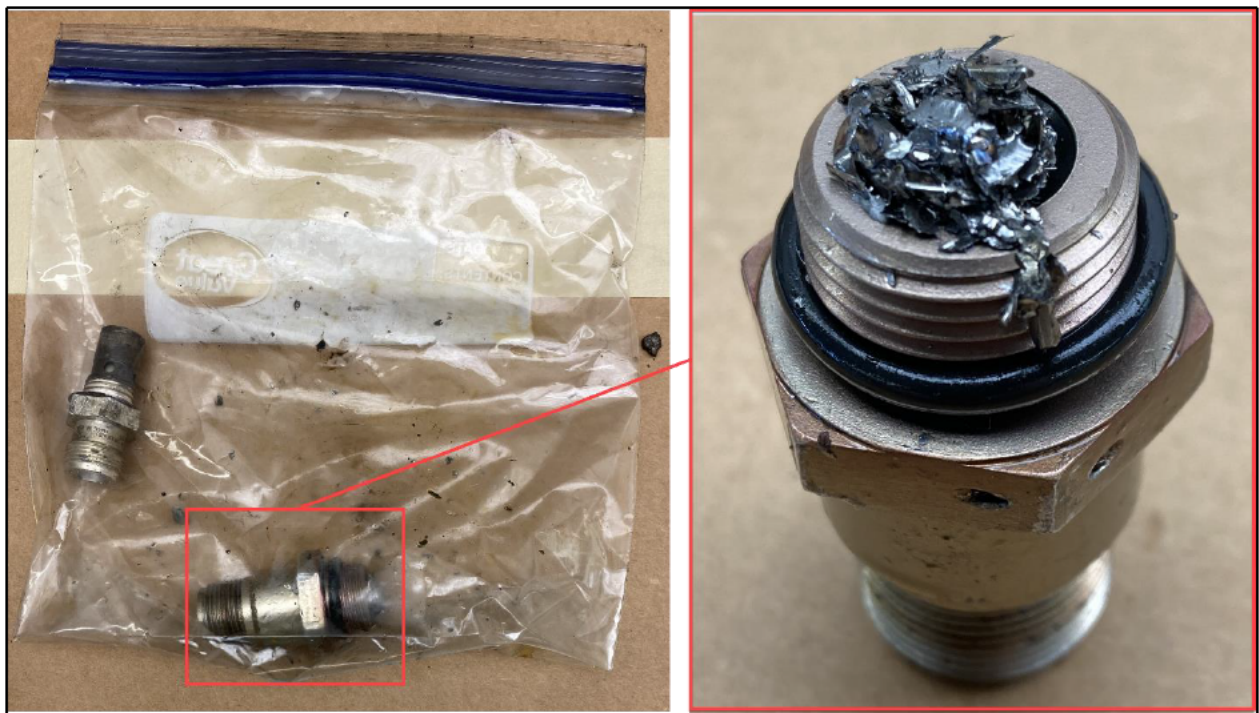
**Photo No. 6, RGB Chip Detector**

**Chip Detector:** The RGB magnetic chip detector, which was received in a sealed plastic bag along with one of the engine igniters, had metallic debris attached to the poles (Photo No. 6).

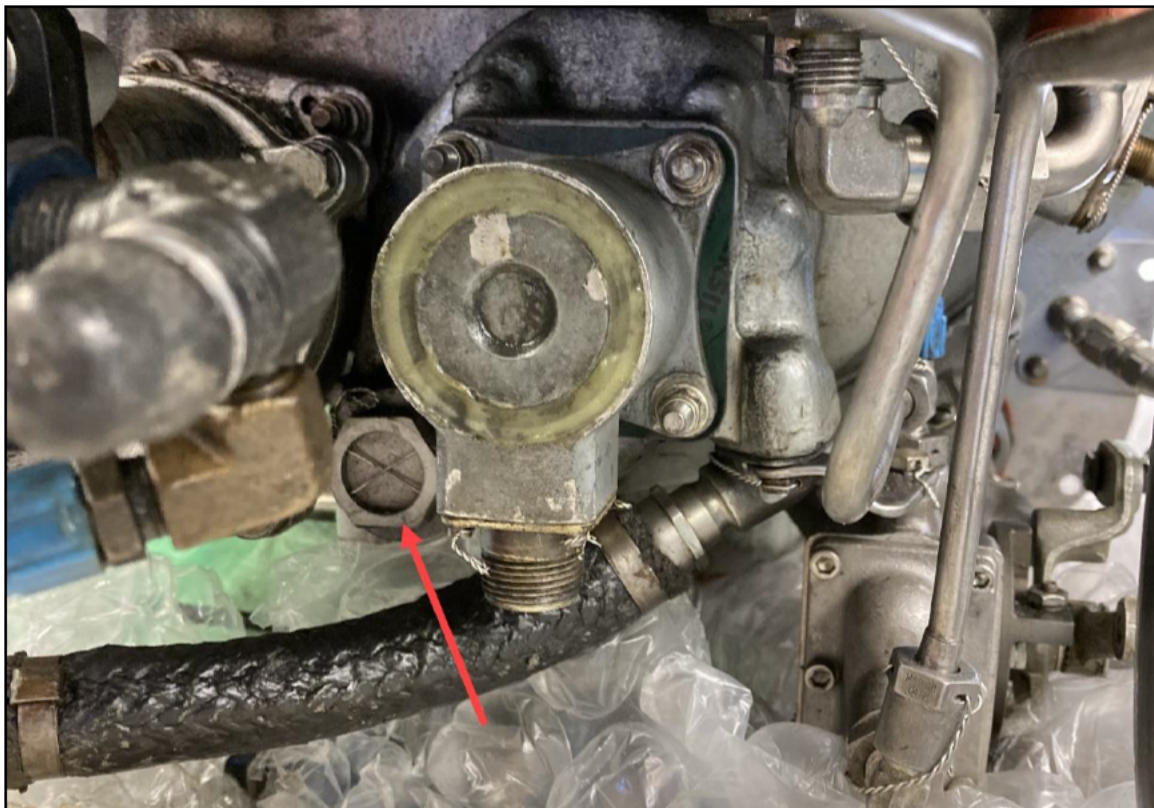
**Photo No. 7, AGB Chip Detector Plug**

A lock wired plug was installed at the AGB chip detector port, indicative of the engine not having one installed (Photo No. 7).

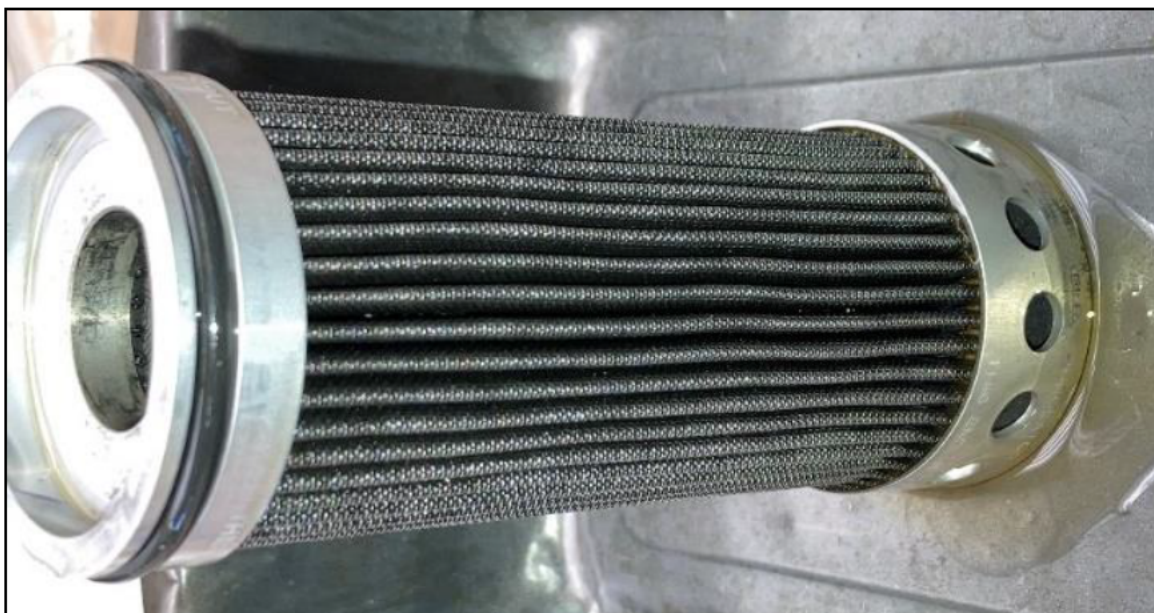
**Photo No. 8, Oil Filter**

**Oil Filter:** The oil filter was shipped in a sealed bag. It was oil wetted and visually free of debris (Photo No. 8).

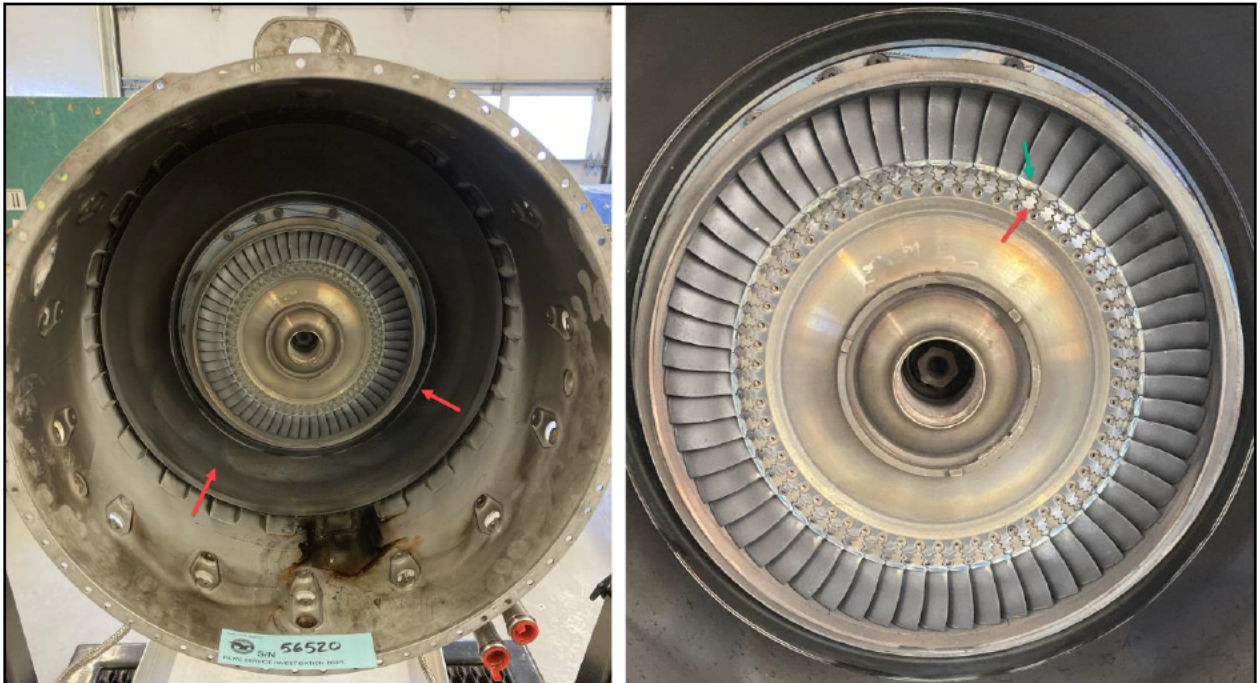
Photo No. 9, Compressor Turbine Disc

The CT turbine showed rotational contact marks on the disc firtrees (red arrow right view of Photo No. 9), blade platforms and blade firtrees (green arrow right view of Photo No. 9). The compressor pack was free to rotate with no noticeable abnormal noise.

The combustion liner was not shipped with the engine, but the small and large exit ducts were installed in the engine, (arrows in left view of Photo No. 9).

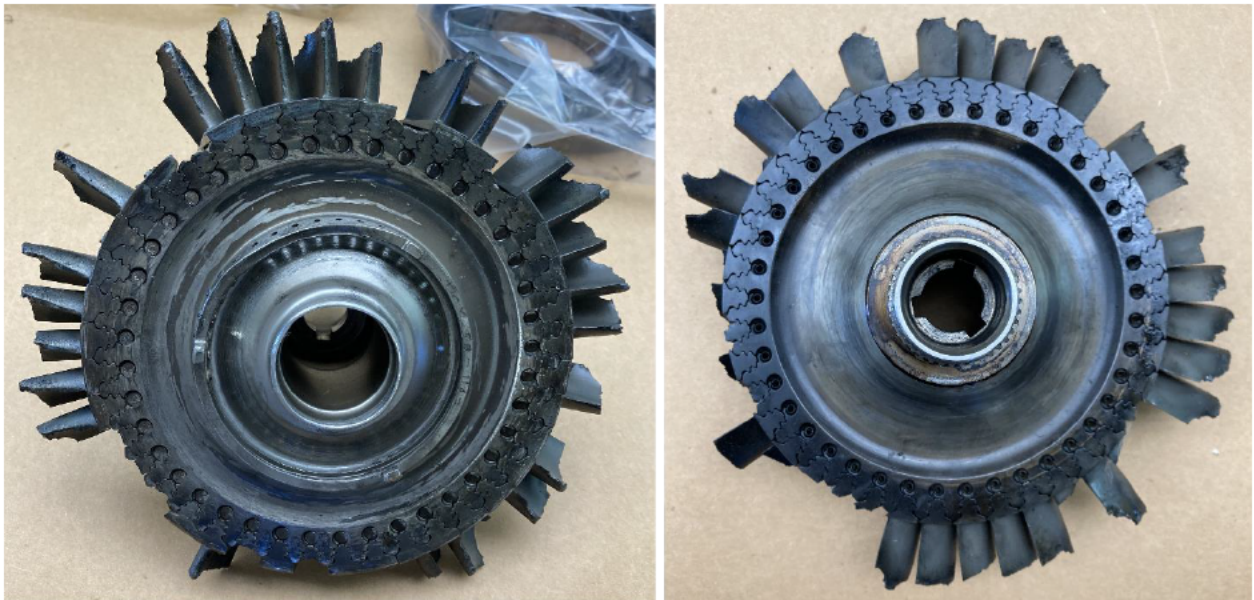
Photo No. 10, Power Turbine Disc

- 2.2 The power turbine (PT) vane, shaft, disc, blades, shroud and containment assembly all exhibited rotational contact damage. Optical examination of the fractured PT blades and No. 3 bearing outer race fractured surfaces using a stereoscope, showed a fracture morphology indicative of overload.

The PT disc was previously disassembled and shipped with the engine in a separate sealed plastic bag. The PT disc and the PT blades showed rotational contact on the upstream face, (left image in Photo No. 10). A portion of the balancing rim, due to rotational contact, was deformed towards the disc center axis. Some PT blades exhibited liberation from just above the firtree, some above the platform and others along the blade span (Photo No. 10 to 12). Impact damage was observed to both the blade remnants and the fracture surfaces. In undamaged regions of the fracture surfaces a rough granular topography was observed.

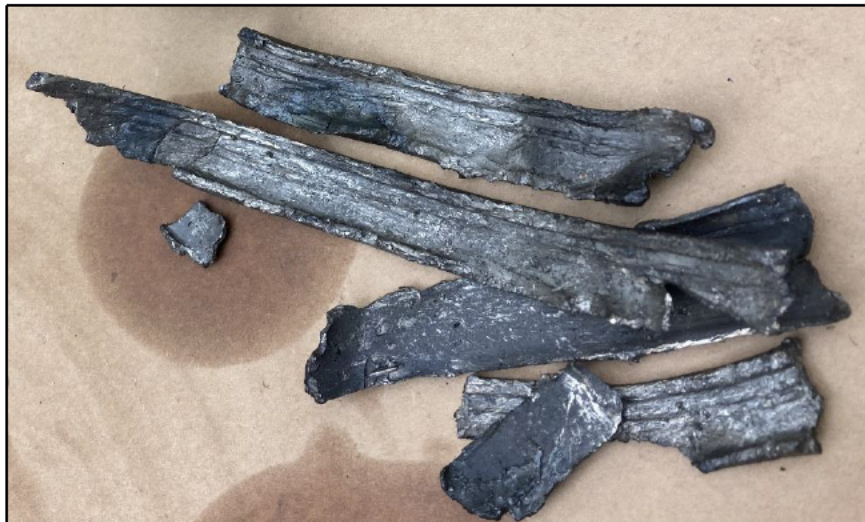
Photo No. 13, Power Turbine Shroud Ring

The PT shroud ring was fractured into multiple pieces and received in several plastic bags. Not all the pieces were accounted for, however, all the shroud blade contact surfaces showed signs of circumferential contact wear, obliterating the ring shroud surface (Photo No. 13). The PT containment and reinforcement rings exhibited an oval shape suggesting two higher energy release areas (red arrows in Photo No. 14). Additionally, it was observed that the containment ring exhibited along its width, a straight and clean cut likely produced during the initial disassembly at the Operator's hangar (purple arrow in Photo No. 14)

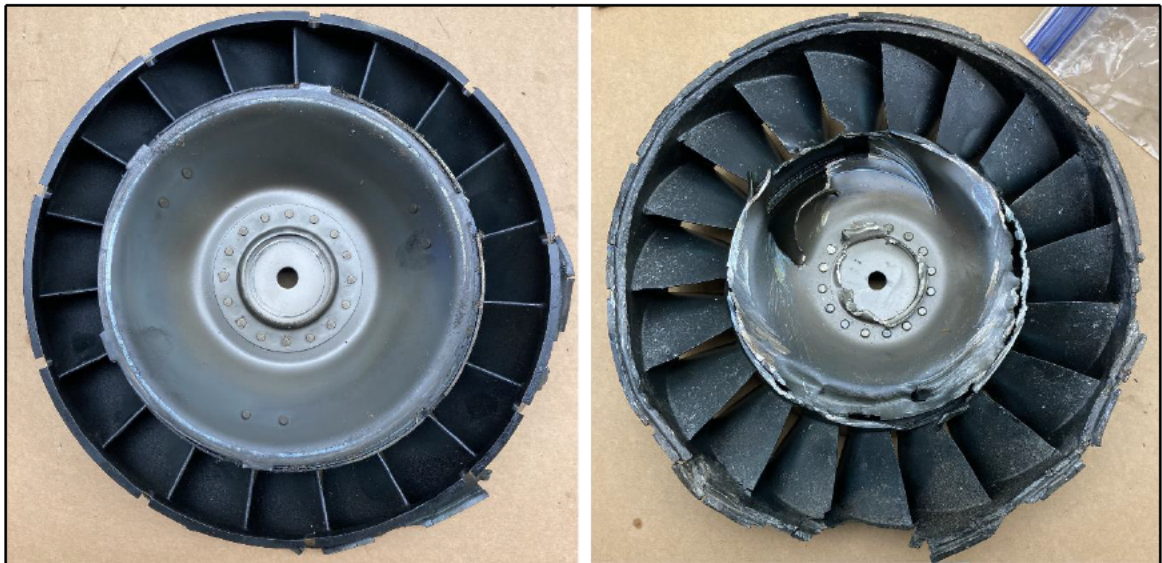
Photo No. 15, Power Turbine Vane

The PT vane and baffle shown in Photo No. 15, exhibited rotational contact marks from contact with the upstream PT blades and PT disc. The PT vane was identified as a non-P&WC approved repair by Southwest Turbines (STI prefix, red circle in Photo No. 16).

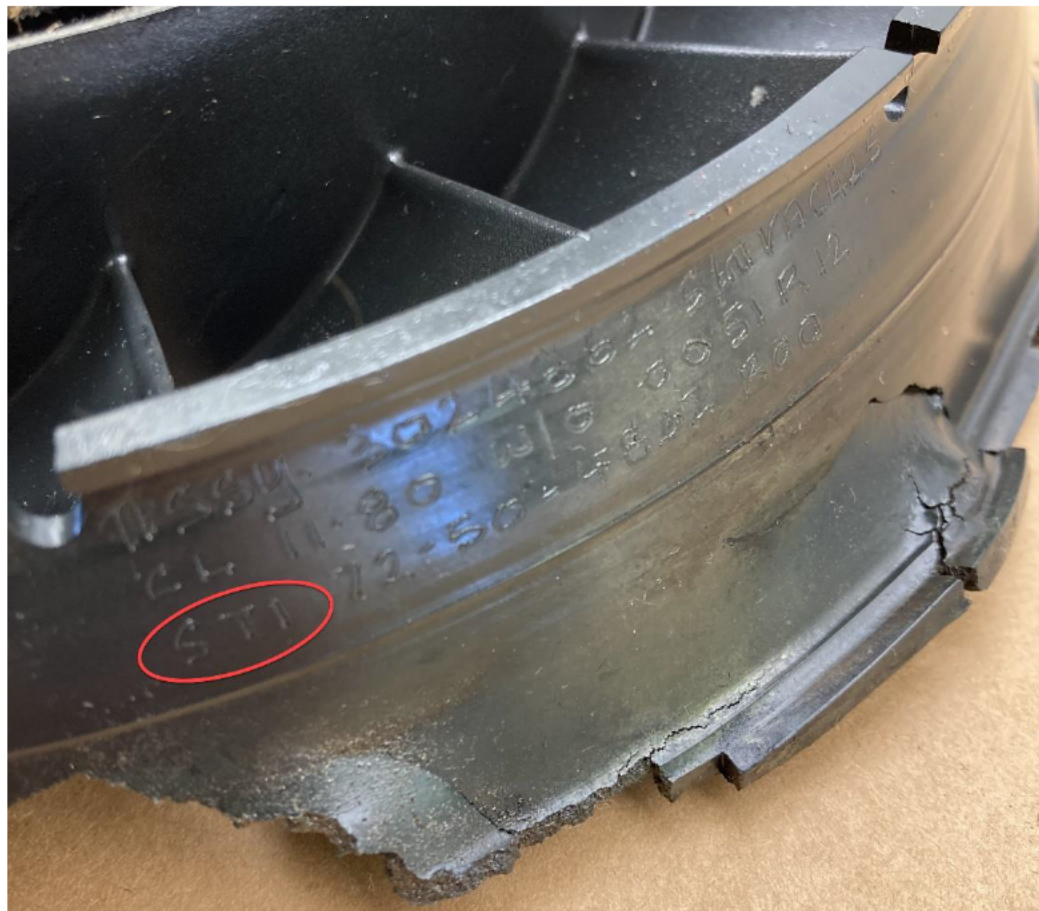
Photo No. 16, Power Turbine Vane Identification

- 2.5 The “STI” prefix identification observed on the PT vane suggests that a non-P&WC approved repair was performed on it but, it is not believed that this repair was the root cause of the engine malfunction.
- 2.6 The propeller shaft key washer marks and metal deformation exhibited evidence that the RGB was previously disassembled and reassembled with non-P&WC tooling. No entry of any RGB maintenance was documented in the engine logbook images provided by the NTSB IIC.

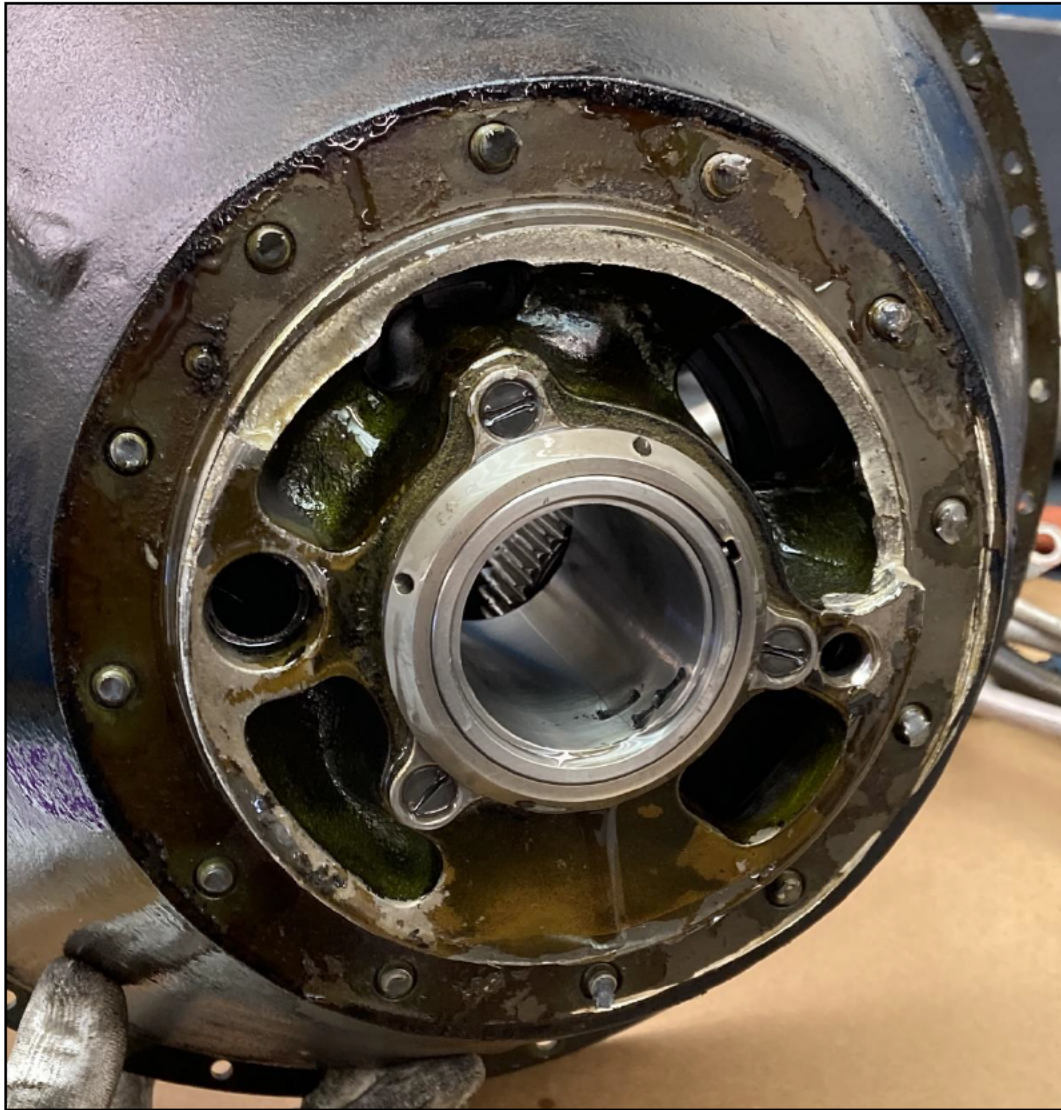
**Photo No. 17, Reduction Gear Box Rear Housing**

The bolts retaining the PT shaft housing to the RGB rear housing were all fractured (Photo No. 17). The PT shaft housing and the No. 3 bearing cover exhibited rotational contact damage (Photo No. 18). The PT shaft exhibited signs of heat tinting and rotational scoring on the midsection surface (Photo No. 19). The No. 3 bearing flanged outer ring was fractured into two halves (Photo No. 20). The bearing inner ring raceway exhibited signs of overheating similar to the PT shaft in color. The No. 3 bearing cage was deformed in an oval shape (Photo No. 20). The bearing rollers (Photo No. 20), which were all released from the cage, were found in the No. 4 bearing housing region (Photo No. 21). The No. 4 bearing did not show any signs of distress.

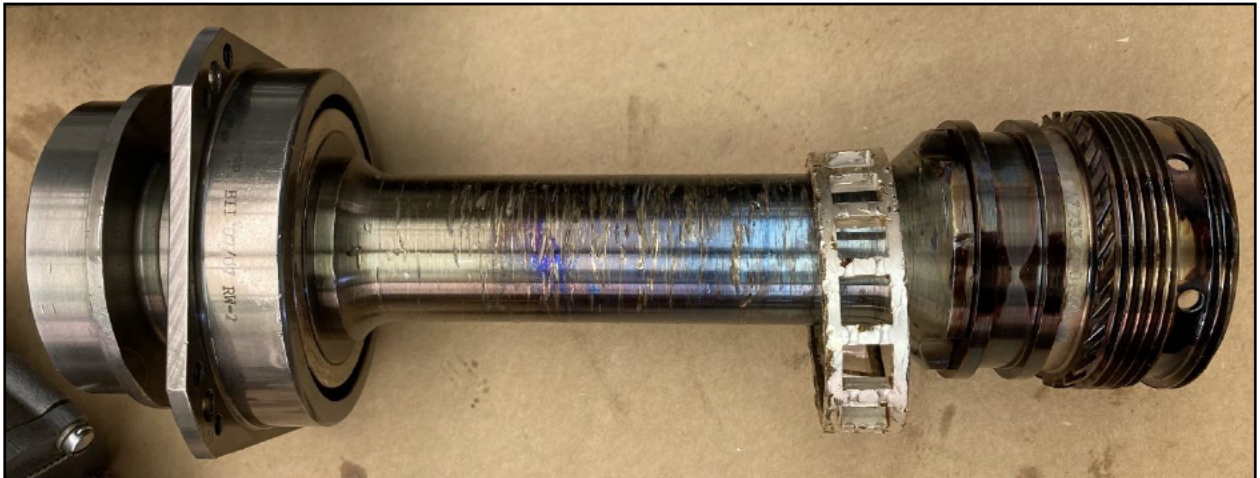
**Photo No. 19, Power Turbine Shaft**

- 2.3 The PT high energy event and unbalanced spool caused the No. 3 bearing to break apart. Similarly, the No. 3 bearing, PT shaft housing and cover exhibited rotational damage. One roller from the No. 3 bearing only showed deep linear scoring matching the wear observed on the PT shaft and the indentation in the 1<sup>st</sup> stage carrier sleeve. Most of the No. 3 rollers exhibited signs of axial loading.

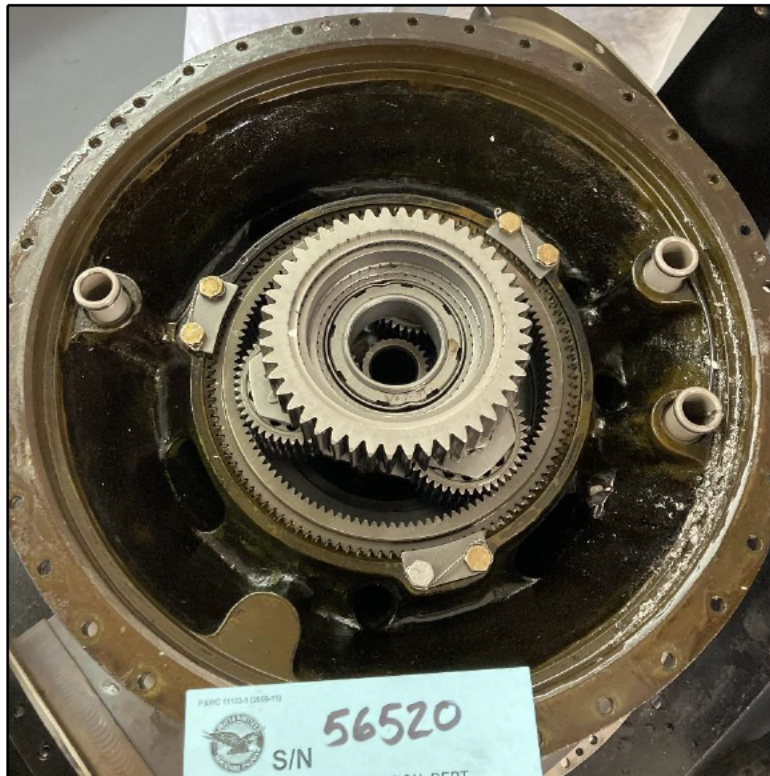
Photo No. 22, RGB Rear Housing Front RGB Housing Interface

The RGB rear housing “A” flange, as shown in Photo No. 22, with the exception of metallic debris, did not exhibit visible distress. The RGB rear housing “B” flange, interfacing with the PT shaft housing flange, exhibited rotational contact distress (red arrows). The “B” flange retaining bolts were all fractured (white arrows, Photo No. 23).

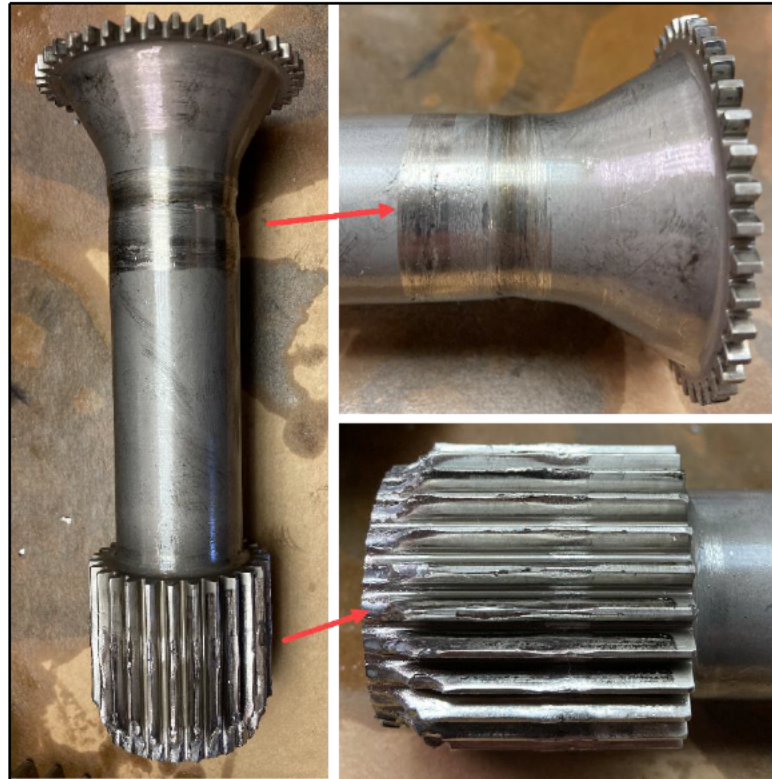
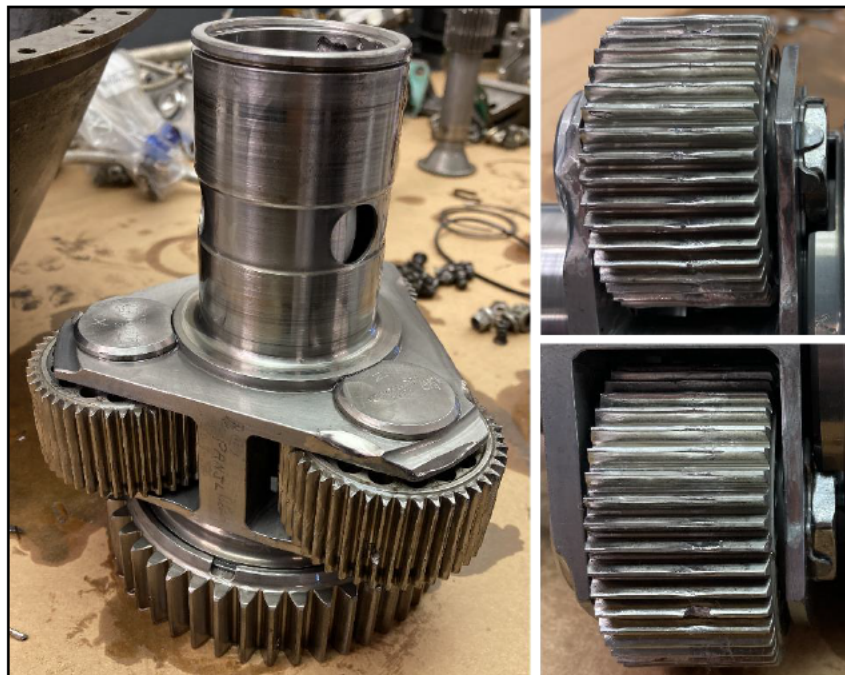
- 2.4.2 The second effect was an increase in radial and axial movement of the 2<sup>nd</sup> stage carrier assembly due to the reduced support by the 2<sup>nd</sup> stage ring gear. The oscillating movement of the unsupported assembly was transmitted to the 1<sup>st</sup> stage carrier sun gear, where damage was observed on the mating teeth. Additionally, the movement through the 1<sup>st</sup> stage sun gear into the PT input shaft resulted in both an excessive axial load as observed on the roller endfaces and a nonconcentric radial load on the No. 3 bearing outer ring resulting in its fracture. The loss of support from the

The 1<sup>st</sup> stage sun gear and planet gear mating teeth shown in Photo No. 24 & 25, exhibited signs of distress resulting in material loss.

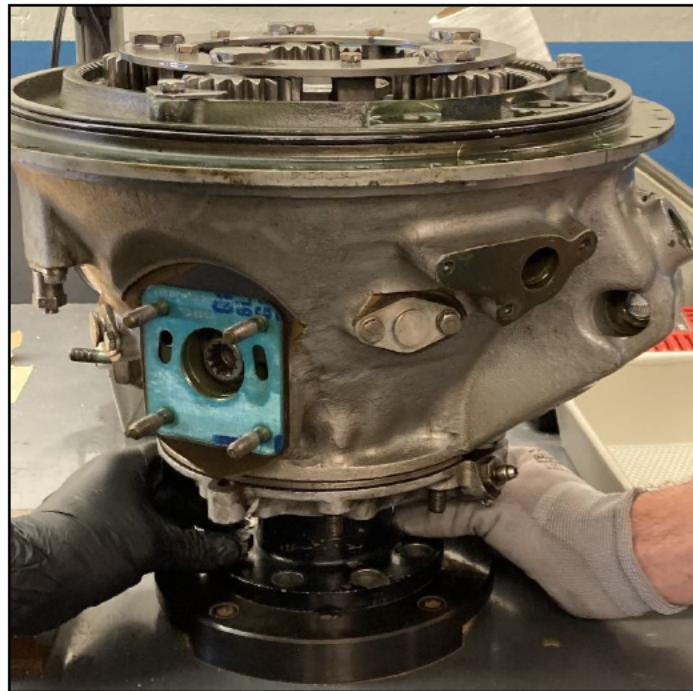
**Photo No. 26, RGB Front Housing**

No visual anomaly was observed on the exterior surfaces of the RGB front housing (Photo No. 26). The 2<sup>nd</sup> stage carrier and planet gears visually exhibited normal in-service condition (Photo No. 27). It was observed that the 2<sup>nd</sup> stage ring gear was incorrectly assembled. The ring gear retaining slot was located forward of the three retaining plates and as a result was found capable of moving freely axially within the RGB housing splines (Photo No. 28). All three 2<sup>nd</sup> stage ring gear retaining plates and respective RGB housing mounting holes did not show signs of distress.

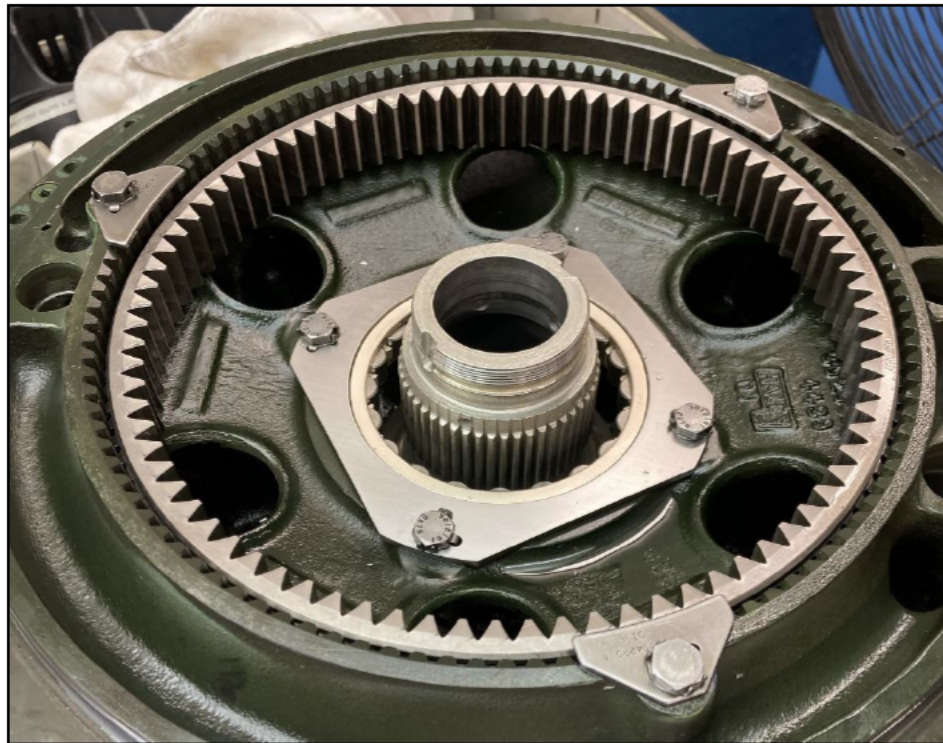
Photo No. 28, RGB 2<sup>nd</sup> Stage Ring Gear and Retaining Brackets

- 2.4 The RGB 2<sup>nd</sup> stage ring gear was observed to be installed incorrectly. It was installed in front of the retaining plates instead of fixed within the dedicated slot on the ring gear. The incorrect assembly permitted the 2<sup>nd</sup> stage ring gear to migrate forward into the RGB front housing inducing a twofold effect.

- 3.1 The incorrect installation of the 2<sup>nd</sup> stage ring gear caused the front RGB housing splines to shear off on the entire circumference, subsequently decoupling the PT rotor from the propeller shaft and potentially causing the PT rotor to exceed the governed speed limits. Additionally, the reduced support of the 2<sup>nd</sup> stage ring gear also caused an imbalance movement in the RGB gear assembly which was transmitted to the No. 3 bearing and ultimately damaged the PT rotor assembly.

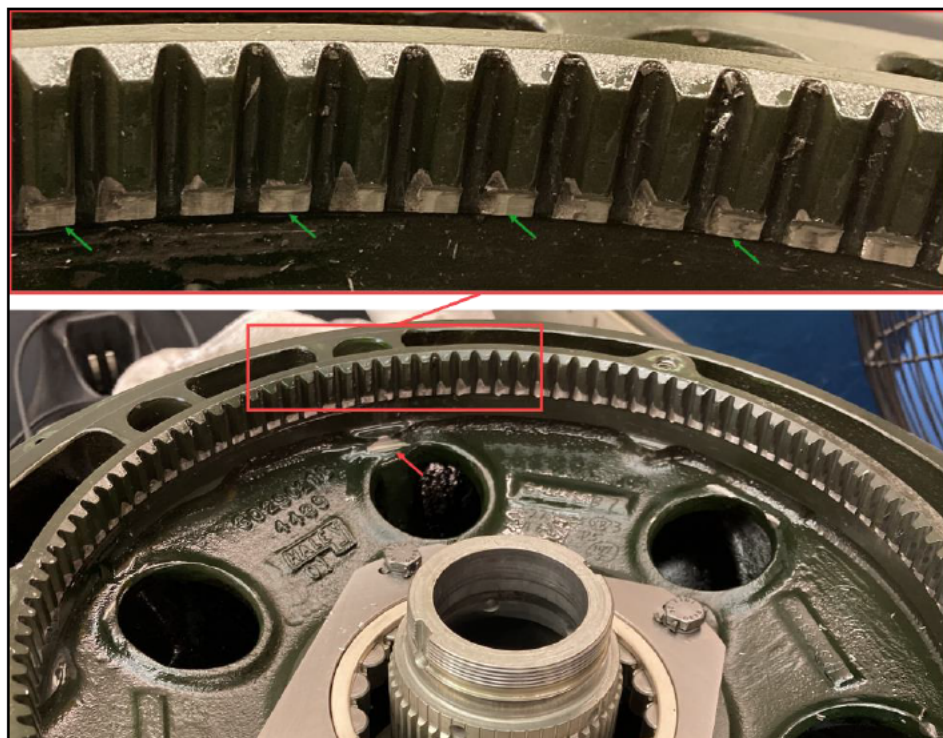
Photo No. 29, RGB Front Housing 2<sup>nd</sup> Stage Ring Gear Splines

- 2.4.1 The first effect was a reduction in the 2<sup>nd</sup> stage ring gear axial meshing spline engagement, to the point where the remaining contact surface could no longer sustain the ring gear load. Consequently, the small overlapping region sheared off circumferentially allowing the ring gear to spin freely. The effect of the 2<sup>nd</sup> stage ring gear free spinning resulted in the decoupling of the PT disc from the propeller shaft and potentially to an ungoverned speed increase of the PT rotor.

Removal of the 2<sup>nd</sup> stage ring gear revealed distress over the full circumference of the front RGB housing mating splines that resulted in material loss of the spline teeth forward ends (green arrows in Photo No. 29). Matching contact/wear marks were observed on the 2<sup>nd</sup> stage ring gear spline teeth ends (Photo No. 30). The 2<sup>nd</sup> stage ring gear was also found to have contacted the RGB front housing surfaces adjacent to the housing splines machining these regions flat, shown by the red arrow in Photo No. 29.

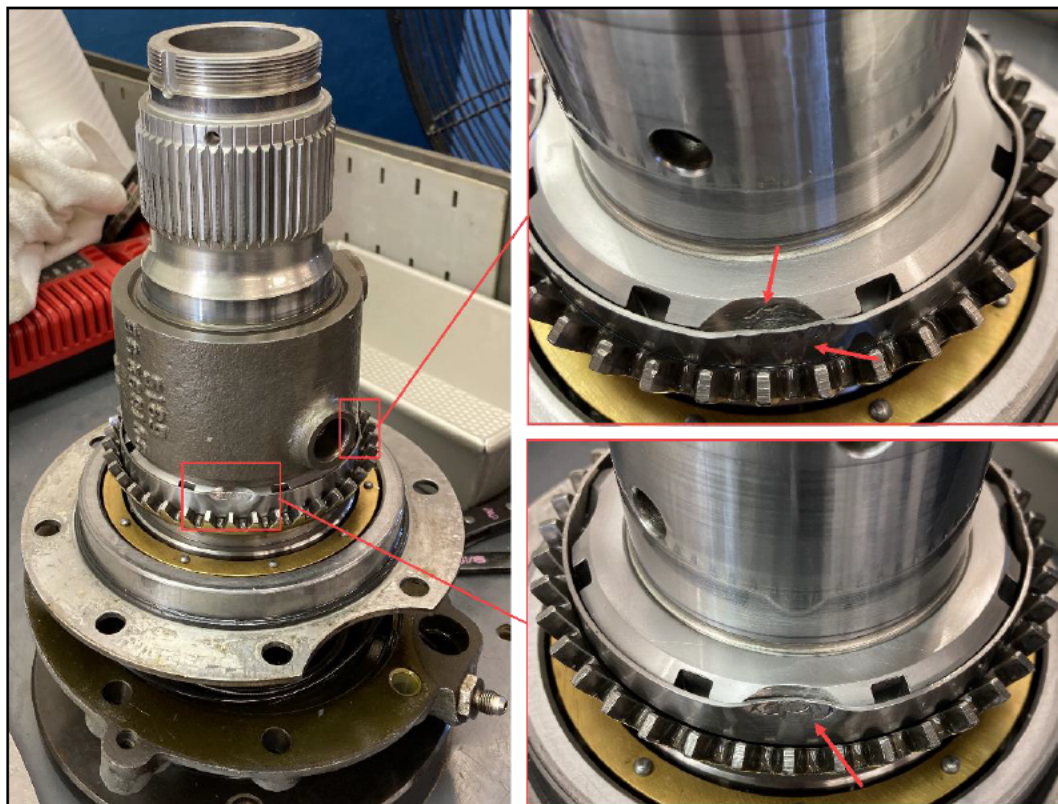
Photo No. 31, Propeller Shaft Assembly and Key Washer

The propeller shaft assembly exhibited no evidence of distress. However, the propeller shaft retaining nut and key washer exhibited tool marks and localized damage indicative of previous removal (red arrows in top right image of Photo No. 31). Tool marks were observed on the key washer swaged section that were not consistent with the condition left when using the dedicated P&WC tooling red arrow in bottom right image of Photo No. 31.
