# National Transportation Safety Board

ERA23LA328

## **AIR TRAFFIC CONTROL**

Group Chairman's Factual Report

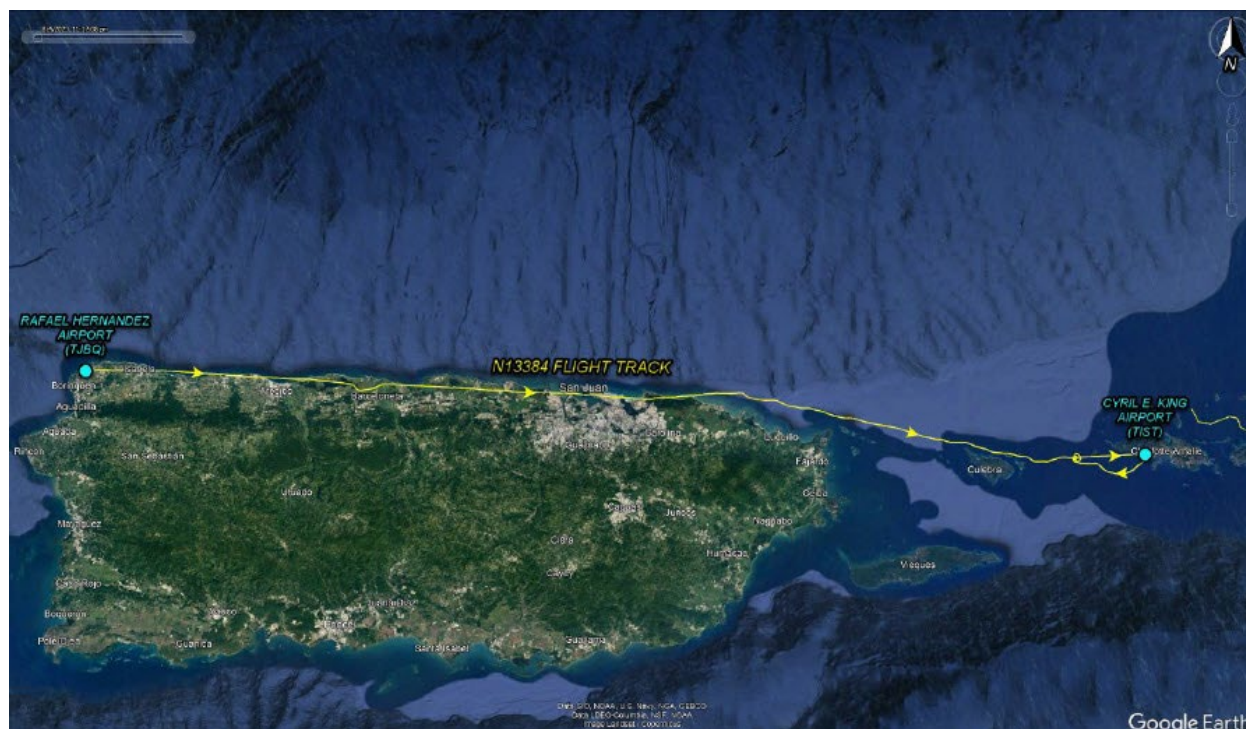
**Figure 1.** Overhead view of the entire accident flight track overlaid onto satellite imagery with pertinent information annotated.

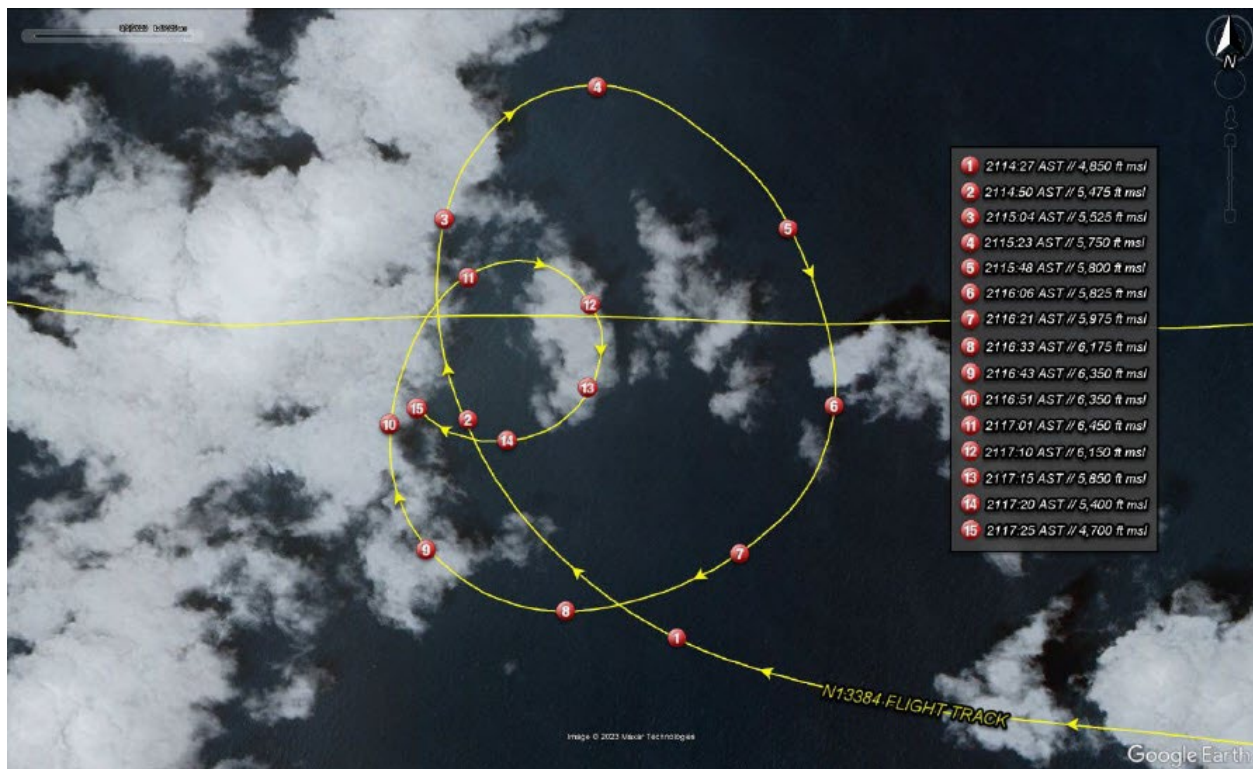
**Figure 2.** Overhead view of the final segment of the accident flight track overlaid onto satellite imagery with pertinent track information provided.

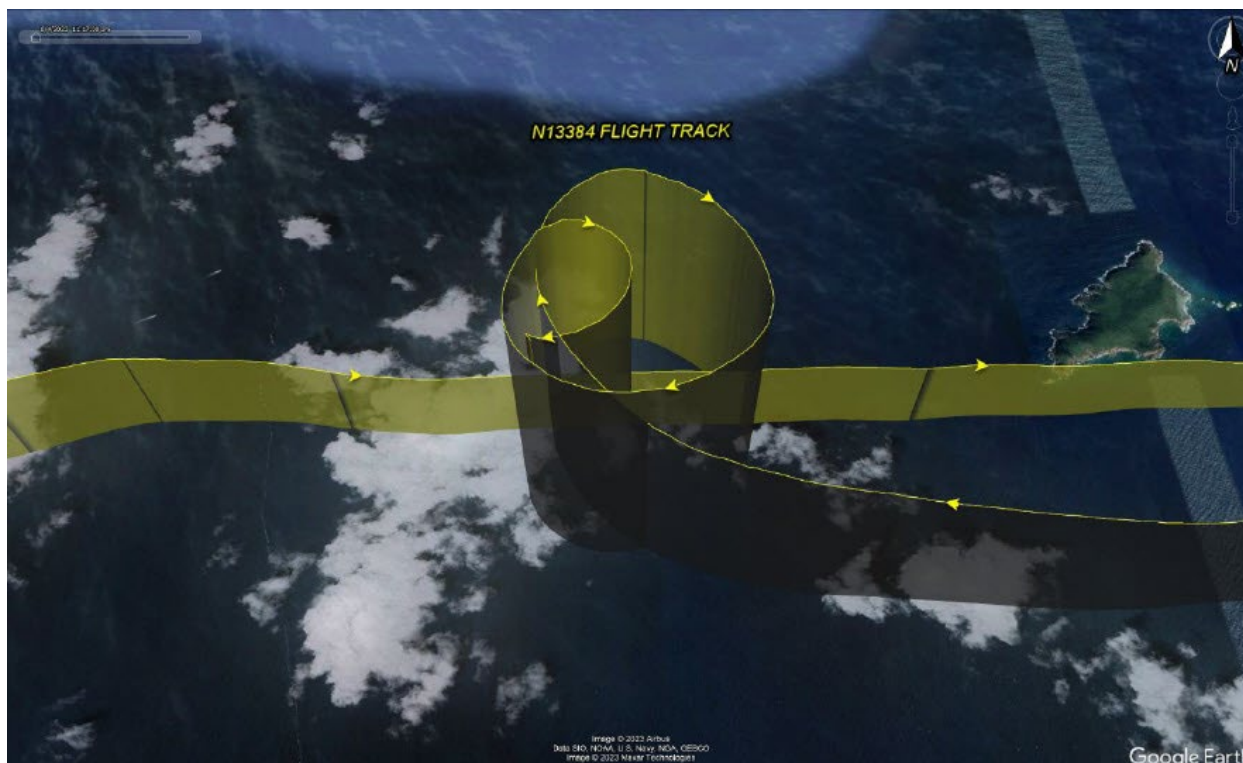
**Figure 3.** Profile view of the final segment of the accident flight track overlaid onto satellite imagery with pertinent information annotated.

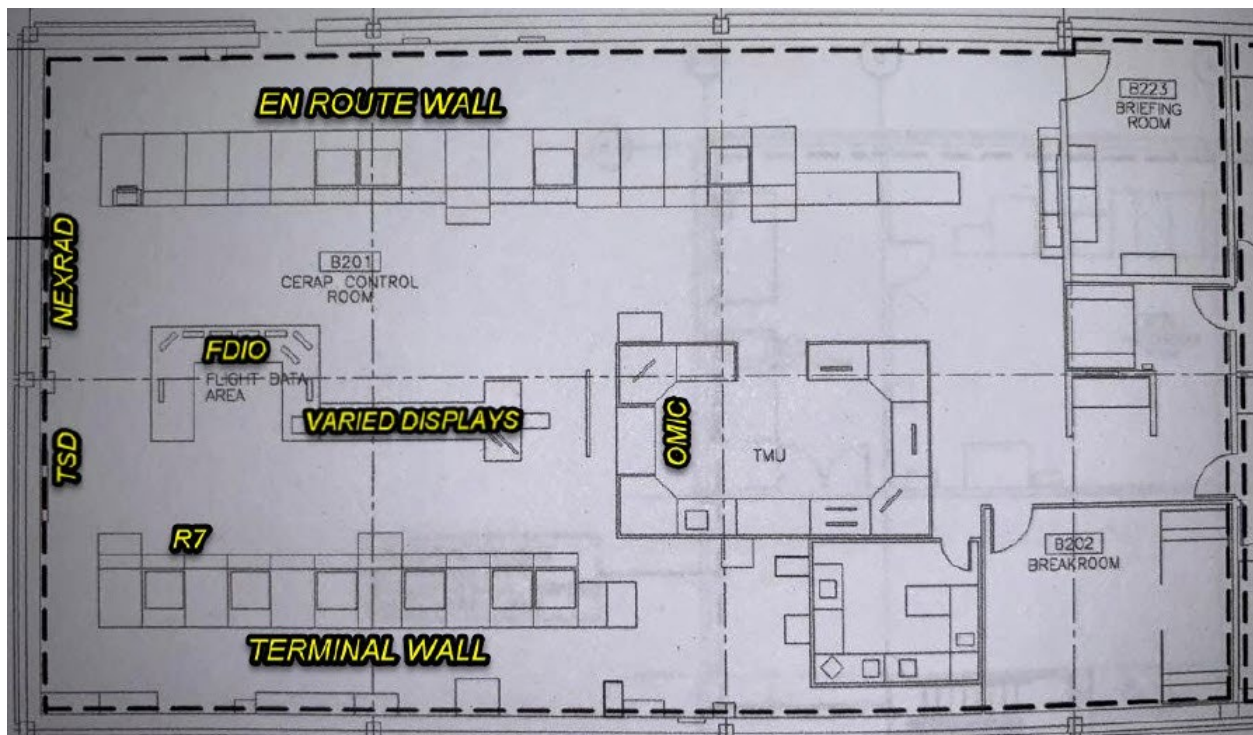
**Figure 4.** ZSU CERAP control room layout with pertinent information labeled. (Diagram provided by the FAA).

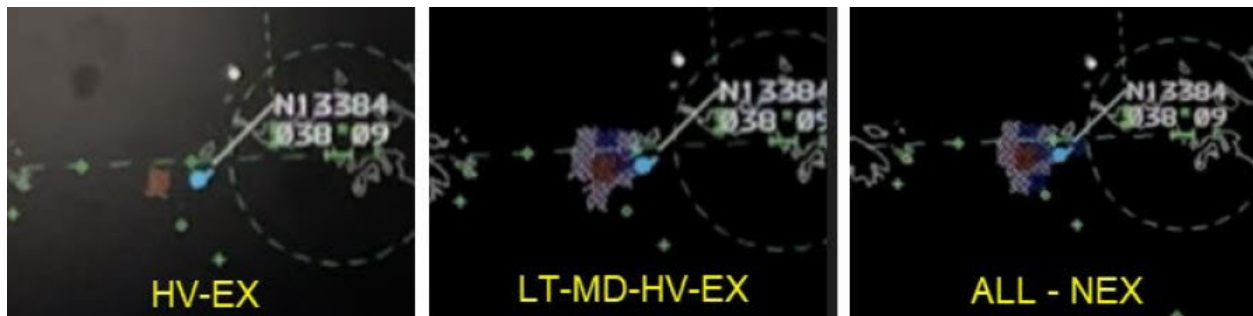
were selected for display in accordance with facility standard operating procedure (SOP). Figure 4 is a side-by-side comparison with the different levels of precipitation as would have been visible to the controller if those levels had been selected (EX-extreme, HV-heavy, MD-moderate, and LT-light).

**Figure 5.** Comparison of MEARTS display at 2113:30 AST comparing from left to right: Heavy-Extreme precipitation only; Light through Extreme precipitation; light through extreme and NEXRAD precipitation.

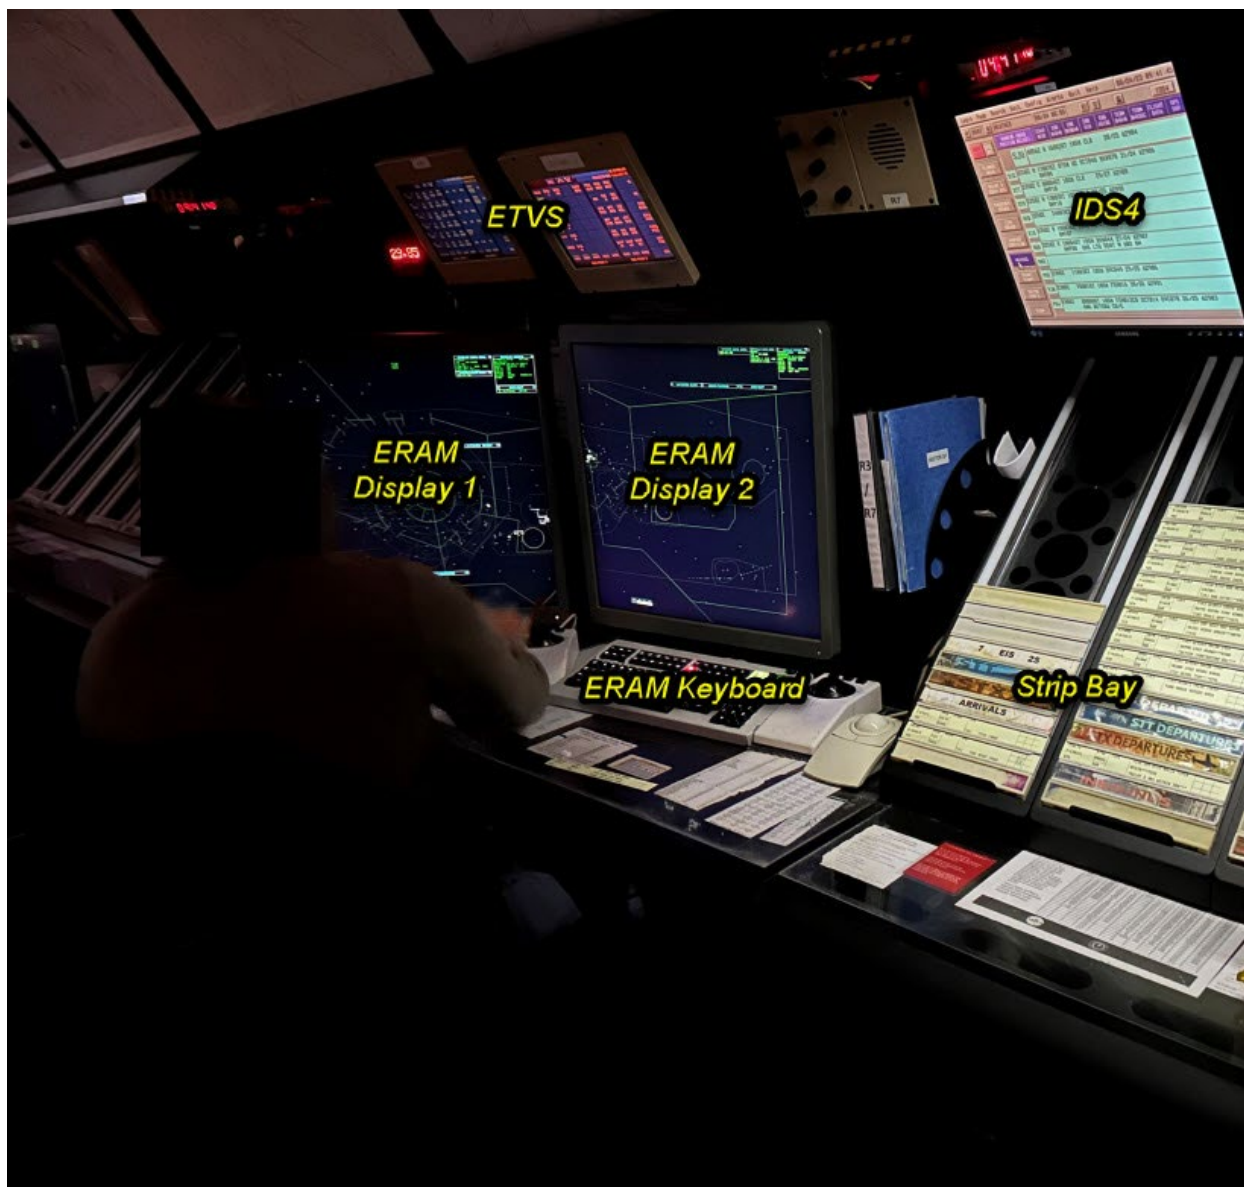
**Figure 6.** Photograph of the R7 position combined as it was at the time of the accident with pertinent information labeled.

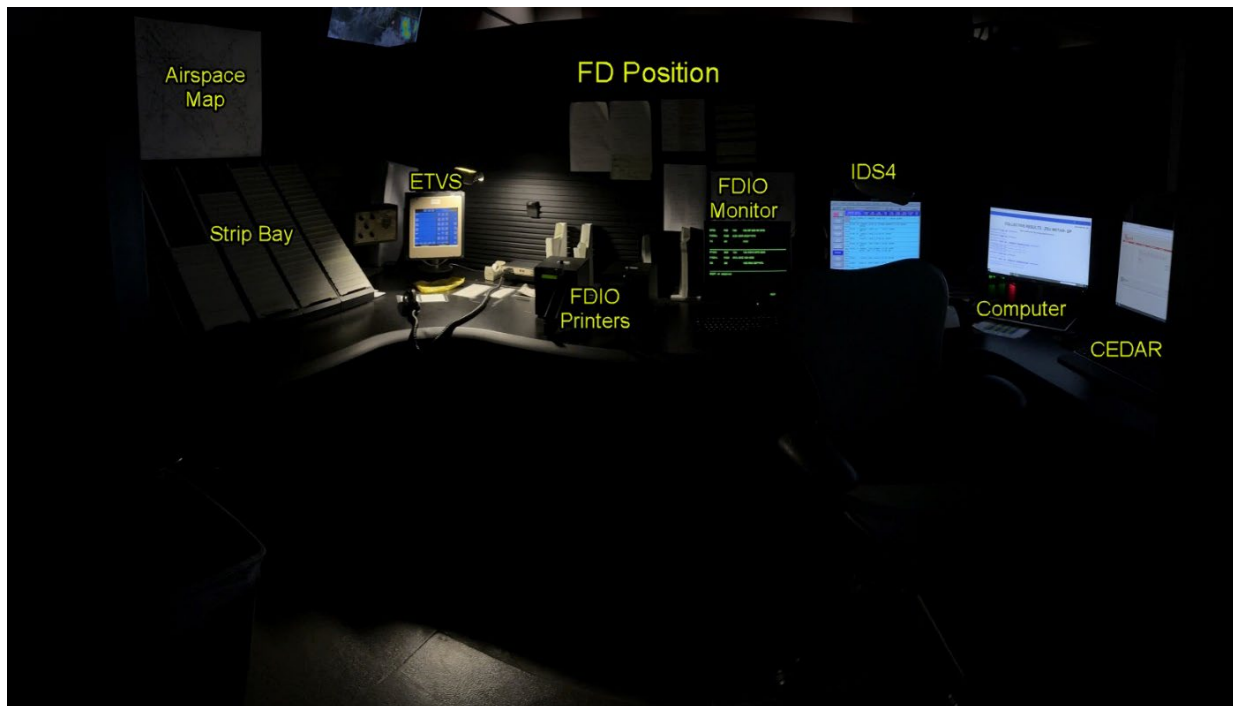
**Figure 7.** Photograph of the Flight Data workstation with pertinent information labeled.

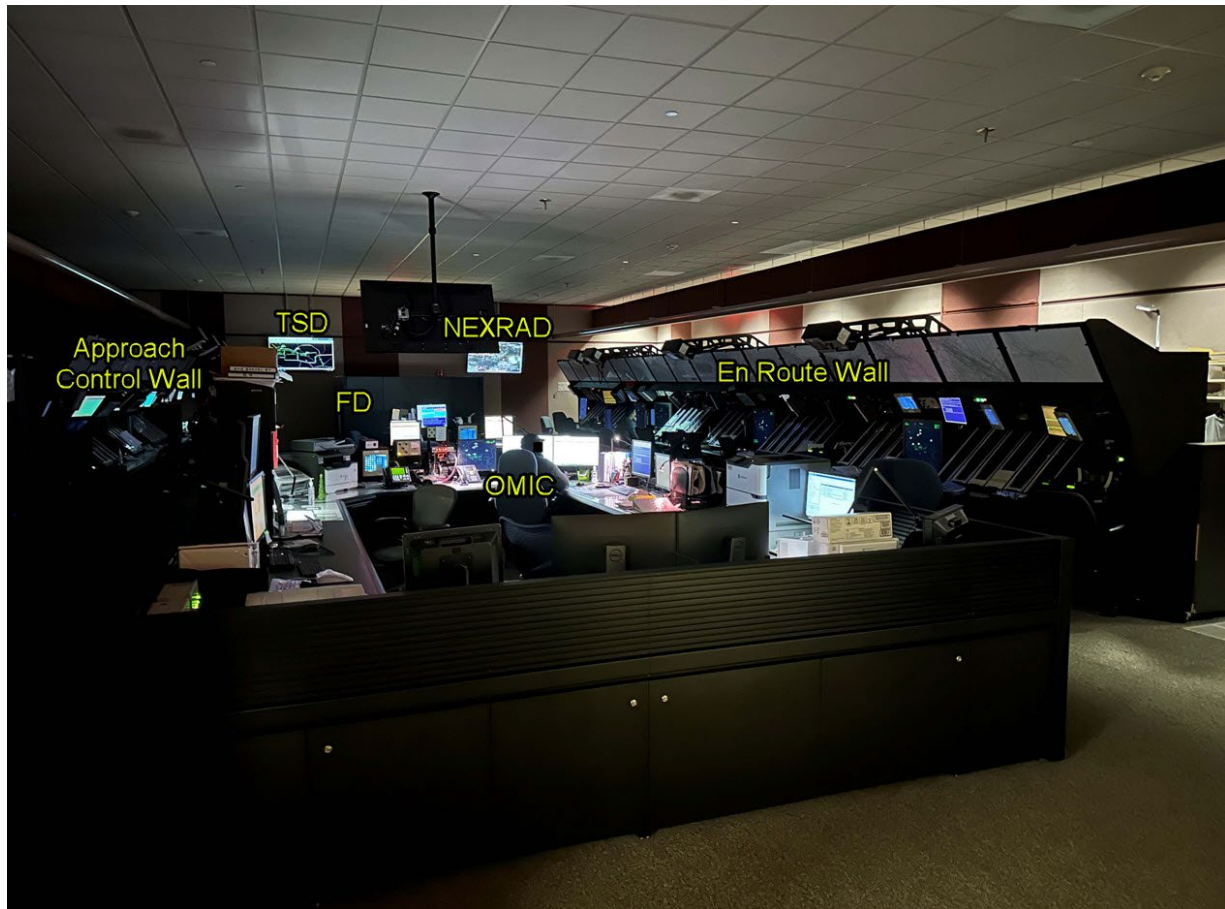
**Figure 8.** View of the operational area from the entrance with pertinent information labeled.

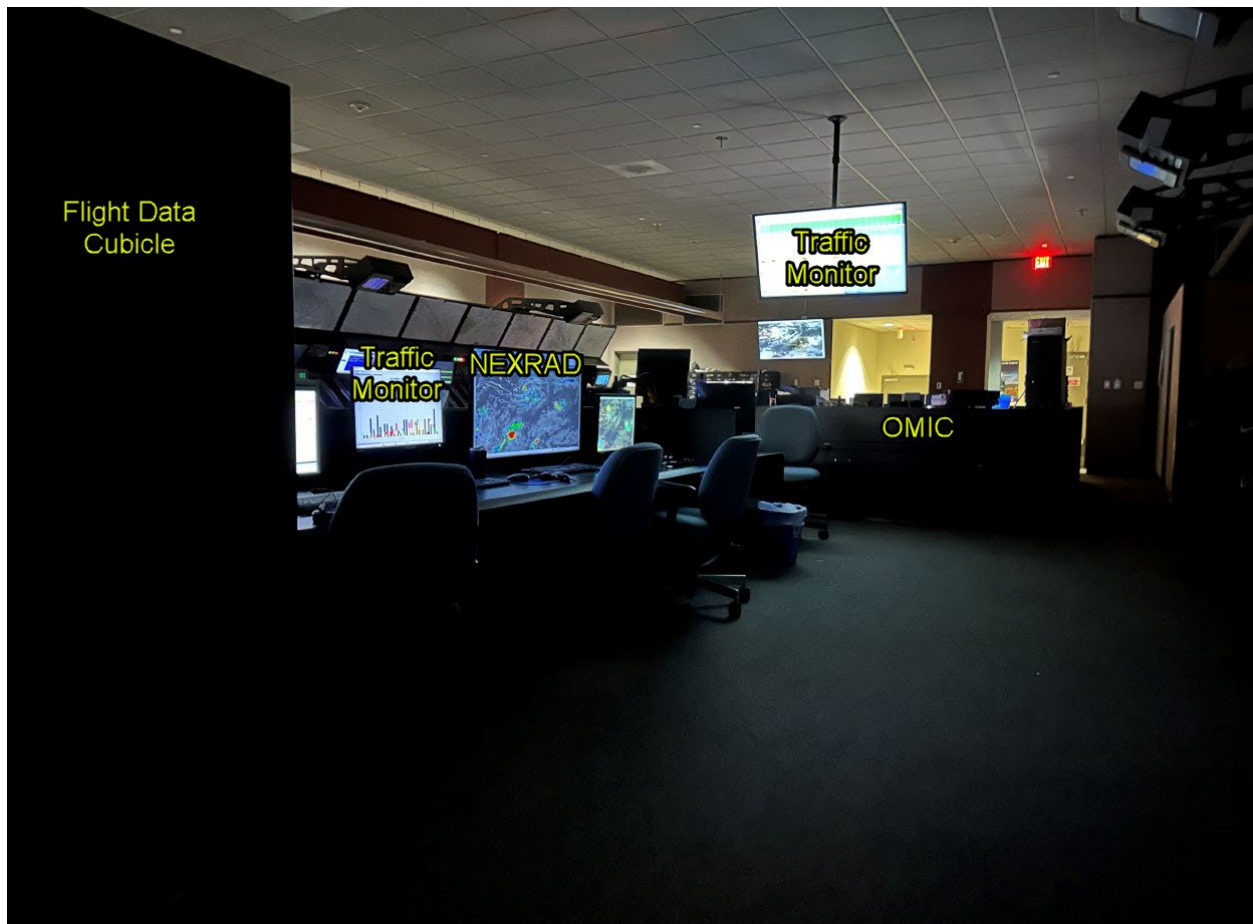
due to the smaller monitor size and location behind the controller and about 10-12 feet away. Figure 9 is a view of these monitors as seen from the R7 position.

**Figure 9.** From the R7 position looking back toward the secondary NEXRAD display with pertinent information labeled.
