ERA23LA333

## INVESTIGATION PHOTOGRAPHS

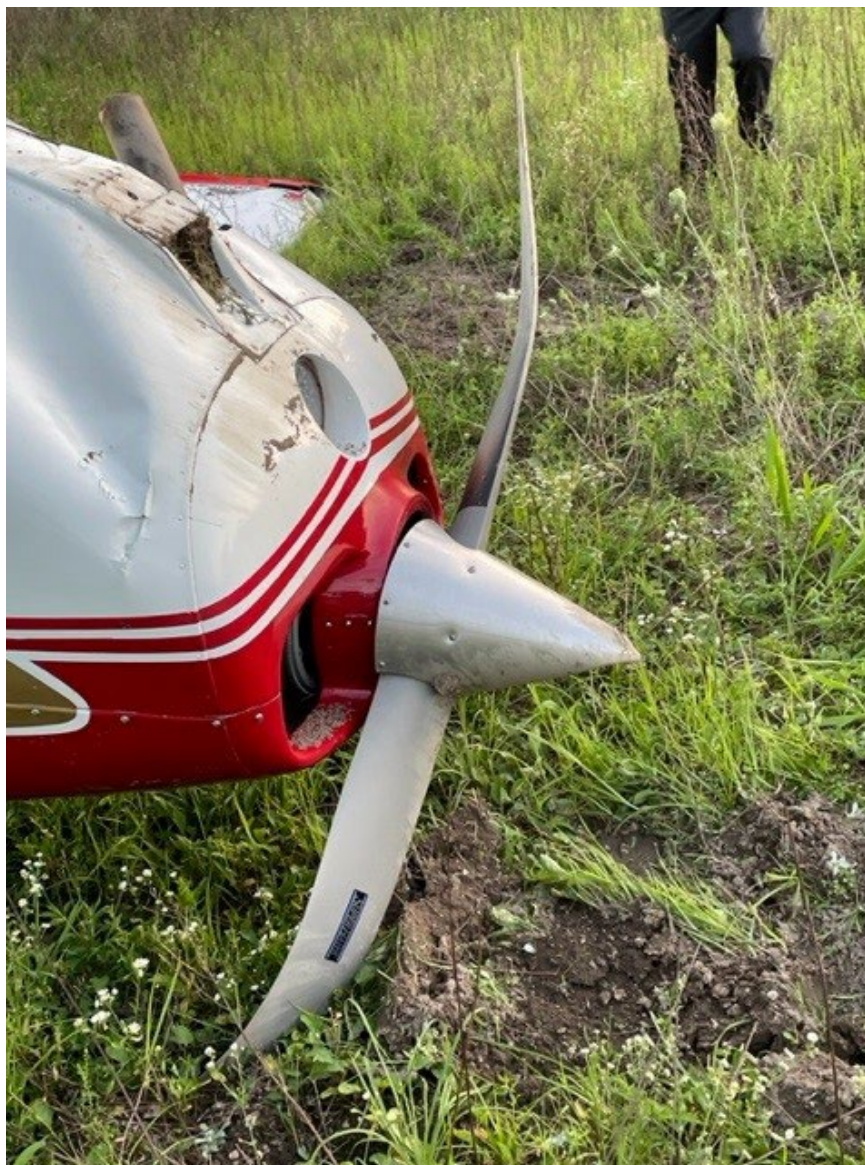
**Photograph 1 - Propeller and Engine Compartment (Courtesy of FAA)**

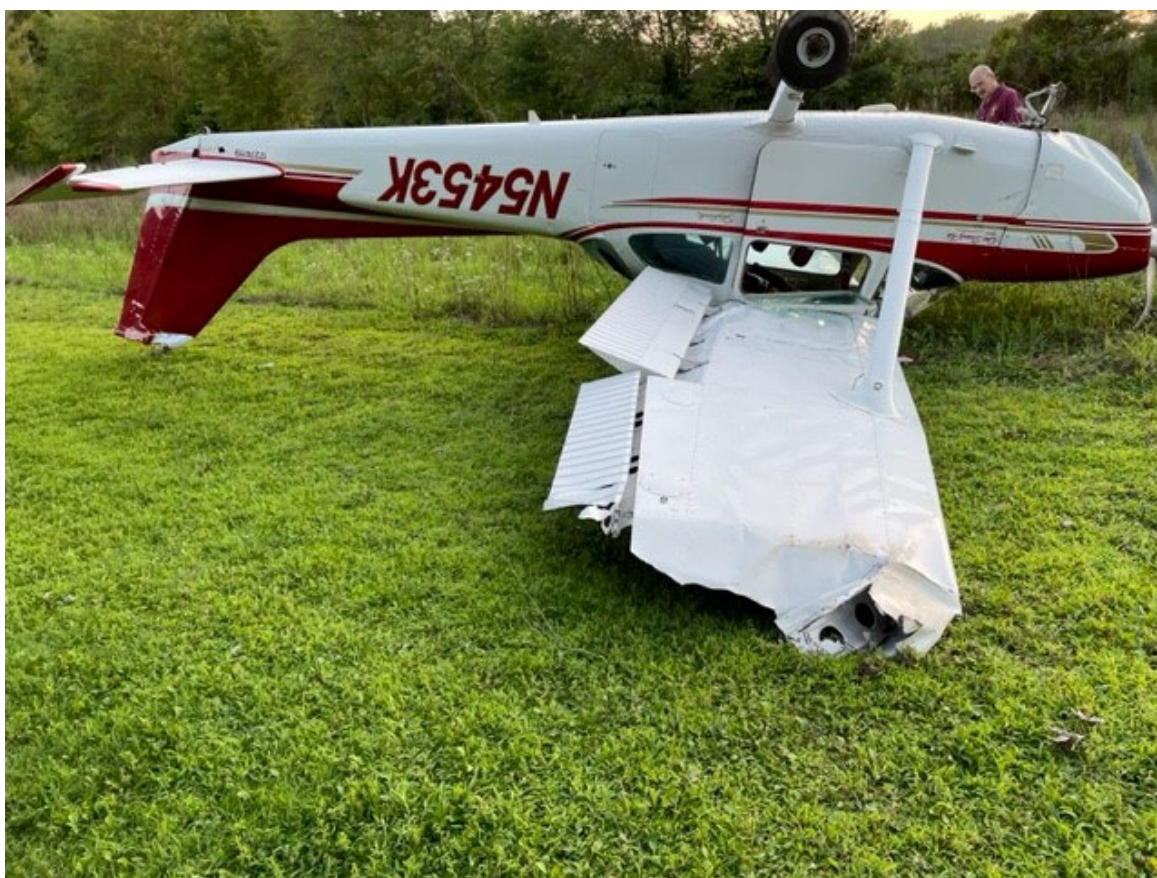
**Photograph 2 - Main Wreckage (Courtesy of FAA)**

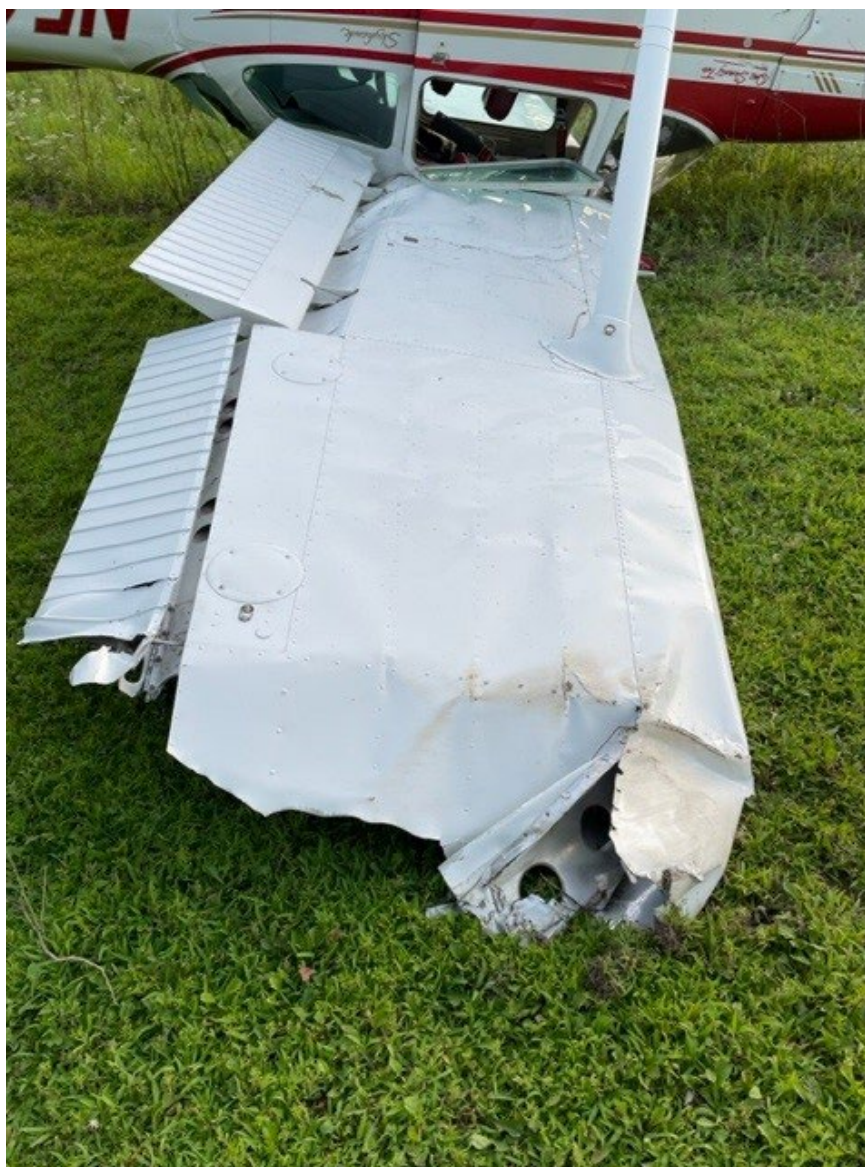
**Photograph 3 - Left Wing Damage (Courtesy of FAA)**
