ERA23LA337

## **WRECKAGE PHOTOGRAPHS**

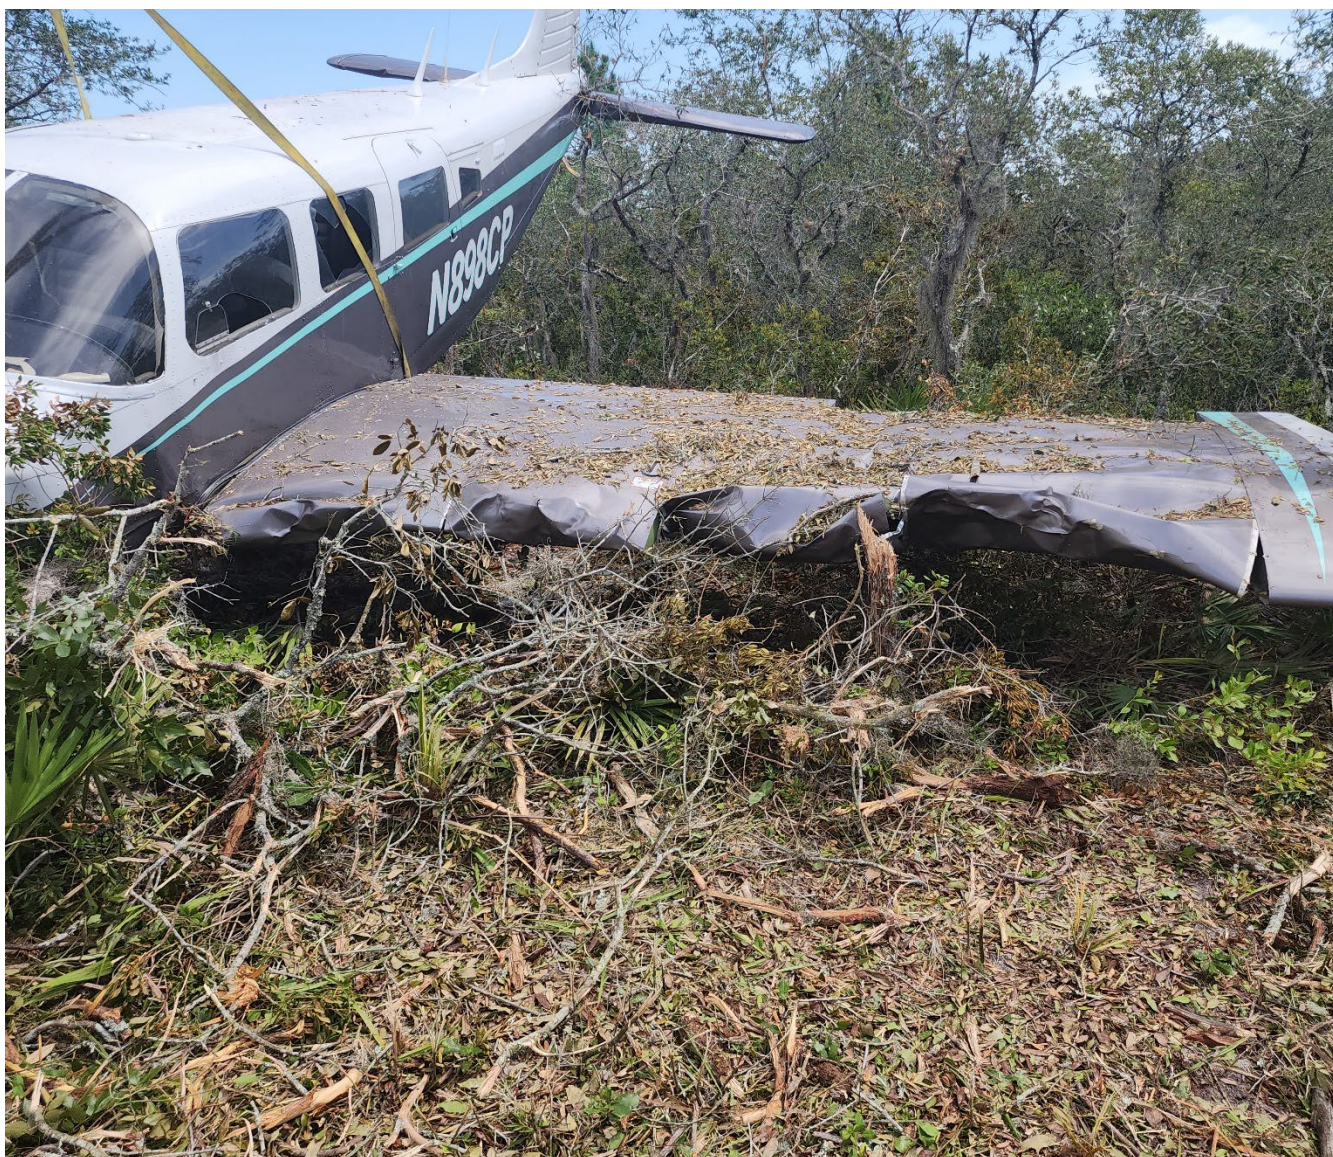
**Photograph 1 - Wreckage at accident site (Courtesy of FAA)**

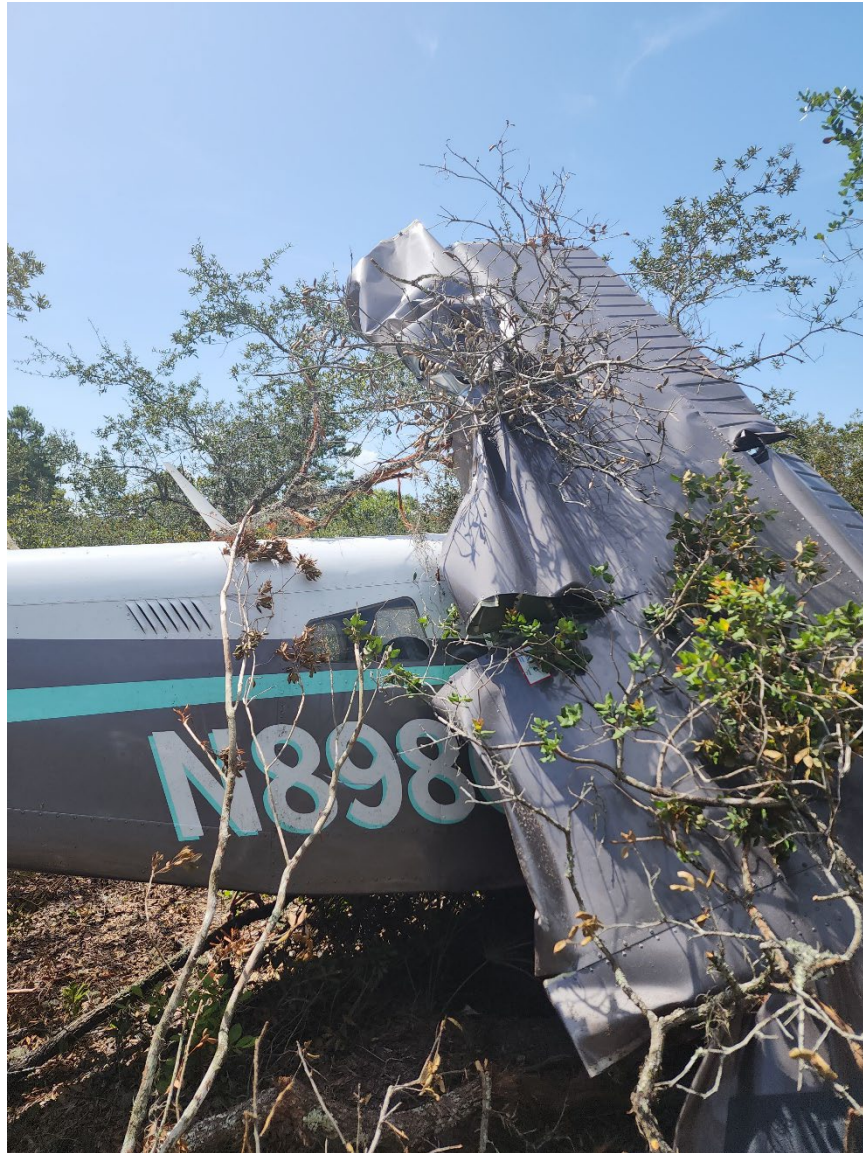
**Photograph 2 - Wreckage at accident site (Courtesy of FAA)**

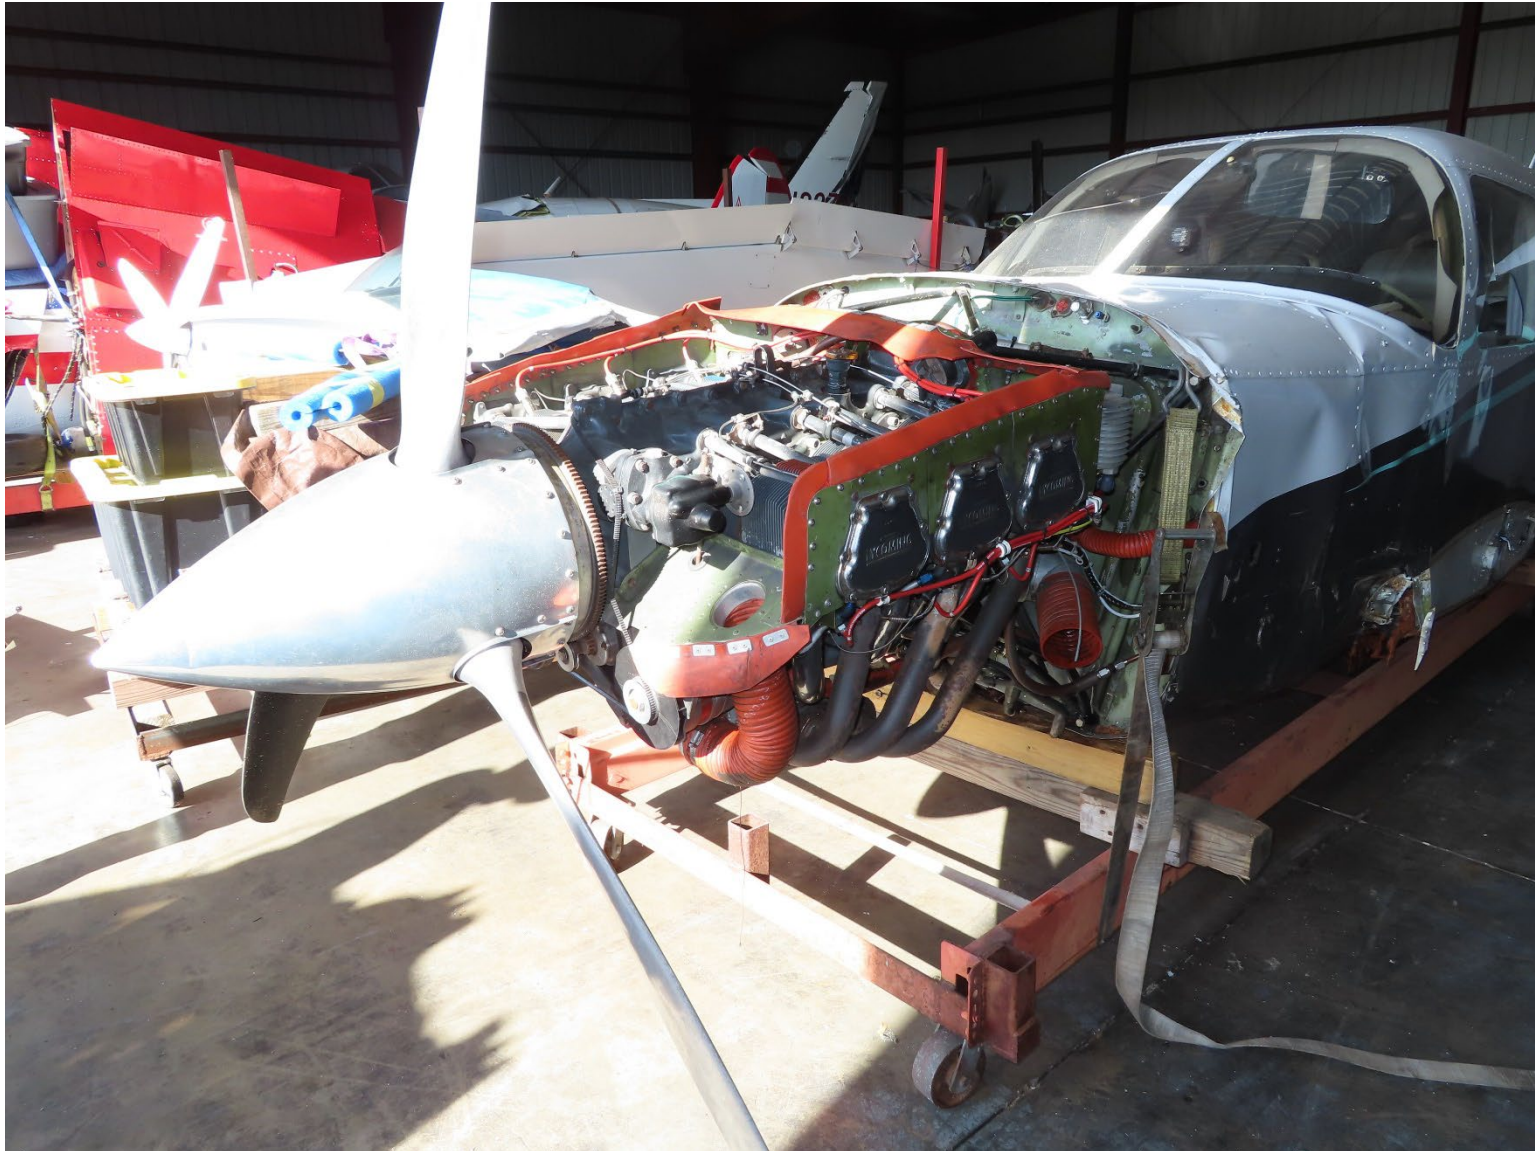
**Photograph 3 - Engine overview (Courtesy of Piper)**

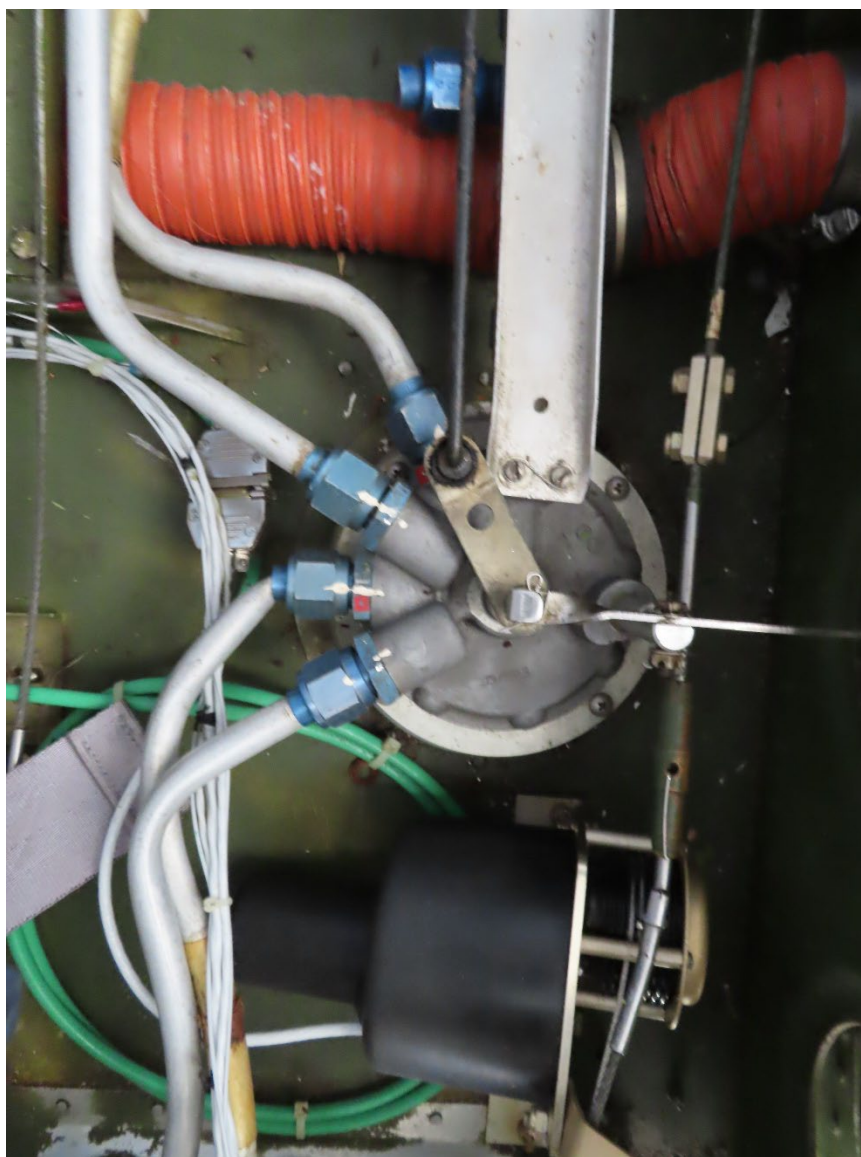
**Photograph 4 - Fuel selector valve (Courtesy of Piper)**

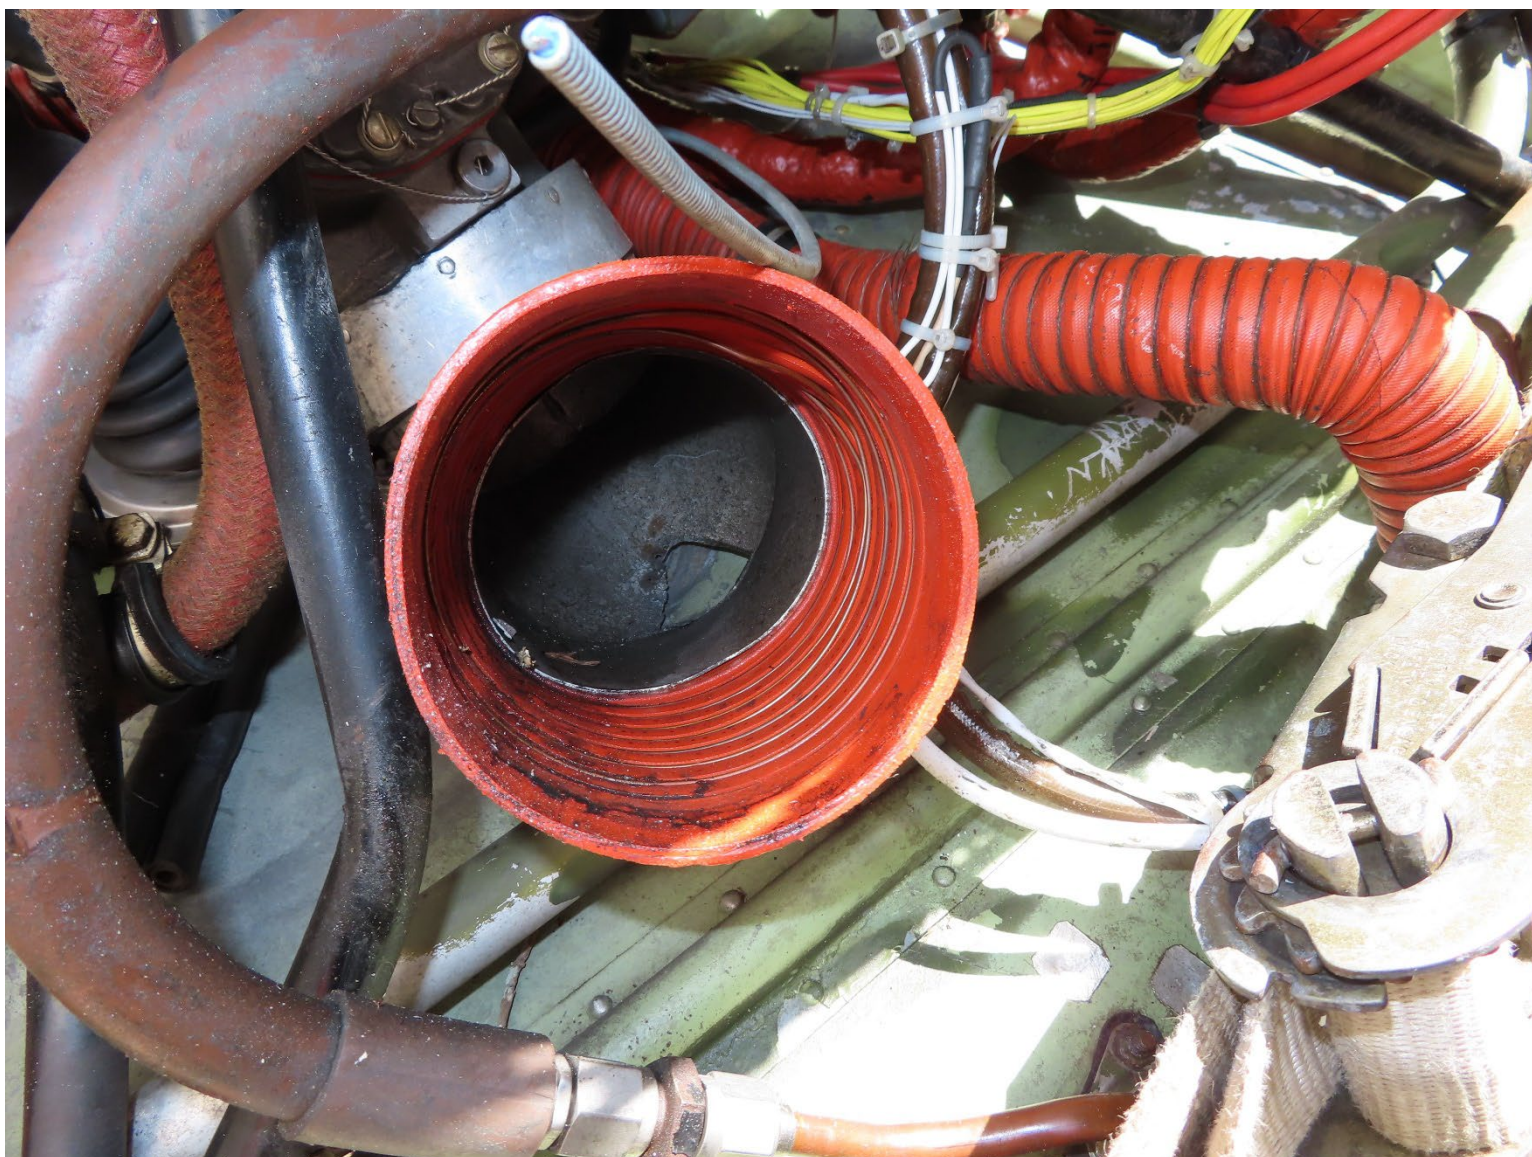
**Photograph 5 - Fuel servo air inlet tube (Courtesy of Piper)**

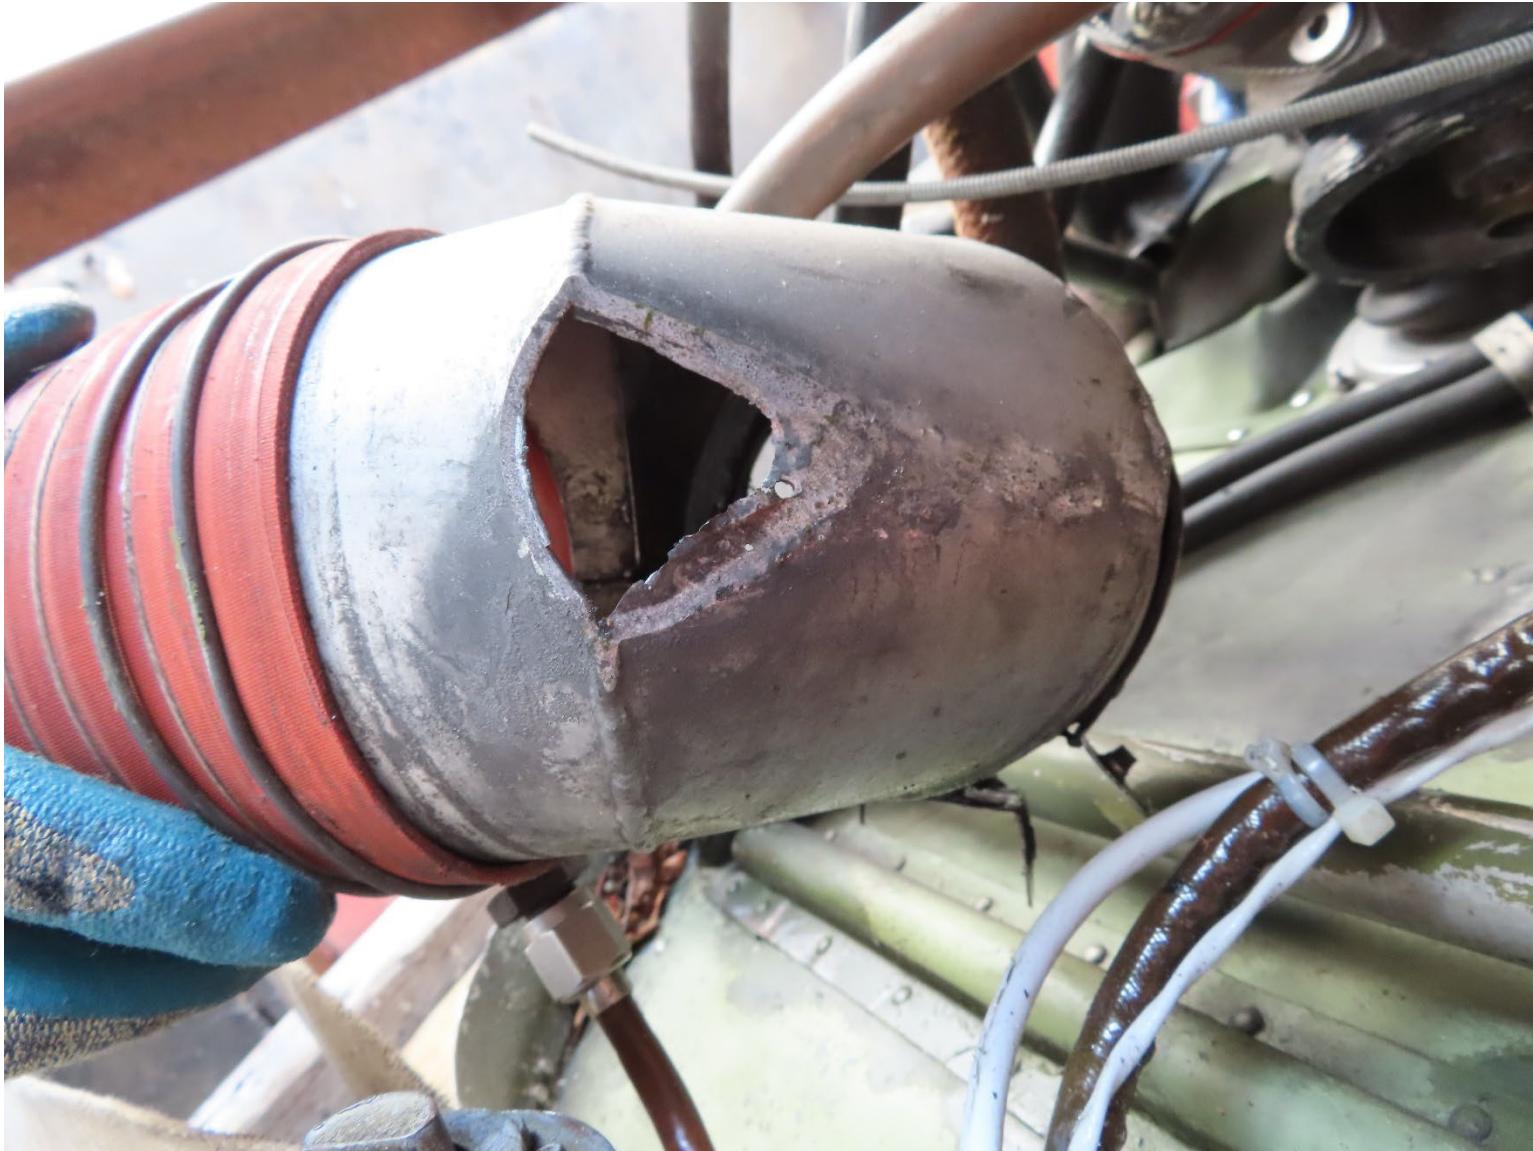
**Photograph 6 - Fuel servo air inlet tube with hole (Courtesy of Piper)**

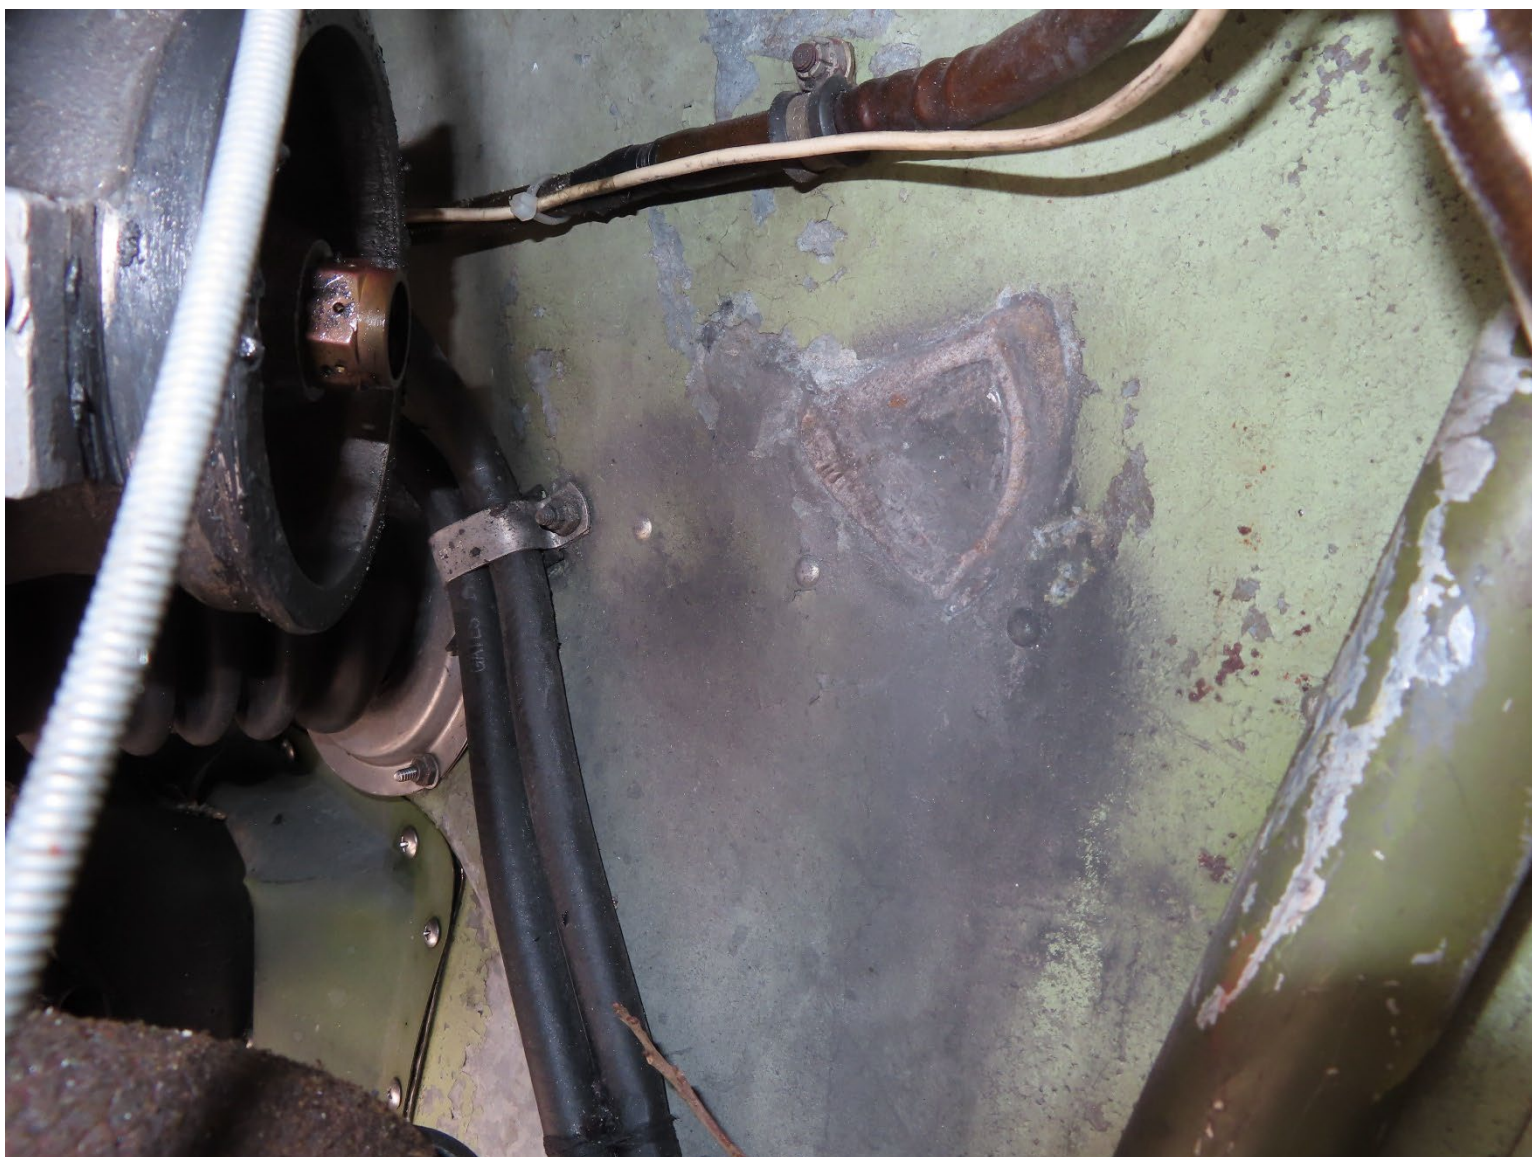
**Photograph 7 - Firewall wear from induction tube (Courtesy of Piper)**

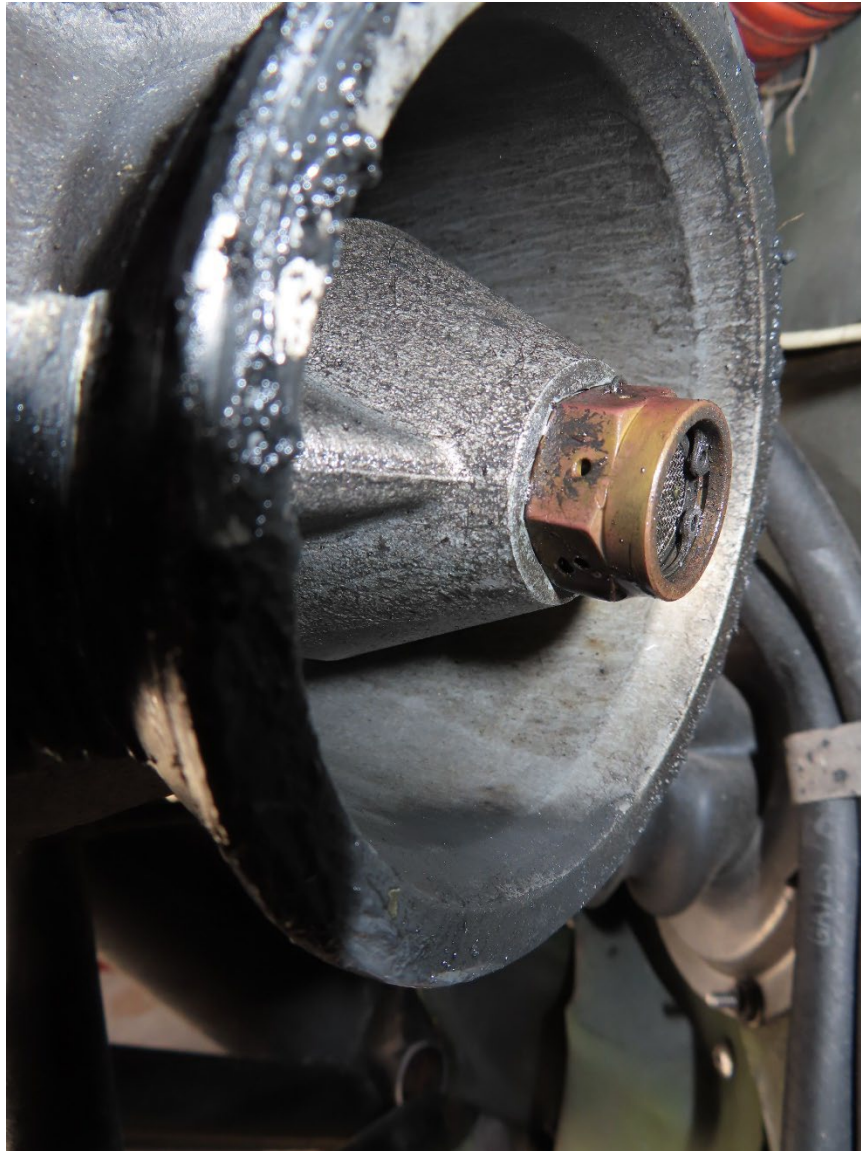
**Photograph 8 - Fuel servo air inlet (Courtesy of Piper)**

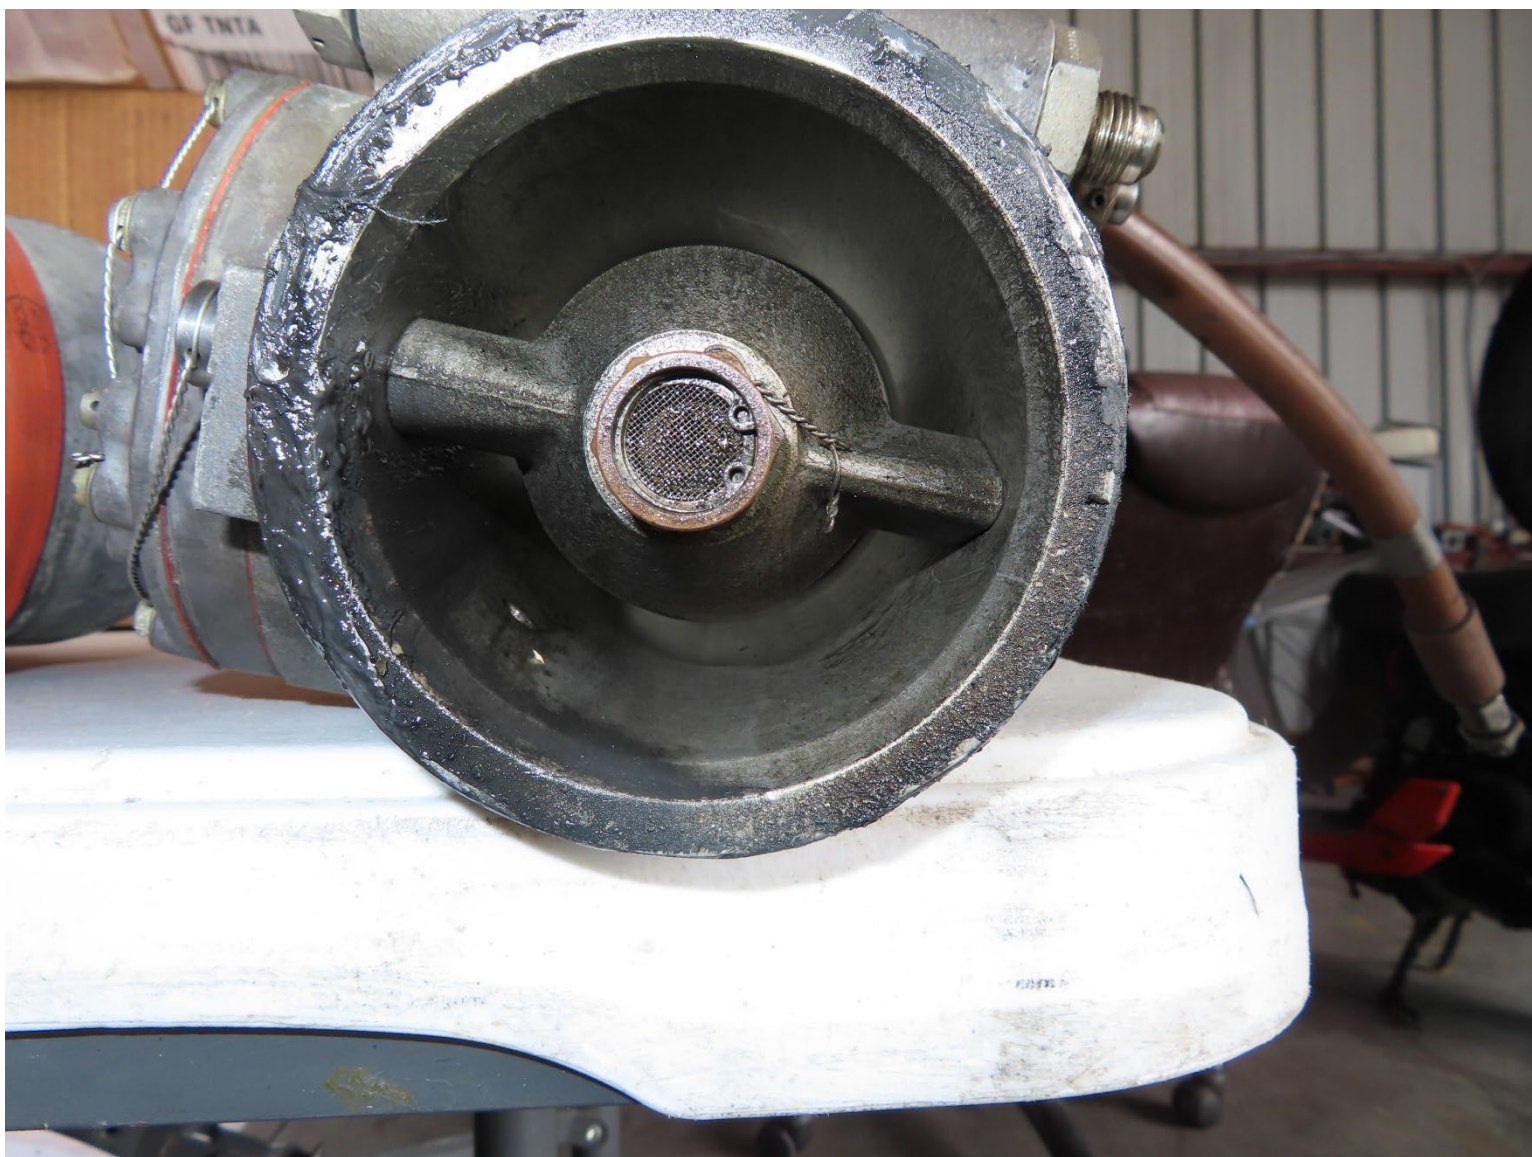
**Photograph 9 - Fuel servo air inlet (Courtesy of Piper)**

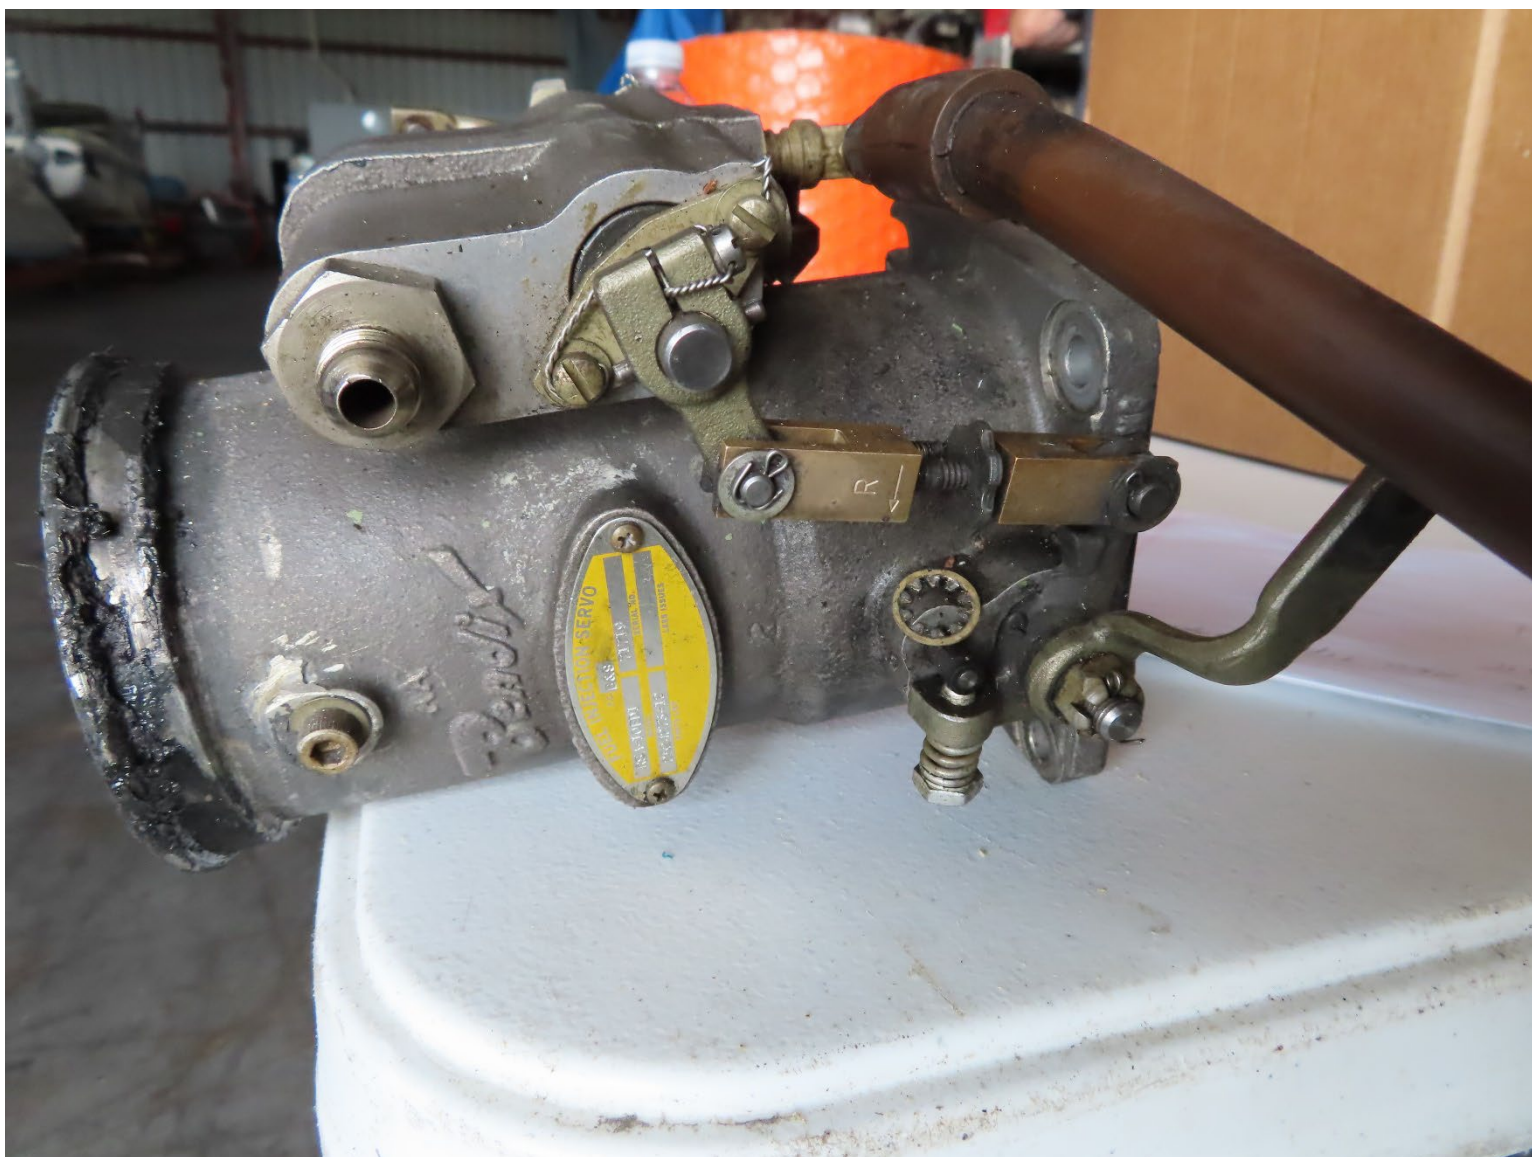
**Photograph 10 - Fuel servo idle mixture linkage (Courtesy of Piper)**

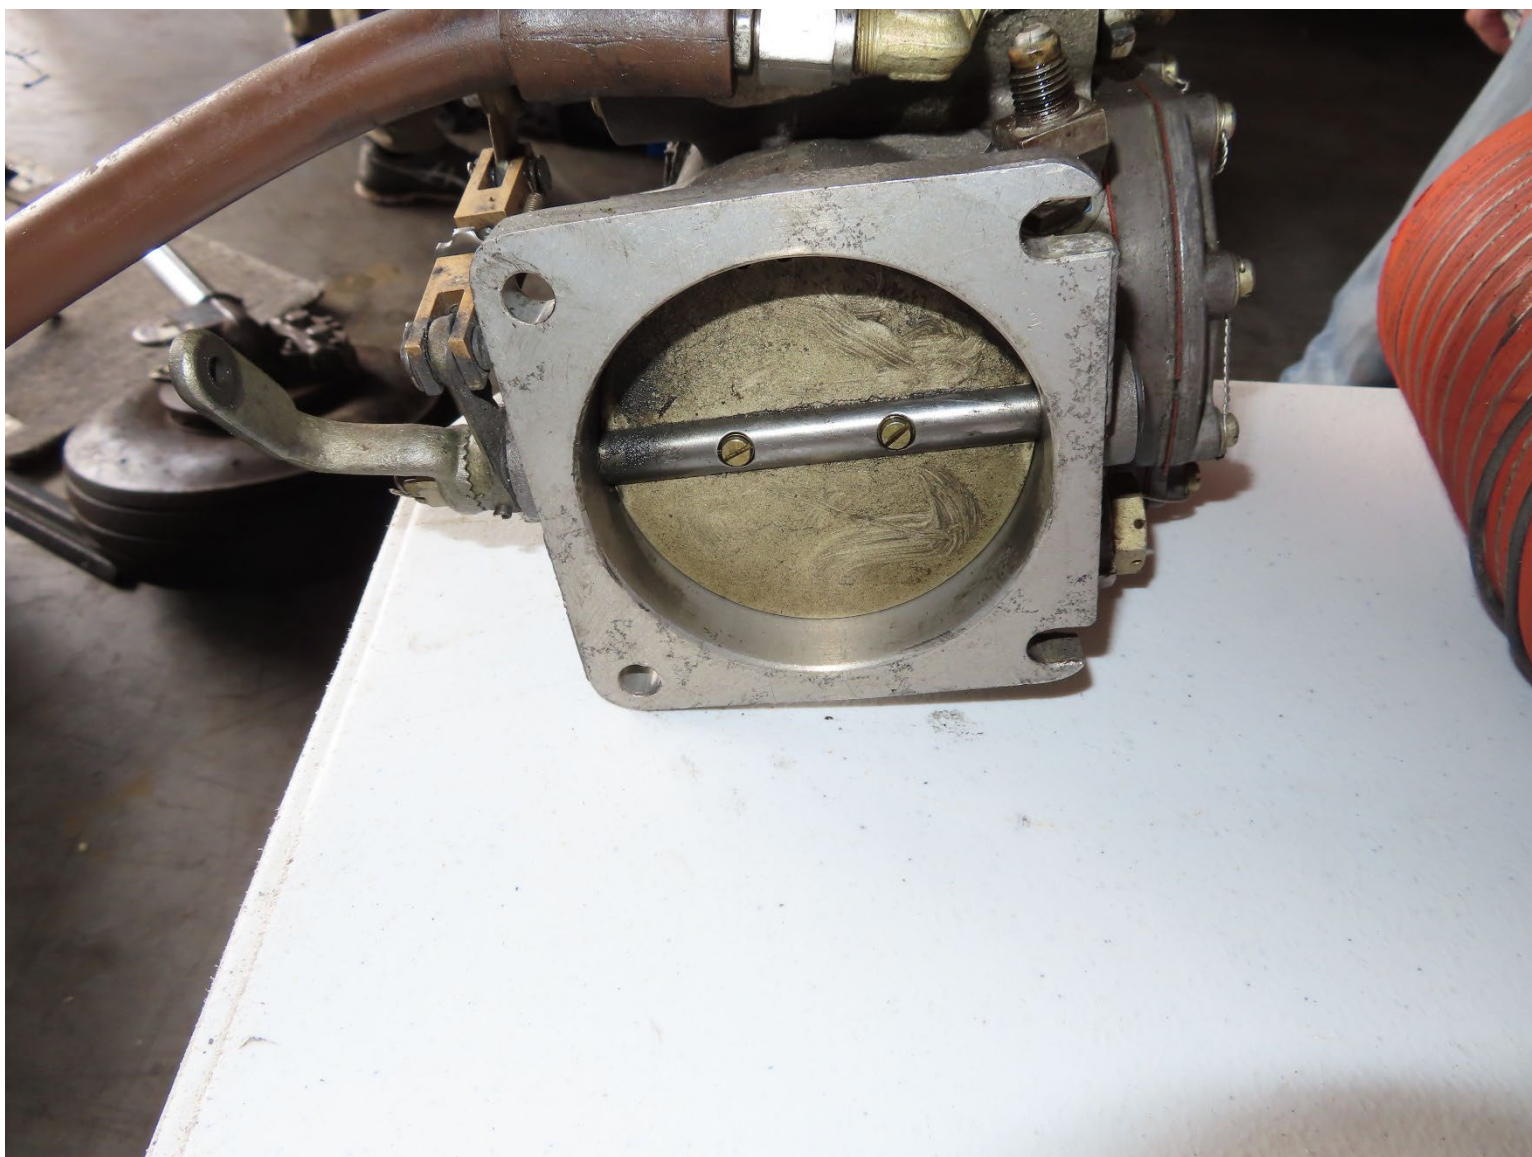
**Photograph 11 - Fuel Servo Throttle Valve (Courtesy of Piper)**
