ERA23LA338

## INVESTIGATION PHOTOGRAPHS

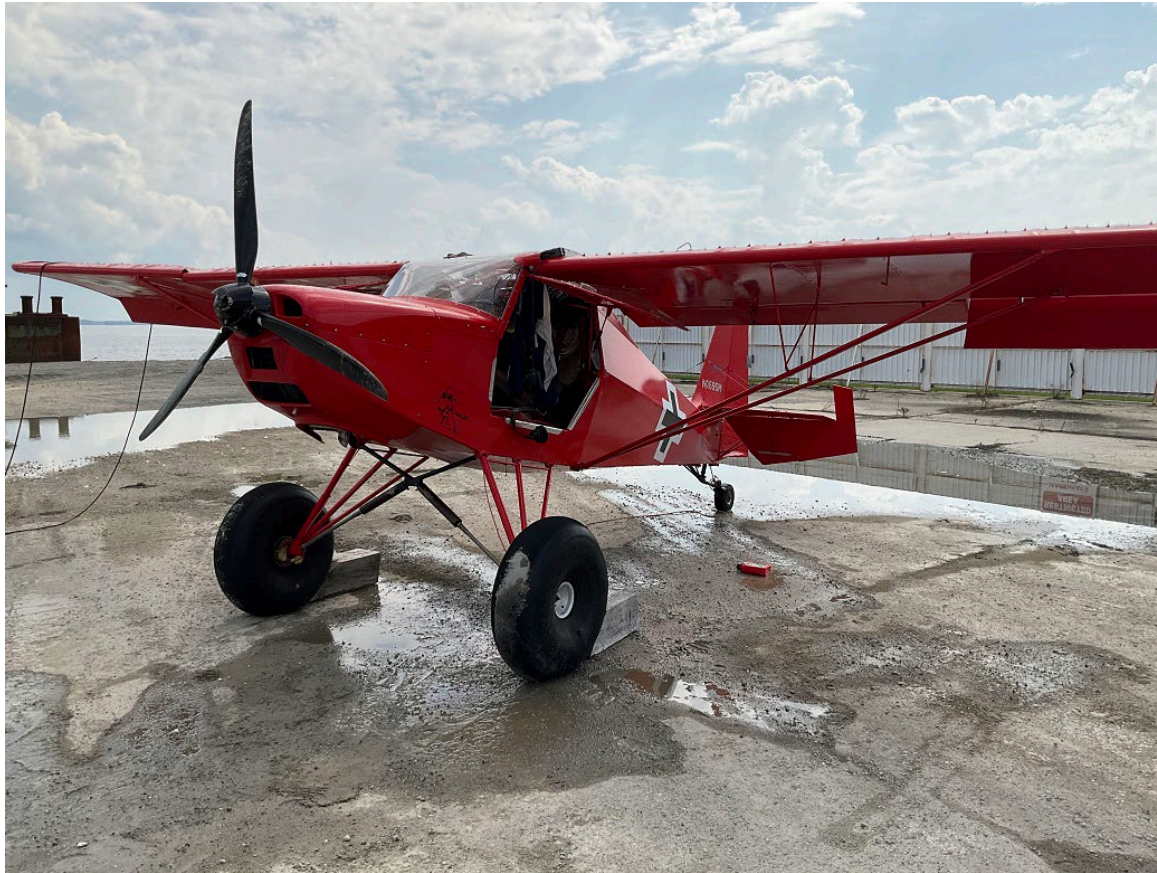
**Photograph 1 - Main Wreckage (Courtesy of FAA)**

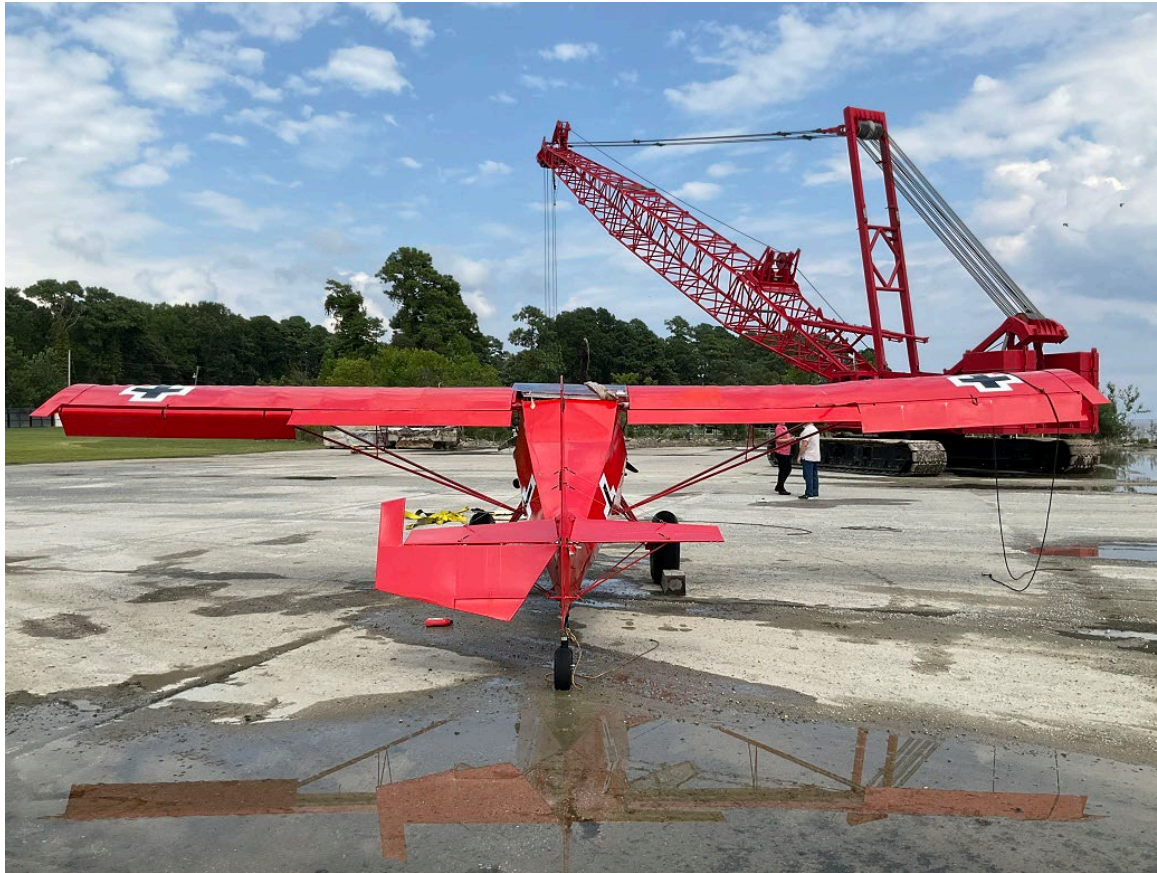
**Photograph 2 - Missing Right Elevator (Courtesy of FAA)**
