ERA23LA347

## INVESTIGATION PHOTOGRAPHS

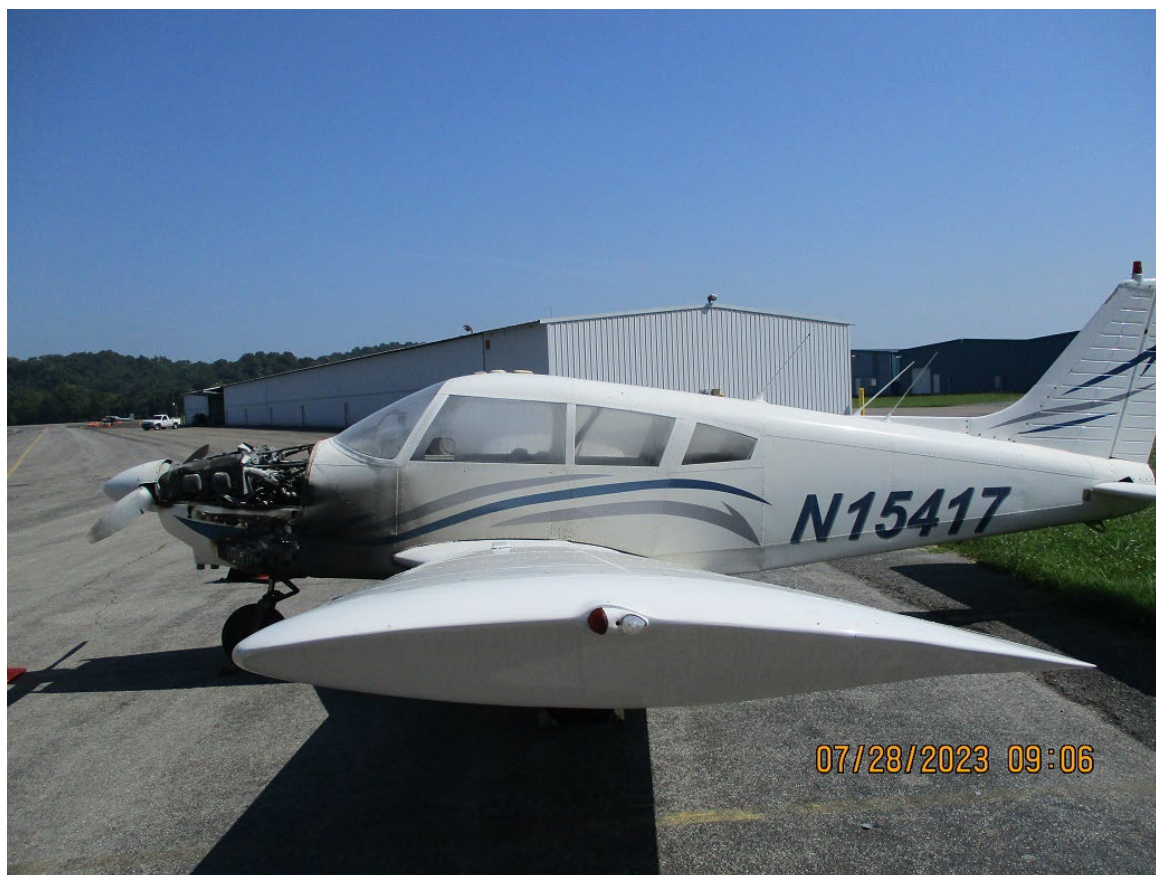
**Photograph 1 - Main Wreckage (Courtesy of FAA)**

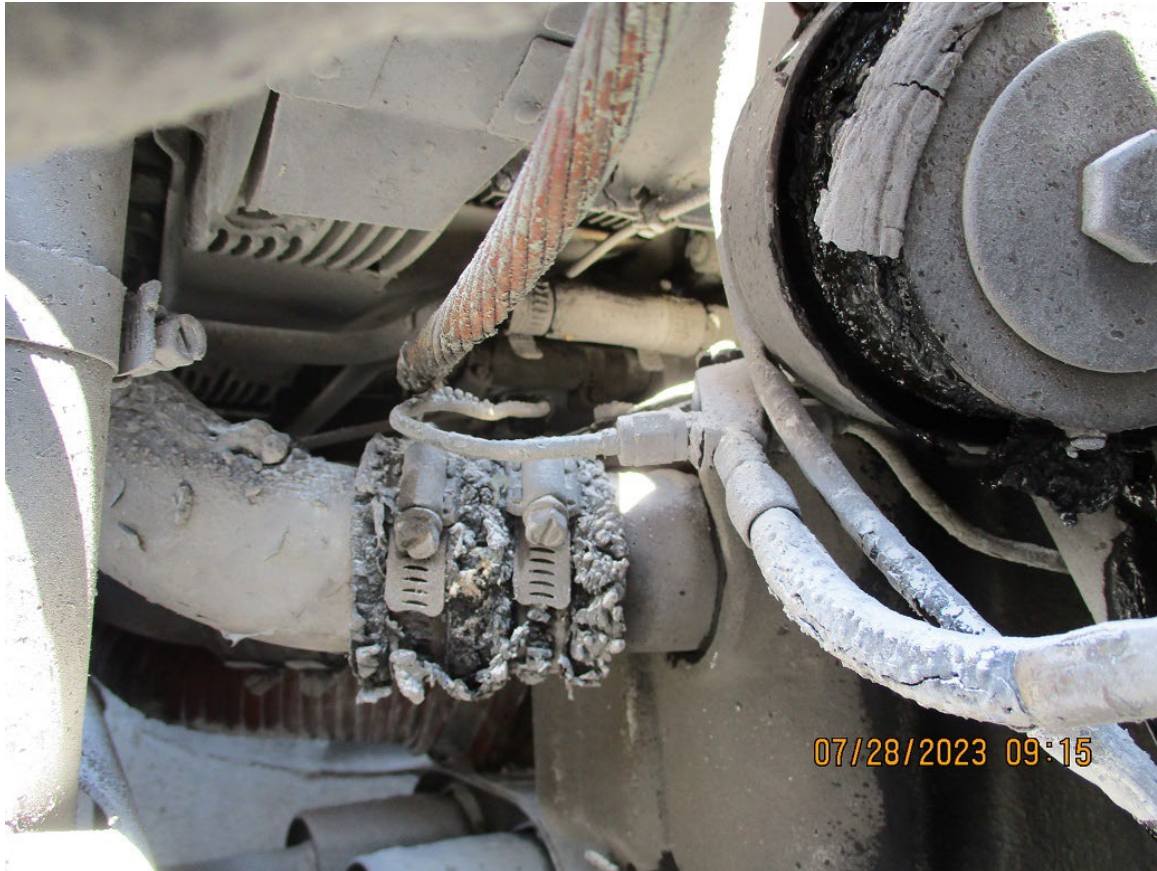
**Photograph 2 - Starter Motor Electrical Lead And Fuel Primer Line (Courtesy of FAA)**

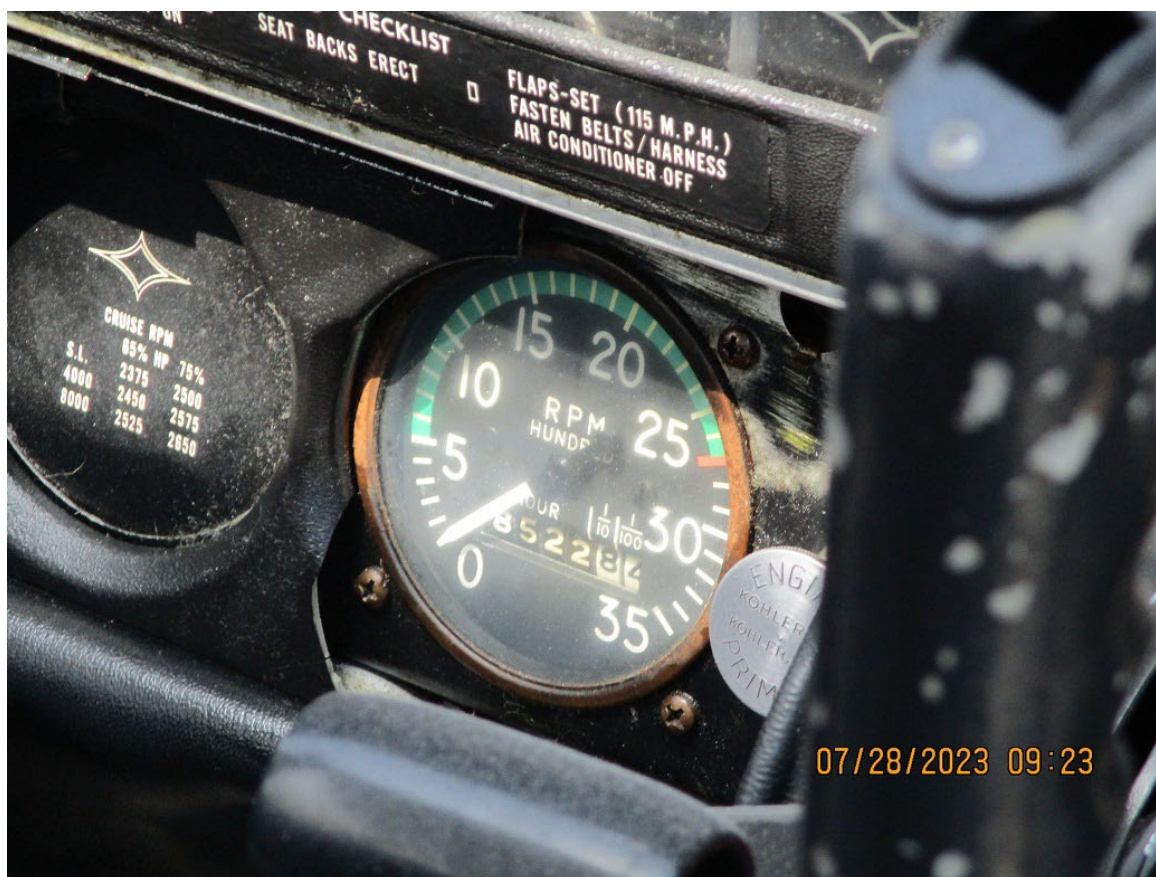
**Photograph 3 - Tachometer (Courtesy of FAA)**
