**Continuation of NTSB Form 6120.1**

**Narrative History of Flight (from the perspective of Charles O'Brien)**

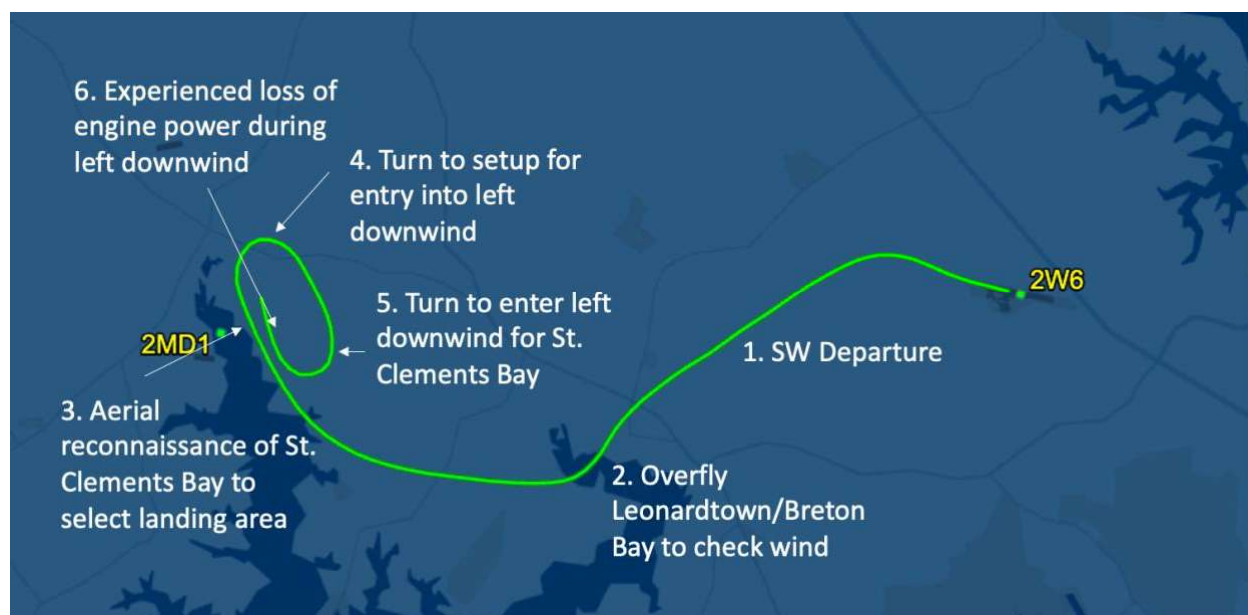
I departed runway 29 at 2W6 with Tony Capozzi, DPE, for my Airplane Single Engine Sea add-on check ride at approximately 1720 Eastern on 24 August 2023 with at least 35 gallons of fuel (as measured by dipstick during pre-flight inspection). Takeoff was normal and we left the pattern to the southwest (1). I leveled at 800 feet to transit to Breton Bay / Leonardtown for initial observation of wind conditions (2). Based on the southerly winds, I decided to proceed towards the head of Saint Clements Bay to conduct various water operations for the check ride. After arriving at Saint Clements Bay, I flew from south to north along the eastern shore of the bay to conduct aerial reconnaissance and select my landing location (3). With my target landing location determined, I made a right-hand 180 degree turn to proceed south and setup to enter a left downwind for landing (4). I made another right-hand 180 degree turn at 800 feet to enter the left downwind (5). On downwind, I began pre-landing configuration changes and checks, including reducing throttle to 20". During configuration checks, I verified the fuel shutoff was in the full downward position and the fuel selector was positioned to "both." I do not fully recall how far I got through configuration checks/changes before I noticed an audible reduction in noise. After hearing the change in sound, I noticed the prop RPM was below 2200. I tried to adjust prop RPM for a response, however there was no change. At this point the check ride needed to be discontinued due to the in-flight mechanical emergency. I verbally stated that "I've lost power" and Tony confirmed by verified by pushing mixture, propeller, and throttle fully in with no response to engine power (6). As a rapid troubleshooting step, I attempted to select individual fuel tanks at some point during this process. I requested help from Tony (which we discussed during our pre-flight brief should an actual in-flight emergency occur) and transferred controls to him. Tony conducted a forced landing on a nearby cornfield. The time from initial identification of a problem until the forced landing was exceptionally brief – I estimate 20 to 30 seconds.
