# National Transportation Safety Board

ERA23LA362

## **WRECKAGE EXAMINATION SUMMARY**

Location: Cincinnati, OH  
Date: September 1, 2023  
Time: 2038 EDT  
0038 UTC  
Airplane: Piper PA-32

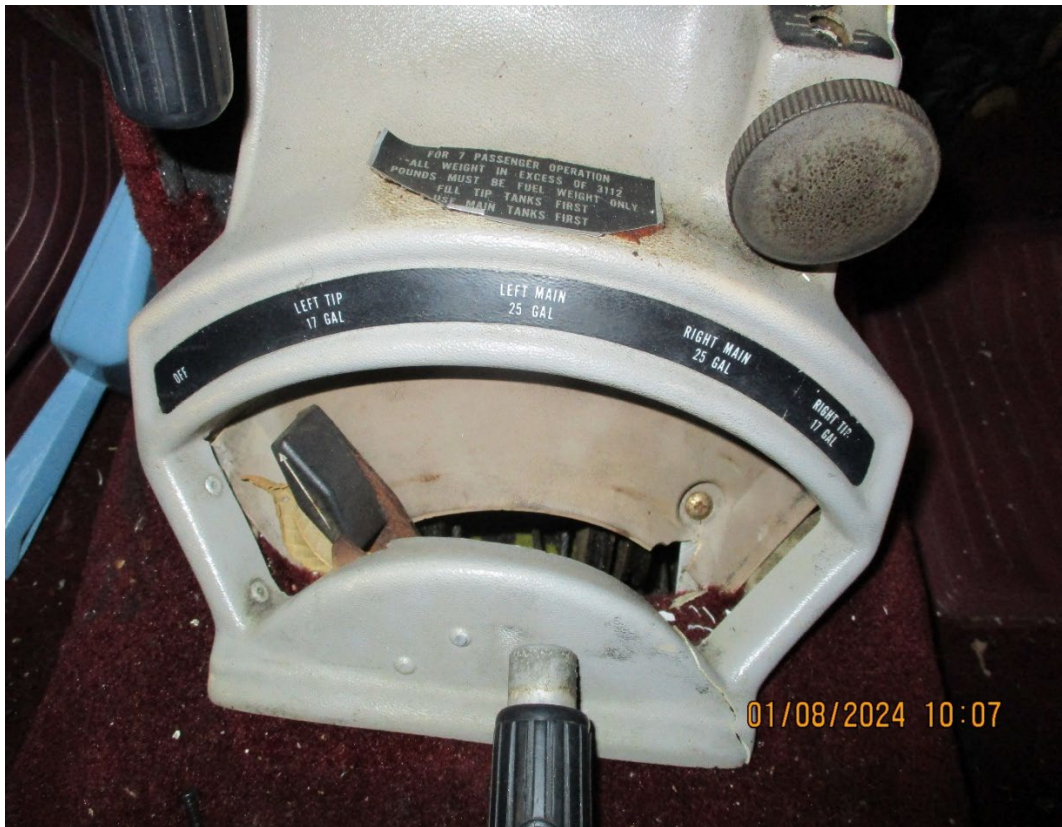
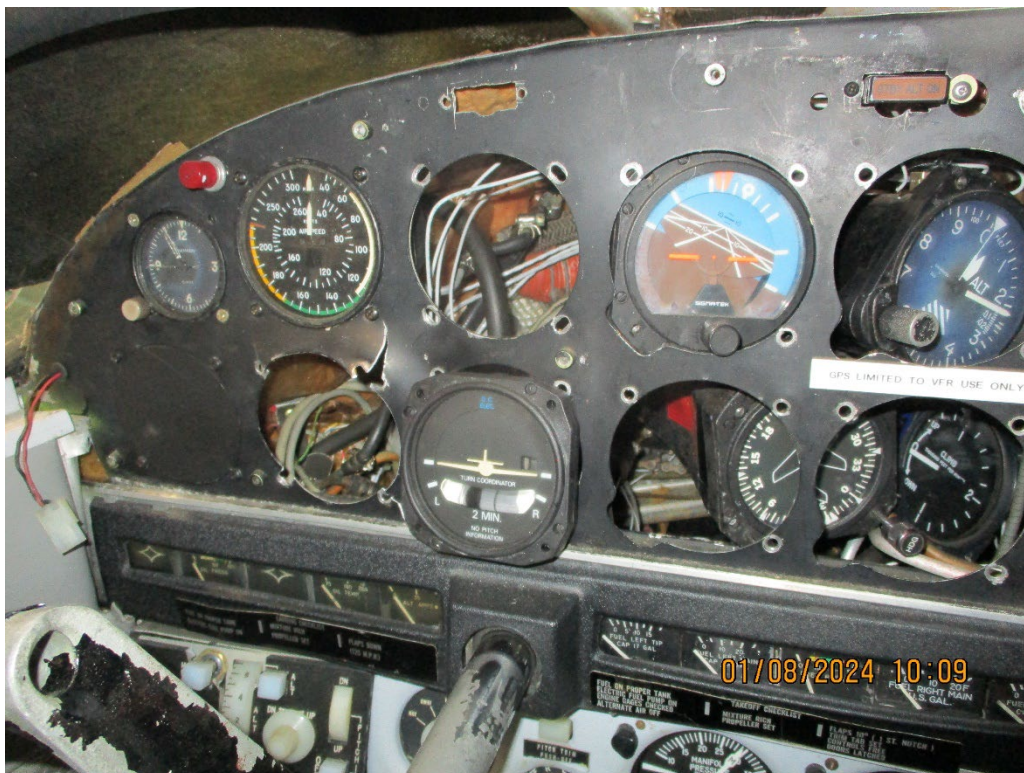
The recovery company cut the wings off the airframe, all primary flight controls were present in the hangar and continuity was verified through cut cables. The fuel selector was in the "off" position. The mixture, propeller and throttle controls moved back and forth in normal operation. The instrument panel was impact damaged and some of the instruments were pushed back inside the panel. There was no evidence of an inflight or postimpact fire.

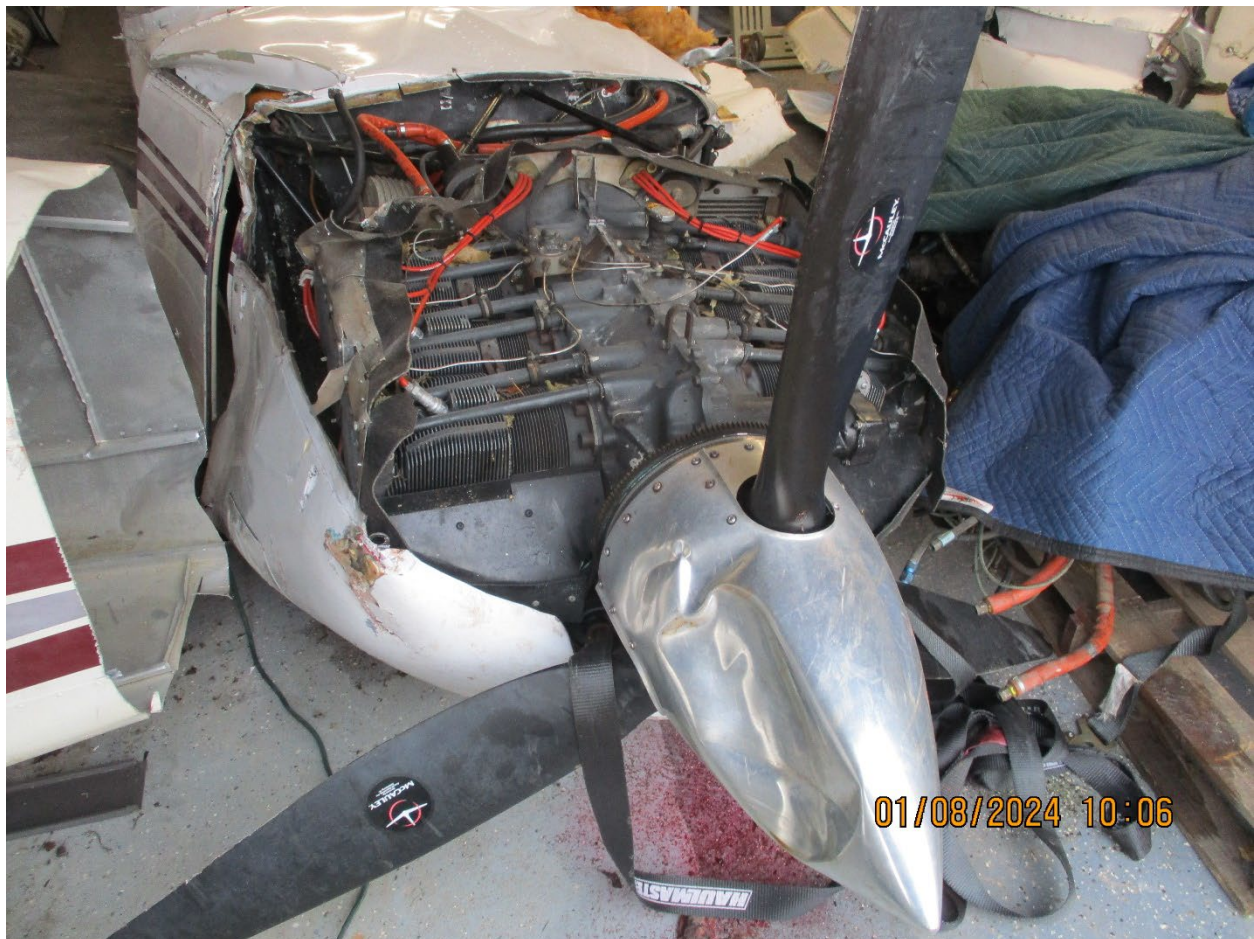
The engine was hung by an engine hoist inside the hangar. The top spark plugs were removed and were clean of debris. The spark plug wires appeared new and in good condition. Thumb compression was established on all cylinders. The magnetos rotated with the continuity check and the impulse couplings could be heard when the propeller was rotated by hand. The fuel flow divider, nor injectors showed any signs of fuel leakage. The propeller blades were straight and not damaged. The spinner dome was impact damaged on one side. There were no signs of oil leakage around the engine. No anomalies were noted with the engine that would have precluded normal operation.
