# National Transportation Safety Board

ERA23LA363

## **AIRFRAME AND ENGINE EXAMINATION**

N1WN, Beech A36

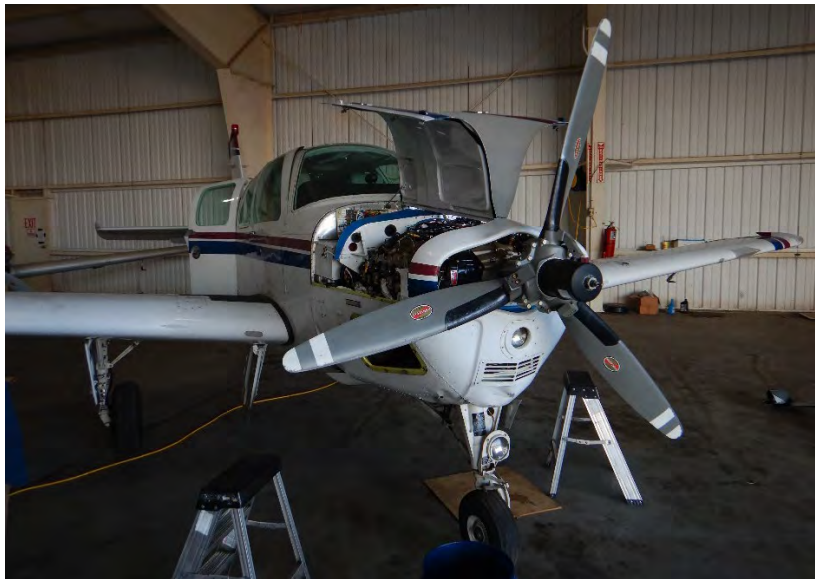
**Photo 1 - View of aircraft from front before examination.**

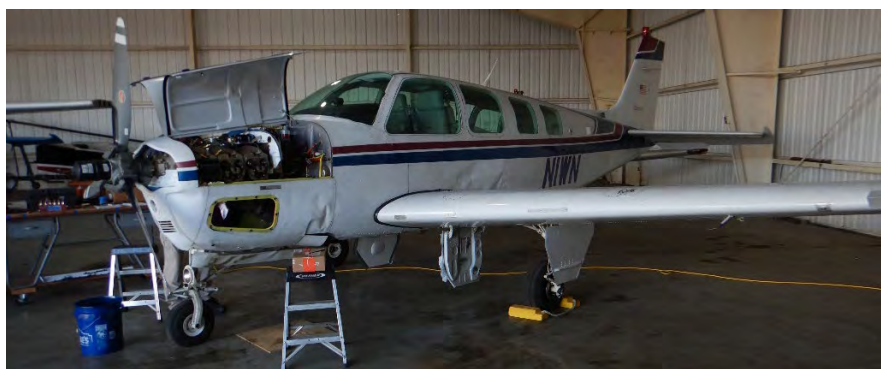
The left wing, with aileron and flap attached, remained attached to the fuselage at the wing root. The left wing was crinkled and buckled consistent with ground contact. The right wing with aileron and flap attached was undamaged.

**Photo 2 - View of aircraft from left before examination.**

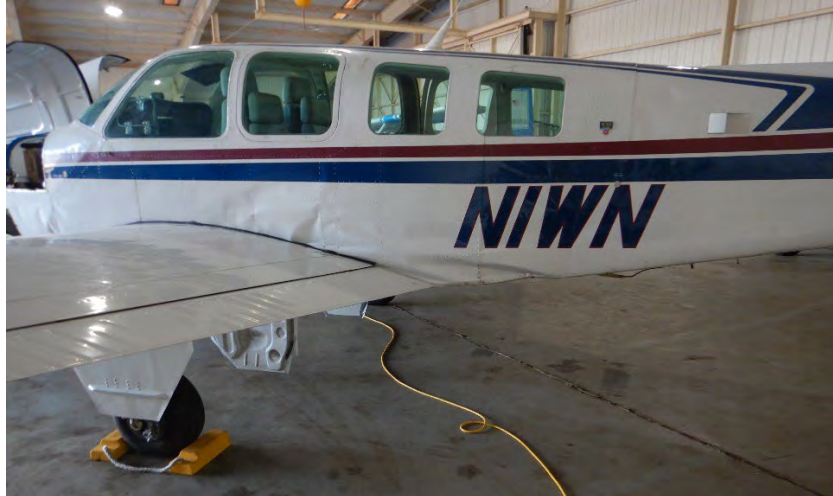
**Photo 3 - View of aircraft from left rear before examination.**

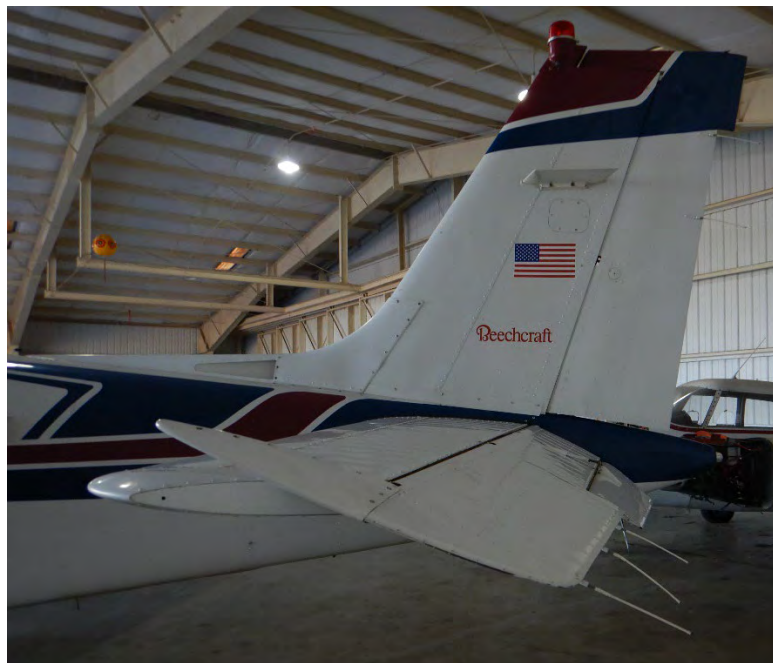
**Photo 4 - View of empennage from left before examination.**

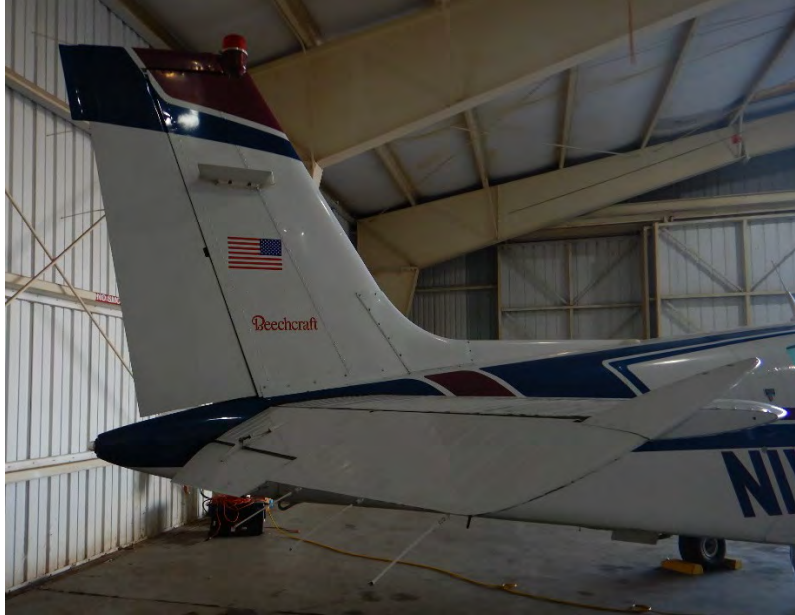
**Photo 5 - View of empennage from right before examination.**

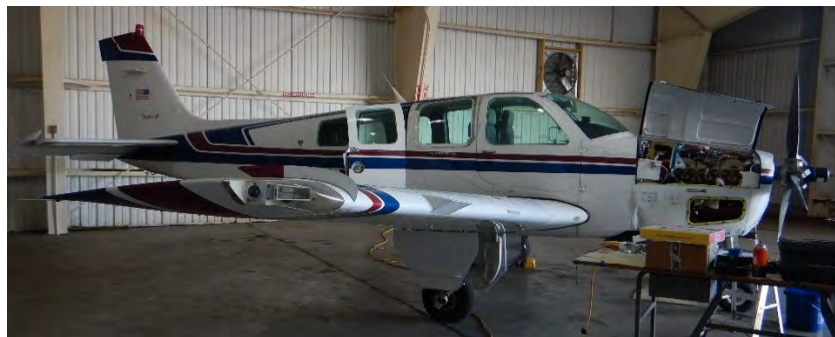
**Photo 6 - View of aircraft from right side before examination.**

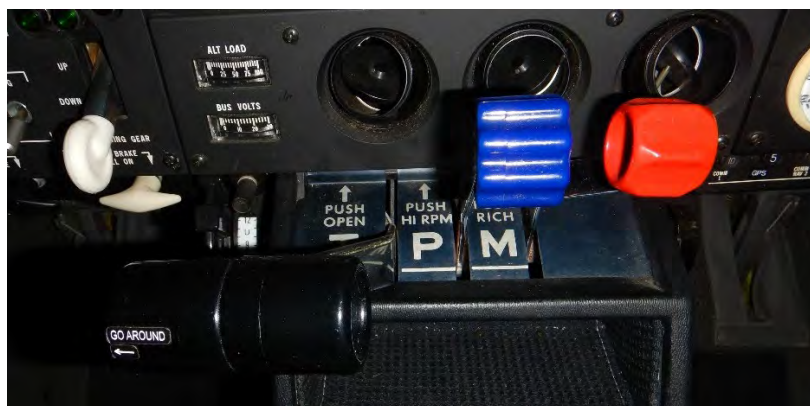
**Photo 7- Throttle quadrant before examination.**

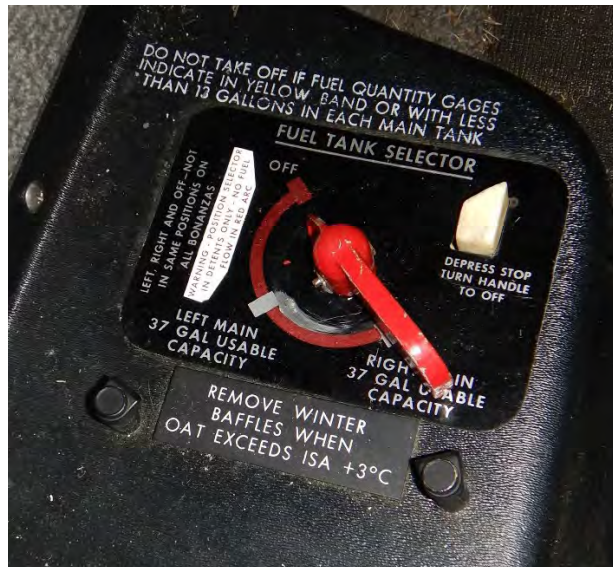
Fuel selector - OFF

**Photo 8 - Fuel selector in OFF position prior to examination.**

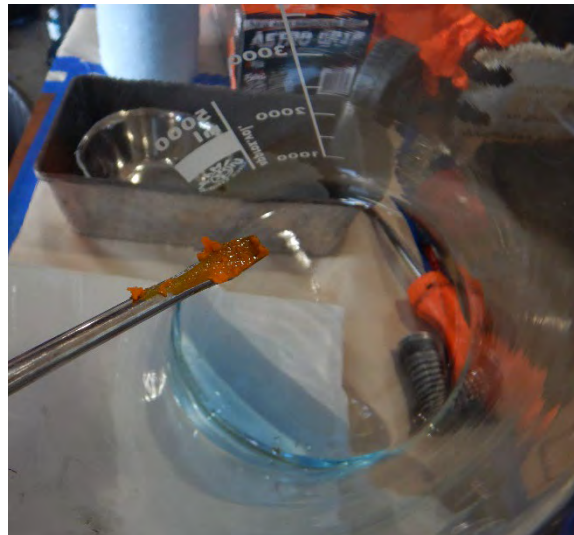
**Photo 9 - Fuel was free from water contamination when tested.**

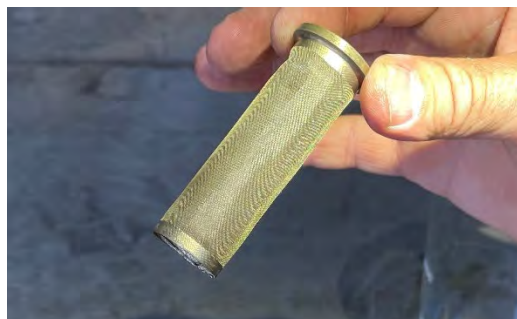
**Photo 10 - Fuel strainer screen free of debris.**

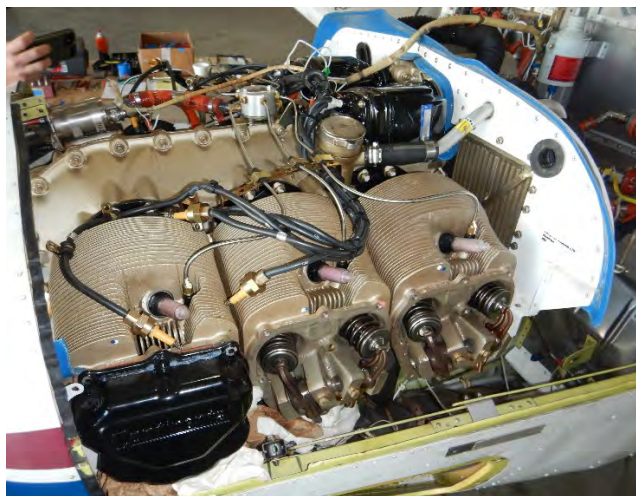
**Photo 11 - Engine upon first view before examination.**

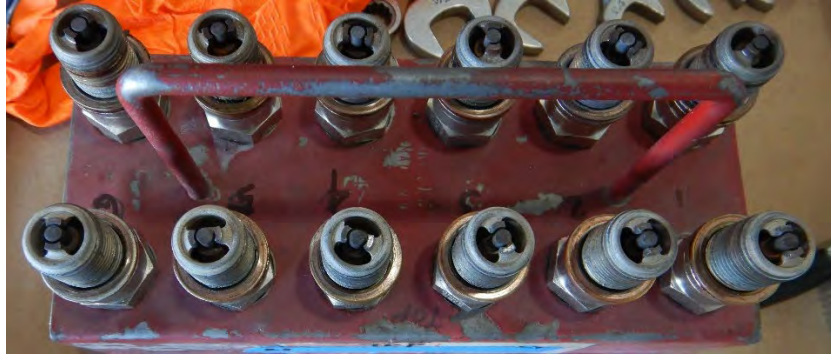
All spark plugs showed normal wear when compared to a Champion Aerospace Aviation Check-A-Plug chart. The lower spark plugs were reinstalled. Borescope examination of the cylinders revealed no anomalies. Thumb compression was achieved on all cylinders when the propeller was rotated by hand. The fuel strainer was removed from the accessory case and contained a small amount of fuel. The oil pan was intact, and the oil filler cap was seated and showed 11 quarts of fuel.

**Photo 12 - Spark plugs showing normal wear.**

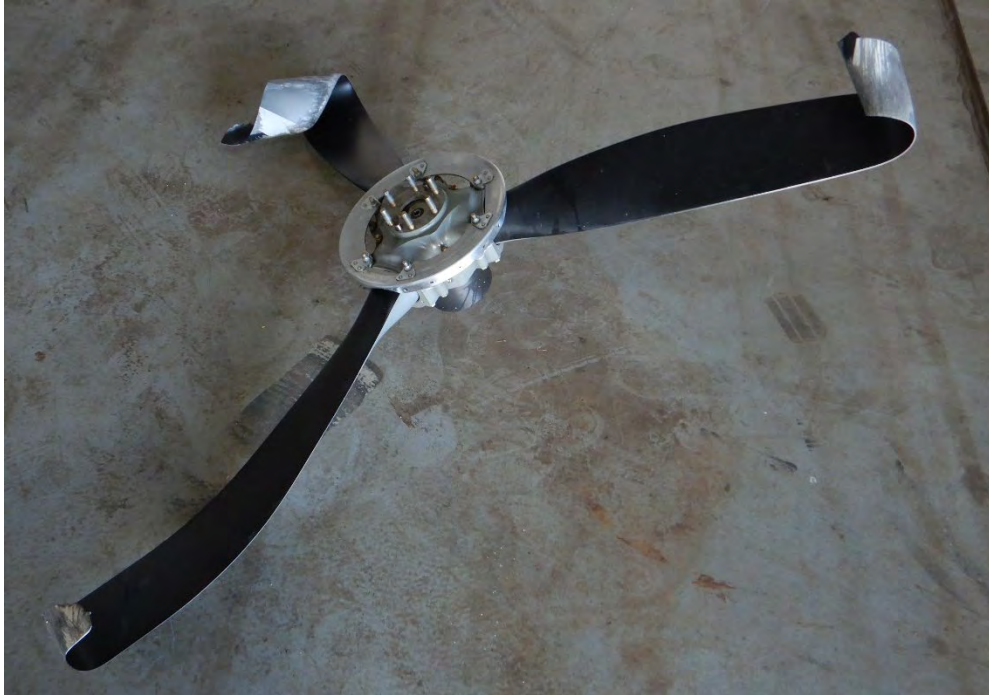
The impact damaged propeller had been replaced with a serviceable one by a mechanic on the field the NTSB hired to assist. The accident propeller blade tips all exhibited similar aft curling, gouging, and chordwise scoring.

**Photo 26 - Propeller with tip curling and chordwise abrasion on all blades.**
