ERA23LA365

## INVESTIGATION PHOTOGRAPHS

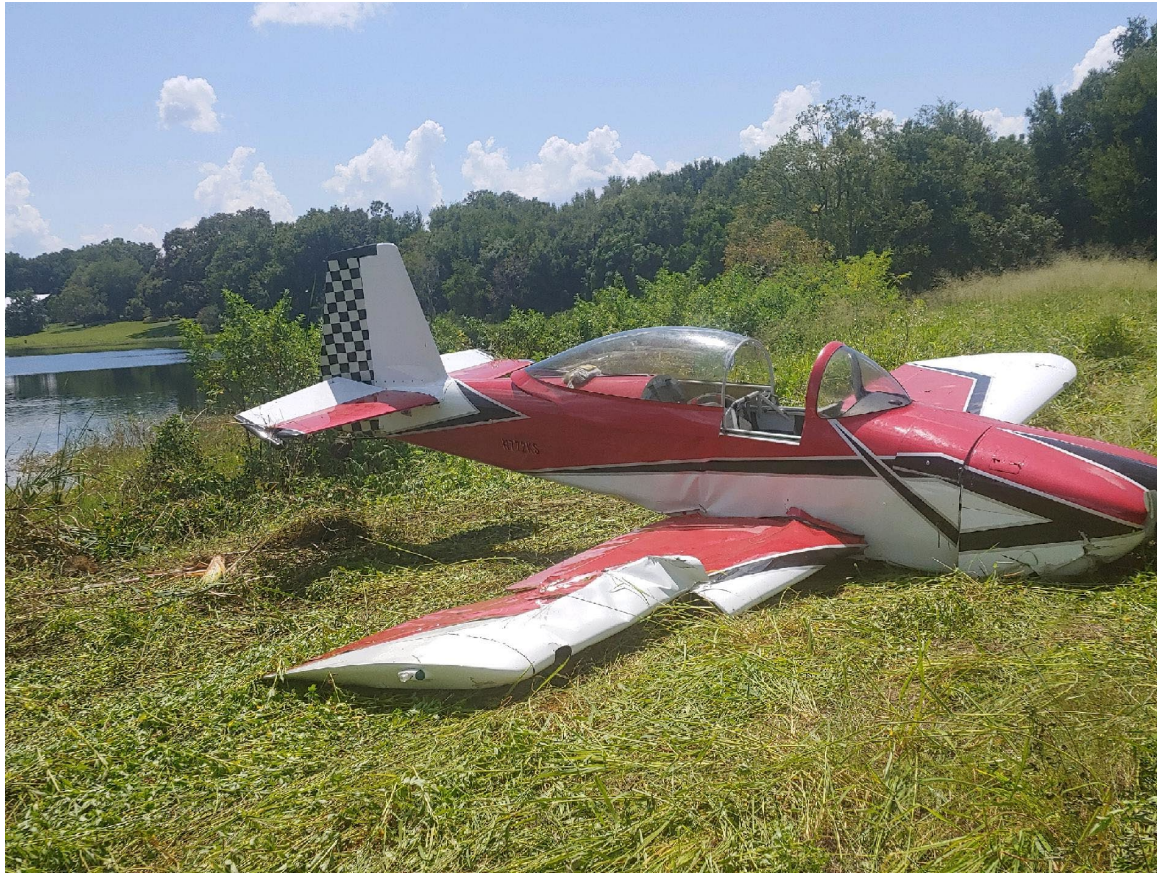
**Photograph 1 - View of the airplane on the side of the lake after being recovered from the water. (Courtesy of FAA)**

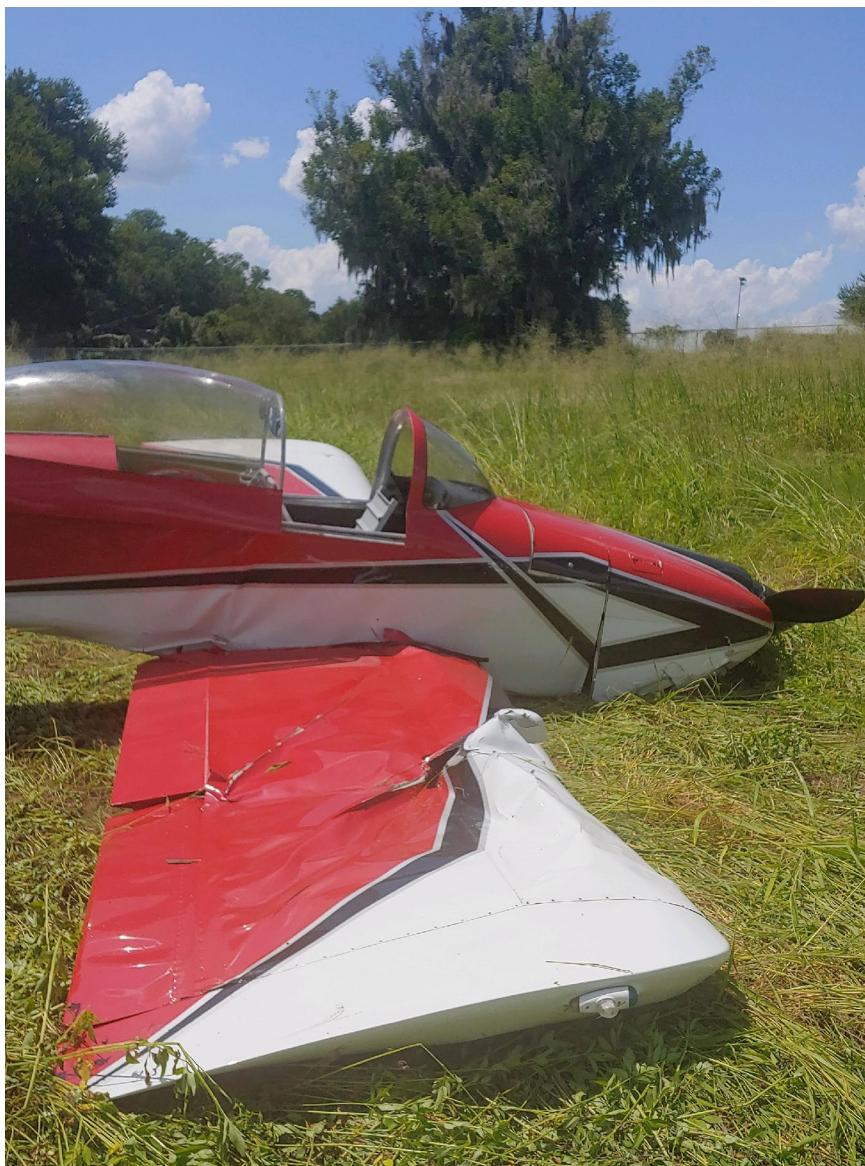
**Photograph 2 - View of damage to the right wing and fuselage (Courtesy of FAA)**

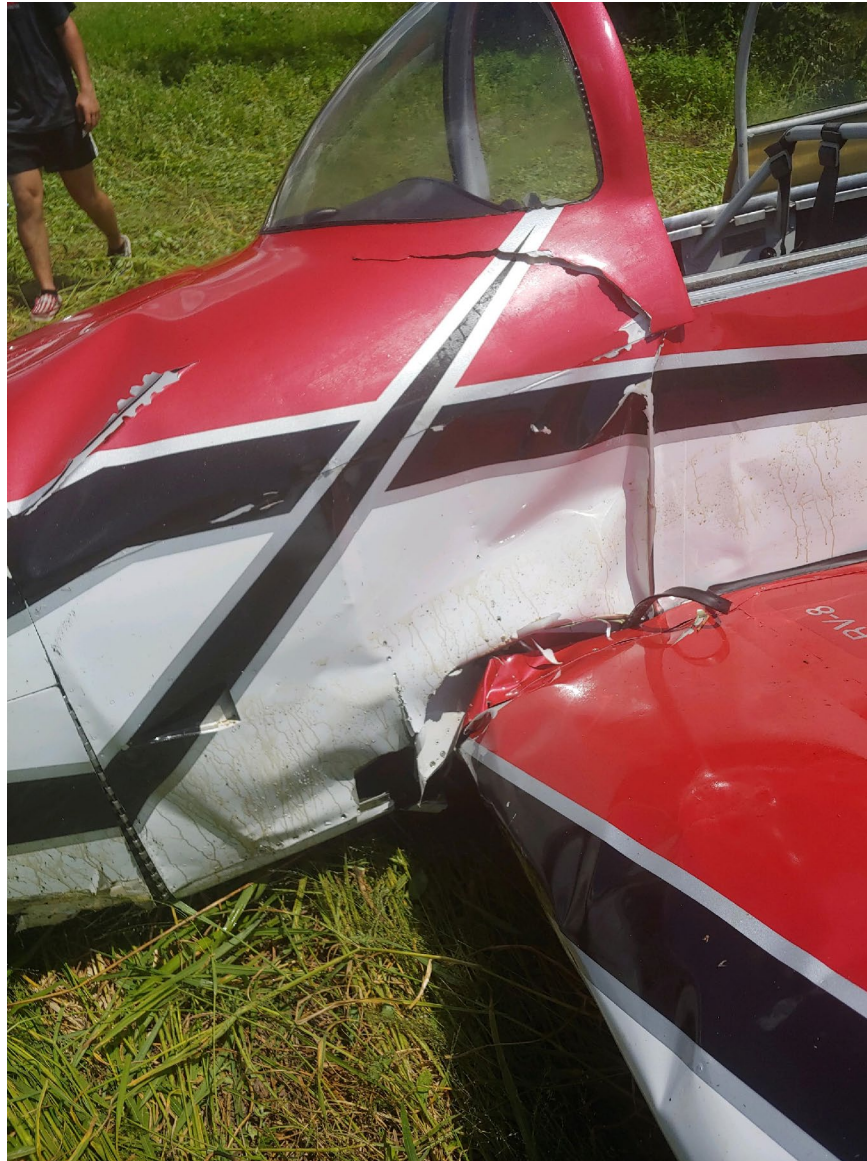
**Photograph 3 - View of damage to the left side of the fuselage. (Courtesy of FAA)**

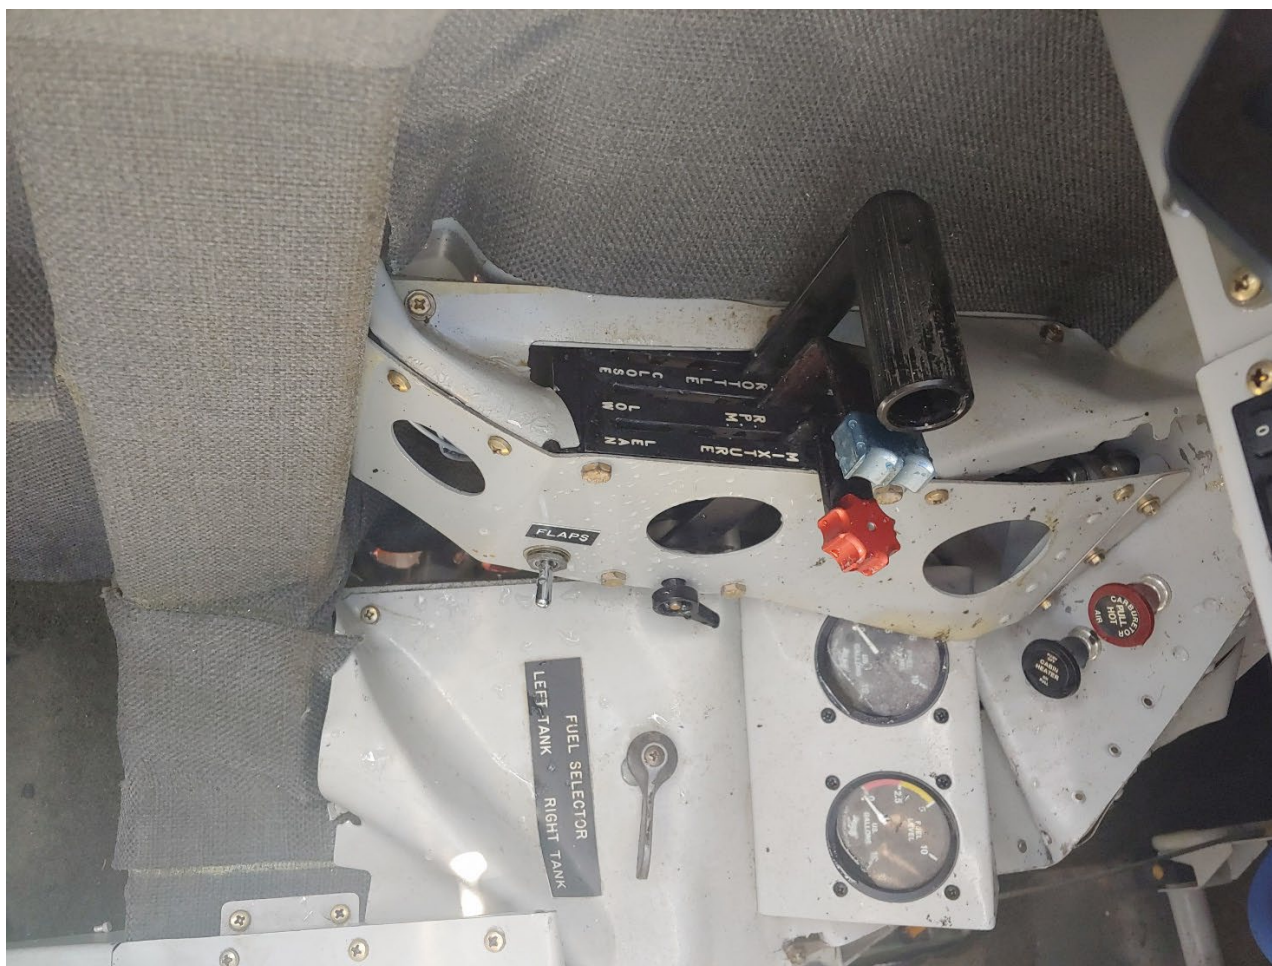
**Photograph 4 - View of the throttle quadrant. (Courtesy of FAA)**

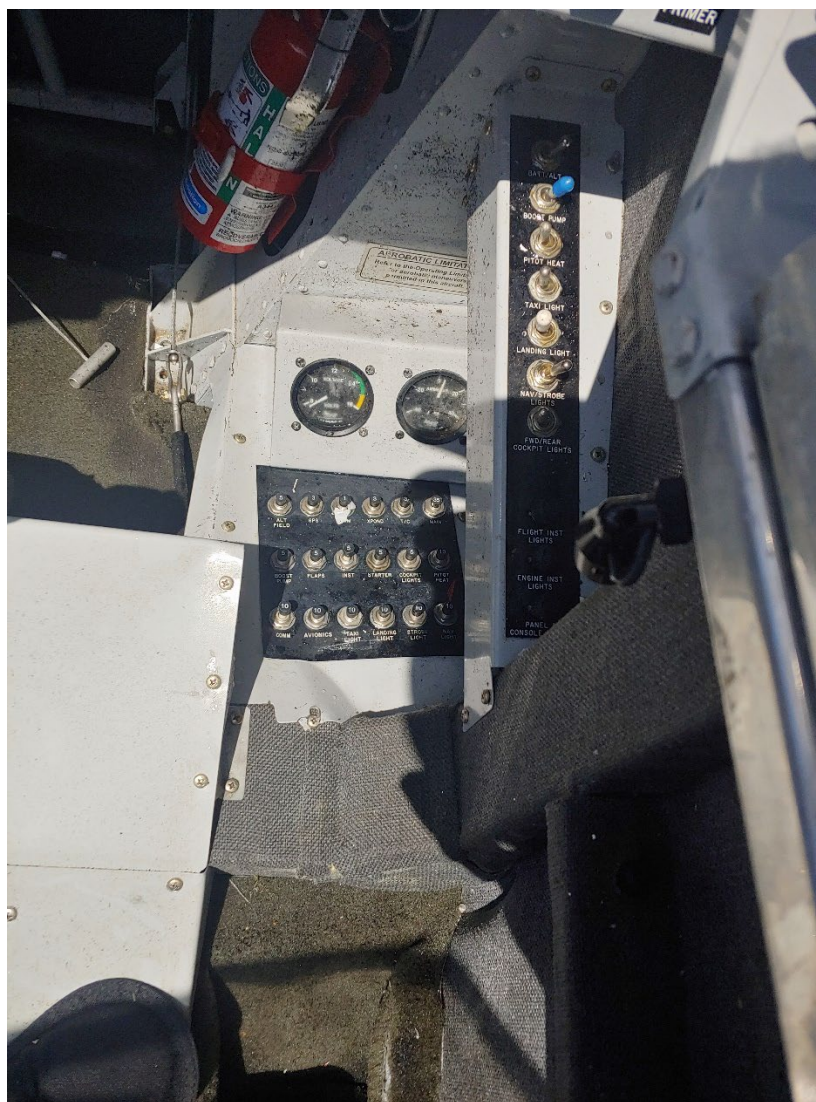
**Photograph 5 - View of switches and circuit breakers. (Courtesy of FAA)**

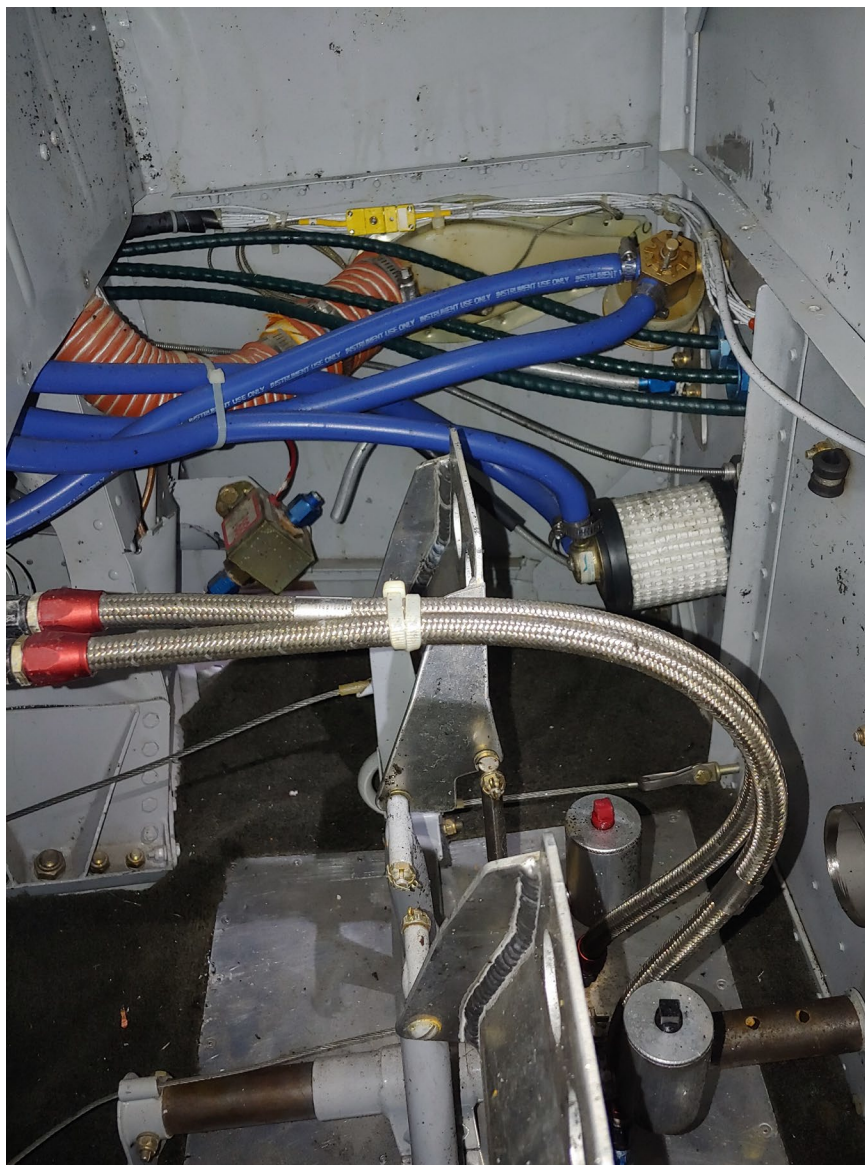
**Photograph 6 - View of boost pump with fractured fuel line. (Courtesy of FAA)**

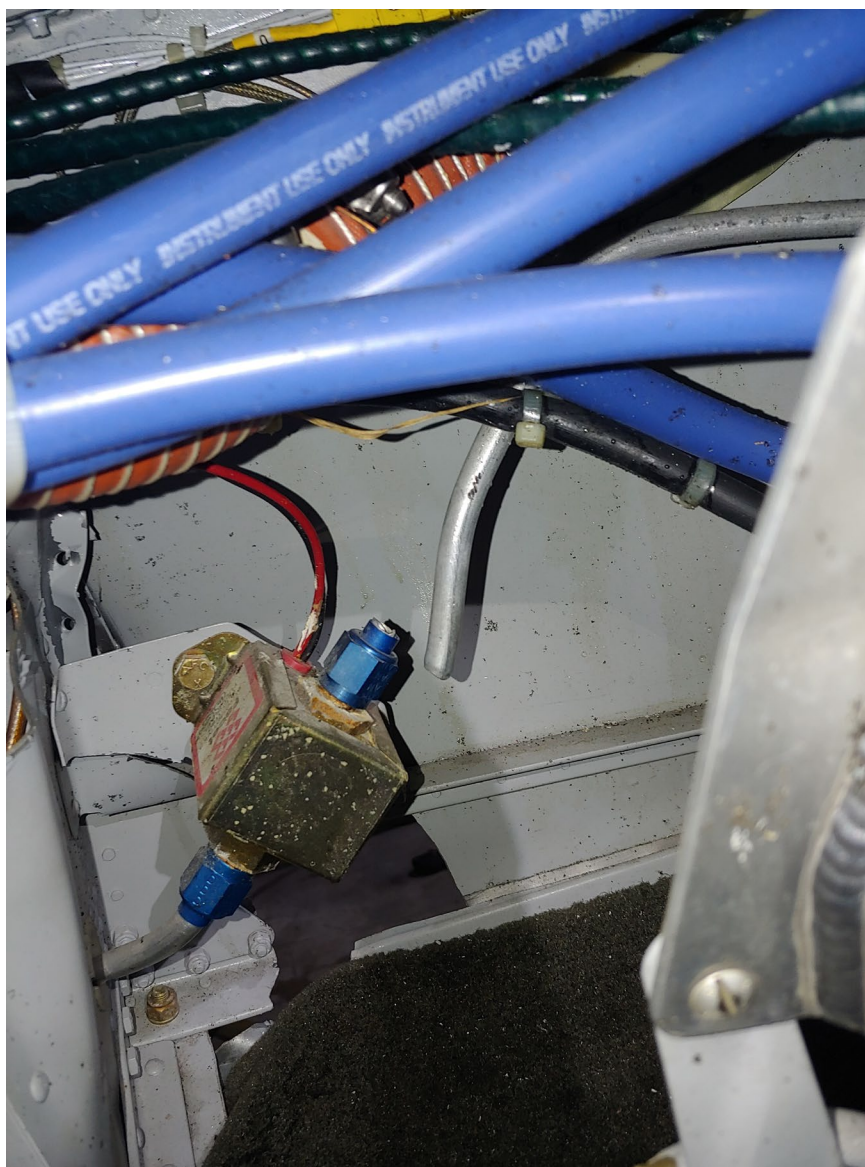
**Photograph 7 - View of boost pump with fractured fuel line. (Courtesy of FAA)**

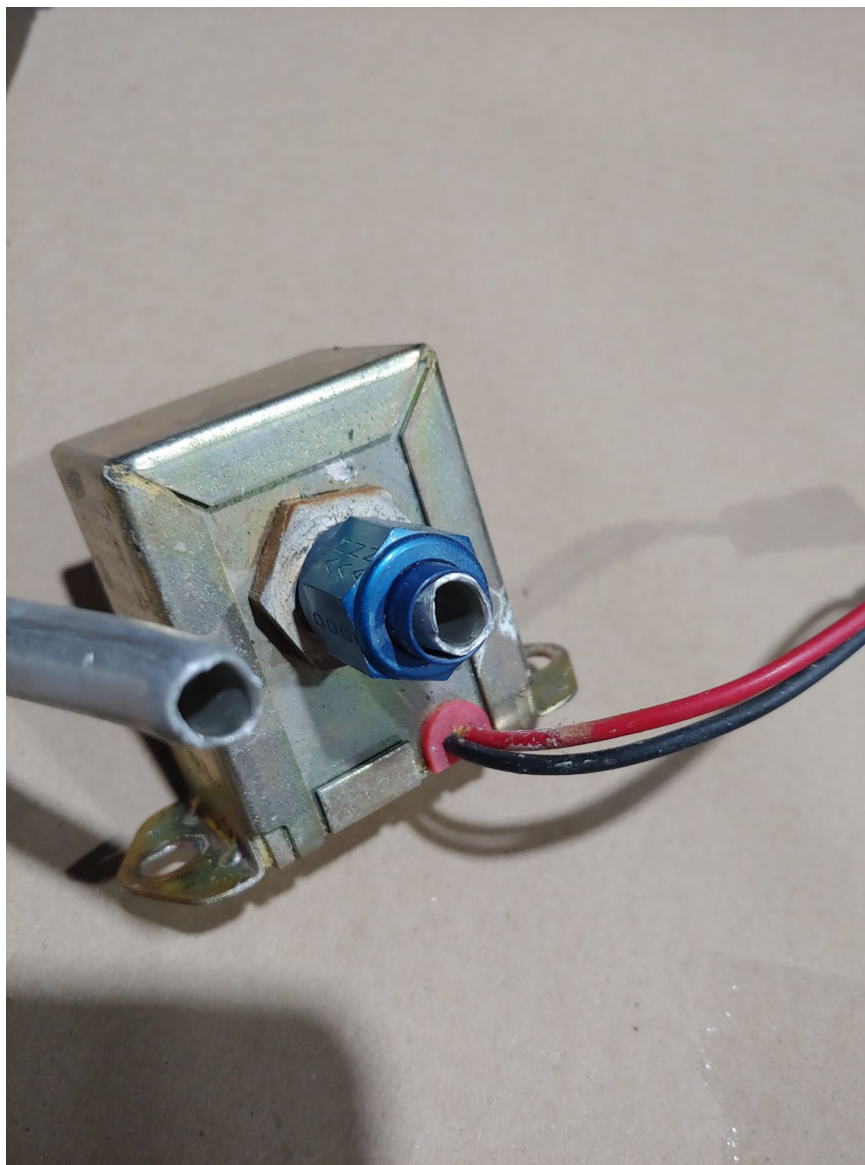
**Photograph 8 - View of boost pump and fractured fuel line. (Courtesy of FAA)**
