**Subject:** ERA23LA365, Memorandum for Record - Electric Fuel Boost Pump  
Location Revision

**Subject:** ERA23LA365, Electric Fuel Boost Pump Location

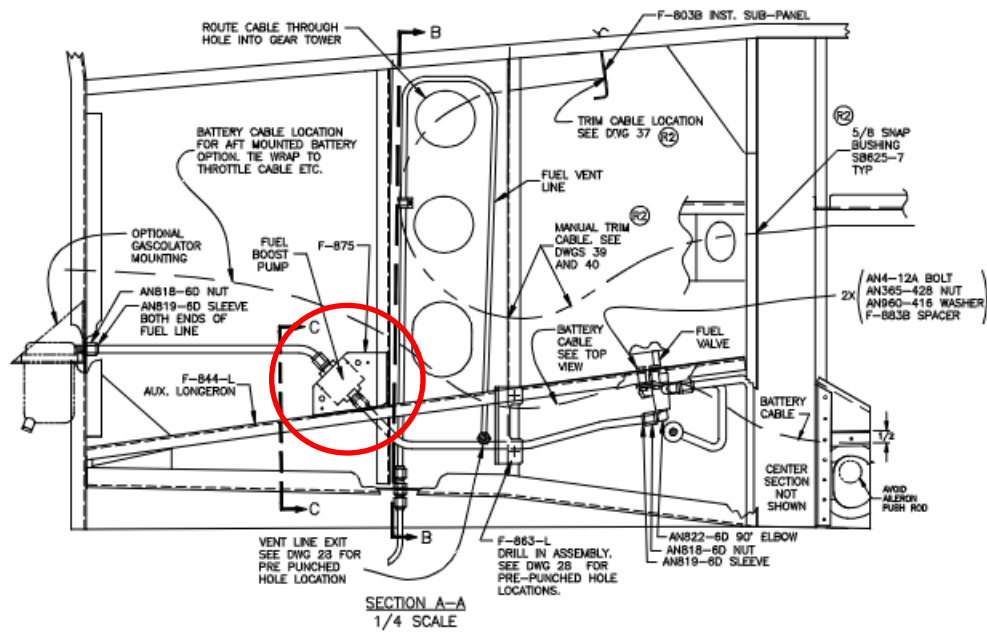
The builder of the aircraft contacted the IIC via electronic mail on October 30, 2024, and reported that he believed there was an error in the NTSB final report which stated, "Photographs from the FAA inspector of the electric fuel boost pump indicated it was not installed on the airplane according to the kit manufacturer's build plan." He included a photograph of the build plans used when the aircraft was manufactured and photographs of the installation of the fuel boost pump. Upon review of this documentation the IIC found that in the original memorandum dated 9/26/2023, below, an incorrect drawing from the manufacturer was used. The drawing used was for the correct airframe but was drawn in January of 2006, Van's Aircraft RV-8 drawing 82\_8, and would not have been available to the builder during the construction of the airplane which was completed in 2005. Upon further review of the manufacturer's drawings, it was found that the builder installed the fuel boost pump correctly in accordance with the build instructions available at the time, Van's Aircraft RV-8 drawing 31\_8.

*Photo 1: View of the correct drawing 31\_8*

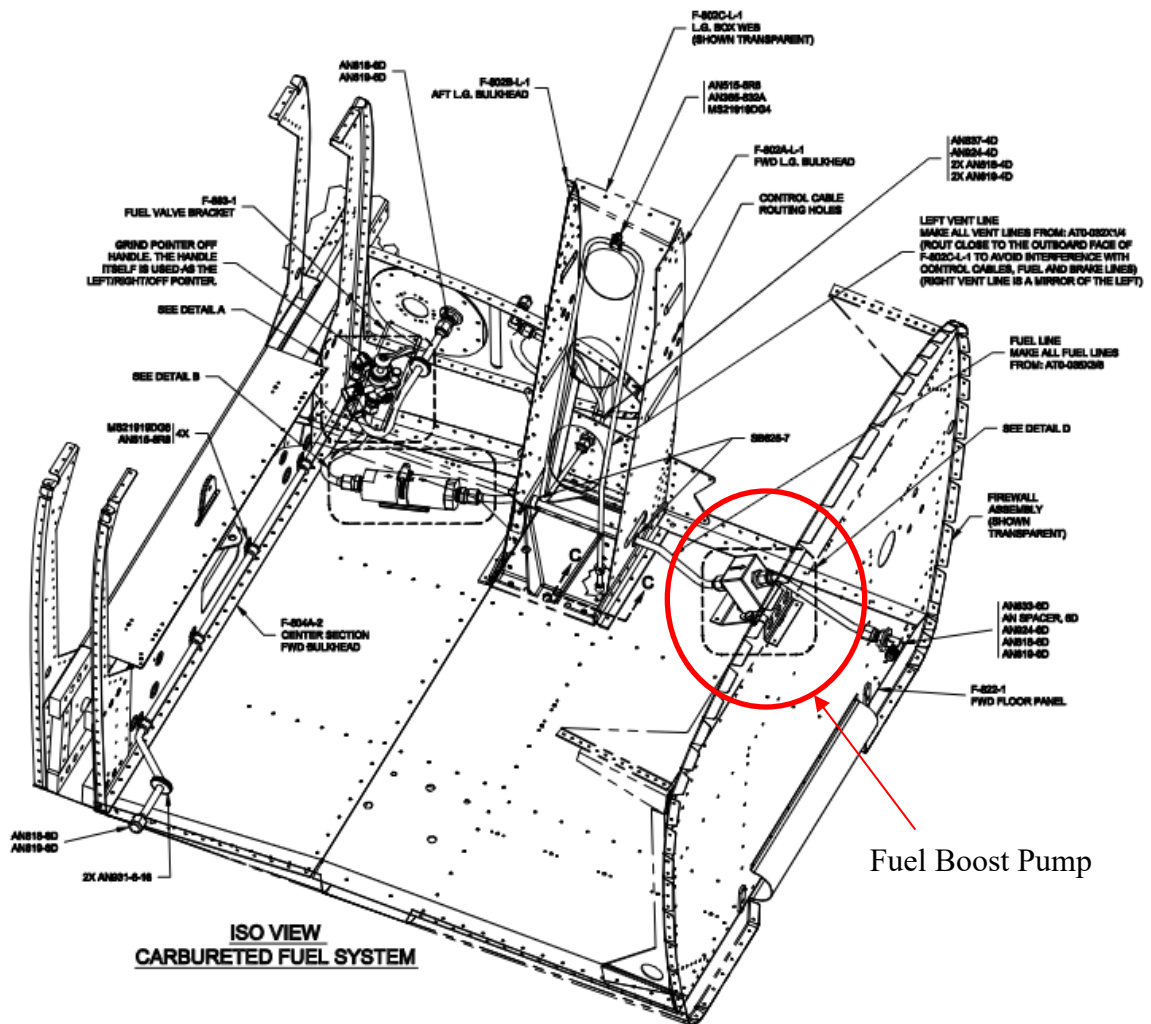
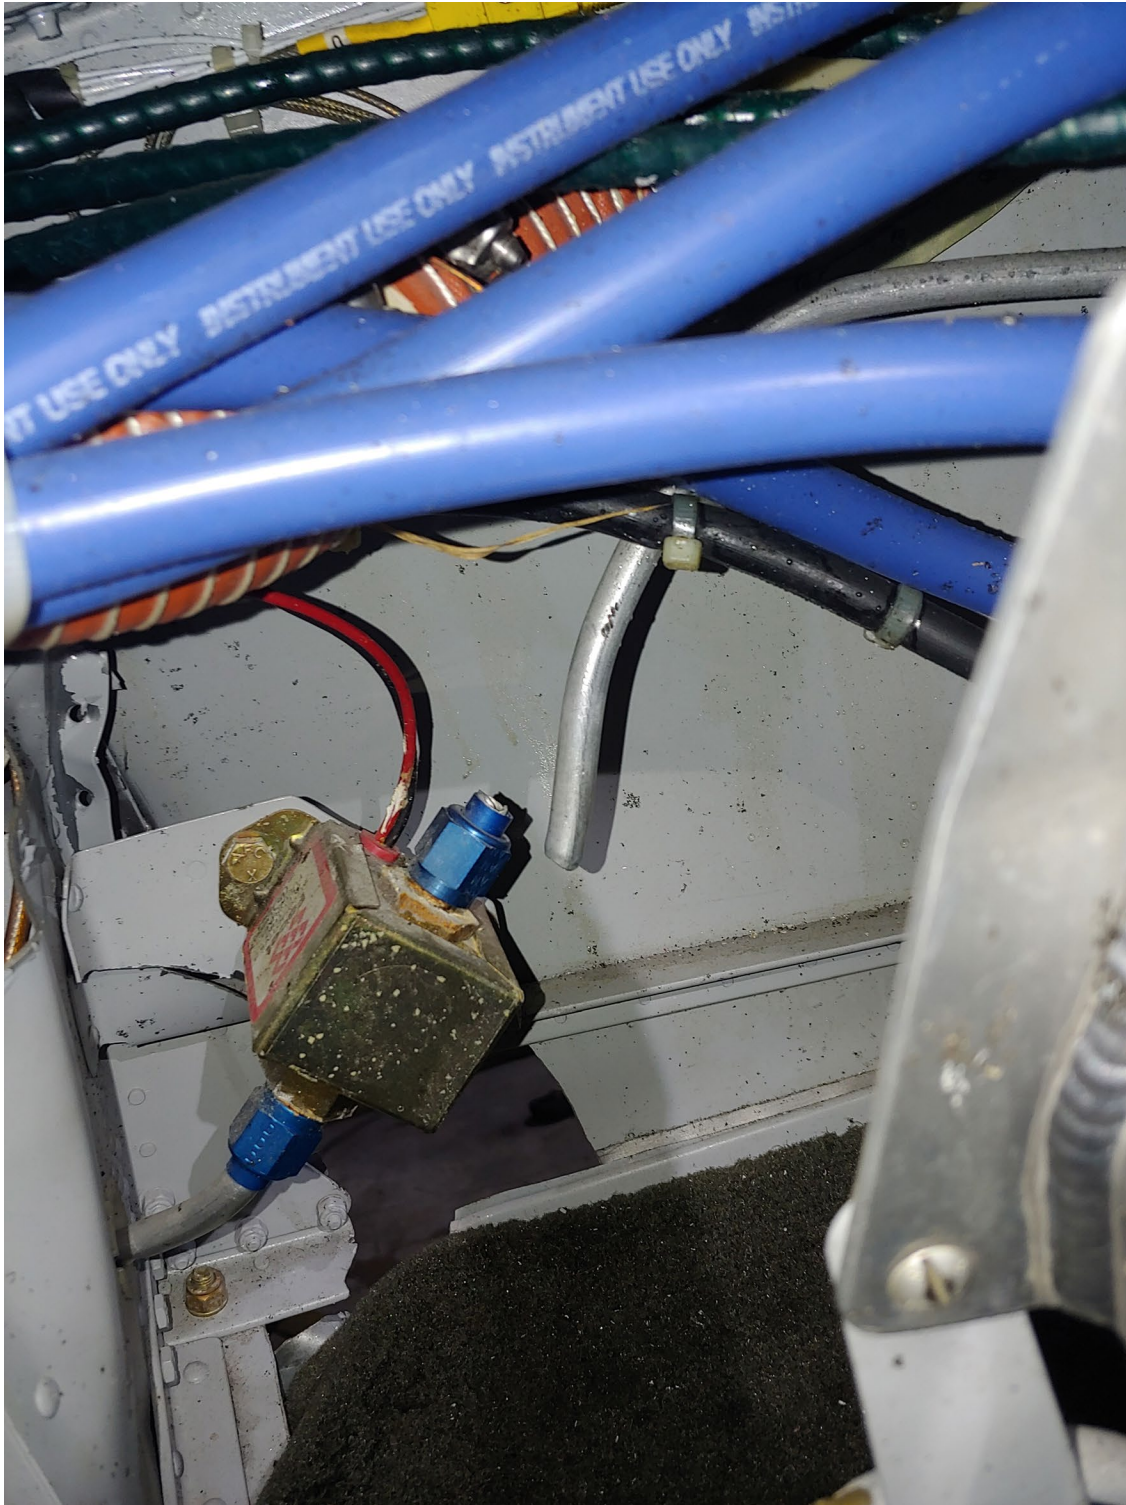
The electric fuel boost pump of the accident airplane was not attached to the airplane in accordance with the build plans of the Van's RV-8. Below is an excerpt from the build plans showing the boost pump mounted to the floor and a photograph, provided to the NTSB IIC by the Federal Aviation Administration Inspector who performed the wreckage examination, showing the boost pump mounted to the side of the fuselage interior.
