ERA23LA368

## INVESTIGATION PHOTOGRAPHS

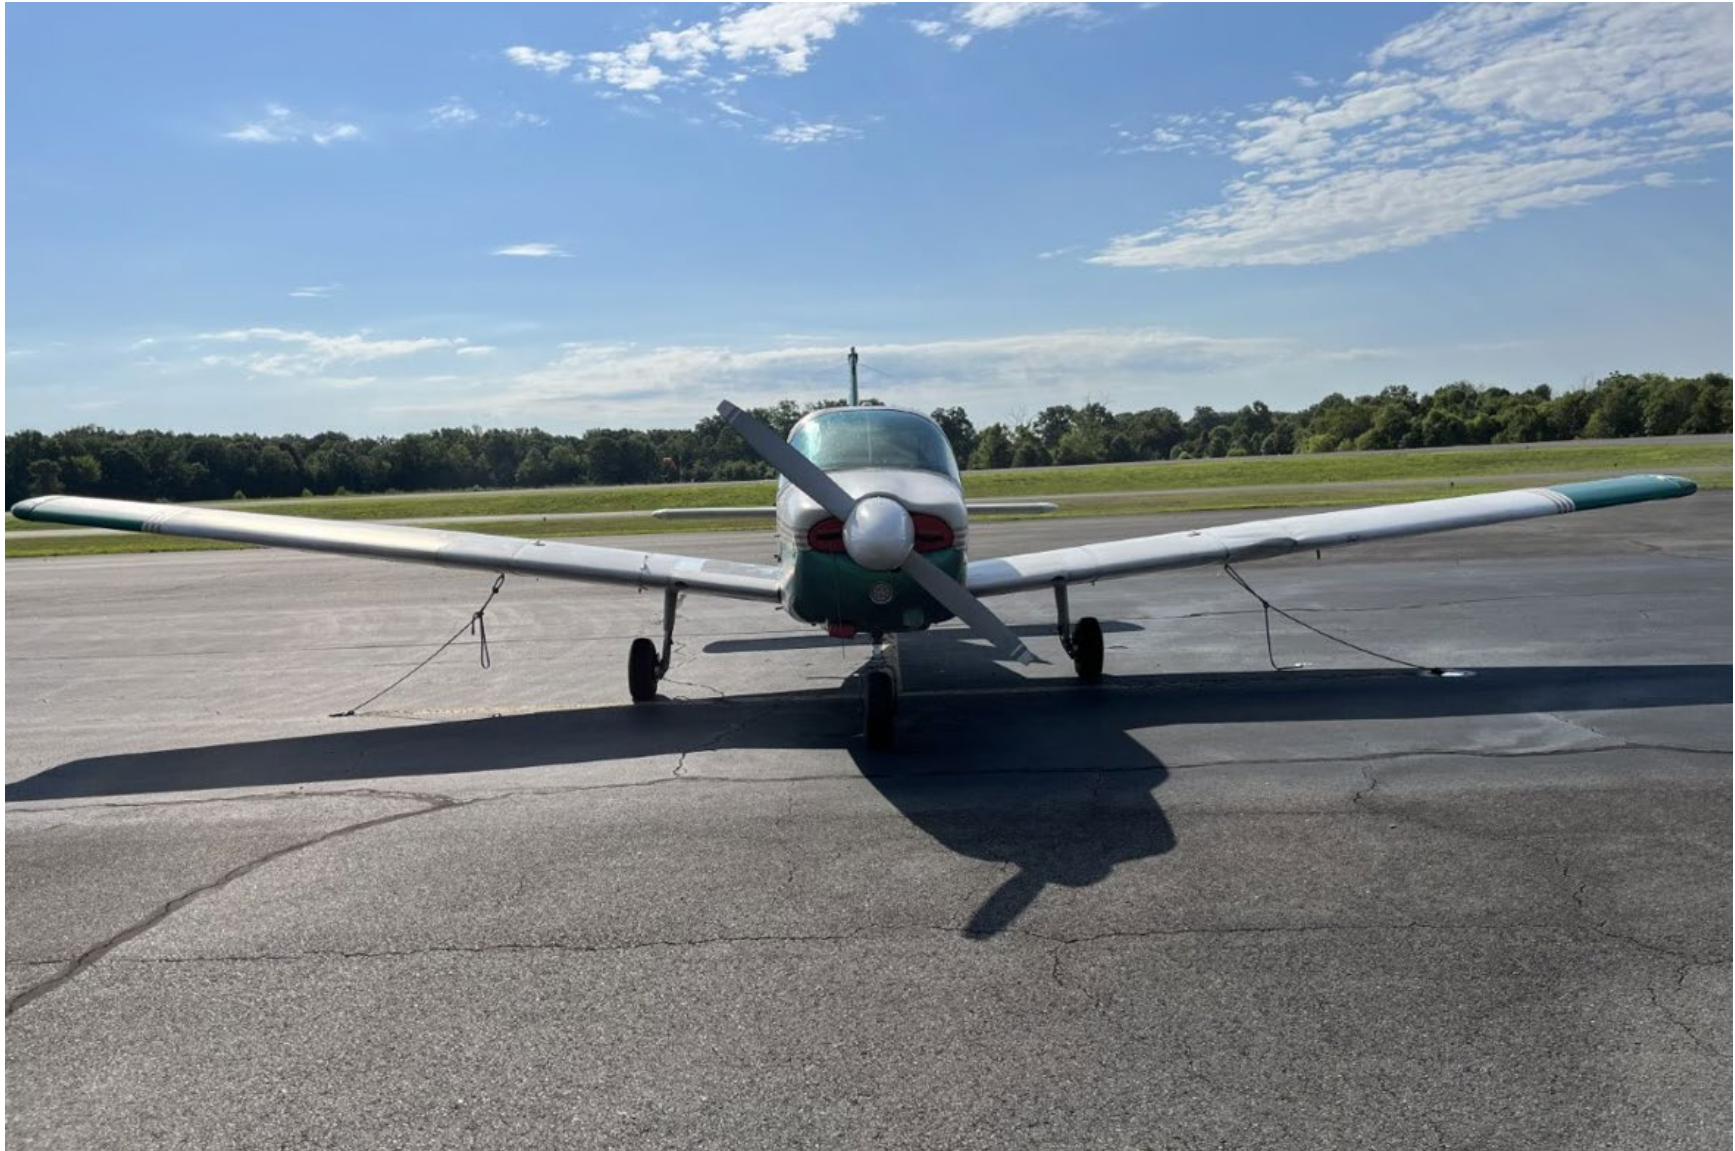
**Photograph 1 - Front view of airplane (Courtesy of FAA Inspector)**

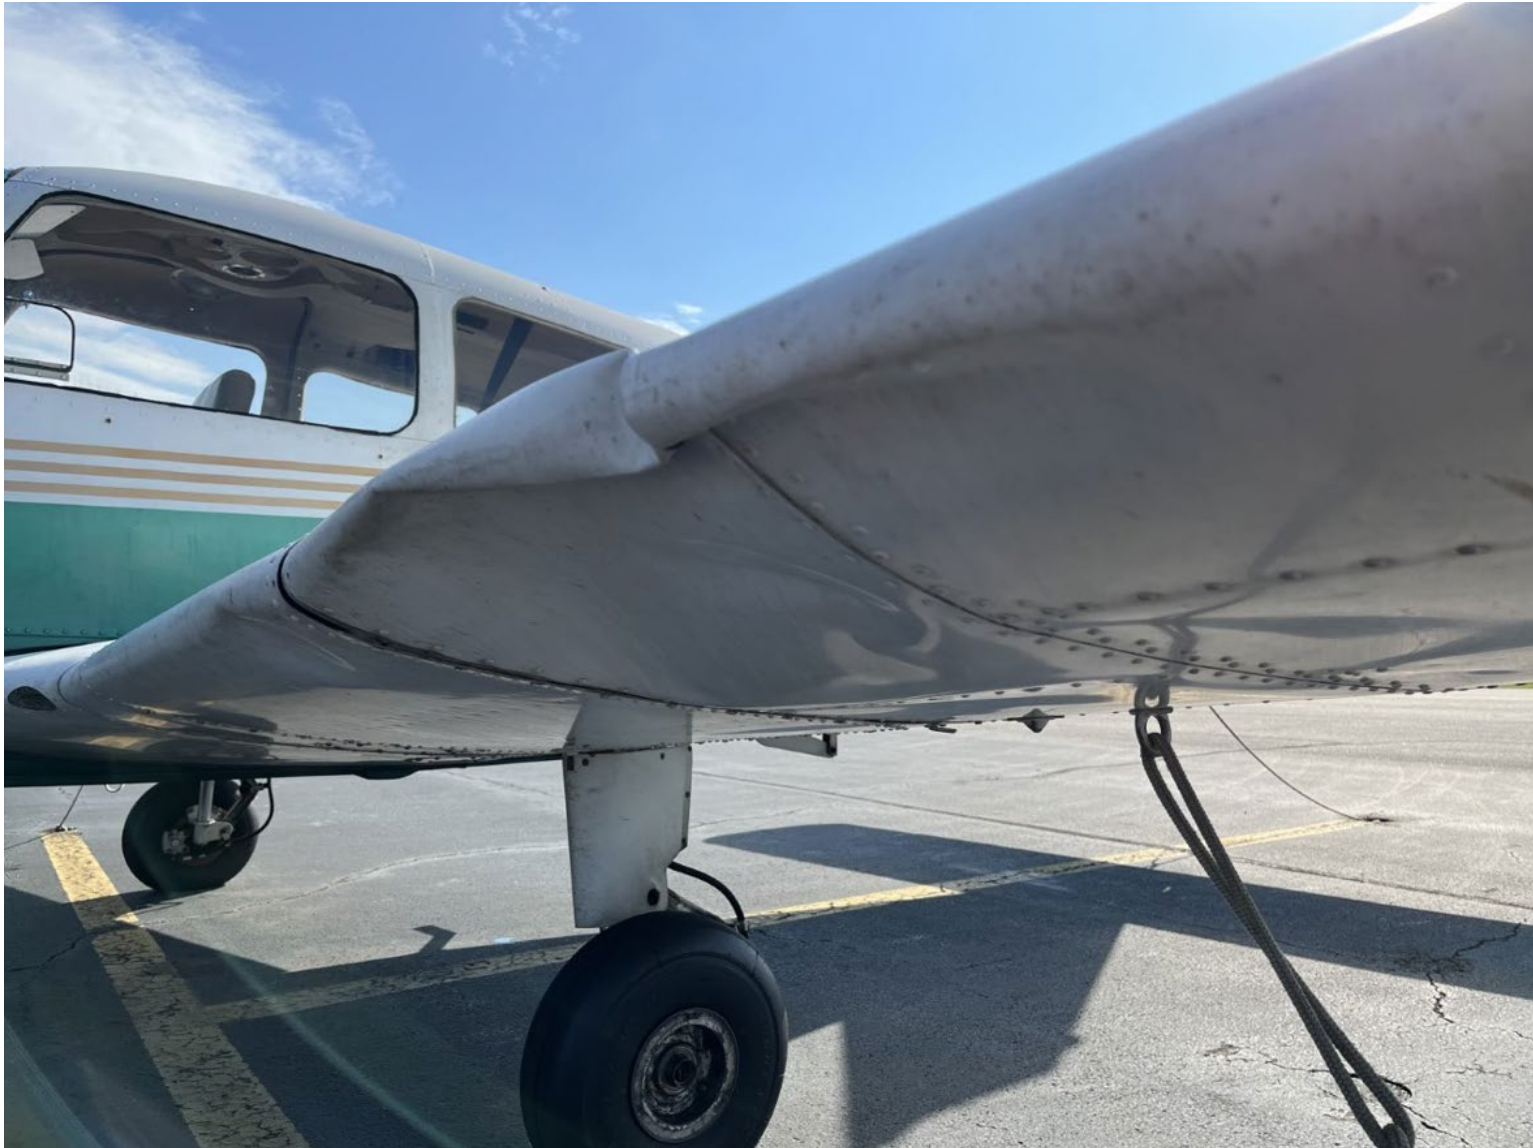
**Photograph 2 - Side view of wing damage (Courtesy of FAA Inspection)**

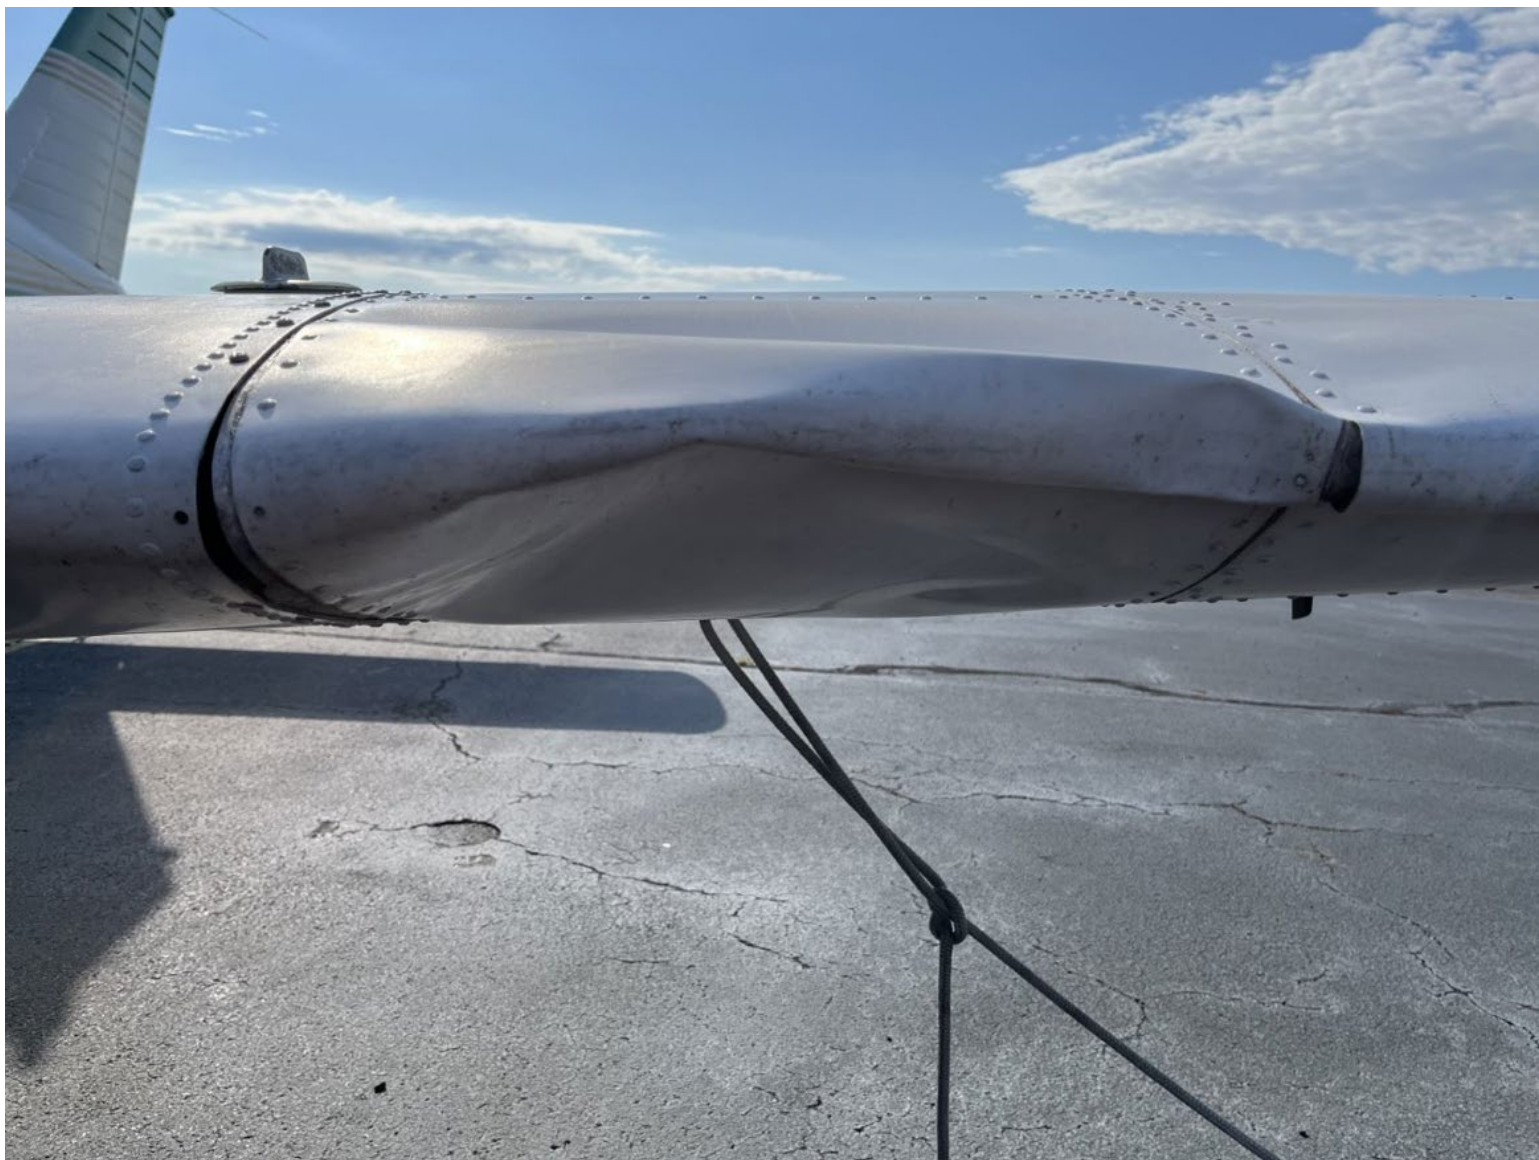
**Photograph 3 - Close view of wing damage. (Courtesy of FAA Inspector)**
