### N8443M Inspector Kachinski On-Scene Investigation Statement

On 09/14/2023 at approximately 1900Z, it was reported that N8443M, A 1976 Cessna 182P, Serial Number 18264605 experienced engine issues and made a forced landing in a soybean field located at [REDACTED] Prospect TN. Upon landing through the soybean field, it appeared that the nose landing gear (and confirmed by the pilot) struck a rut thus resulting in the separation of the nose landing gear from the aircraft and the aircraft flipping over and coming to a rest in an inverted state. It was reported that there were 2 POB with no injuries.

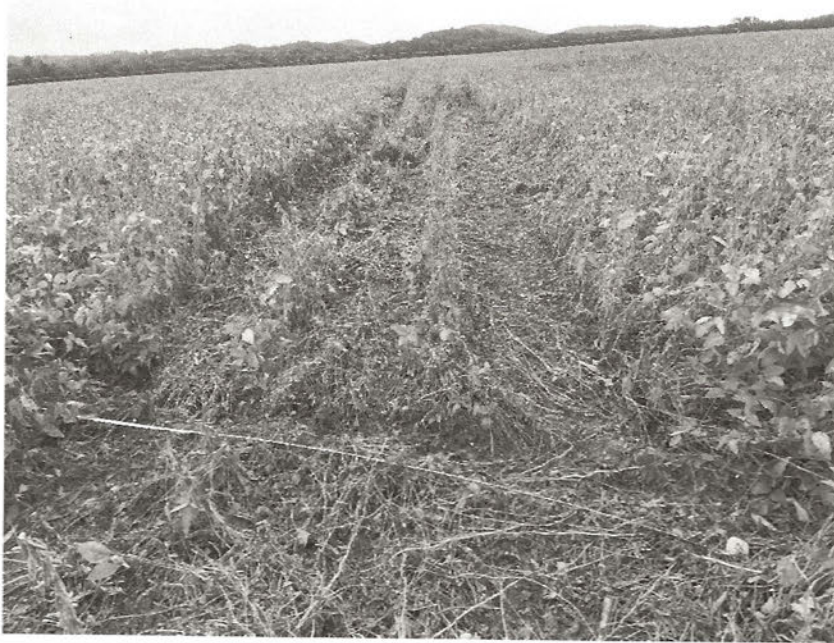
There was approximately 300 feet of soybean that appeared to be pushed down and showed the path of travel of the aircraft upon landing. The path was approximately 129 inches across. Direction of travel/landing was toward a southwest direction. The aircraft was in an inverted position with the tail facing a southwest direction and the nose facing a northeast direction.

*Figure 3 View looking toward start of landing path, Inspector back toward aircraft.*

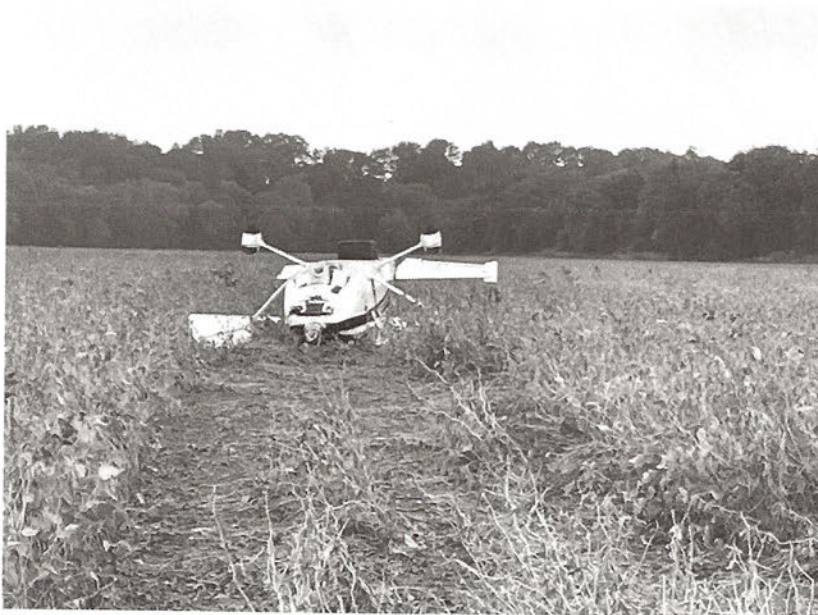
*Figure 4 View facing aircraft from landing path.*

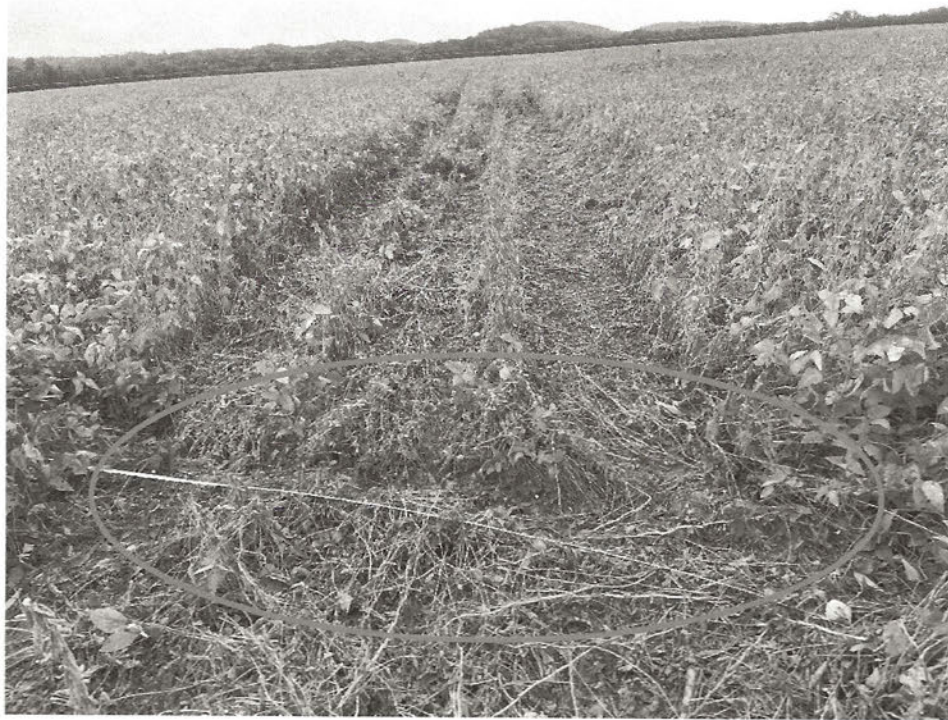
Approximately 200 feet along the path of travel there was a rut in the dirt approximately 4-5 inches deep. Upon surveying the surrounding area, it could be determined the rut was made from a large irrigation sprayer that moves around the area on tractor tires.

*Figure 5 Circled area identifying the rut along landing path.*

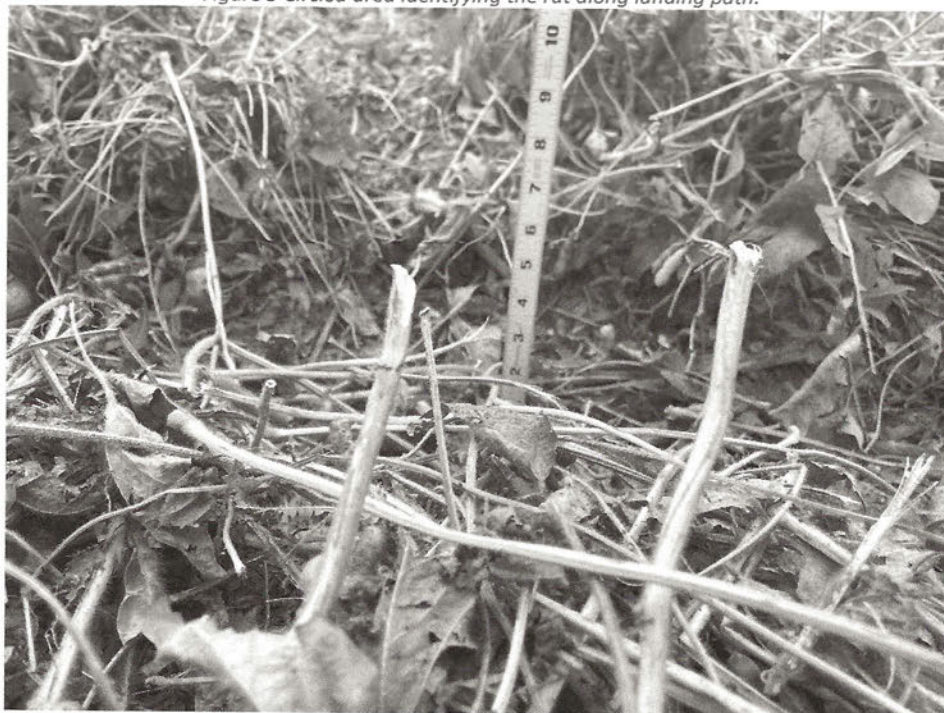
*Figure 6 Rut is approximately 4-5 inches deep.*

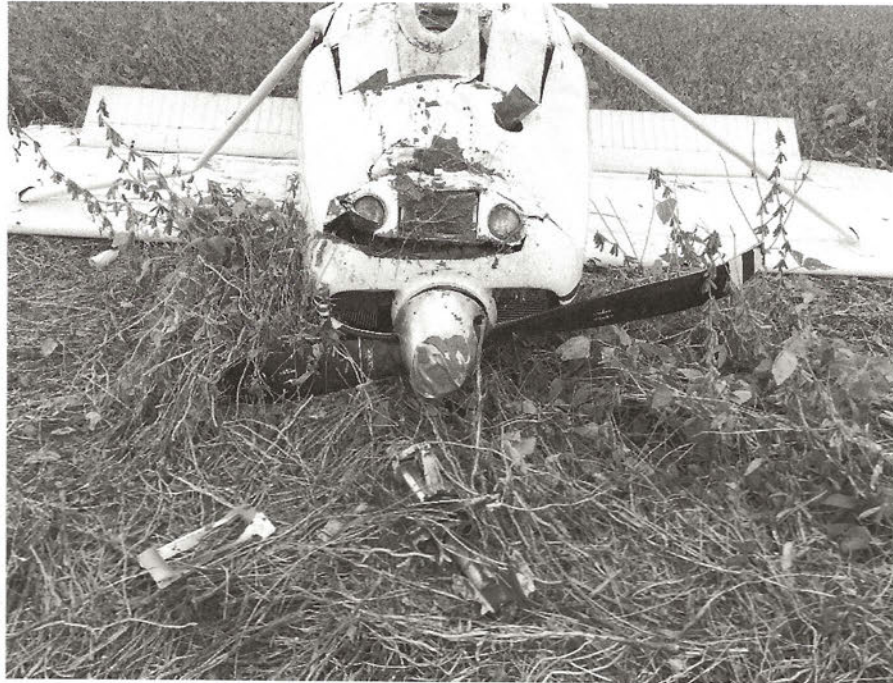
A walkaround of the aircraft was documented. The tips of the propeller were bent aft and curled slightly upward. The spinner was crushed inward. The engine cowlings showed evidence of impact damage with the ground. The landing gear was separated from the aircraft and laying off to the side. It could not be determined if the landing gear was in its final resting place or was moved by emergency personnel.

*Figure 7 View looking at nose of aircraft. Nose landing gear strut in front of spinner in grass.*

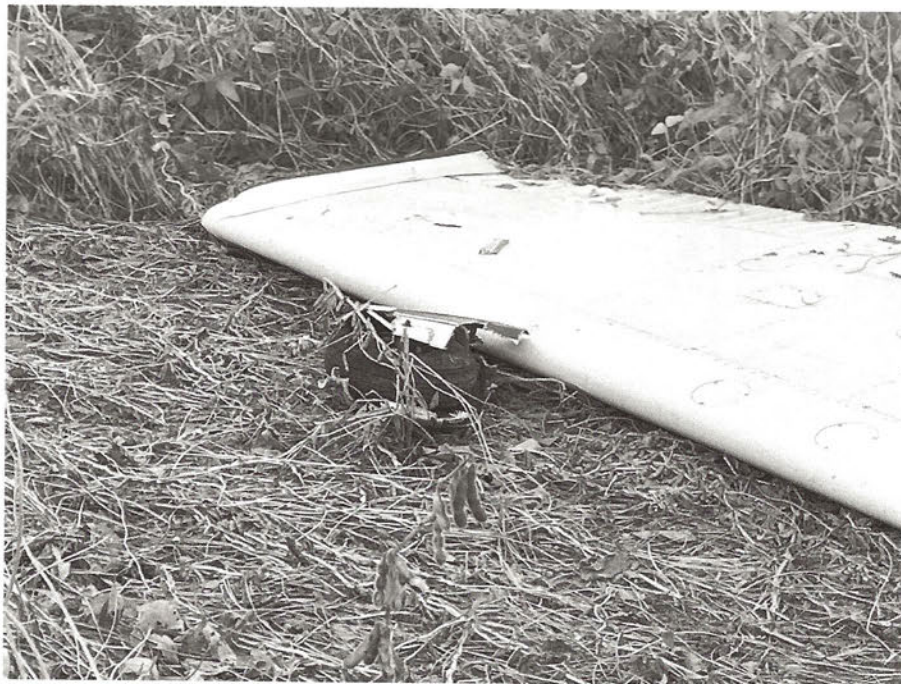
*Figure 8 Nose landing gear wheel pictured laying in front of left wing.*

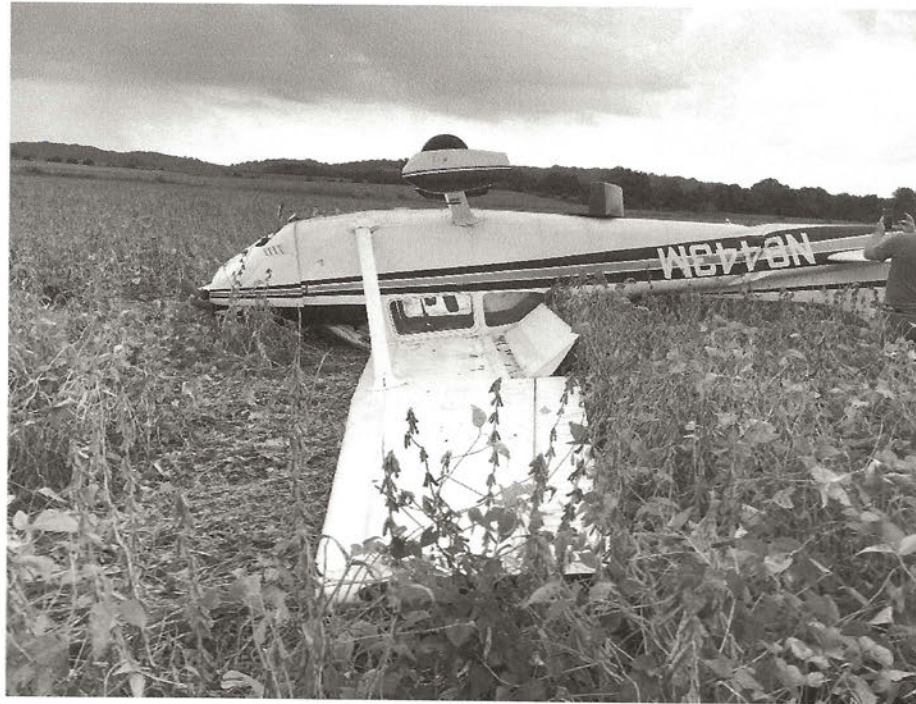
*Figure 9 RH Wing.*

Both aircraft wings were intact and there was no evidence of fuel leakage. The left hand wing strut was bent. Both flaps were in the down position. Both doors appeared to have been broken at the door hinges. The vertical tail was crushed into the ground and the tail section of the aircraft was buckled at the registration marks.
