# National Transportation Safety Board

ERA23LA372

## WRECKAGE EXAMINATION

Location: Prospect, Tennessee  
Date: September 14, 2023  
Time: 1300 CDT  
1800 UTC  
Airplane: N8443M, Cessna 182P

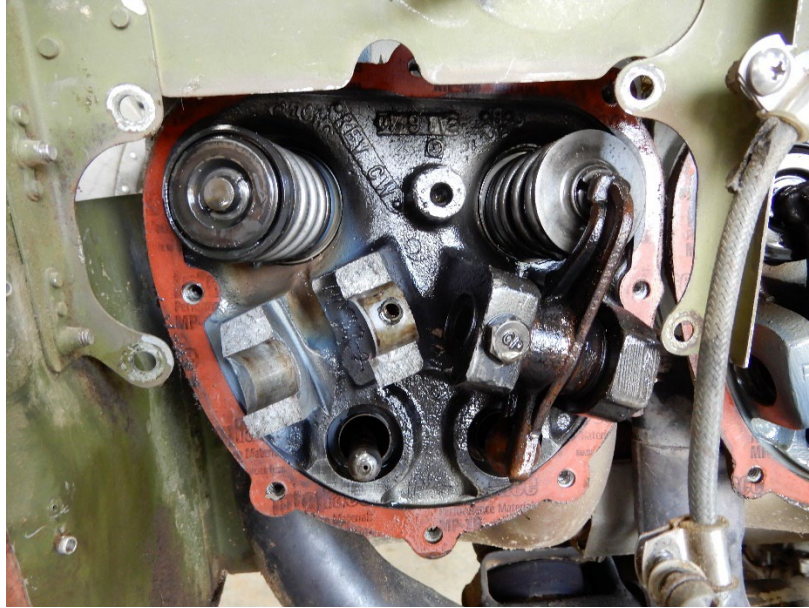
The rocker covers were removed to examine the cylinder heads and check valve action. The nos. 1-5 cylinders were normal in appearance and valve action was correct. When the rocker cover for the no. 6 cylinder was removed, pieces of the exhaust valve rocker boss, the rocker, washers, and the rocker shaft were loose inside. The exhaust valve was closed. The rocker boss was fractured in two places (see Photos 1 and 2).

Photo 1 - No. 6 Cylinder Head (Note fractured exhaust valve boss)

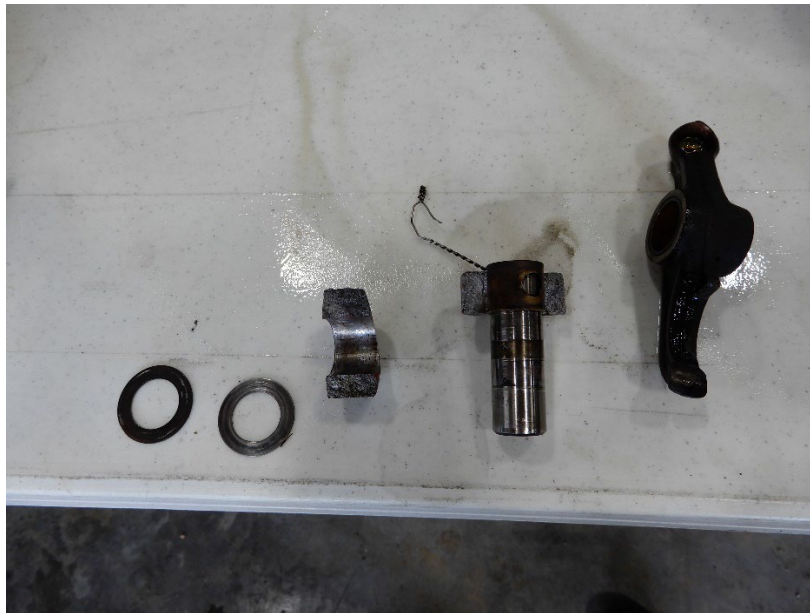
Photo 2 - Loose Parts Found inside No. 6 Cylinder Head Rocker Cover
