# National Transportation Safety Board

ERA23LA372

## **MATERIALS LABORATORY**

Factual Report 24-041

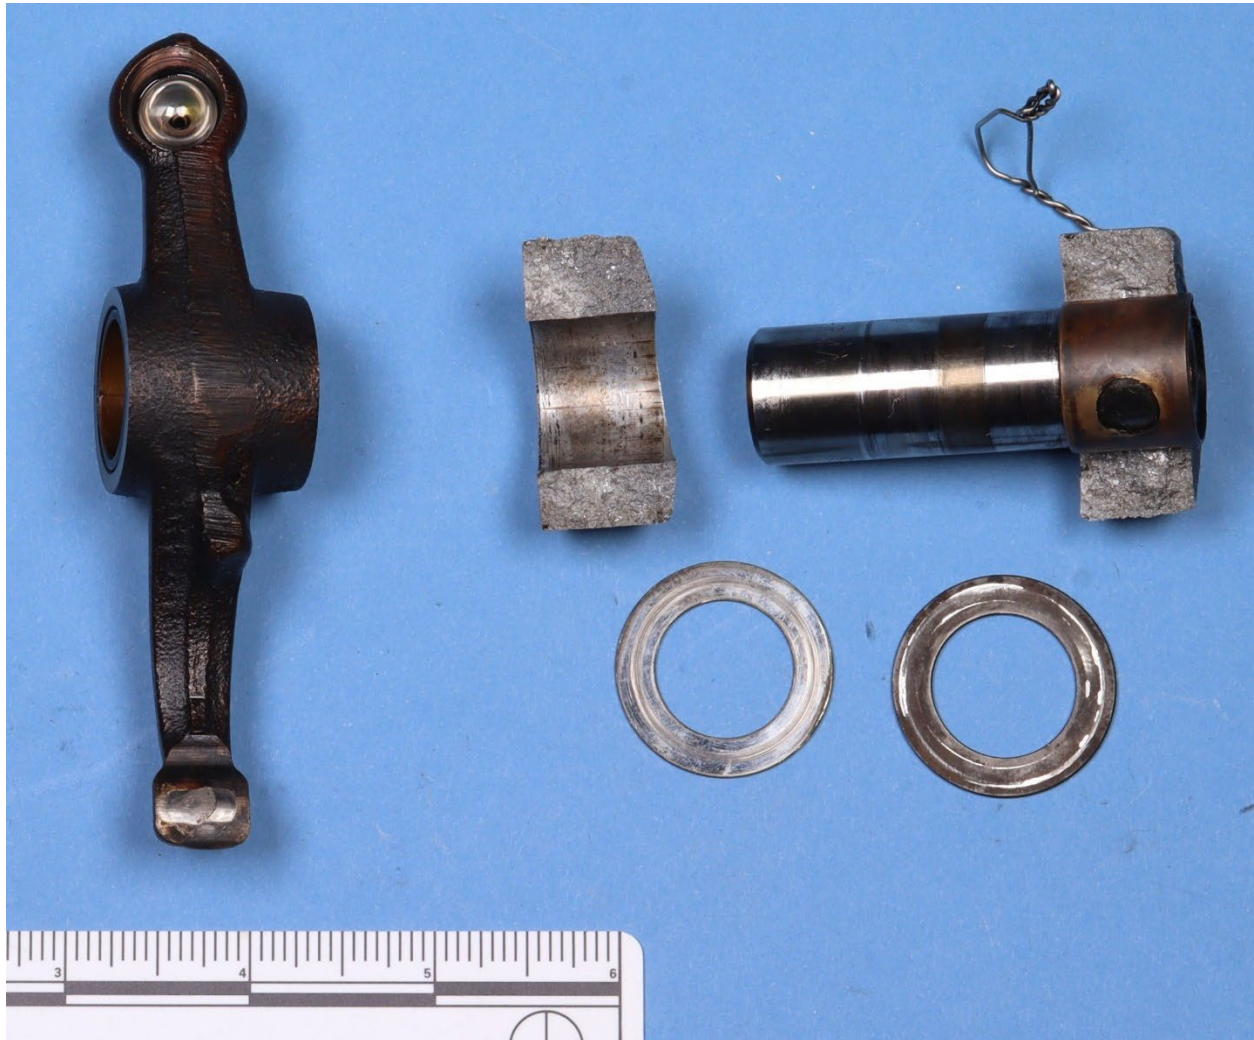
Figure 1 shows the components from the #6-cylinder position, as received. This figure includes one of the rocker arms, two washer/spacers, the arm shaft, and two housing boss fragments around the bores where the arm shaft had been positioned. One of the housing bore fragments was completely separated, while the other was still attached to the shaft via a hex bolt with safety wire through a bushing.

Figure 1. The pieces submitted from the accident, including a rocker arm, two fractured sections of cylinder housing, the adjacent shaft bolted to the right fragment with safety wire, and two washer/spacers.

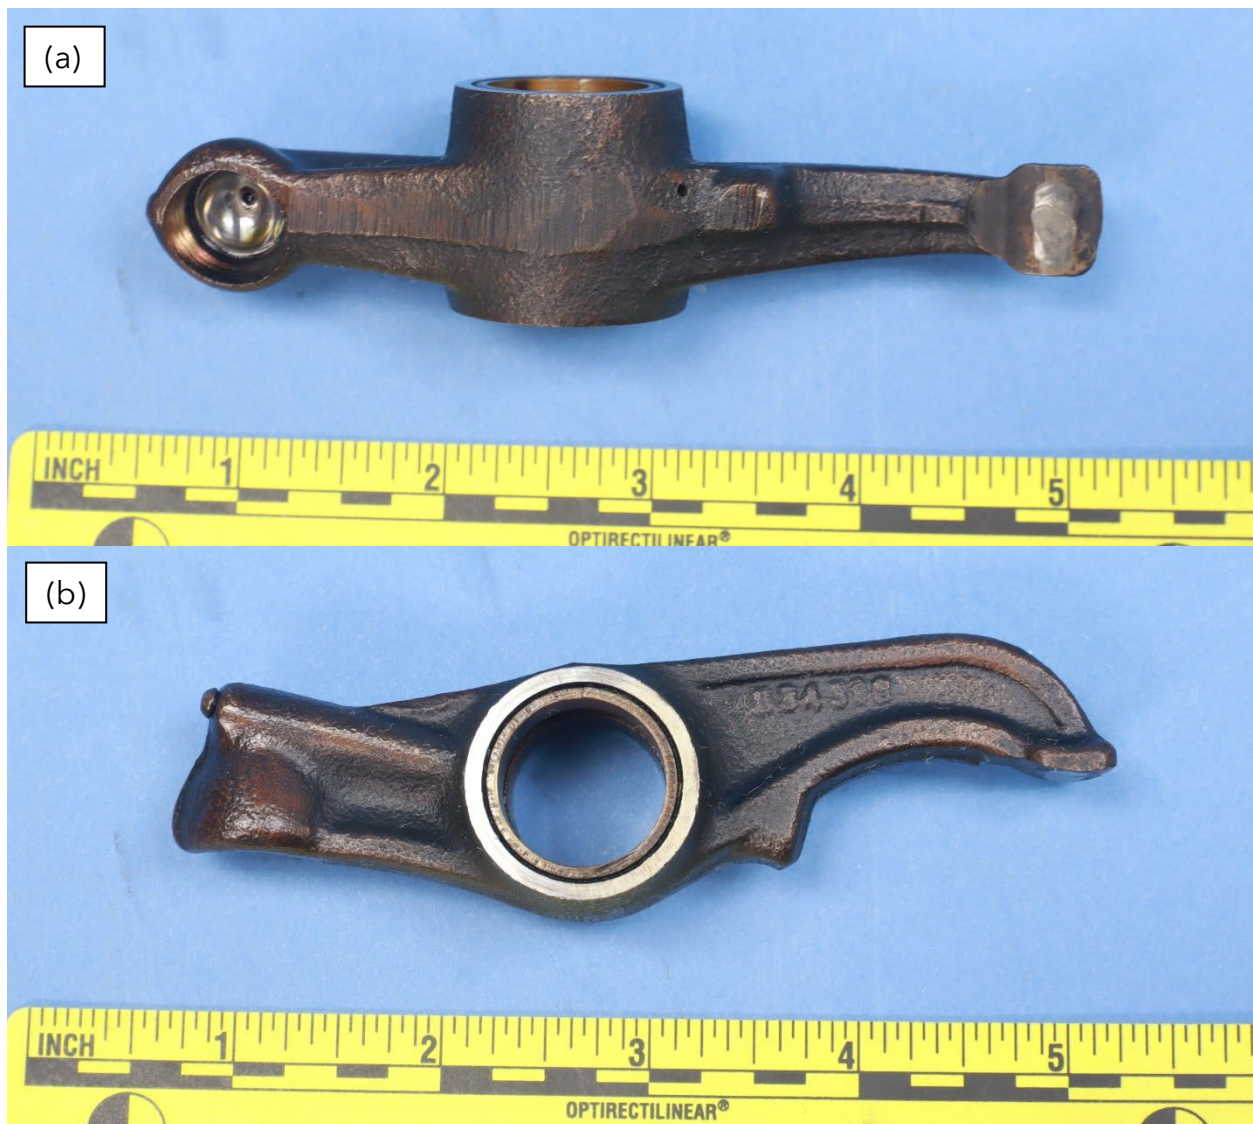
Figure 2 shows the rocker arm as received. The arm exhibited a rough surface texture and center part line, consistent with being die-cast. The bushing was still inside the rocker arm bore, as shown in Figure 2b. This figure also shows the part number on the side, which states, "534358." On the contact surfaces with the pushrod, any wear marks were centered and even. There were no indications of cracks on these surfaces and no plastic deformation present along the sides.

Figure 2. View of the rocker arm from (a) the underside with contact surfaces and (b) the side showing the casting markings and internal bushing.

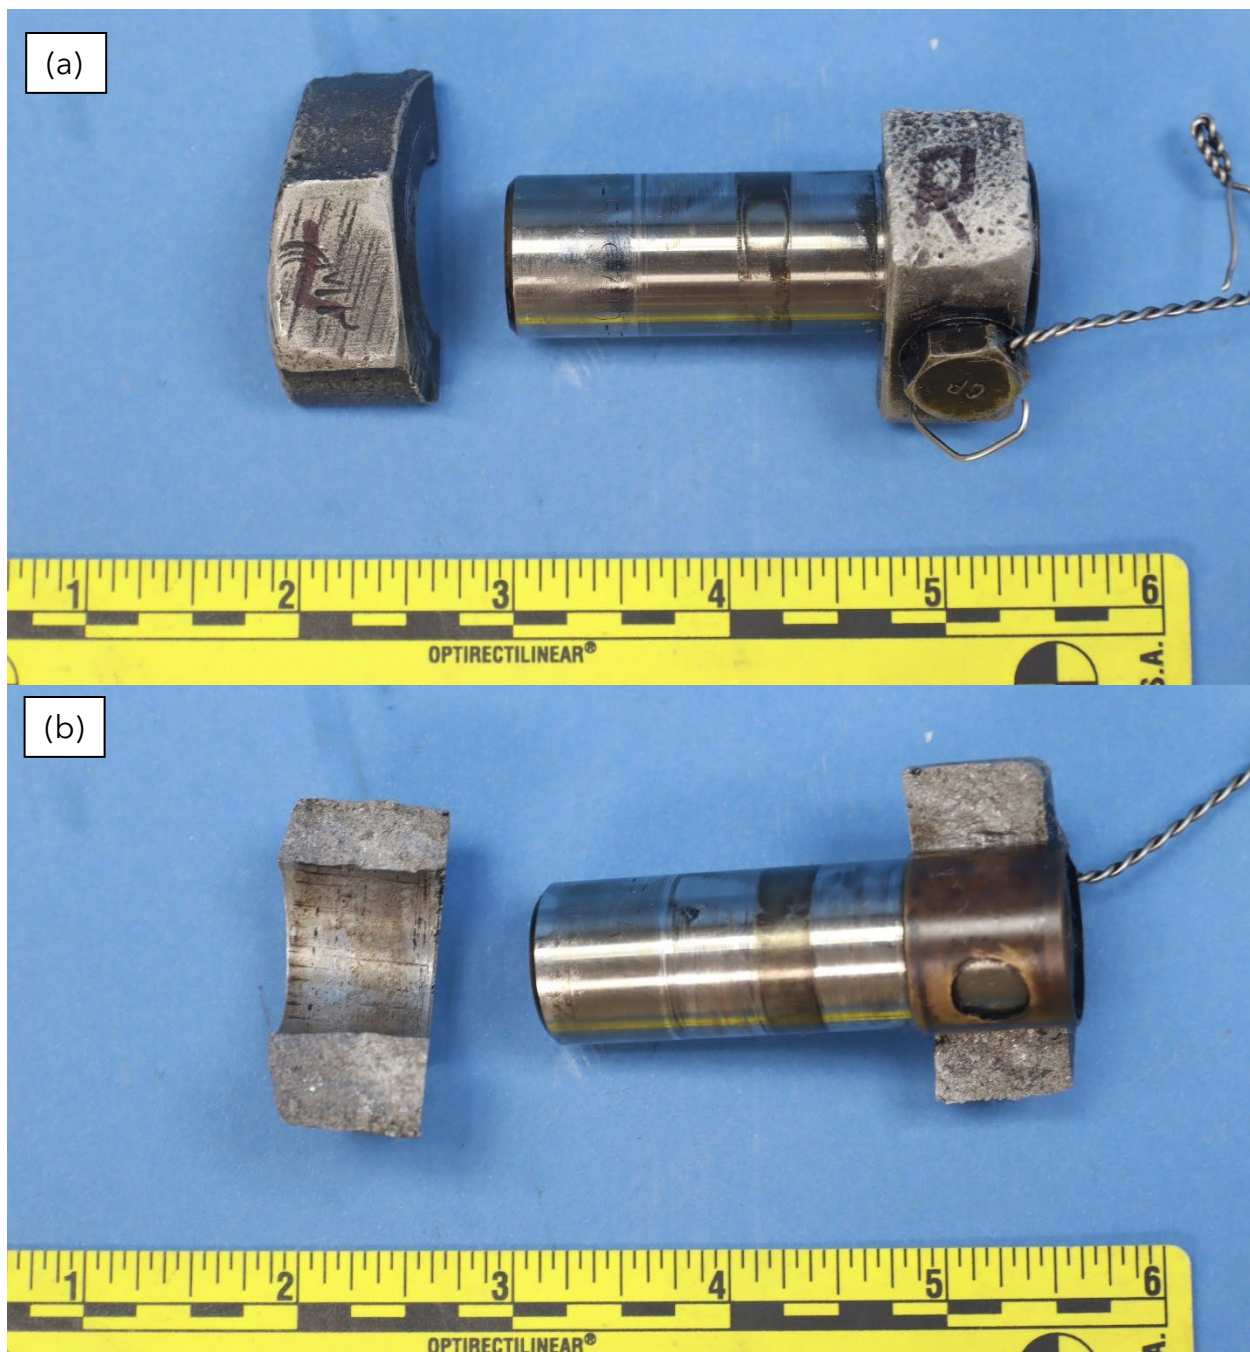
Figure 3 shows the rocker arm shaft and adjacent housing fragments from the top and fracture surfaces. Before receipt, these fragments had been labeled 'L' and 'R'. The right housing fragment was still attached to the arm and bushing by a hex nut with markings 'CP' and safety wire. The arm exhibited circumferential discoloration corresponding to the contact locations with the housing bores and the rocker arm bushing in its bore. Figure 4 shows the side view of this assembly remnant, with the housing having fractured at approximately the widest portion of the bushing diameter and the fracture surface being oriented flat.

Figure 3. View of the rocker shaft and the housing fragments from (a) the top or exterior side and (b) the fracture surfaces on downward-facing sides.

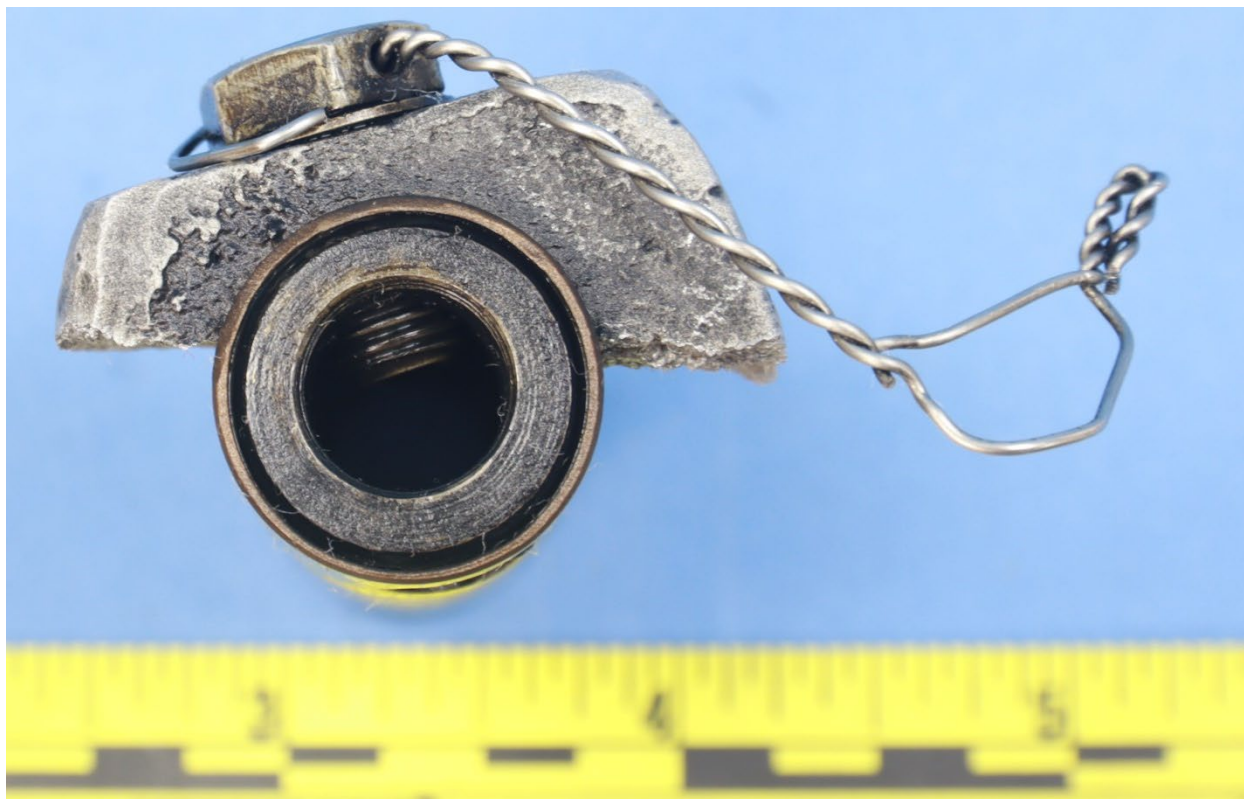
Figure 4. End of the rocker arm shaft attached to a fractured cylinder housing fragment.

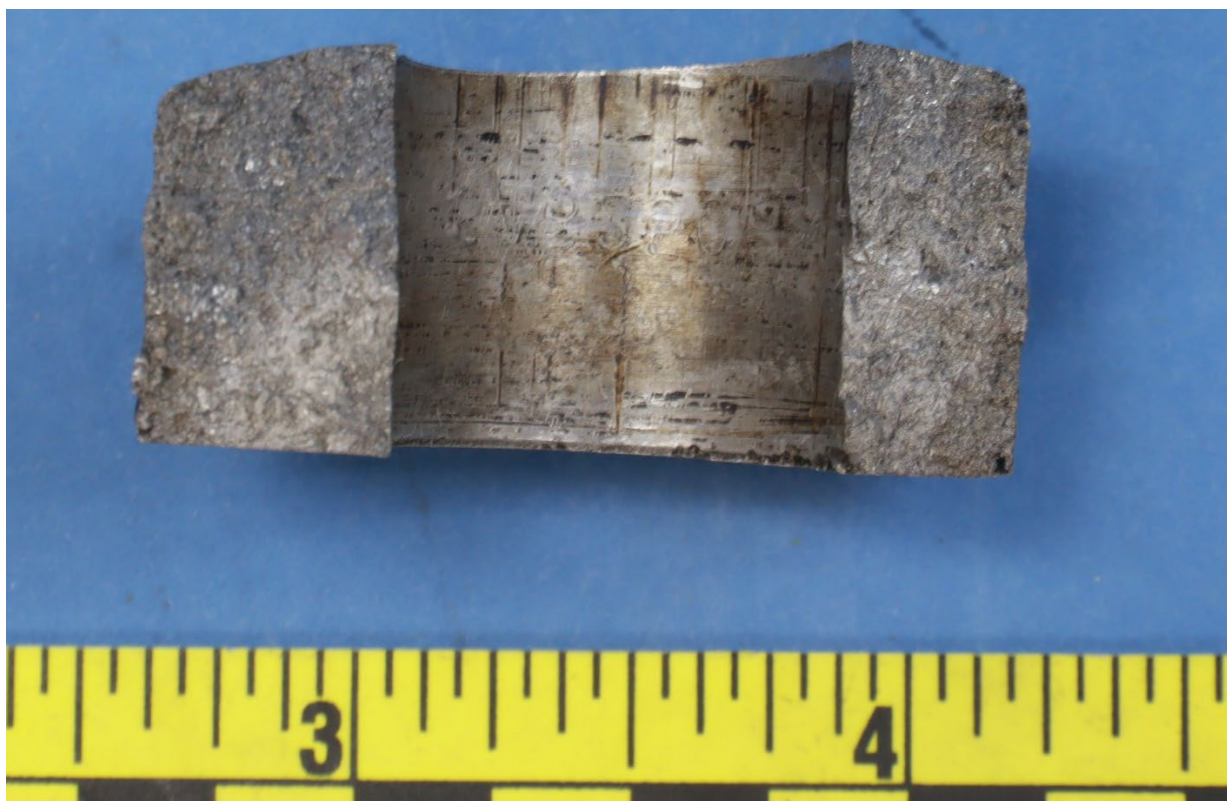
The housing fragments were disassembled from adjacent components and cleaned in an ultrasonic bath of acetone to remove grease and other superficial surface contamination. Figure 5 shows the bore and fracture surfaces of the left or loose housing boss fragment. The bore exhibited longitudinal wear marks, along with some circumferential gouges on the lower portion of the figure.

Figure 5. The fracture surfaces of the loose or left cylinder housing fragment.

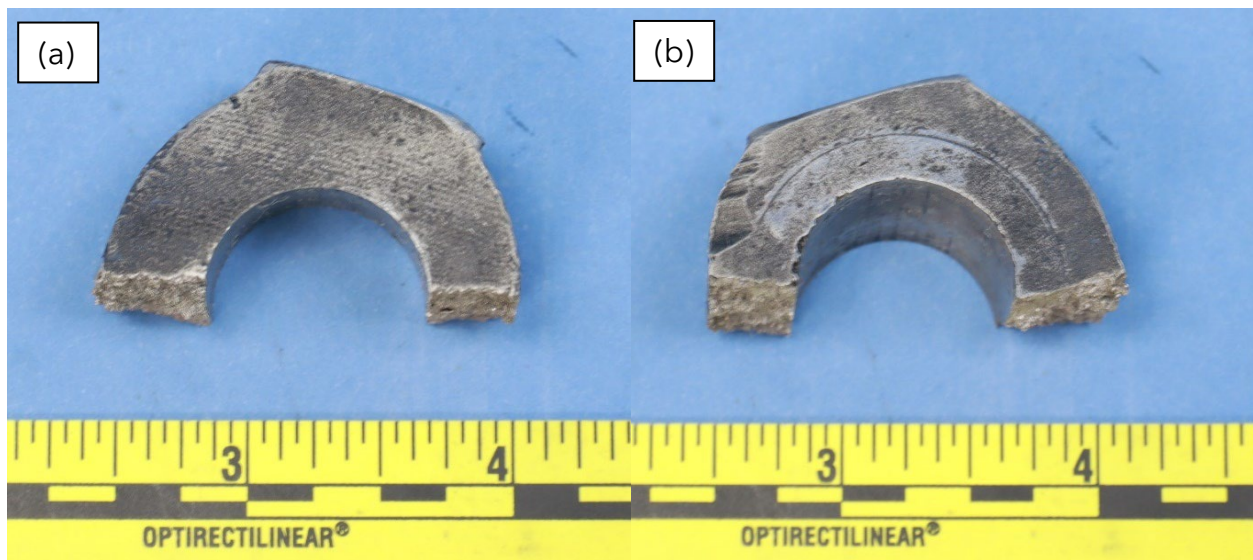
Figure 6 shows the opposite faces of the left housing boss fragment. The side in Figure 6b exhibited the most prominent features, with a circumferential depression and triangular impact marks on the left corner.

Figure 6. The loose cylinder housing from (a) the outboard and (b) inboard faces.

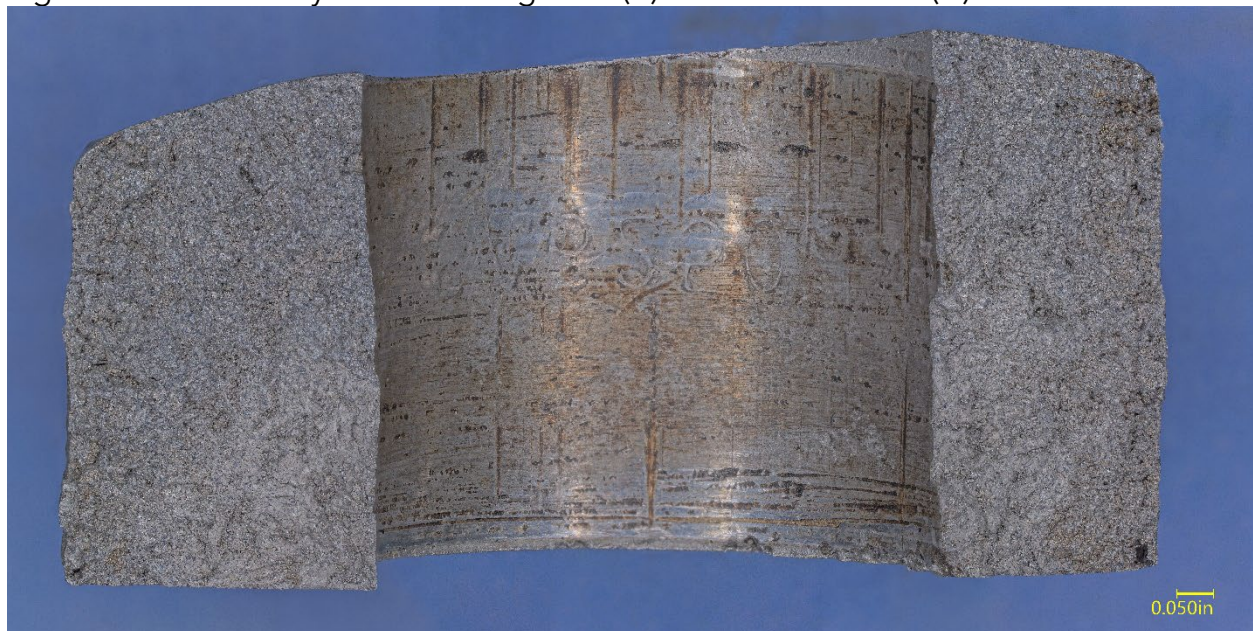
The fracture surface of the fragment is highlighted in Figure 7. Overall, the fracture surface was rough and fibrous in texture and dull in luster. Like the right-side fragment fracture surfaces illustrated in Figure 4, this fracture surface was relatively flat and perpendicular to the bore, located along the widest part of the outer diameter.

Two triangular areas with darker hues were located along the corner with the bore at the bottom of Figure 7. These regions and the surrounding areas exhibited radiating linear features, consistent with those emanating from the inner corners along the bore at the bottom of Figure 7. One of these darker-colored regions is highlighted in Figure 8. The area along the bore exhibited outward deformation, located along regions of the circumferential gouges in the bore. Similar features were observed on one side of the right housing fragment, shown in the bottom center-left of Figure 9.

Figure 7. View of the loose housing fragment fracture surfaces, after cleaning.

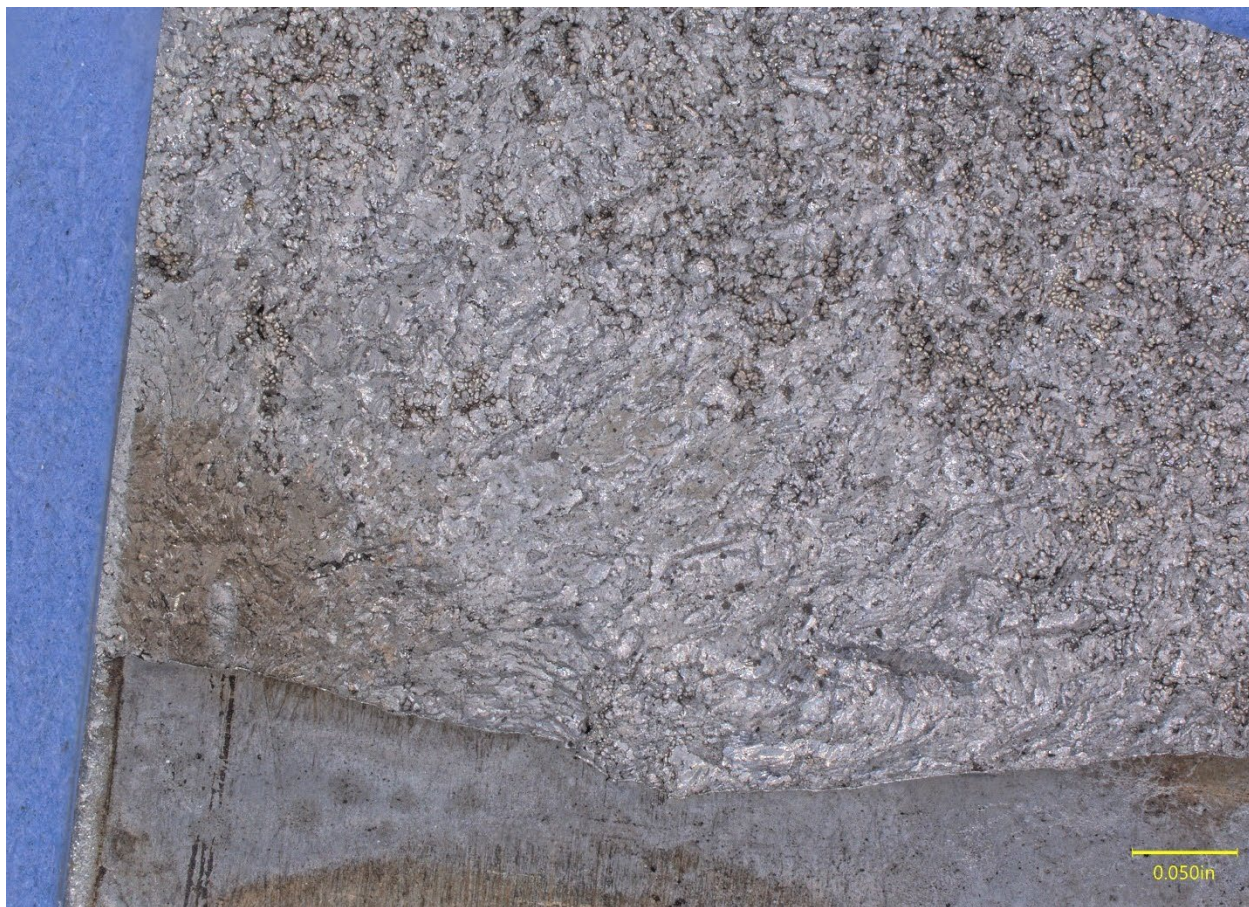
Figure 8. View of an inward corner of the left fracture surface in Figure 7, showing a darker triangular region on the fracture surface.

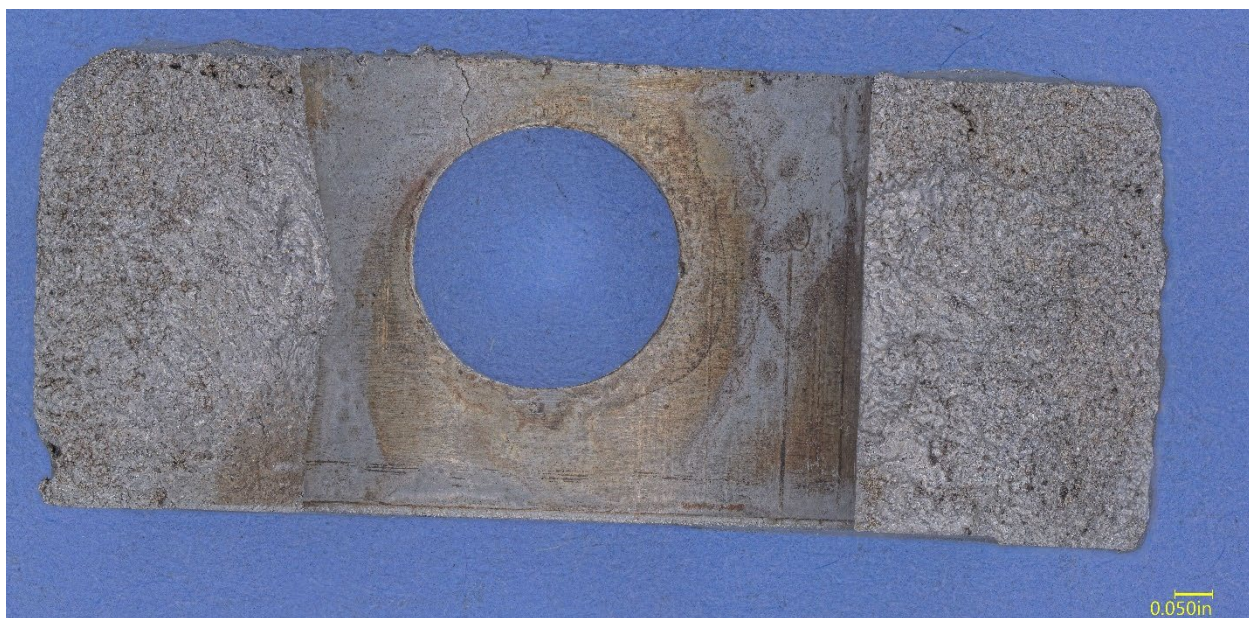
Figure 9. View of the fracture surfaces of the attached cylinder housing fragment, after disassembly and cleaning.

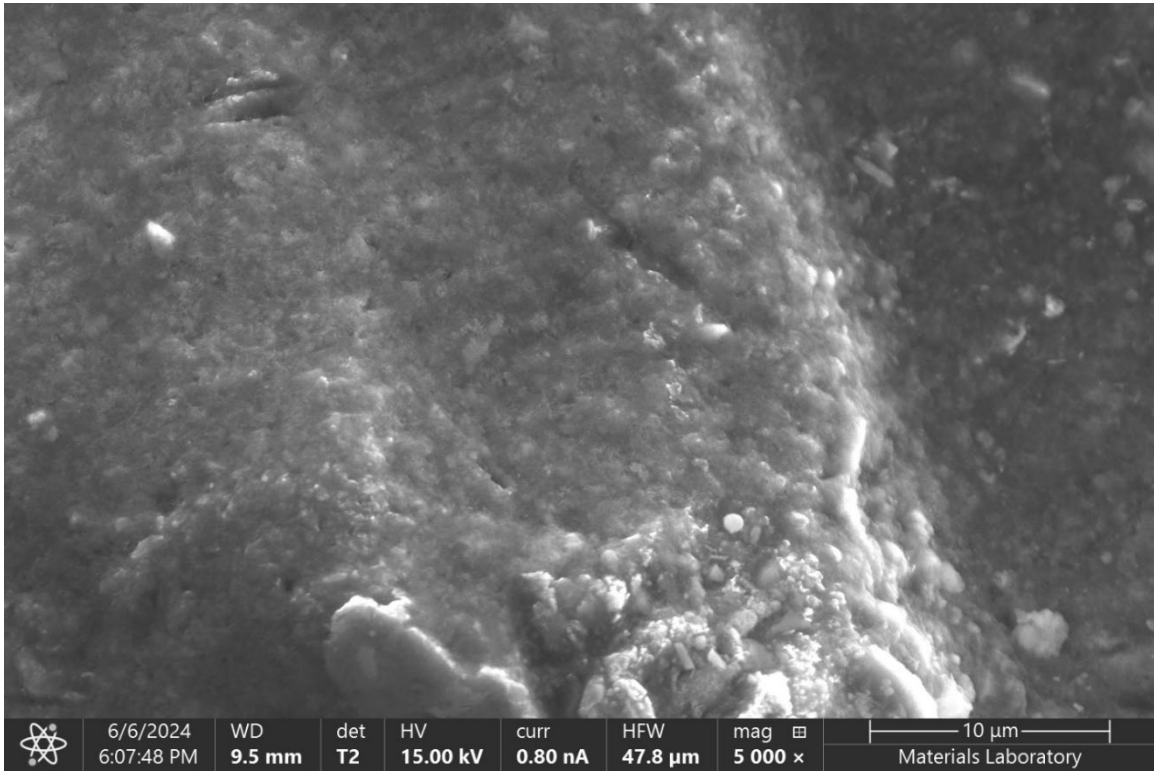
These fracture surfaces were examined using a field-emission scanning electron microscope (SEM). Figure 10 shows a typical view of the fracture surface in the triangular region of Figure 8. This region exhibited a generally flat orientation, with

repeating linear features and a layer of surface oxidation thick enough to obscure many underlying fracture features.

These features were consistent with fatigue striations. The area of these triangular regions adjacent to the bore corner exhibited multiple initiation sites, separated by perpendicular ratchet marks. These features were consistent with multiple fatigue crack initiation sites.

Figure 10. Secondary electron (SE) micrograph of fatigue striations, covered by an oxidation layer on the surface.

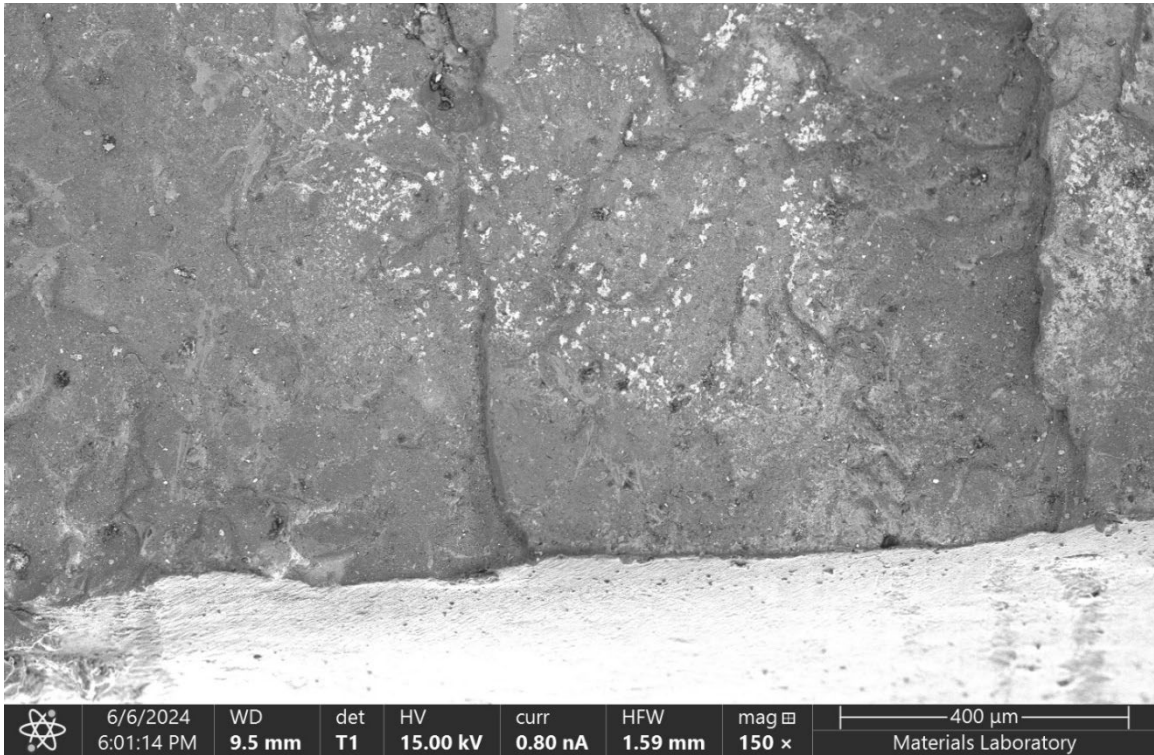
Figure 11. Backscattered electron (BE) micrograph of two individual crack initiation sites along the bore corner.

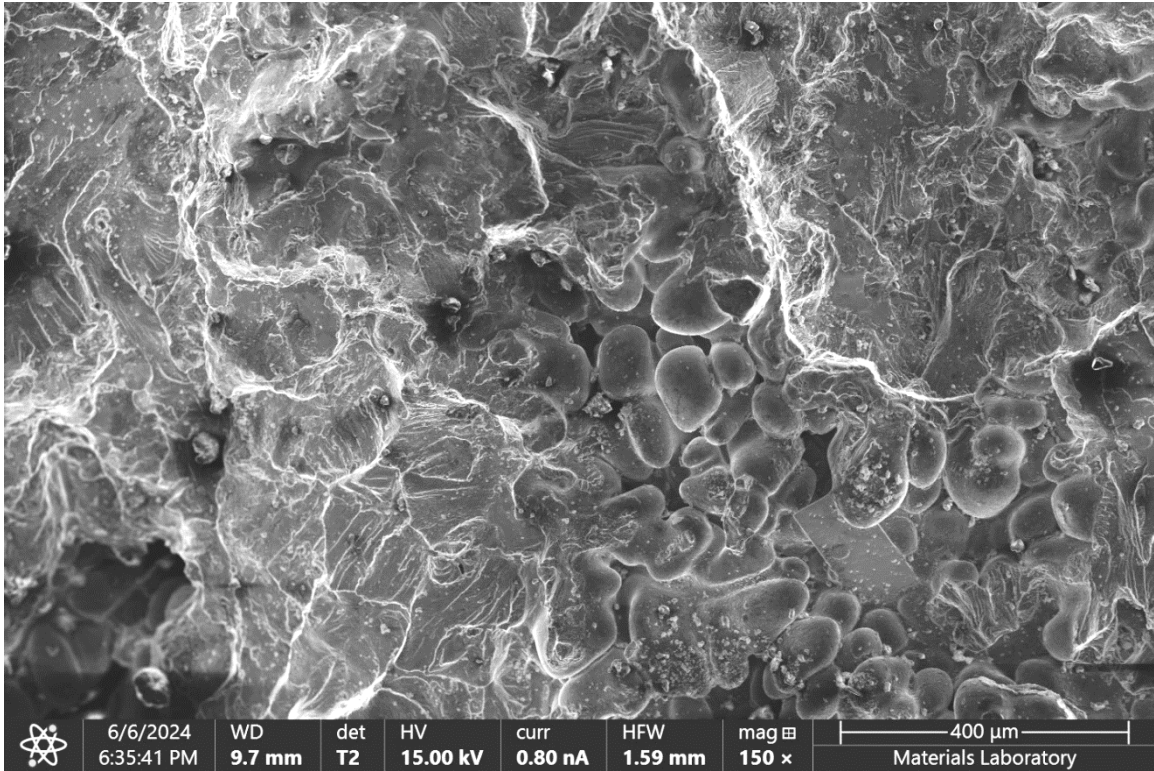
Outside of these triangular fatigue regions, the fracture surface exhibited contrasting features, as illustrated in Figure 12. These features included dimpled rupture and areas of flat, faceted fracture features. These patterns were consistent with subsequent overstress fracture of the casting material. There were also rounded and protruding features within voids found outside the fatigue cracks, as shown in Figure 12. Many of the features within this void exhibited rounded dendrite ends (Figure 13). These structures were consistent with solidification voids that would have been introduced during the casting process.

Figure 12. SE micrograph of dendritic features in the fracture surface of the housing fragment.

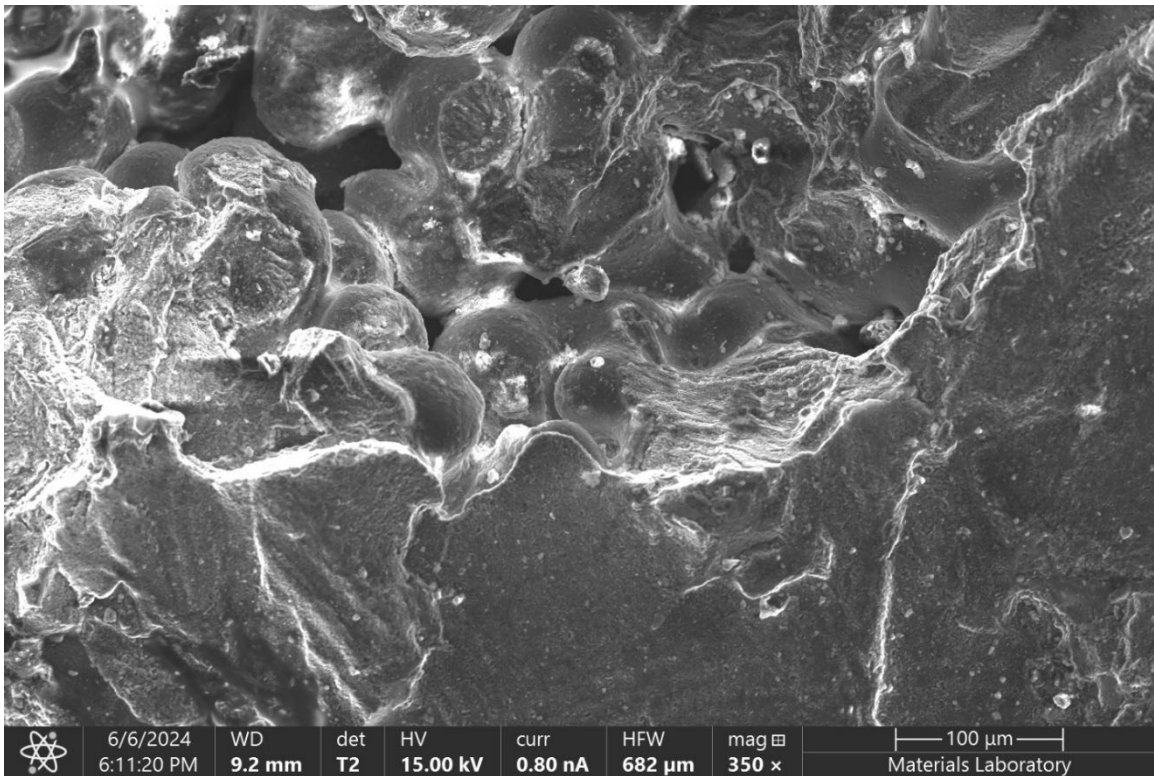
Figure 13. SE micrograph of dendritic features in a solidification void in the fracture surface.

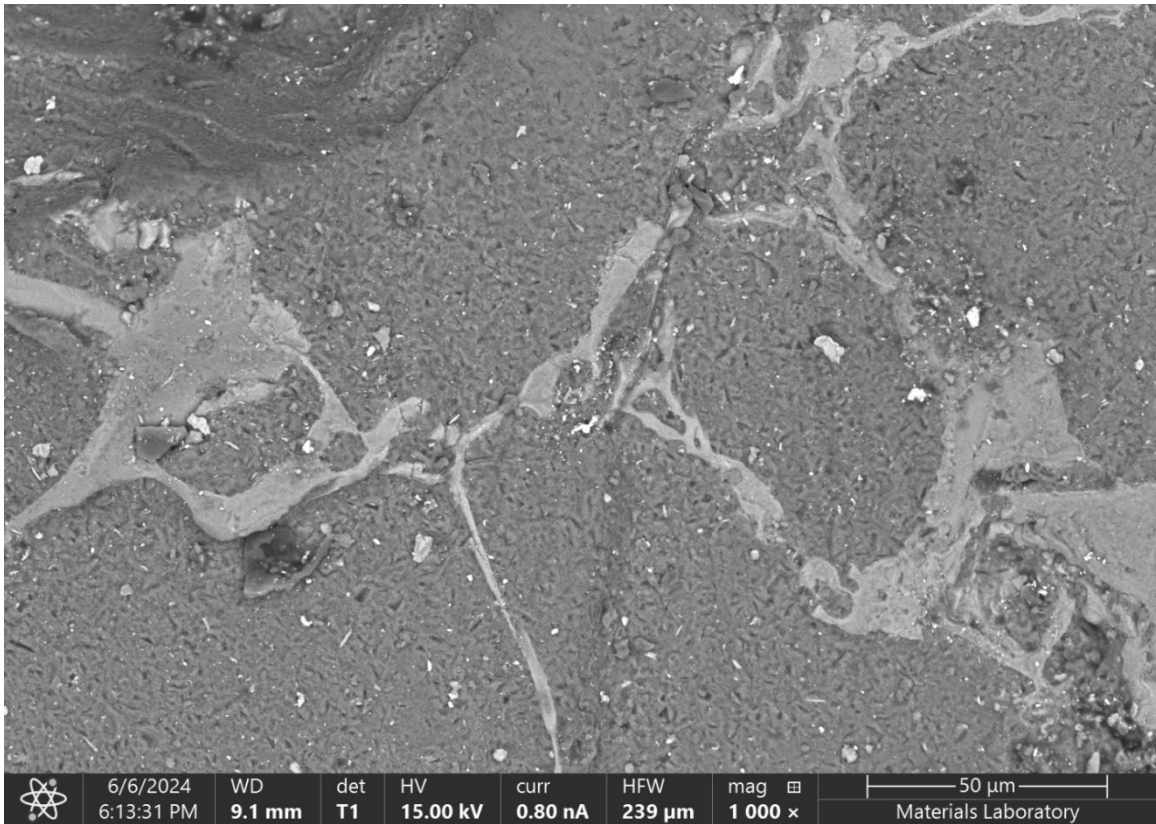
The composition of the fractured housing remnants was consistent with an aluminum-silicon casting alloy, as determined using energy dispersive x-ray spectroscopy (EDS). However, some areas contained inconsistent local compositions, as shown in Figure 14. In this figure, the lighter regions exhibited higher percentages of nickel, whereas the darker gray areas were primarily aluminum. The darkest areas in the figure were mainly silicon. These data were consistent with the segregation of alloying elements from the solidification process.

Figure 14. BE micrograph of different hue intensities consistent with interdentritic material observable on the fracture surface.
