ERA23LA374

## INVESTIGATION PHOTOGRAPHS

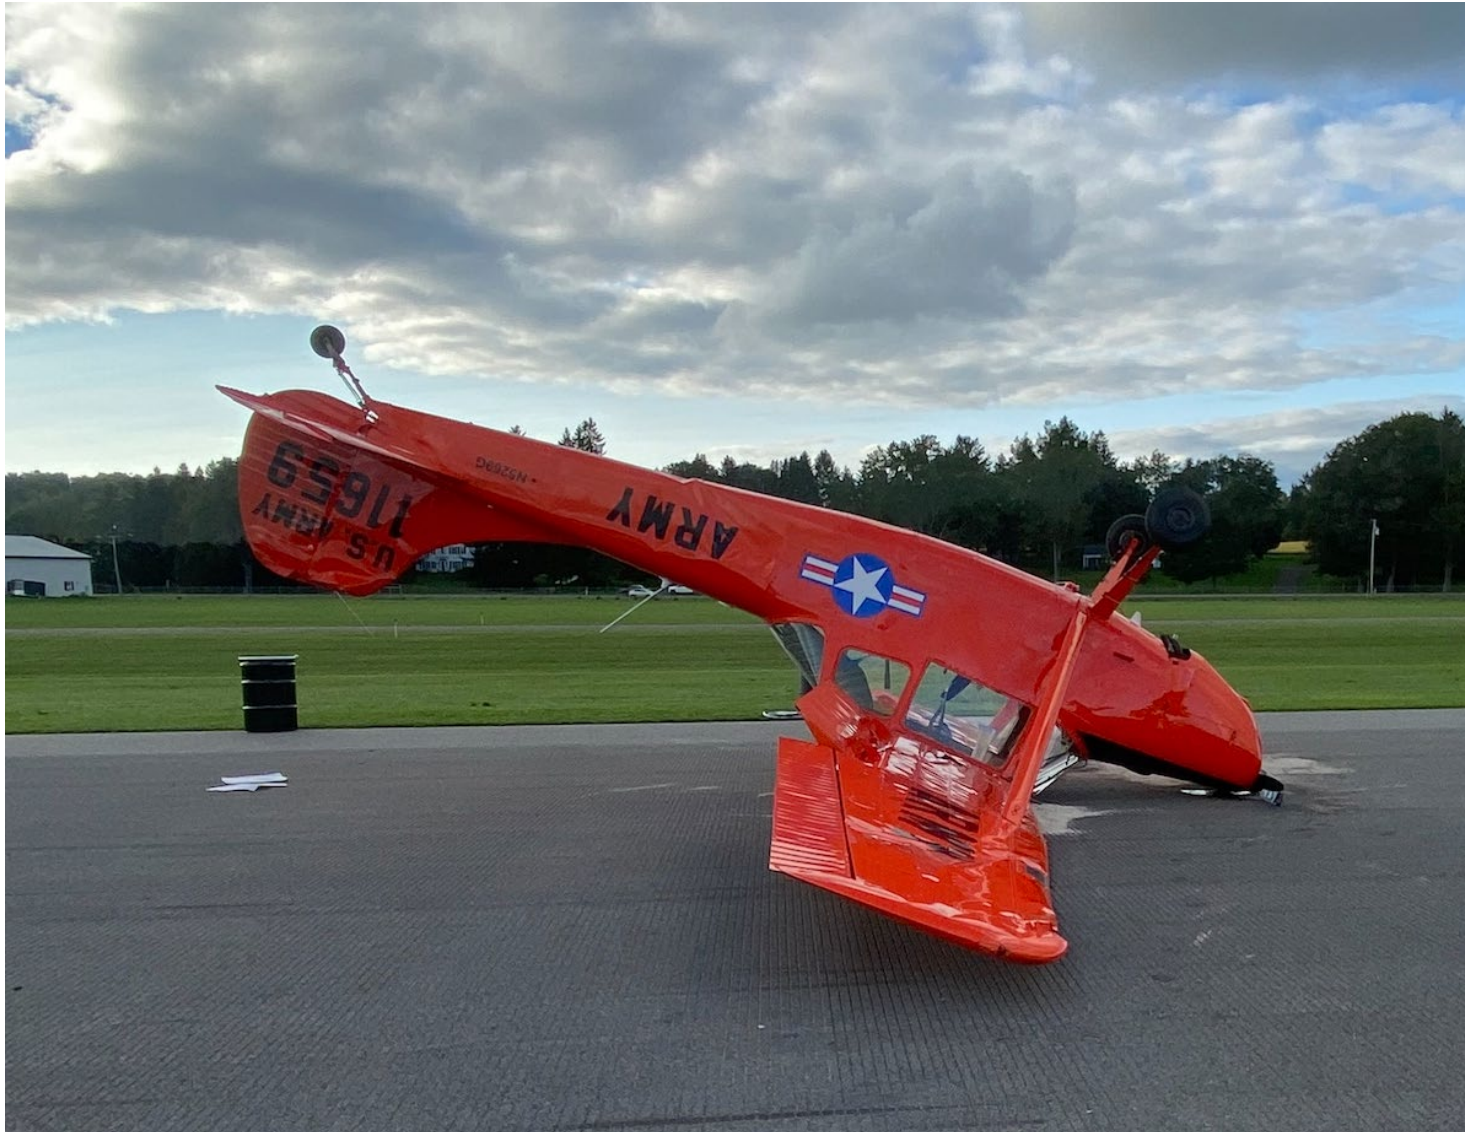
**Photograph 1 - View of inverted airplane from left wing (Courtesy of FAA)**

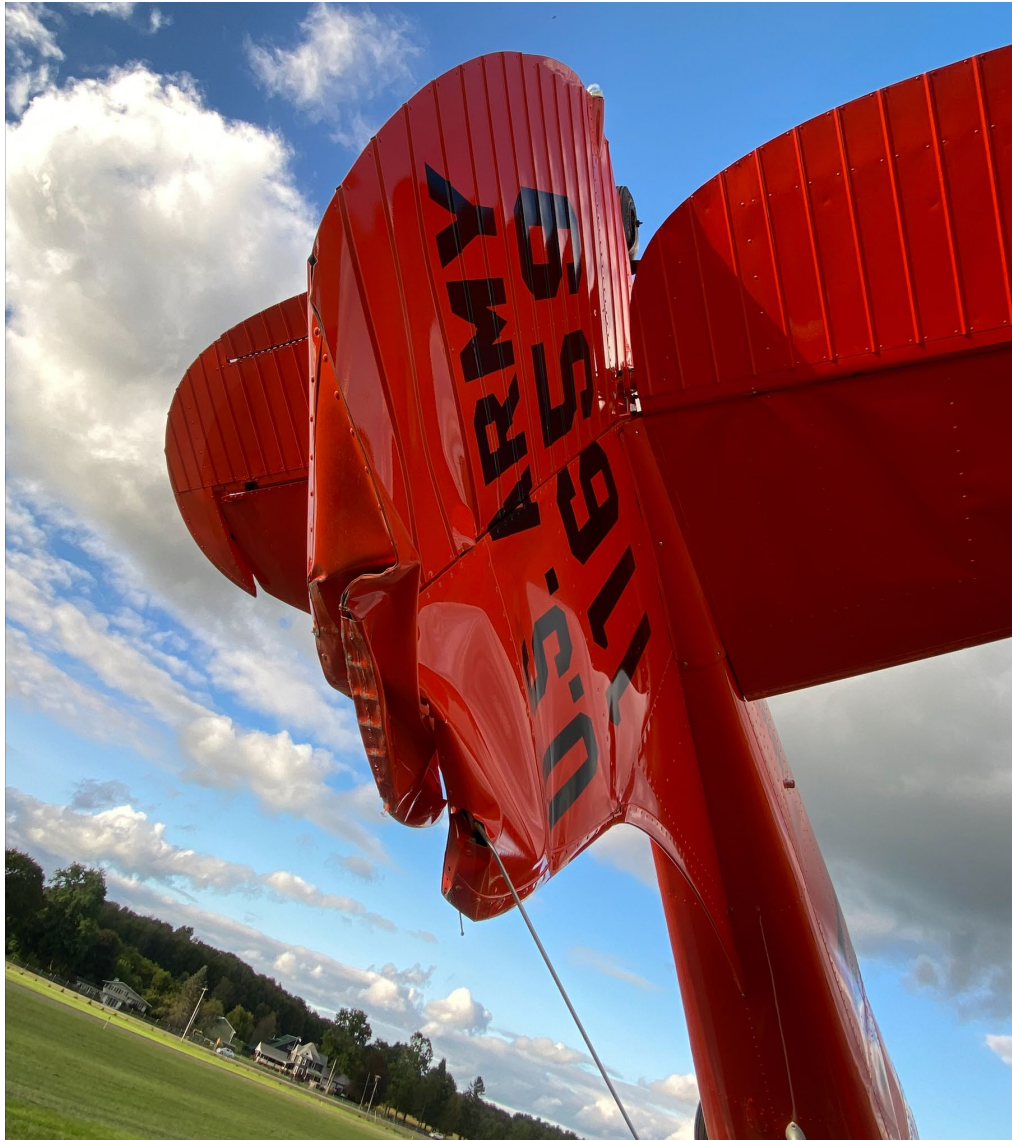
**Photograph 2 - View of damaged empennage (Courtesy of FAA)**

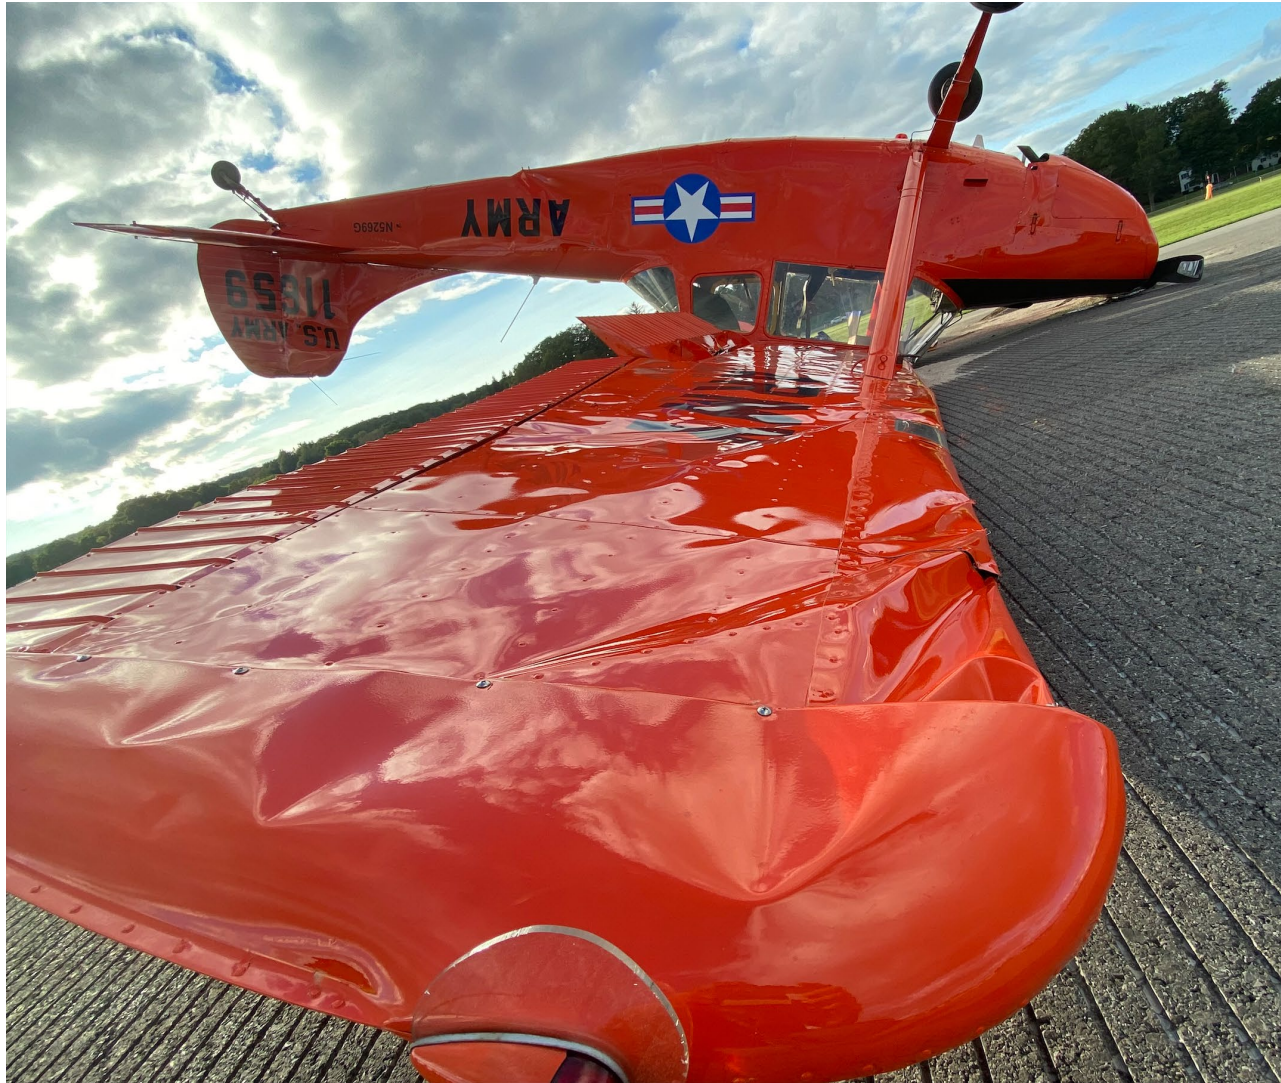
**Photograph 3 - Closeup view of left wing damage (Courtesy of FAA)**
