ERA23LA378

## INVESTIGATION PHOTOGRAPHS

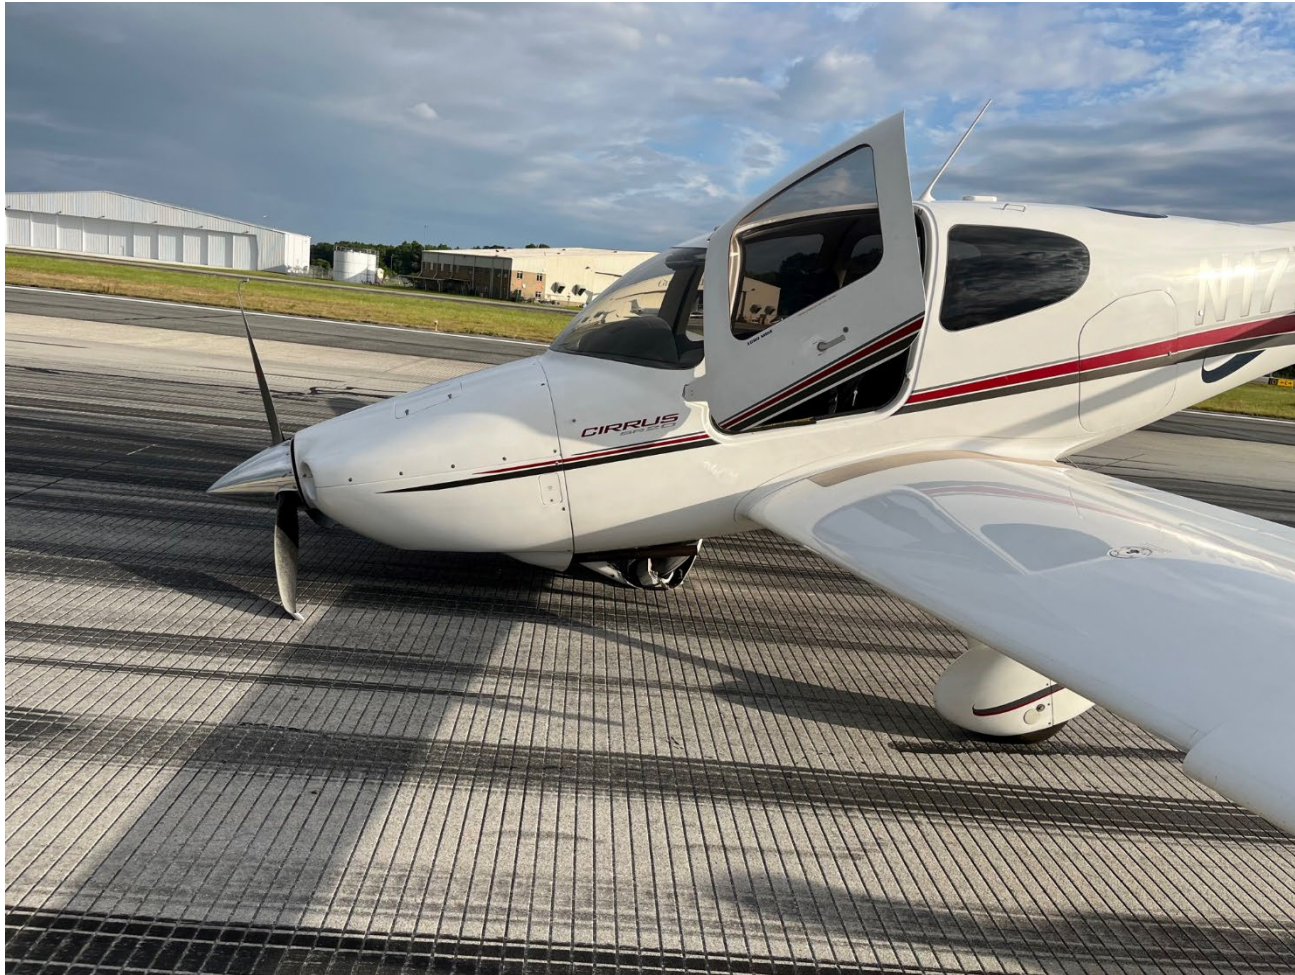
**Photograph 1 - View of left side of airplane with collapsed nose landing gear. (Courtesy of Pilot)**

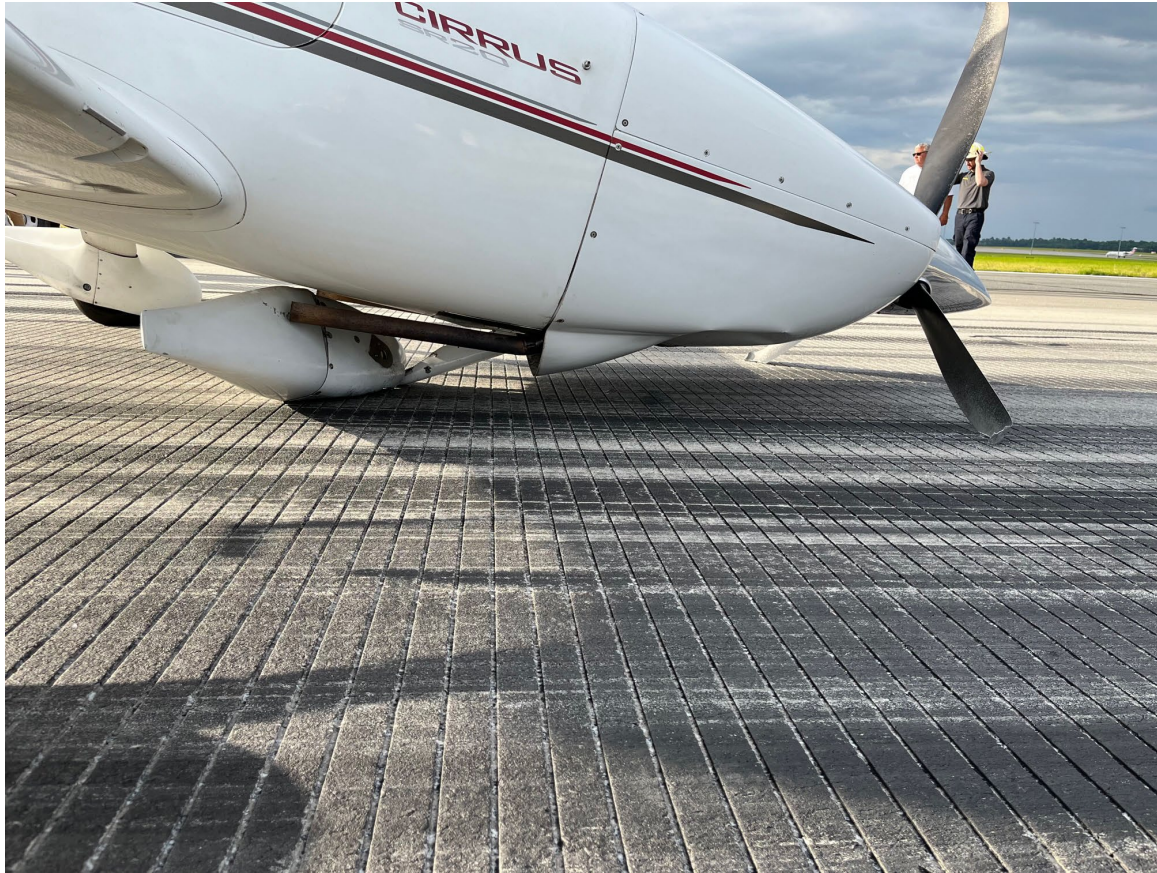
**Photograph 2 - View of right side of airplane with closeup view of nose landing gear damage.  
(Courtesy of Pilot)**

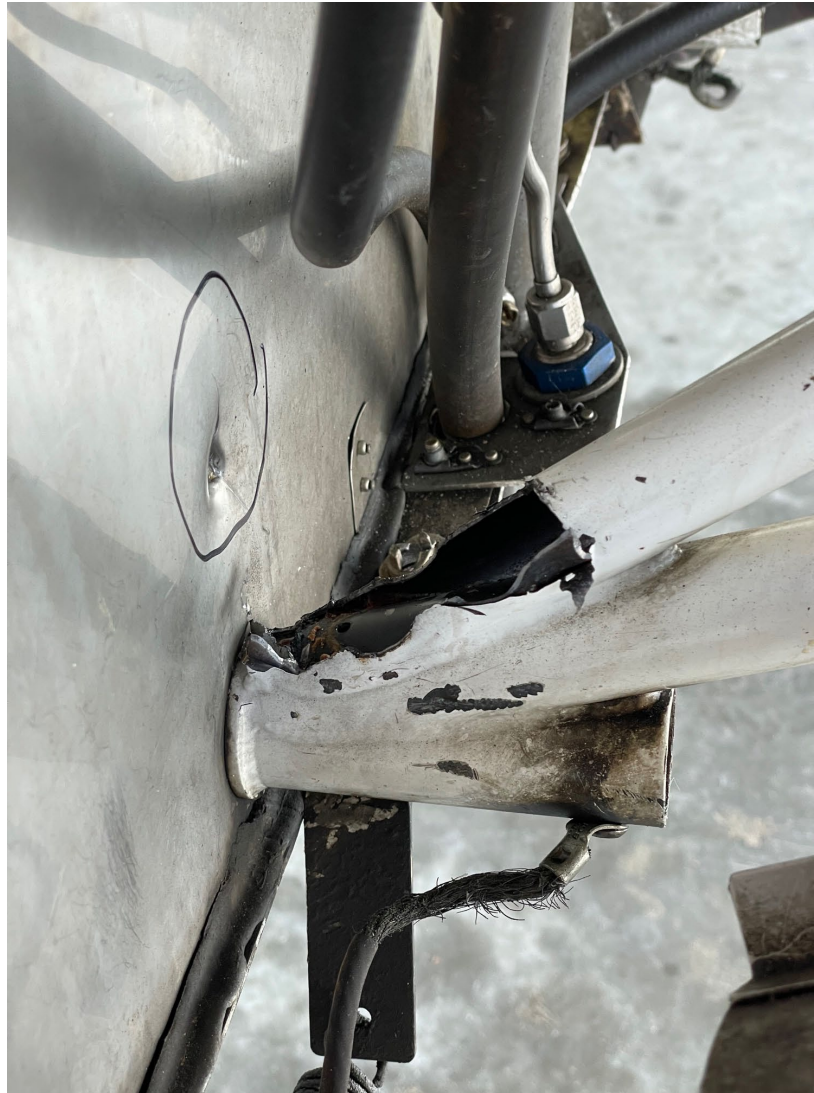
**Photograph 3 - Closeup view of firewall puncture and engine mount damage (Courtesy of Savannah Aviation)**
