ERA23LA383

## INVESTIGATION PHOTOGRAPHS

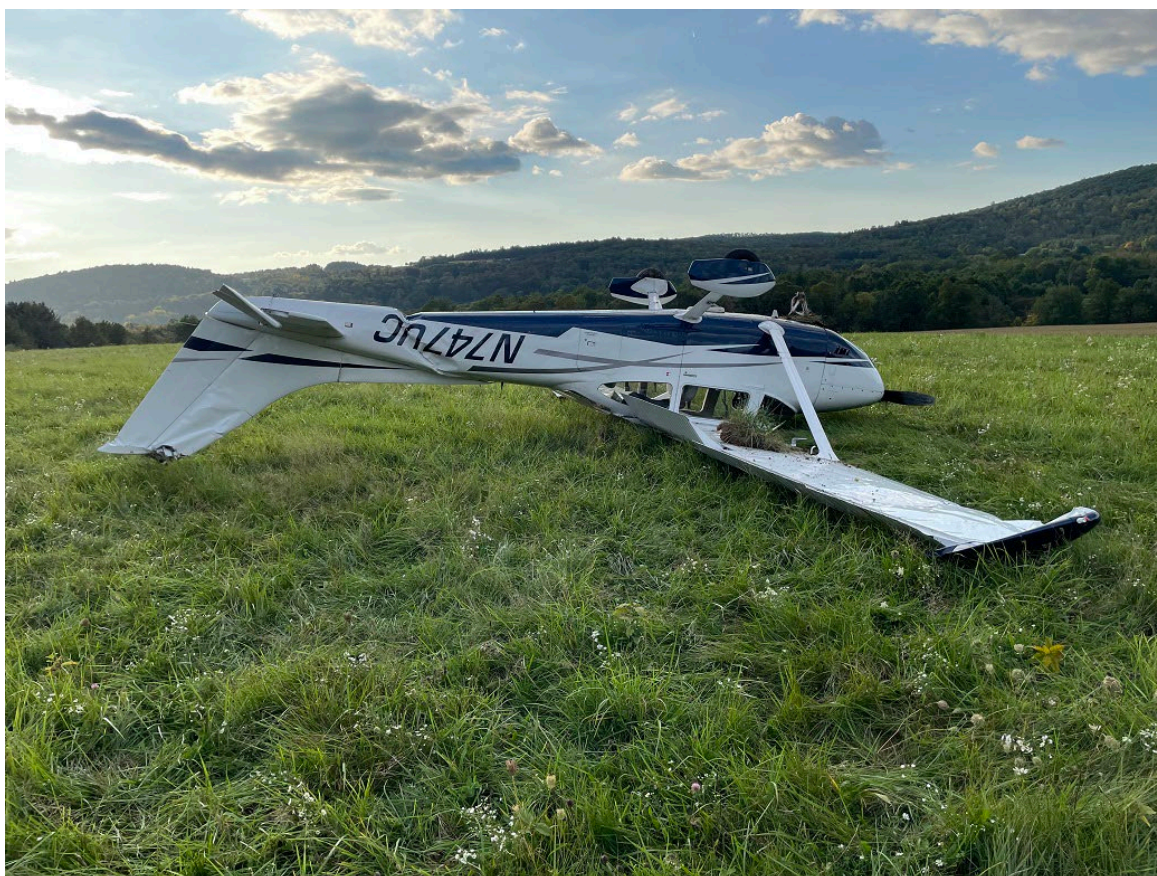
**Photograph 1 - Main Wreckage (Courtesy of Airport Manager)**

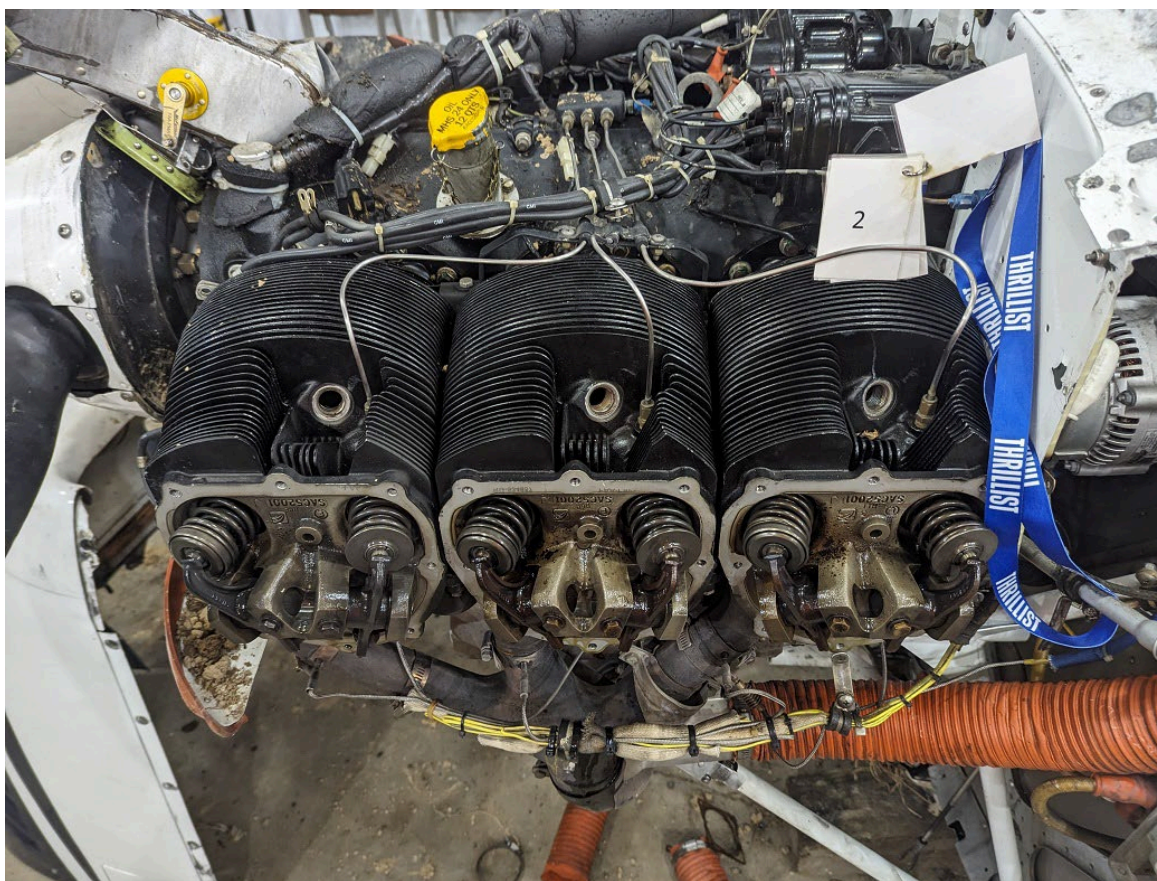
**Photograph 2 - Engine Examination (Courtesy of AMF Aviation)**

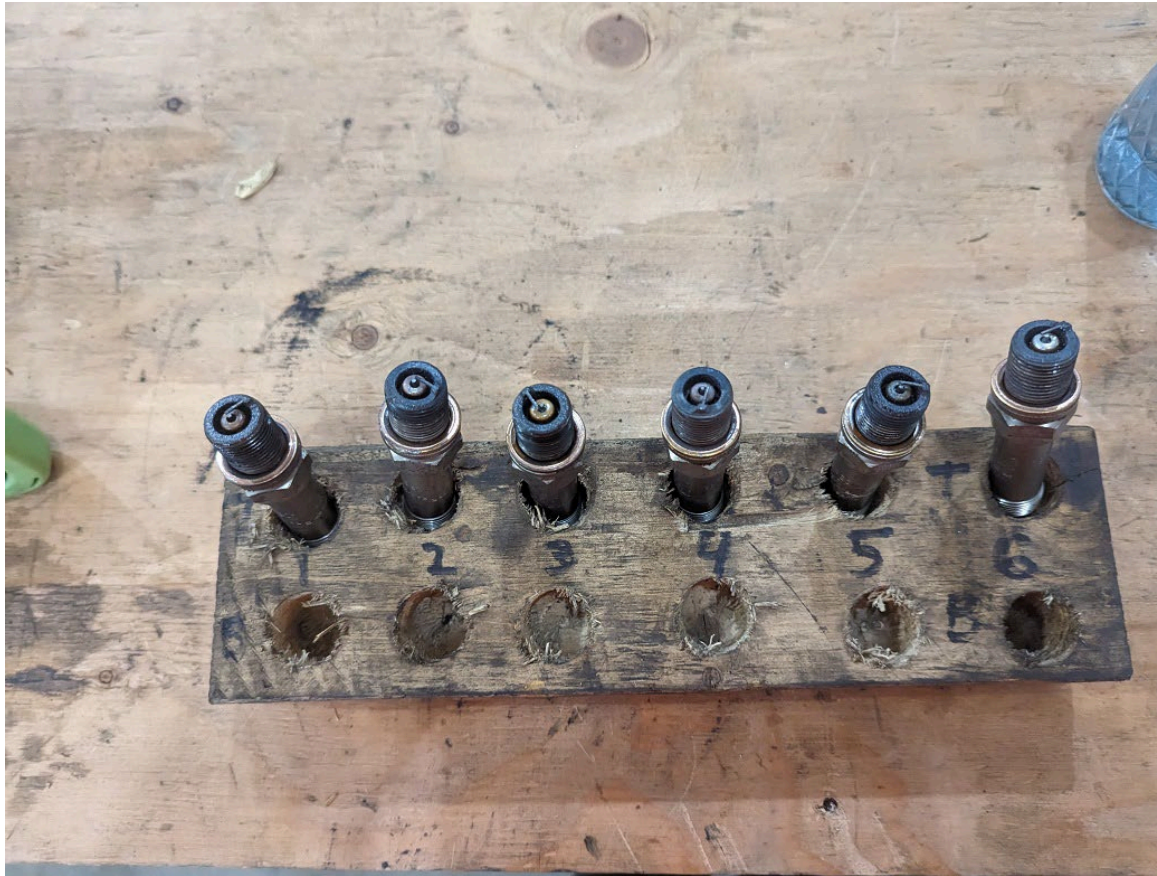
**Photograph 3 - Top Spark Plugs (Courtesy of AMF Aviation)**

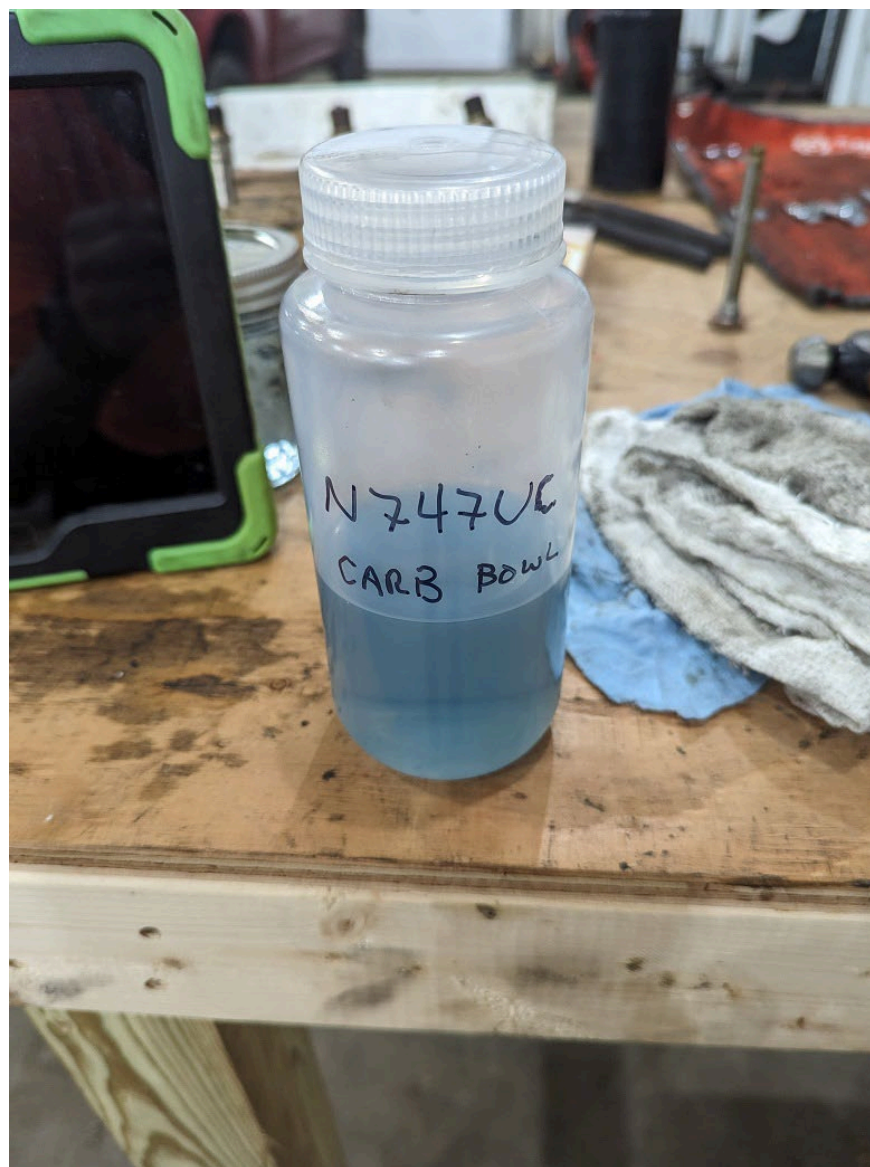
**Photograph 4 - Fuel Sample (Courtesy of AMF Aviation)**

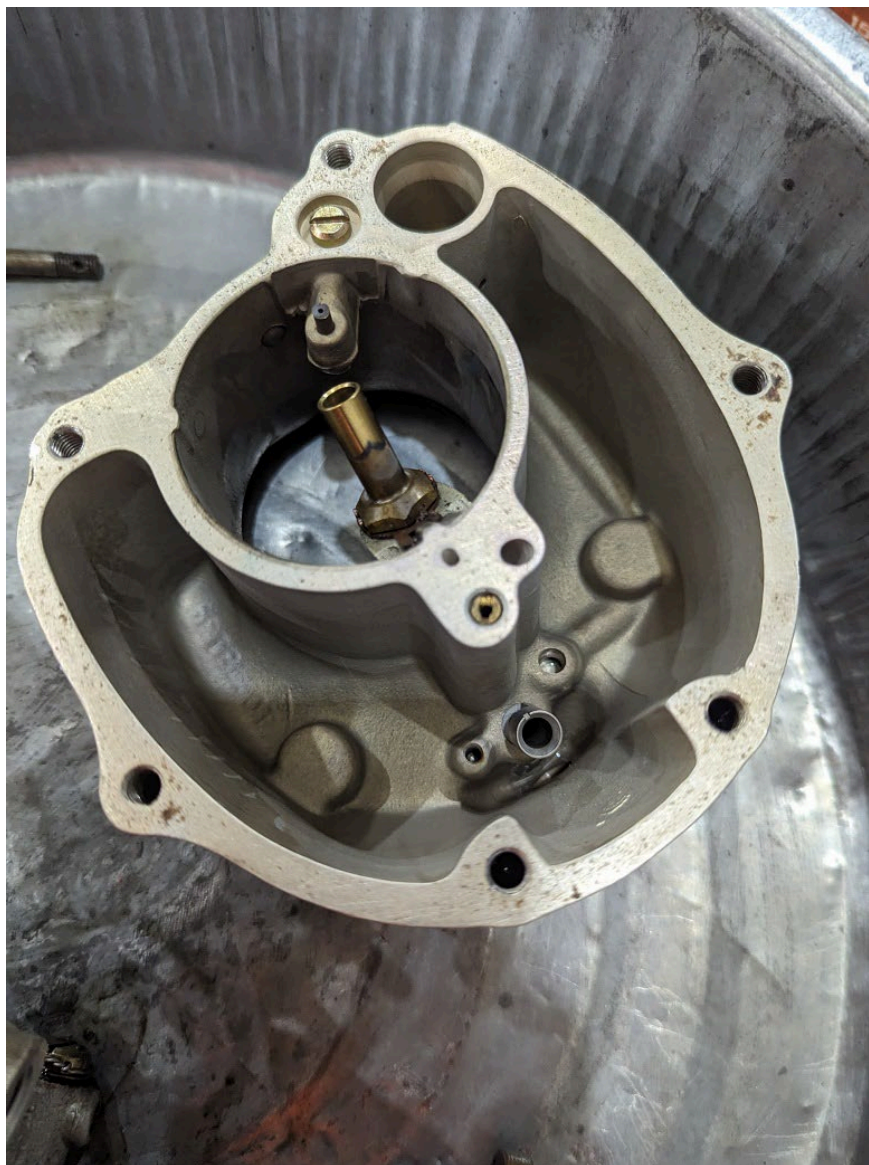
**Photograph 5 - Carburetor (Courtesy of AMF Aviation)**
