ERA23LA387

## INVESTIGATION PHOTOGRAPHS

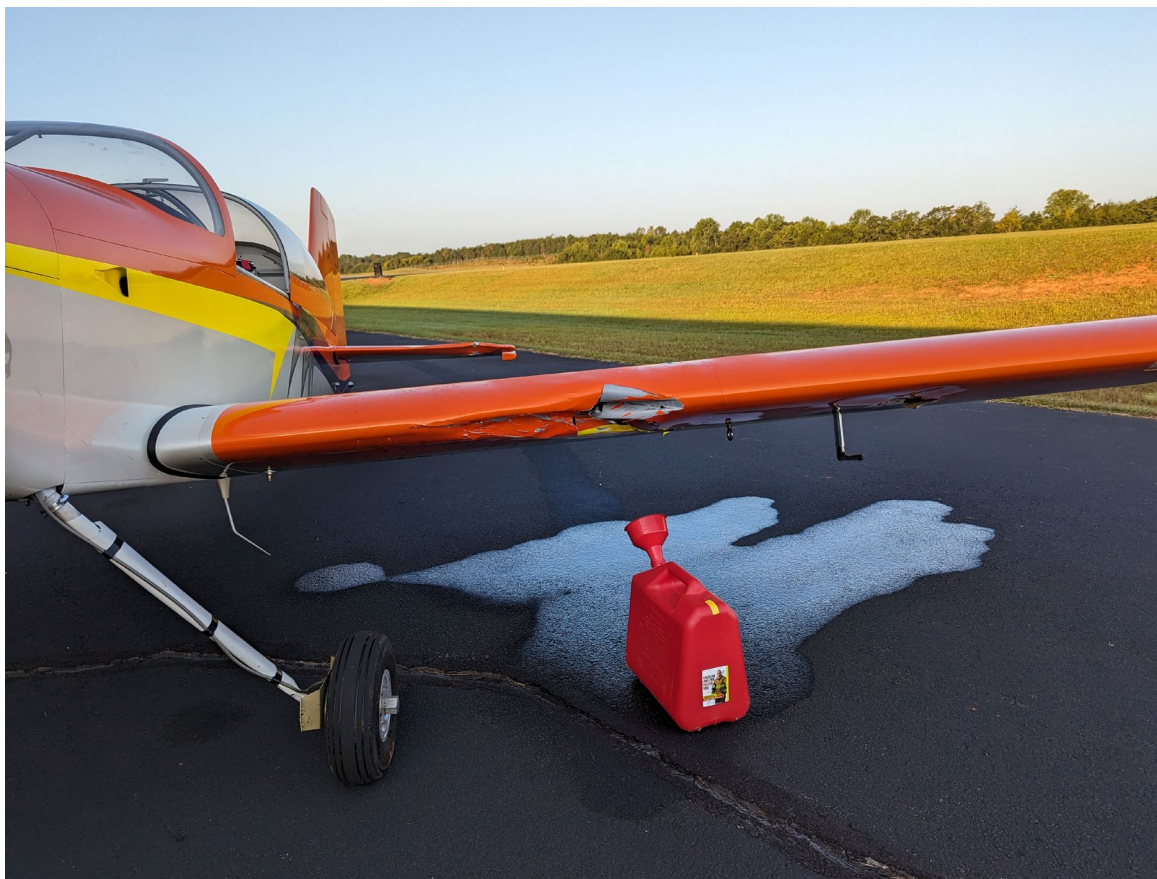
**Photograph 1 - Overview of damage to the left wing. (Courtesy of FAA)**

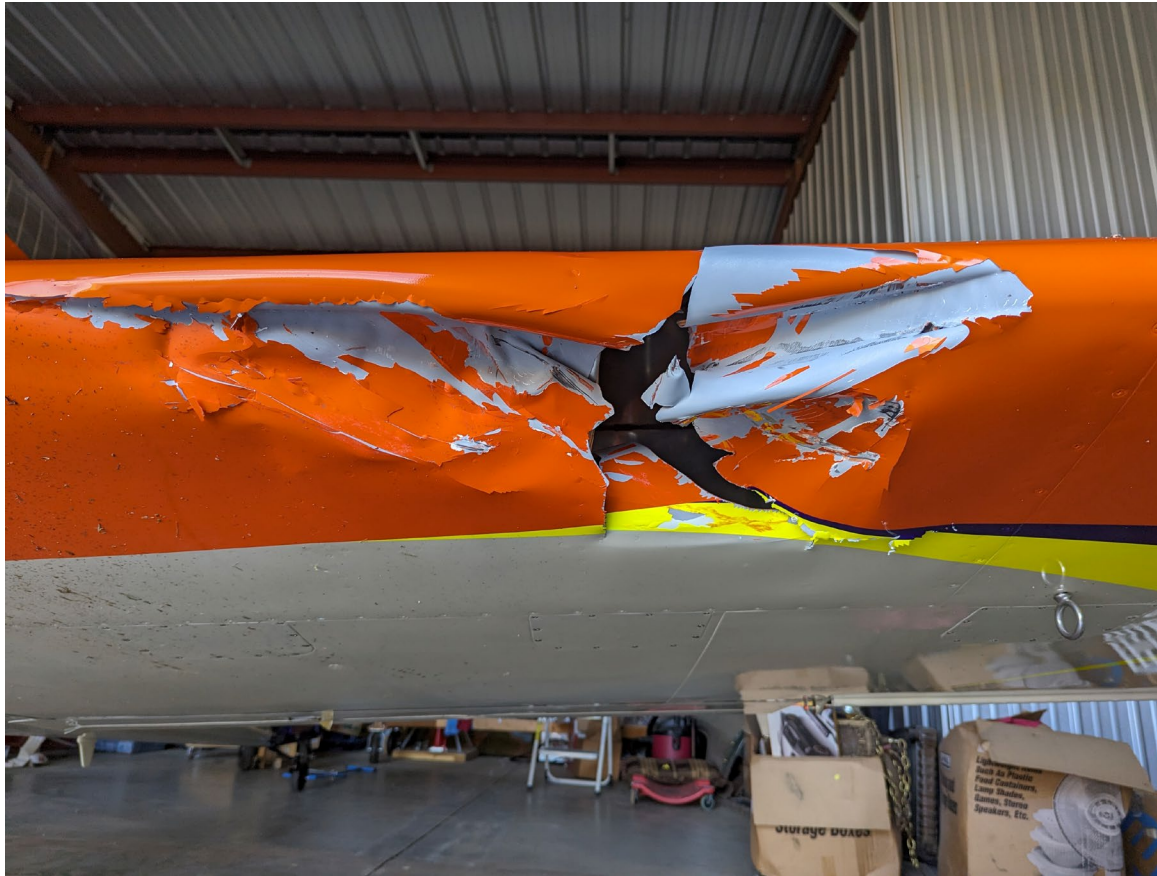
**Photograph 2 - View of damage to the left wing leading edge. (Courtesy of FAA)**

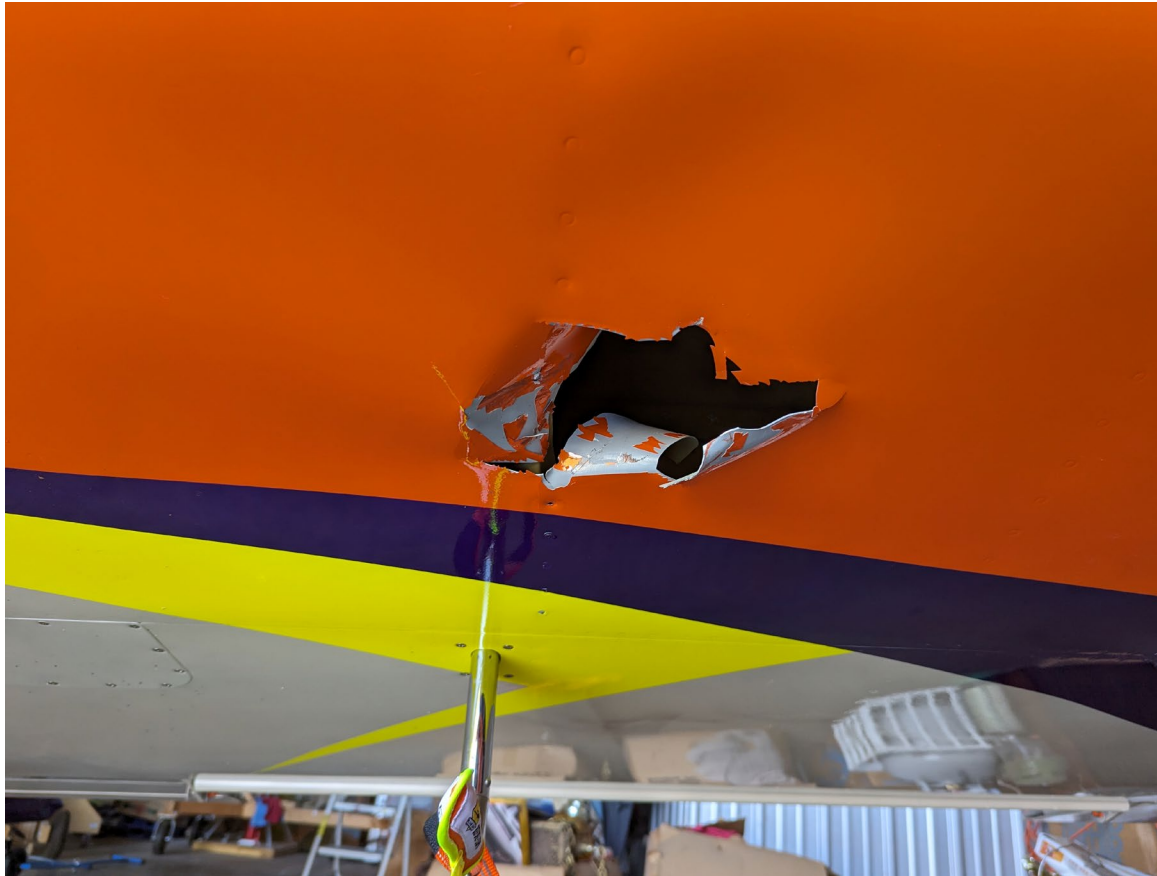
**Photograph 3 - View of damage to the left wing. (Courtesy of FAA)**

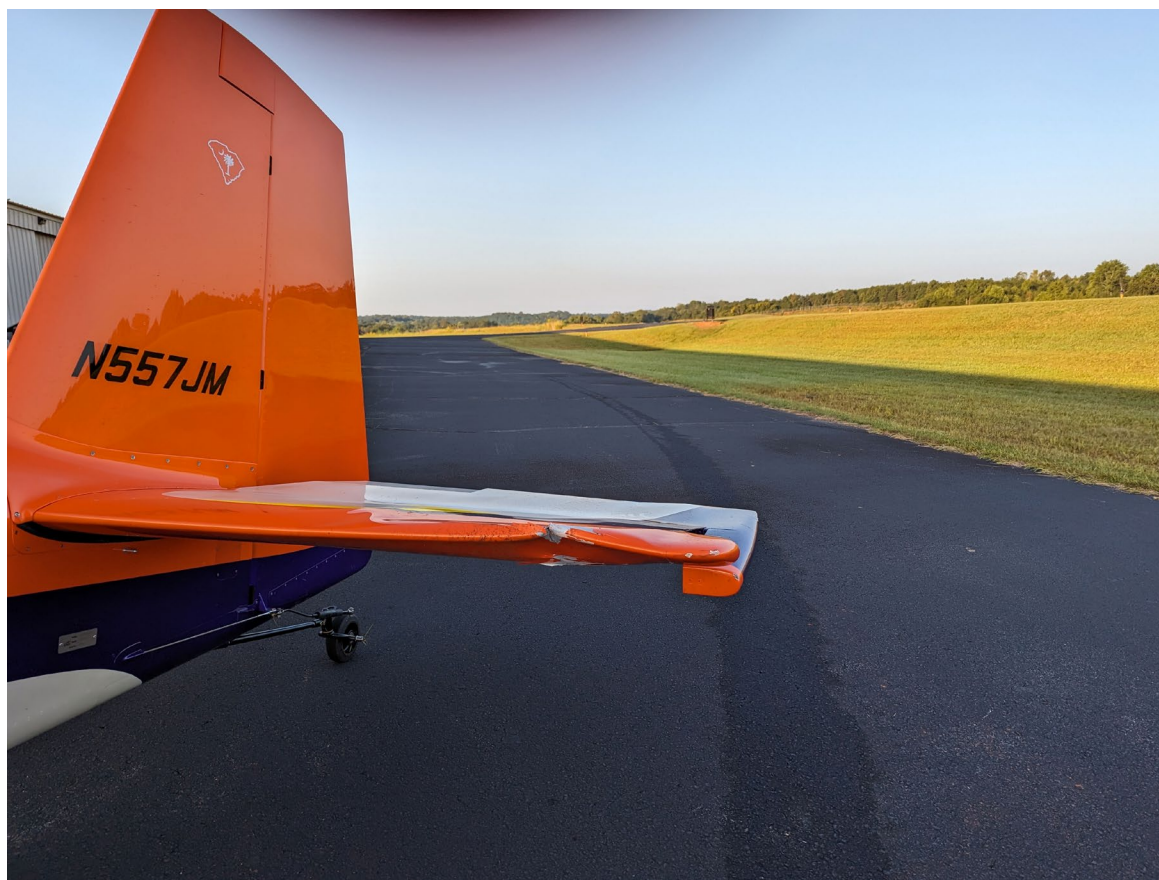
**Photograph 4 - View of damage to the left horizontal stabilizer. (Courtesy of FAA)**
