# National Transportation Safety Board

ERA24FA001

## **MATERIALS LABORATORY**

Factual Report 24-013

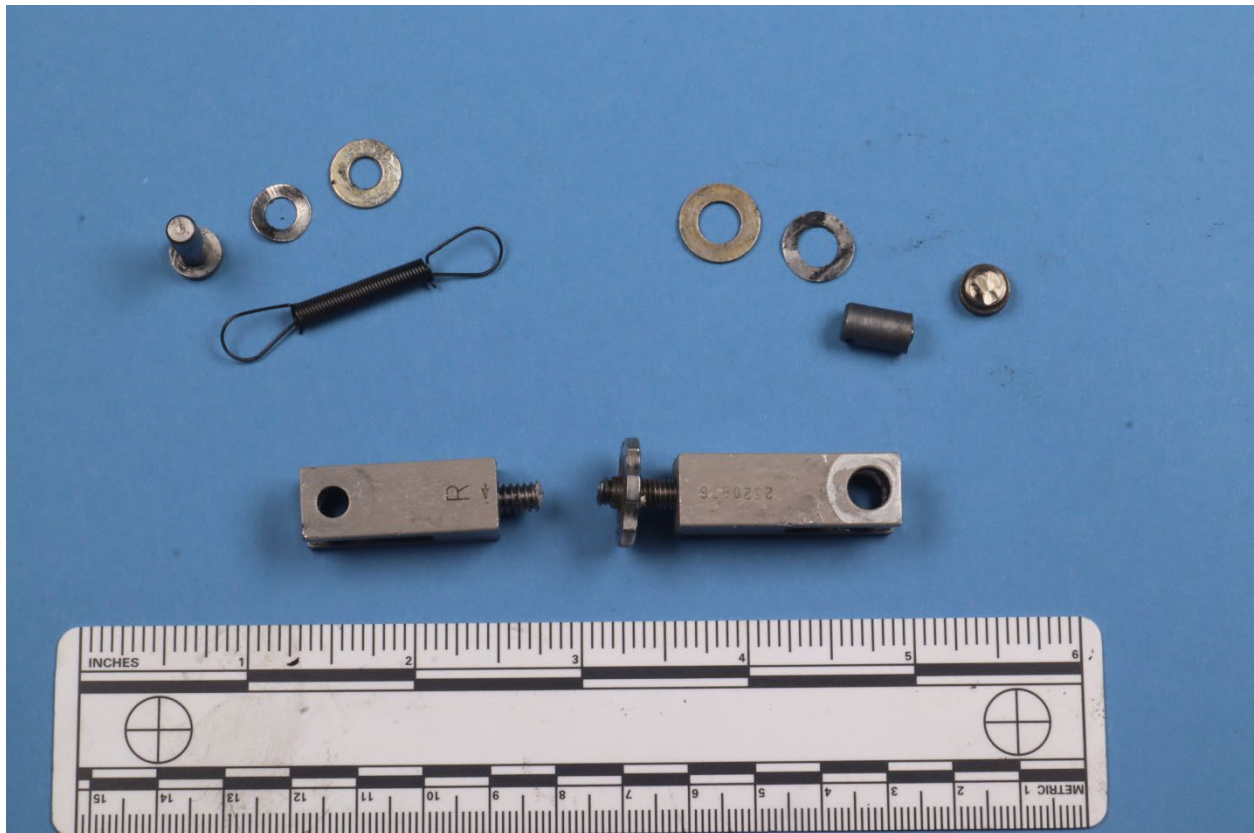
Fuel servo throttle arm and attachment hardware (Figure 1)

**Figure 1.** Portions of the fuel servo throttle arm and associated hardware as received.

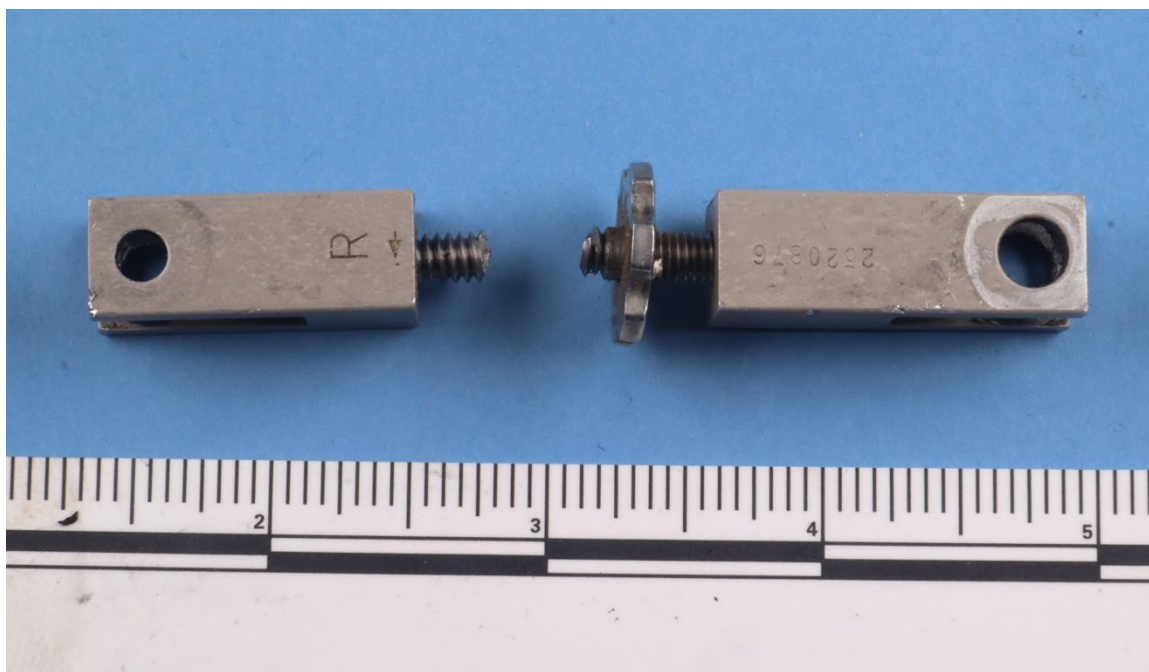
A fuel servo throttle arm was submitted for examination. The throttle arm operated similarly to a turnbuckle with a threaded section joining the two end blocks (Figure 2). The threaded section of the throttle arm was fractured. The threaded section exhibited plastic deformation as illustrated in figure 3. The fracture surface did not exhibit any evidence of preexisting cracks (Figures 4, 5).

**Figure 2.** Two portions of the throttle arm with a fractured threaded section.

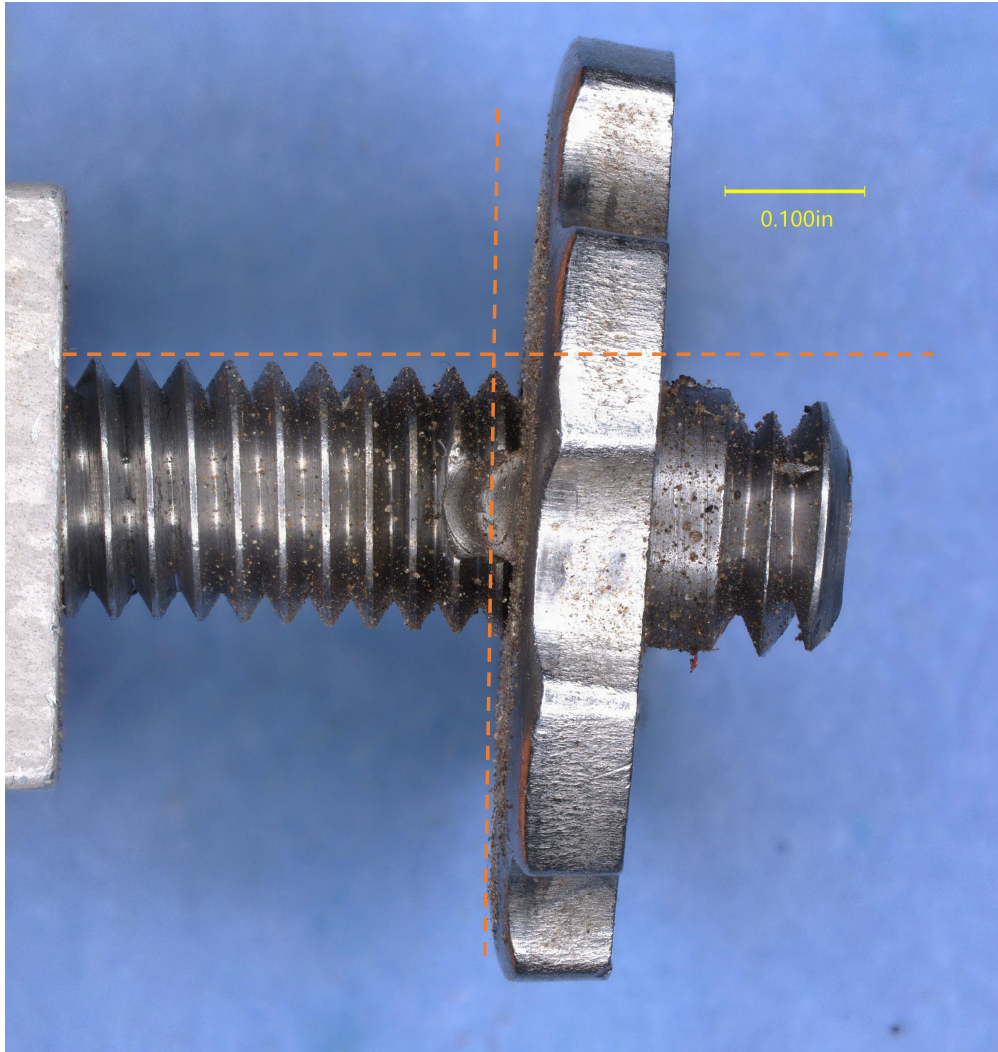
The fracture to the fuel servo throttle arm is consistent with bending overstress.

**Figure 3.** Threaded section of the throttle arm exhibiting plastic deformation.

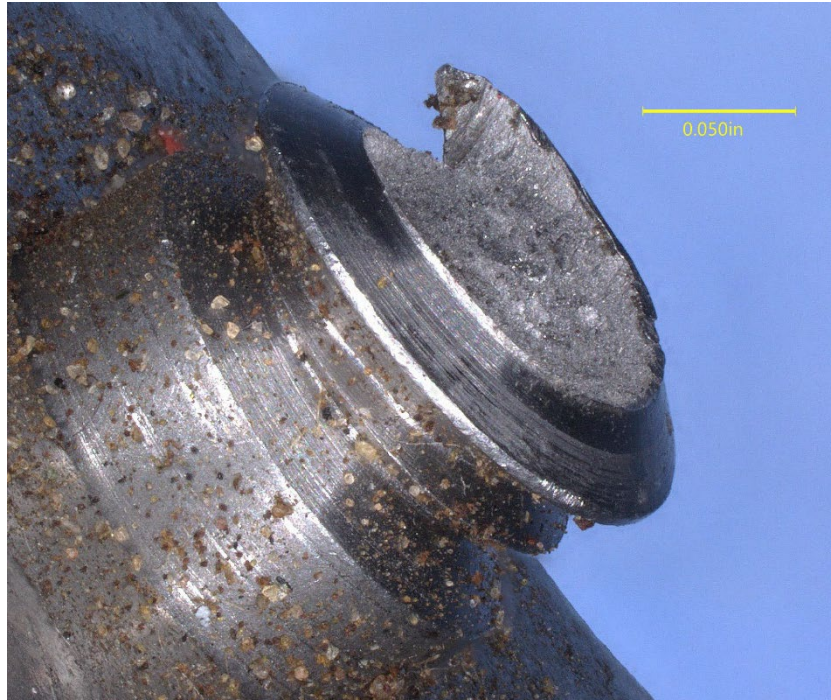
**Figure 4.** Fracture surface on the threaded section of throttle arm.

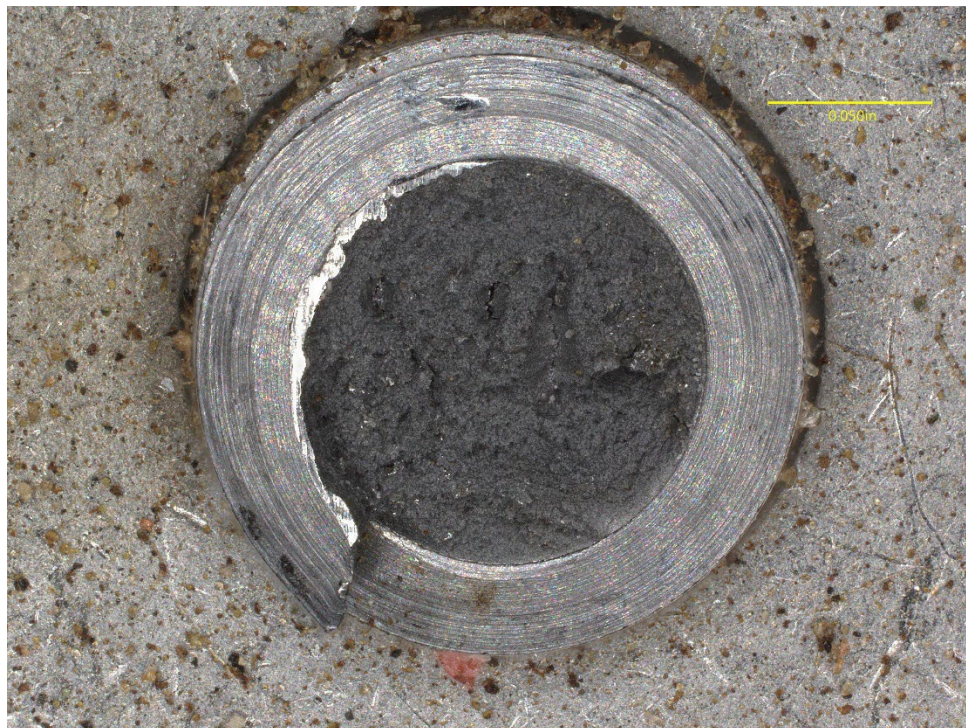
**Figure 5.** Fracture surface on the threaded section of the throttle arm.
