# National Transportation Safety Board

ERA24FA001

## **AIRCRAFT PERFORMANCE**

Specialist's Study - Supplemental

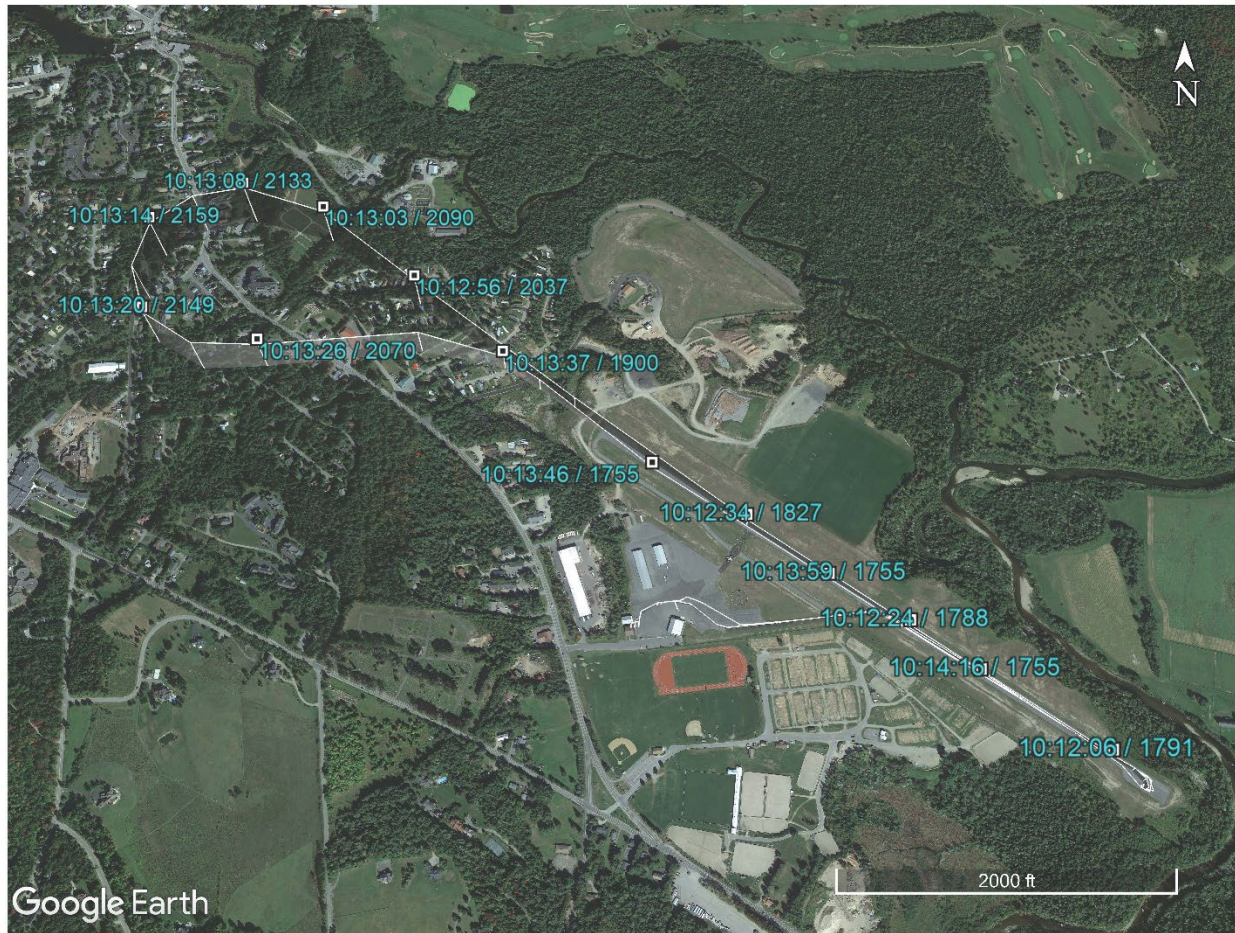
A view of the flight path on a Google Earth background is shown in Figure 1. The airplane lifted off from runway 32 shortly after 10:12:20 and continued to track the runway centerline until 10:13:03, when it began a left turn back to the airport, landing on runway 14 about 10:13:46.

Figure 1. Flight track on a Google Earth background. Annotations indicate the time EDT (hh:mm:ss) and recorded altitude (ft).

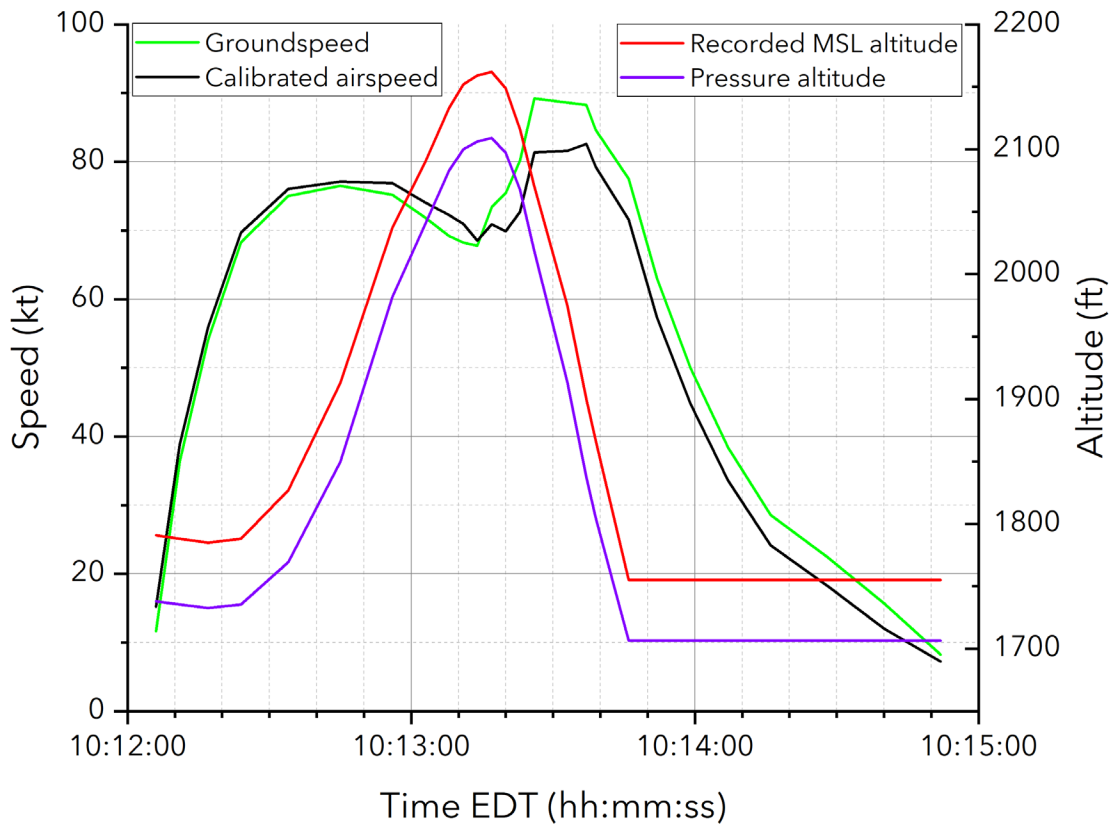
Figure 2. Groundspeed, calibrated airspeed, recorded MSL altitude and pressure altitude as functions of time.

Figure 2 plots the groundspeed, calibrated airspeed, recorded MSL altitude and pressure altitude for the flight as functions of time. The initial climb was accomplished at about 77 knots calibrated airspeed (KCAS), consistent with the guidance from the Pilot's Operating Handbook (POH) [4]. At 10:12:56, the airspeed began to decrease, reaching a minimum of 68.5 KCAS at 10:13:14. The airspeed then increased to over 80 KCAS, but decreased to 71.5 KCAS at the estimated touchdown time of 10:13:46.

The maximum recorded MSL altitude was 2162 ft at 10:13:17, or about 400 ft AGL.

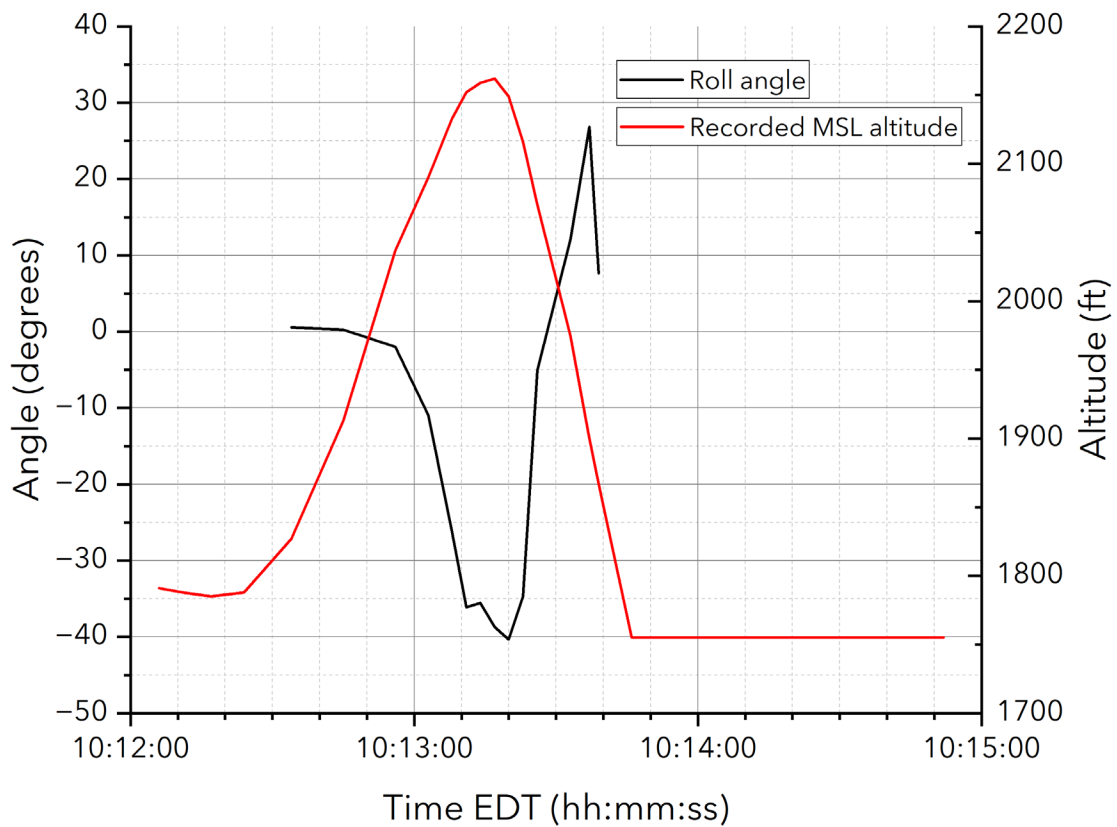
Figure 3. Roll angle and recorded MSL altitude as functions of time.

The airplane began a roll to the left at 10:12:56, reaching a roll angle of  $-40^{\circ}$  at 10:13:20, before rolling back to the right, reaching a roll angle of  $27^{\circ}$  at 10:13:37 as the airplane aligned with runway 14.

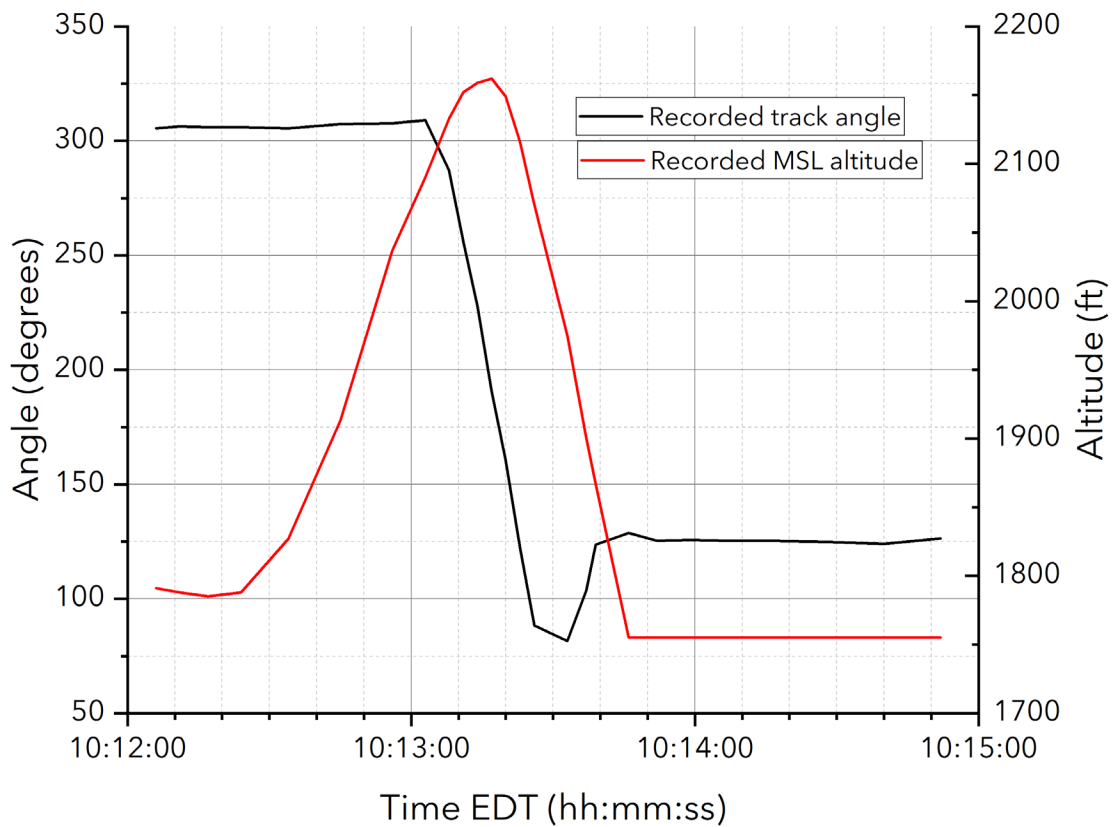
Figure 4. Recorded track angle and recorded MSL altitude as functions of time.

Figure 4 shows the recorded track angle as a function of time, along with the recorded MSL altitude. Between 10:13:03 and 10:13:25, the track angle changed by about  $9.6^{\circ}/s$ , as compared with a standard rate turn of  $3^{\circ}/s$ .

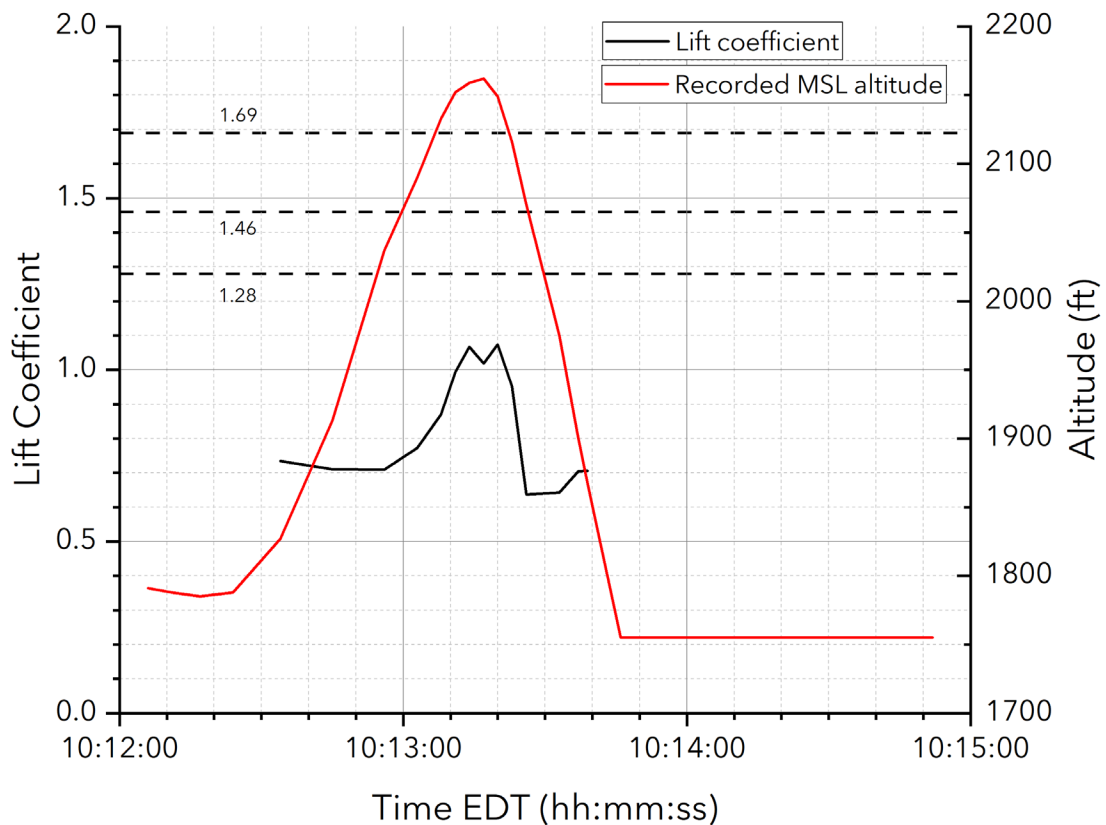
Figure 5. Lift coefficient and recorded MSL altitude as functions of time.

Figure 5 plots the lift coefficient and recorded MSL altitude as functions of time. The increase in lift coefficient at 10:12:56 corresponds to the change in roll angle at the same time. The lift coefficient remains well below the maximum lift coefficient  $C_{Lmax}$  calculated from the power-off, flaps-up, wings-level stall speeds in the POH, which was found to range from 1.28 to 1.46 for flaps up, and from 1.46 to 1.69 for flaps 10°, depending on the location of the center of gravity.

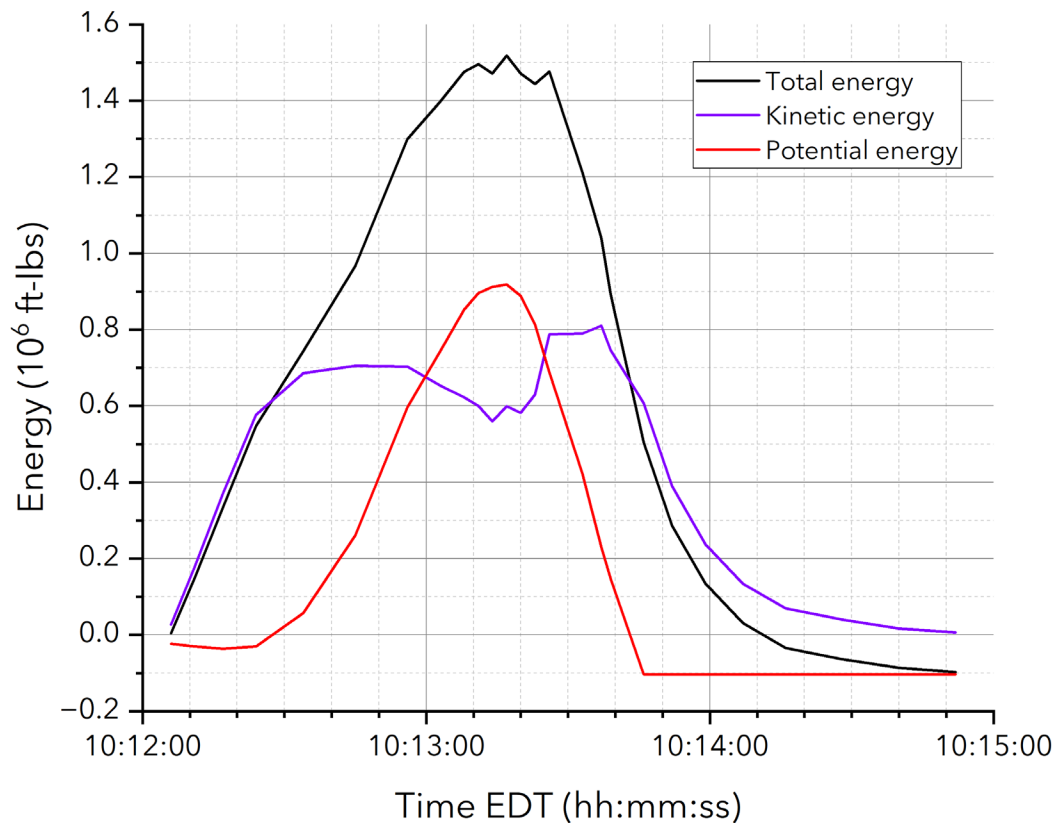
Figure 6. Potential energy, kinetic energy and total energy as functions of time.

Figure 6 plots the potential energy, kinetic energy and total energy (the sum of the potential and kinetic energy) as functions of time. The initial rate of increase in total energy is similar to the accident flight, but the total energy reaches a plateau and does not begin to decrease until the airplane is descending back toward the airport; the decrease in total energy is consistent with a reduction in engine power and/or increasing flap deflection as the airplane slows to land.
