# National Transportation Safety Board

ERA24FA026

## **SOUND SPECTRUM STUDY**

Location: Marion, Ohio  
Date: October 31, 2023  
Time: 11:23 eastern daylight time  
Aircraft: Piper PA32-300

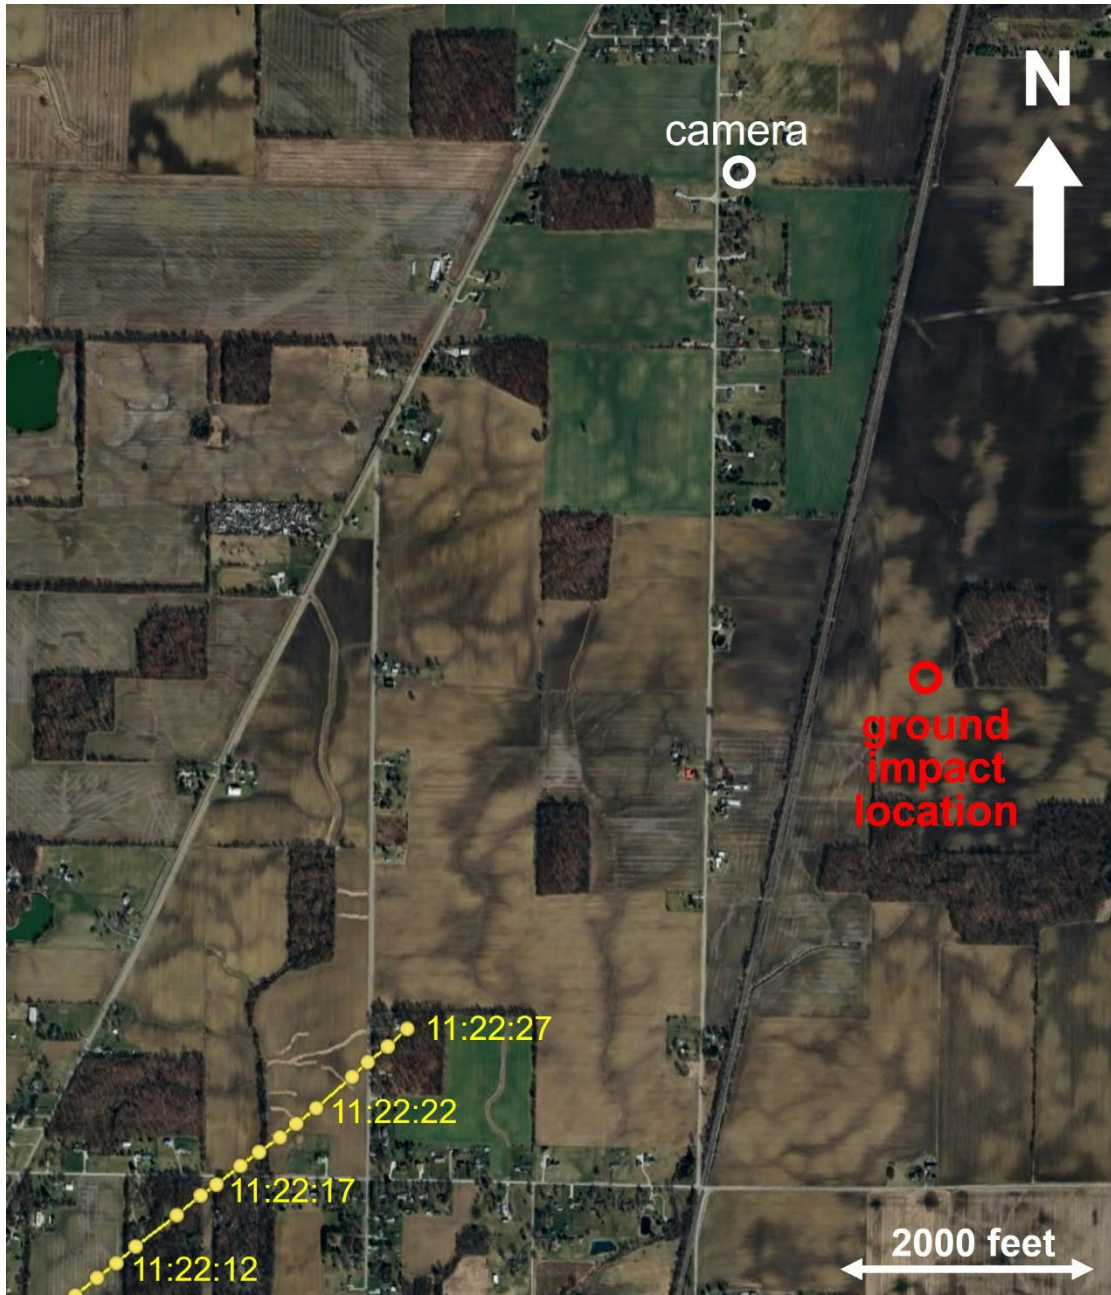
**Figure 1.** Aerial view of the accident area

Figure 1 is an aerial view of the accident area. It shows the camera location and the location of ground impact. The yellow markers are the locations where data was available in an ADS-B record. Four markers are labeled with ADS-B times in format HH:MM:SS. The last available point was at time 11:22:27.

Figure 1 shows that the distance from the last available ADS-B location to the ground impact location is about 5000 feet. The distance from the 11:22:12 location to the 11:22:27 location is about 3000 feet. Therefore, the average ground speed between the 11:22:12 location to the 11:22:27 location was  $3000/(27-12)=200$  feet/second or 118 knots.

The airplane heading between the 11:22:12 location and the 11:22:27 location in Figure 1 was toward the ground impact location. If the ground speed continued to

be 200 feet/second and the heading was unchanged up to the location of ground impact, it would have taken the airplane  $5000/200=25$  seconds past time 11:22:27. Based on this ground speed assumption, the estimated ground impact time is 11:22:52. However, since the airplane impacted the ground in a steep nose-down attitude, the ground speed could have been lower as the airplane was approaching the location of ground impact.

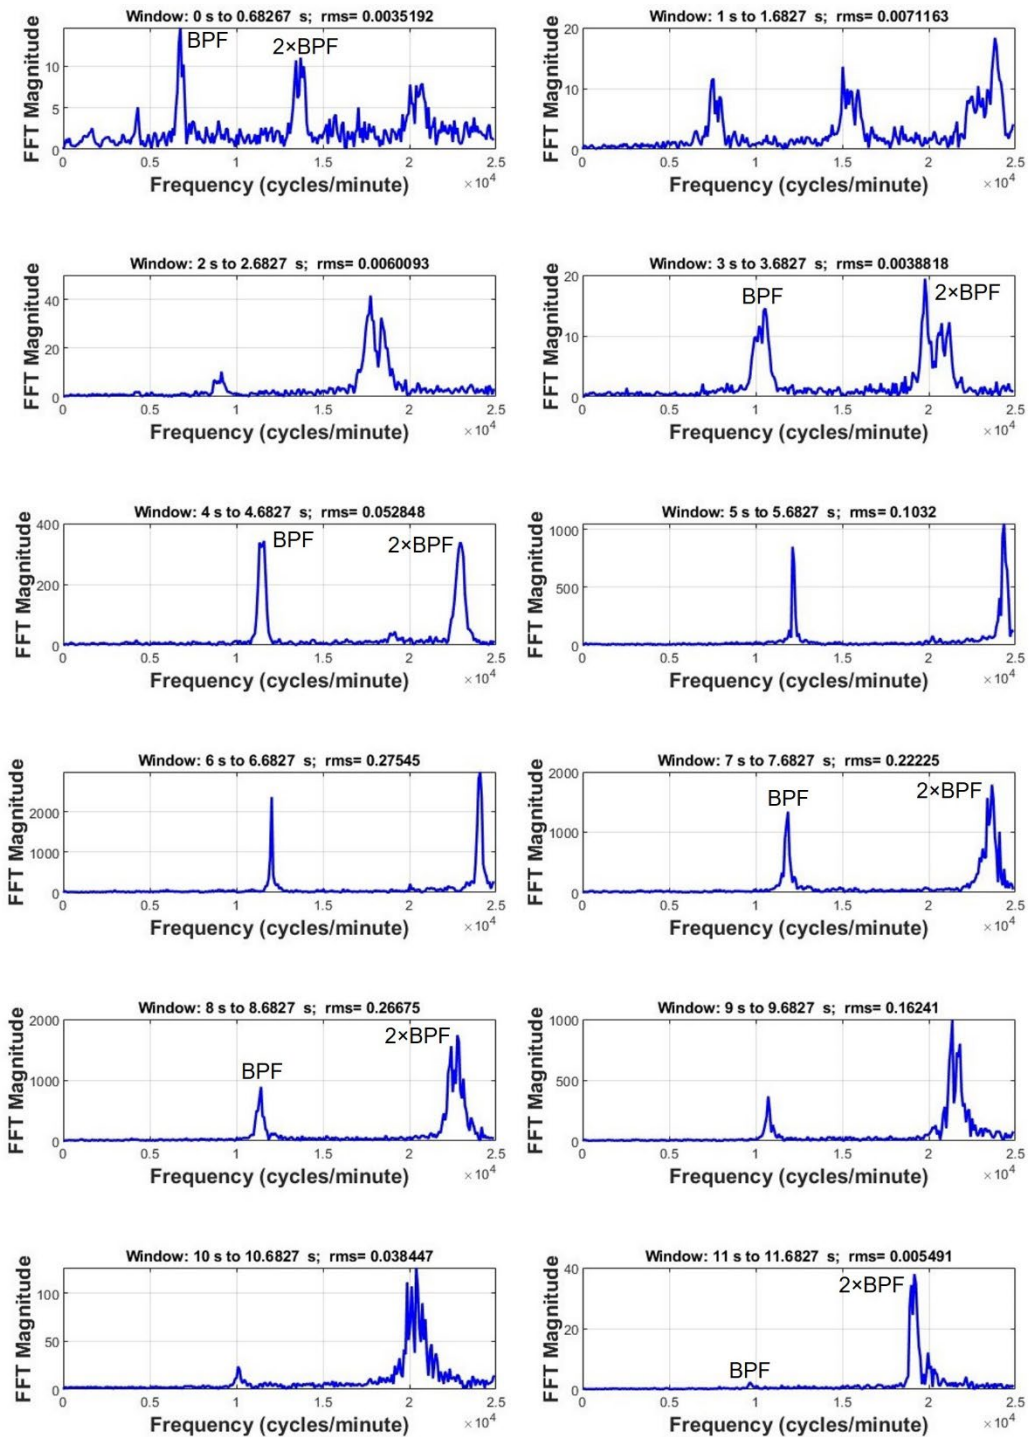
**Figure 2.** Sound spectra

The sound in the video was analyzed with the FFT (Fast Fourier Transform) algorithm that used 32768-point windows. The windows were 0.6827 seconds wide and the frequency resolution was 88 cpm (cycles per minute). Figure 2 shows twelve spectra with window starting times between 0 seconds and 11 seconds in increments of one second. Spectral peaks due to the blade passage frequency (BPF) and the second harmonic of the BPF are marked in the figure.

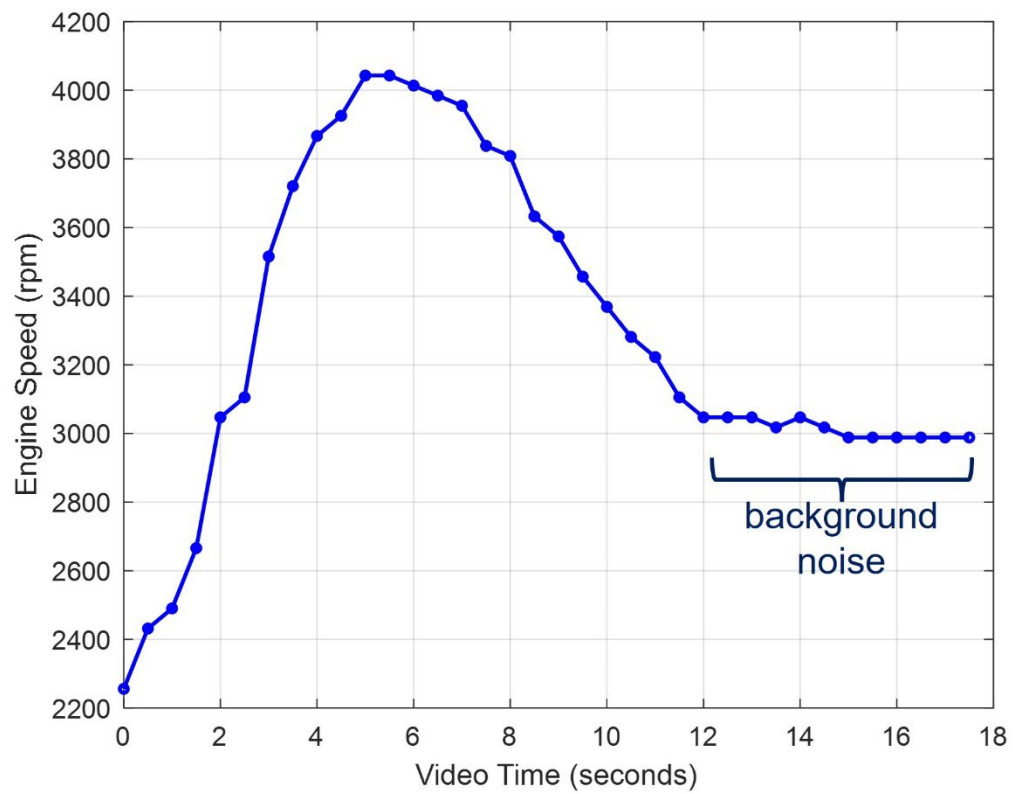
**Figure 3.** Engine speed estimates based on recorded blade passage frequency

The propeller had three blades. Therefore, the engine speed estimates were one third of the BPF frequencies in Figure 2. Figure 3 shows the estimated engine speeds based on BPF frequencies computed in processing windows with starting times between zero and 17.5 seconds in increments of 0.5 seconds. Past time 12 seconds in Figure 3, the estimated engine speed is marked as 'background noise.' It is marked so because there was an interfering sound signal at about 3000 cpm that was present even after the airplane crashed. The intensity of the interfering signal was very low.

The high engine speed estimates in Figure 3 could have been caused entirely or in part by frequency shifts caused by the Doppler effect. This possibility will be explored below in detail.

The rated speed of the airplane Lycoming TIO-540 engine is 2700 rpm. Figure 3 shows maximum estimated speed of 4043 rpm as estimated based on the recorded BPF. This very high estimated engine speed could indicate extreme engine overspeeding, or a large frequency shift due to the Doppler effect, or a combination of engine overspeeding and Doppler frequency shift.

Under these extreme assumptions, the total speed of the airplane was  $\sqrt{200^2 + 220^2} = 297$  feet/second. The Doppler multiplier was 1.36 and the adjusted speed estimate was  $4043/1.36=2973$  rpm. The Doppler-adjusted estimated engine speed of 2973 rpm was higher than the rated engine speed of 2700 rpm. Furthermore, the adjusted 2973 rpm engine speed estimate was based on the assumption that the airplane was flying with the 297 feet/second speed directly toward the camera, which is unlikely. If the airplane was not flying directly toward the camera, the Doppler multiplier would have been less than 1.36 and the adjusted engine speed estimate would have been higher than 2973 rpm.

Consequently, since even extreme assumptions could not explain the very high BPF-based estimated engine speed of 4043 rpm as being entirely due to the Doppler effect, it was concluded that at least part of the high speed estimate was due to the engine overspeeding. It is likely that the Doppler effect also contributed to the high speed estimate. It was not possible to estimate the maximum engine speed because spectral analysis could not estimate the frequency of the emitted blade passage frequency. It could not separate the recorded frequency into a frequency emitted by the propeller blades and a frequency shift due to the Doppler effect.
