# National Transportation Safety Board

ERA24FA026

## **MATERIALS LABORATORY**

Factual Report 24-033

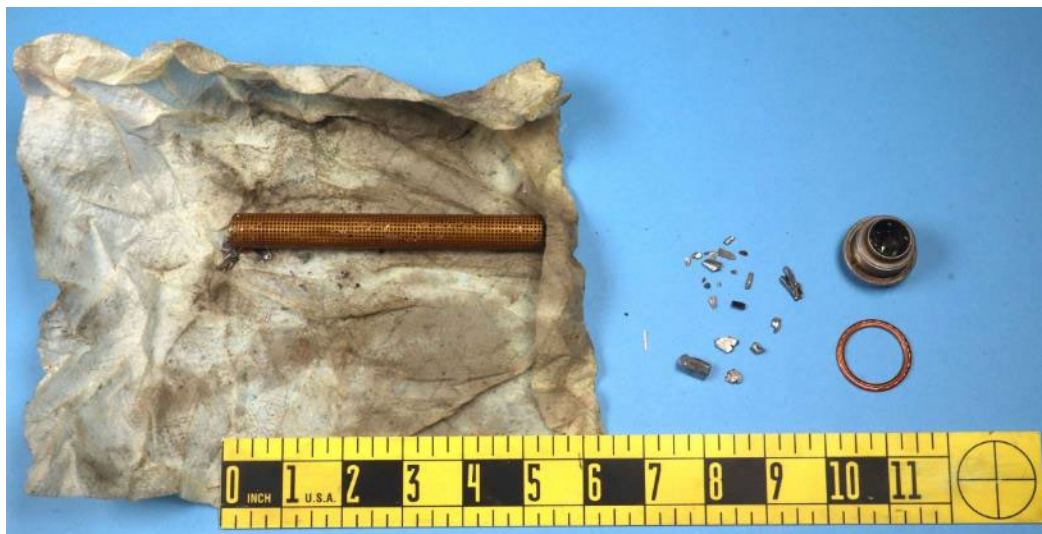
An image of the as-received oil screen, cap and particles is shown in figure 1. The particles, along with loose particles on the paper towel; were collected onto glassine paper and imaged as a group using a digital microscope shown in figure 2. The particles were then separated magnetically into two groups of magnetic and non-magnetic particles as shown in figures 3 and 4 respectively.

**Figure 1.** As-received oil screen, cap, copper washer and particles.

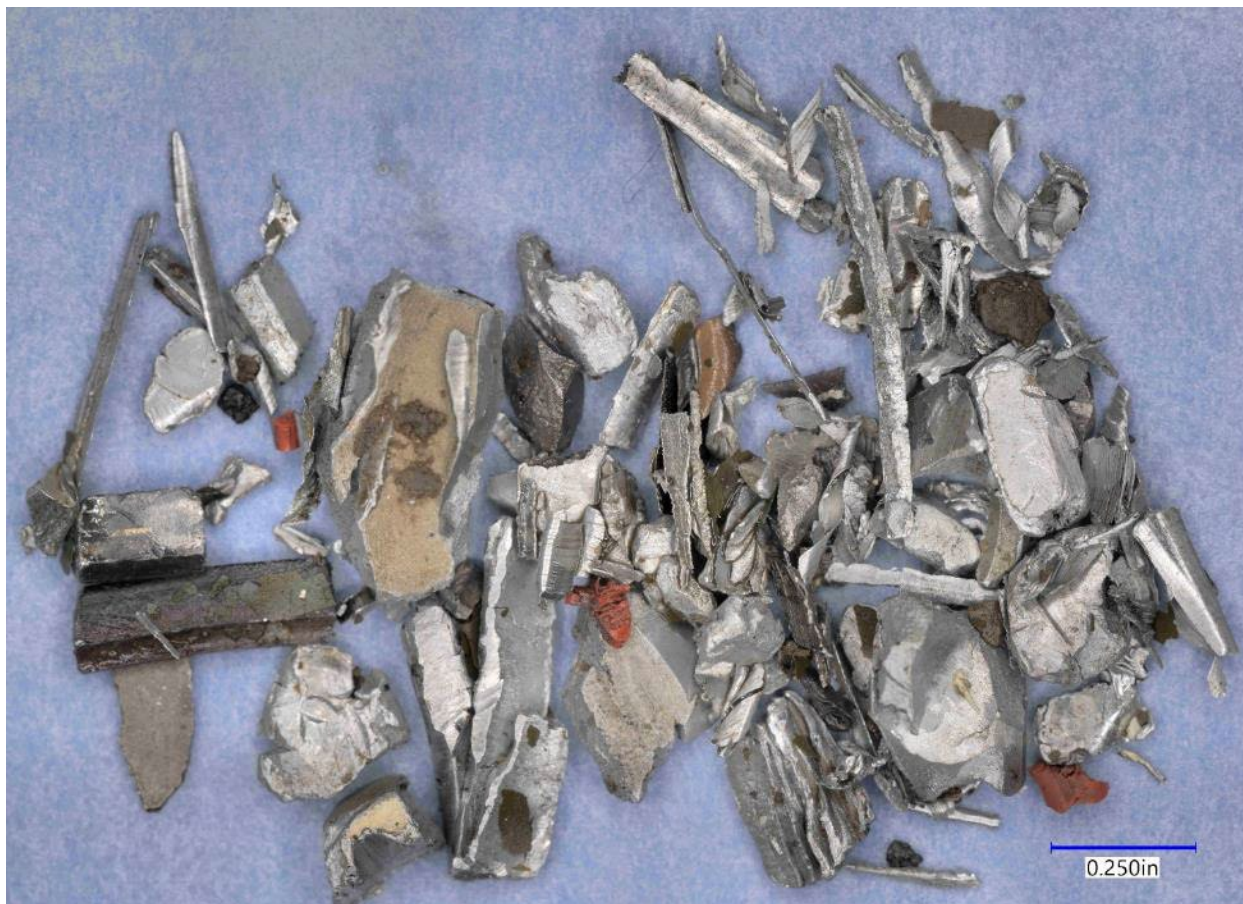
**Figure 2.** All as-received particles.

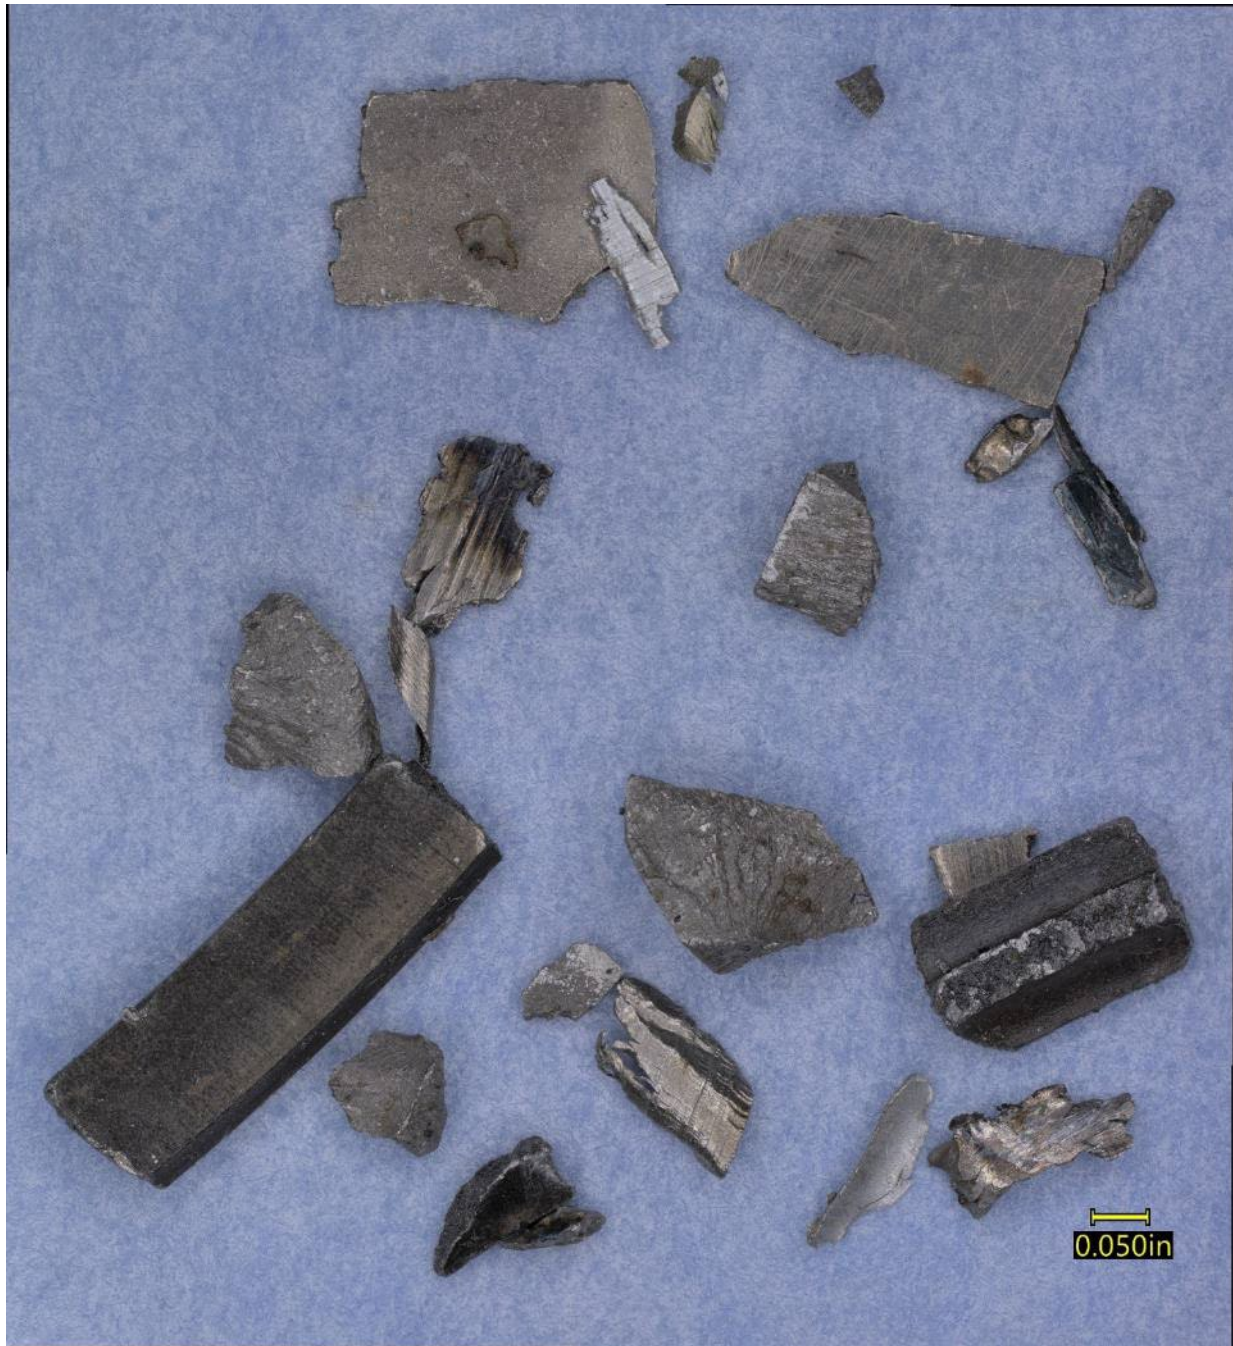
Table 1 lists the elements detected from the six magnetic particles analyzed. All particles revealed a significant carbon component as well as a significant ferromagnetic component in the form of iron or nickel along with trace or minor concentrations of suspected environmental contamination.

**Figure 3.** As-received magnetic particles.

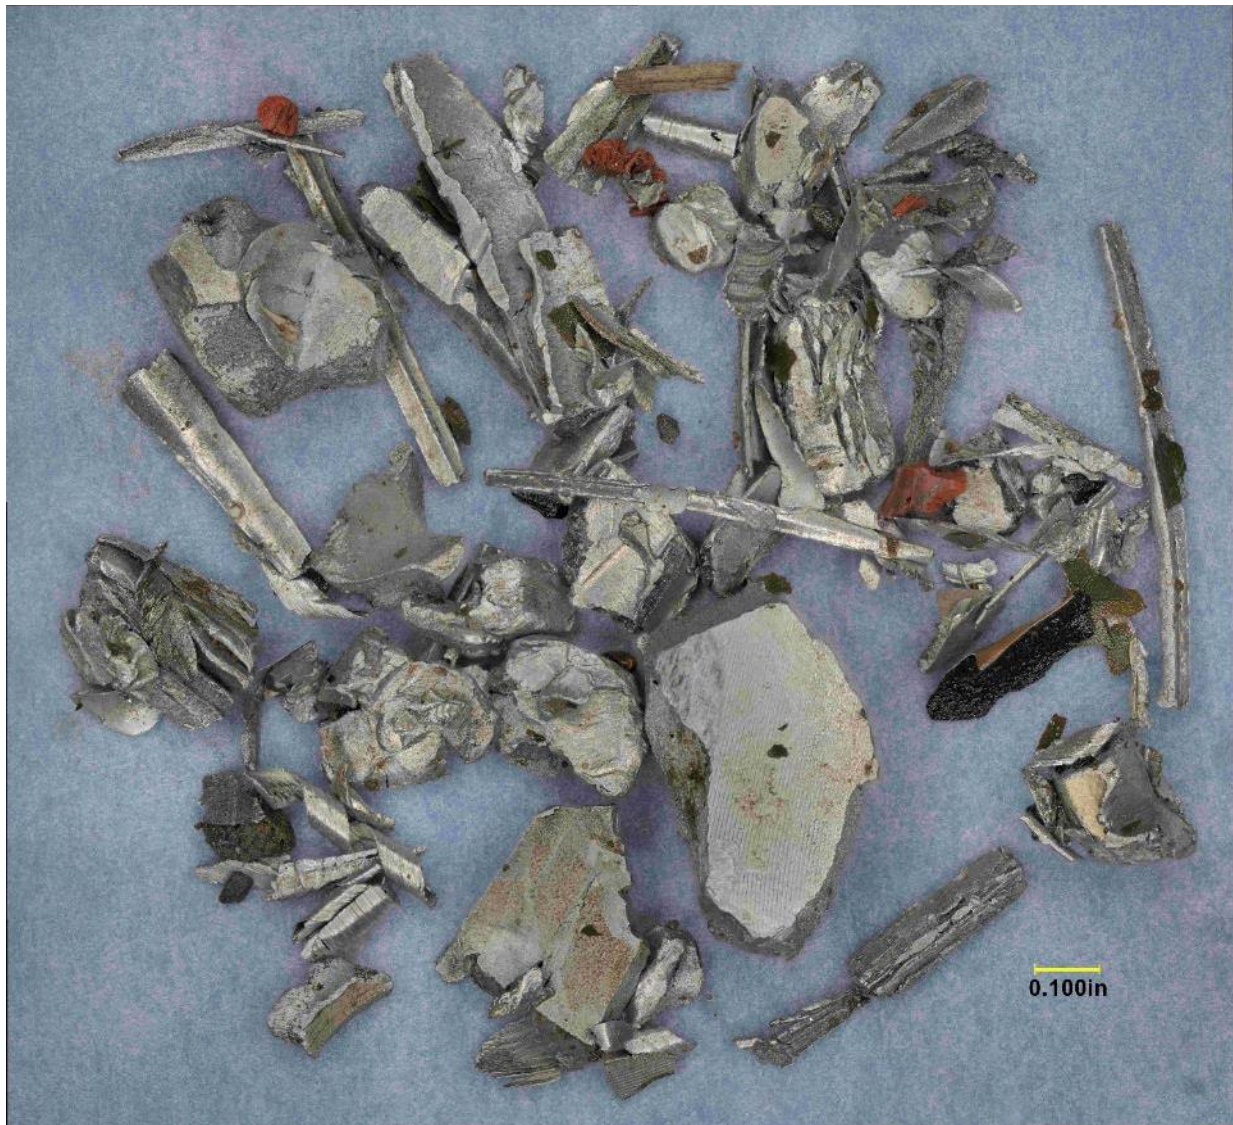
In Table 2, the non-magnetic particles numbered 1, 2, and 3 appear to be pieces of an O-ring, gasket, or other plastic-type organic material. The EDS results reveal that the rest of the particles (4 - 9) are aluminum particles with trace or minor concentrations of environmental contamination.

**Figure 4.** As-received non-magnetic particles.

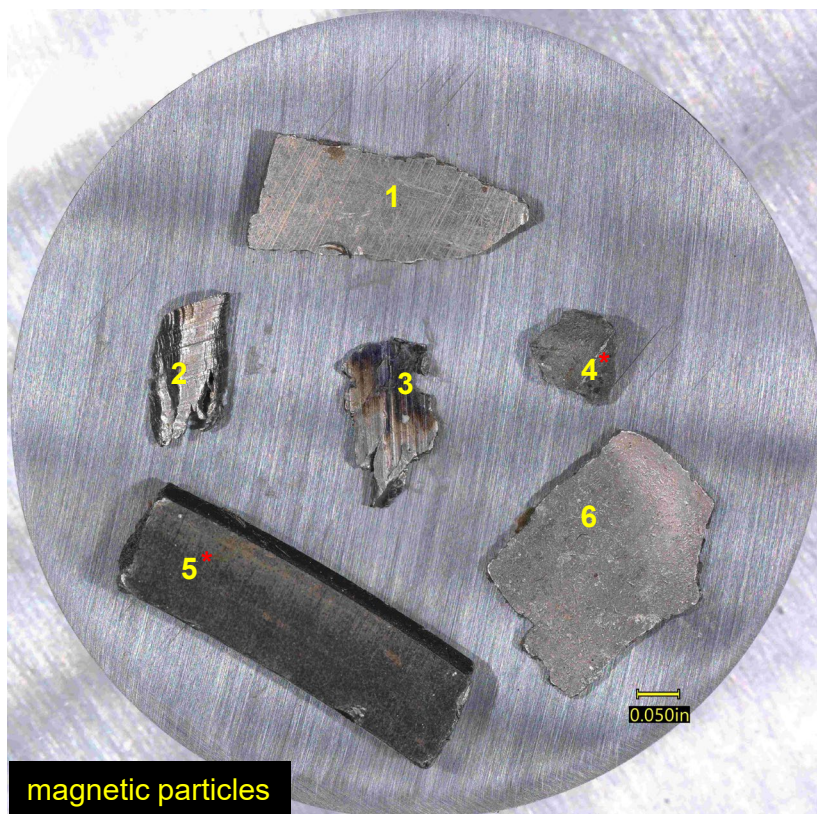
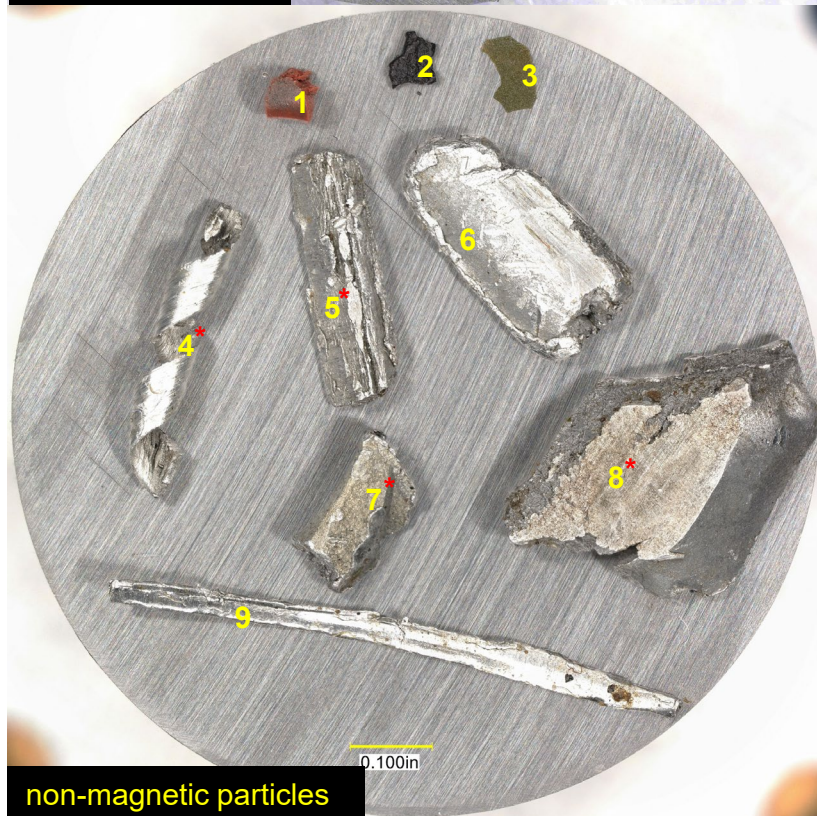
Representative particles from each group were not cleaned but were placed on a beryllium (Be) stub within the Scanning Electron Microscope (SEM) for subsequent identification using Energy Dispersive Spectroscopy (EDS). Representative particles were given arbitrary numbers are shown on Be stubs in figure 5. The red asterisks in the image denote particles that were later cleaned ultrasonically in acetone and re-analyzed for identification. An image of these cleaned particles on a Be stub are shown in figure 6.

Trace, minor and even major concentrations of lead was found in several of the particles in both groups. Upon removing the particles from the Be stubs, a liquid residue; thought to be oil from the oil screen remained on the stub. This liquid was analyzed and compared with a clean area on the stub. EDS results revealed a major carbon peak along with trace aluminum, silicon, sulfur and lead.

**Figure 5.** Grouped particles place on separate Be stubs. The red asterisk denotes particles later cleaned and re-analyzed.

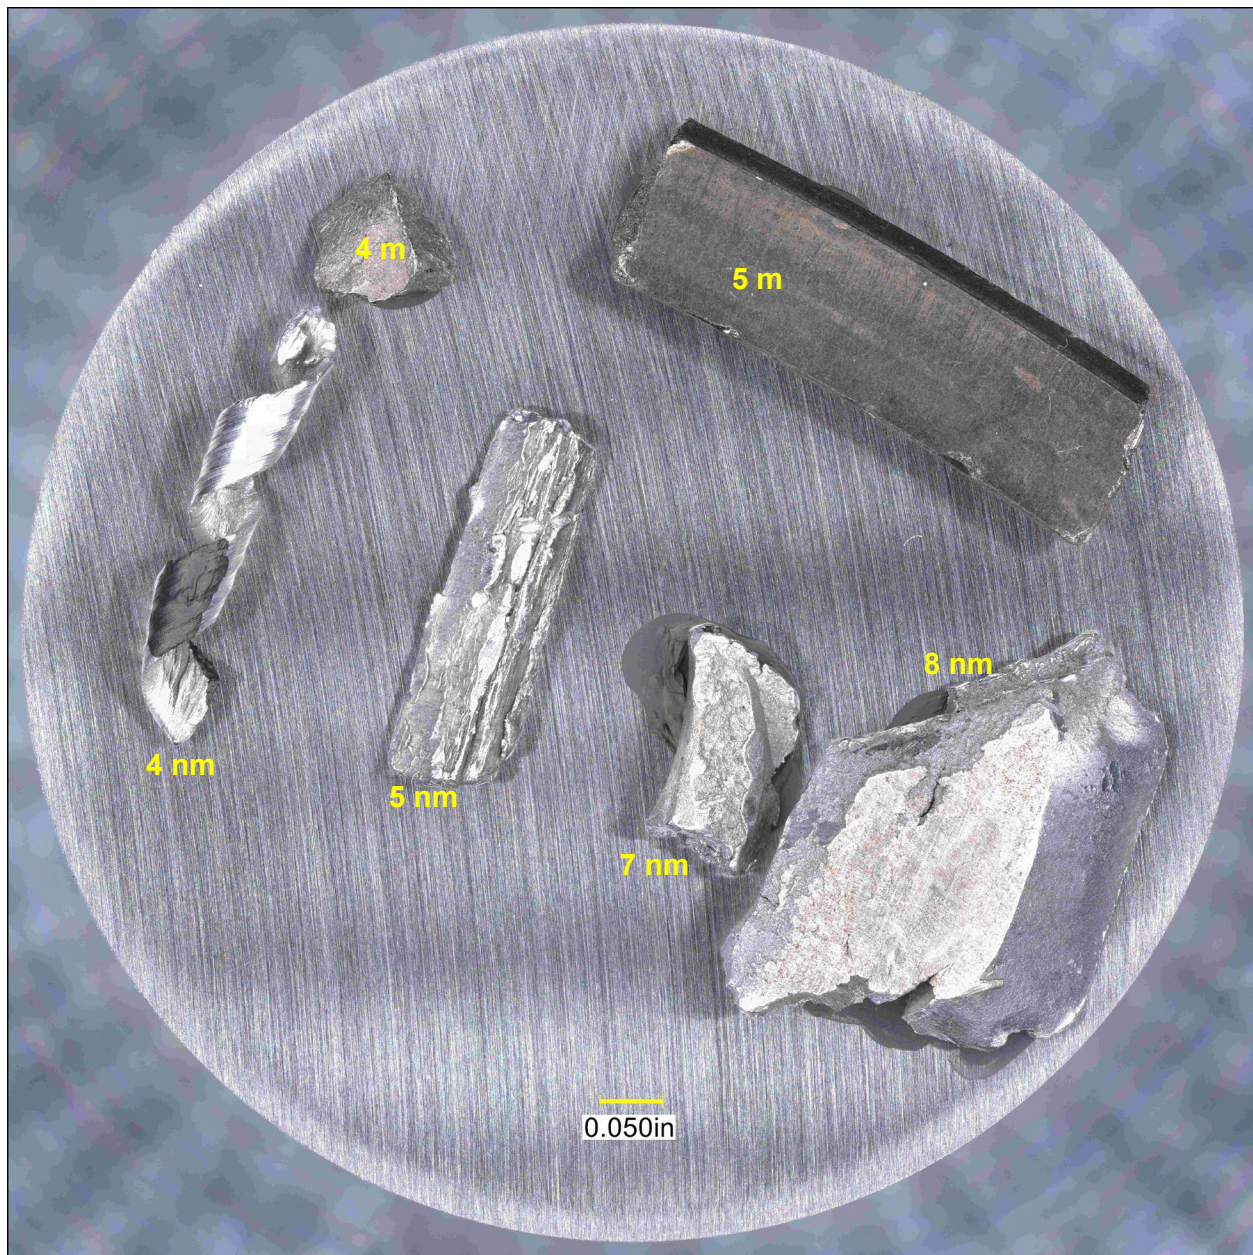
Particles 4 and 5 from the magnetic group and particles 4, 5, 7 and 8 from the non-magnetic group were cleaned ultrasonically while submersed in acetone for 30 minutes. The particles were allowed to dry then placed on a clean Be stub for further analysis. Table 3 lists the elements revealed after cleaning. With a minor amount of chrome and trace nickel detected, particle 4 is most likely a ferritic stainless steel while particle 5 resembles plain steel. EDS analyses confirmed that all the cleaned non-magnetic particles are aluminum as the amounts of carbon, oxygen and other contaminants decreased significantly or were not detected due to the cleaning process.

**Figure 6.** Cleaned particles on Be stub where 'm' denotes magnetic particles while 'nm' denotes non-magnetic particles.
