ERA24FA026

## INVESTIGATIVE PHOTOS

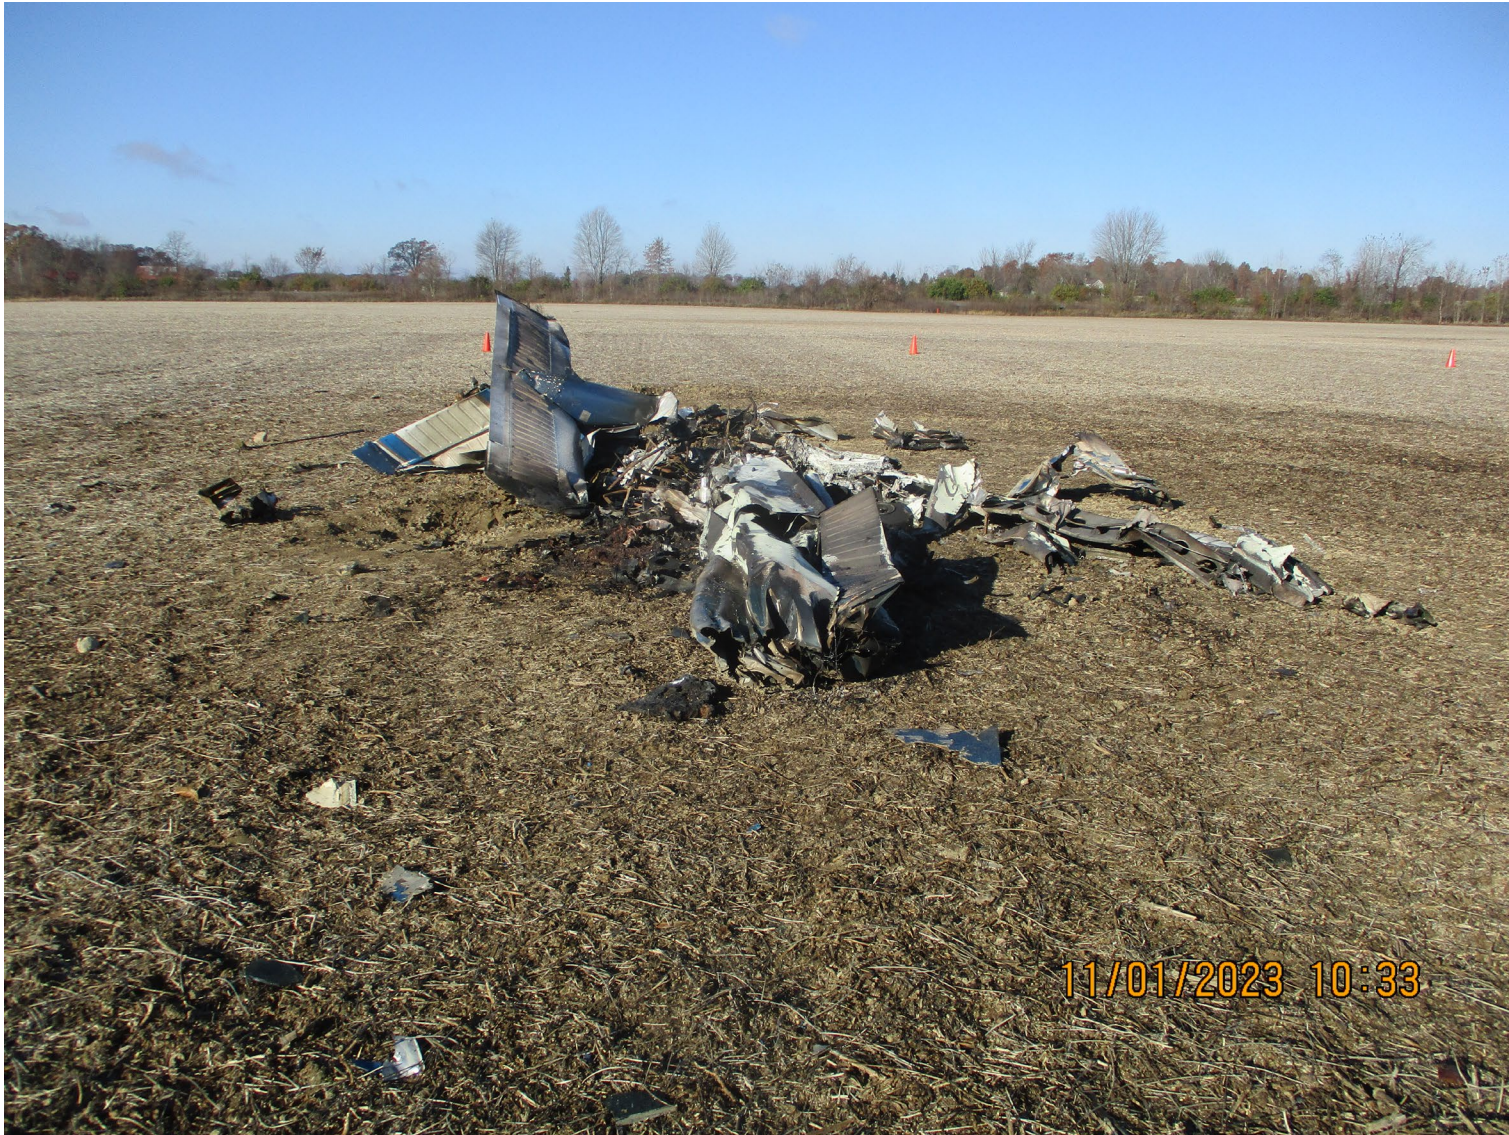
**Photograph 1 - Main wreckage**

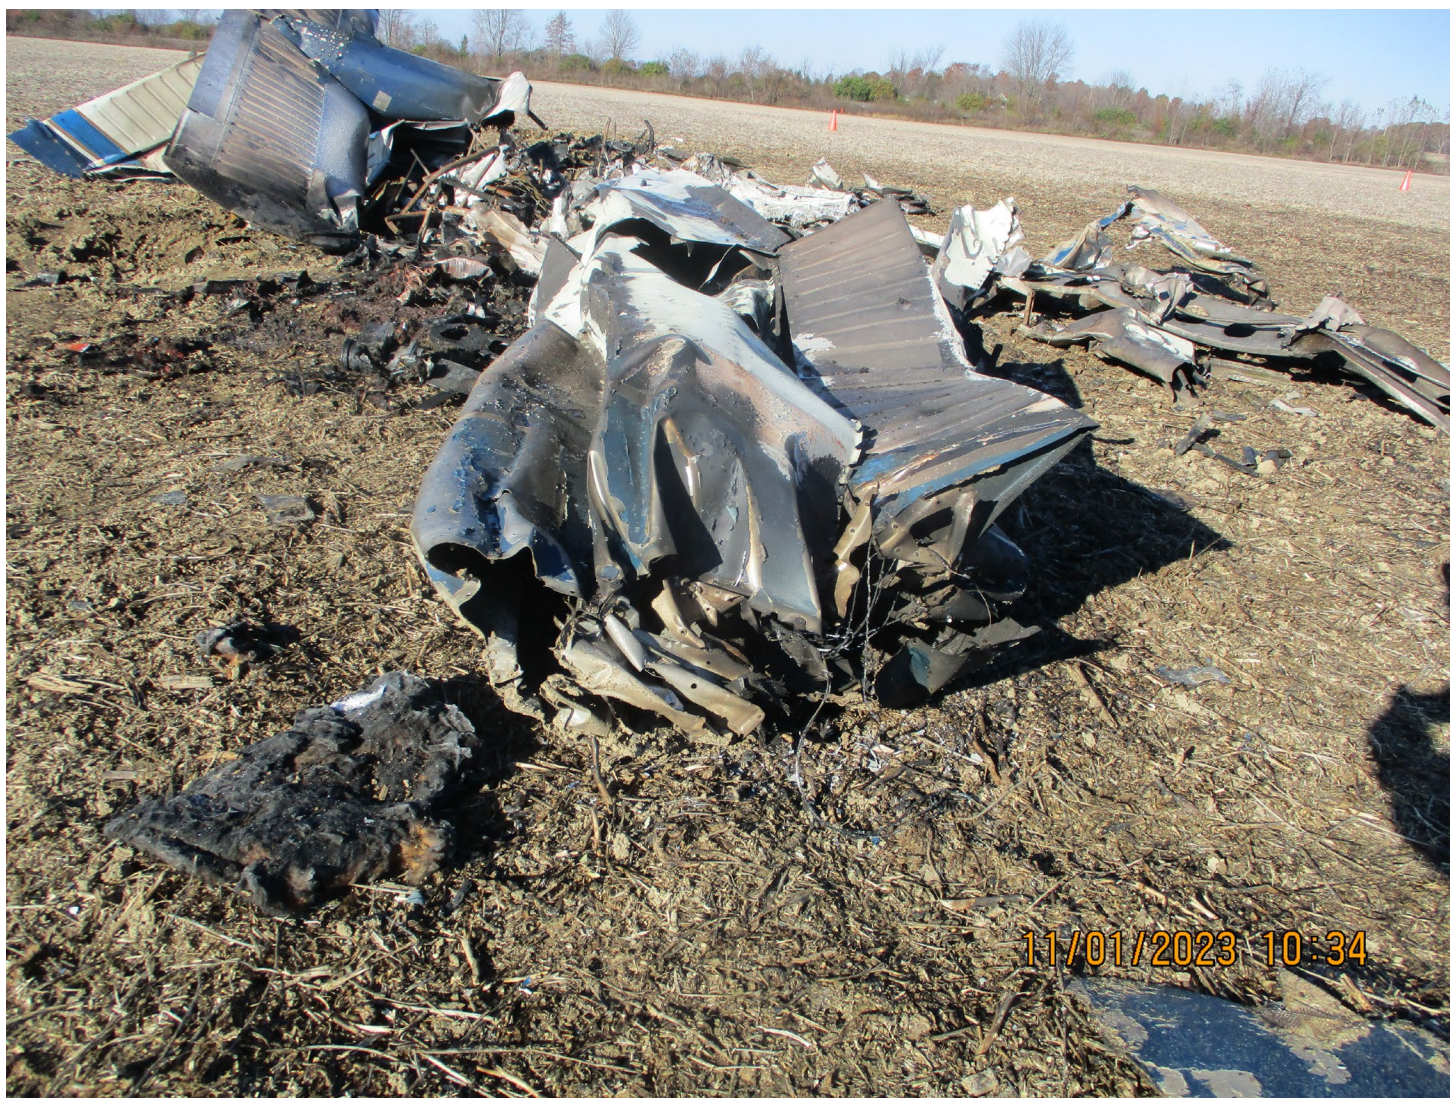
**Photograph 2 - Left wing, Note: accordion crushing**

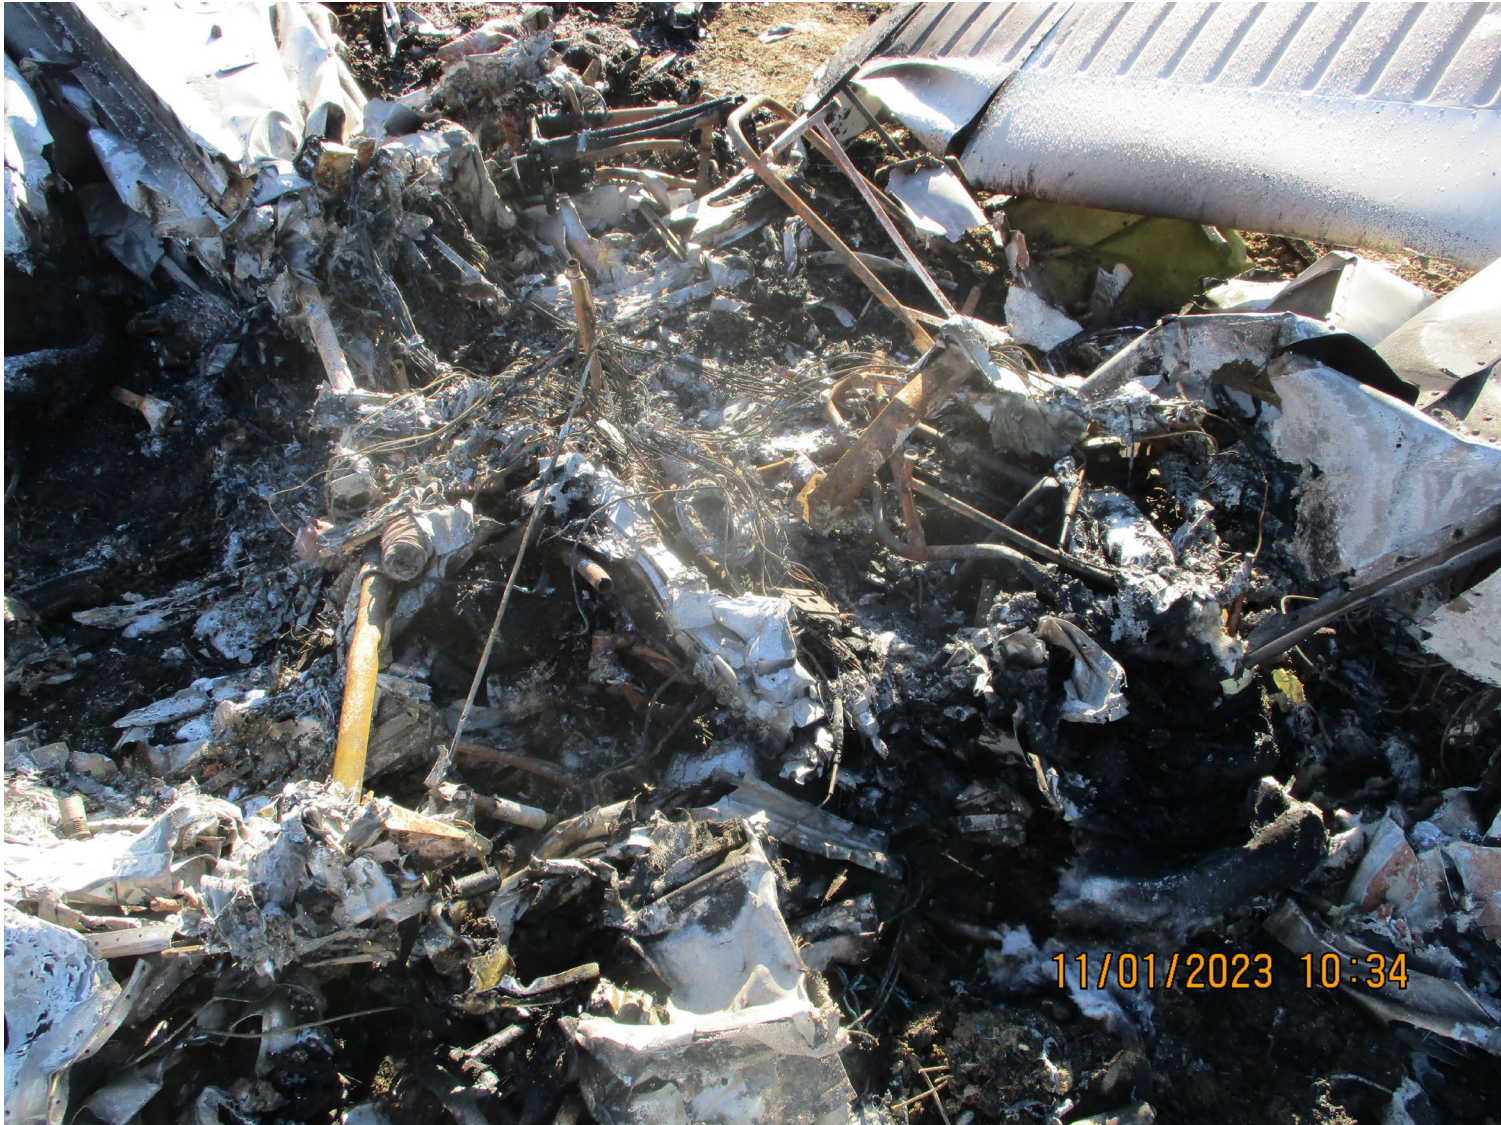
**Photograph 3 - Cabin and instrument panel**

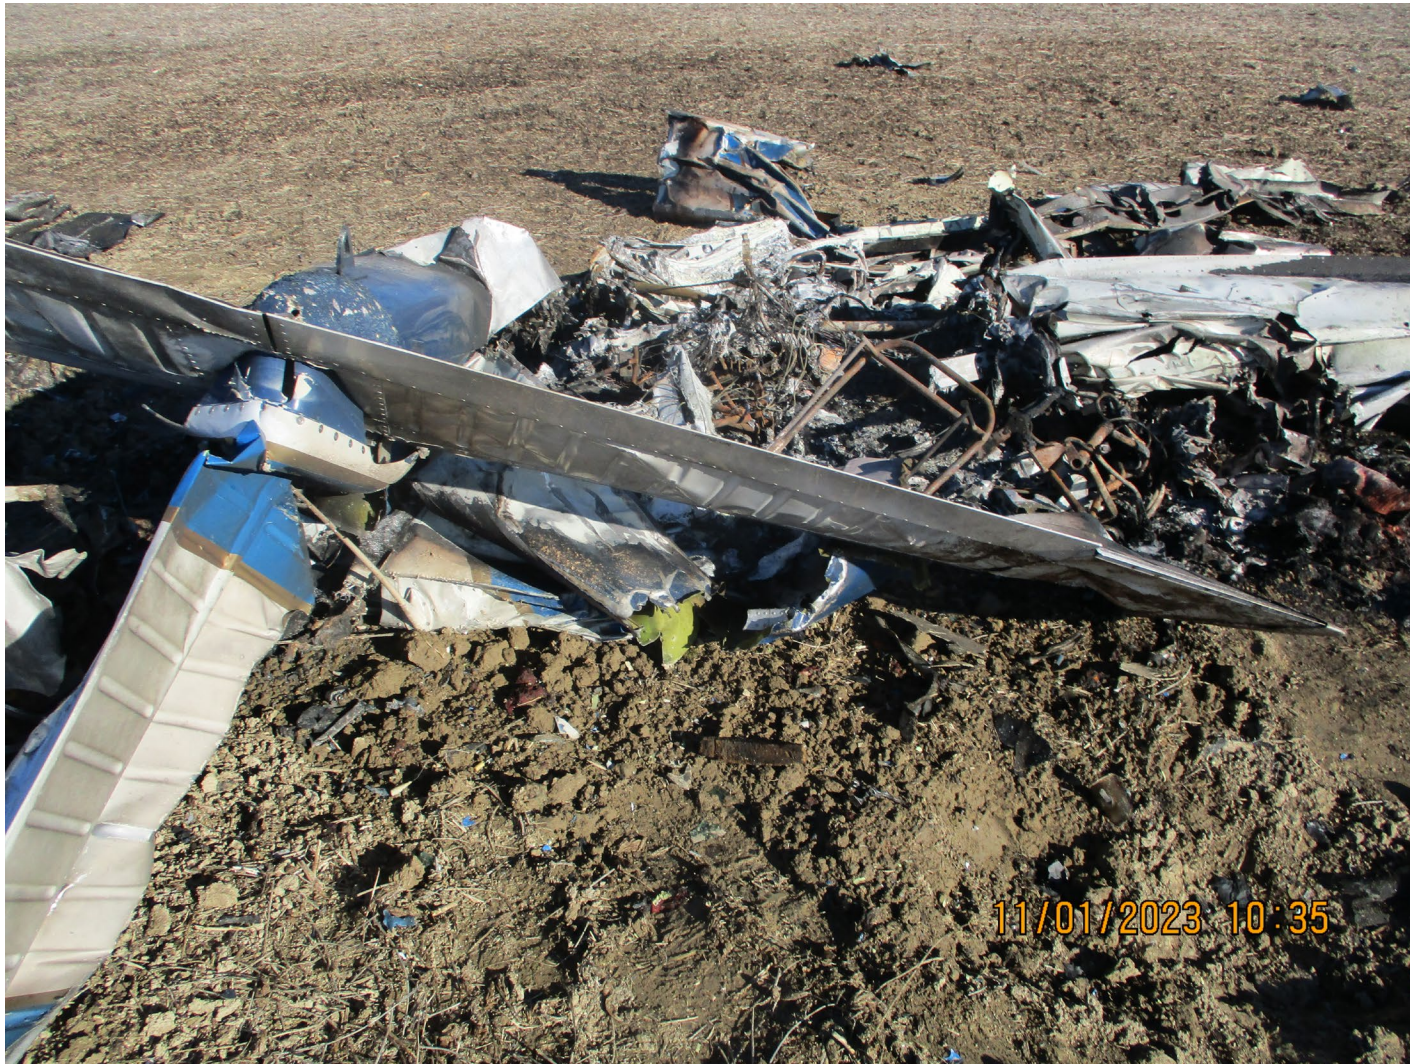
**Photograph 4 - Tail view**
