# National Transportation Safety Board

ERA24FA036

## **WRECKAGE EXAMINATION SUMMARY**

Location: Micanopy, Florida  
Date: November 14, 2023  
Time: 1408 EST  
1908 UTC  
Airplane: Piper PA-28-180, N7806W

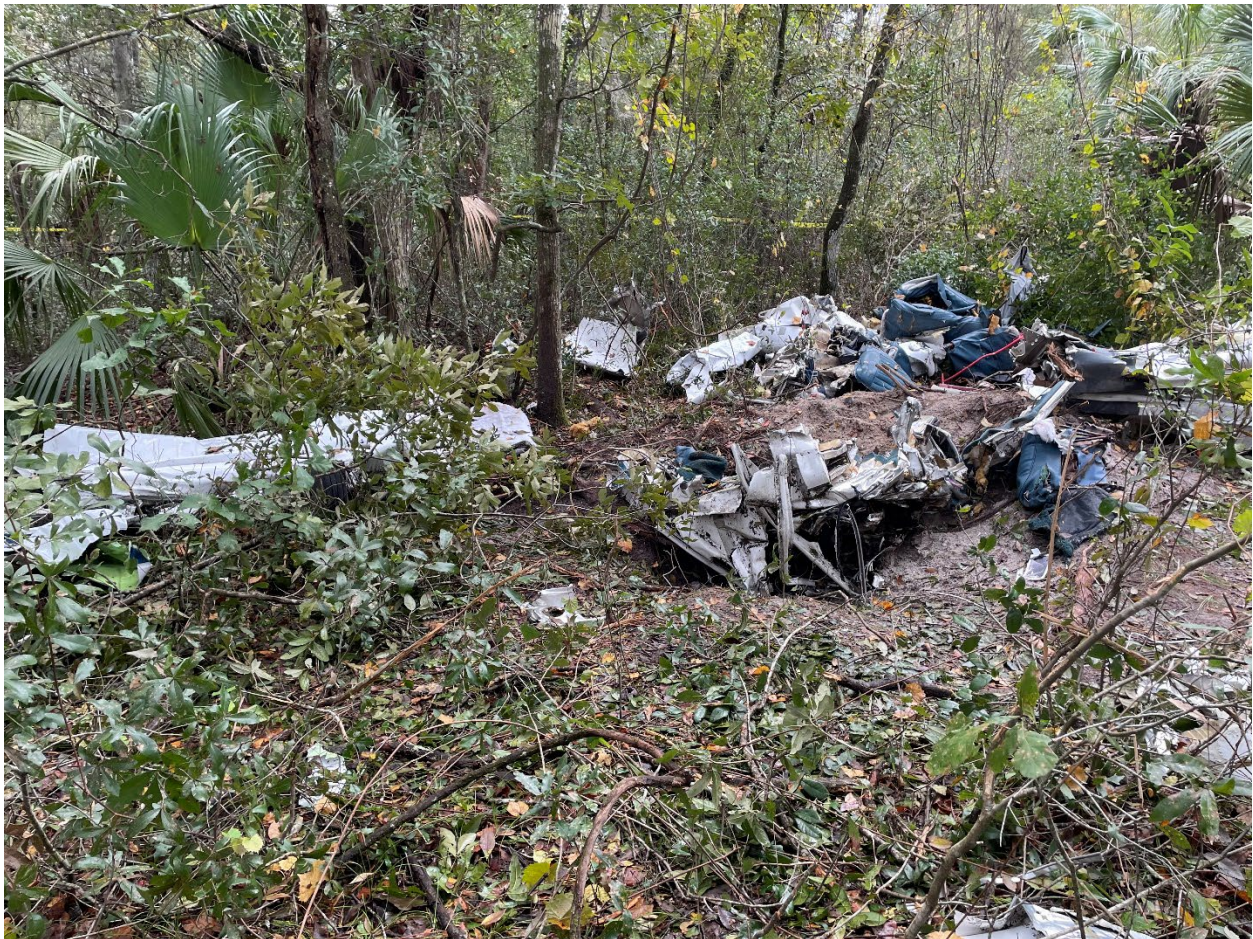
The airplane came to rest in a state park at an elevation of 100 ft mean sea level. It struck several trees before impacting the ground. The airplane came to rest in a crater that was about 4 ft deep. All major components of the airplane were located in the vicinity of the main wreckage.

**Figure 3. Overview of Accident Site**

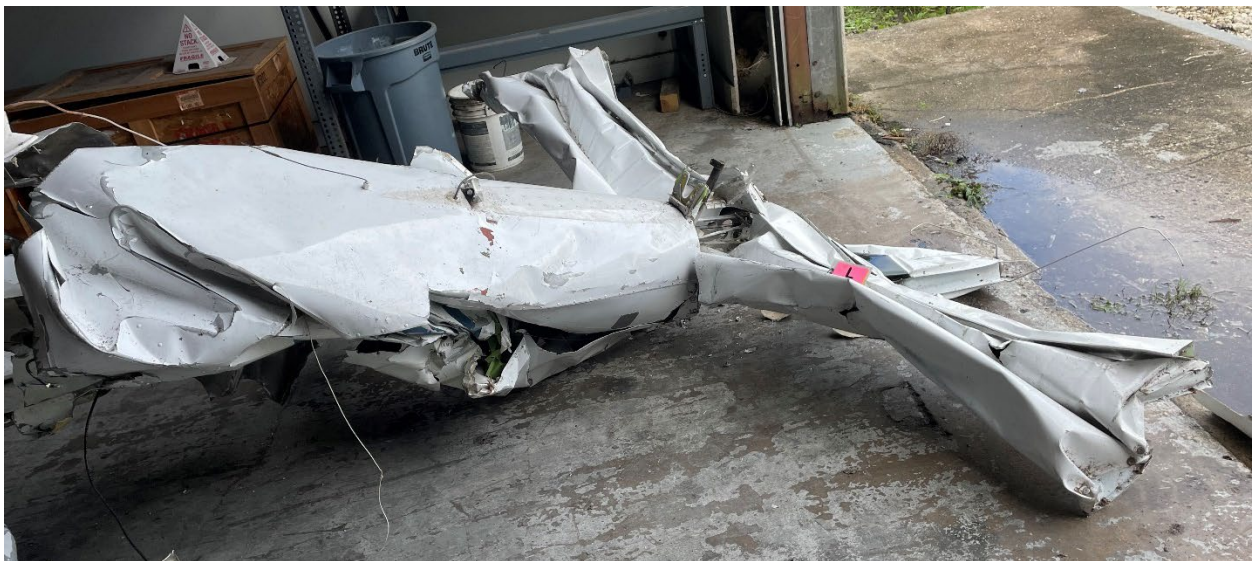
The empennage was impact separated from the fuselage. The stabilator remained attached to the empennage. The trim tab remained attached to the stabilator. The trim drum was measured and it corresponded to between the neutral and nose down position. The vertical stabilizer was impact separated and located in the vicinity of the main wreckage. The rudder was impact separated from the vertical stabilizer and located in the vicinity of the main wreckage. The stabilator balance weight remained attached to the stabilator.

**Figure 4. View of empennage.**

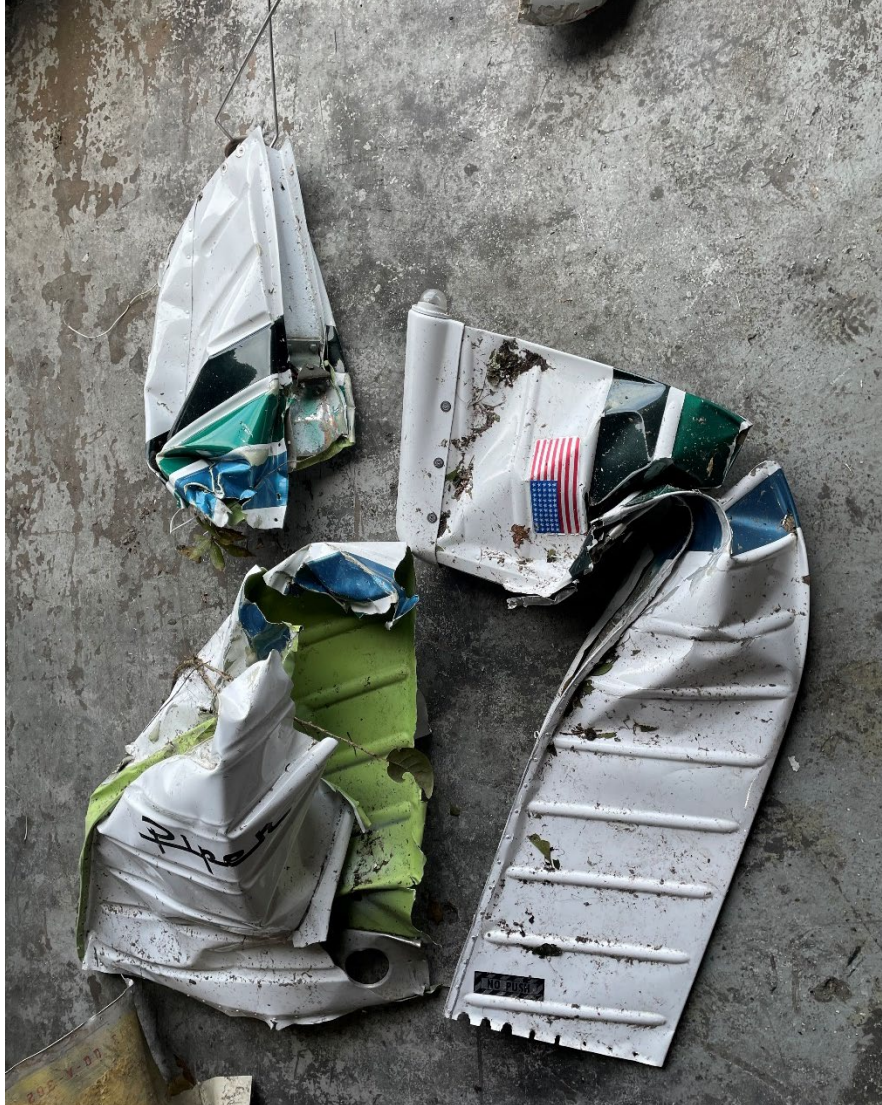
**Figure 5. View of rudder and vertical stabilizer.**

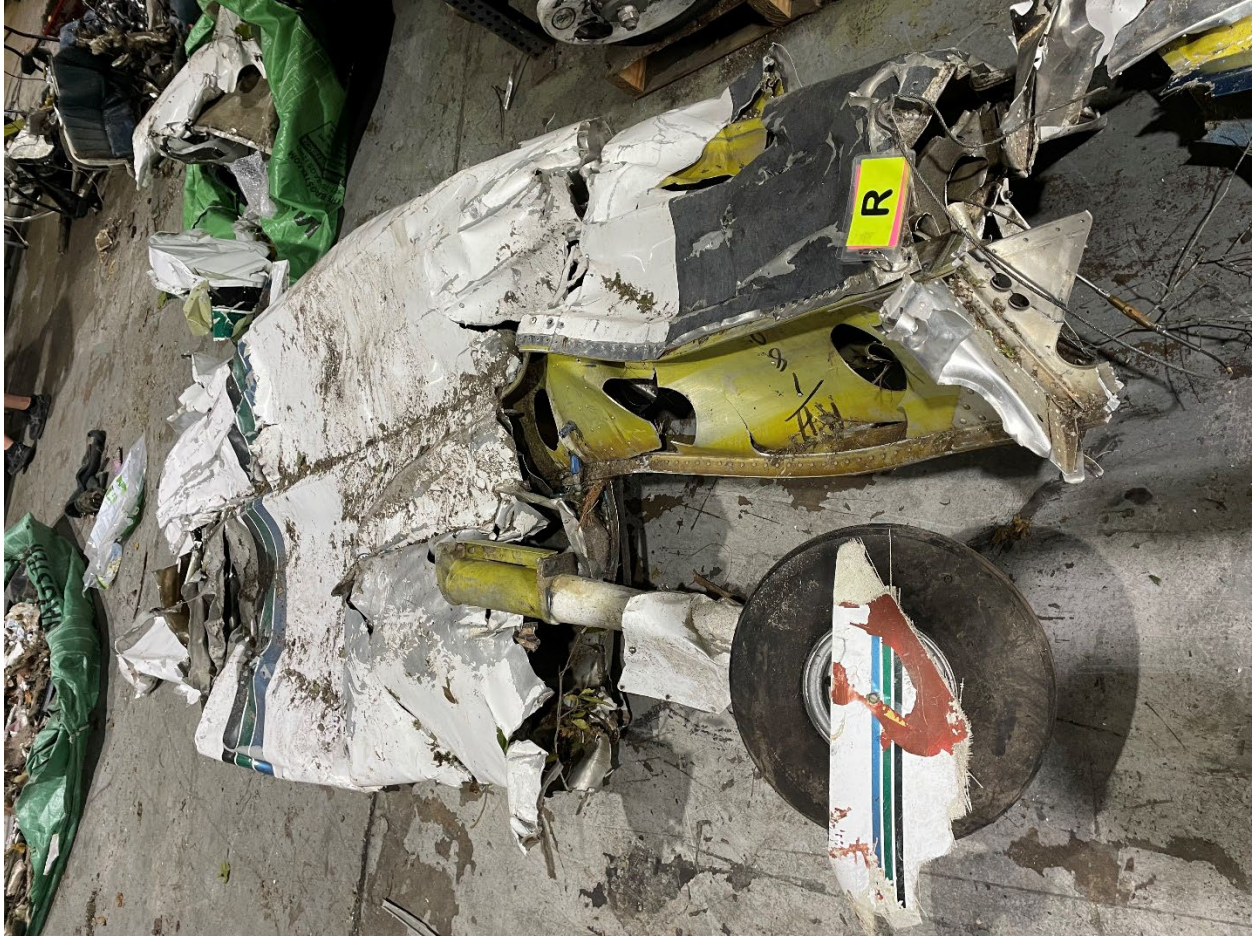
The right wing was separated from the fuselage at the wing root. The forward section of the right wing was impact crushed aft. The right fuel tank cap was not seated. The outboard approximate 4 ft of the wing was impact separated and located along the debris path. The right aileron remained attached to the right wing by the inboard attach point. The right flap remained attached to the right wing through the inboard attach point. The right-wing tip was separated and located along the debris path. The right-wing tip light lens cover was located to the right of the impact crater. The right-wing fuel tank was breached.

**Figure 6. View of right wing layout.**

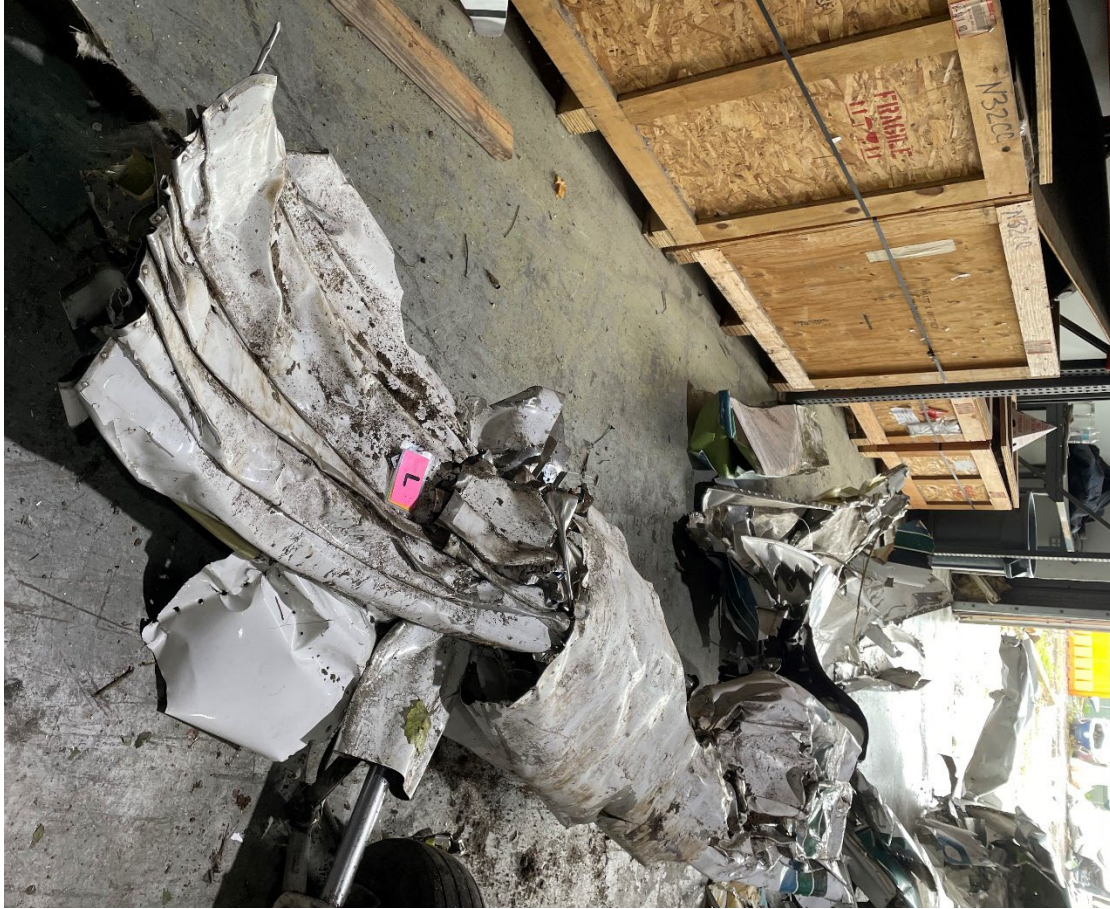
The left wing was fragmented. The inboard section of the left wing was impact crushed aft. The left aileron was impact separated and located in the vicinity of the main wreckage. The left flap remained attached to the inboard section of the left wing. The left-wing tip was separated and located in the vicinity of the main wreckage. The left-wing fuel tank was breached.

**Figure 7. View of left wing layout.**

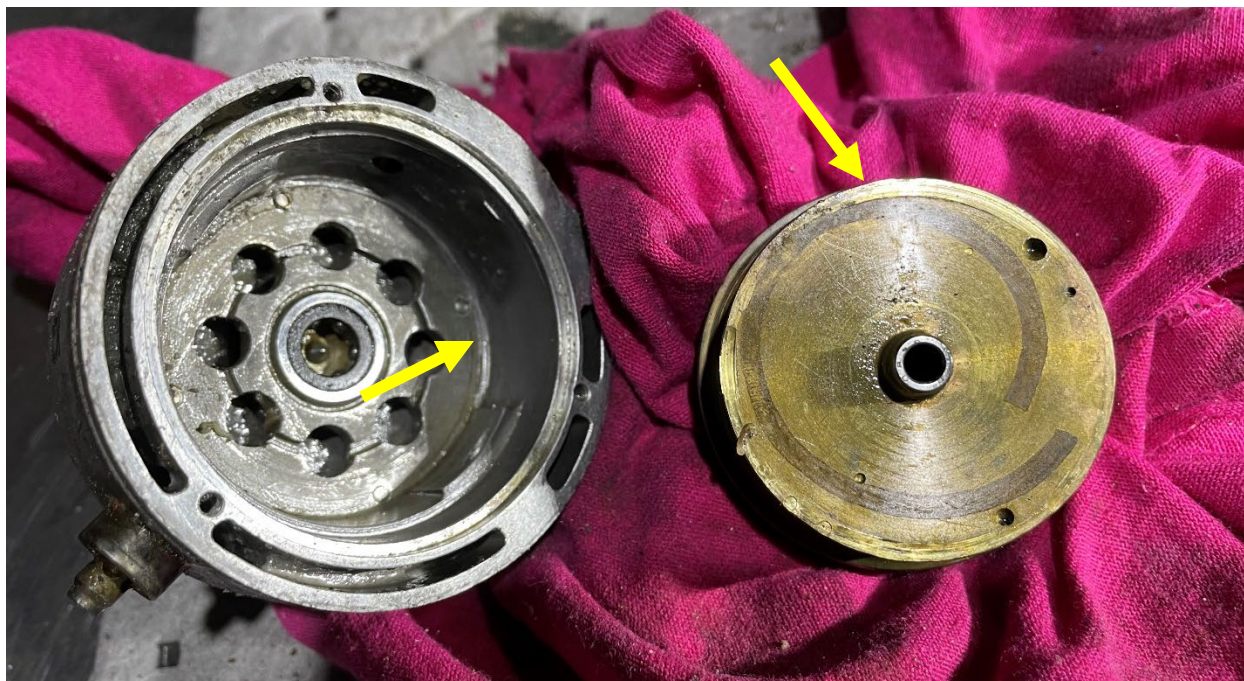
The attitude indicator was separated from the instrument panel and disassembled. Rotational scoring was noted on the gyroscope and the gyroscope housing.

**Figure 8. View of attitude indicator gyroscope and gyroscope housing. Yellow arrows point to rotational scoring.**

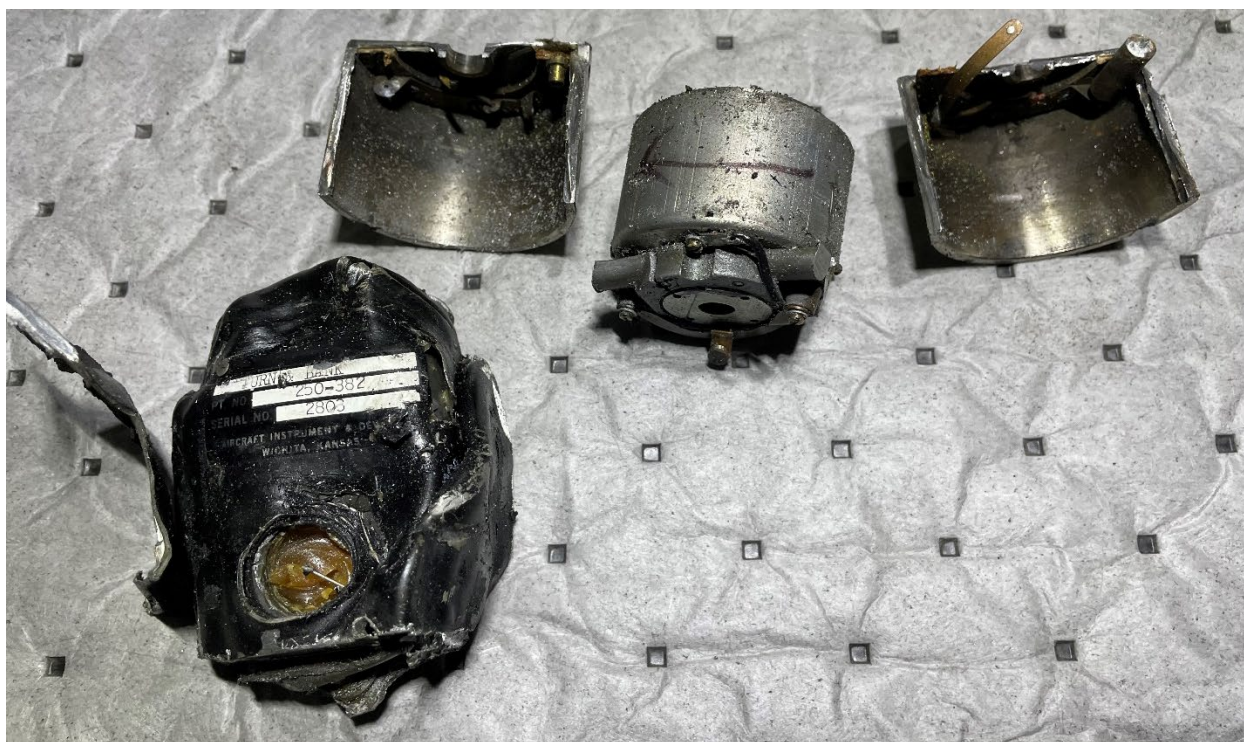
The turn and bank indicator was removed from the instrument panel. It was electronically powered. It was disassembled and vertical scoring was noted on the gyroscope.

**Figure 9. View of turn and bank electronic gyroscope and gyroscope housing.**

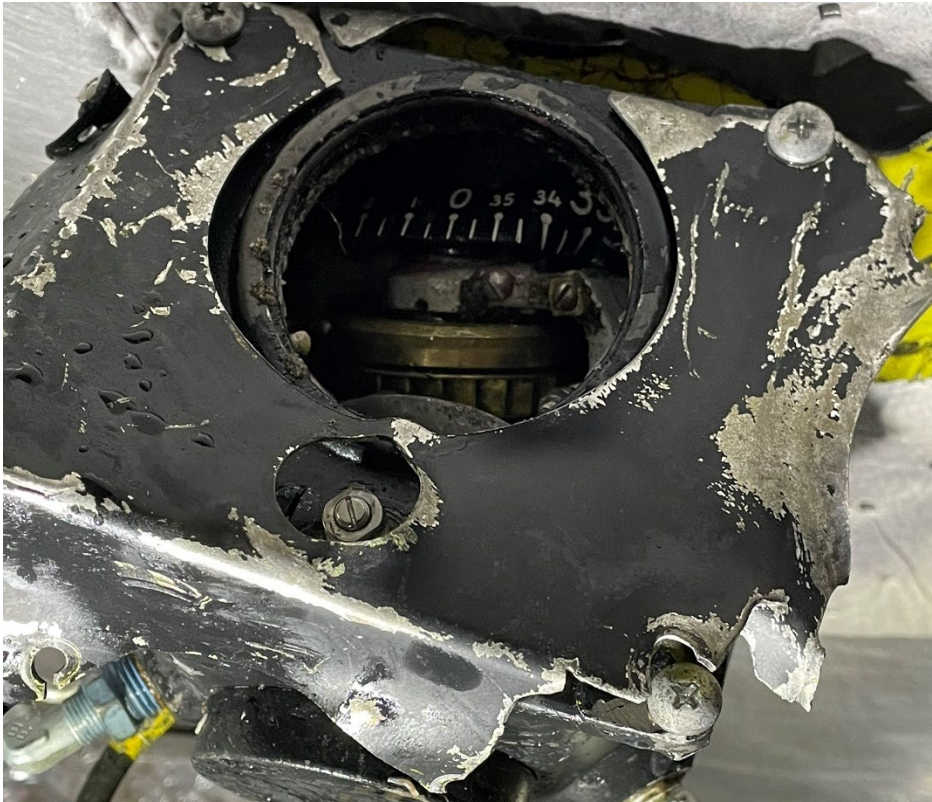
The heading indicator was removed from the instrument panel and examined. The gyroscope was noted in the instrument.

**Figure 10. View of heading indicator.**

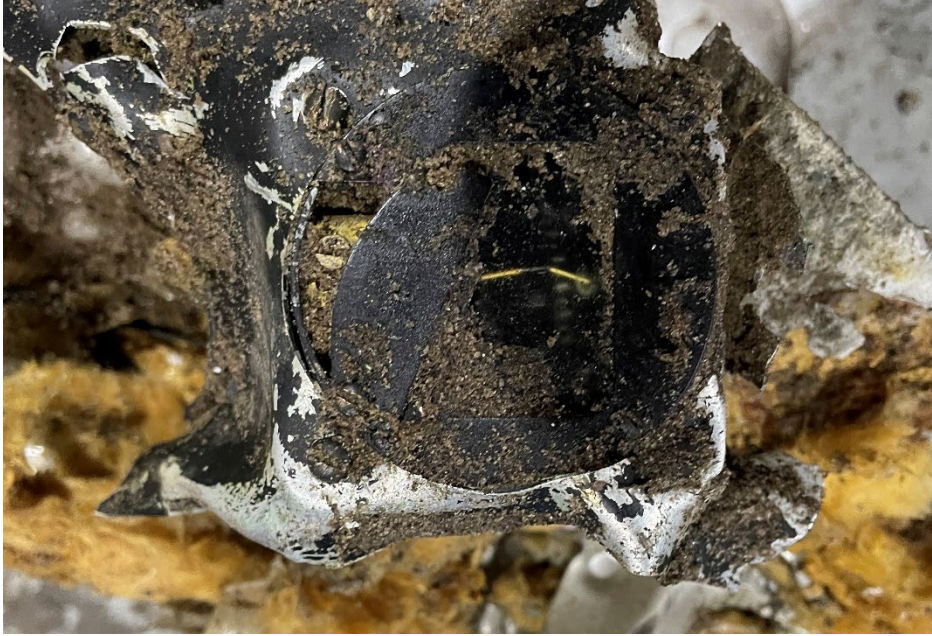
The compass was separated from the instrument panel. During examination, the compass float moved when the instrument was manipulated.

**Figure 11. View of compass as found.**

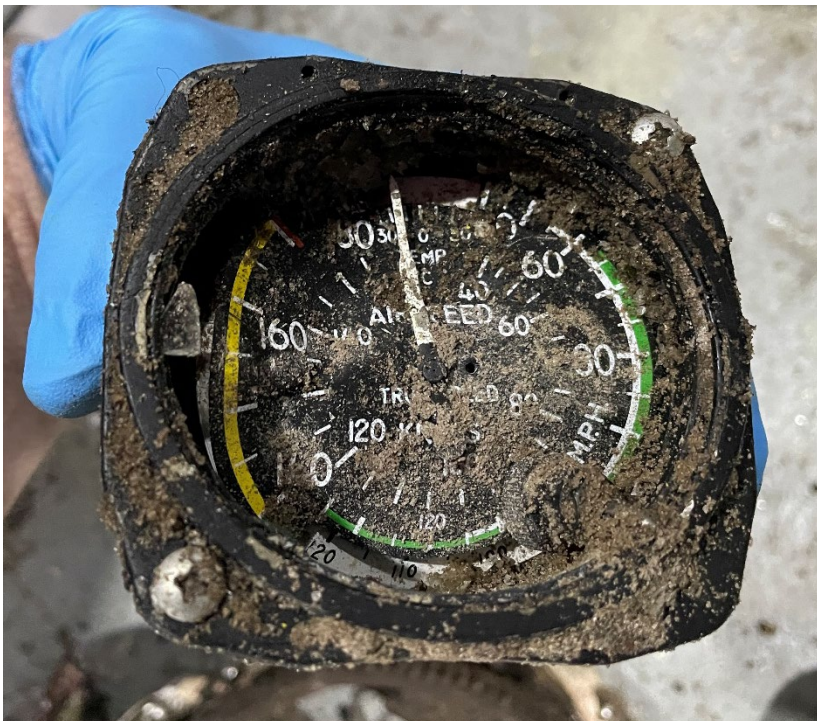
The airspeed indicator was located separated from the instrument panel. The airspeed needle was located in the maximum position on the instrument.

**Figure 12. View of airspeed indicator as found. Note needle position.**

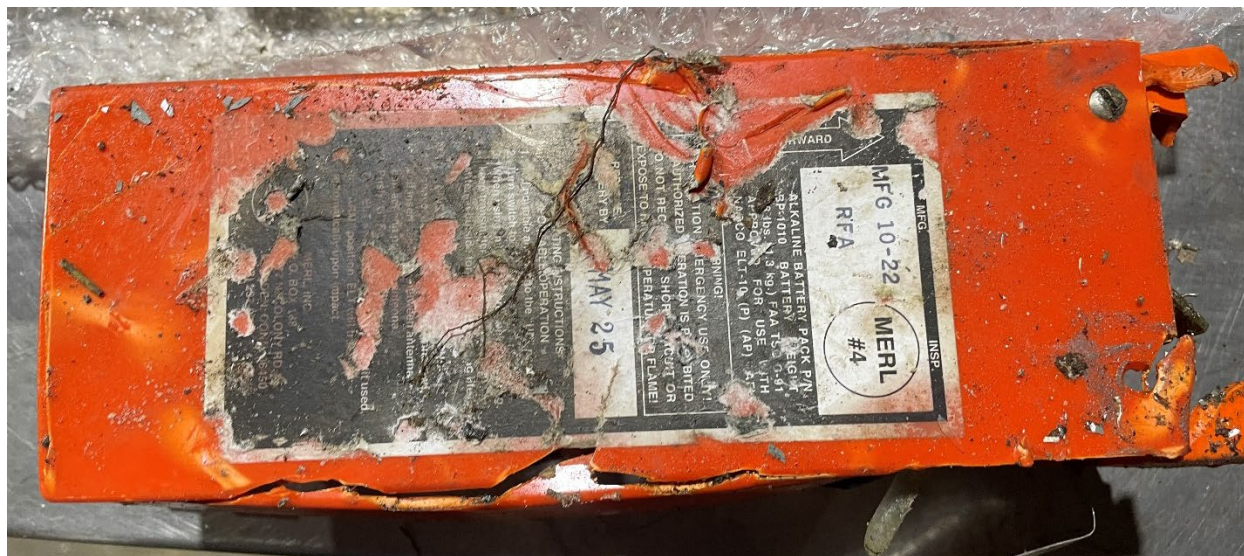
The ELT was located in the vicinity of the main wreckage. The housing was fractured and the battery expiration date noted on the house was May 2025. According to the FAA inspector, during the initial on-scene investigation the ELT was heard operating.

Figure 13. View of ELT.

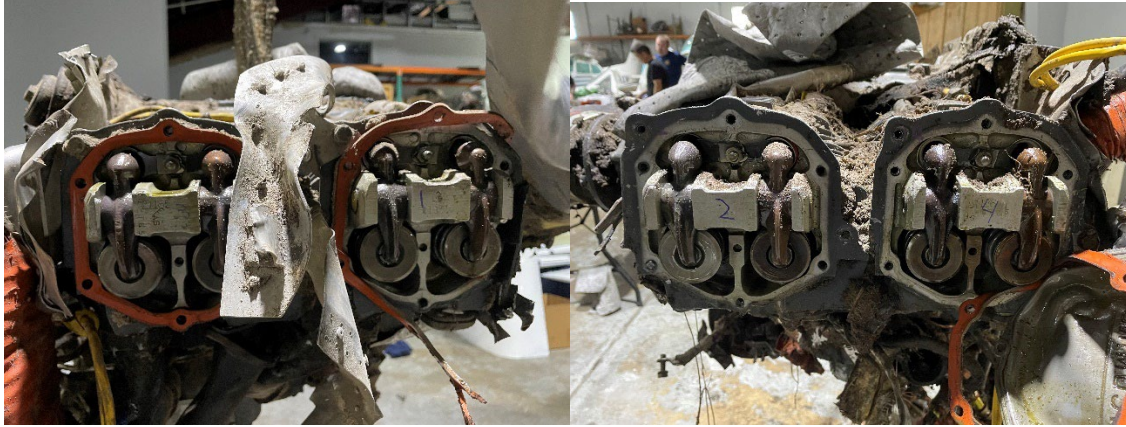
The engine remained attached to the forward section of the fuselage through all engine mounts. The engine mounts and cables were cut to facilitate the engine examination. The crankshaft could not be rotated by hand. The propeller flange was impact bent but remained attached to the crankshaft. The rocker box covers were removed, and no anomalies were noted with the rocker arms. The cylinders were examined with a light boroscope, sand and oil were noted in the cylinders, but no anomalies were noted.

**Figure 14. View of left and right side of engine with rocker box covers removed.**

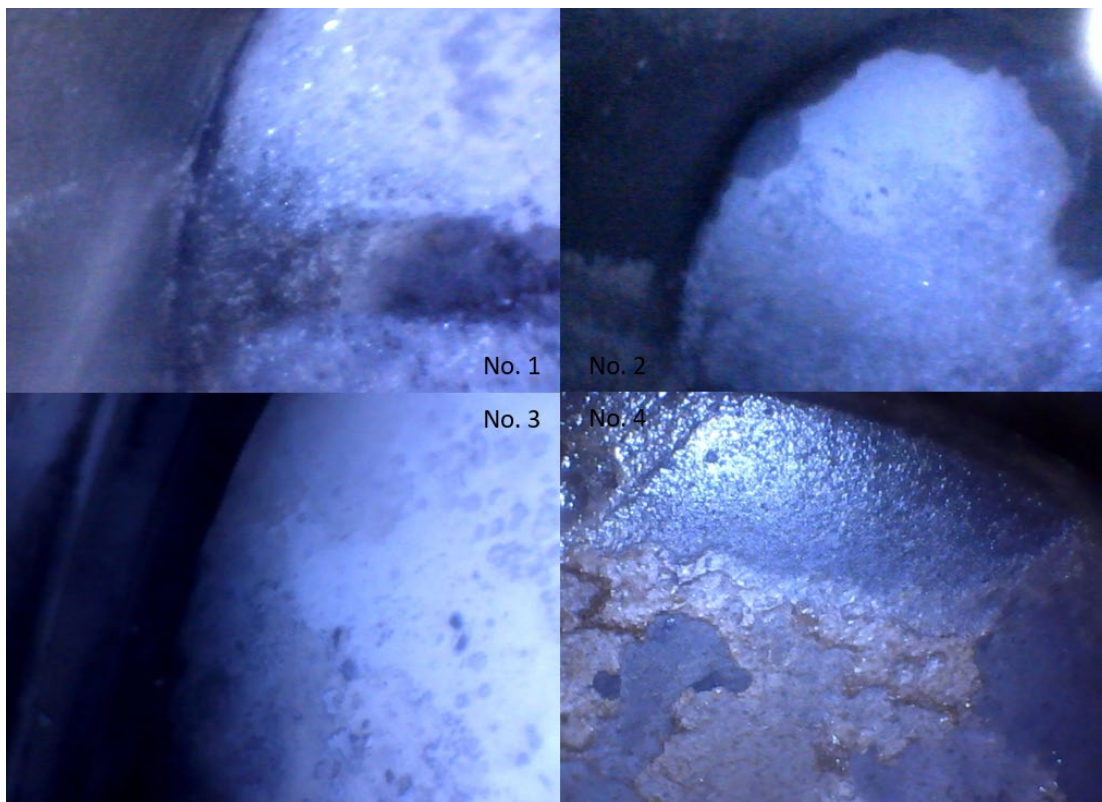
**Figure 15. Boroscope photographs of piston faces for all cylinders.**

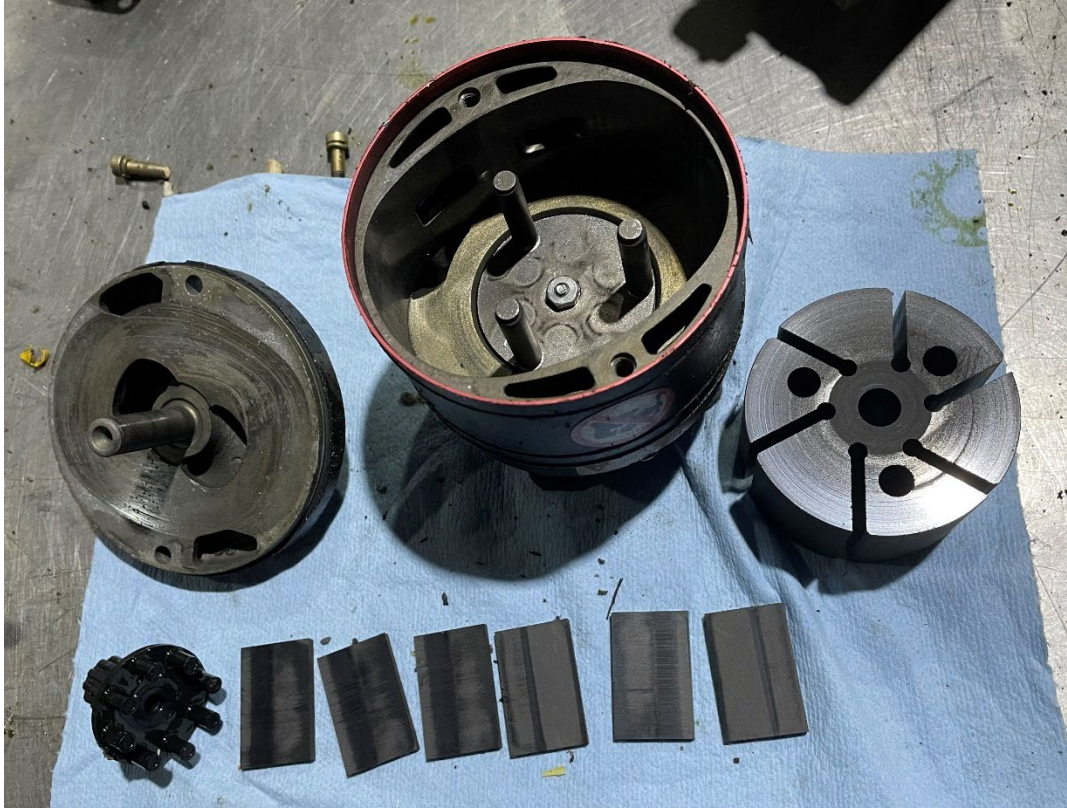
The vacuum pump was removed from the accessory section of the engine and disassembled. The rotor and vanes remained intact, and the drive splines were intact.

**Figure 16. View of disassembled vacuum pump.**

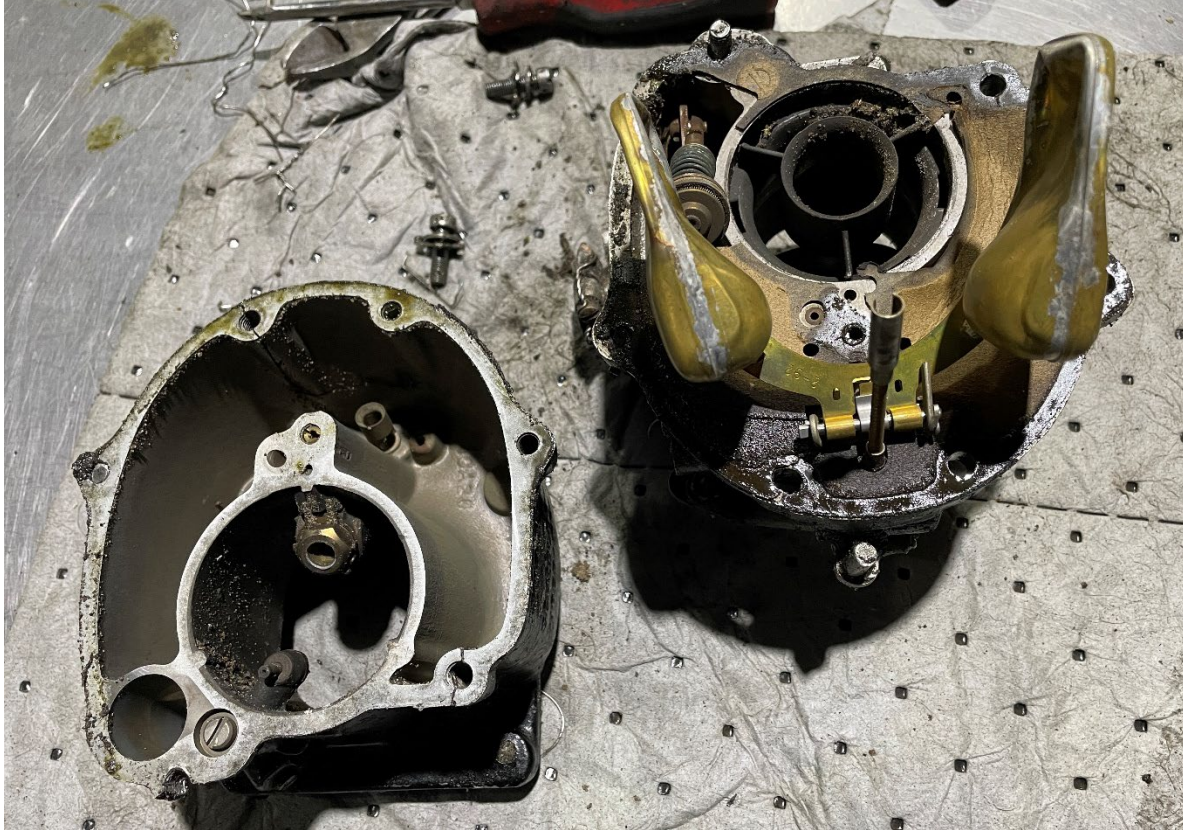
The carburetor was impact separated from the engine but remained attached through cables. The fuel filter was removed, and no debris was noted in the filter. The carburetor was disassembled. The butterfly valve operated when the arm was moved by hand. The carburetor bowl did not contain fuel, however the carburetor floats exhibited hydraulic deformation. The needle valve was examined with no anomalies noted.

**Figure 17. View of disassembled carburetor.**

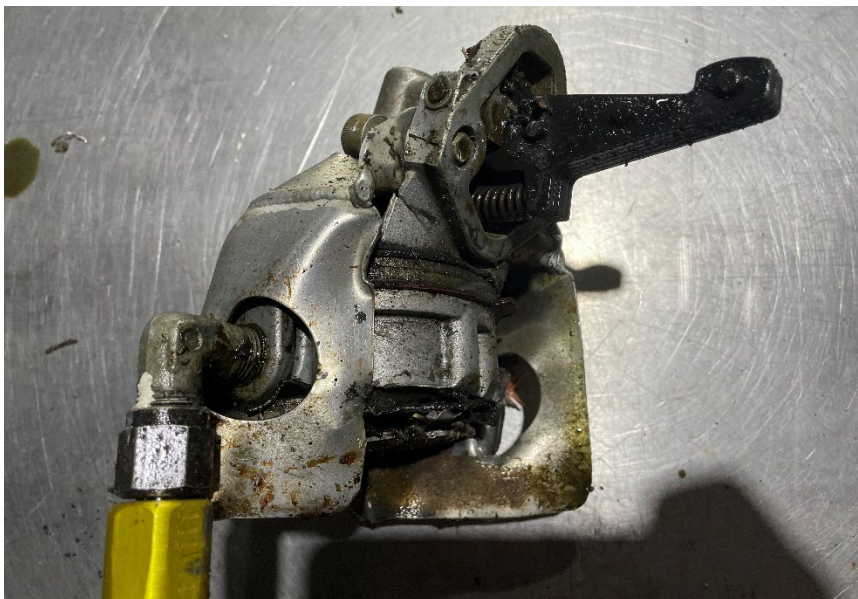
The mechanical fuel pump was removed from the engine and exhibited impact damage.

**Figure 18. View of mechanical fuel pump as found.**

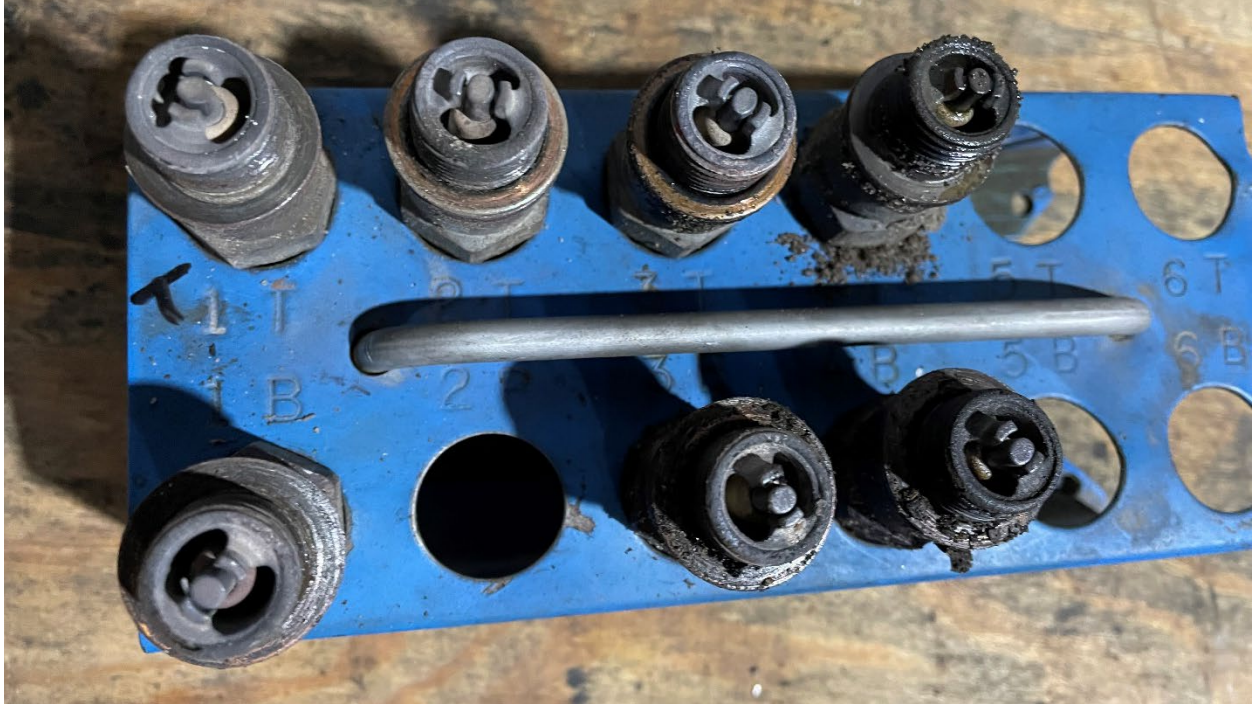
All spark plugs were removed except the No. 2 bottom spark plug, which was impact damaged. The spark plugs were massive electrode type, all were light grey in color, and exhibited worn out - normal wear when compared to the Champion Check-A-Plug Chart. The No. 4 top spark plug was oil soaked.

**Figure 19. View of spark plugs.**

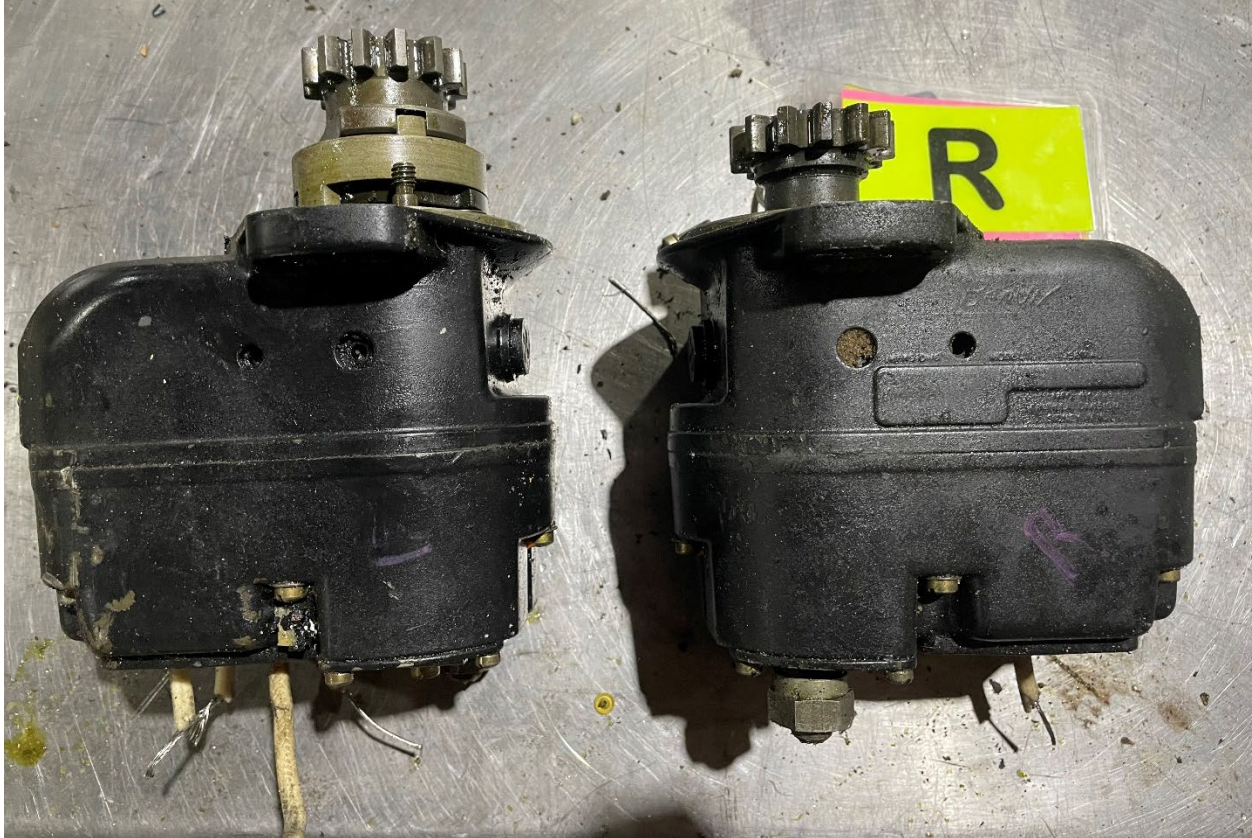
The magnetos were removed from the engine. Both magnetos were operated using an electric drill and sparked on all towers.

**Figure 20. View of magnetos.**

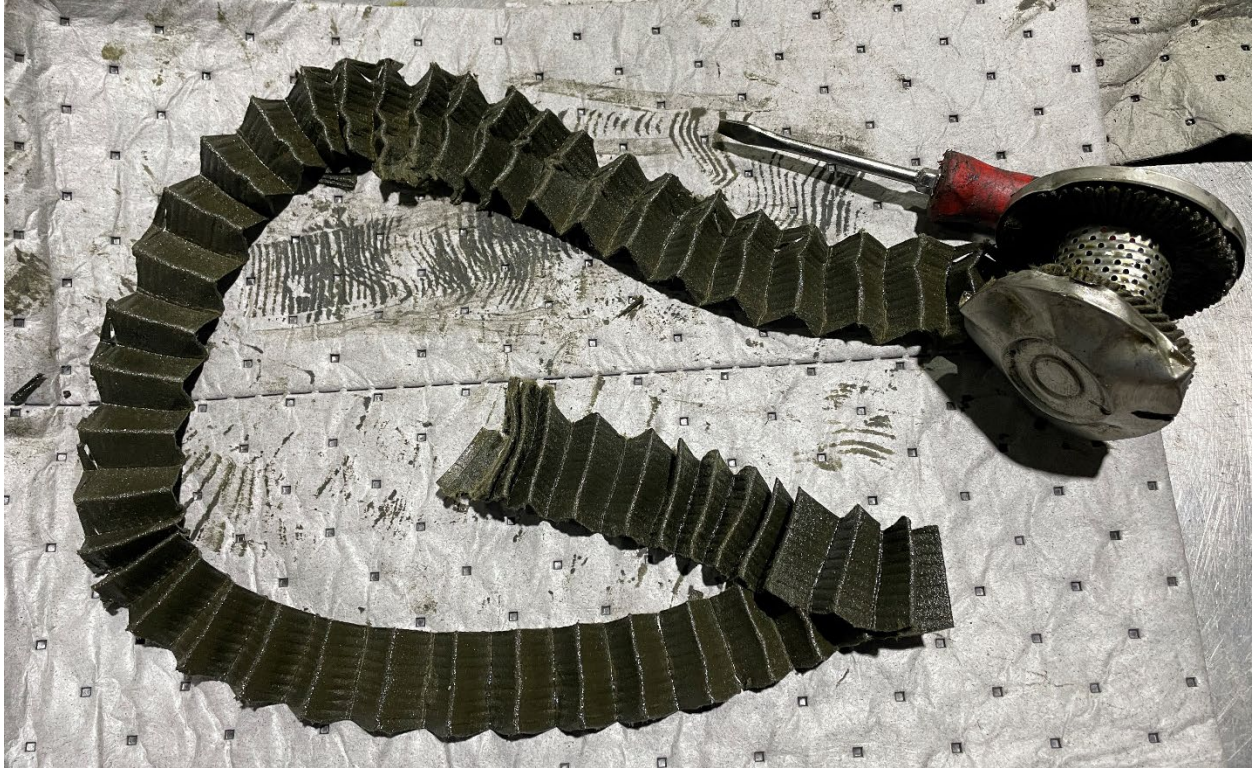
The oil filter was removed from the accessory section of the engine and disassembled. No metallic debris was noted in the filter. The oil suction screen was removed from the oil sump and was not obstructed. The oil filler neck was impact separated and located in the vicinity of the engine. The oil dip stick remained inside the oil filler neck.

**Figure 21. View of disassembled oil filter.**

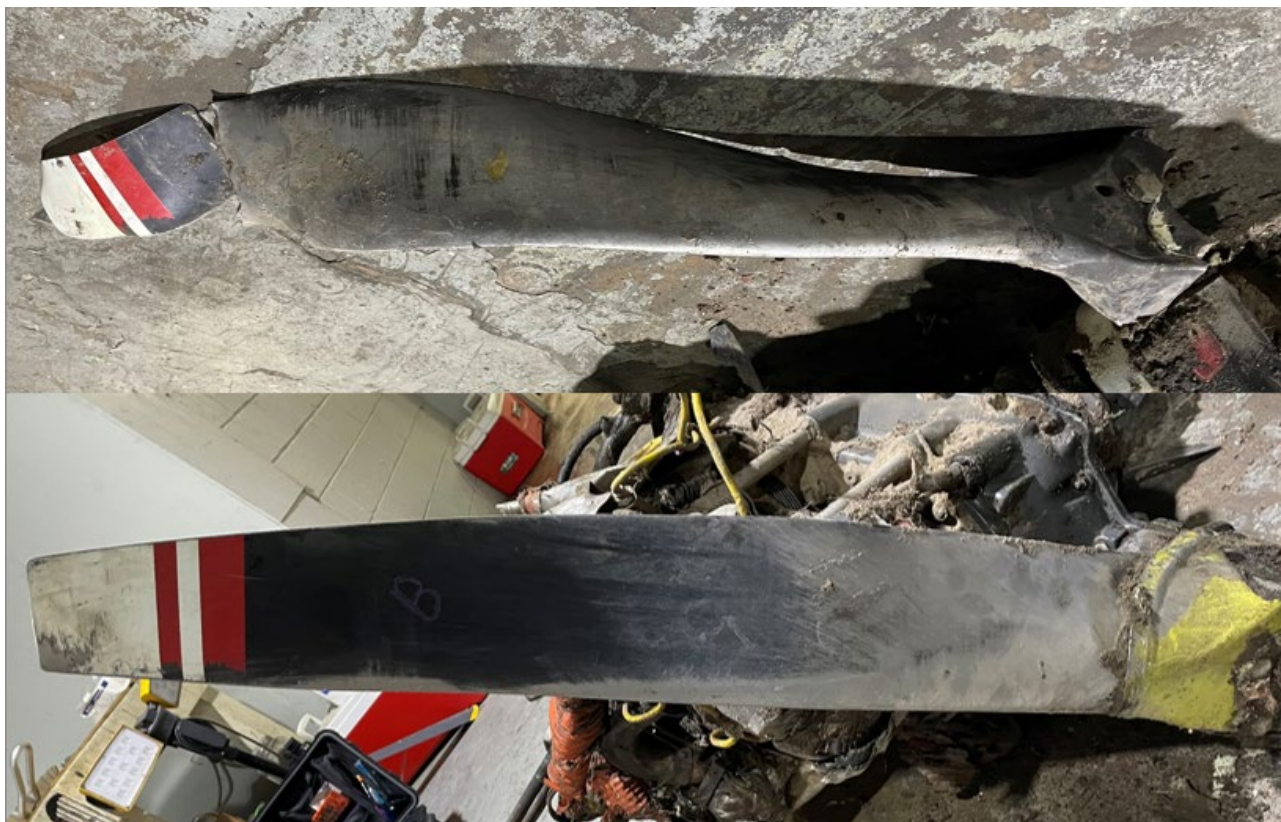
The airplane was equipped with a 2-blade, fixed pitch, McCauley propeller. Blade A was impact separated from the propeller hub and exhibited chordwise scratching, S-bending, and 6-inches of the propeller tip was torn from the blade and located about 30 ft from the main wreckage. Blade B remained attached to the propeller hub, it exhibited chordwise scratching and S-bending.

**Figure 22. View of propeller blades.**

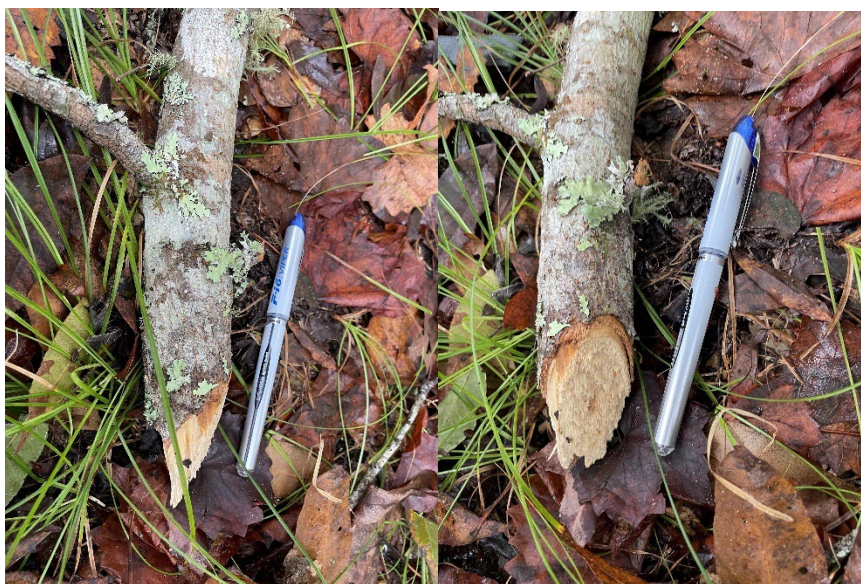
Furthermore, a branch that was about 2 inches in diameter was cut at a 45-degree angle.

**Figure 23. View of wood located near accident site.**
