# National Transportation Safety Board

ERA24FA050

## **MATERIALS LABORATORY**

Addendum Report 24-044B

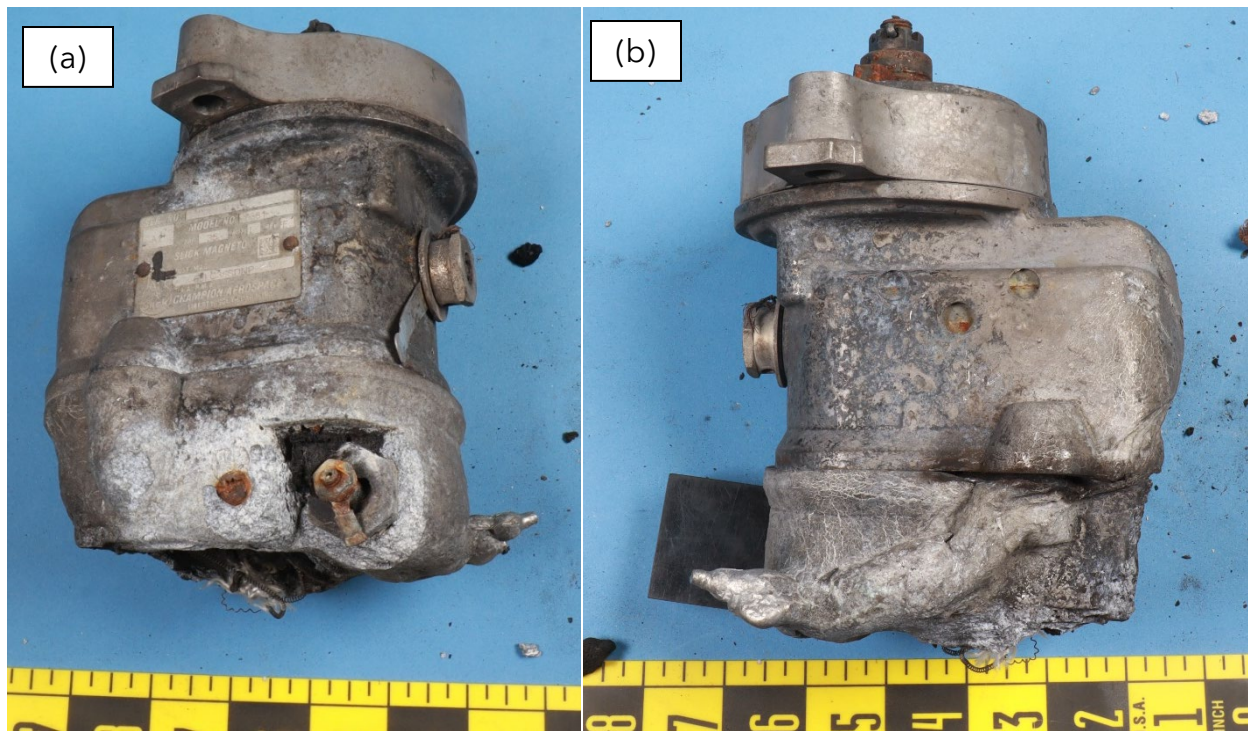
The magneto is shown from four sides in Figure 1 and Figure 2. The plate in Figure 1a stated:

These figures demonstrate the extent of exterior damage to the housing. The sides in Figure 1b and Figure 2b show flow and deformation on the housing, with small folds and lenticular wrinkles, consistent with high temperature exposure. The housing damage was most severe on the bottom side, shown in Figure 3. The housing exhibited a complete absence of material, forming a hole, with thin, white-colored edges. Black, carboniferous fragments readily fell out of the magneto interior when handled. These features were consistent with the component having been exposed to a fire.

Figure 1. Opposite views of the sides of the magneto assembly.

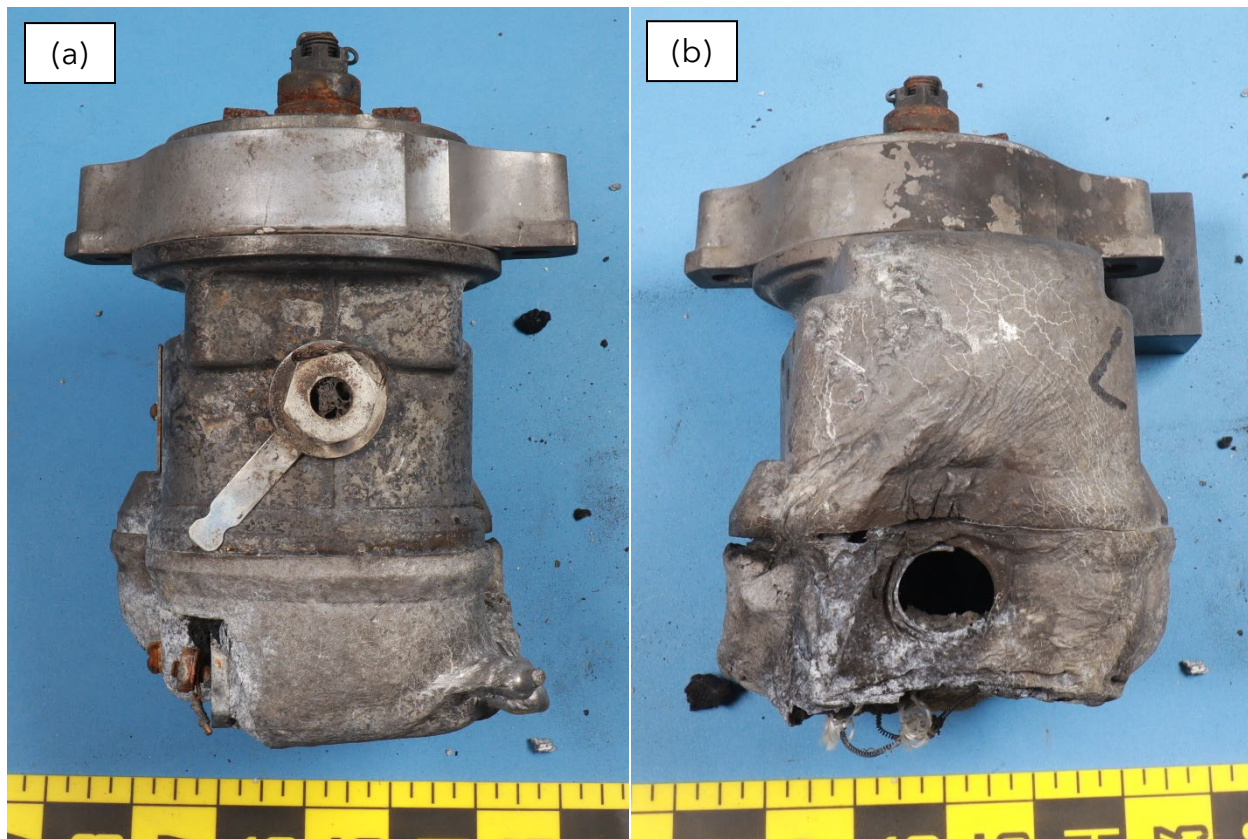
Figure 2. Opposite view of the sides 90° from those in Figure 1.

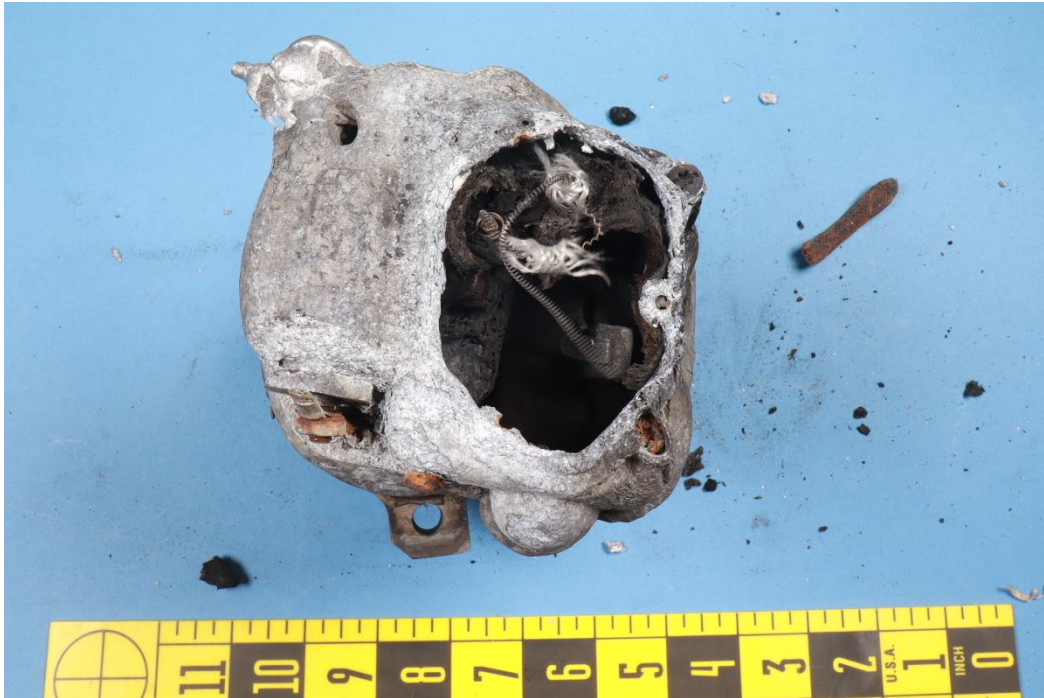
Figure 3. View of the missing area of the magneto housing, consistent with heat damage.

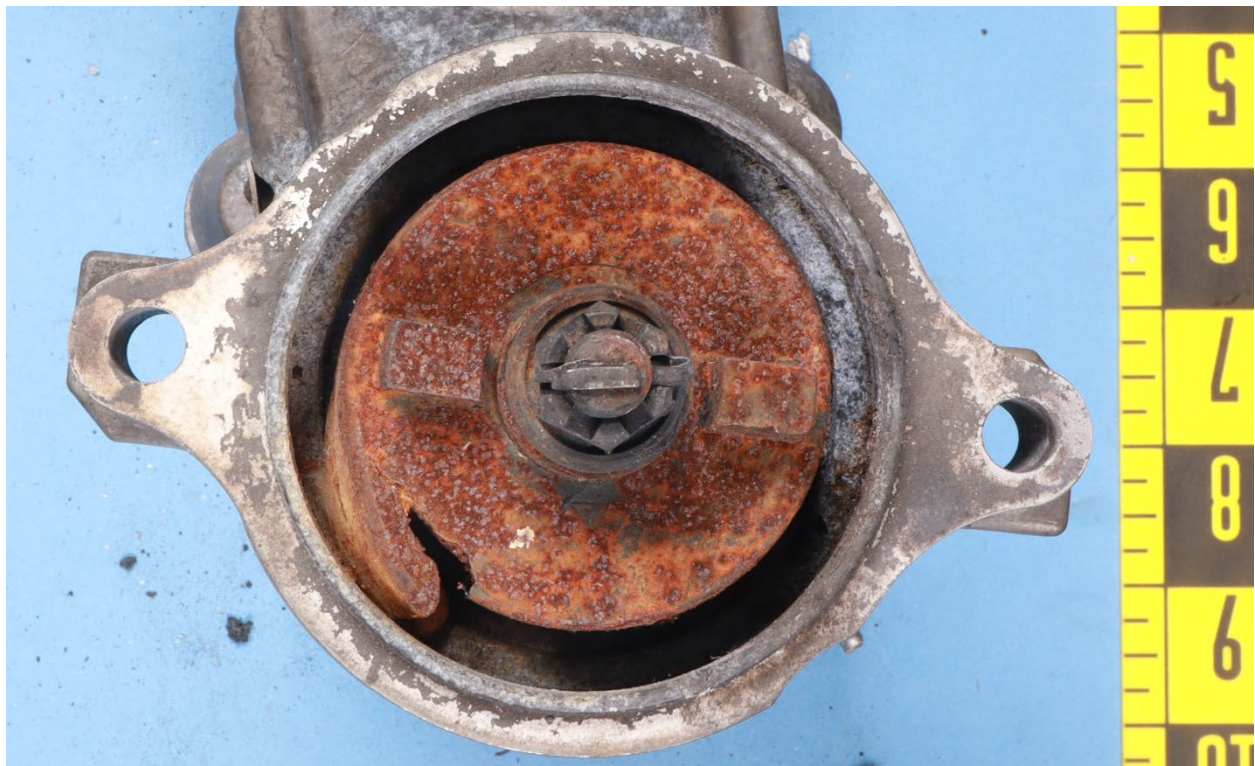
Figure 4 shows the opened end of the magneto, revealing the impulse hub assembly. The exterior-facing impulse shell, hub, nut, and cotter pin exhibited enough surface oxidation (i.e., rust) to form a mottled rough surface and obscure most underlying features. Of note on the shell was a crack and an outward tear in part of the skirt or flange on the left side of Figure 4.

Figure 4. View of the opened end of the magneto with the impulse hub assembly, showing the cracked impulse coupling shell.

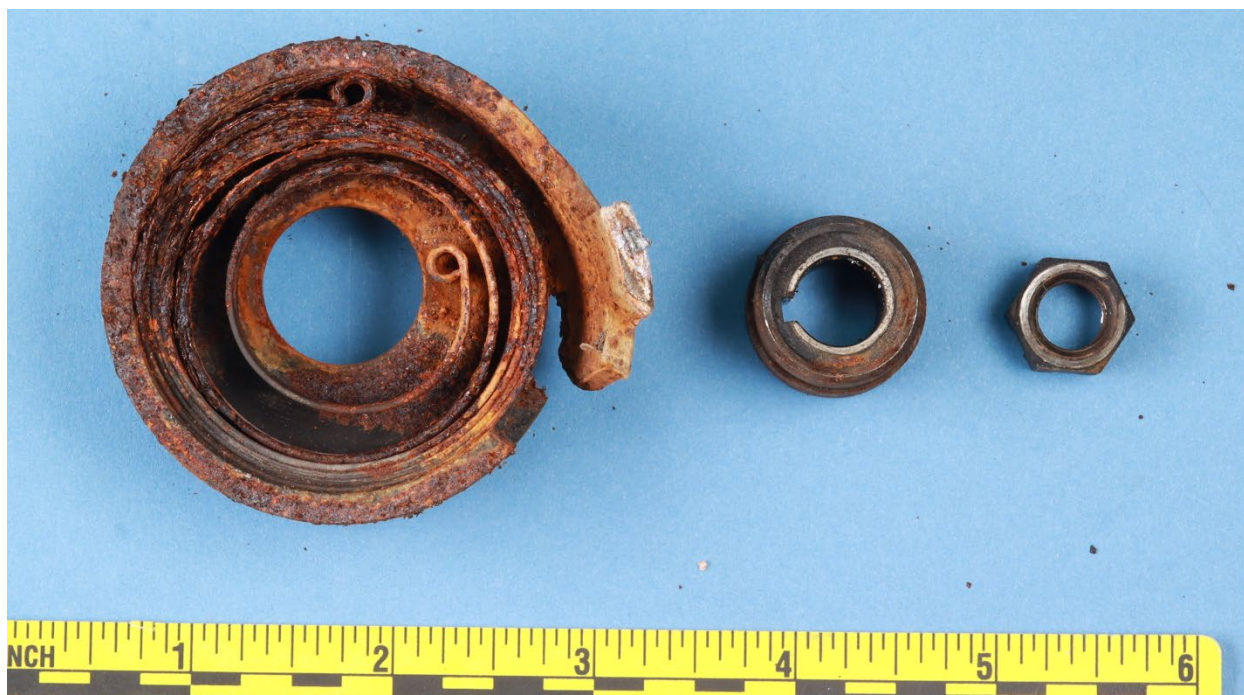
The cotter pin was removed, followed by the nut, hub, washer, and shell, revealing the underlying impulse hub assembly. The underside surfaces of the removed shell components are illustrated in Figure 5. The circular spring under the shell was affixed to both the shell interior and the other spring surfaces. The spring did not experience spring-back forces when actuated, consistent with being stress-relieved and annealed from exposure to high temperatures. There were no indications of any remaining greases or oils.

Figure 5. View of the underside of the impulse shell with coiled spring, the hub, and nut after disassembly.

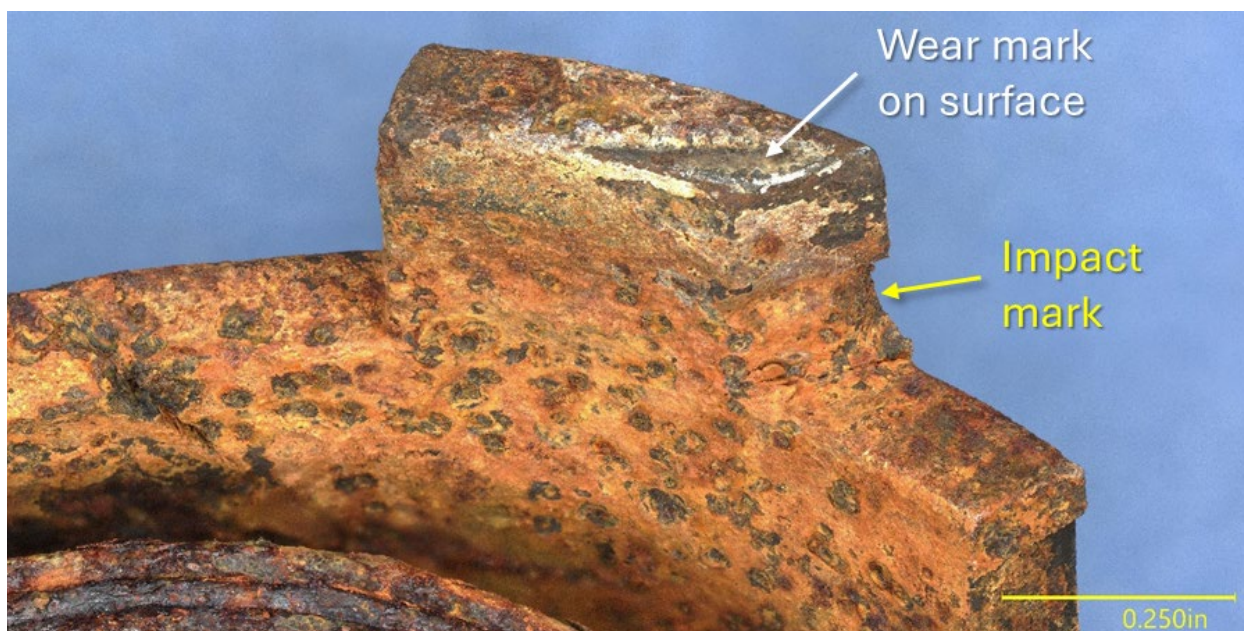
As shown in Figure 6, the boss protruding from the shell skirt exhibited a wear mark with smearing and an absence of corrosion product. In addition, there was also an impact mark and deformation at the edge of the boss, shown in Figure 6 and Figure 7. This edge contacted the stop pin, shown in Figure 8 and Figure 9. The portion of the skirt exhibited a crack and tear, as demonstrated in Figure 7. The region exhibited outward deformation at the tear, consistent with outward forces in this location.

Figure 6. View of the wear mark on the stop boss protruding from the impulse shell skirt.

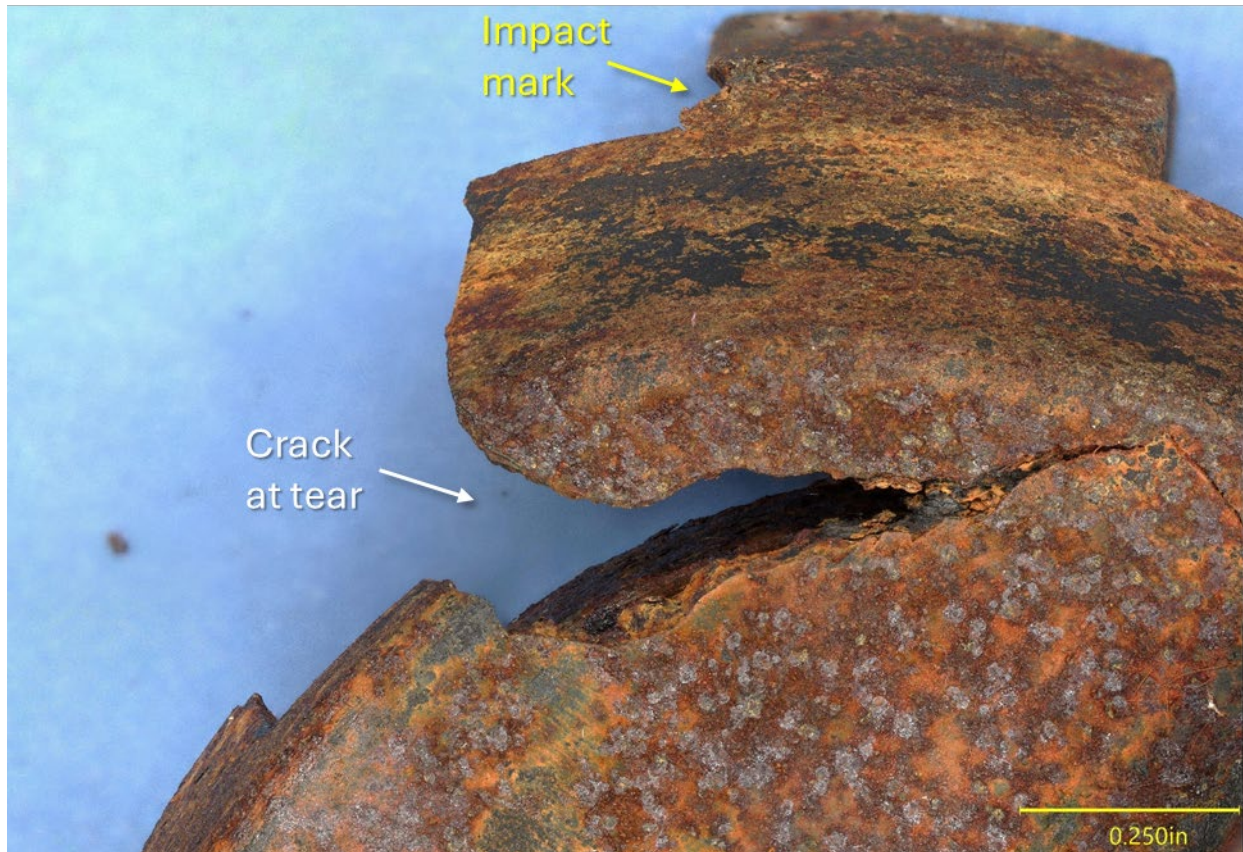
Figure 7. View of the surface opposite that in Figure 6, showing the tear and outward deformation of the skirt from the main body of the impulse shell.

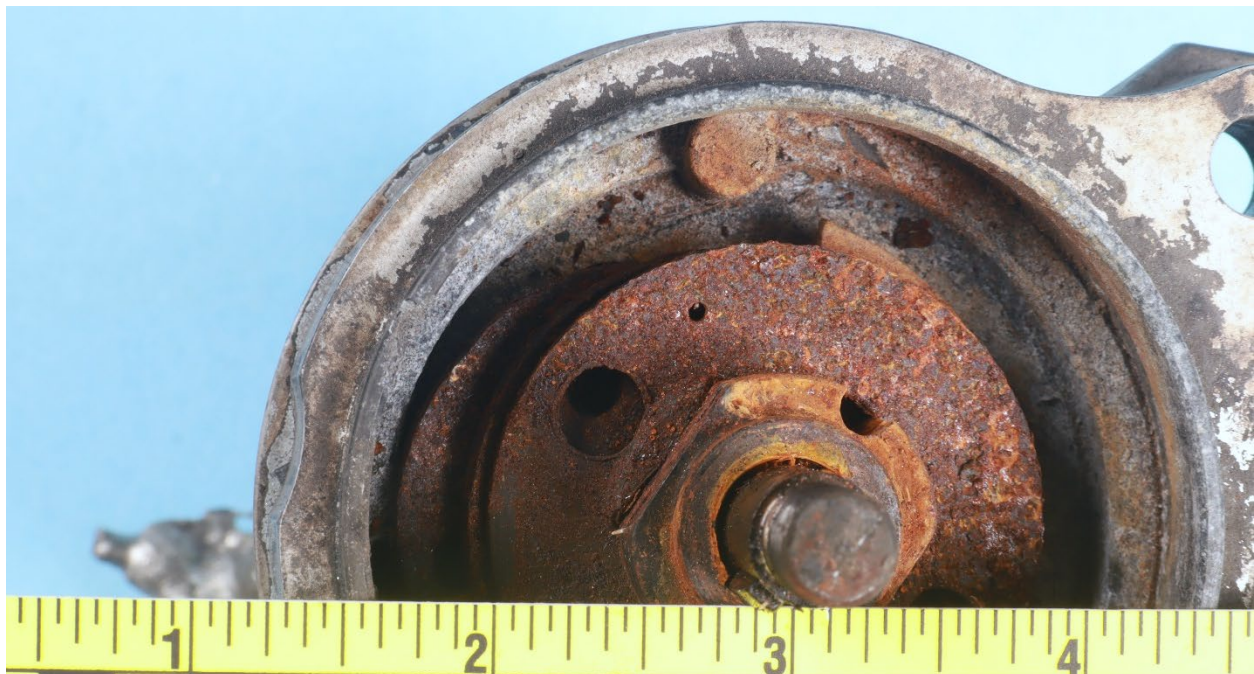
The stop pin shown in Figure 8 and Figure 9 exhibited corrosion and surface contamination over most surfaces, though to a lesser extent on the face and corner facing the impulse shell boss. The stop pin exhibited a cylindrical shape, with no indications of flattening on one side.

Figure 8. Closer view of the stop pin after impulse shell removal (and after rivets shown in Figure 9 had fallen out).

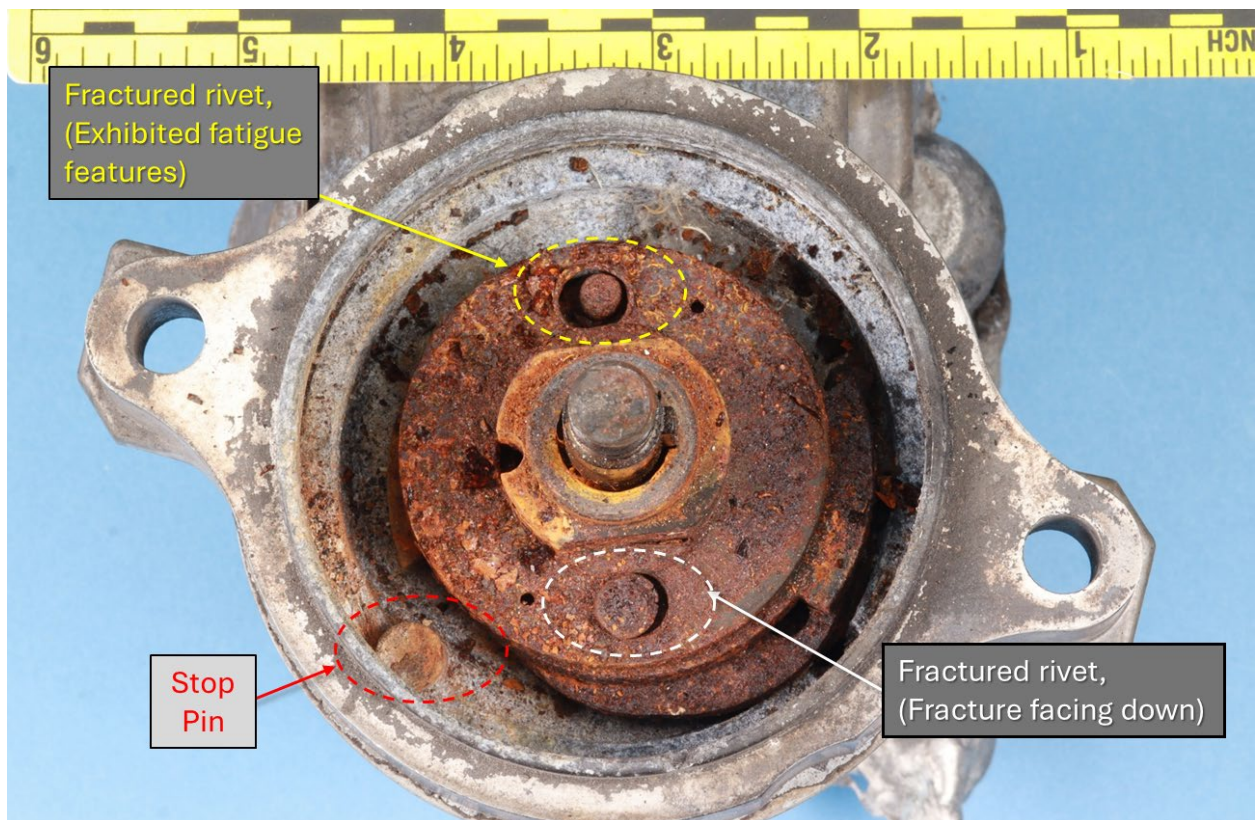
Figure 9 shows another view of the hub interior after removal of the shell, revealing two fractured rivets, which readily fell out when upended, and a stop, located in the same position as the tear on the impulse shell. Figure 10 shows the underlying impulse hub plate without the rivet remnants. The holes exhibited elongation and deformation about the edges. Figure 11 shows this end of the magneto after removal of the impulse coupling hub plate.

Figure 9. View of the underlying impulse hub assembly, after removal of the shell, nut, and washer.

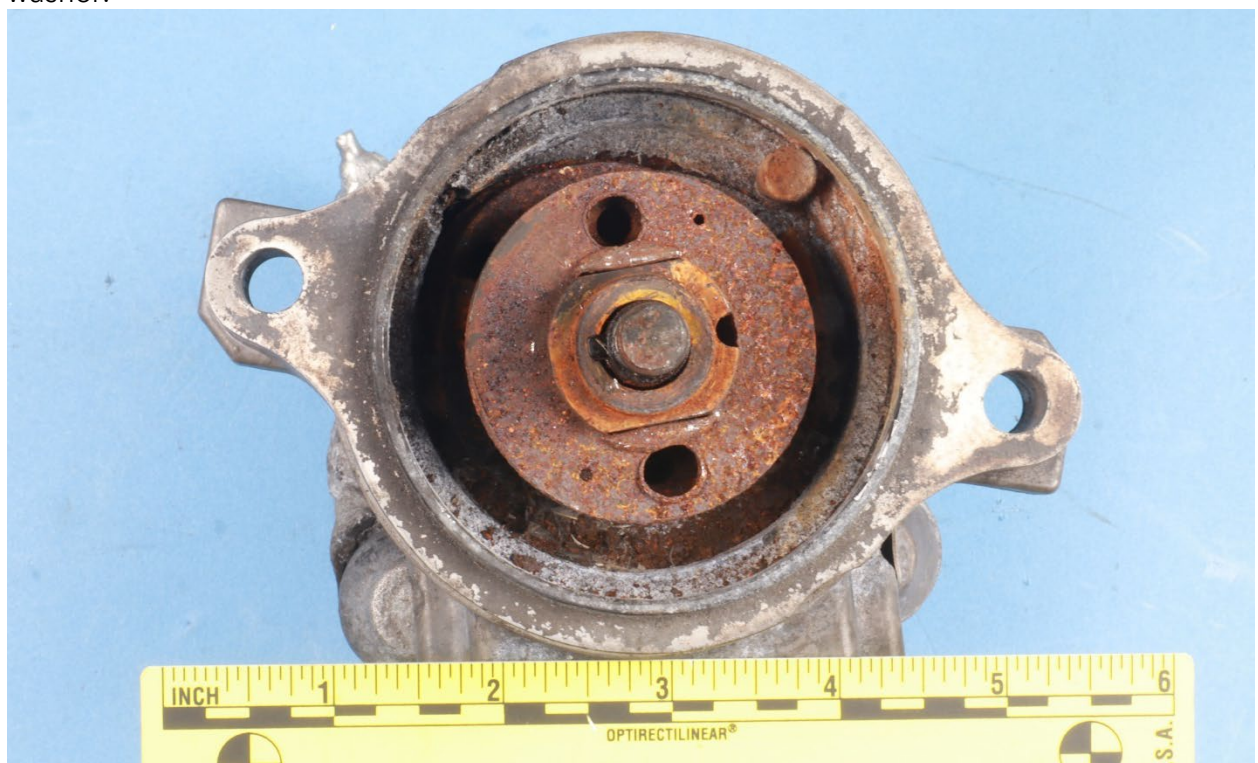
Figure 10. View of the impulse hub from Figure 9, after rivet removal, showing the widened rivet holes with deformation indications.

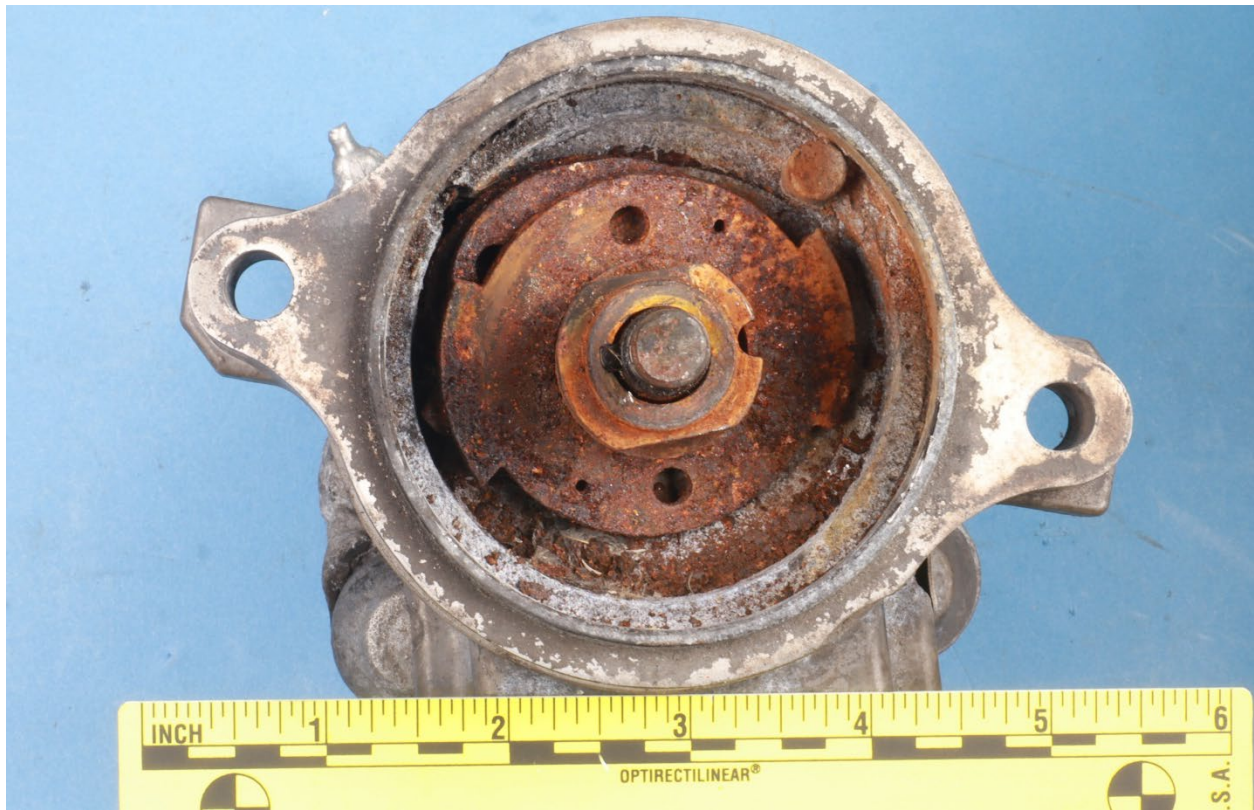
Figure 11. View of the underlying pawls under the key, after removal of the hub.

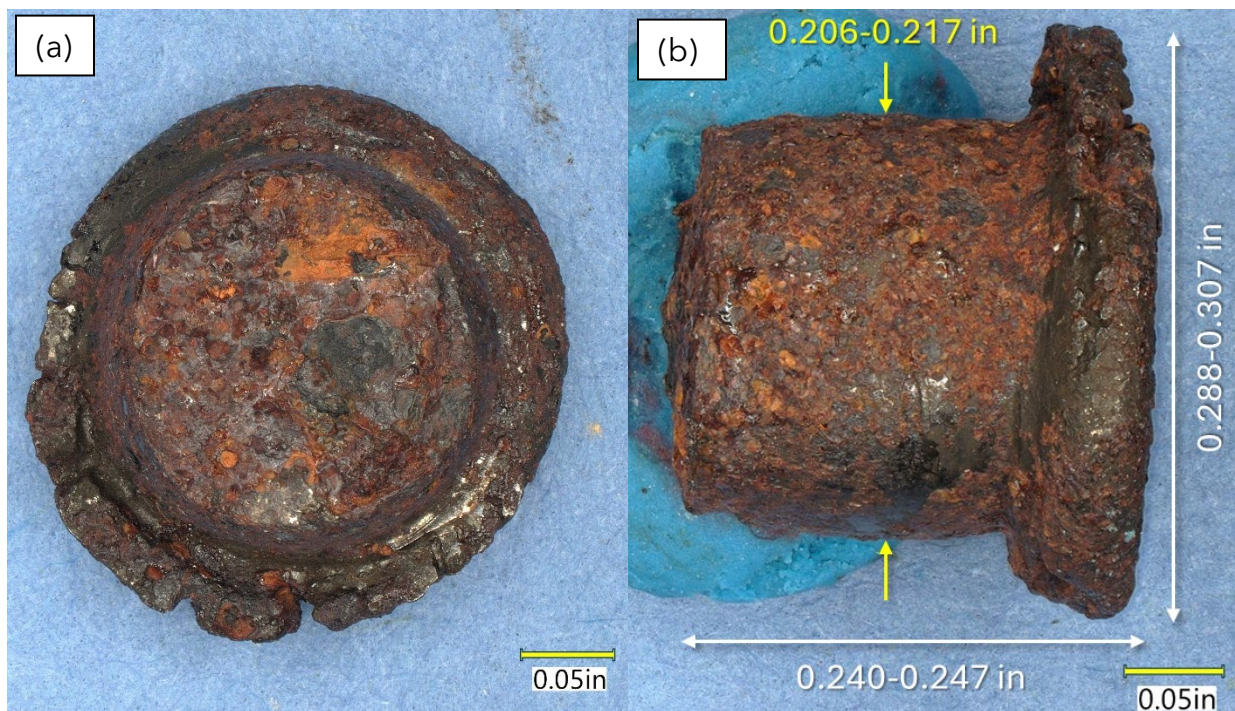
Figure 12 and Figure 13 show the rivet remnants in their condition after removal from the magneto. Like the other steel parts in this part of the assembly, the rivet remnants were heavily oxidized, and almost all the underlying features were obscured. The various dimensions of the rivet remnants were measured, as annotated in Figure 12 and Figure 13, and compiled in Table I.

Figure 12. The upward-facing rivet (located on the top of Figure 9) from (a) the fracture surface and (b) the side, as disassembled.

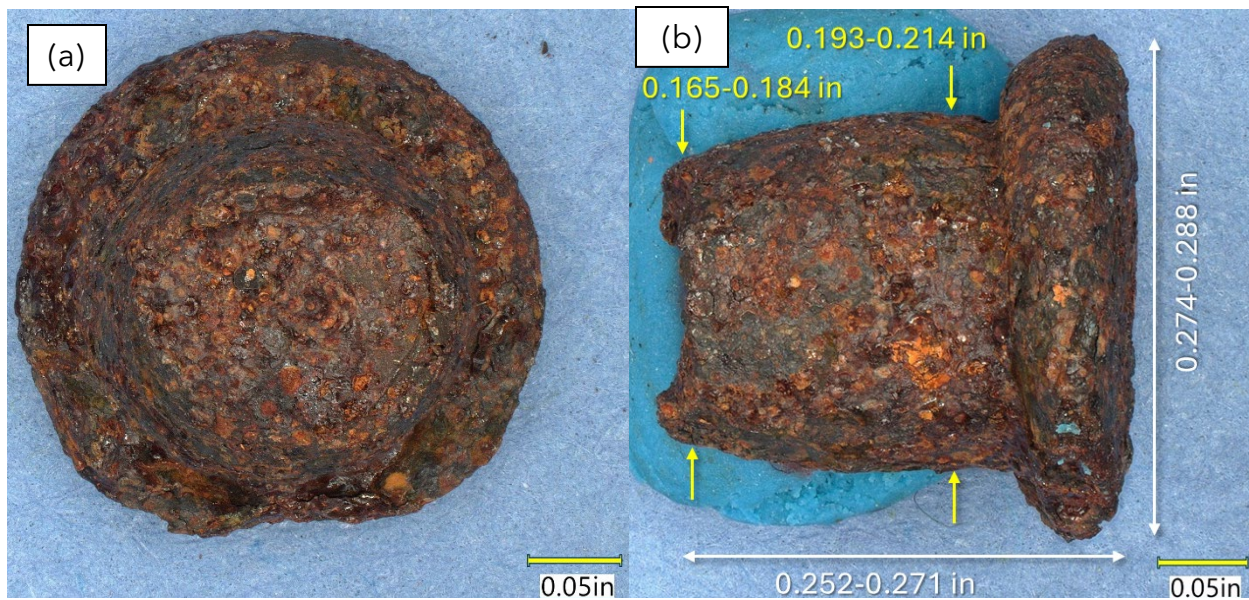
Figure 13. The downward-facing rivet (located on the bottom of Figure 9) from (a) the fracture surface and (b) the side, as disassembled.

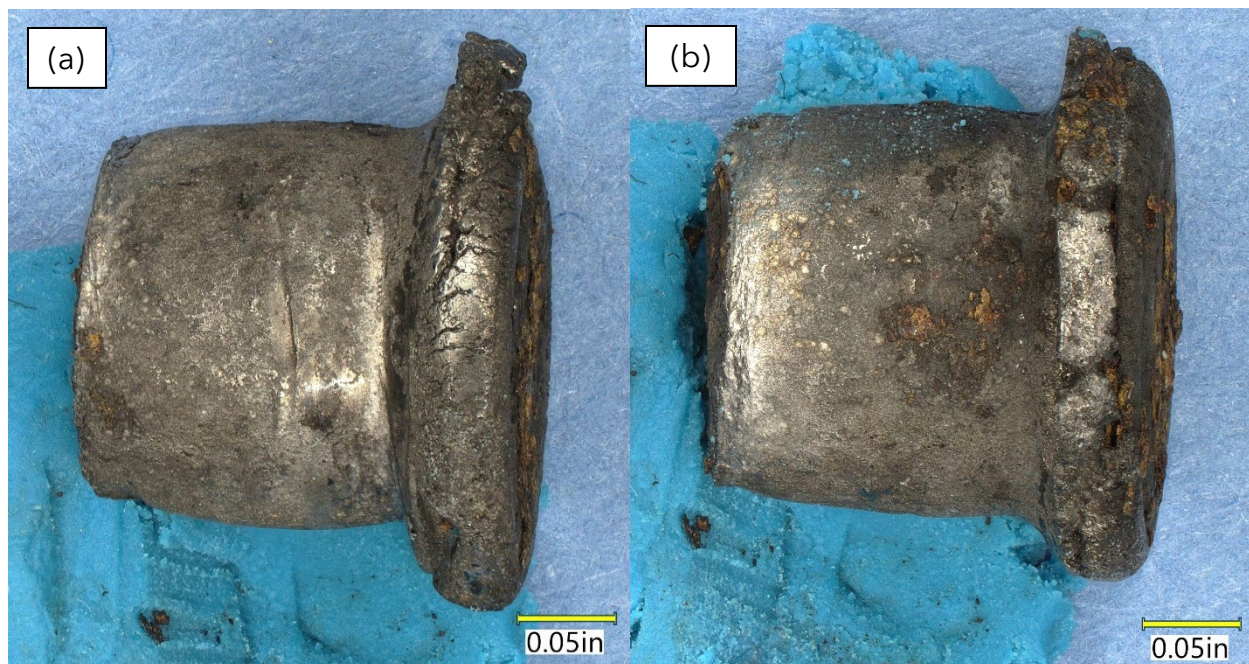
Figure 14 shows 180° views of the side of the downward-facing rivet remnant. This rivet exhibited a decrease in diameter near the fracture surface, consistent with necking deformation, and an area of outward protrusion on the fracture edge, shown in Figure 14b. There were also two parallel impact marks on the shaft, and an upward deflection of the head in the upper part of Figure 14a.

Figure 14. Side views of the downward-facing rivet, after removal of most of the surface rust.

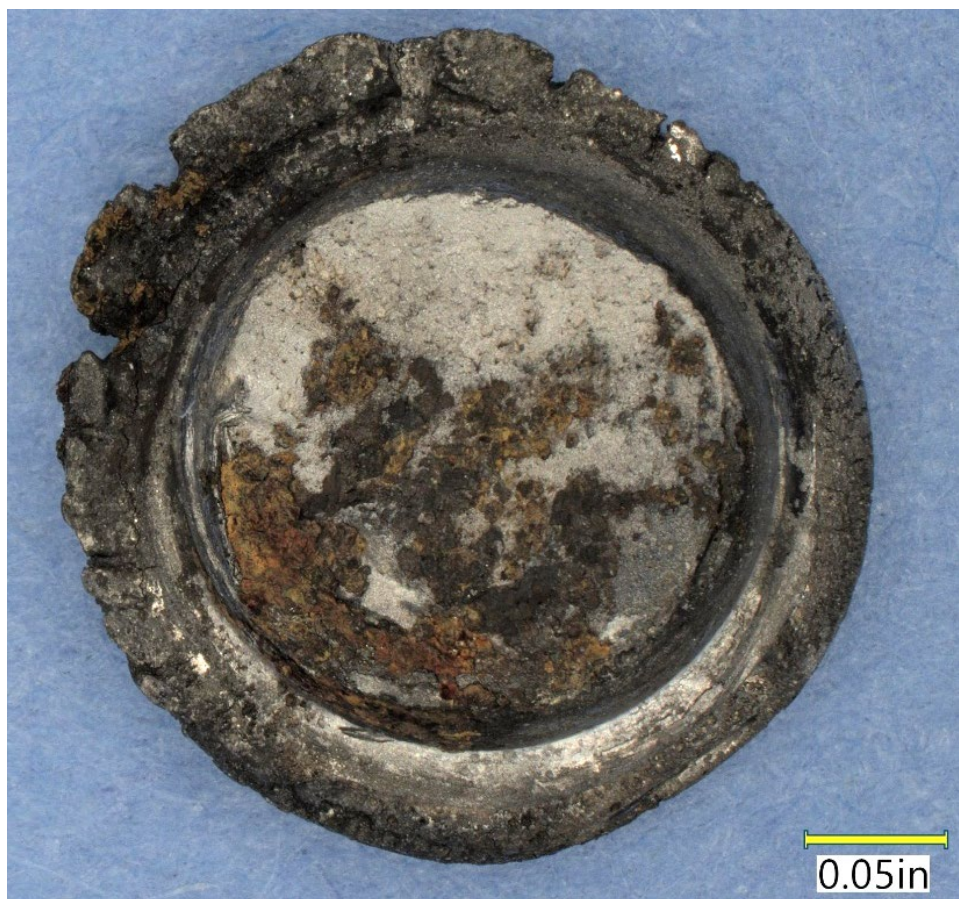
Figure 15 shows the fracture surface of the downward-facing rivet, after cleaning. While much of the surface was still visually obscured by surface oxidation, enough underlying fracture features could be observed. Overall, the surface exhibited a rough texture with a dull, matted luster. Closer examination of the surface using a field emission scanning electron microscope (SEM) showed dimpled rupture features, consistent with overstress (Figure 16). While there were also pock-marked features on the surface (an artifact of the cleaning process), the actual dimple features were locally parallel in direction, as illustrated in Figure 17. The patterns of the slanted dimpled rupture show a curving upward direction on part of the fracture, as shown in Figure 16. These features were consistent with loading in torsion and shear.

Figure 15. View of the fracture surface of the downward-facing rivet, after removal of most of the surface contamination.

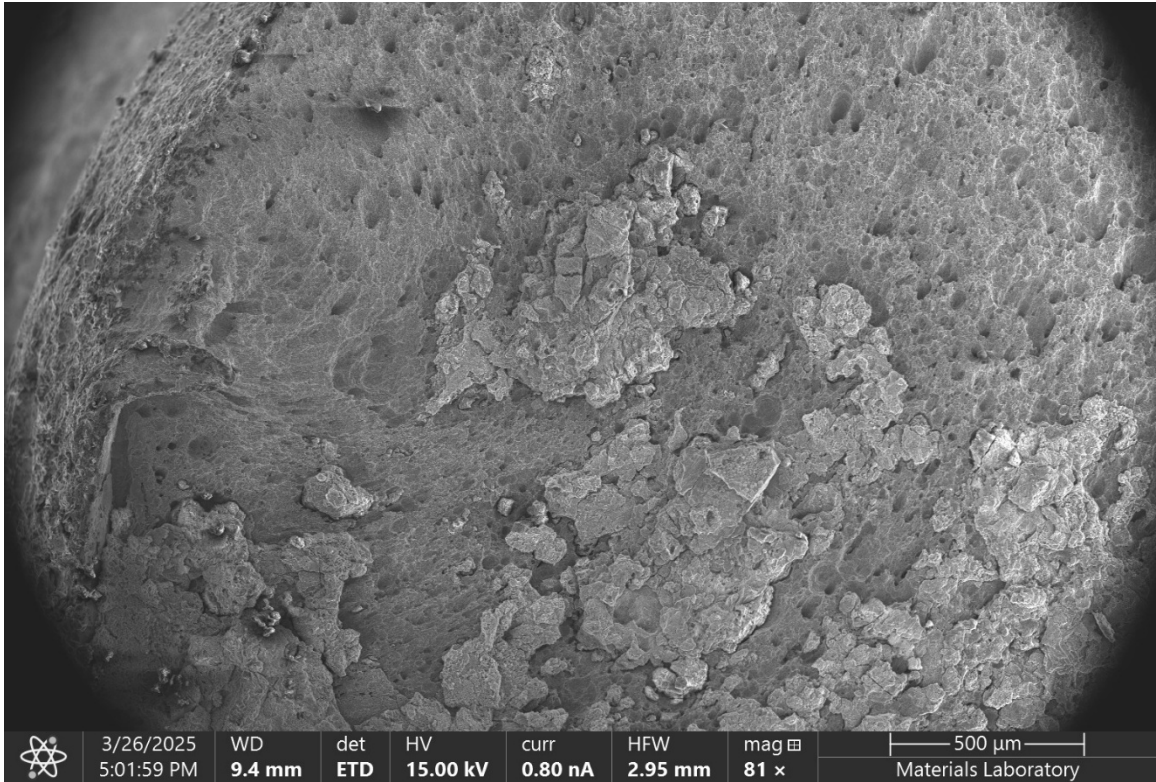
Figure 16. Secondary electron (SE) micrograph of a portion of the fracture surface in Figure 15, showing slanted dimpled rupture in different directions.

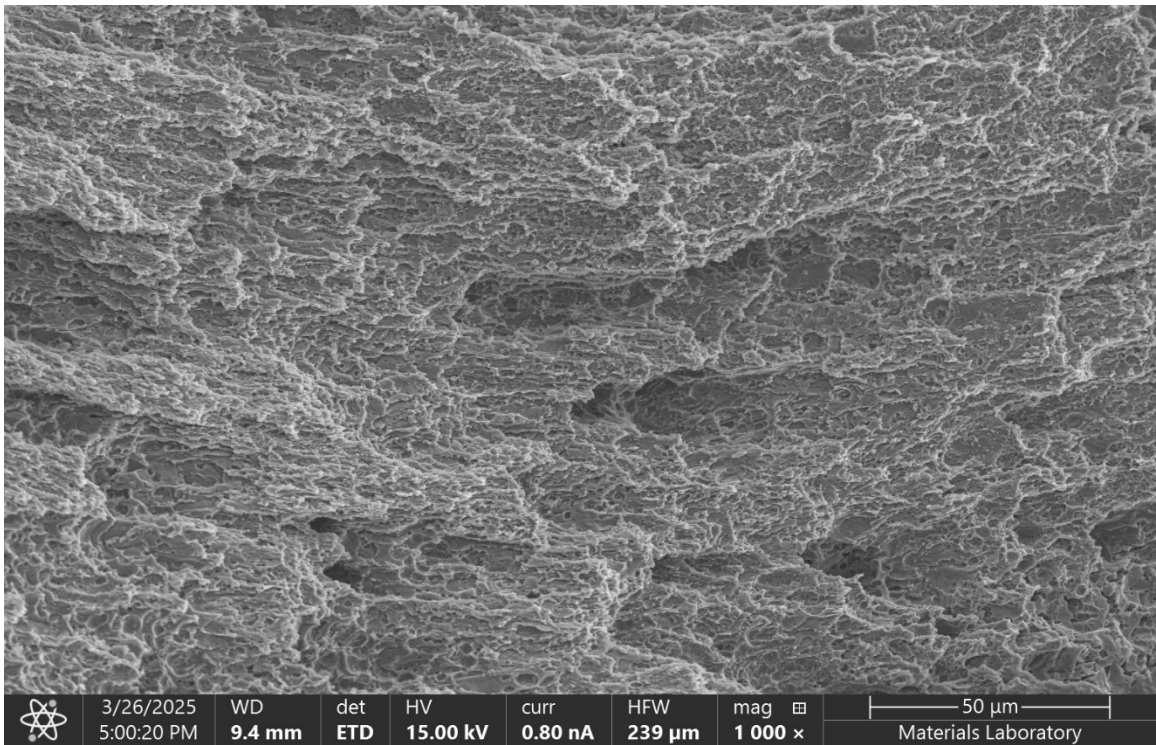
Figure 17. SE micrograph of slanted dimpled rupture in Figure 16.

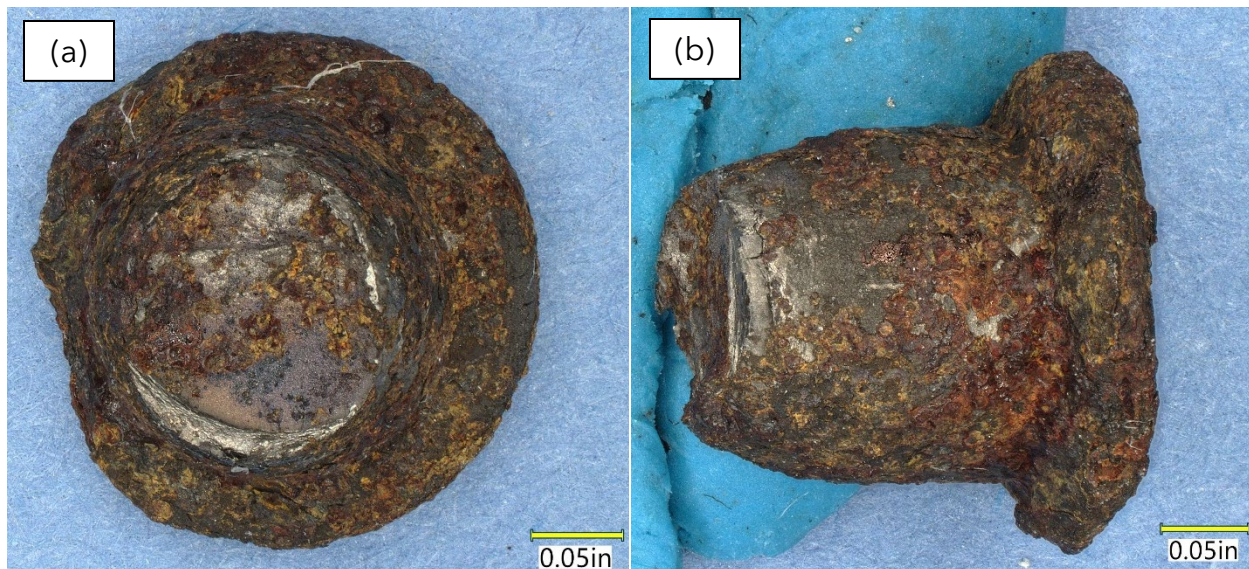
Figure 18 and Figure 19 show the upward-facing rivet remnant after cleaning. This fracture surface exhibited a flat, tan-colored, half-moon-shaped area, surrounded by areas of lighter, more reflective metallic color. On the upper and lower edges shown in Figure 18a and Figure 19, these areas exhibited erratically oriented lines and material loss, consistent with wear.

Figure 18. Fracture surface and side views of the upward-facing rivet, after removal of much of the surface contamination.

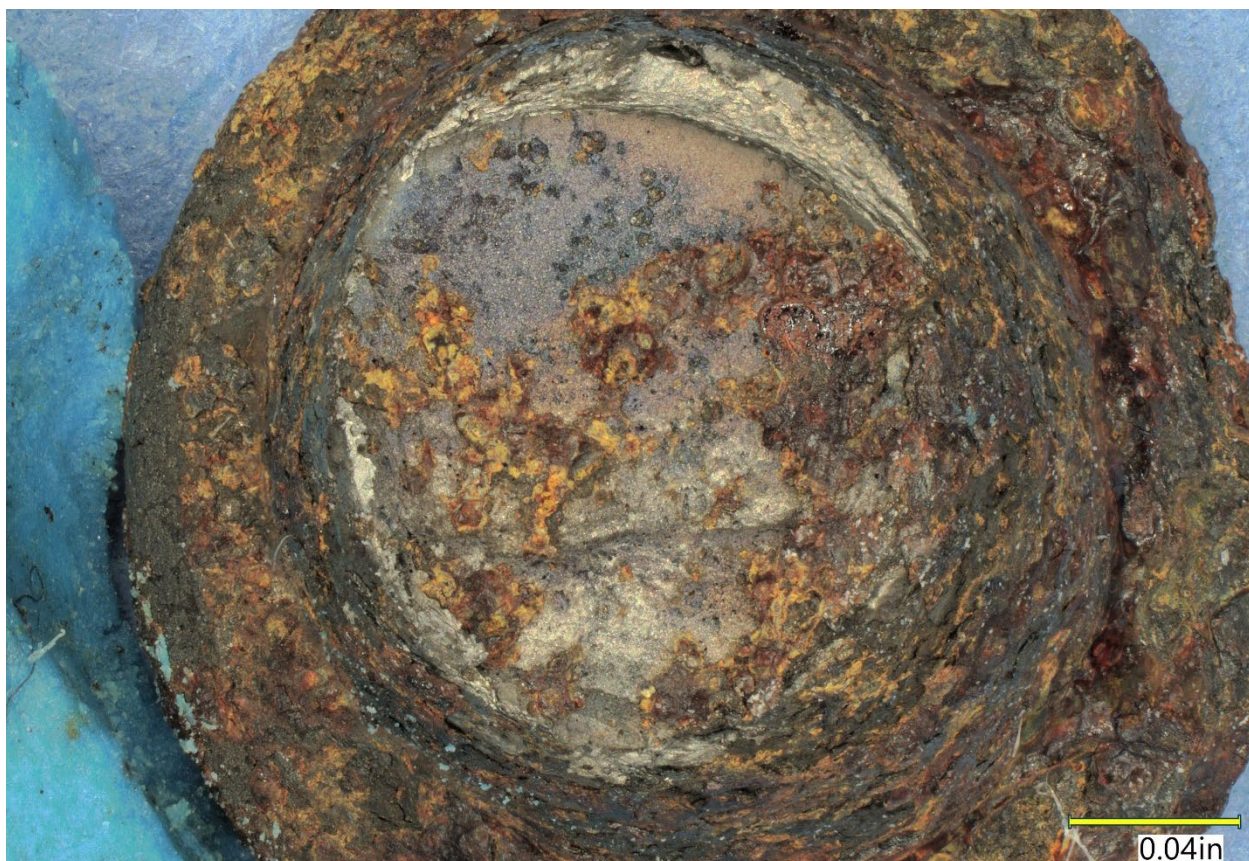
A closer view of the upper edge in Figure 19 showed areas with linear marks perpendicular to the edge, consistent with ratchet marks. Figure 20 shows this edge as viewed using a SEM, with Figure 21 depicting a closer view of two of these ratchet marks, created when propagating cracks coalesce, indicative of multiple crack initiation sites. A closer view of the fracture features in this area, illustrated in Figure 22, revealed the remainder of parallel striations, consistent with fatigue crack propagation. Further away from the edge of the fracture surface, the fracture features transitioned to dimpled rupture, as shown in Figure 23.

Figure 19. Closer view of the upward-facing rivet fracture surface, showing areas of wear and a flat, discolored portion of the fracture surface.

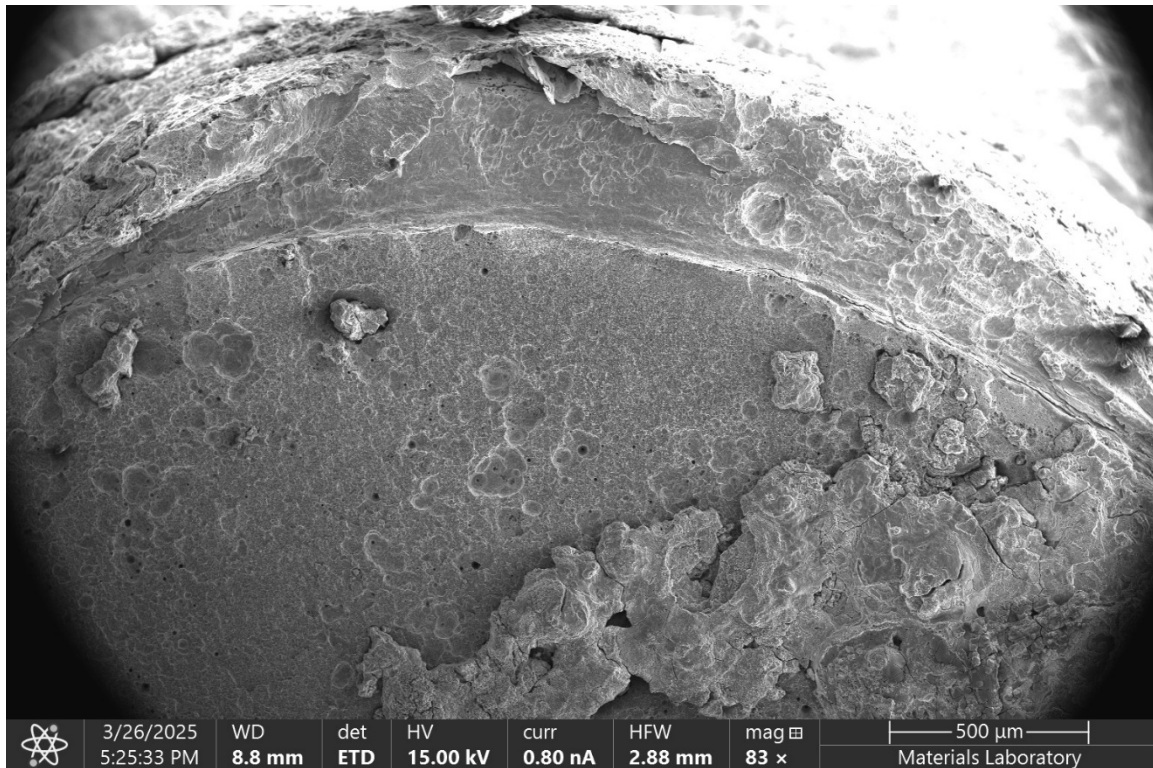
Figure 20. SE micrograph of the upper edge of the fracture surface in Figure 19.

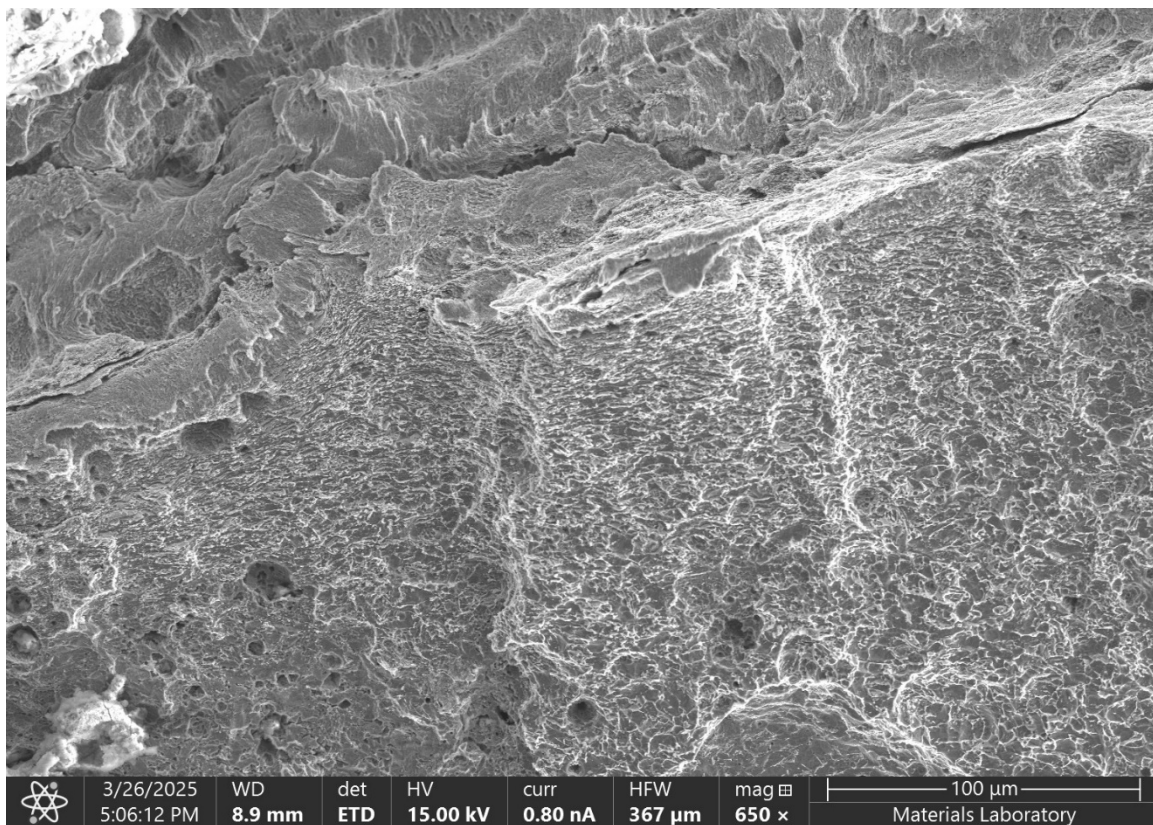
Figure 21. SE micrograph of a closer area of the ratchet mark features in Figure 20.

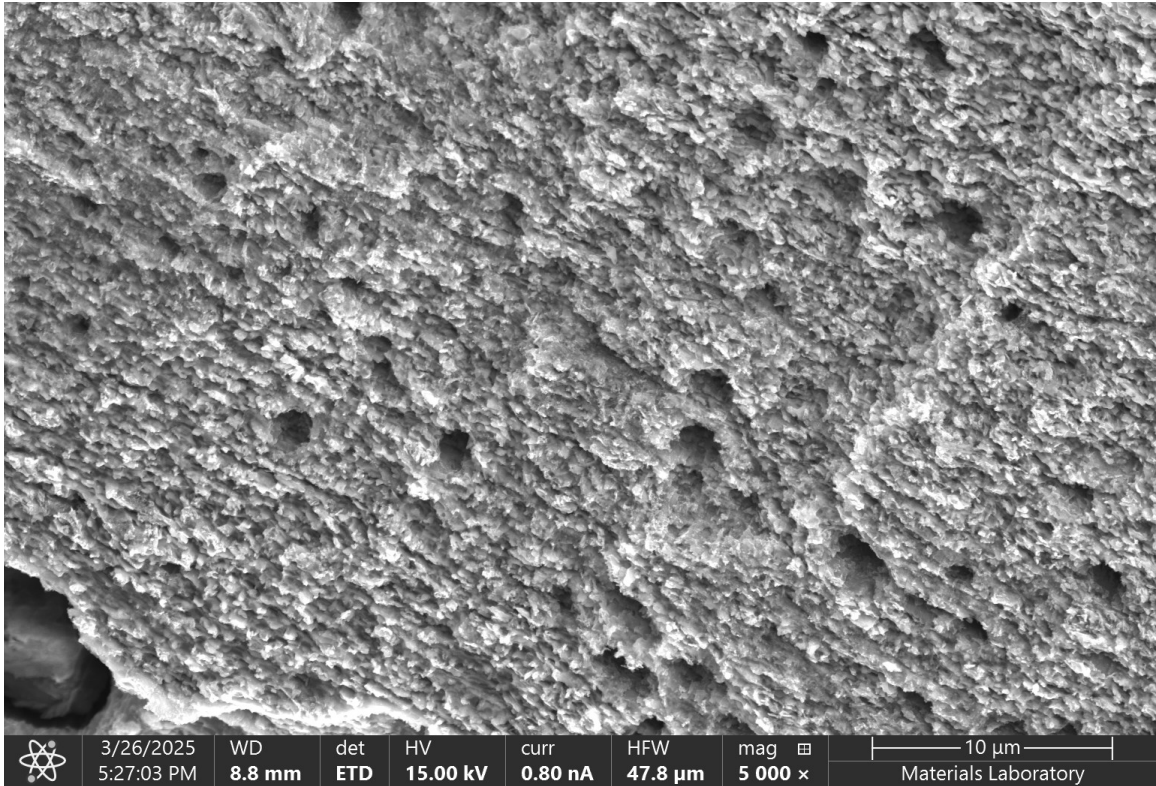
Energy dispersive x-ray spectroscopy (EDS) examination of the cleaned areas of the rivet remnants found their chemical compositions consistent with plain carbon steel. These features were consistent with fatigue cracking initiating at areas of wear on the outer surface of the upward-facing rivet shaft. This rivet was located away from the stop pin. Once the cracking had propagated deep enough, this rivet fractured completely. The opposite rivet fractured from torsional and shear overstress. The impulse shell impacted the stop with enough force to create impact marks and partially tear the flange of the shell in this area.

Figure 22. SE micrograph of striation remnants near the fracture surface edge of the upward-facing rivet.
