# National Transportation Safety Board

ERA24FA050

## **MATERIALS LABORATORY**

Addendum Report 24-044B

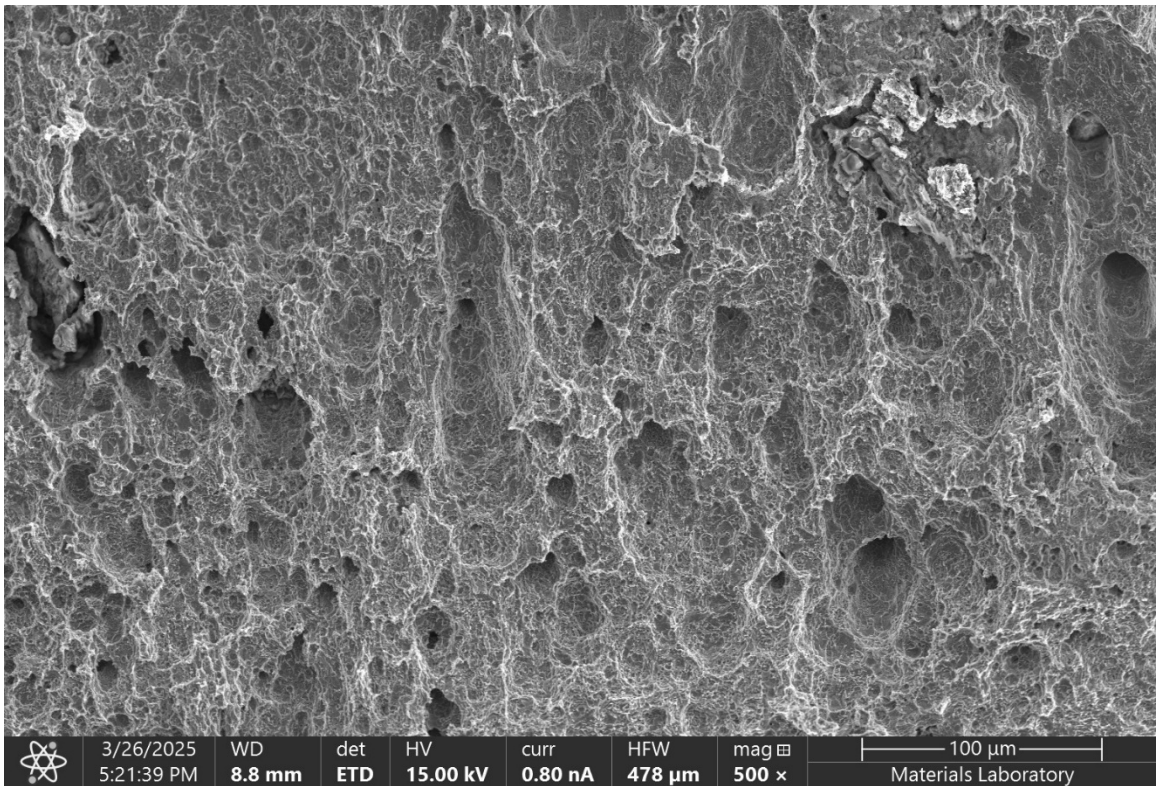
A closer view of the upper edge in Figure 19 showed areas with linear marks perpendicular to the edge, consistent with ratchet marks. Figure 20 shows this edge as viewed using a SEM, with Figure 21 depicting a closer view of two of these ratchet marks, created when propagating cracks coalesce, indicative of multiple crack initiation sites. A closer view of the fracture features in this area, illustrated in Figure 22, revealed the remainder of parallel striations, consistent with fatigue crack propagation. Further away from the edge of the fracture surface, the fracture features transitioned to dimpled rupture, as shown in Figure 23.

Figure 23. SE micrograph of dimpled rupture on the fracture surface away from the edge.
