# National Transportation Safety Board

ERA24FA050

## **MATERIALS LABORATORY**

Factual Report 24-044

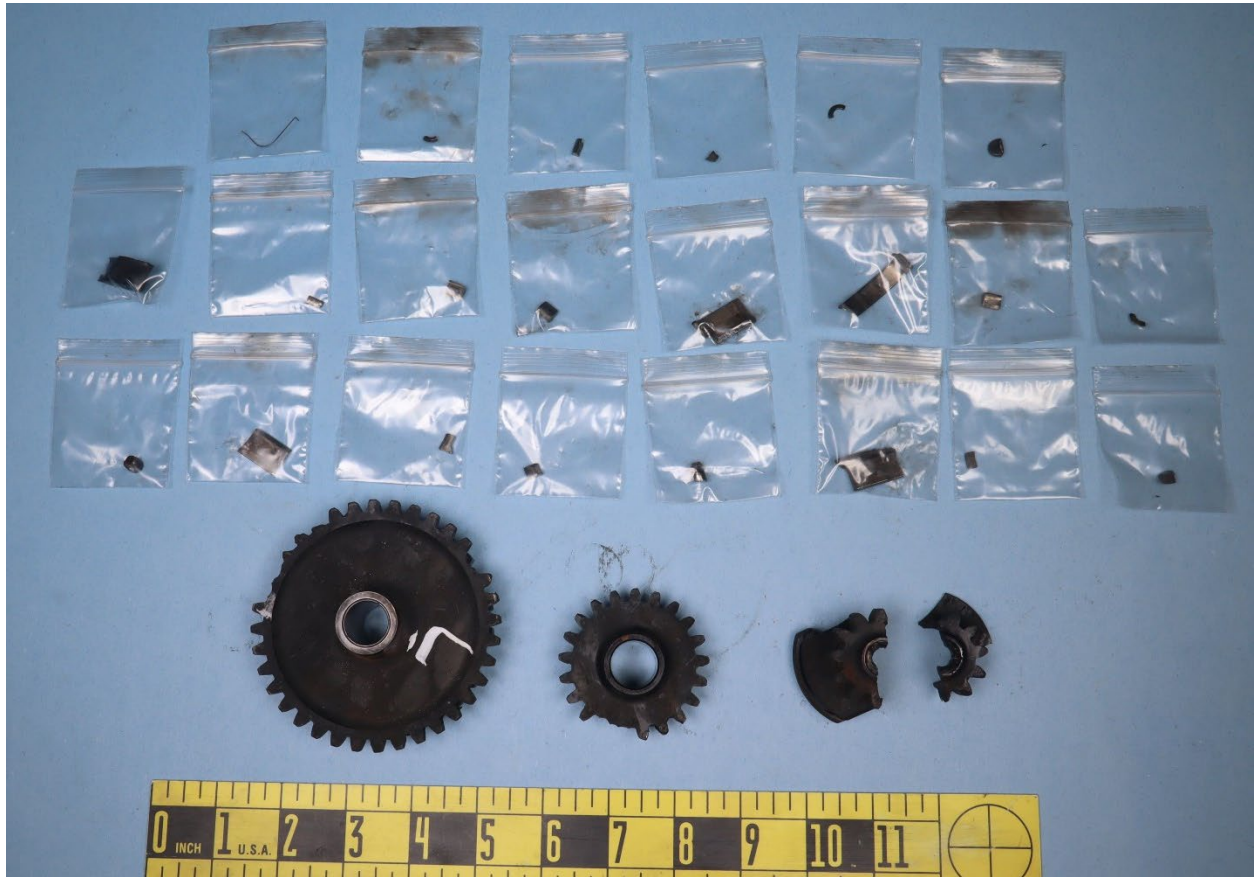
Figure 1 shows the gear and separated components, placed in individual bags, as received. The gears were labeled separately from the fractured remnants of gear teeth, flanges, and the rivet remnants. The remnants were submitted individually in separate plastic bags.

**Figure 1.** The pieces submitted from the accident, including the fuel pump idler gear, left crankshaft idler gear, left magneto gear, and multiple loose gear teeth and debris in individual bags.

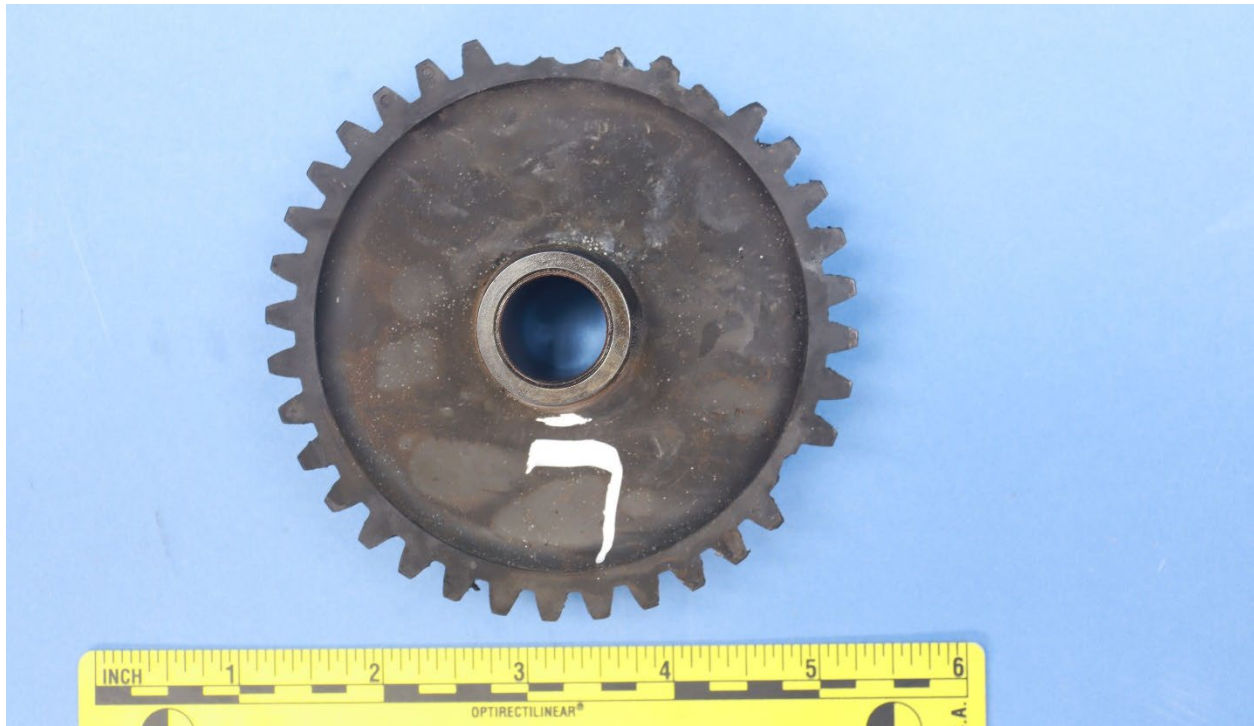
The remainder of the left crankshaft idler gear is shown from the forward and aft faces in Figure 2 and Figure 3. This part was a combination gear, with a larger gear on the side facing the reader in Figure 2. From this view, there were three entirely fractured teeth—two at the 12 o'clock position and one entirely fractured tooth at the 4 o'clock position. There were also three partially missing teeth clockwise from the top fractured tooth. None of the teeth from the smaller gear had fractured.

**Figure 2.** The marked face of the left crankshaft idler gear, as received.

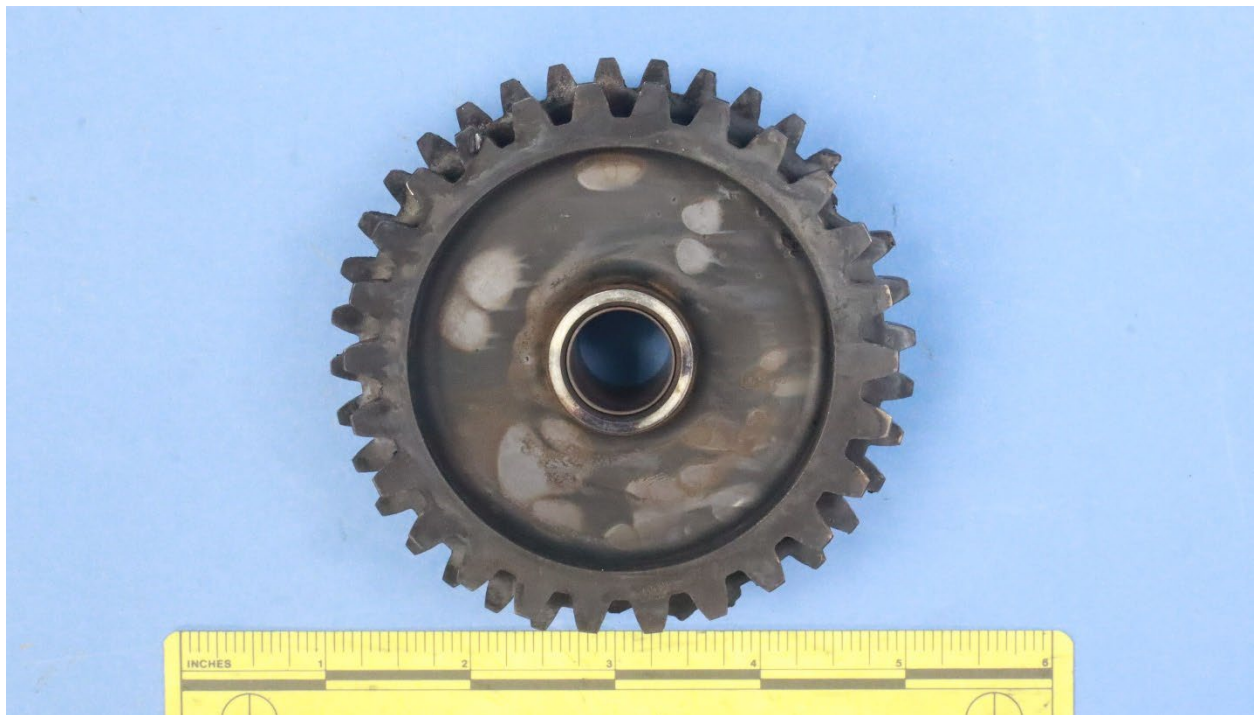
Figure 3 and Figure 4 show the fractured teeth surfaces as received. In each of these, the fracture surfaces exhibited the same color and hue as the surrounding regions. There were three additional damaged or partially fractured teeth adjacent to the two fractured teeth along the clockwise direction (Figure 5). The degree of damage decreased in the clockwise direction. The teeth surrounding the lone fractured tooth from the 4 o'clock position exhibited small impact marks, evidenced by some plastic deformation. However, there was no missing material or partial fractures.

**Figure 3.** The left crankshaft idler gear viewed opposite from **Figure 2**.

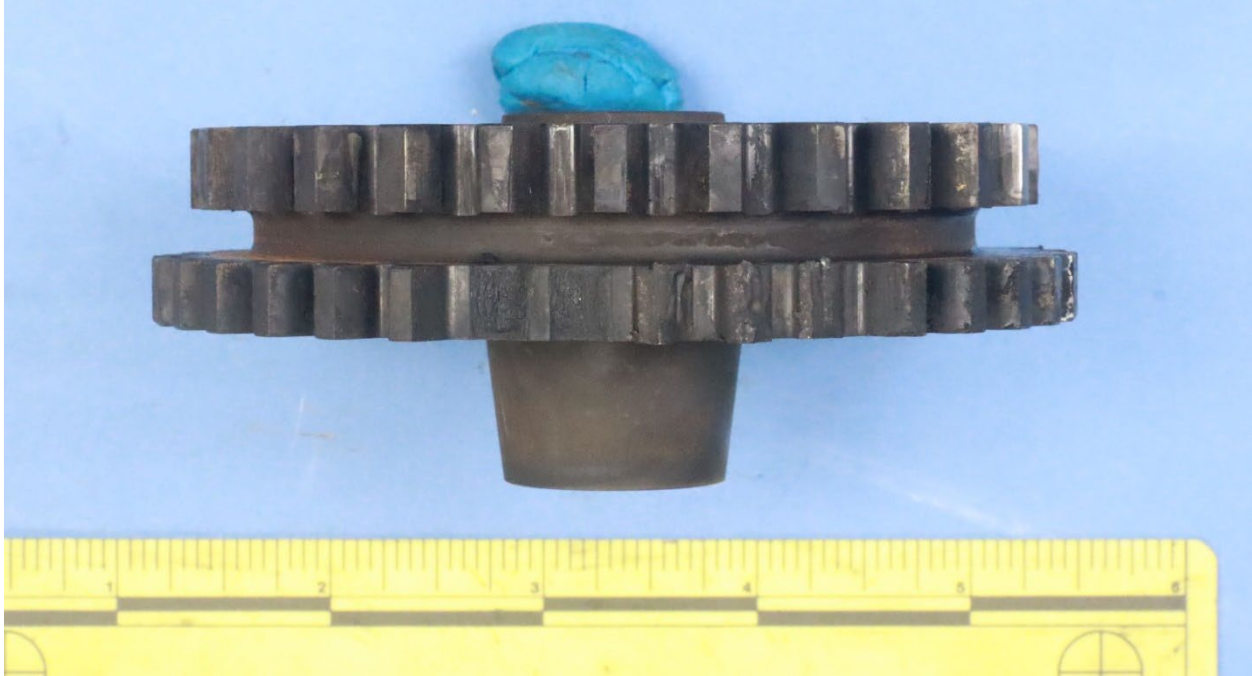
**Figure 4.** View of the two fractured teeth at the 12 o'clock position on the crankshaft idler gear as clocked in figure 2.

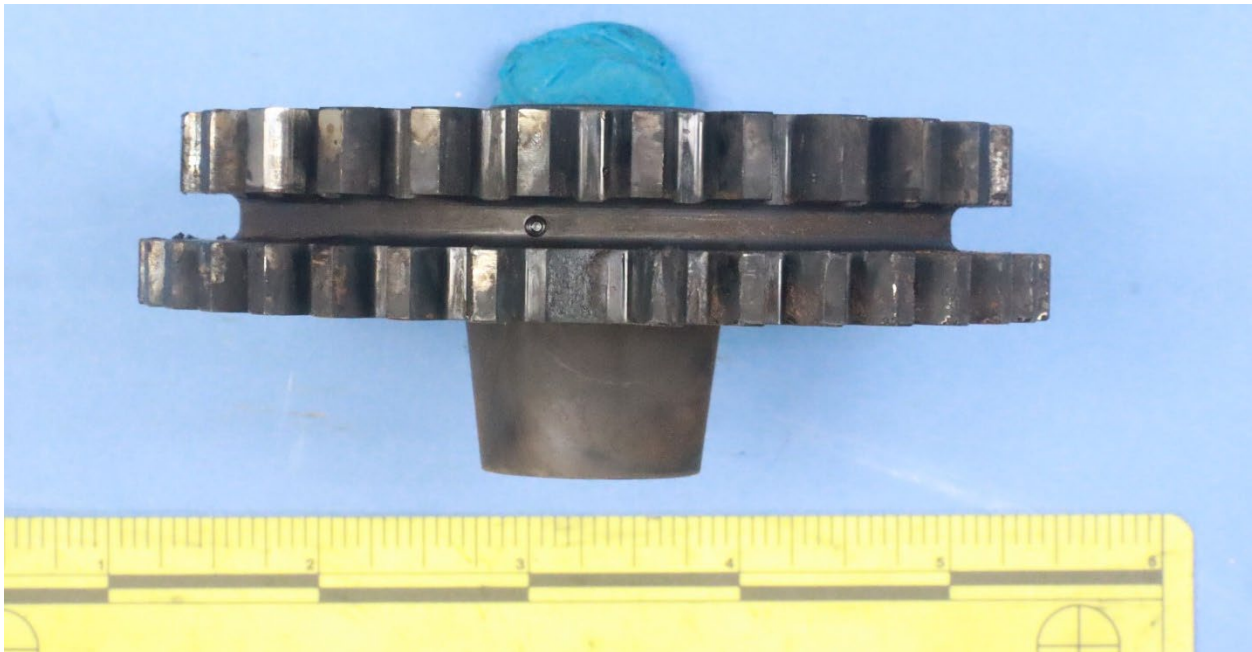
**Figure 5.** The fractured tooth on the crankshaft idler gear approximately 120° from the fractures in **Figure 4**.

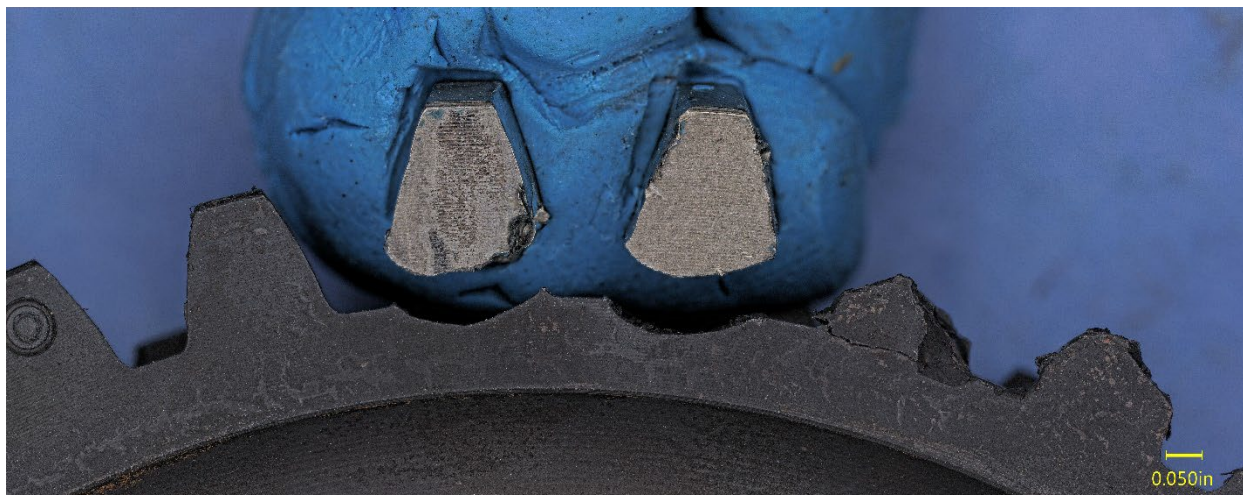
The fractured and liberated teeth were examined and were matched with their respective fracture locations on the gear. Figure 6 shows the locations of the fractured teeth near the gear viewed from the aft side. The mating fracture surfaces are shown closer in Figure 7 through Figure 9. As demonstrated in Figure 6, the gear fractures were oriented convex inboard. The fracture surfaces were generally rough and fibrous in texture, with a dull luster. The liberated teeth exhibited a lighter and more metallic hue than the gear, which was darker in color.

**Figure 6.** View of the two fractured teeth from the idler gear, positioned near their respective fracture locations.

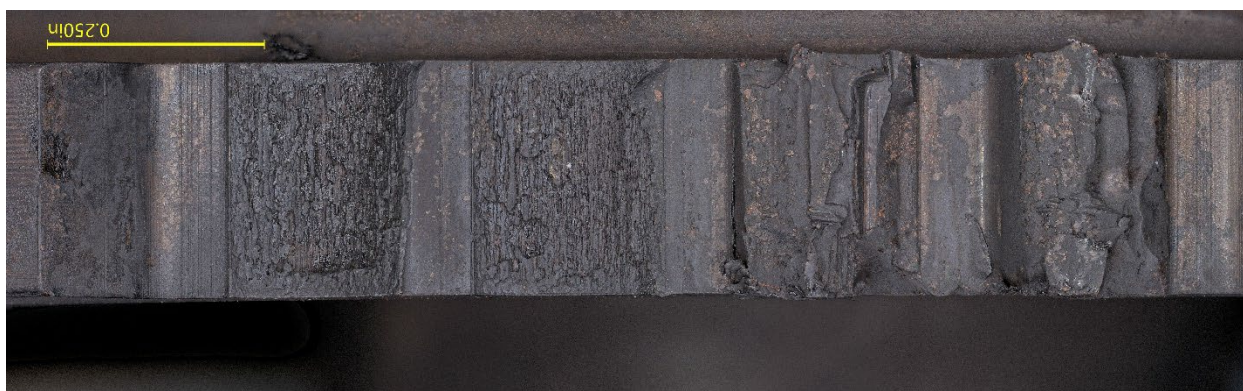
**Figure 7.** View of the fractured teeth surfaces in **Figure 6**, showing the adjacent damaged teeth remnants.

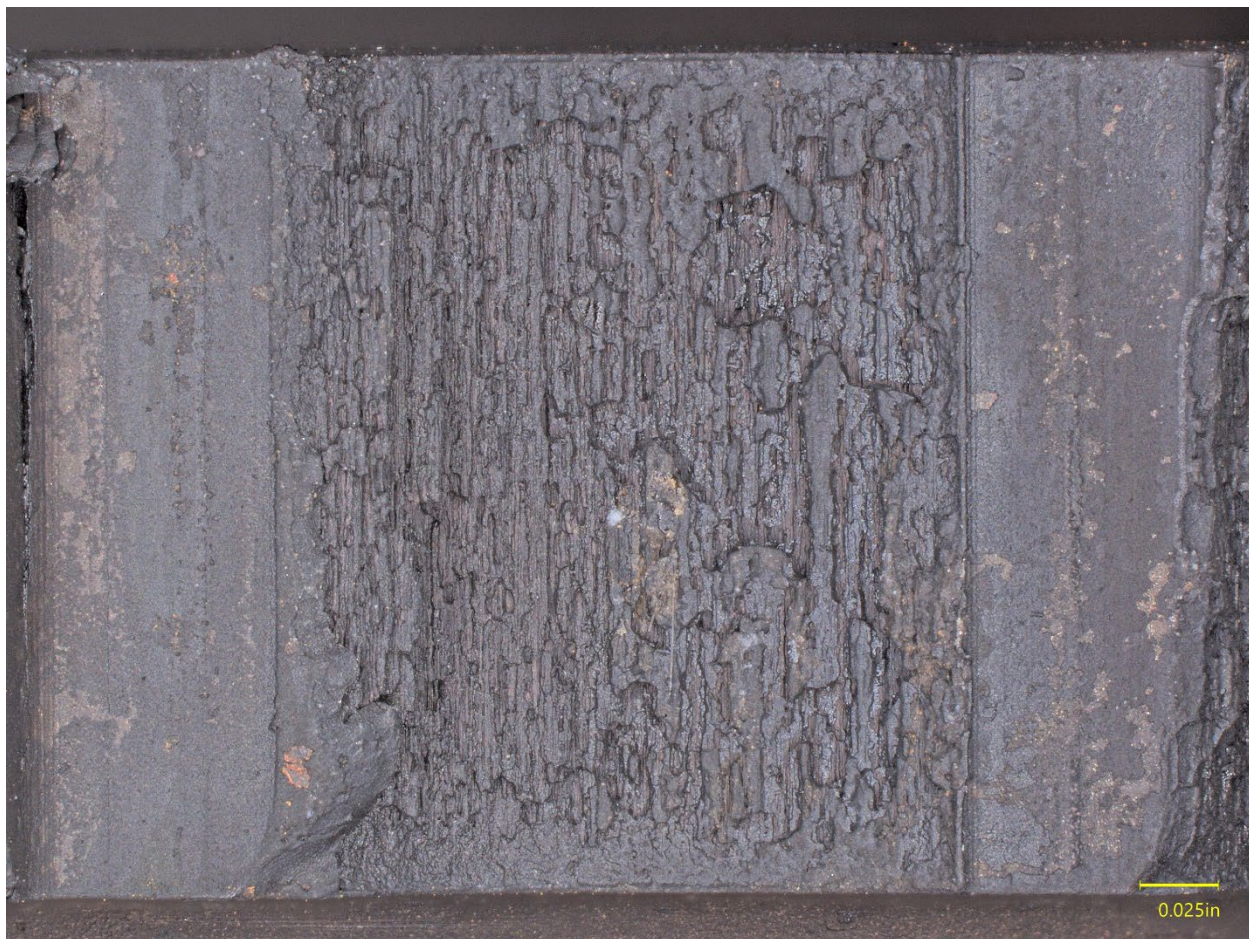
The fractured tooth, shown on the left in Figure 6, Figure 8, and Figure 9, was examined using a field emission scanning electron microscope (SEM). The overall view of the tooth is shown optically in Figure 9. This figure shows an area of smoother, more reflective material on the top, consistent with a corresponding area on the gear fracture. Figure 10 shows the lower edge of the left tooth fracture, revealing two distinct regions with separate fracture features. The center or core is shown closer in Figure 11 and Figure 12.

**Figure 8.** View of the left tooth fracture surface on the idler gear from Figure 7.

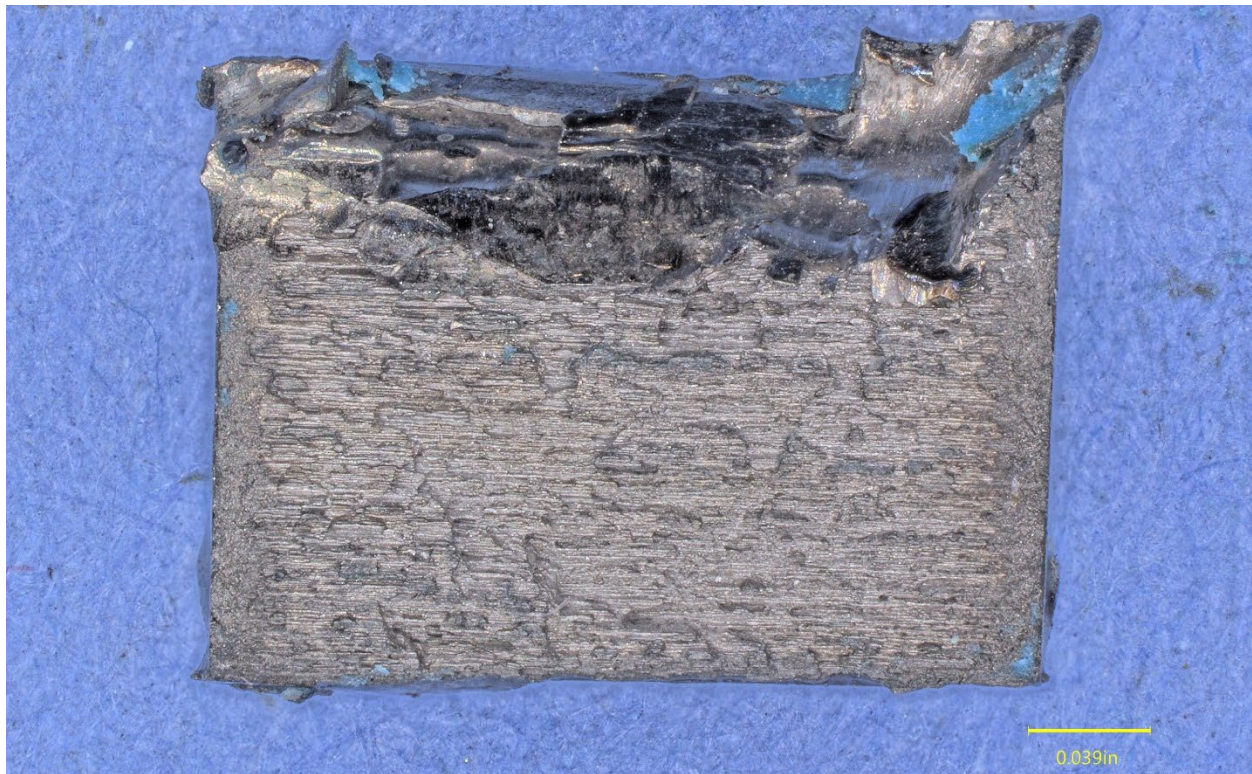
**Figure 9.** View of the left tooth fracture surface from the liberated tooth.

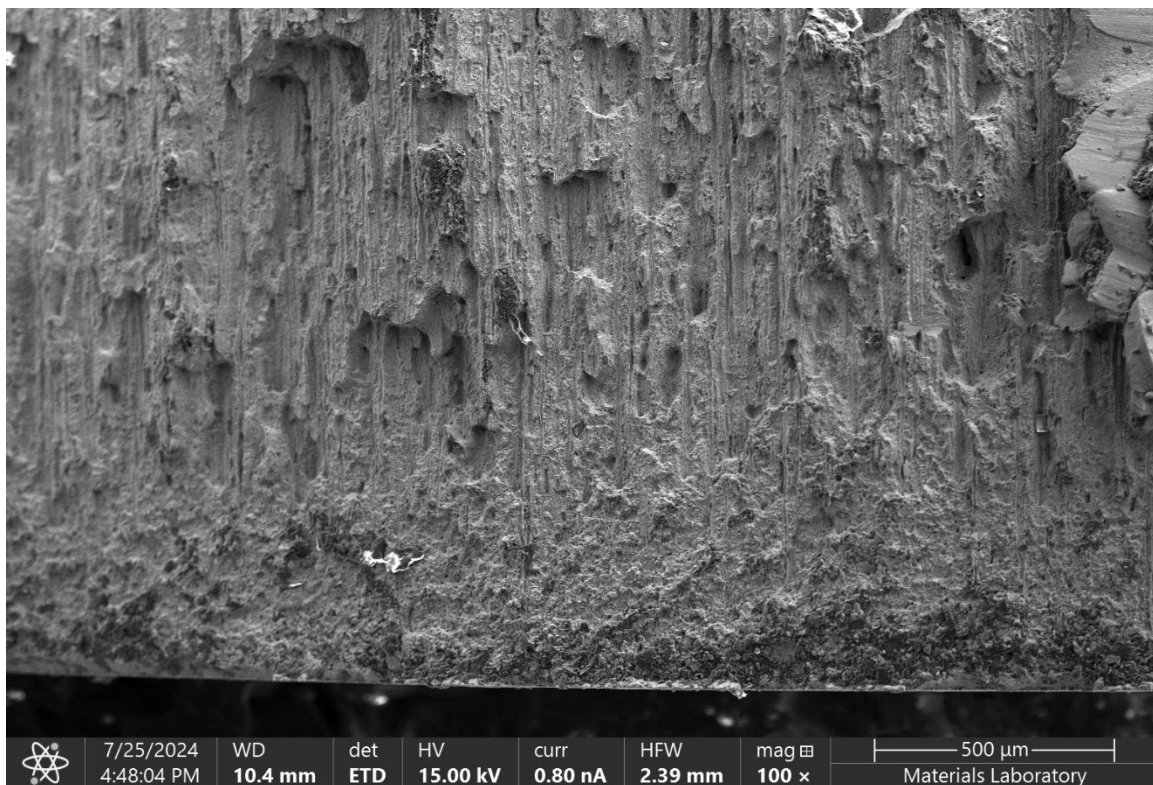
**Figure 10.** Secondary electron (SE) micrograph of the bottom edge of the tooth fracture surface in **Figure 9**, showing two distinct regions.

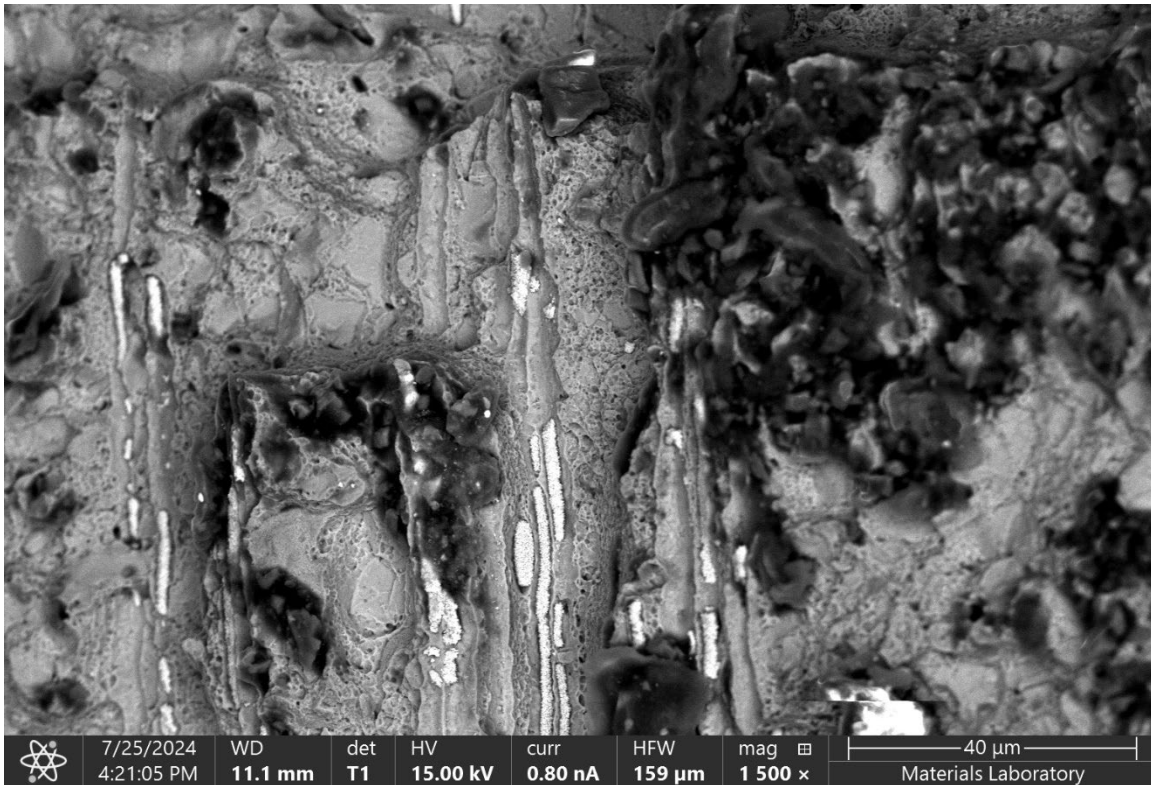
This region exhibited elongated features, consistent with the grain direction from the forging process. The fracture surface exhibited elongated phases, shown as white spots in Figure 11.<sup>2</sup> An EDS examination found these to be consistent with manganese sulfides, typically found in steel components.

**Figure 11.** Backscattered electron (BE) micrograph of the core (center) of the fracture surface of the tooth in **Figure 9**.

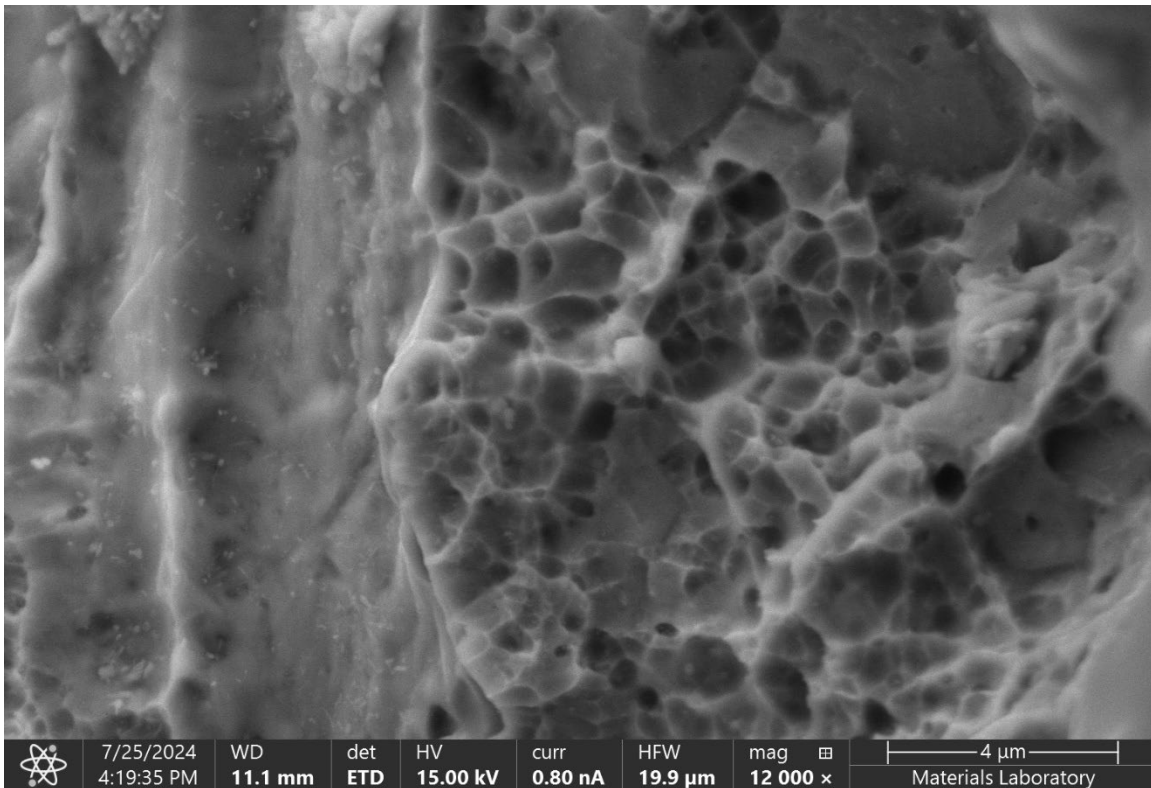
Between these particles, the fracture surface exhibited dimpled rupture, as typified in Figure 12. The part of the tooth fracture surface closest to the edge exhibited mixed dimpled rupture and blocky intergranular facets (Figure 13). This fracture morphology was consistent with the hardened carburized surface layer. All these features were consistent with an overstress fracture of the tooth.

**Figure 12.** SE micrograph of dimpled rupture in the fracture surface in **Figure 11**.

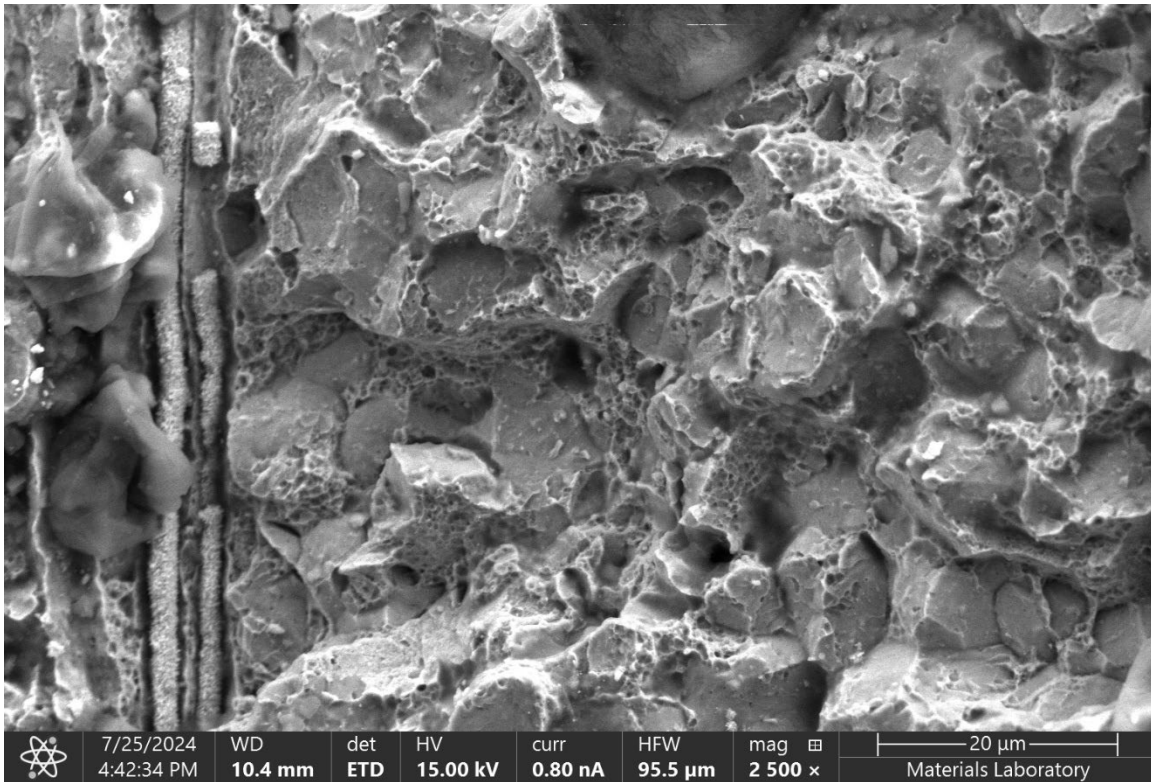
**Figure 13.** SE micrograph of mixed intergranular and dimpled rupture near the fractured tooth edge.

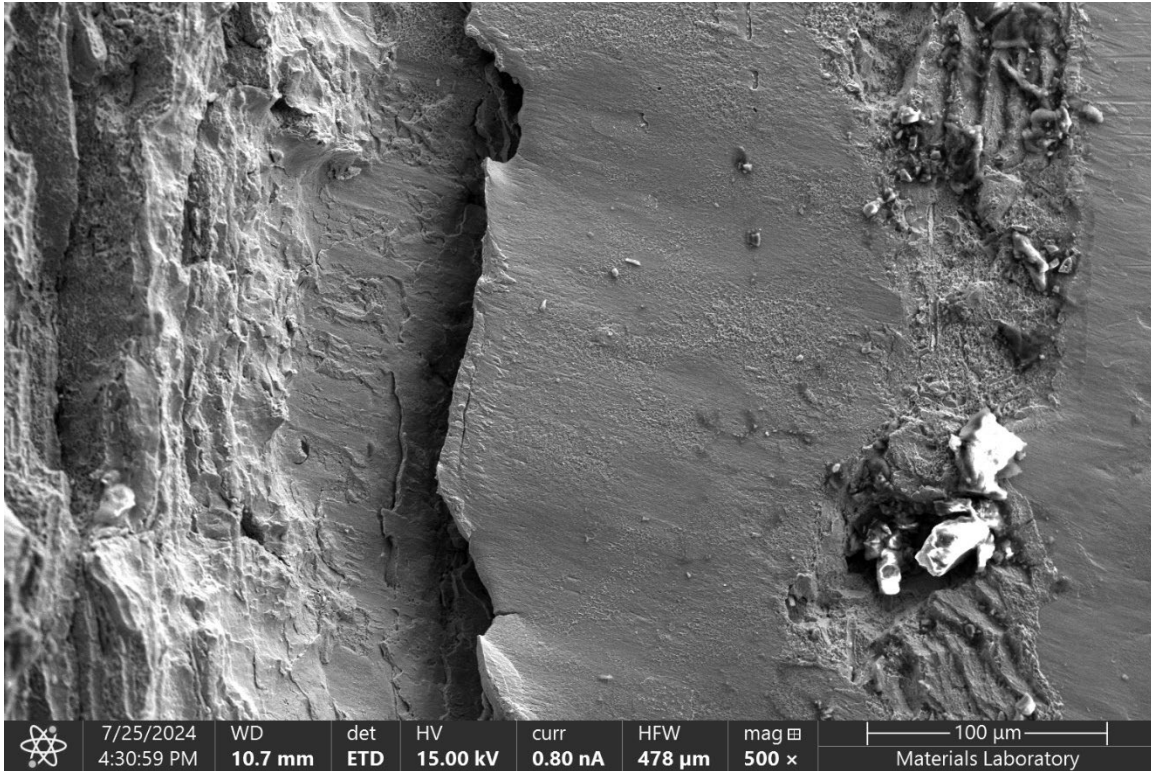
The smoother region of the tooth is shown in Figure 14. A closer view of this region revealed elongated dimpled rupture, consistent with overstress in a shear direction (Figure 15). These features were consistent with an overstress fracture of the tooth, with a bending and shear component at the end of the fracture sequence. There were no features present that were consistent with progressive cracking.

**Figure 14.** SE micrograph of the rounded area of the fractured tooth (upper part of **Figure 9**).

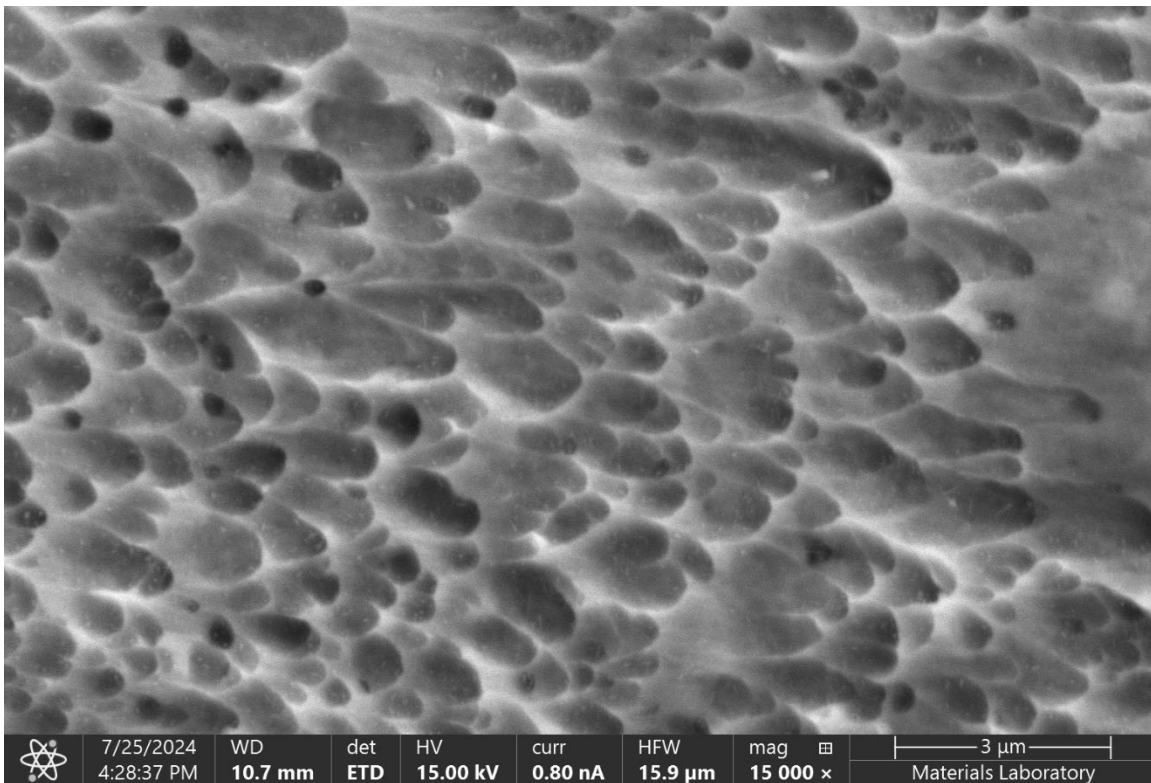
**Figure 15.** SE micrograph of dimpled rupture from the smoother area in **Figure 14**.

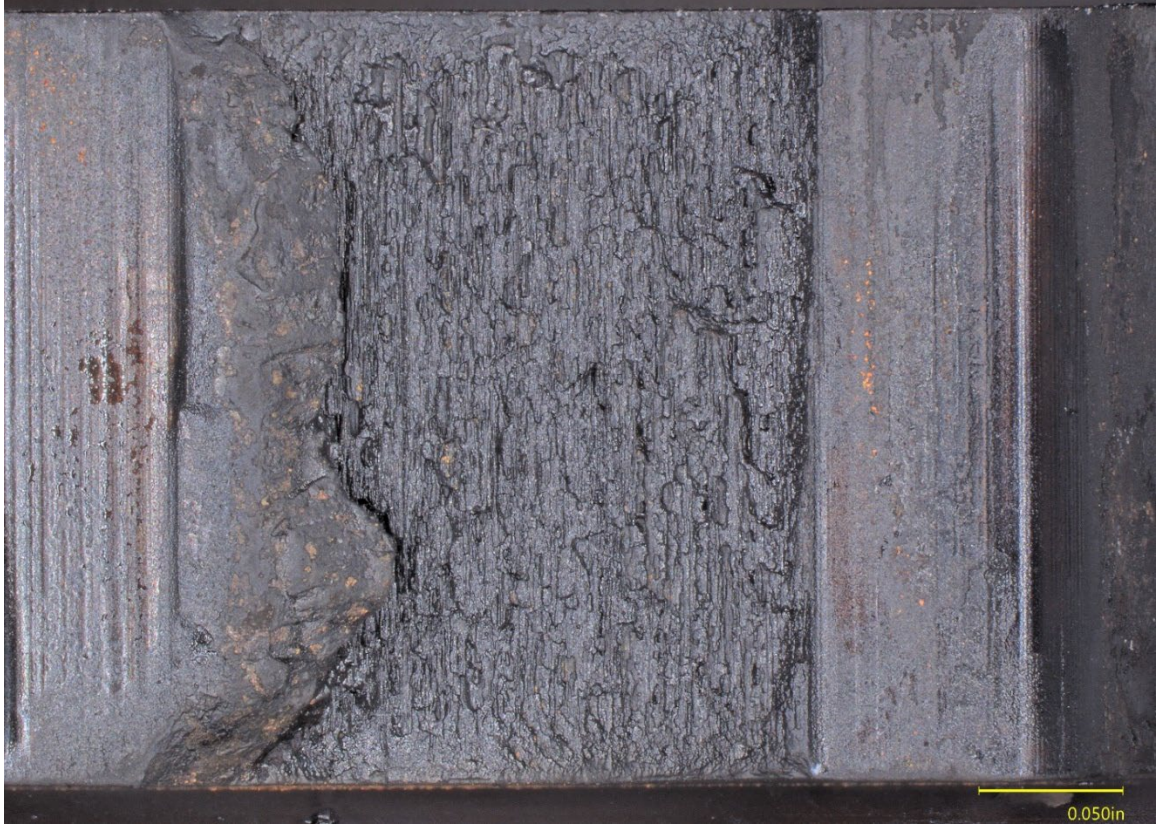
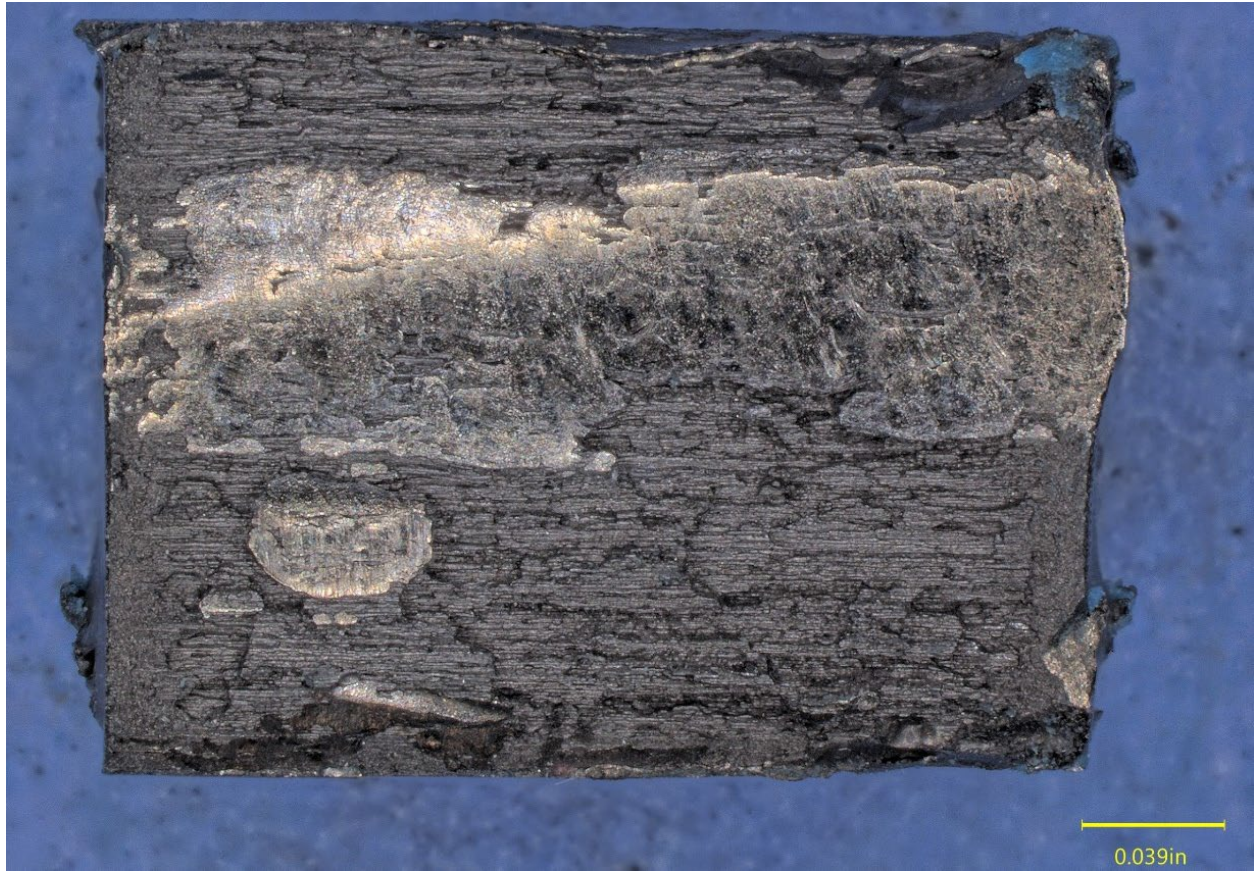
Figure 16 and Figure 17 show the mating fracture surfaces of the right gear tooth. These exhibited a similar pattern to the left tooth, exhibiting a core central area of elongated fibrous fracture features with a finer, blockier periphery. Examination of the tooth using an SEM found features consistent with the left tooth, exhibiting dimpled rupture with mixed dimpled rupture and intergranular facets along the edge. These features were consistent with an overstress fracture of the tooth.

Figure 16. View of the right side crankshaft idler gear tooth fracture in **Figure 7**.

Figure 17. The mating right side tooth fracture of the idler gear, showing smearing along the centerline.

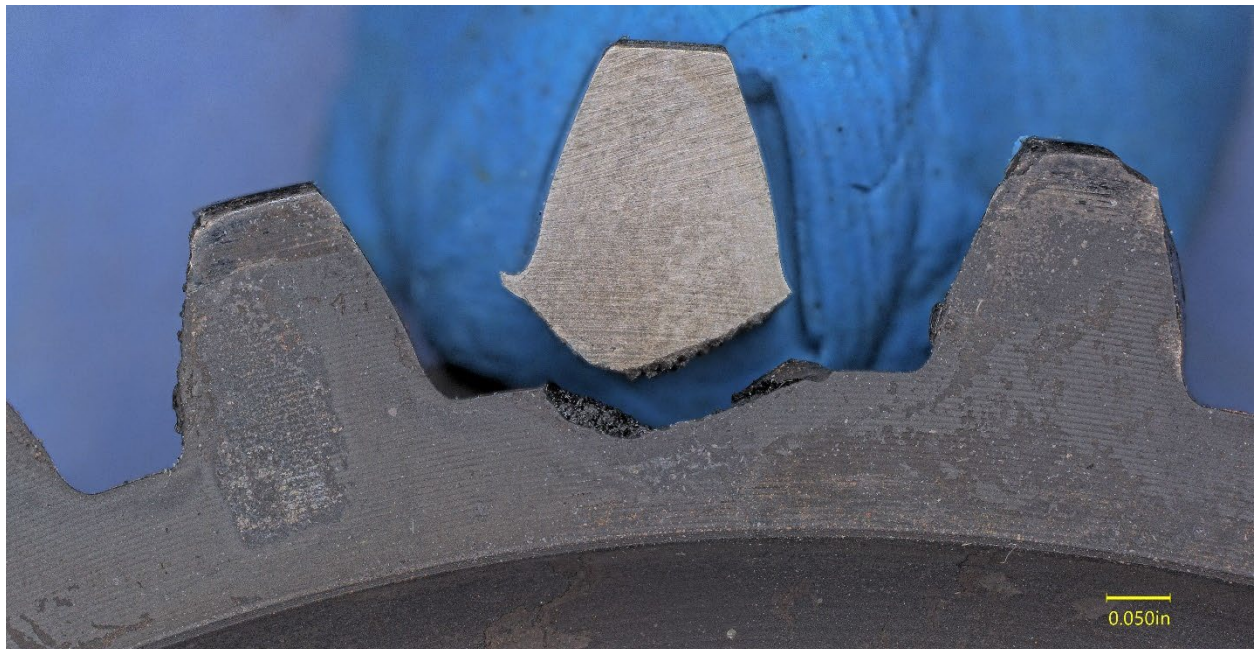
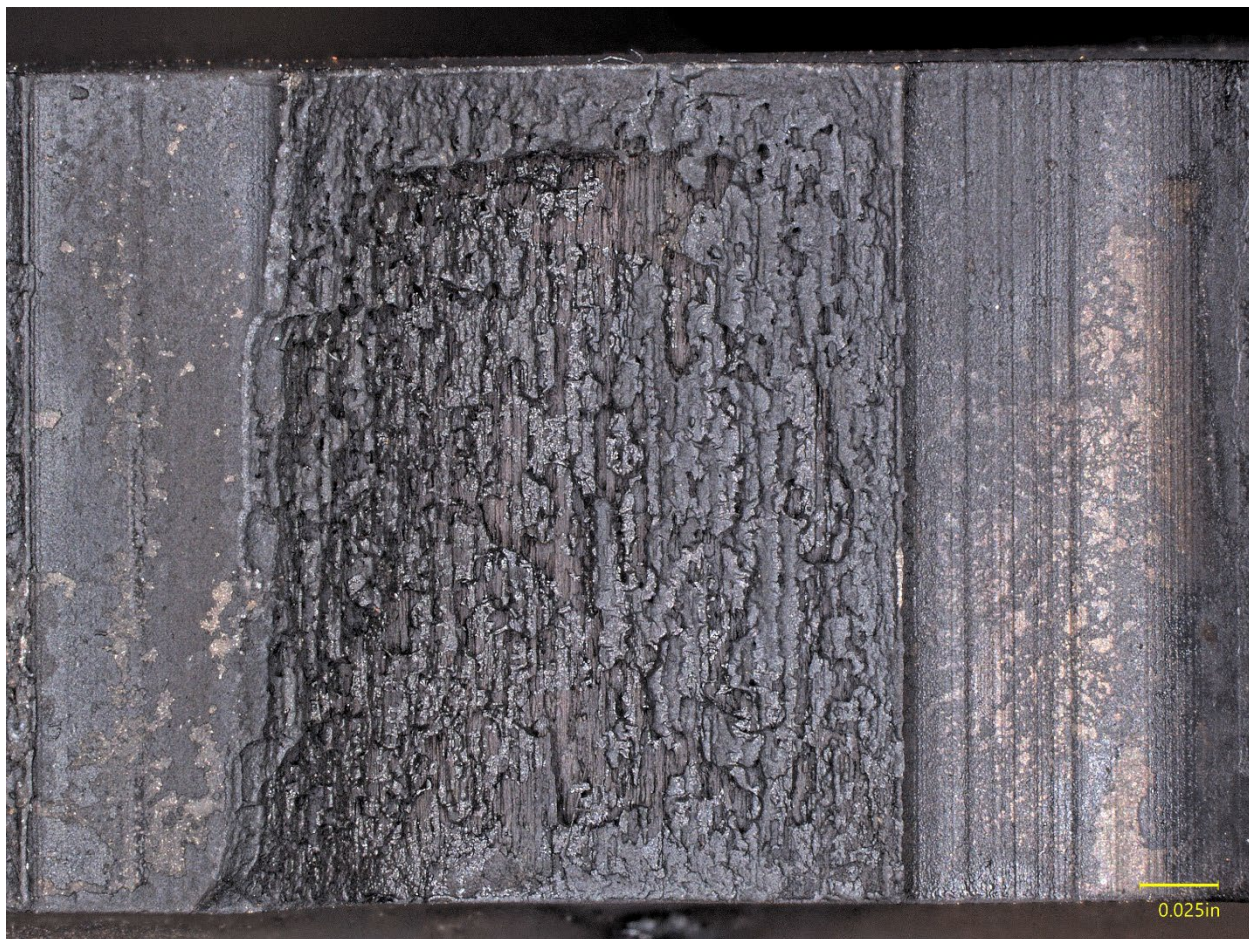
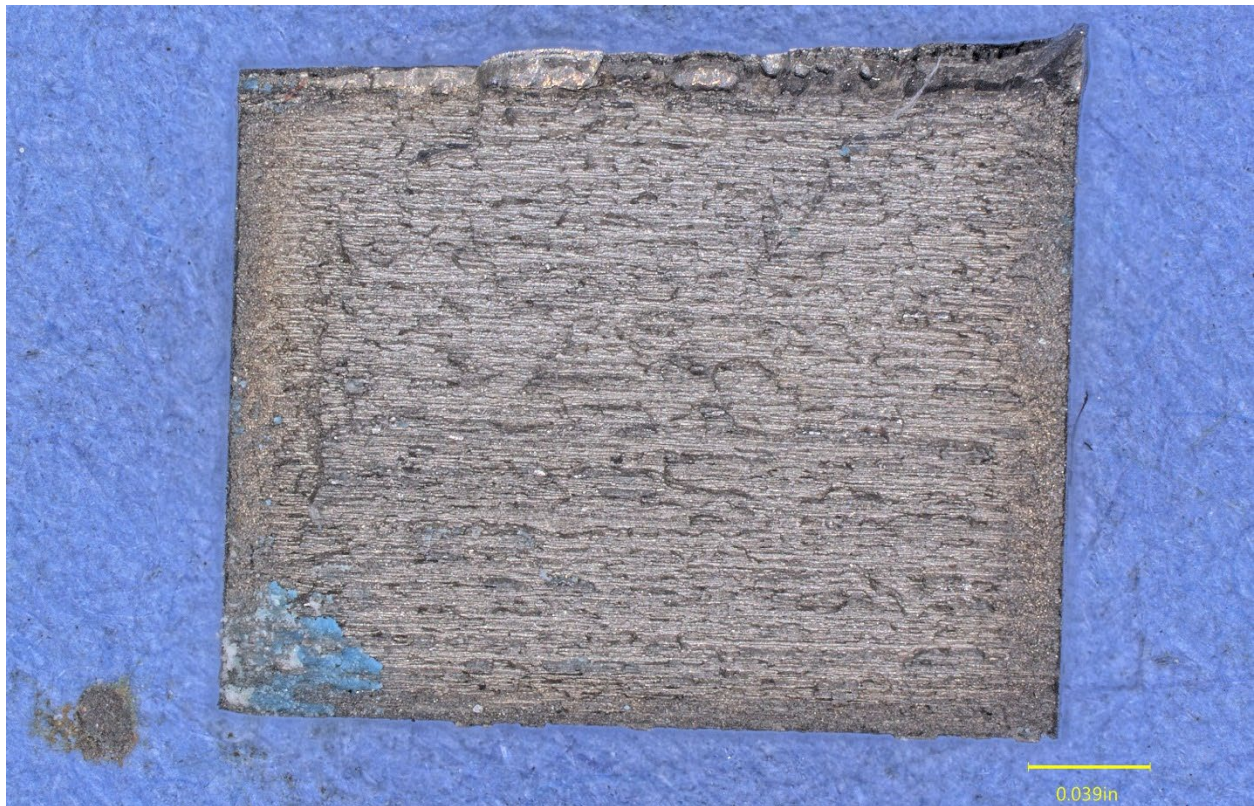
Figure 18 shows the single tooth positioned as fractured. Like the other two separated teeth, the fracture surface exhibited a general concave appearance. Figure 19 and Figure 20 show the mating fracture surfaces of the tooth and the gear at this location. These exhibited the same pattern as the other two teeth, and examination of the fracture surface revealed nearly identical features to those of the other two fractured teeth, consistent with overstress fracture at this location.

**Figure 18.** The opposite single tooth fracture of the crankshaft idler gear.

**Figure 19.** The single tooth fracture surface on the crankshaft idler gear.

**Figure 20.** The fractured tooth fracture surface opposite the gear surface in **Figure 19**.
