# National Transportation Safety Board

ERA24FA050

## **MATERIALS LABORATORY**

Factual Report 24-044

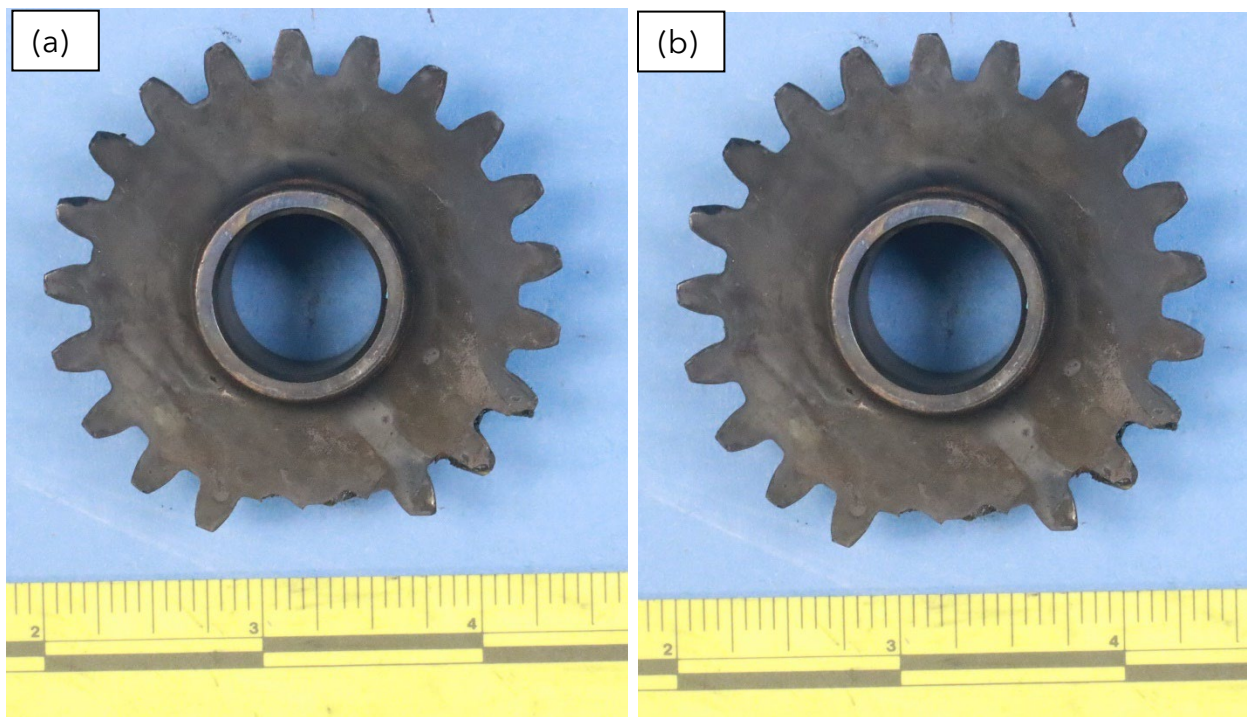
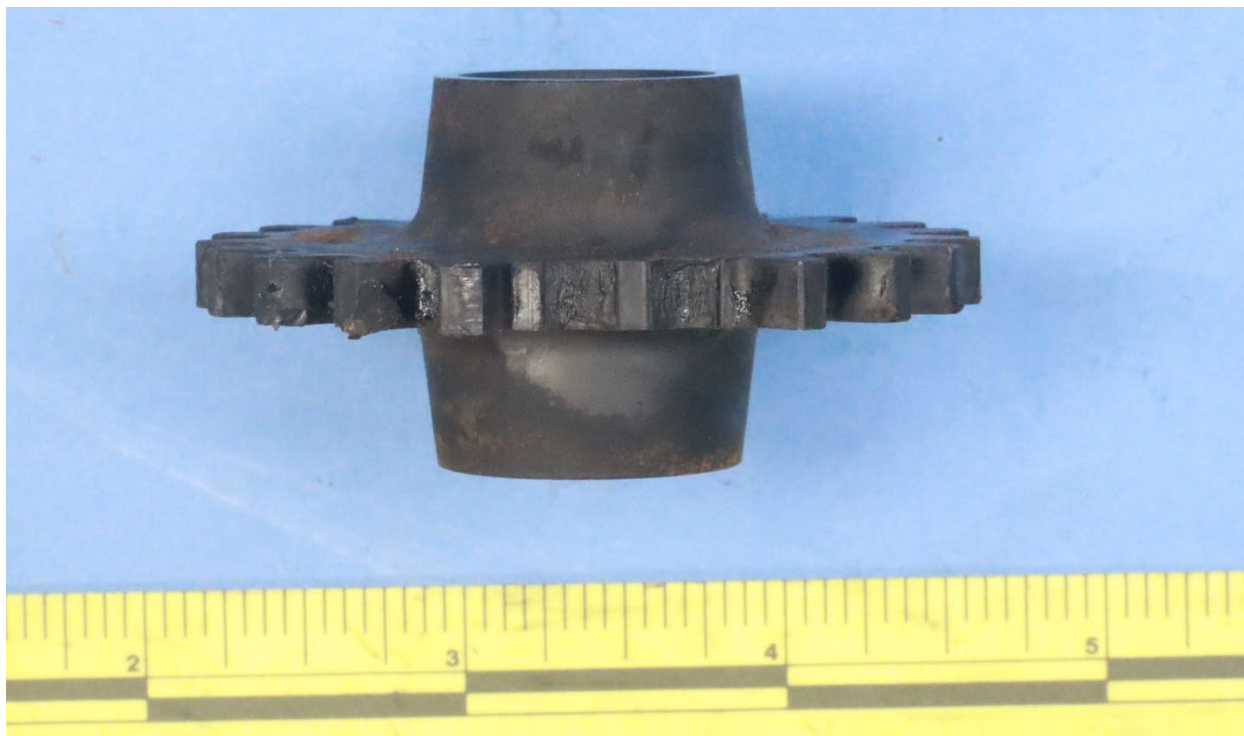
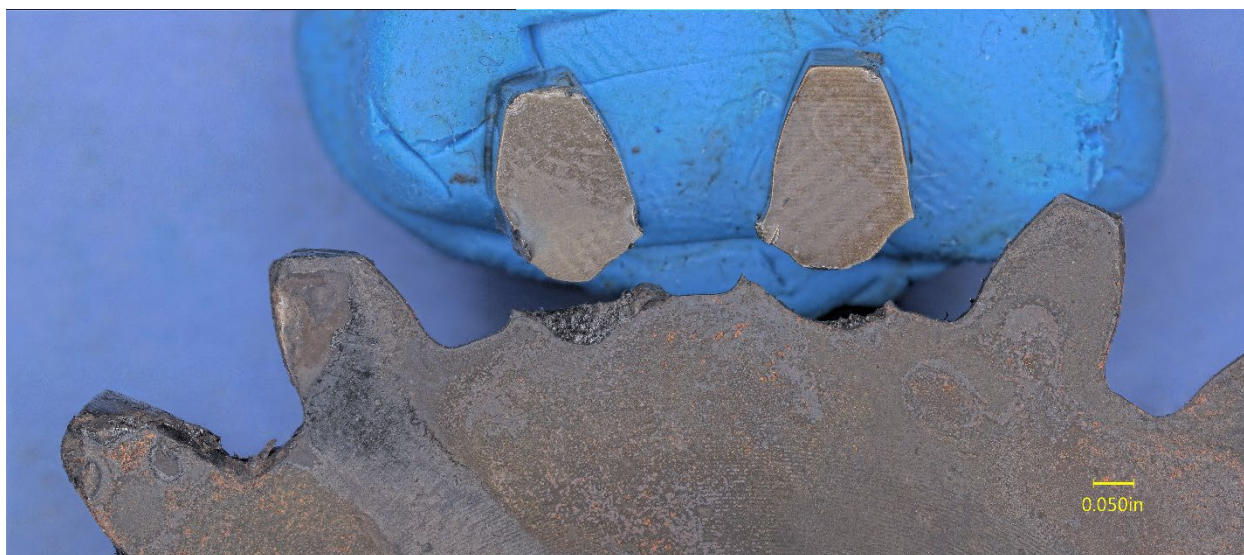
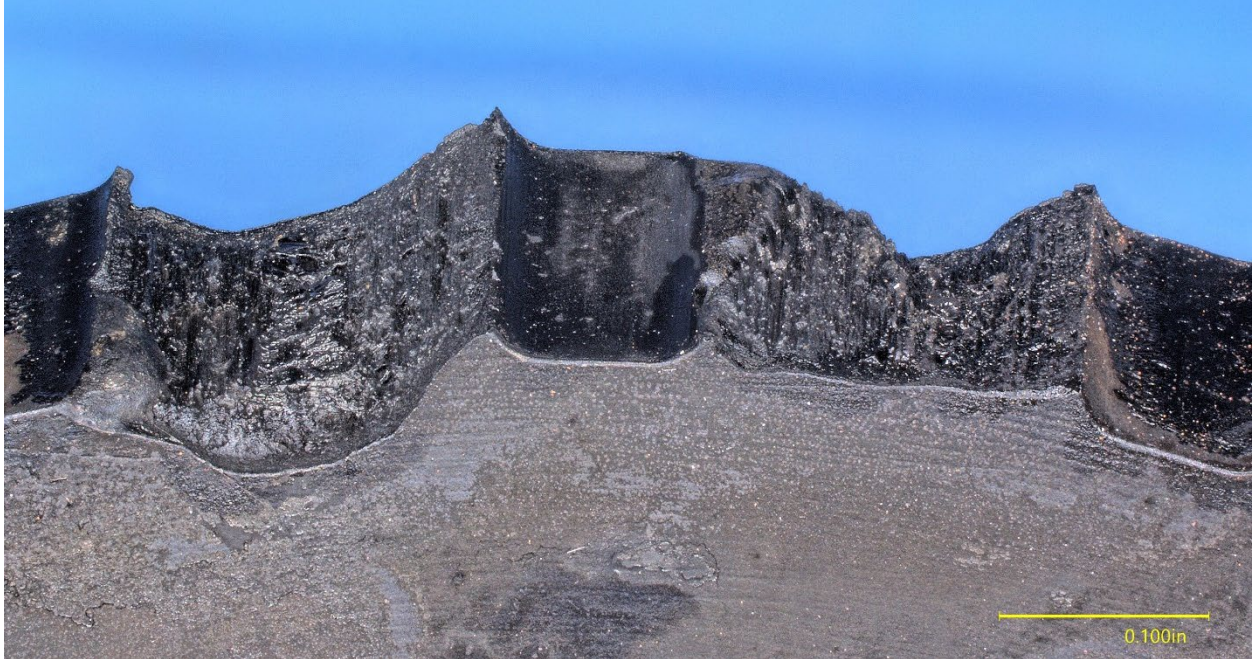
Figure 21 shows the fuel pump idler gear, viewed from opposite locations. This component exhibited two adjacent fractured teeth, as illustrated in Figure 22. The teeth on either side of the fractured ones were intact but exhibited batter and plastic deformation, as demonstrated with the two teeth in the counterclockwise direction in Figure 23. Figure 23 also shows the two liberated teeth, recovered from the engine teardown. These two teeth exhibited the same hue as the gear, and had a similar convex fracture shape. The curve of the fracture surfaces is shown in Figure 24.

**Figure 21.** The fuel pump idler gear, viewed from opposite faces.

**Figure 22.** The fractured teeth locations of the fuel pump idler gear, as received.

**Figure 23.** Side view of the fractured teeth of the fuel pump idler gear, positioned to show their locations prior to fracture.

**Figure 24.** Angled view of the fuel pump idler gear fracture surfaces.

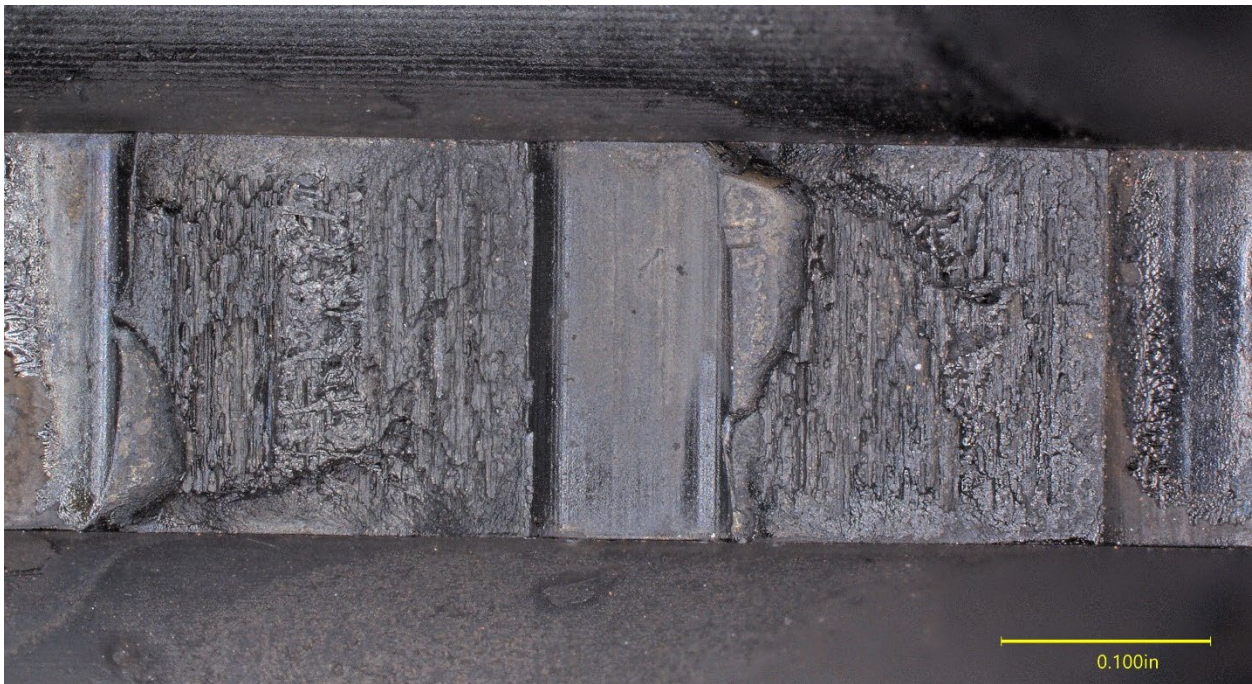
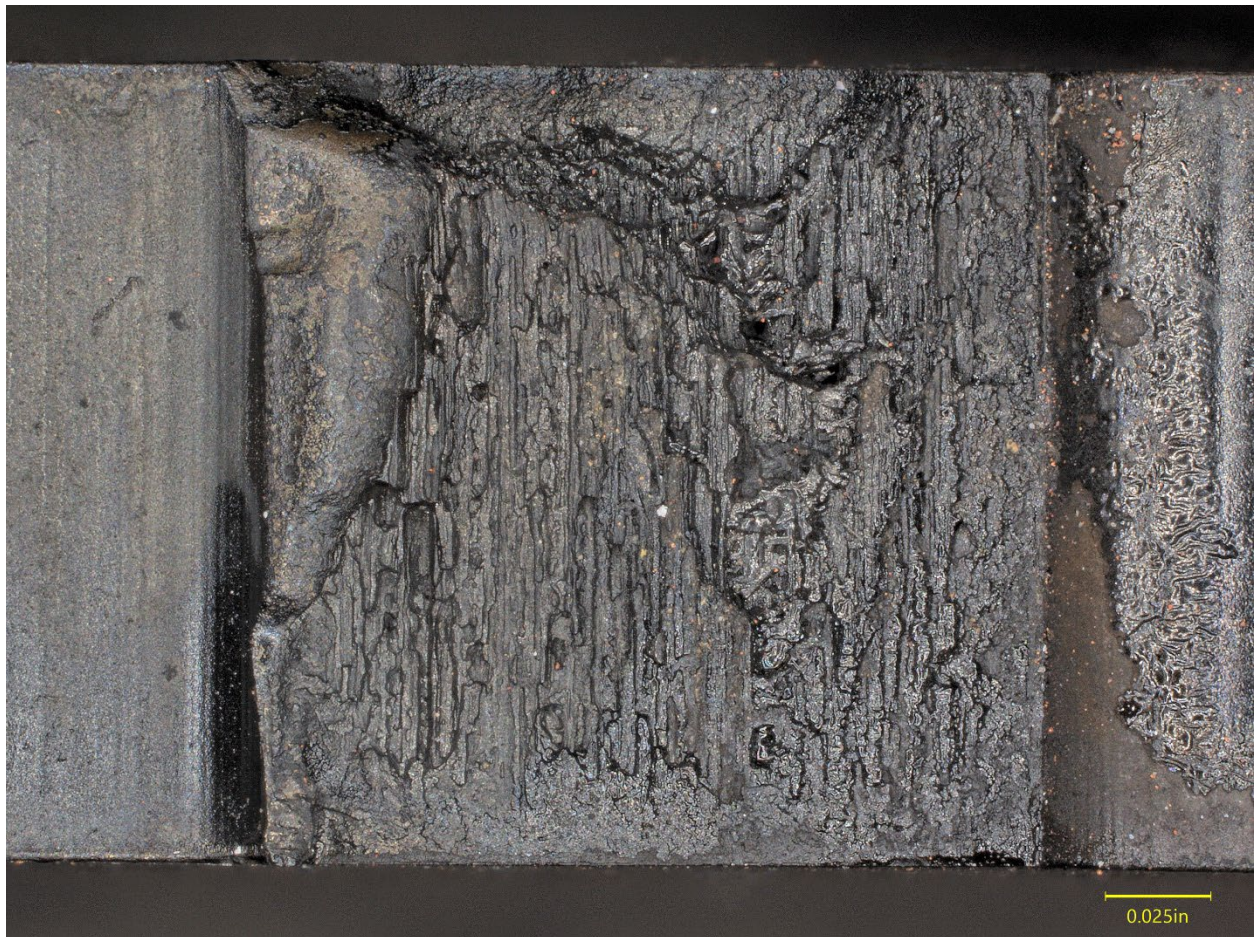
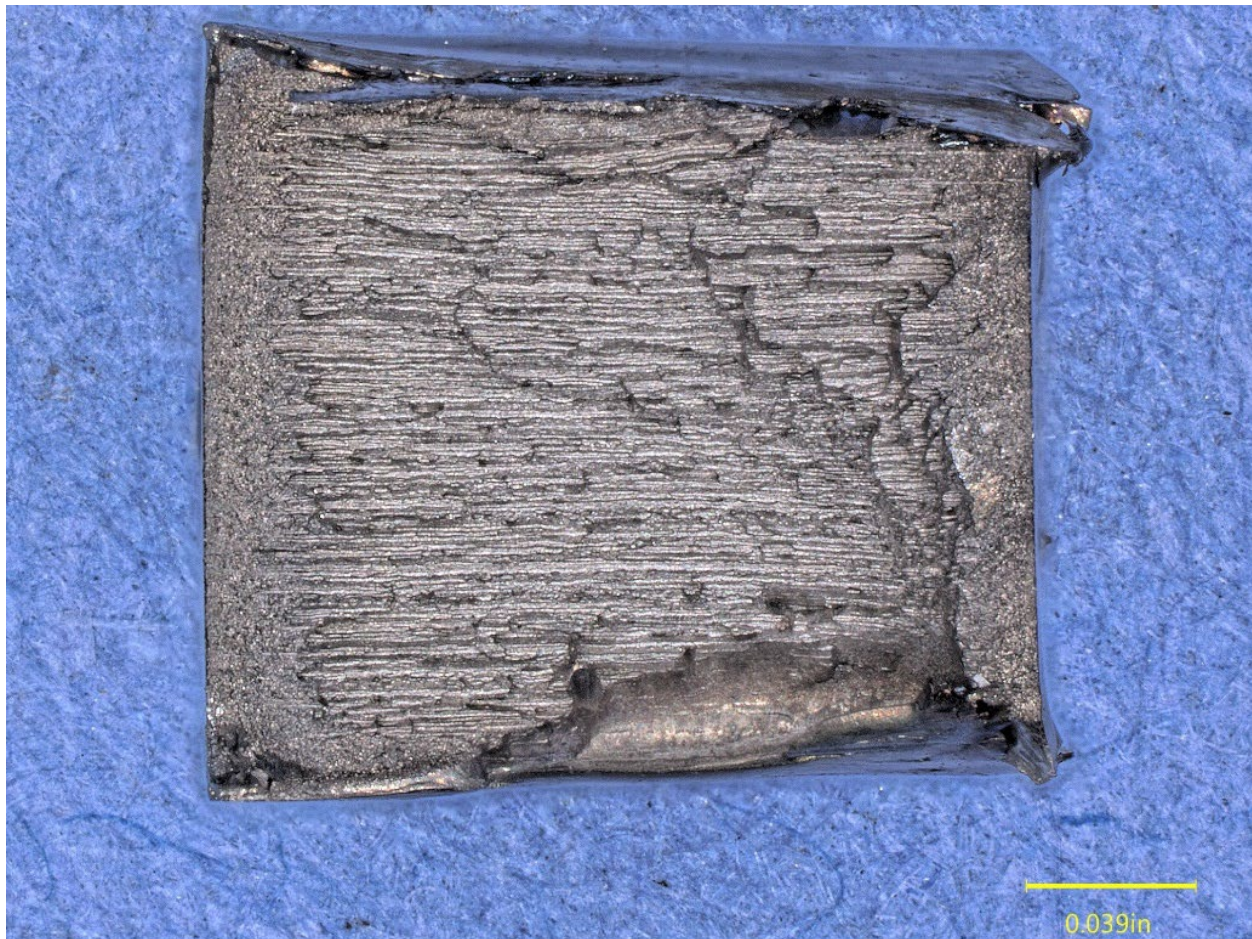
Figure 25 illustrates the two tooth fractures on the fuel pump idler gear. Figure 26 and Figure 27 show the mating faces of the left tooth in Figure 25. This surface exhibited an elongated fracture morphology, with finer features along the edges. The tooth was examined using a SEM. A typical area of the center of the fracture surface is shown in Figure 28. This view demonstrates the elongated morphology of the fracture, consistent with the elongated grains of the forged part.

**Figure 25.** Straight view of the fractured teeth locations on the fuel pump idler gear.

**Figure 26.** View of the left tooth fracture on the fuel pump idler gear from **Figure 25**.

**Figure 27.** Fracture surface of the left liberated tooth from the fuel pump idler gear.

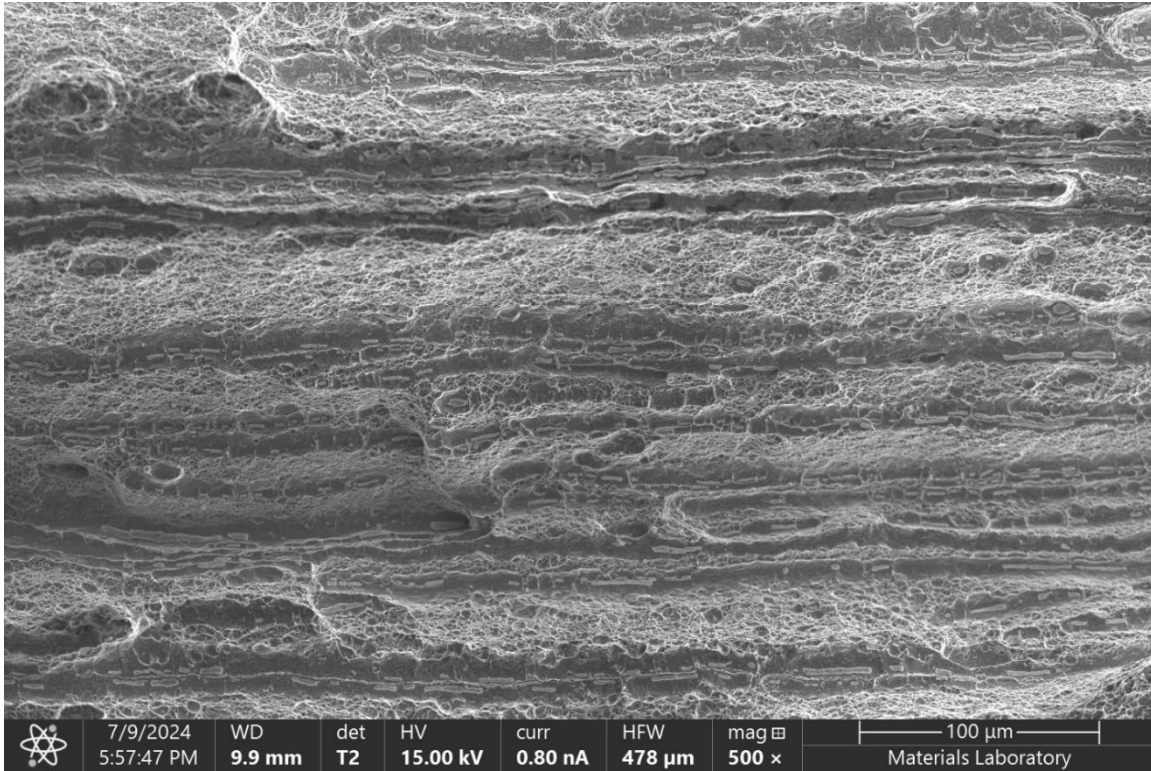
**Figure 28.** Secondary electron (SE) micrograph of a typical area of the center of the left tooth fracture surface from the fuel pump idler gear.

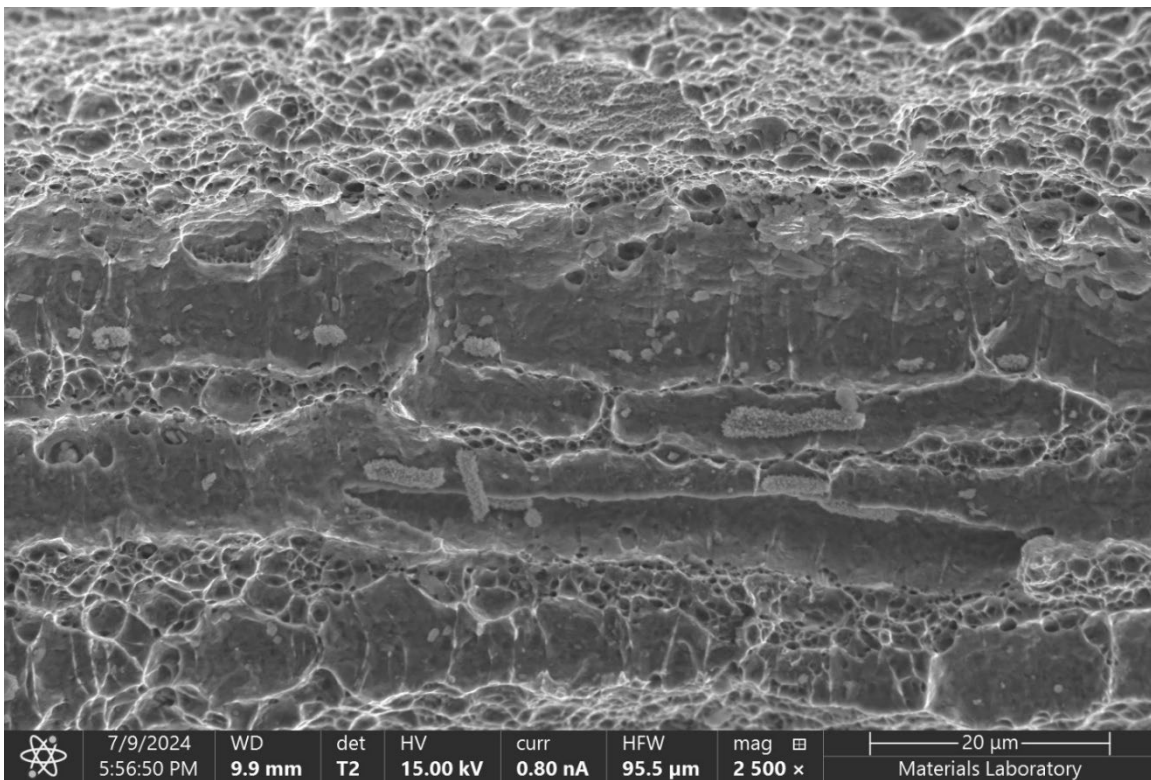
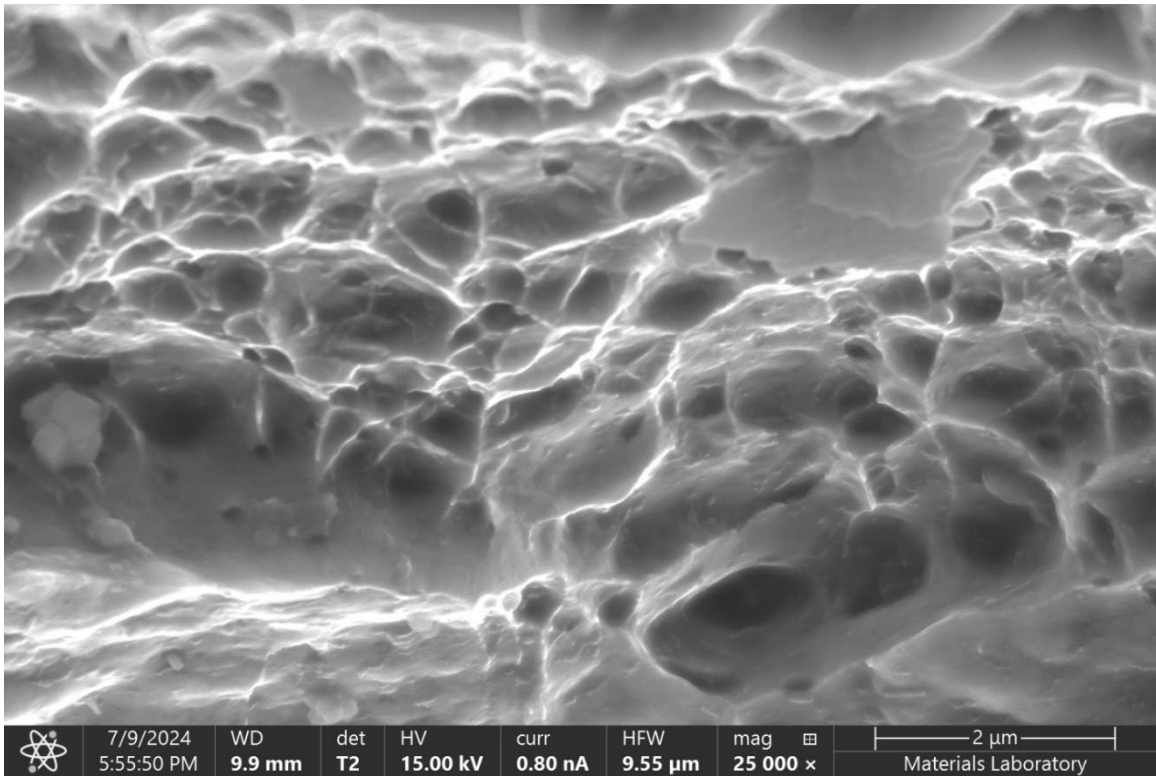
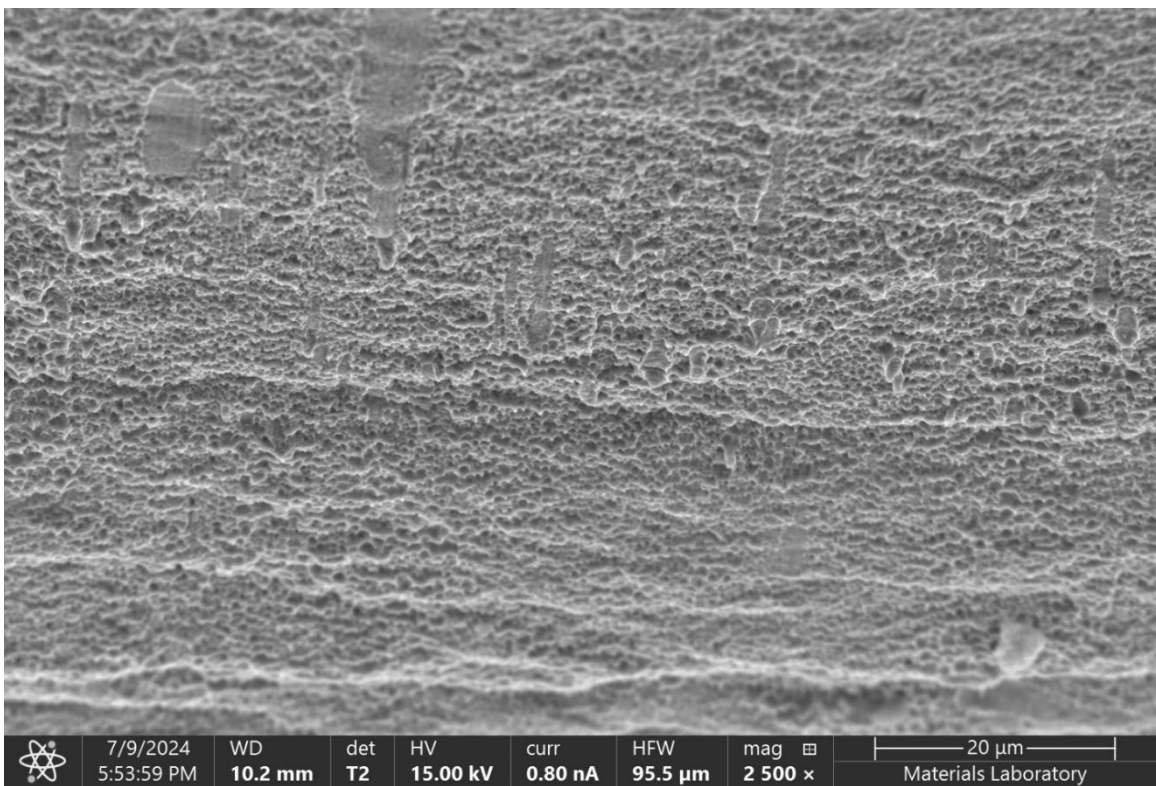
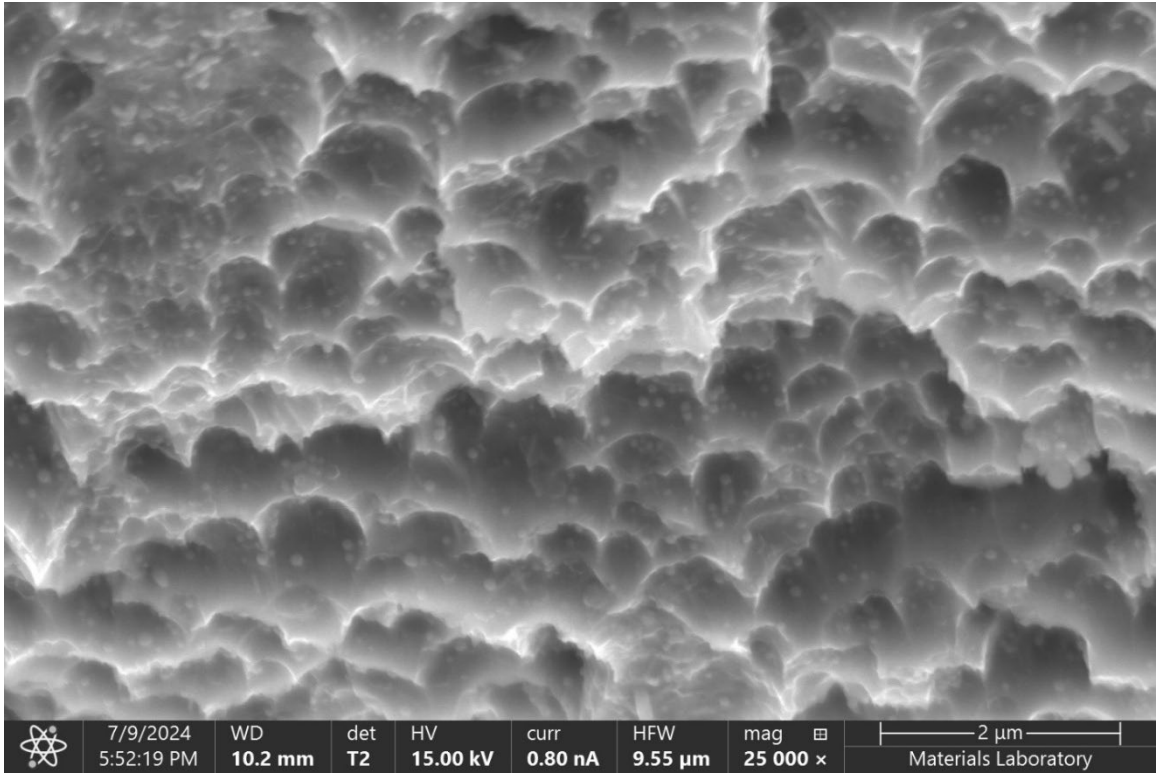
A closer view, shown in Figure 29, revealed areas of large elongated dimples. These longer dimples were interspersed with finer dimpled rupture, as typified in Figure 30. The smooth area along the edge also exhibited finer dimpled rupture features, as shown in Figure 31 and Figure 32. These features were consistent with an overstress fracture of the left fuel idler gear tooth.

**Figure 29.** SE micrograph of a closer view of **Figure 28**, showing dimpled rupture.

**Figure 30.** SE micrograph of the finer dimpled rupture features in **Figure 29**.

**Figure 31.** SE micrograph of the smoother area in **Figure 27**, showing dimpled rupture.

**Figure 32.** SE micrograph of a closer view of the dimpled rupture in **Figure 31**.

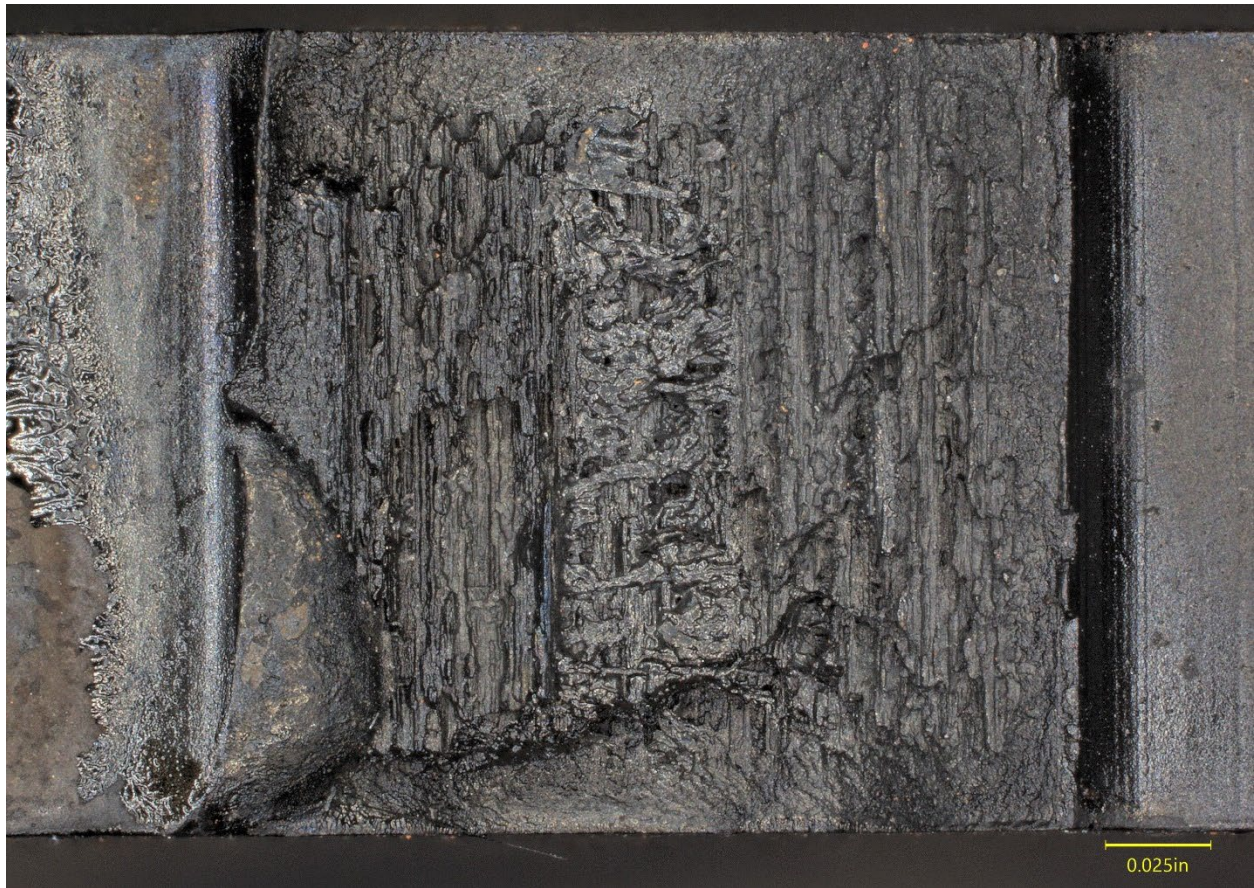
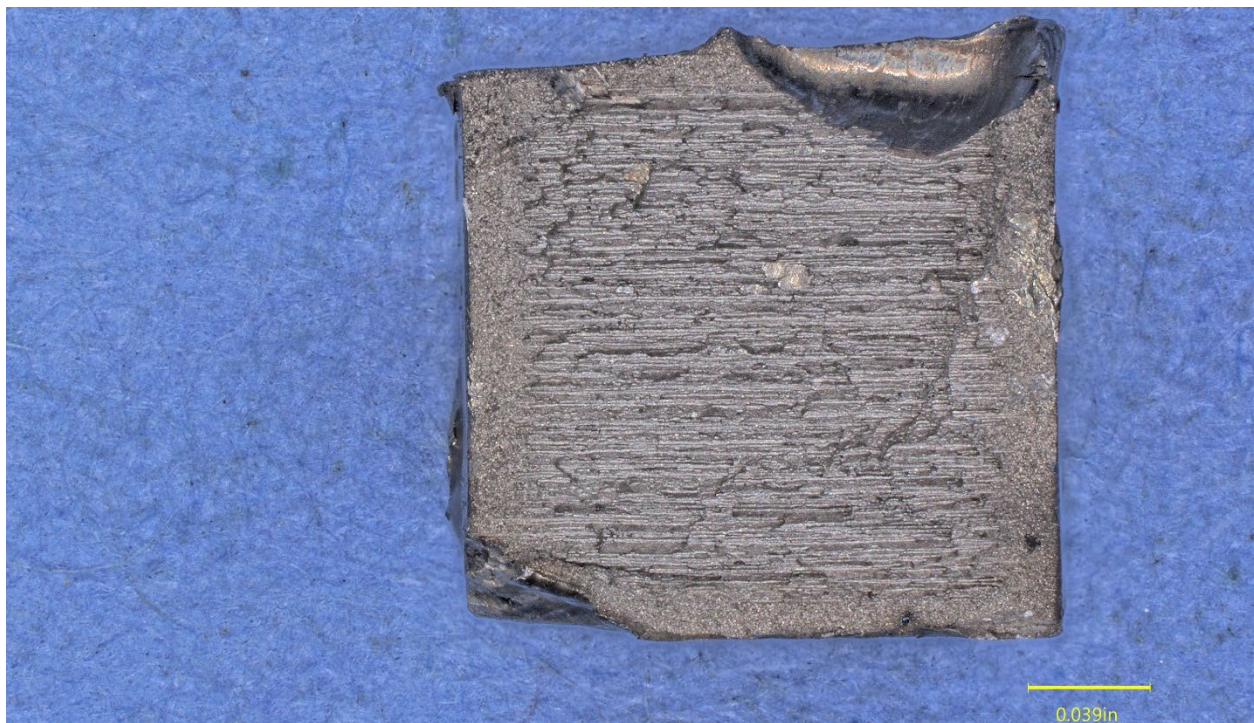
Figure 33 and Figure 34 show the mating fracture surfaces of the other (right) tooth from the fuel pump idler gear. This fracture surface exhibited a similar morphology as the left fractured tooth. Examination in optical and electron microscopes revealed features consistent with an overstress fracture of this tooth.

**Figure 33.** The right tooth fracture surface from the fuel pump idler gear in **Figure 25**.

**Figure 34.** Right liberated tooth fracture surface that mates with the surface in **Figure 33**.

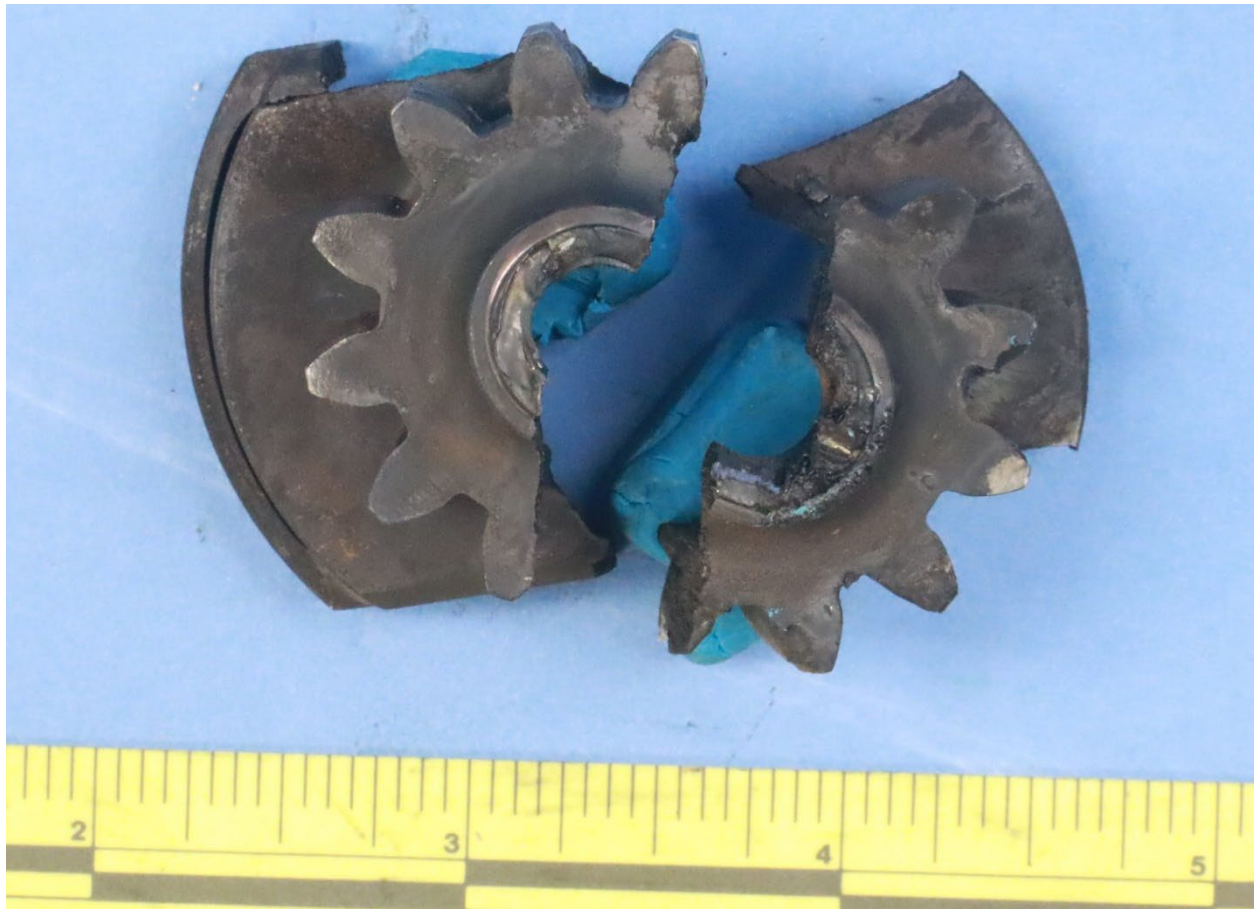
The remnants of the left magneto gear are shown in Figure 35, as received. From the view in this figure, the fracture exhibited a Z-shaped orientation, with two parallel but nonaligned fractures between the center bore and the exterior surface. The fracture on the bottom left bisected a gear tooth, whereas the fracture in the upper right was located between two teeth. Several areas of the flange had fractured from the gear.

**Figure 35.** The fragments of the fractured left magneto gear, as received.

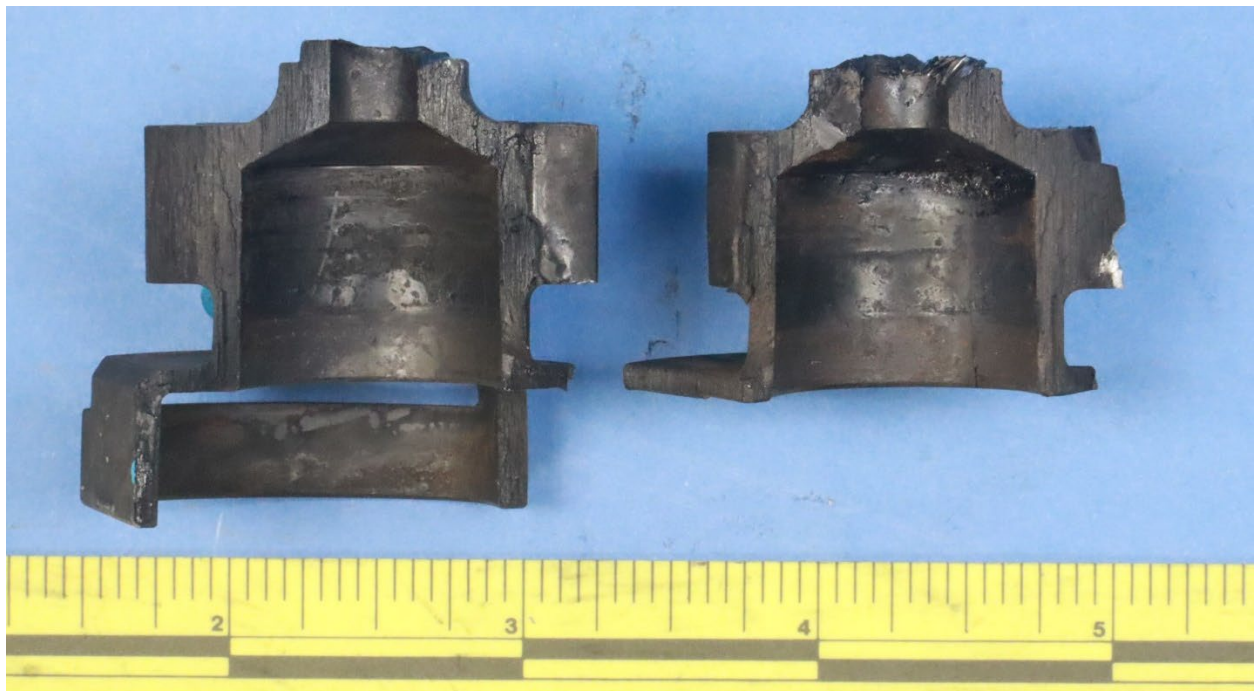
Figure 36 shows the mating faces of the magneto gear. These surfaces were generally rough and fibrous in texture, with a dull, dark hue consistent over all of the surfaces of the gear fragments. The fibrous direction was vertical in Figure 36, consistent with the grain direction from forging at manufacture.

**Figure 36.** The opposite-facing fracture surfaces of the left magneto gear, as received.

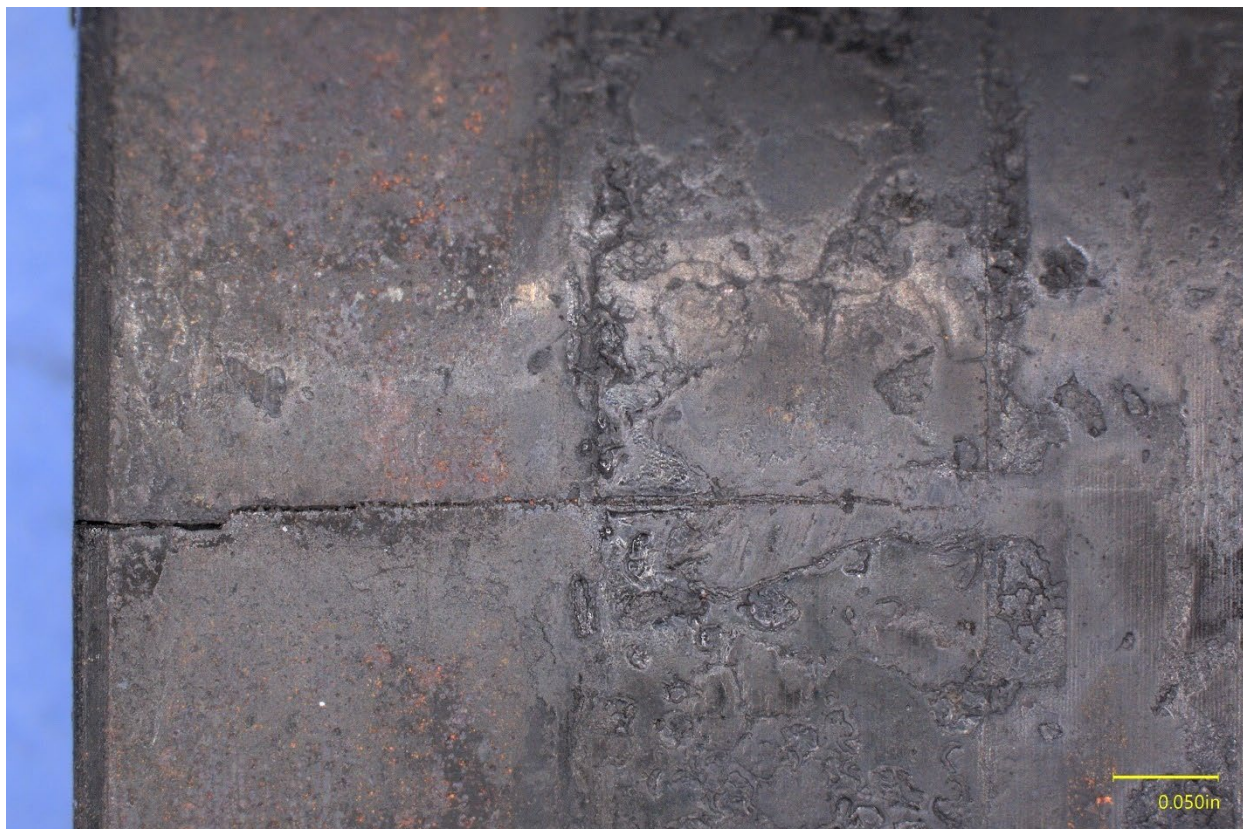
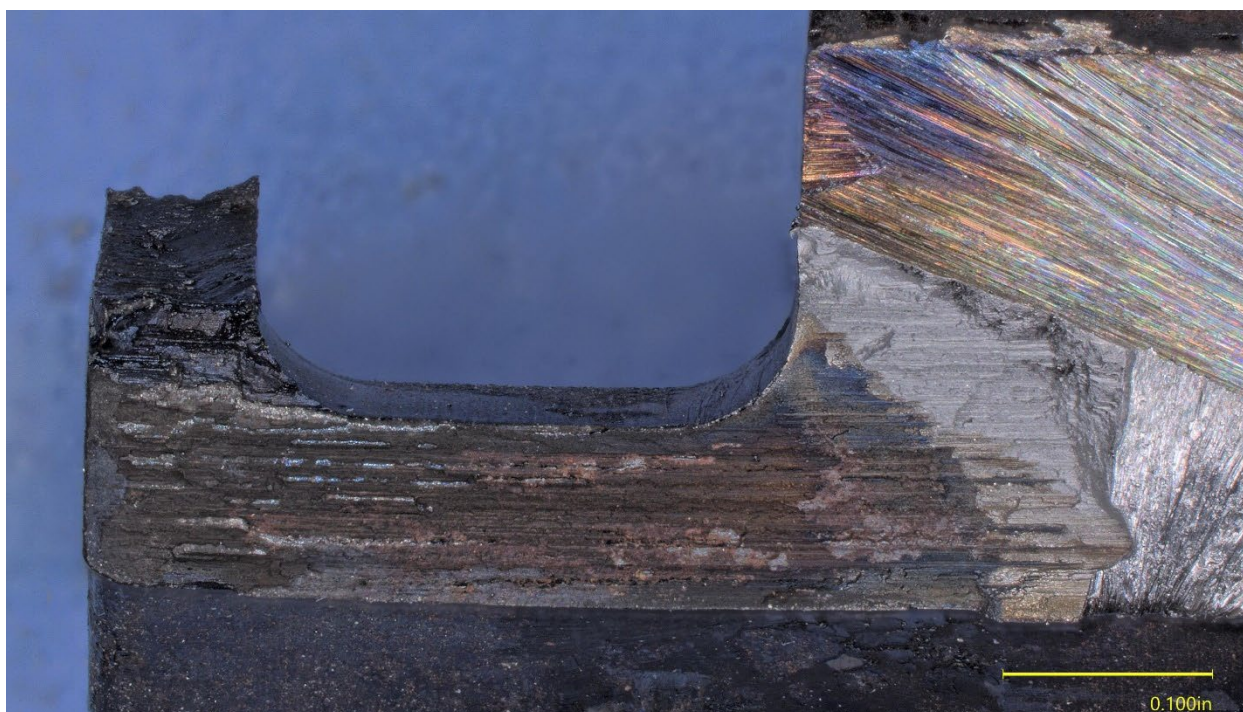
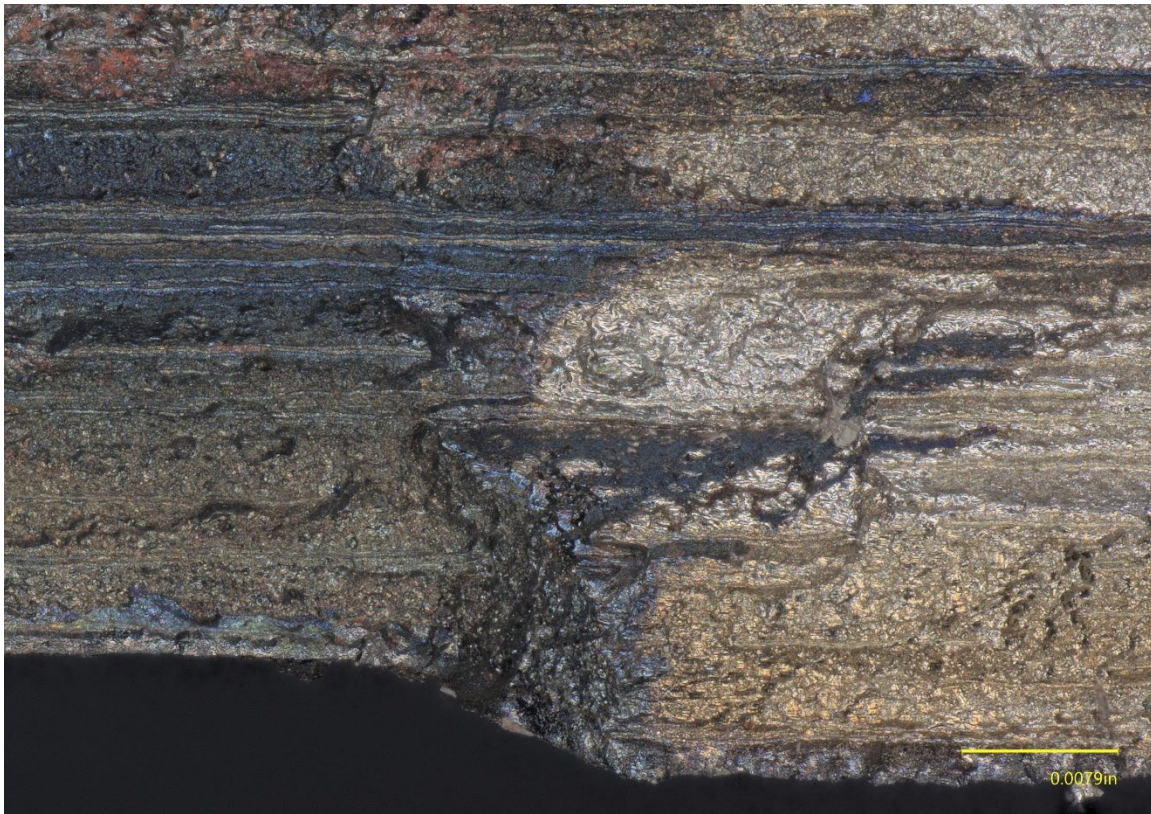
A longitudinal crack was also present at the barrel portion of the larger gear remnant, shown in Figure 37. This crack was intentionally backcut and laboratory-opened to expose the crack faces. One of the opened faces is shown in Figure 38. The existing crack face was dark in color, and the area fractured in the laboratory is dull, light metallic gray. This color contrast shows the crack's edge, as illustrated in Figure 39.

**Figure 37.** View of a crack on the boss of the larger magneto gear remnant.

**Figure 38.** View of the opened crack in **Figure 37**, showing the crack (dark) and intentionally opened areas (lighter metallic gray).

**Figure 39.** View of the end of the opened crack (right side in **Figure 38**).

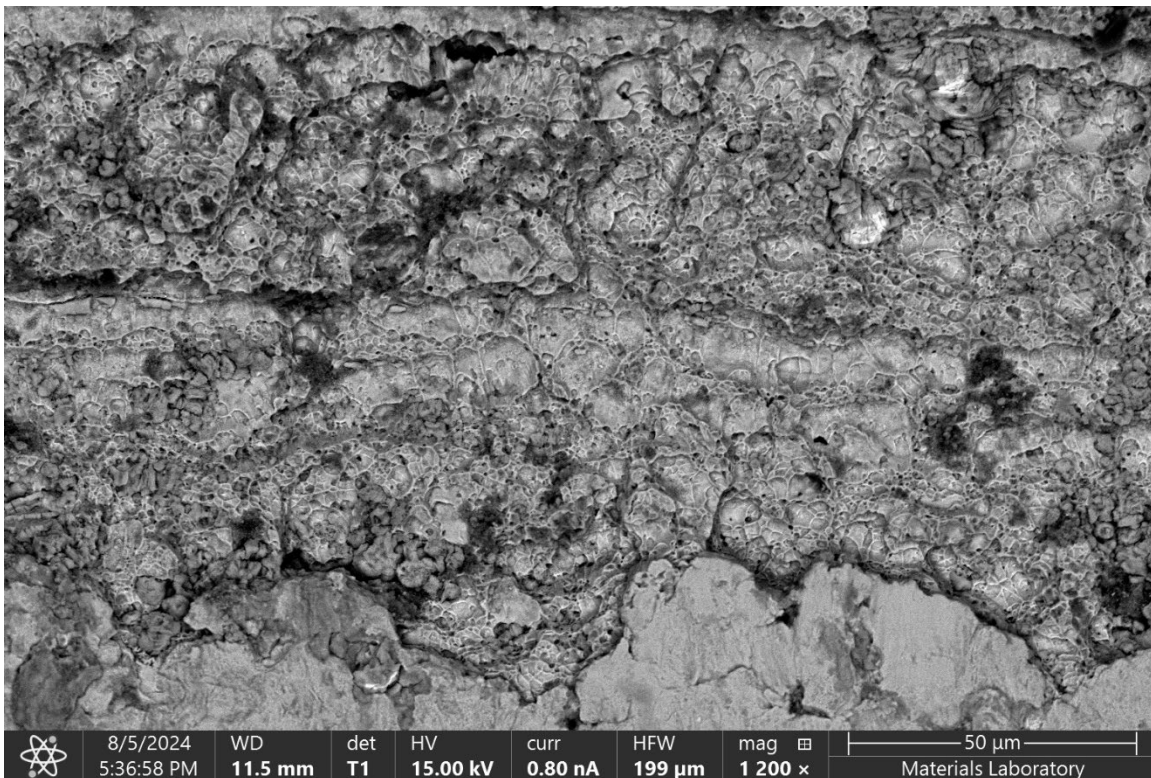
This opened fracture was examined in the SEM. As illustrated in Figure 40, the opened crack exhibited dimpled rupture, consistent with an overstress fracture. These features were consistent in the crack face and the laboratory-opened areas of Figure 38.

**Figure 40.** BE micrograph of a typical area of the opened crack of the magneto gear.

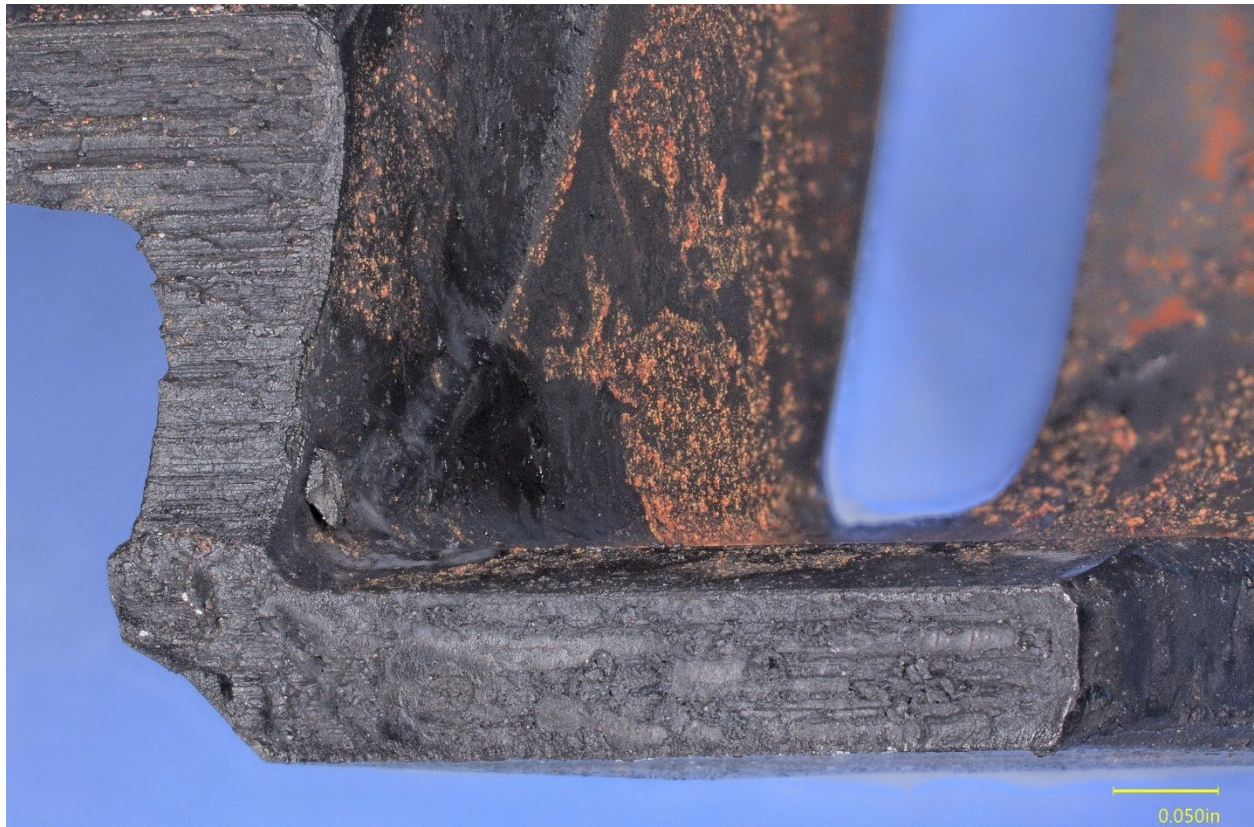
The opposite interior region of the magneto gear fracture surface is displayed in Figure 41. This figure showed the directional and fibrous nature of most of the fracture surfaces. The material near the fracture surface, as exemplified in the right of the fracture in Figure 41, exhibited necking and material thinning. The bottom center left of the figure displays a small area with finer features.

**Figure 41.** Closer view of the fracture surface from the interior side of the magneto gear.

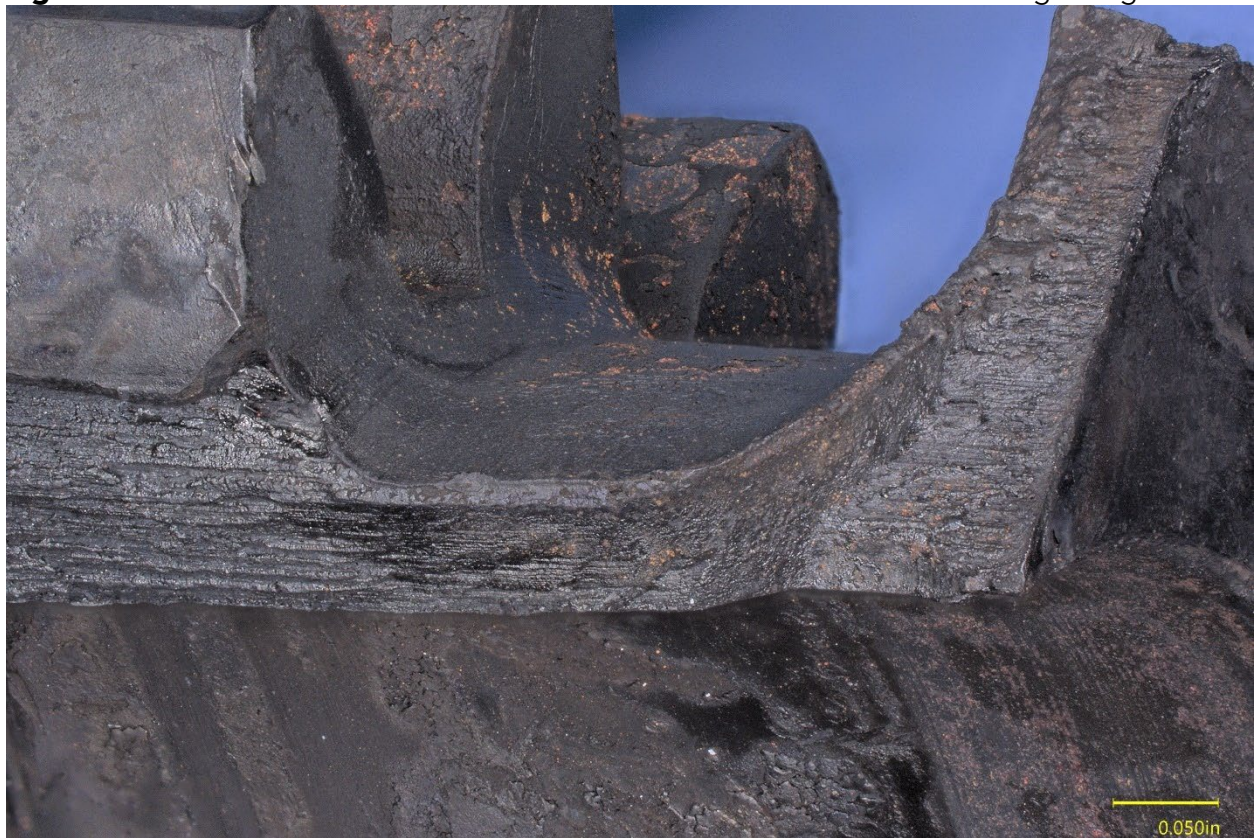
Figure 42 shows an area with a geometrical transition, exhibiting finer fracture features and curved river patterns consistent with fracture direction outward from the upper surface. These areas were examined after cleaning with a solution designed to remove high-temperature surface contamination of metal alloys.<sup>3</sup>

**Figure 42.** View of the opposite edge of the fracture surface from **Figure 41**.
