# National Transportation Safety Board

ERA24FA050

## **MATERIALS LABORATORY**

Factual Report 24-044

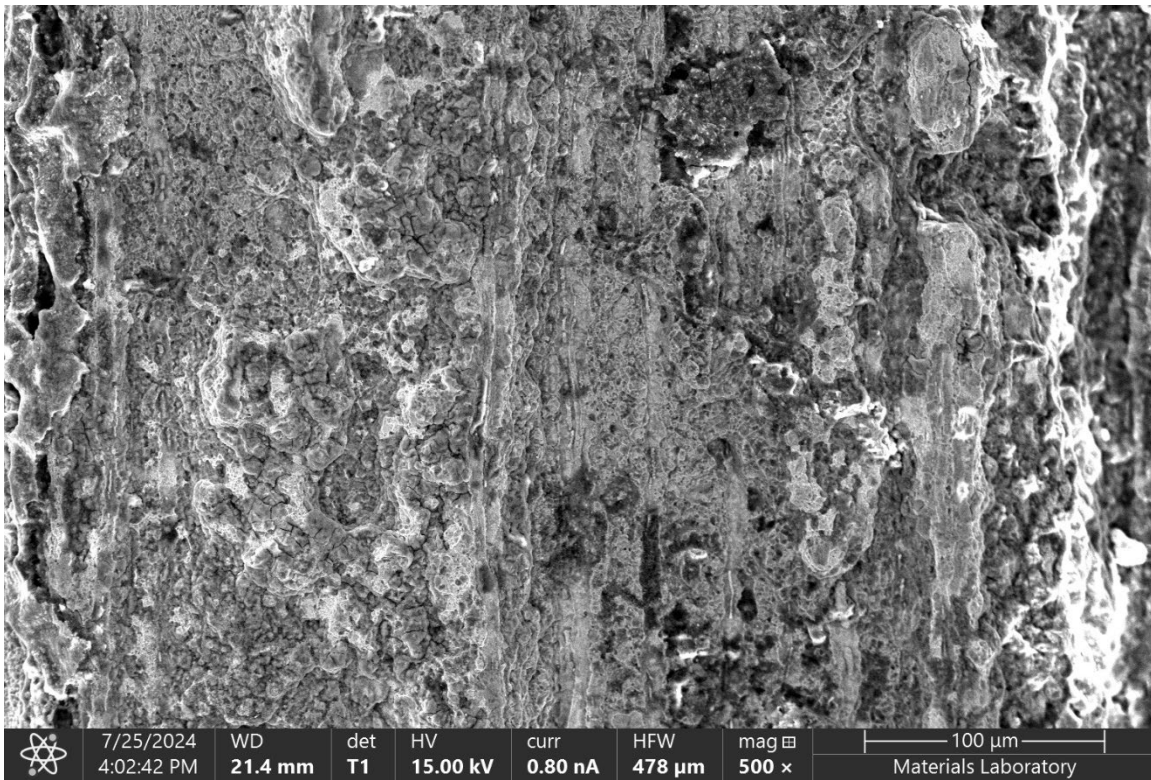
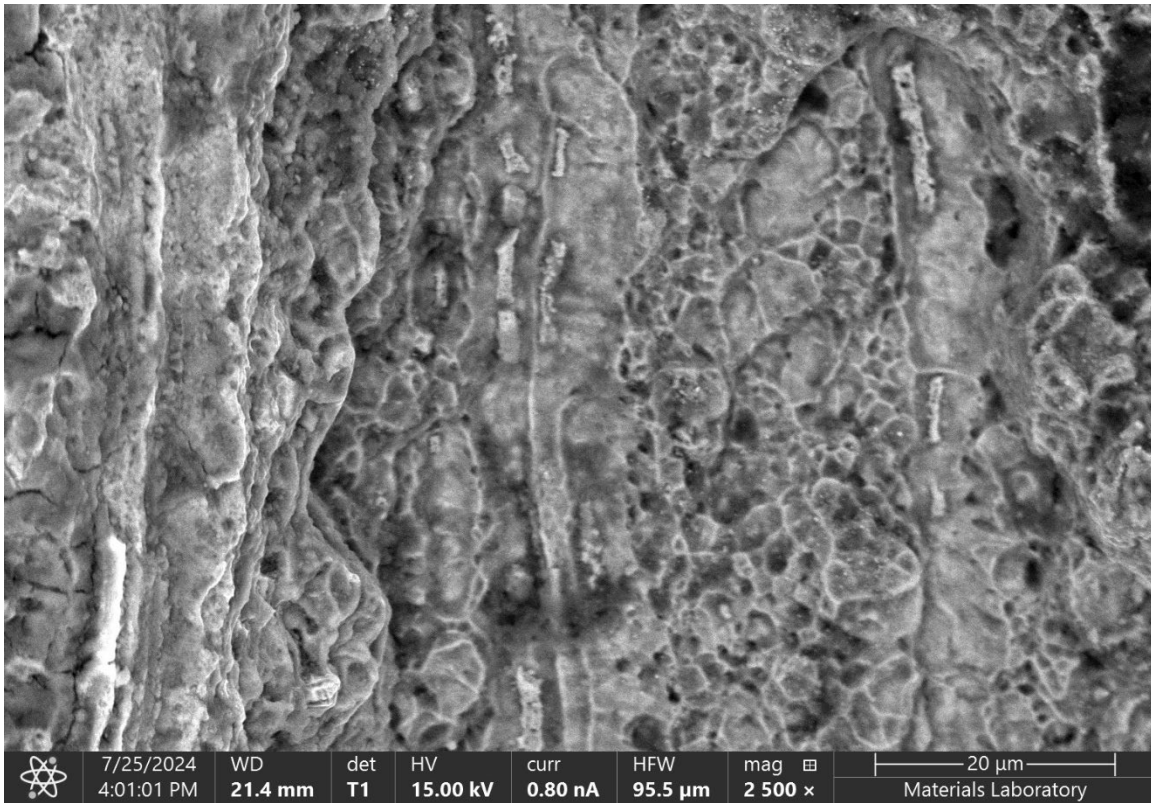
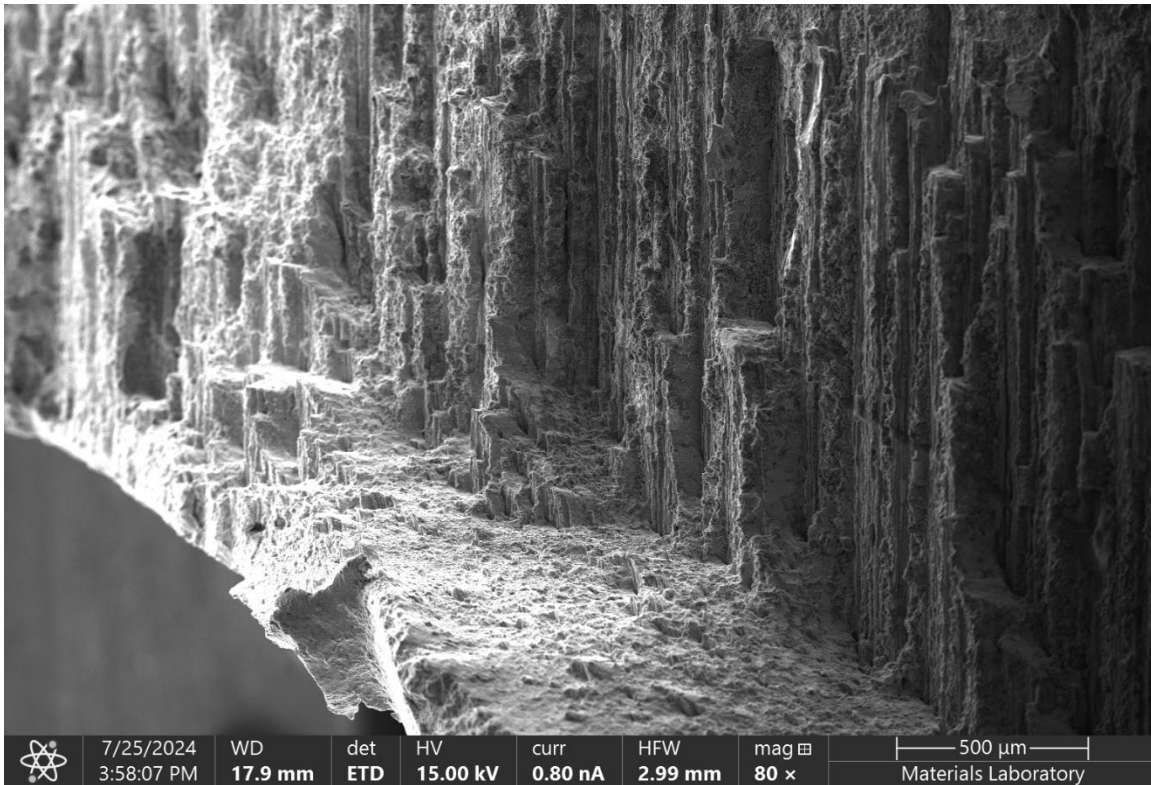
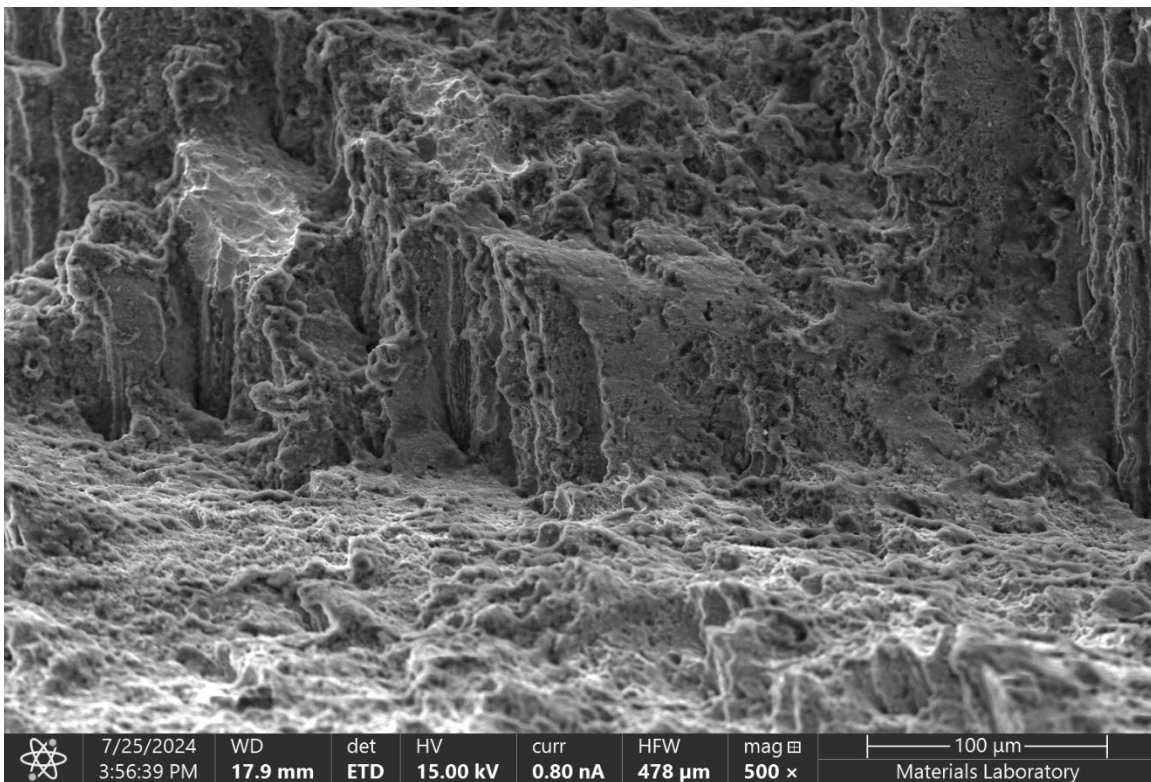
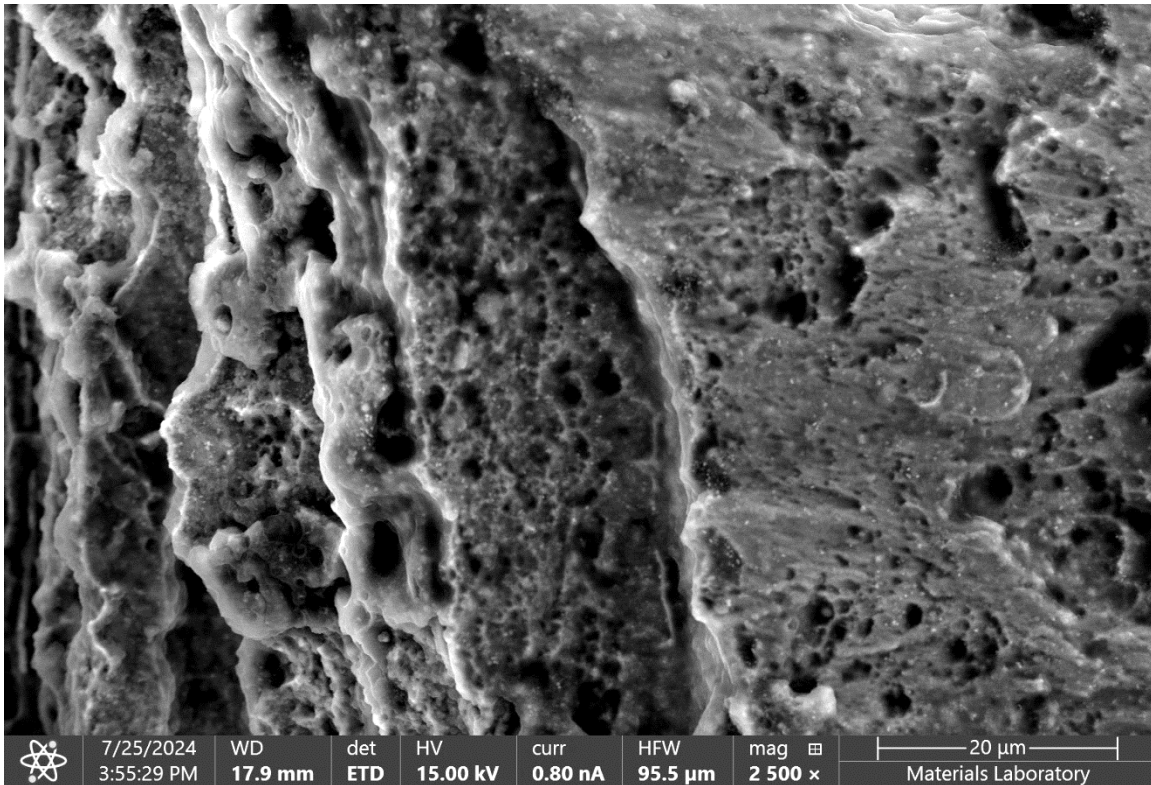
Figure 43 shows a typical area of the cleaned fracture from Figure 41. This area exhibited a mixed region of elongated dimples adjacent to manganese sulfide particles and finer, more equiaxed dimpled rupture, as illustrated in Figure 44. The area from Figure 42, where the river patterns emanate, is highlighted in Figure 45. This region shows an angled ridge with flatter, finer features adjacent to vertically oriented blockier, prismatic features. Figure 46 shows a closer view of this transition—on the angled area at the bottom of the figure, the fracture exhibited dimpled rupture, angled toward the upper left. A closer view of the prismatic region is shown in Figure 47. This region exhibited fine dimpled rupture and smearing, oriented toward the upper left. These areas were consistent with overstress fractures in tension and shear.

**Figure 43.** BE micrograph of the transition area in **Figure 42**.

**Figure 44.** SE micrograph of dimpled rupture from the area in **Figure 43**.

**Figure 45.** SE micrograph of the flat edge transition to the prismatic fracture features of the magneto gear fracture surface.

**Figure 46.** SE micrograph of the central area in the fracture surface in **Figure 45**.

**Figure 47.** SE micrograph of dimpled rupture on the ridges on the center of **Figure 46**.

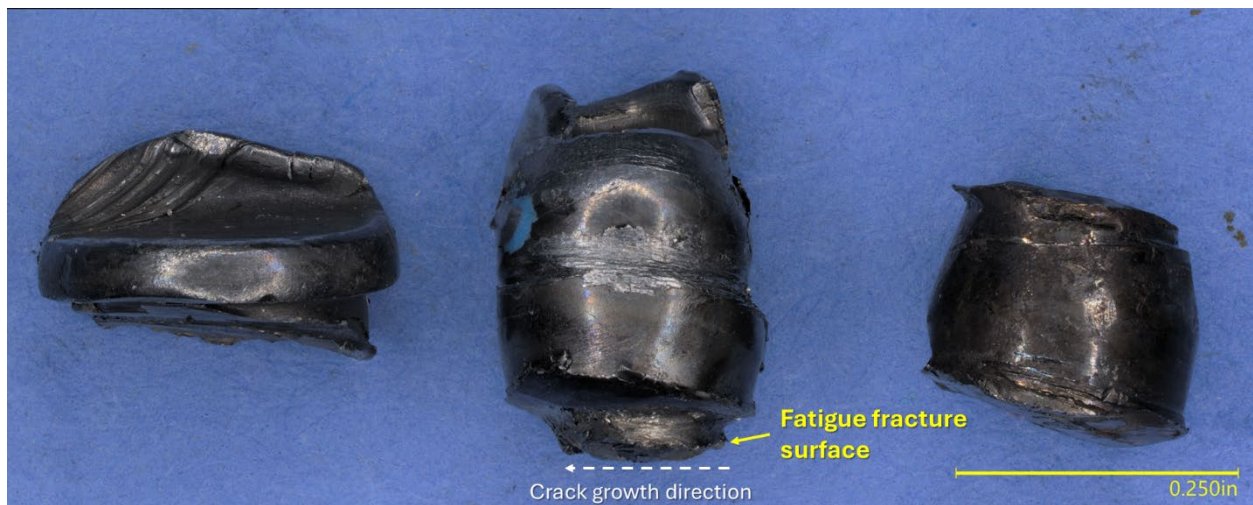
The remnants from magneto impulse hub assembly rivets are illustrated in Figure 48. The three remnants exhibited wear and impact damage as evidenced by plastic deformation, gouges, folds, and batter. As shown in Figure 48, each piece exhibited a fracture surface, with the middle remnant having two.

The width of the head or flange section of the left remnant in Figure 48 was 0.324 inches and the total combined length of all the three remnants was approximately 0.735 inches. The outer diameter of the shaft at the fracture location was 0.244 inches. This outer diameter width was consistent on all three remnants, ranging from 0.242 inches on the right remnant to 0.244 inches for the middle and left remnants.

**Figure 48.** Side view of the three fractured rivet remnants. The arrow denotes the location of the fatigue cracking.

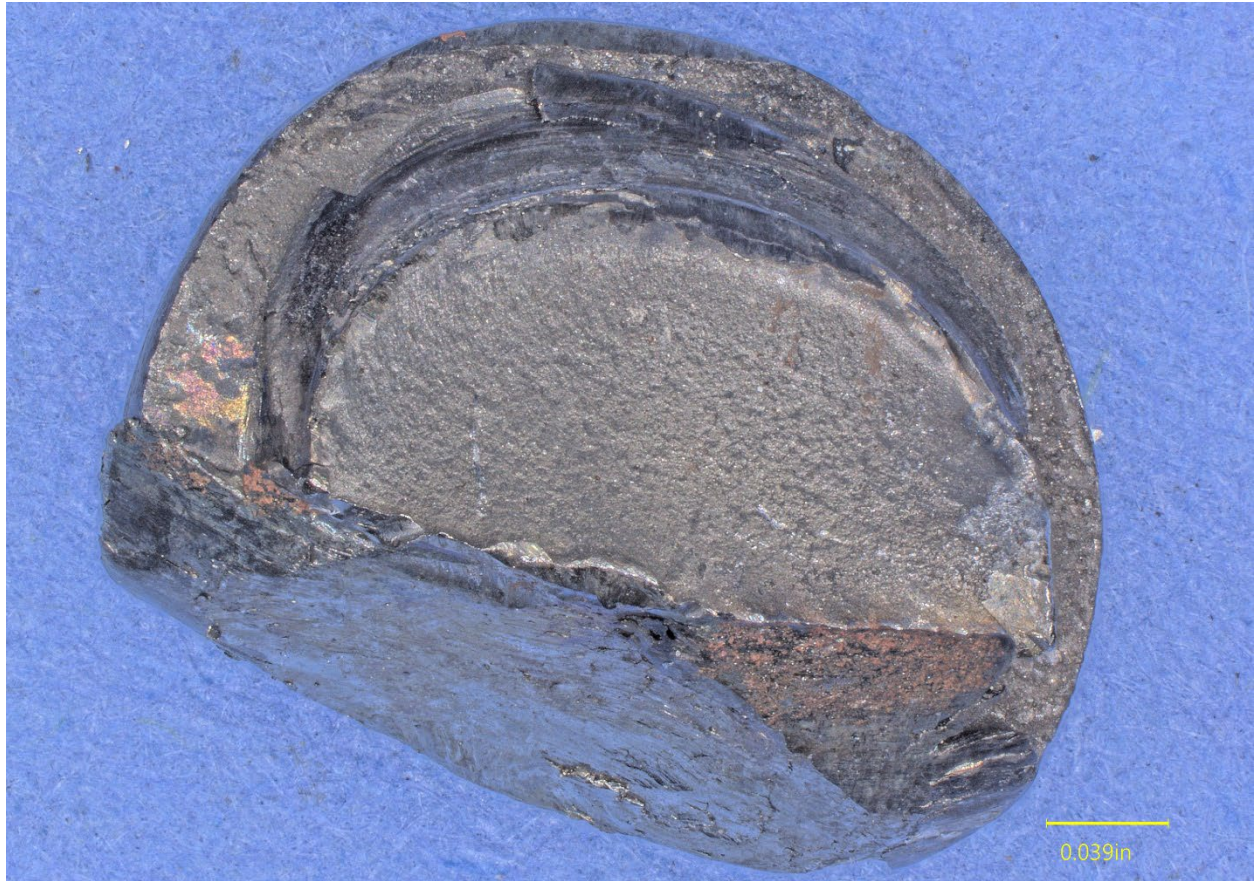
These fracture surfaces are shown in Figure 49 through Figure 51. Figure 49 shows the leftmost fracture near the flanged head. The bottom third of the remnant shown in Figure 49 was absent. This surface was entirely obliterated from wear damage. The remainder of the fracture surface exhibited a dull, fibrous appearance. This surface exhibited swirling river patterns, shear lips along the periphery, and outward bending on the top side surface. Examination in a SEM found dimpled rupture. These features were consistent with overstress fracture in multiple loading directions.

**Figure 49.** The fracture surface of the remnant near the rivet head (left in **Figure 48**).

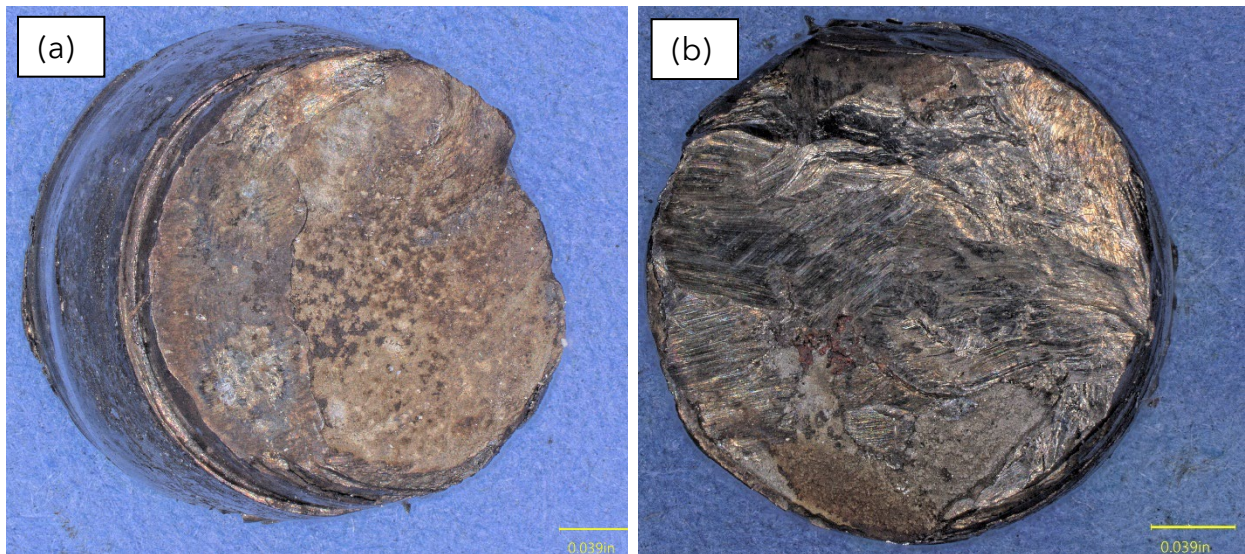
Figure 50 shows the different surfaces of the middle remnant. The bottom side, as positioned in Figure 48, had been entirely obliterated, as shown by Figure 50b. The opposite surface, shown in Figure 50a, exhibited a surface oxidation layer and features that were rough and fibrous. This surface was examined using an SEM, revealing dimpled rupture, both equiaxed and slanted. These features were consistent with overstress fracture.

**Figure 50.** The (a) top and (b) bottom fractures of the middle remnant in **Figure 48**.

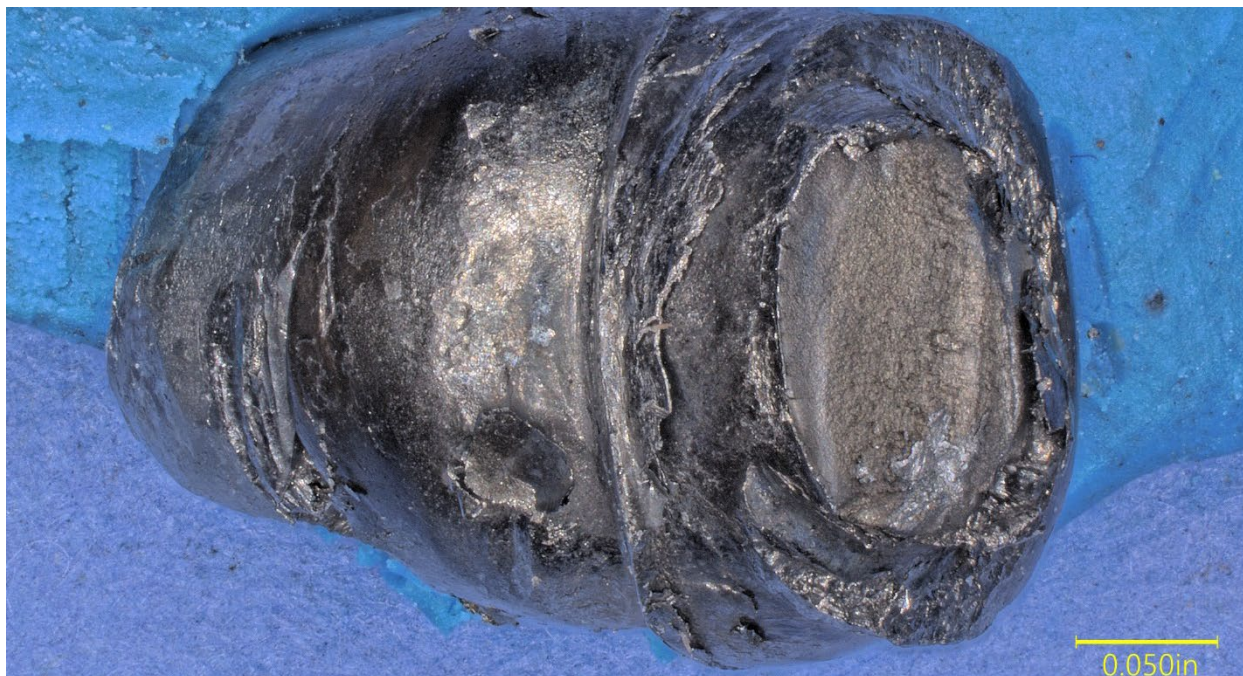
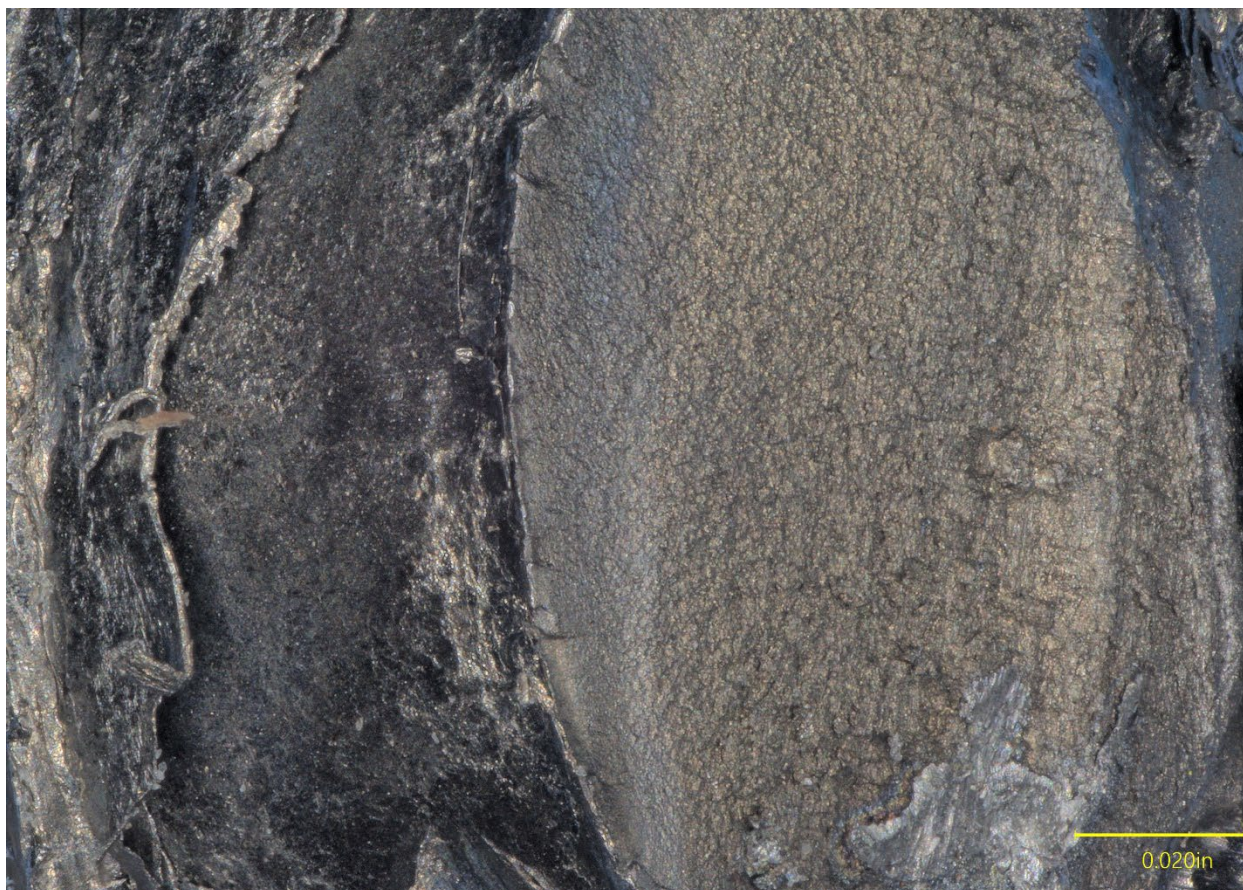
The right remnant fracture surface is illustrated in Figure 51. Most of the sides of the remnant exhibited plastic deformation, gouges, and batter, consistent with post-fracture damage against other metallic components. The ovoid region to the figure's right exhibited features consistent with progressive cracking. Figure 52 shows a closer view of this part of the fracture surface, exhibiting crack arrest and ratchet marks.

**Figure 51.** Angled view of the left fracture of the right remnant in **Figure 48**.

**Figure 52.** Closer view of the left edge of the fracture surface in **Figure 51**, showing ratchet marks and crack arrest marks.

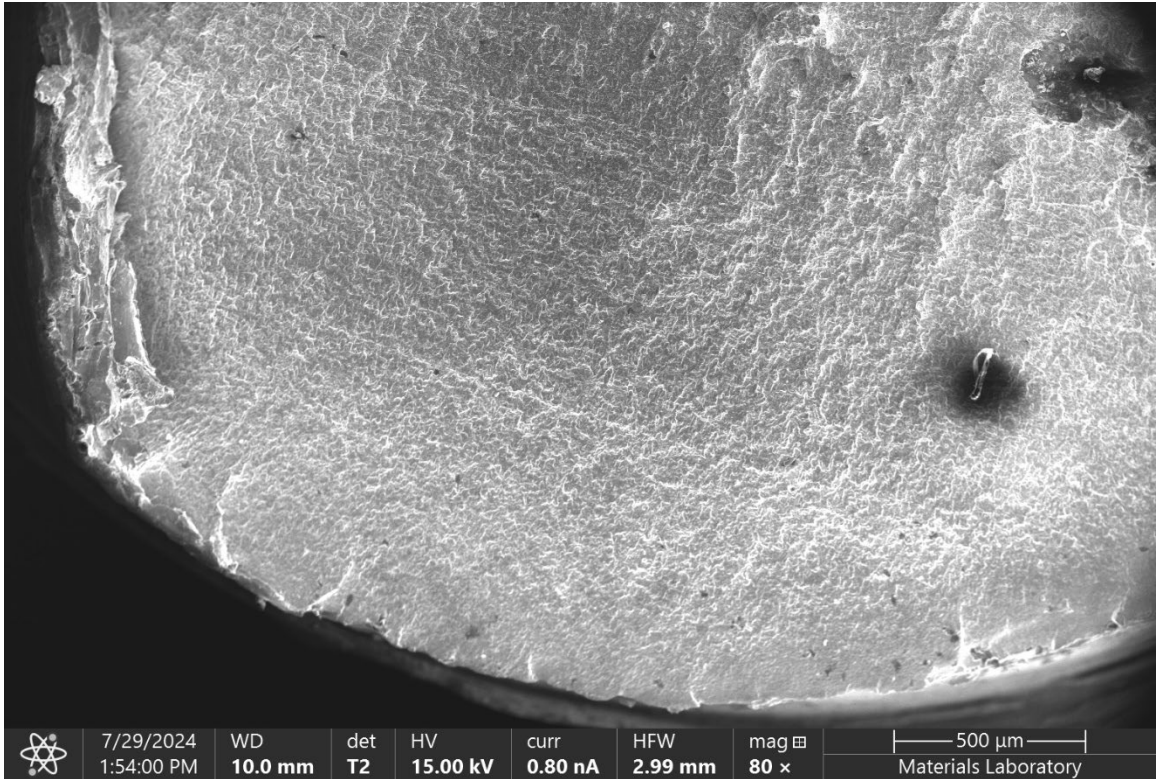
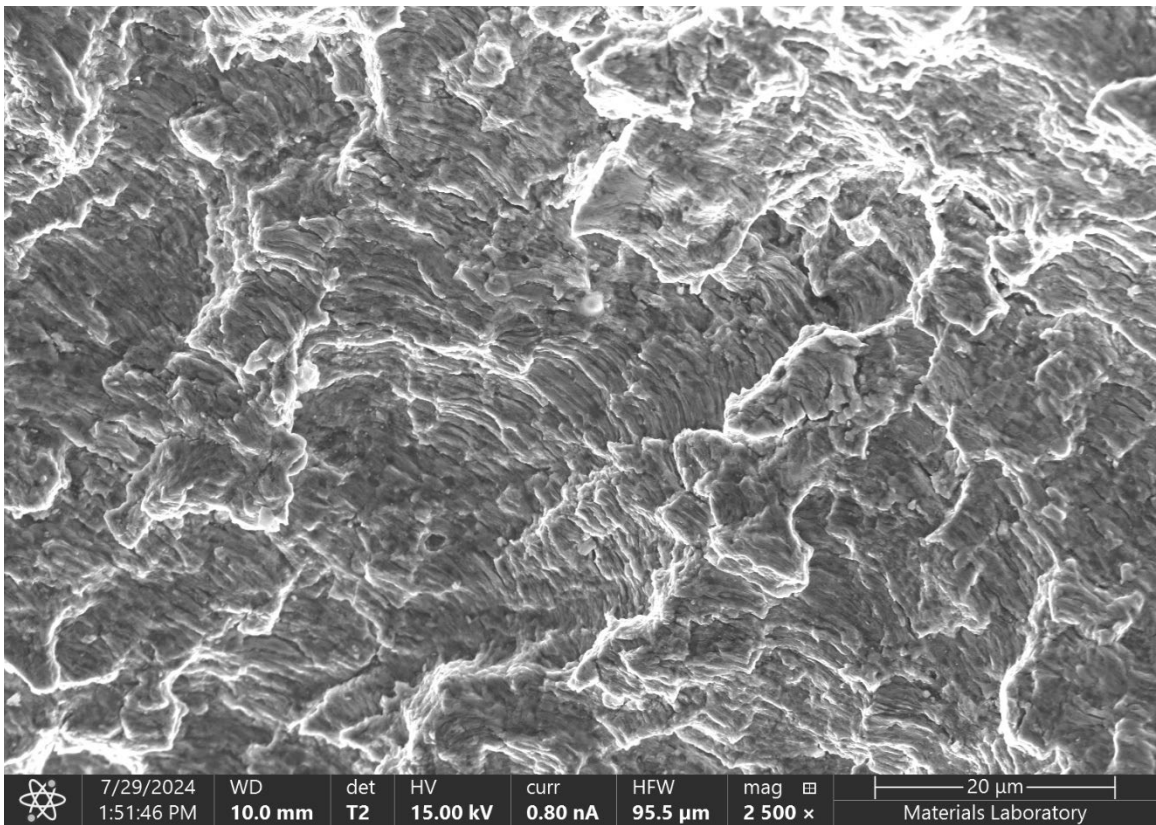
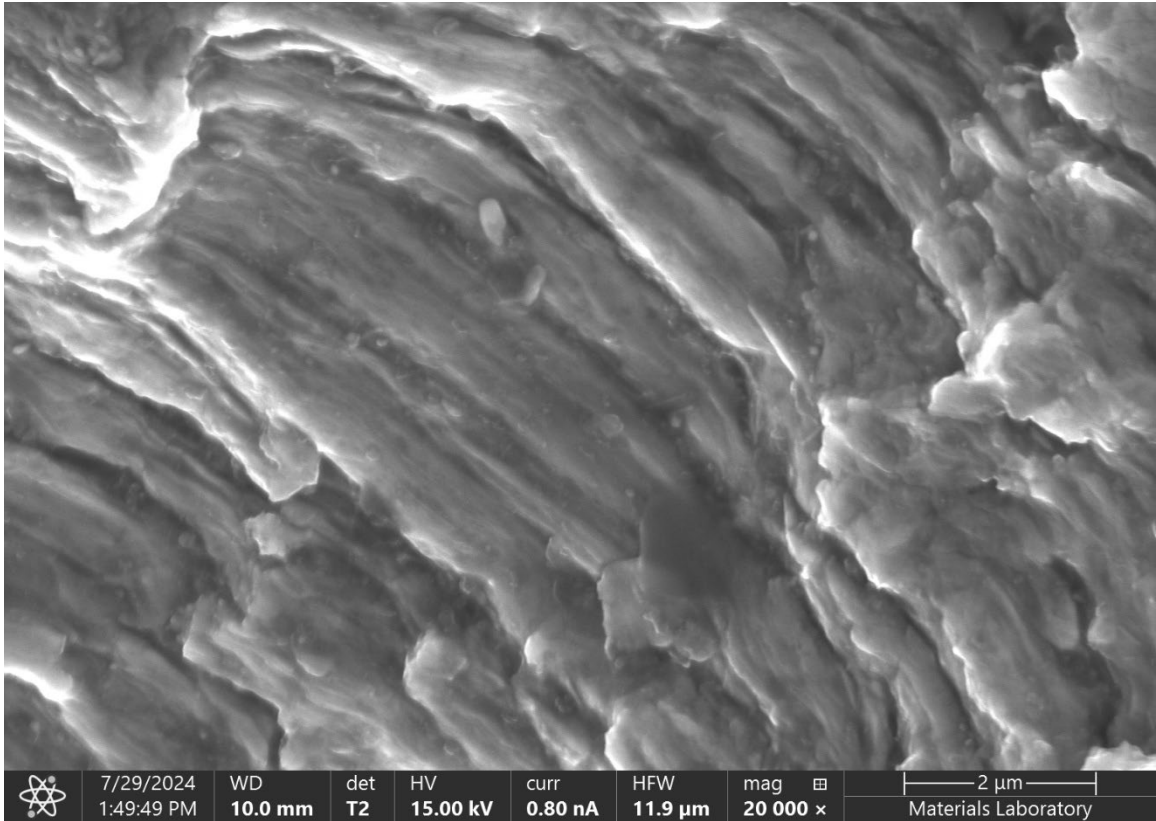
Examination using a SEM shows these crack arrest and ratchet marks (Figure 53). The ratchet marks, indicative of multiple crack initiation sites, were located along the edge of the fracture surface. A closer view of the fracture surface revealed fatigue striations as shown in Figure 54 and Figure 55. These features were consistent with fatigue crack propagation.

**Figure 53.** SE micrograph of the remnant fracture surface, from the edge.

**Figure 54.** SE micrograph of fatigue striations on the remnant fracture surface.

**Figure 55.** SE micrograph of a closer view of the striations in **Figure 54**.

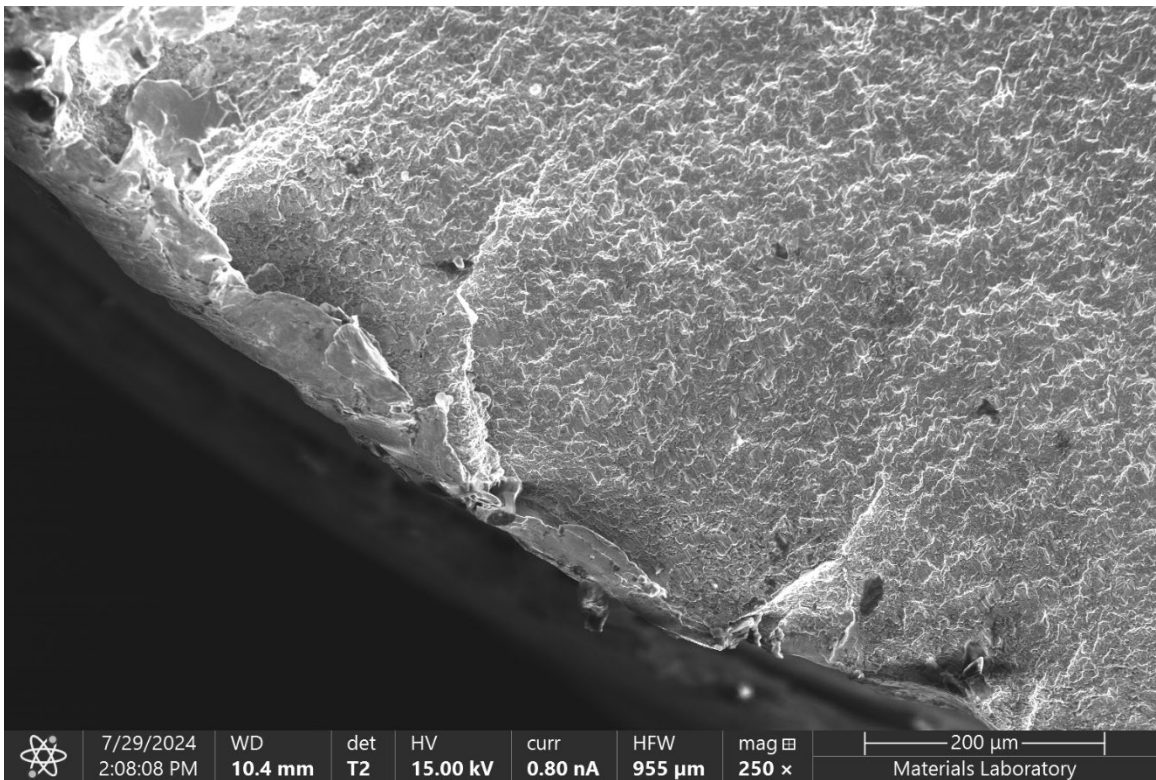
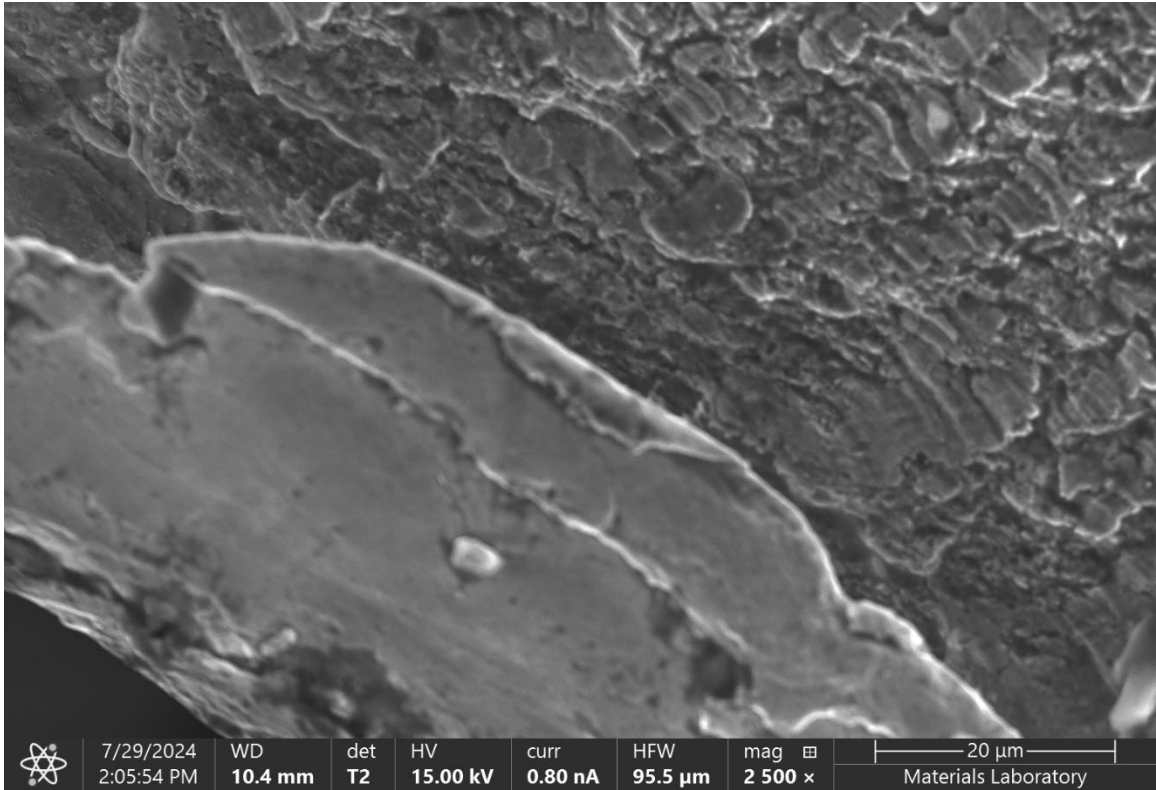
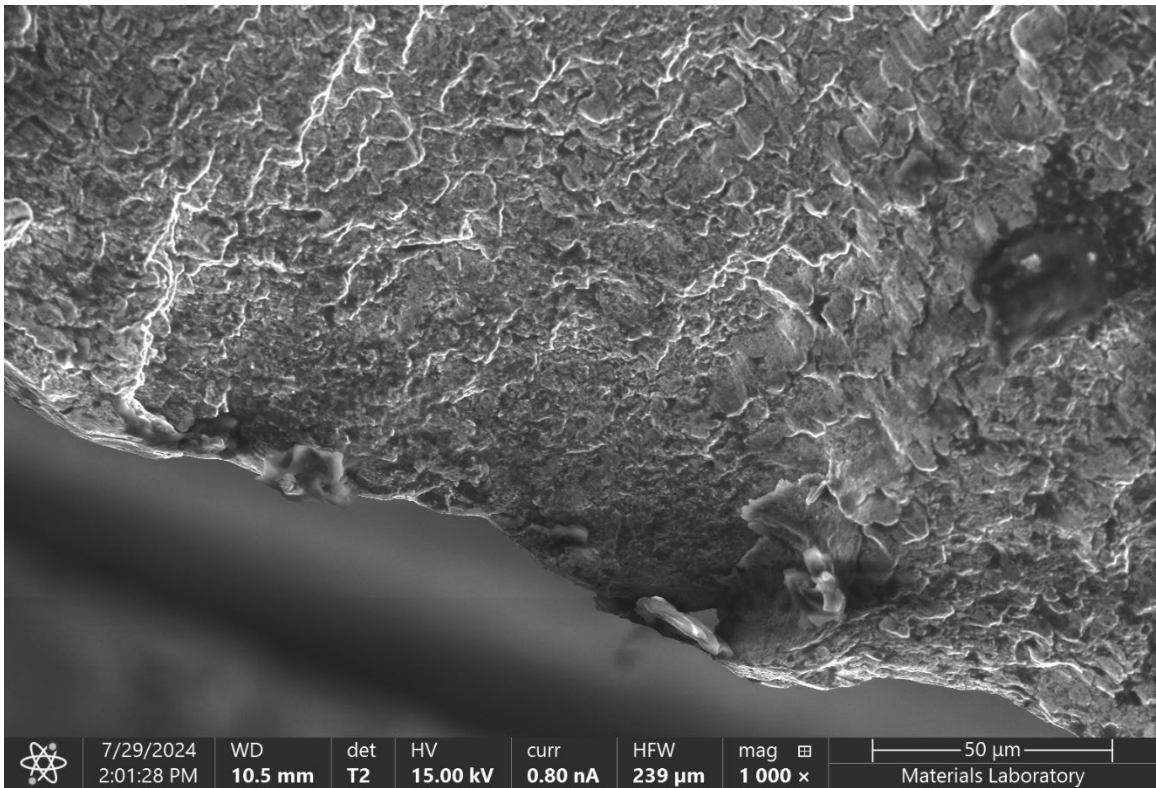
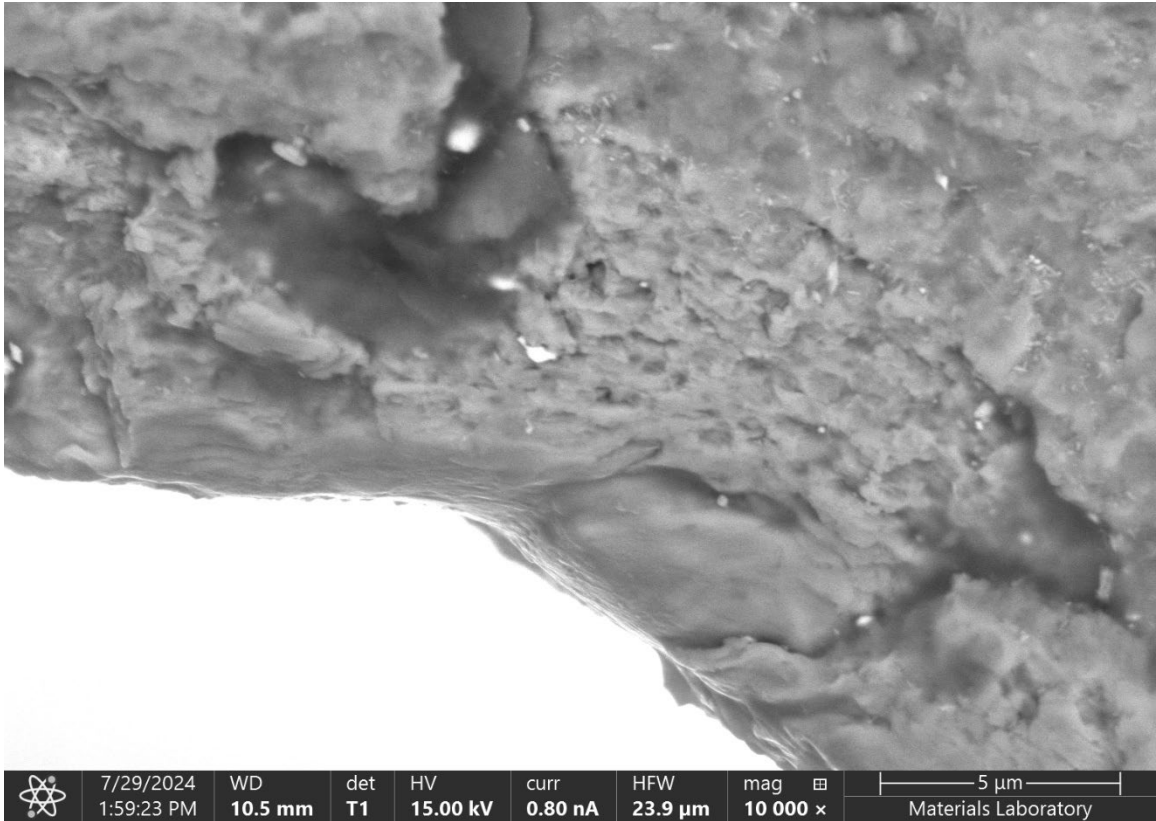
Figure 56 shows ratchet marks separating individual crack initiation sites along the surface. Each of these initiation sites exhibited upward-facing areas of local plastic deformation. Figure 57 shows a closer view of the middle crack initiation site from Figure 56. This site contained the upward-oriented deformation (out of focus in Figure 57) and fatigue striations, propagating from the location. Figure 58 shows a different initiation site, absent a surface deformation feature. In this case, there was a small depression at the surface edge, with striations emanating from the location. A closer view in Figure 59 did not reveal any dissimilar material at the divot on the surface. Fine striations could be seen propagating from the rounded divot.

**Figure 56.** SE micrograph of several crack initiation sites on the remnant fracture edge.

**Figure 57.** SE micrograph of the central initiation site at an area of plastic deformation in **Figure 56**.

**Figure 58.** SE micrograph of the rightmost initiation site in **Figure 56**.

**Figure 59.** BE micrograph a closer view of the initiation site in **Figure 58**.
