# National Transportation Safety Board

ERA24FA050

## **WRECKAGE EXAMINATION SUMMARY**

Location: Attalla, Alabama  
Date: November 27, 2023  
Time: 1748 CST  
2348 coordinated universal time (UTC)  
Airplane: N4187Q, Piper PA-32R-301T

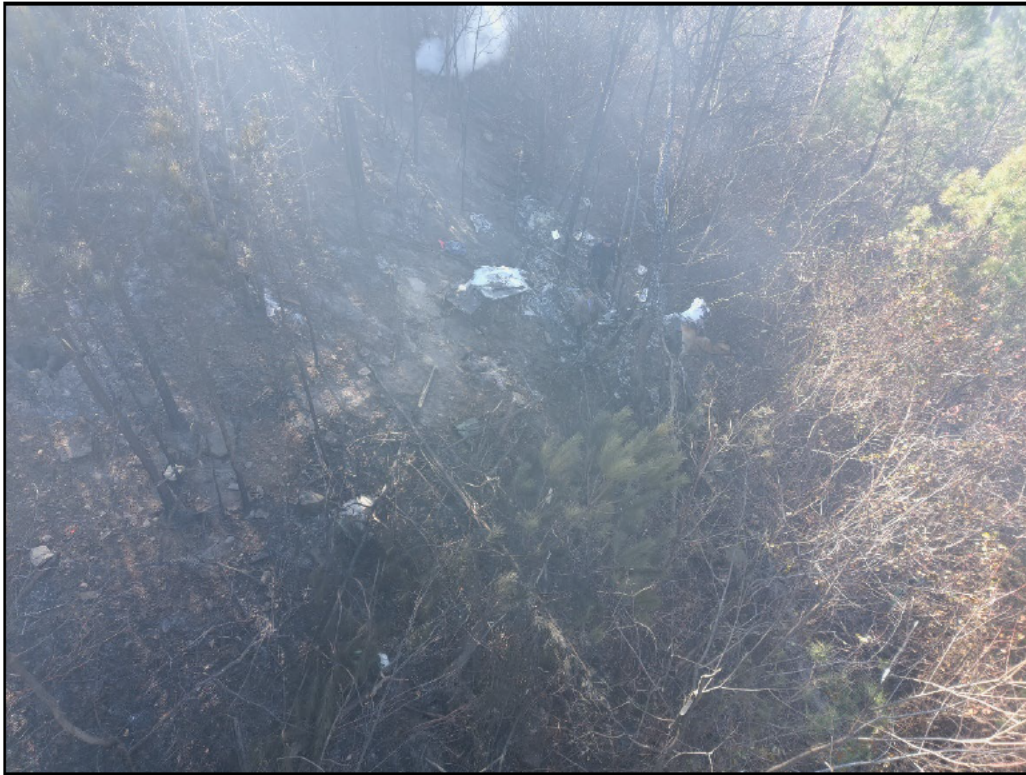
Examination of the accident site revealed the airplane impacted in heavy wooded mountainous terrain (Figure 7).

**Figure 7 Drone Image Showing Wreckage and Accident Site**

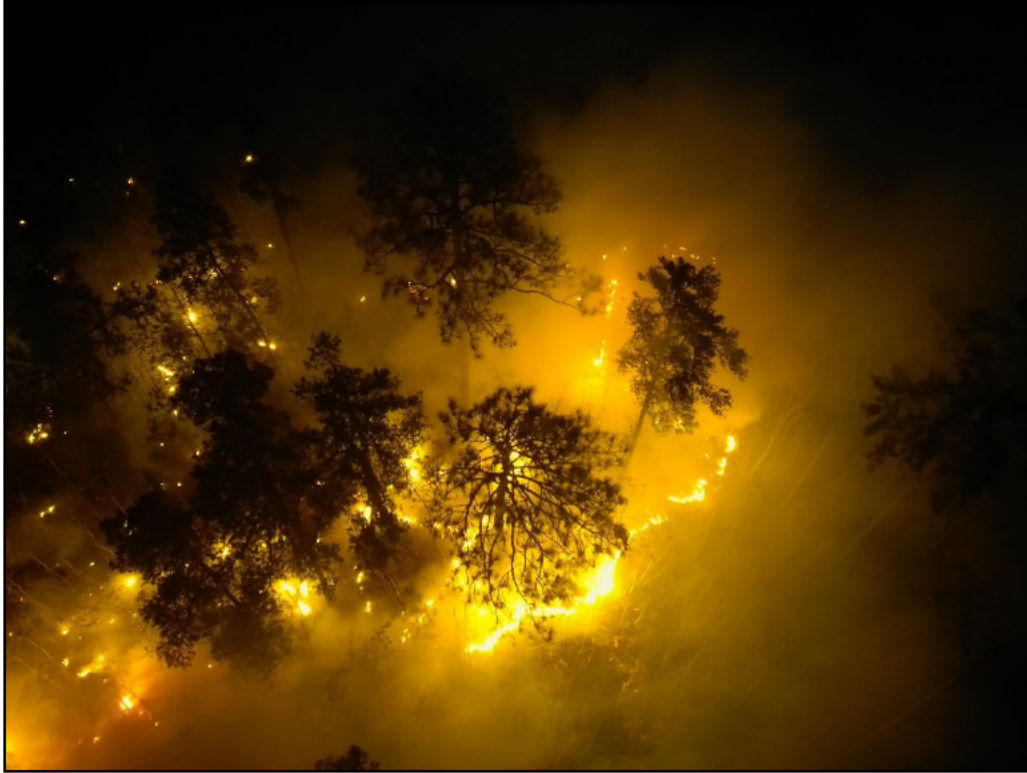
The post impact fire started a forest fire which burned several acres (Figure 8). Small fires remained burning throughout the on-site examination.

**Figure 8 Drone Image Taken About 1 Hour After Accident Showing Fire**

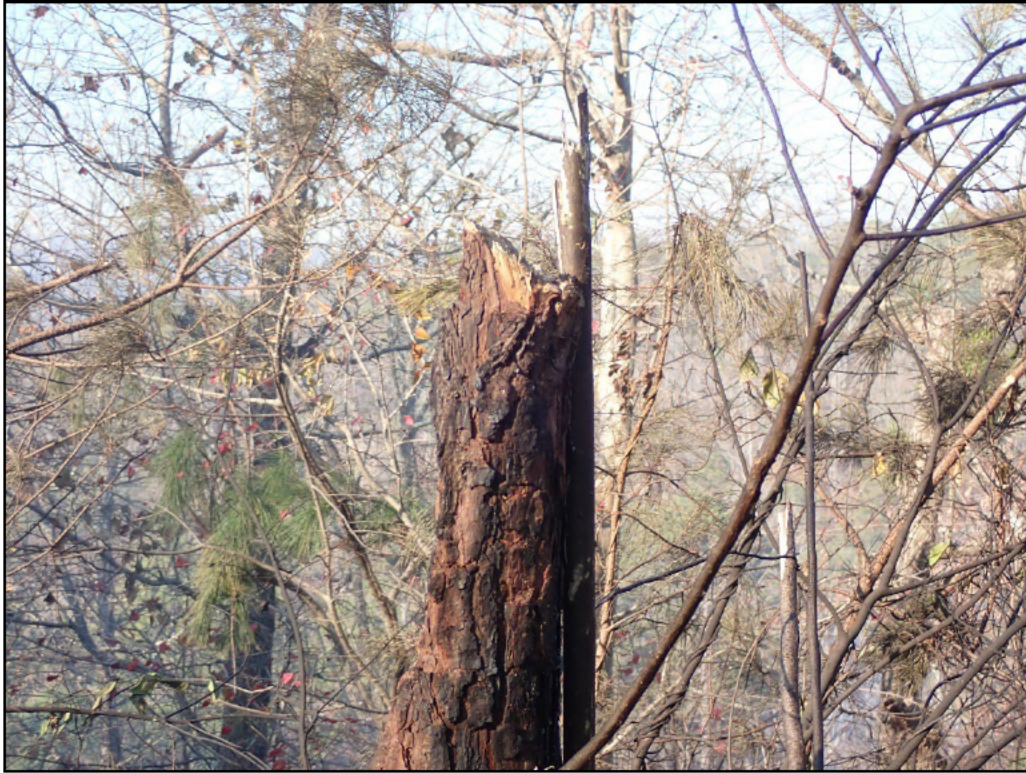
Further examination of the accident site from the 1st impacted tree to the resting position of the main wreckage revealed impacted damaged trees at decreasing heights of about a 10° slope. The damage was consistent with being wings level. One tree trunk exhibited a 45° slash mark (Figure 9).

**Figure 9 View of Tree with 45 Degree Slash**

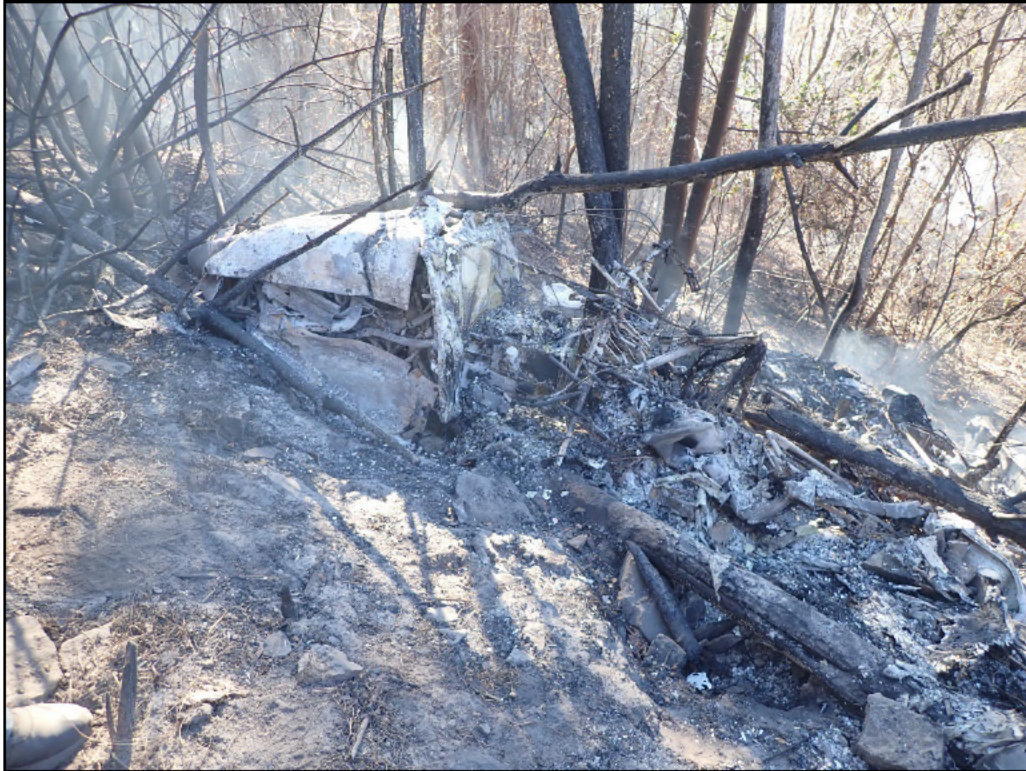
Examination of the wreckage revealed fire damage nearly consumed the cockpit, cabin, and empennage up to about 60 inches forward of the leading edge of the stabilator (Figure 10).

**Figure 10 Left Side View of the Remains of the Cockpit, Cabin, and Engine Assembly with Attached Propeller.**

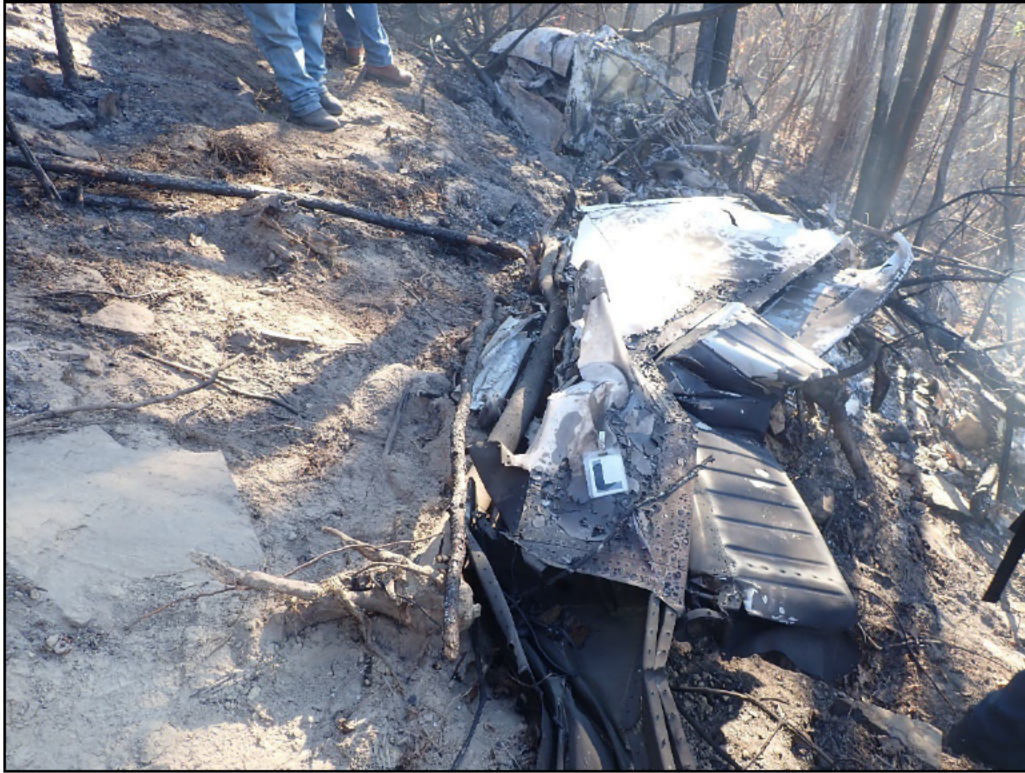
Examination of the remaining section of left wing (Figure 11) revealed it was separated at the root and displayed downward bending on the top and bottom spar caps of the main spar. Major leading-edge impact was noted approximately 60 inches outboard of the main gear attachment. The left aileron consisted of 2 pieces. One piece, the outer section, measuring 15 inches in length was bent up and aft and was torn from the inboard portion and was not attached to the wing. About 40 inches of the outboard end of the left flap was not attached but recovered. The inboard end of the flap was not recovered. The pitot tube remained attached to the wing.

**Figure 11 View of the Remains of the Left Wing**

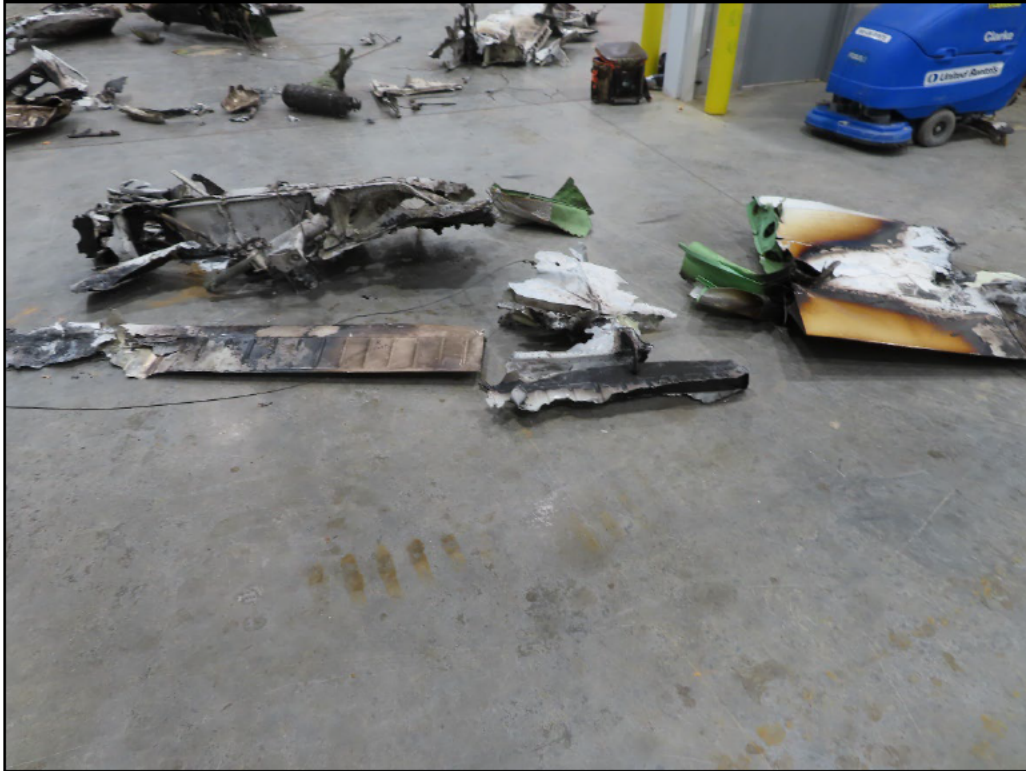
Examination of the remaining section of the right wing (Figure 12) revealed multiple semi-circular indentations on the leading edge consistent with tree strikes; the indentations were of varying diameters. One such tree strike was located 54 inches outboard of the wing root and directly in front of the main fuel tank which breached the fuel tank. The fuel tank outlet finger screen appeared clean.

**Figure 12 Remaining Sections of Right Wing, Landing gear, and Sections of Flap and Aileron**

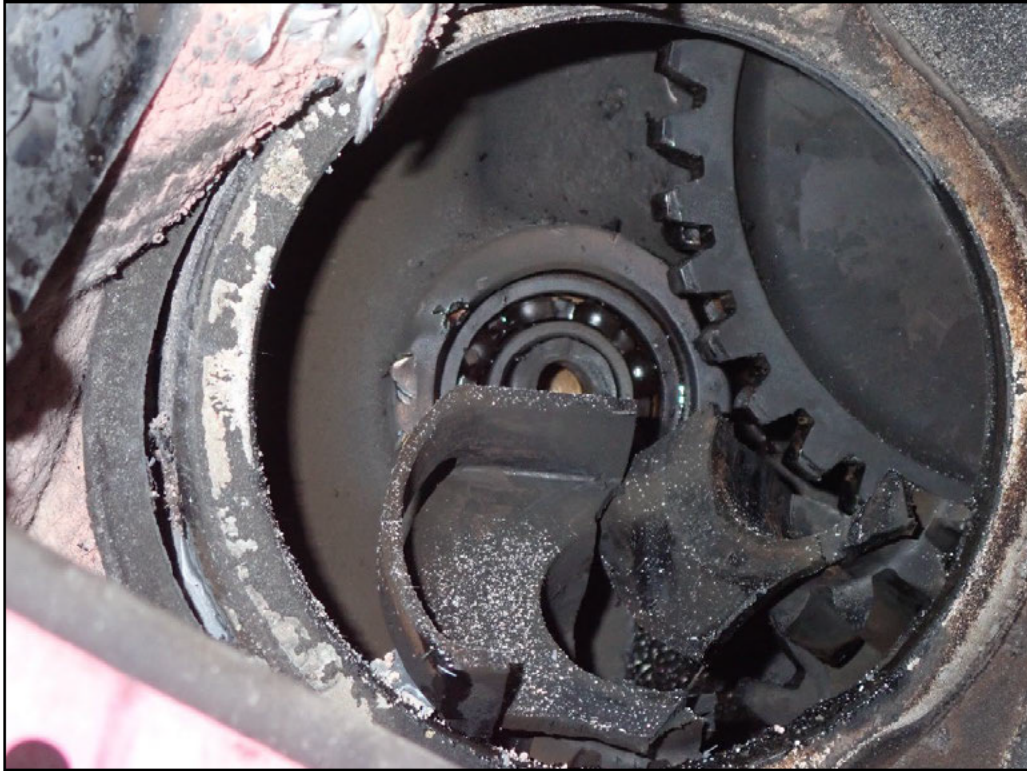
Following removal of the heat damaged left magneto which was retained for further examination by the NTSB Materials Laboratory, the left gear retainer assembly, part number (P/N) LW-19096 was fractured (Figure 13), and the cushions were damaged. Also, the left crankshaft idler gear assembly, P/N 71668 and the fuel pump idler gear assembly, P/N 71664 exhibited damaged or missing teeth (Figure 14).

**Figure 13 View Showing the Fractured Left Gear Retainer**

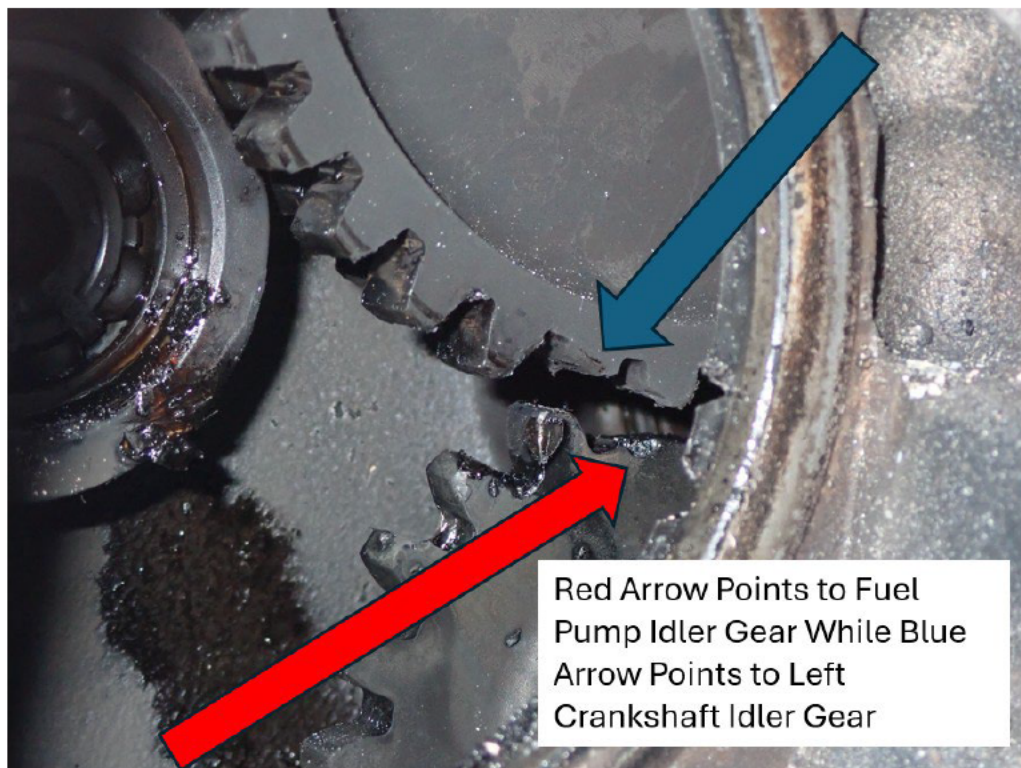
**Figure 14 View of Damaged Teeth of Fuel Pump Idler Gear and Left Crankshaft Idler Gear**

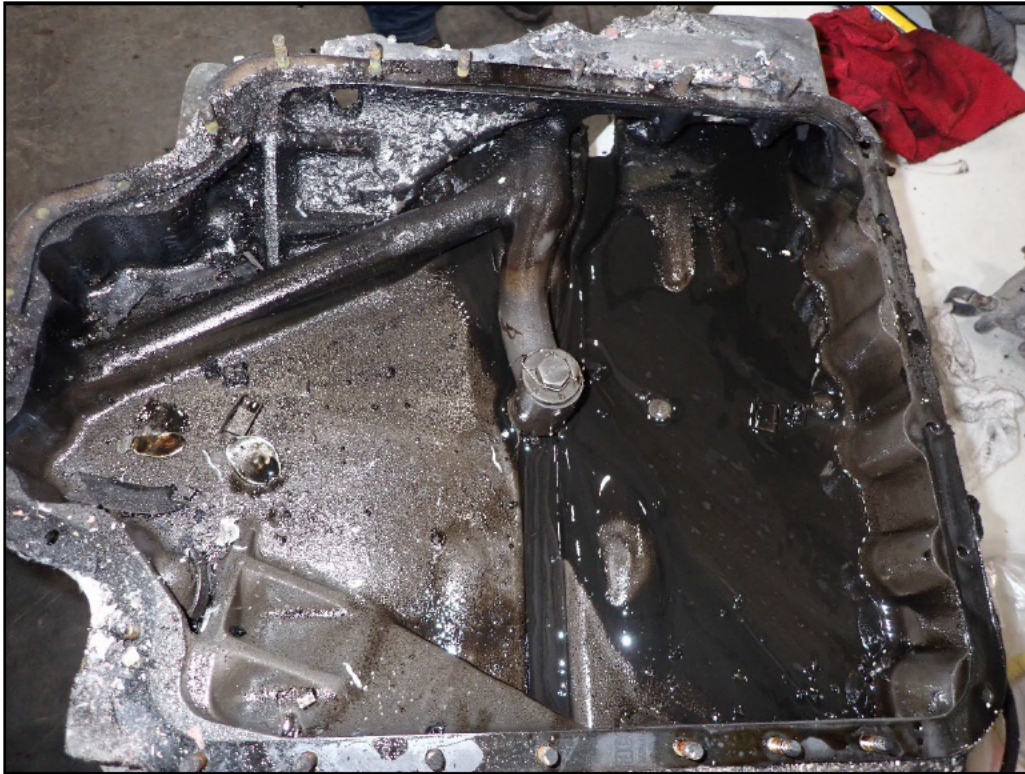
Following removal of the oil sump, debris was noted inside it including sections of the cushion from the left magneto (Figure 15). Debris that was ferrous was collected and retained for examination by the NTSB Materials Laboratory (Figure 16).

**Figure 15 View of Debris Inside Oil Sump**

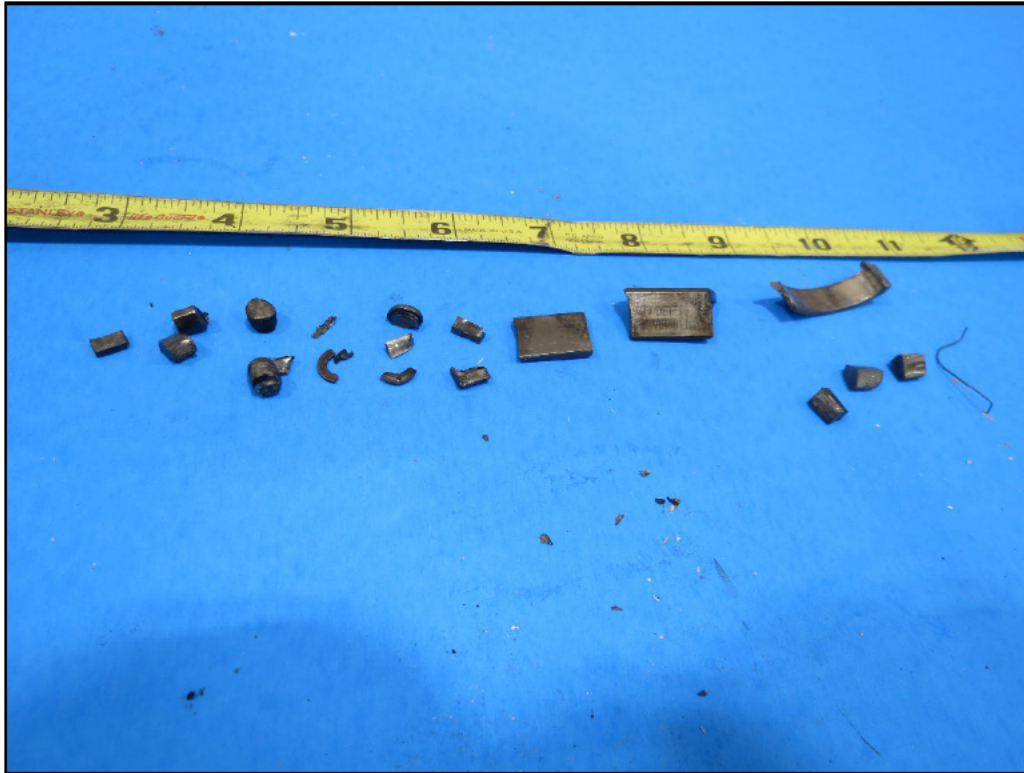
**Figure 16 Ferrous Debris Retained From Oil Sump**

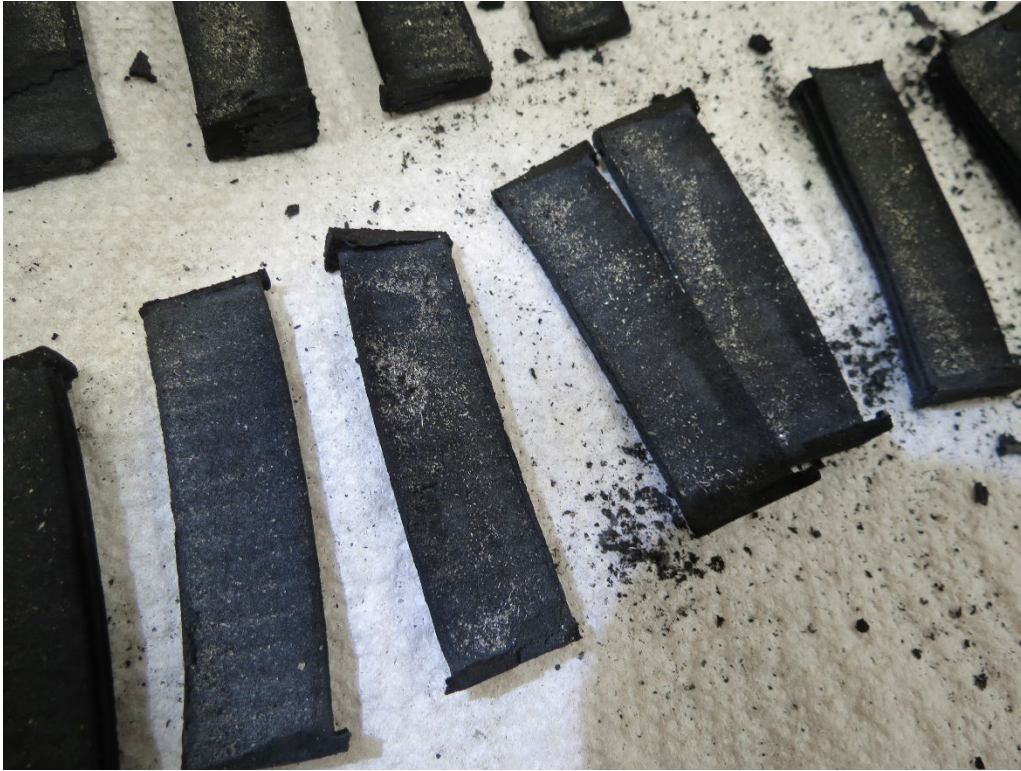
Examination of the heat damaged oil filter revealed the filter element was charred but a small amount of ferrous material was noted on the filter element (Figure 17).

**Figure 17 View of Debris on Oil Filter Element**

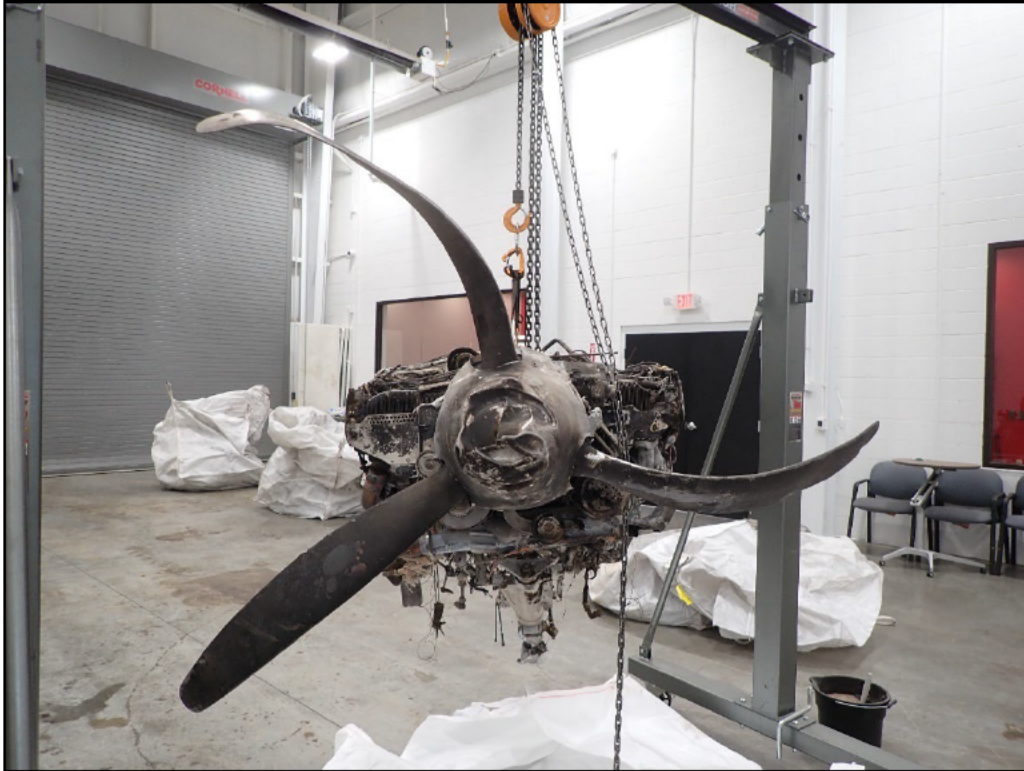
The propeller remained attached to the engine and all three blades remained secured inside the propeller hub (Figure 18).

**Figure 18 Forward View of the Propeller and Engine Assemblies**
