ERA24FA050

## INVESTIGATION PHOTOGRAPHS

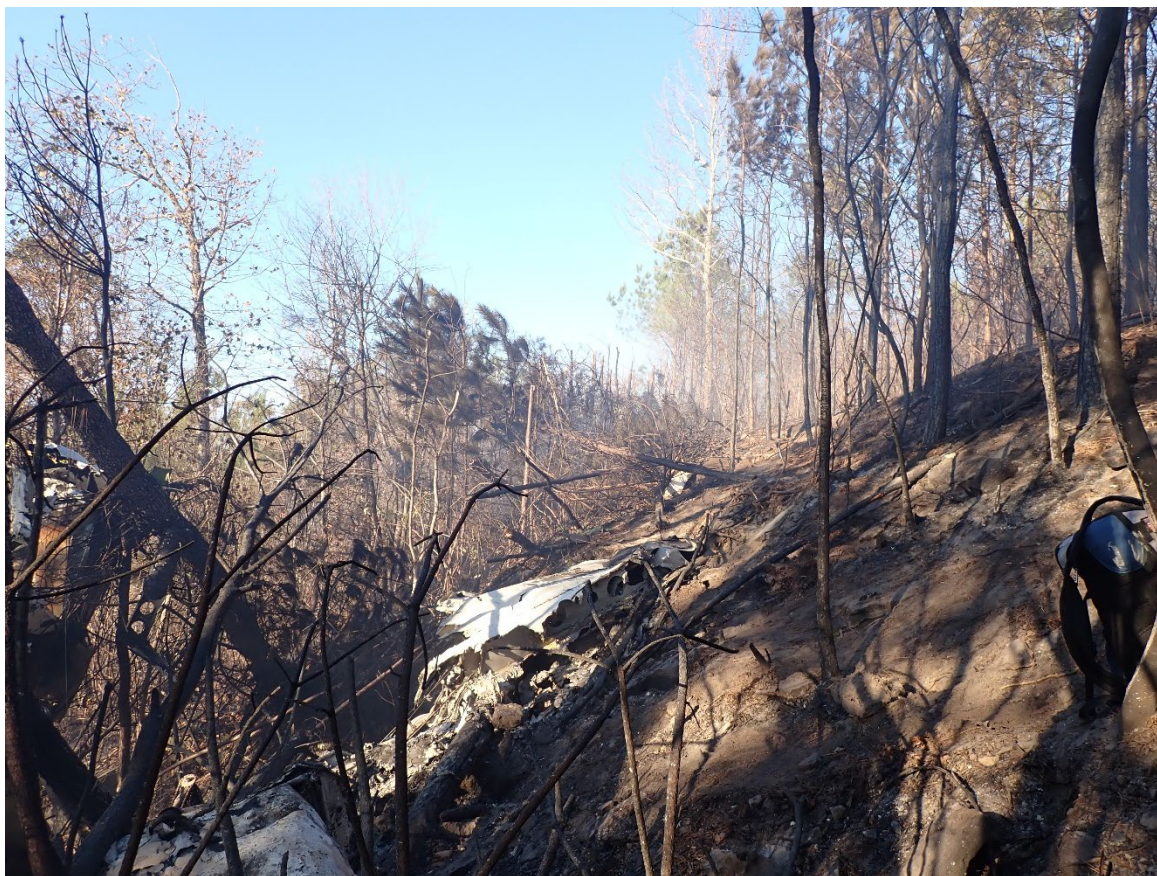
**Photograph 1 - NTSB Digital Photograph. View Looking From Main Wreckage Towards Impacted Trees**

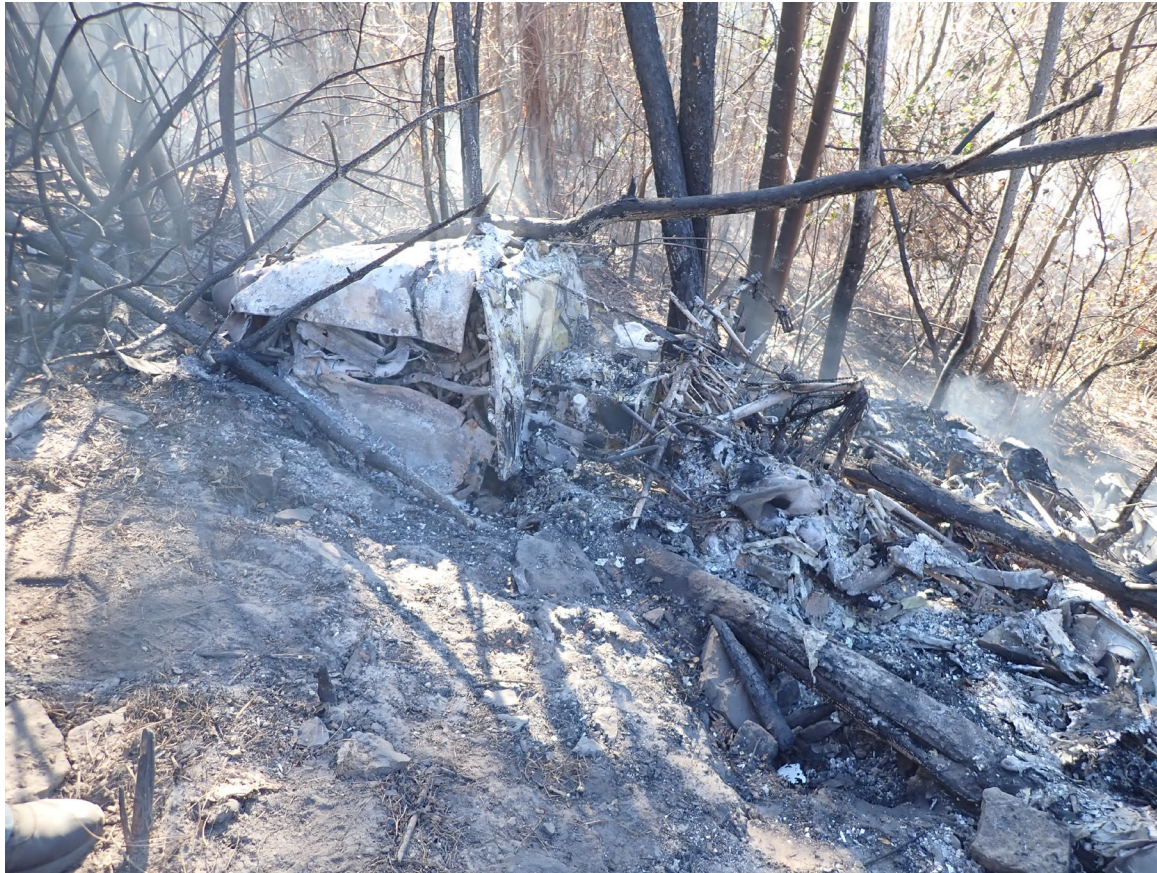
**Photograph 2 - NTSB Digital Photograph. Left Side View of the Engine Assembly with Attached Propeller, Cockpit and Cabin Areas**

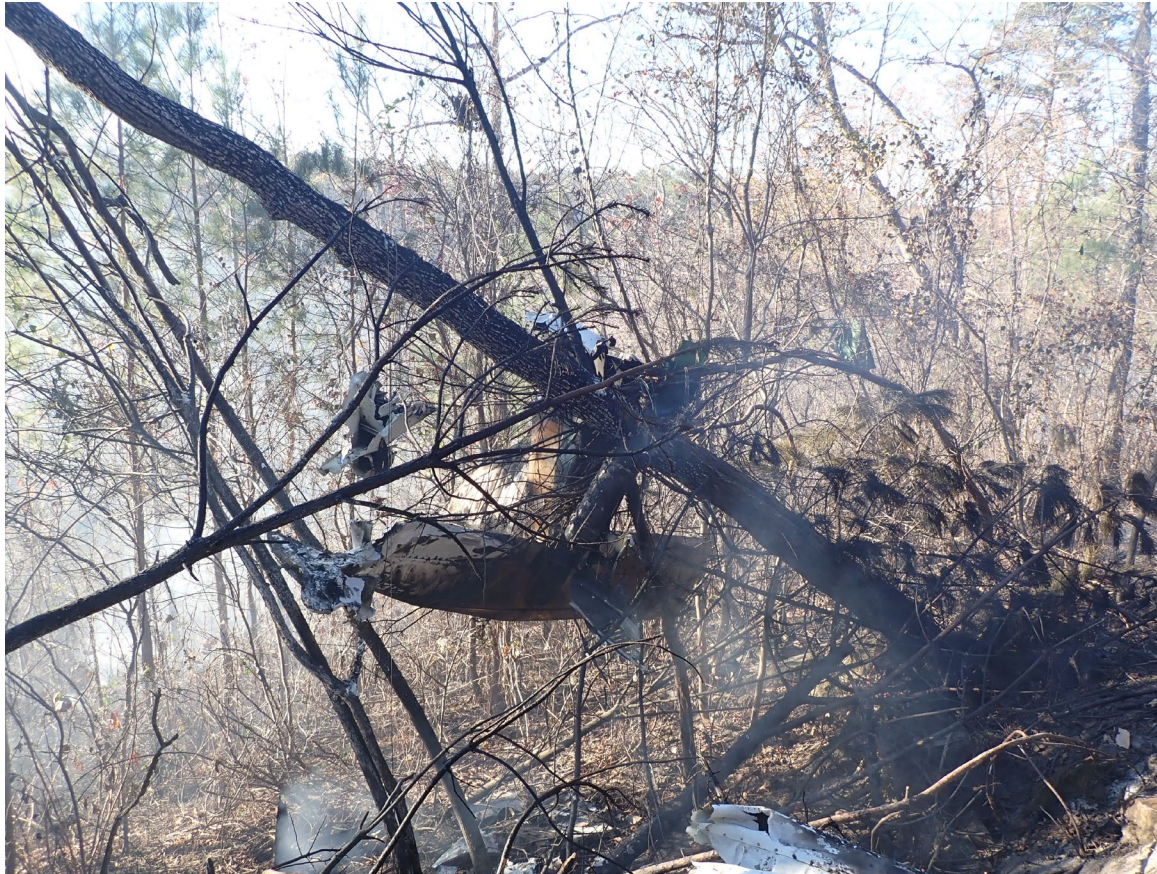
**Photograph 3 - NTSB Digital Photograph. View of the Aft Empennage Suspended in Tree**

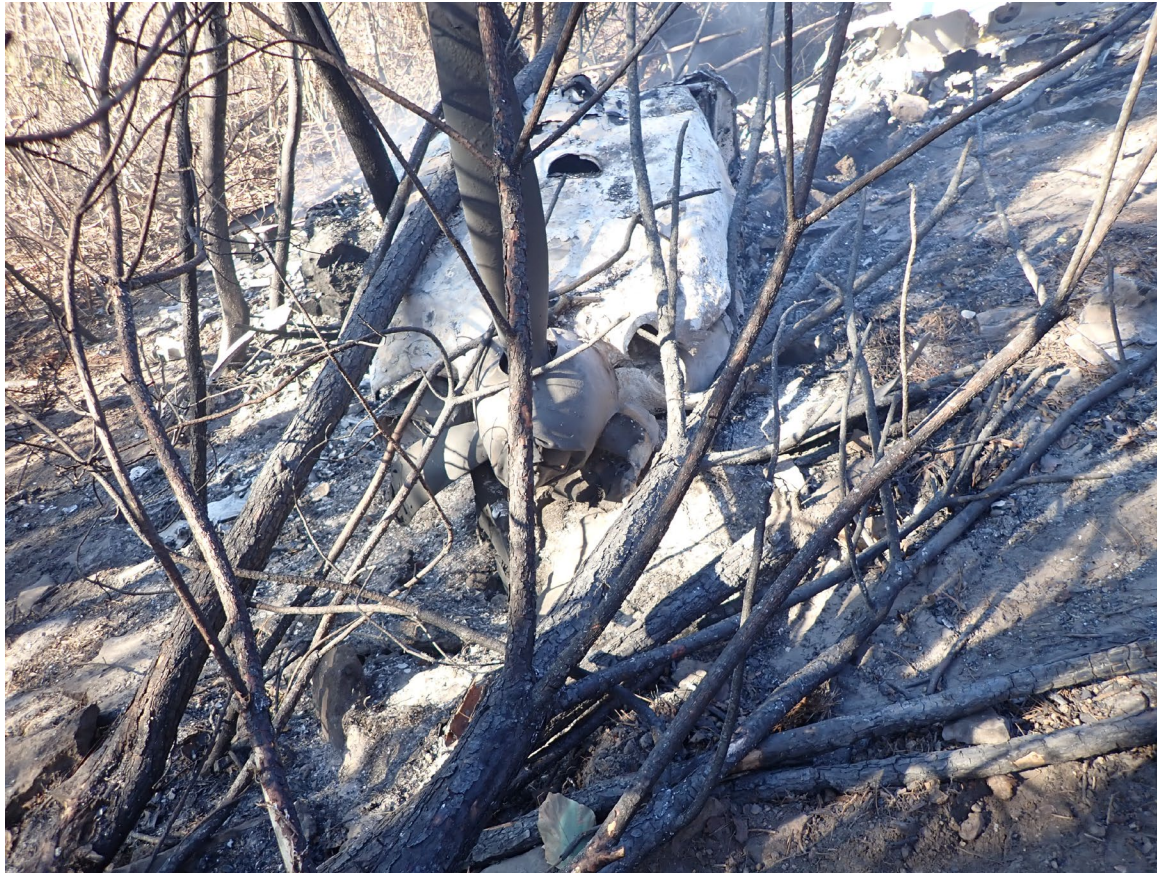
**Photograph 4 - NTSB Digital Photograph. Frontal View of the Engine Assembly with Attached Propeller**

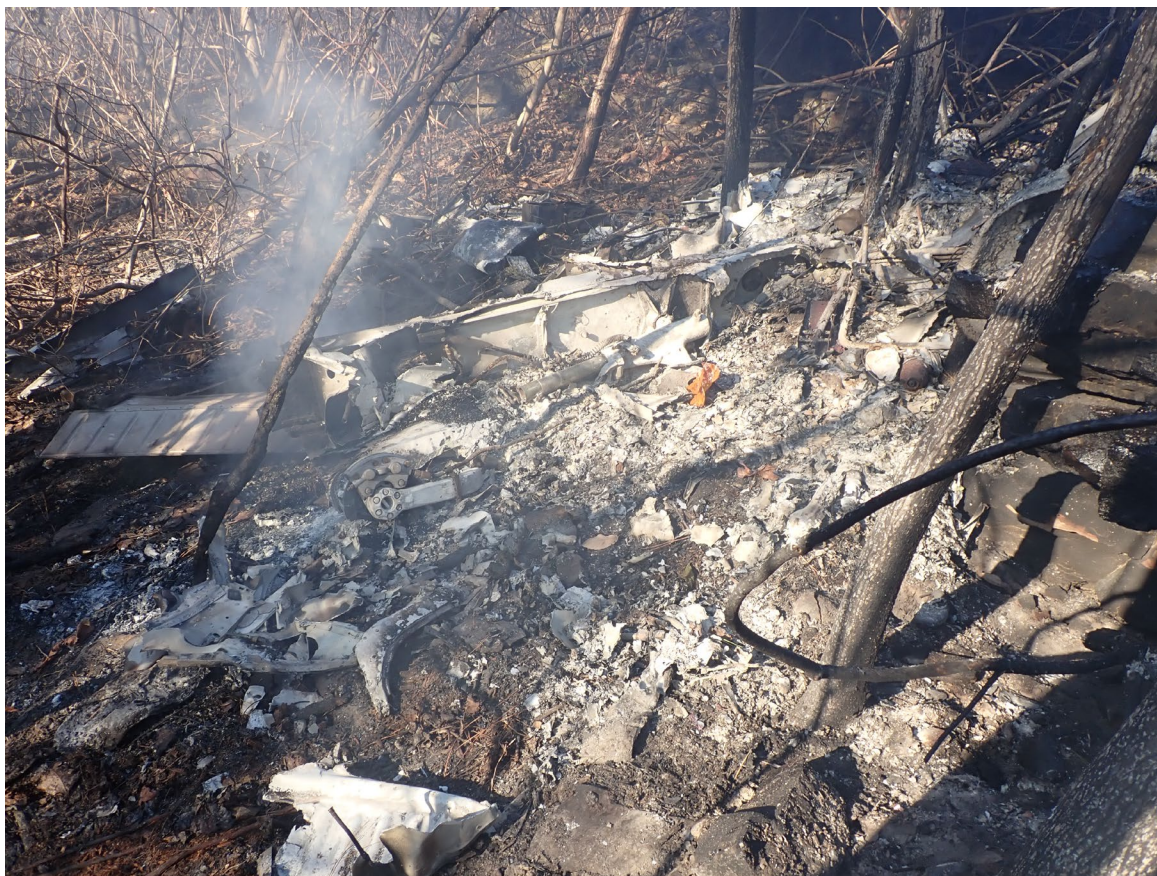
**Photograph 5 - NTSB Digital Photograph. View of the Right Wing**

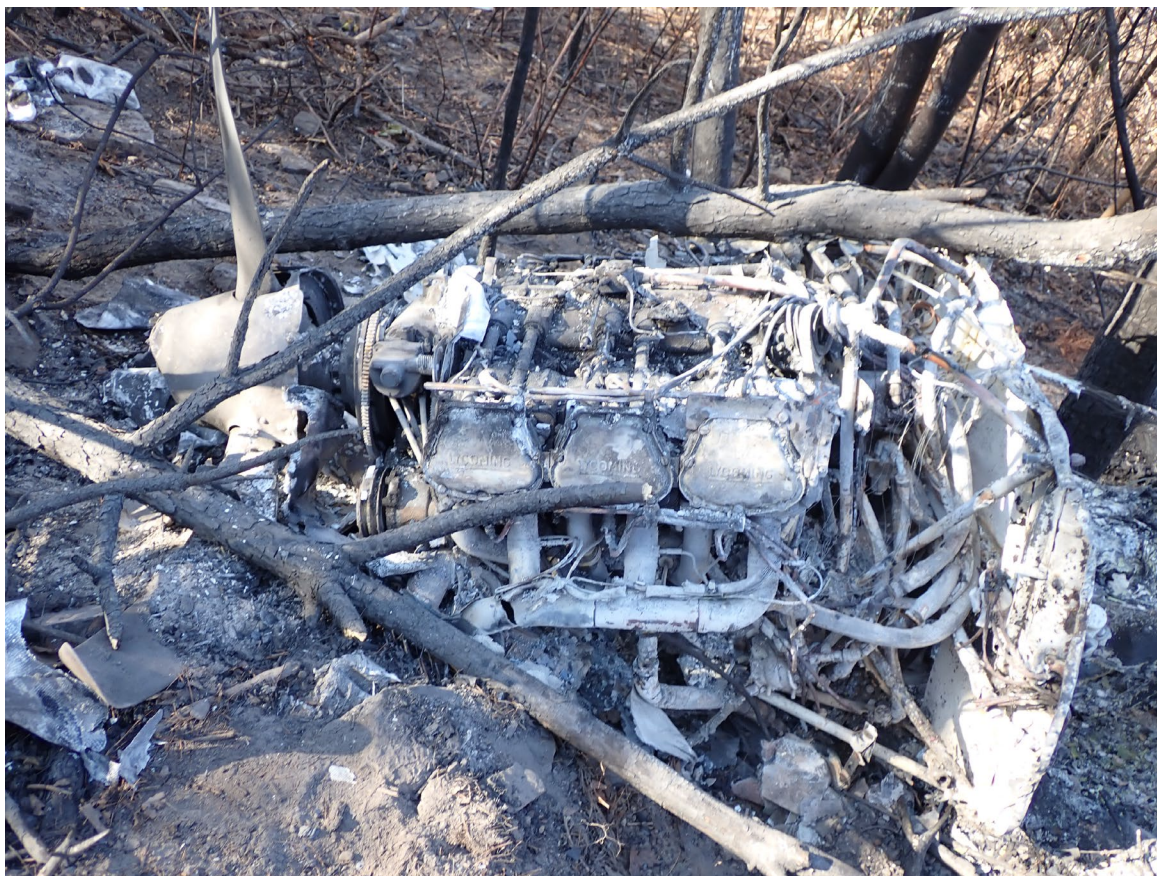
**Photograph 6 - NTSB Digital Photograph. Left Side View of the Upright Engine Assembly with Attached Propeller After Removing Upper Engine Cowling**

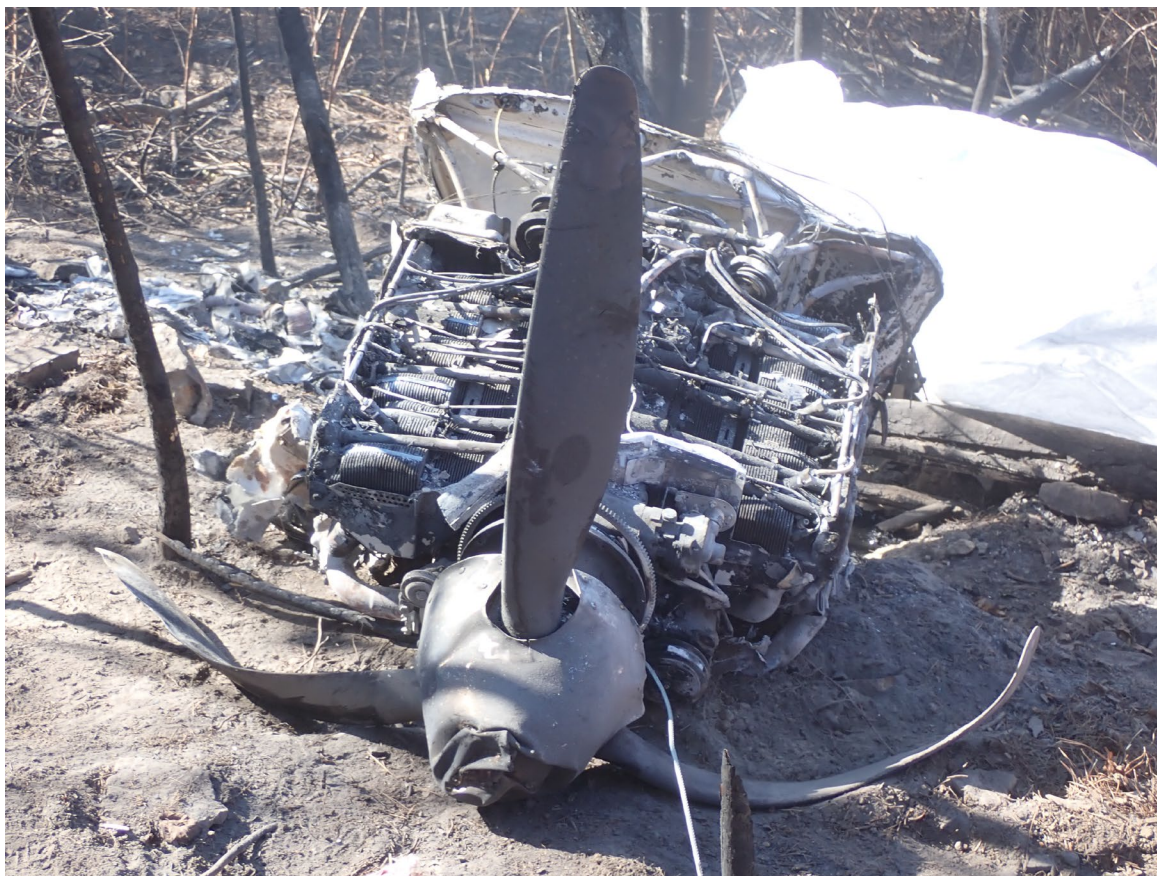
**Photograph 7 - NTSB Digital Photograph. Frontal View of the Upright Engine Assembly with Attached Propeller Following Removal of the Upper Cowling**

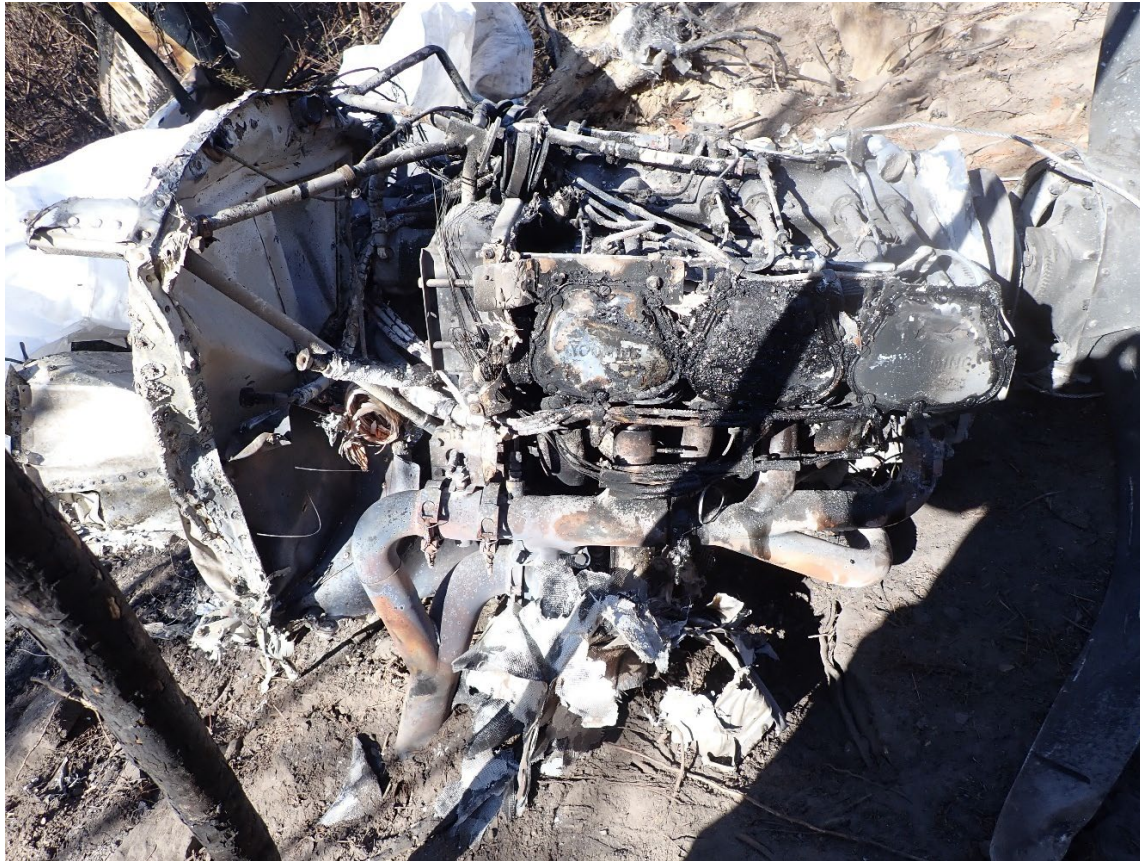
**Photograph 8 - NTSB Digital Photograph. Right Side View of the Upright Engine Assembly with Attached Propeller Following Removal of the Upper Cowling**

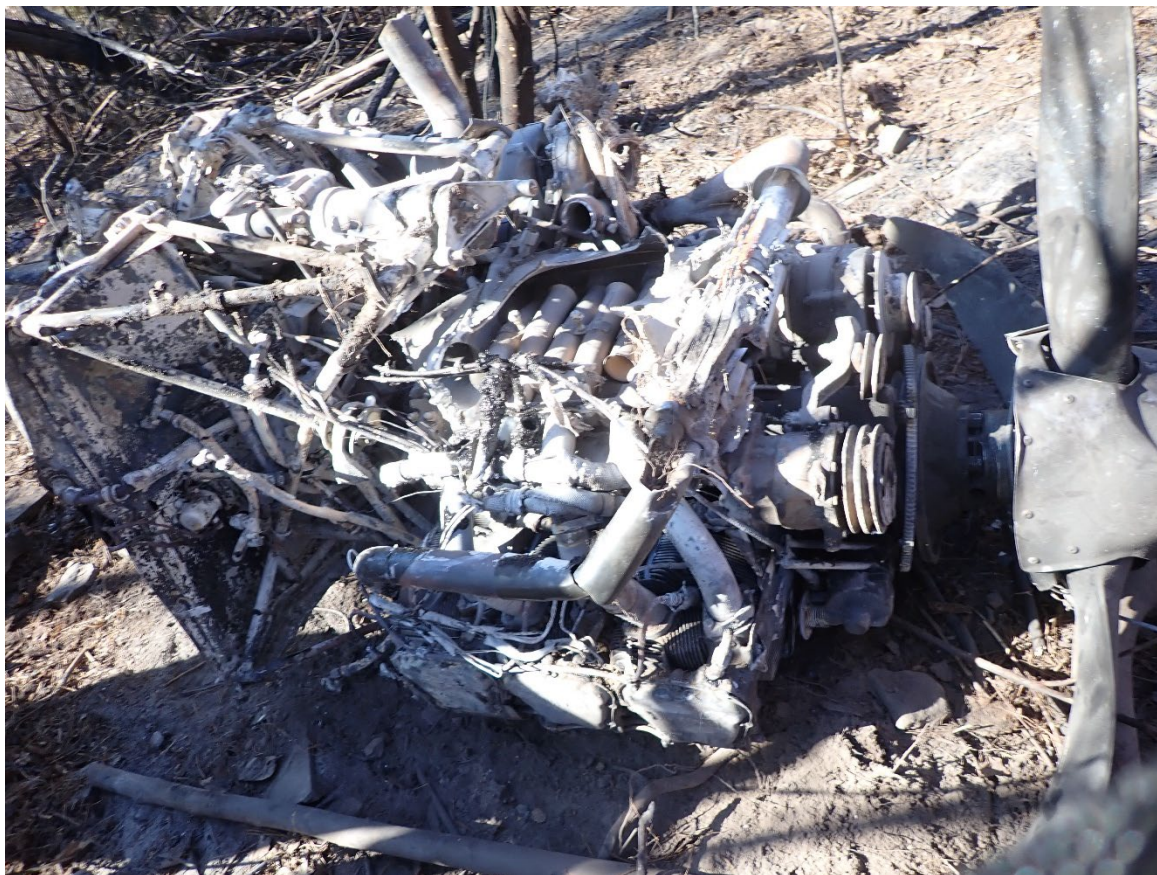
**Photograph 9 - NTSB Digital Photograph. Left Side View of the Inverted Engine Assembly Following Removal of the Cowling**

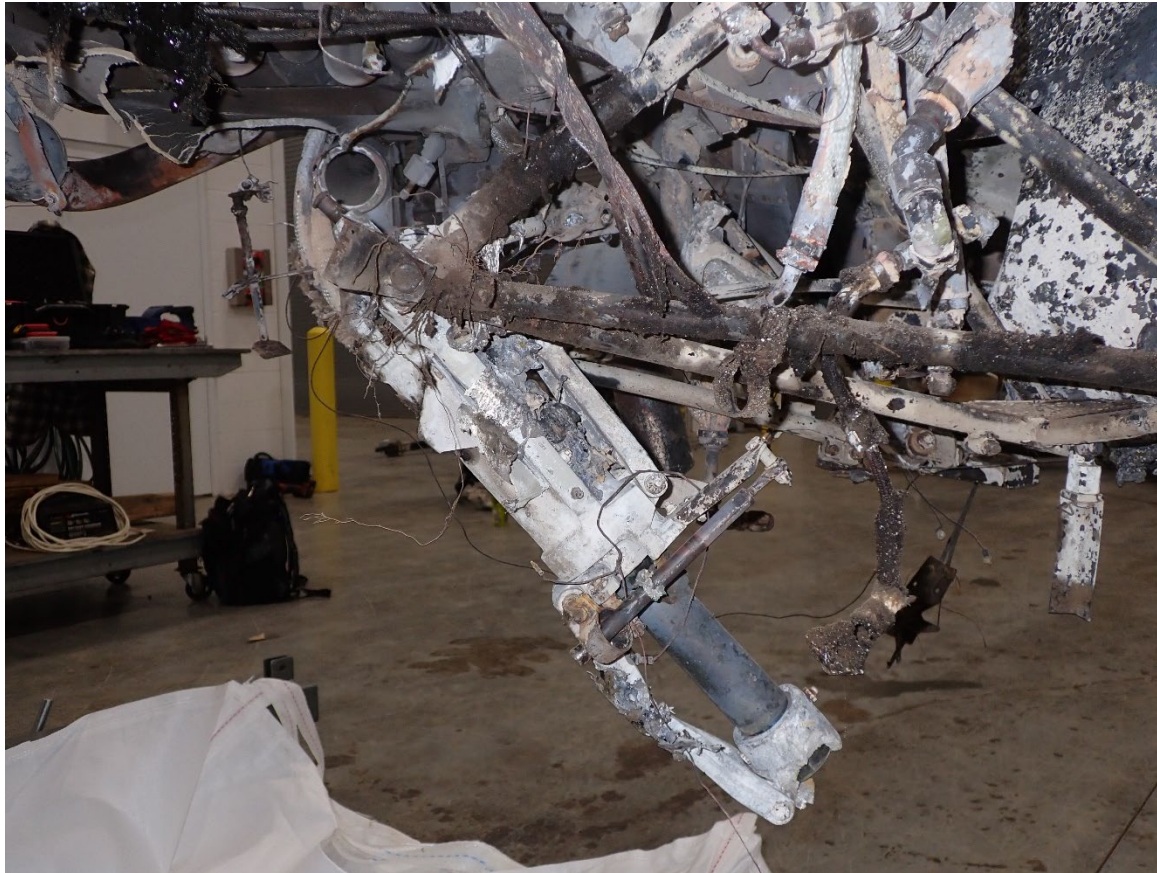
**Photograph 10 - NTSB Digital Photograph. View Focused on the Remaining Portion of the Nose Landing Gear**

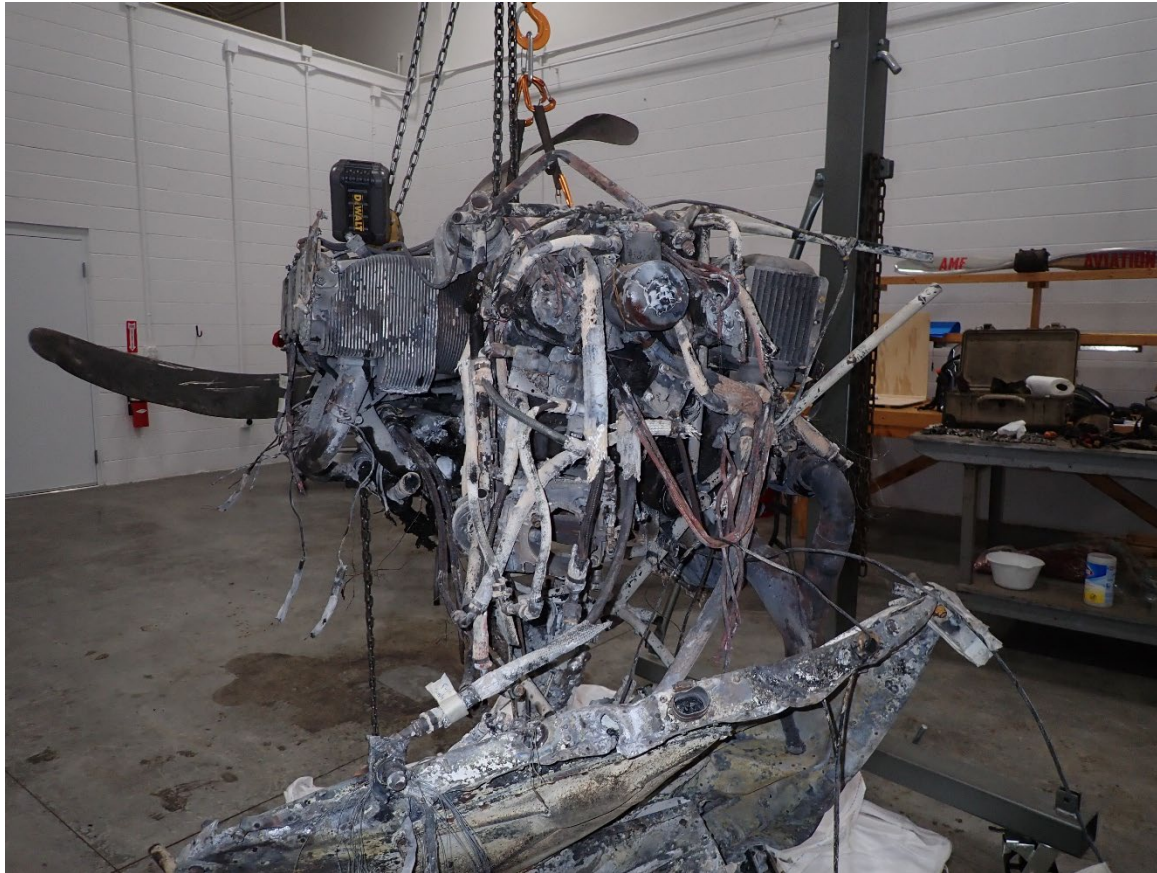
**Photograph 11 - NTSB Digital Photograph. Rear View of the Engine Assembly Following Removal of the Firewall**

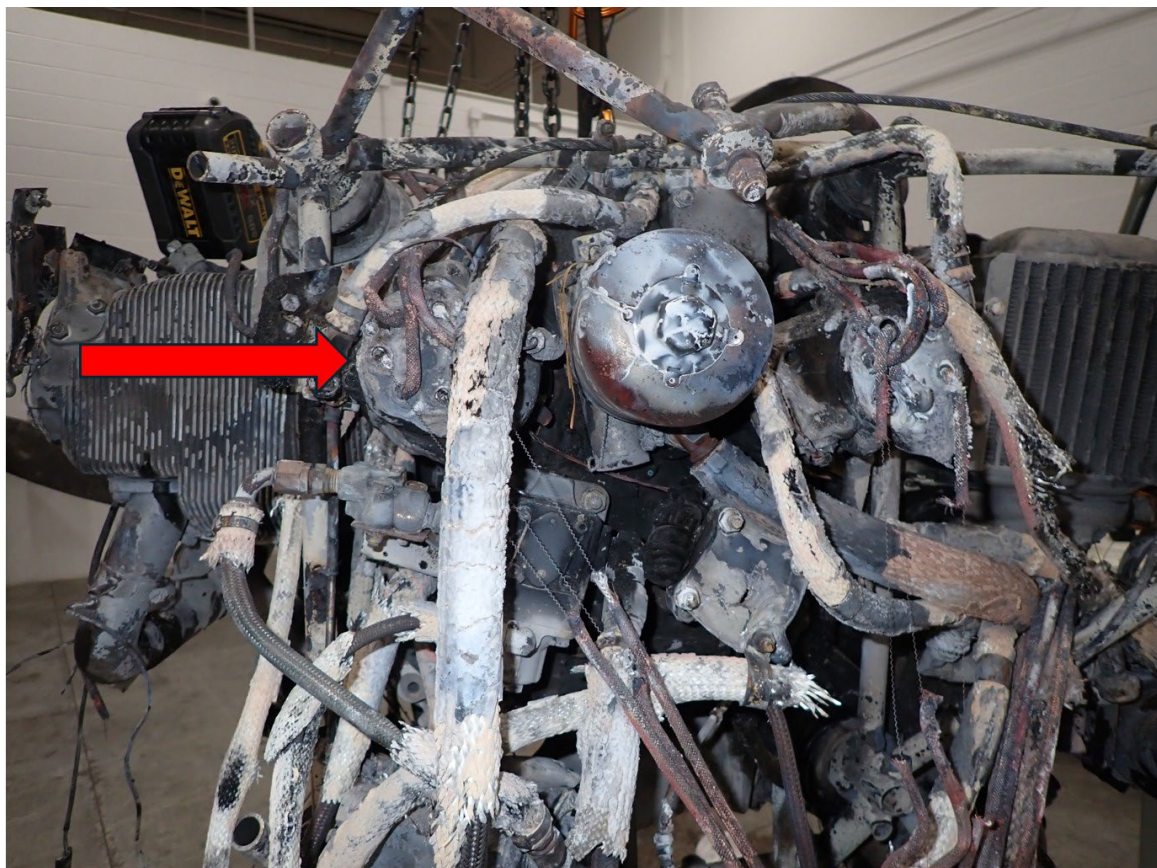
**Photograph 12 - NTSB Digital Photograph. Arrow Points to Heat Damaged Left Magneto**

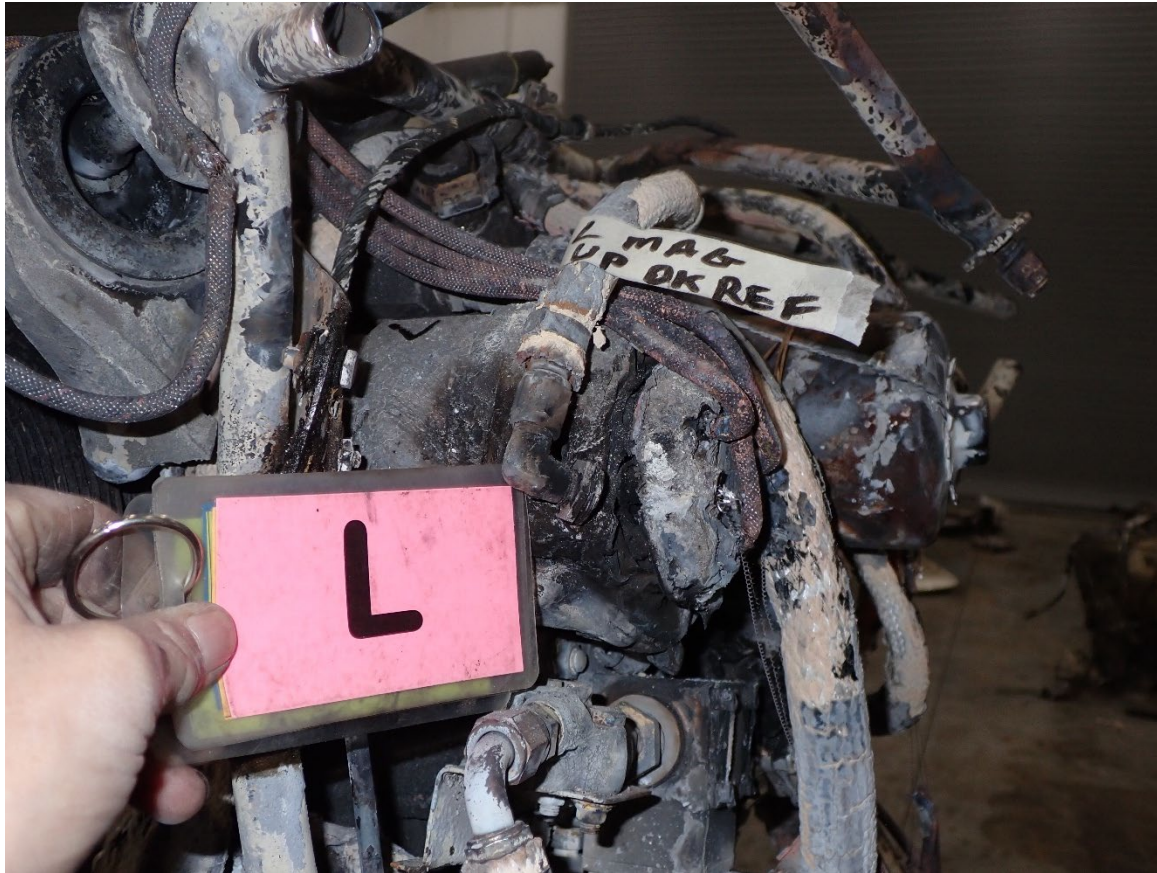
**Photograph 13 - NTSB Digital Photograph. Close-Up View of Heat Damaged Left Magneto**

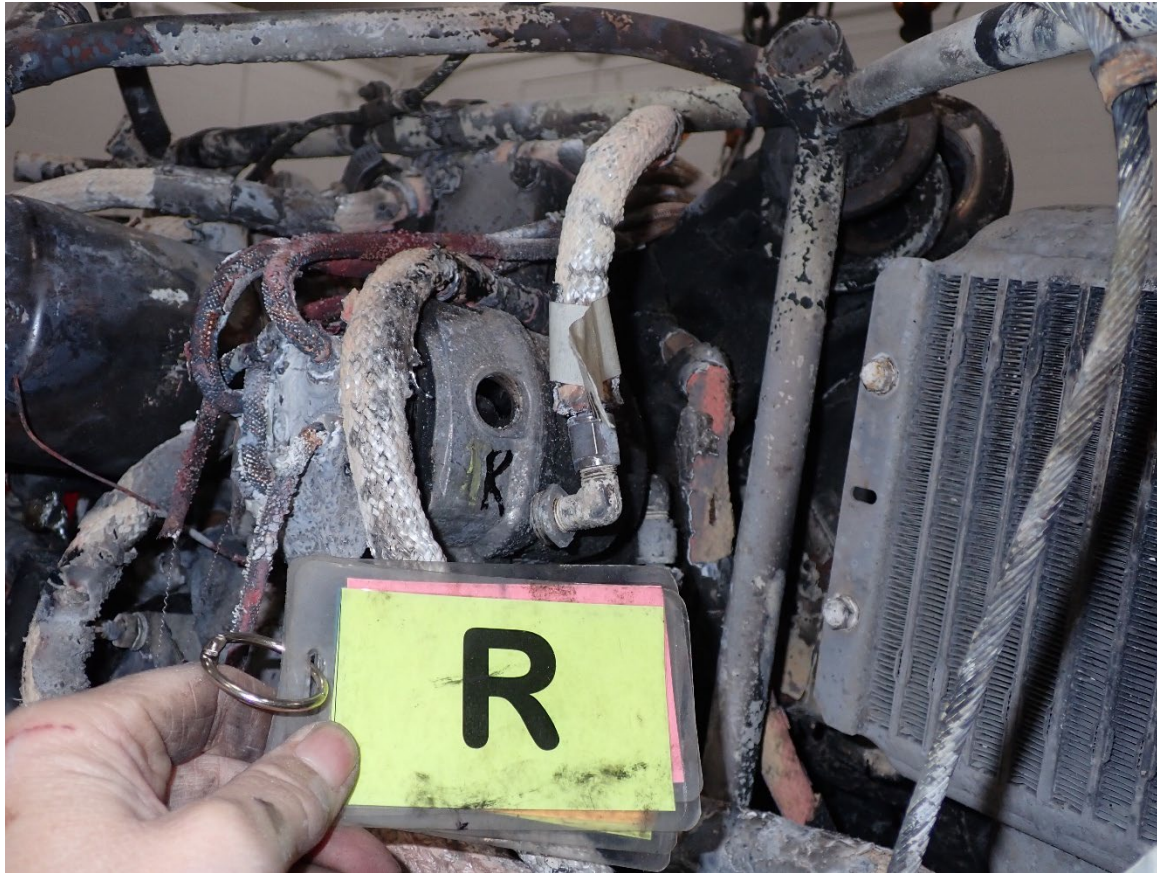
**Photograph 14 - NTSB Digital Photograph. View of Heat Damaged Right Magneto**

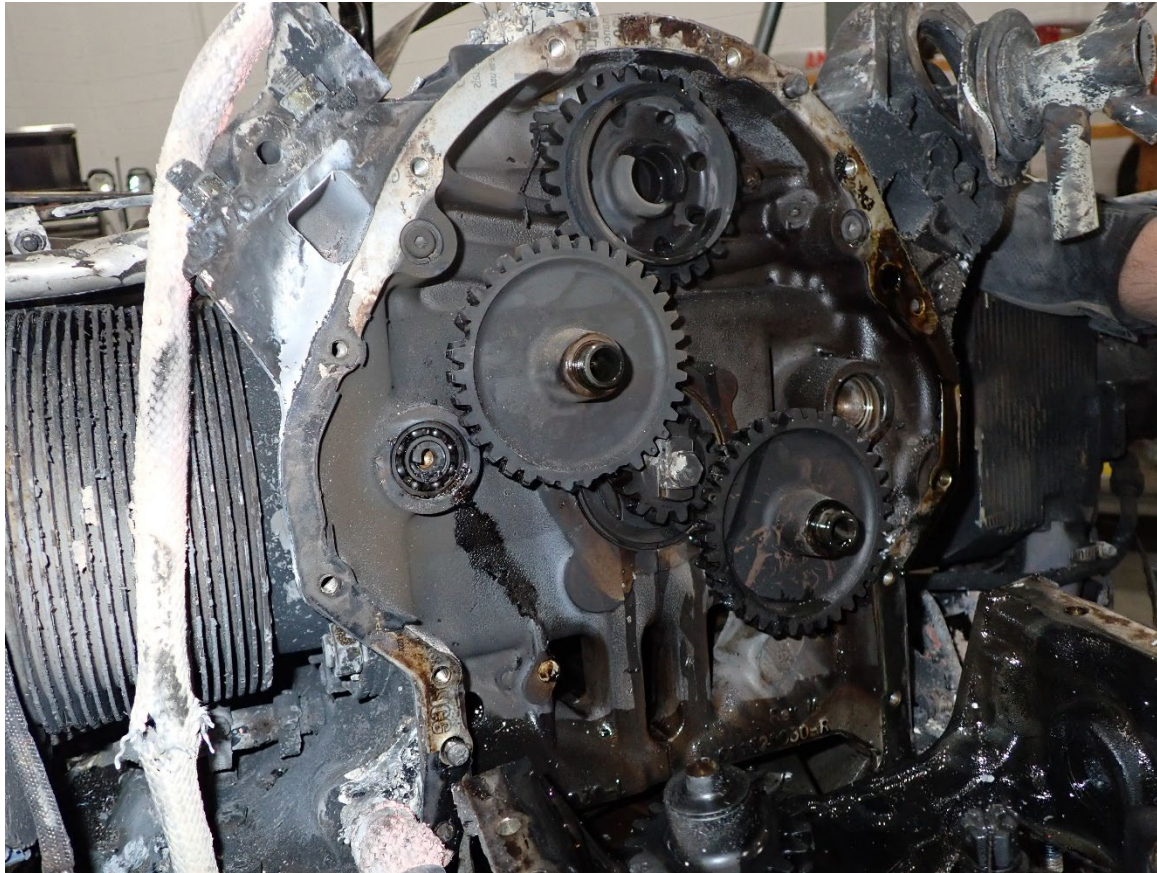
**Photograph 15 - NTSB Digital Photograph. View of the Accessory Section of the Engine Following Removal of the Accessory Case**

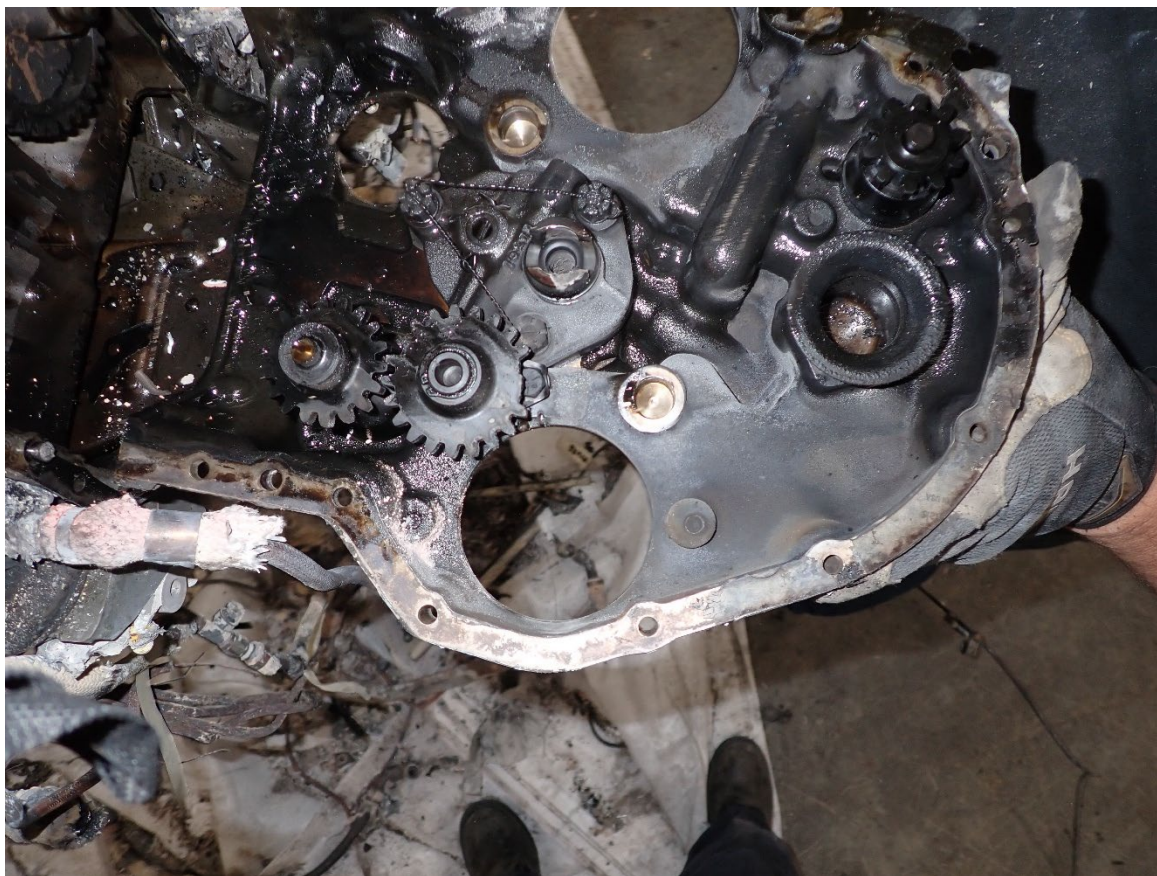
**Photograph 16 - NTSB Digital Photograph. View of the Accessory Case Following Removal From the Engine**

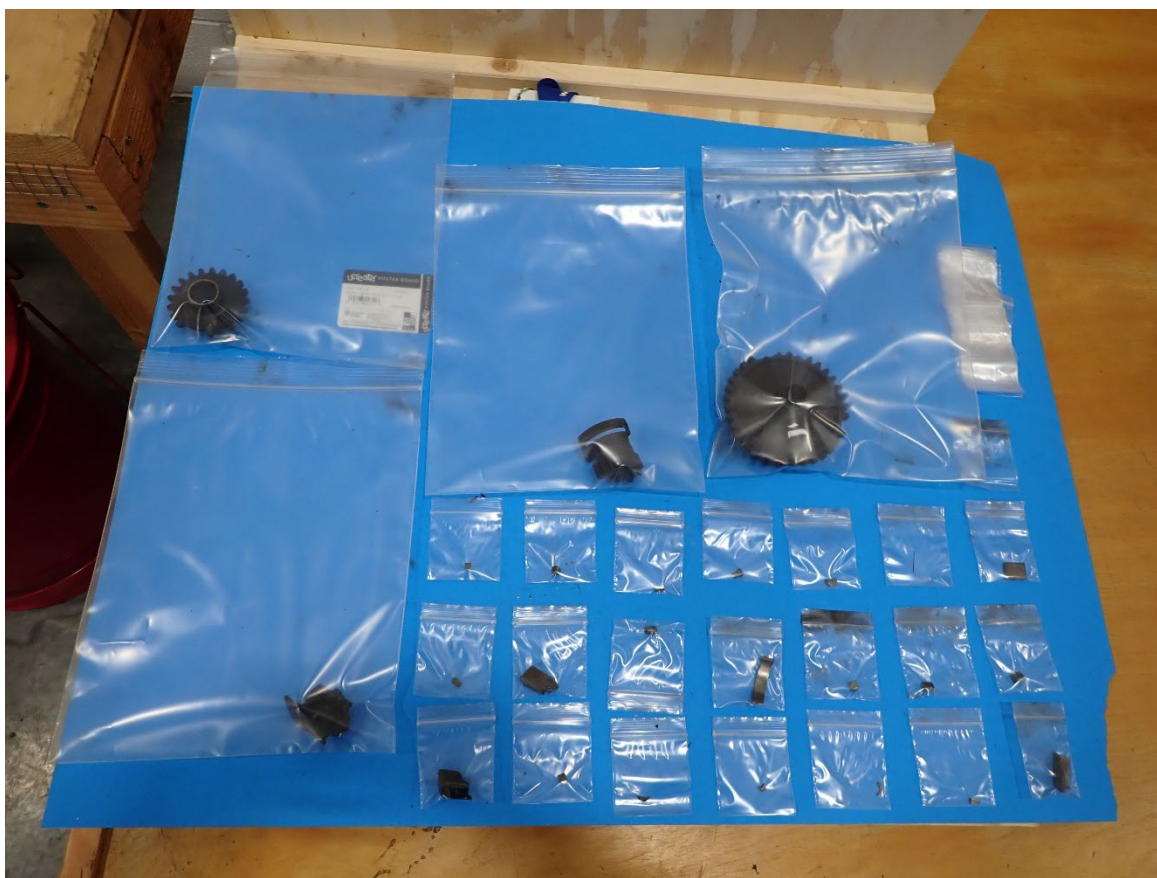
**Photograph 17 - NTSB Digital Photograph. View of the Parts Retained For NTSB Metallurgical Examination**

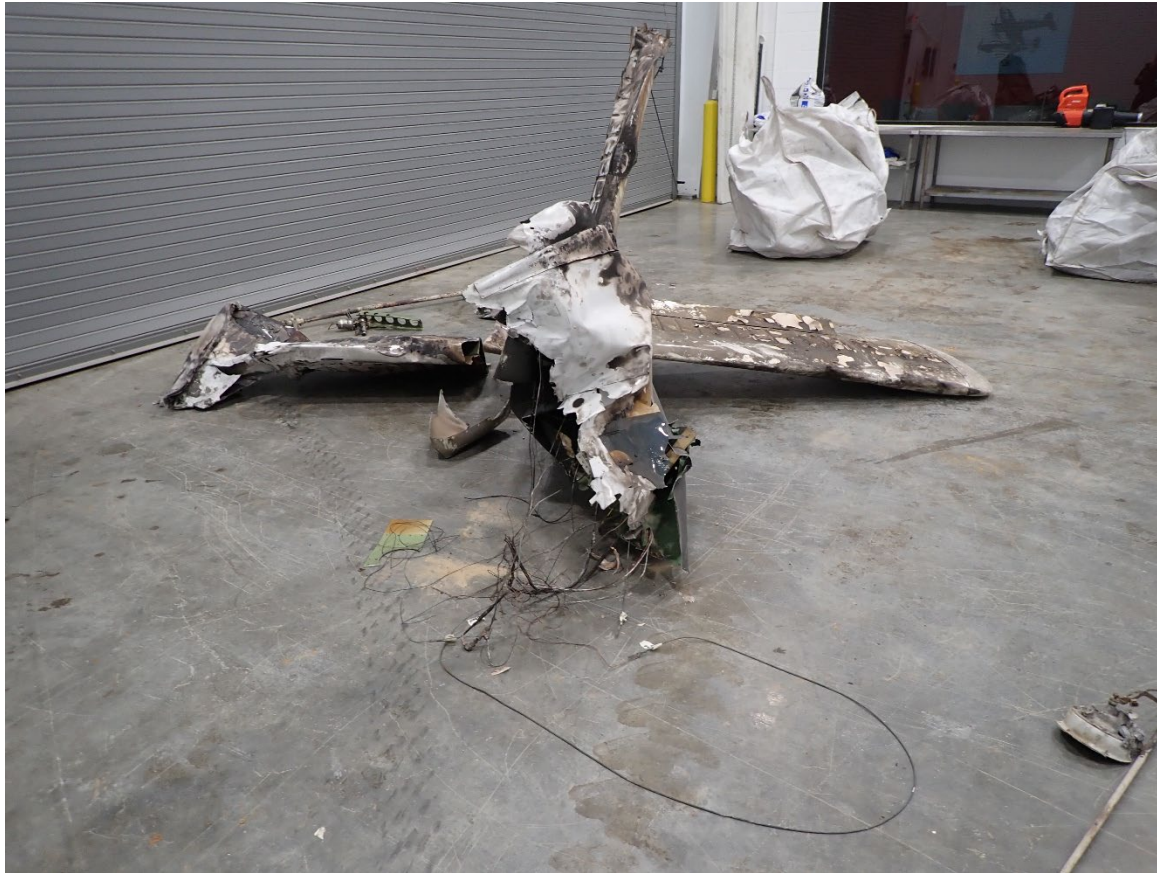
**Photograph 18 - NTSB Digital Photograph. View of the Aft Empennage Following Wreckage Recovery**

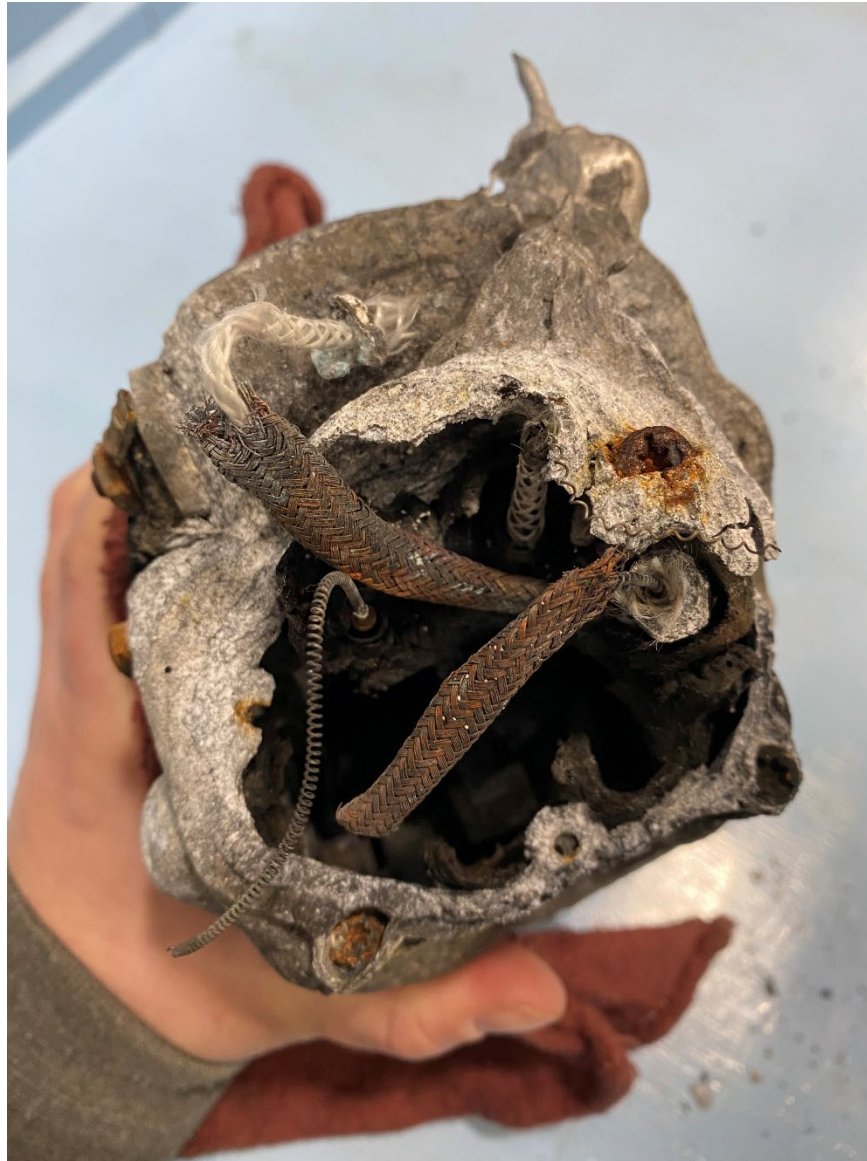
**Photograph 19 - AMF Aviation Digital Photograph. View of the Left Magneto**

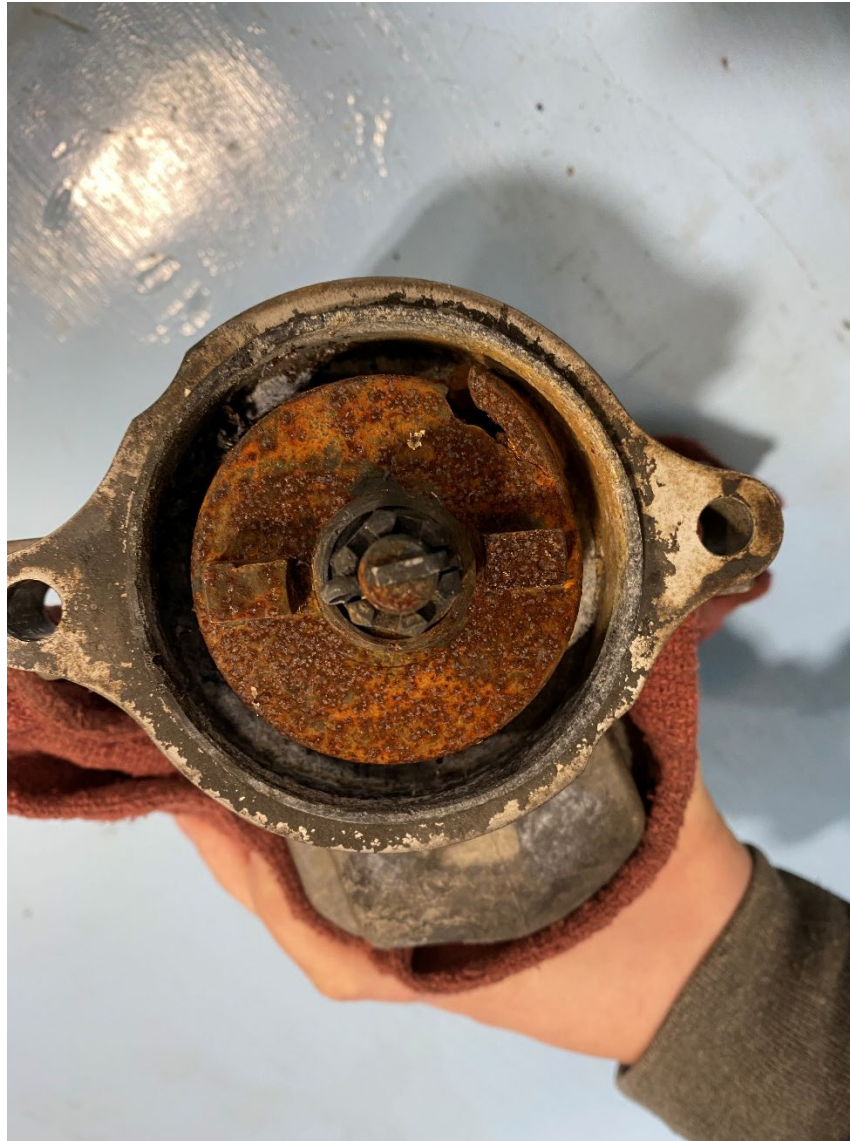
**Photograph 20 - AMF Aviation Digital Photograph. View of the Impulse Coupling End of Left Magneto**

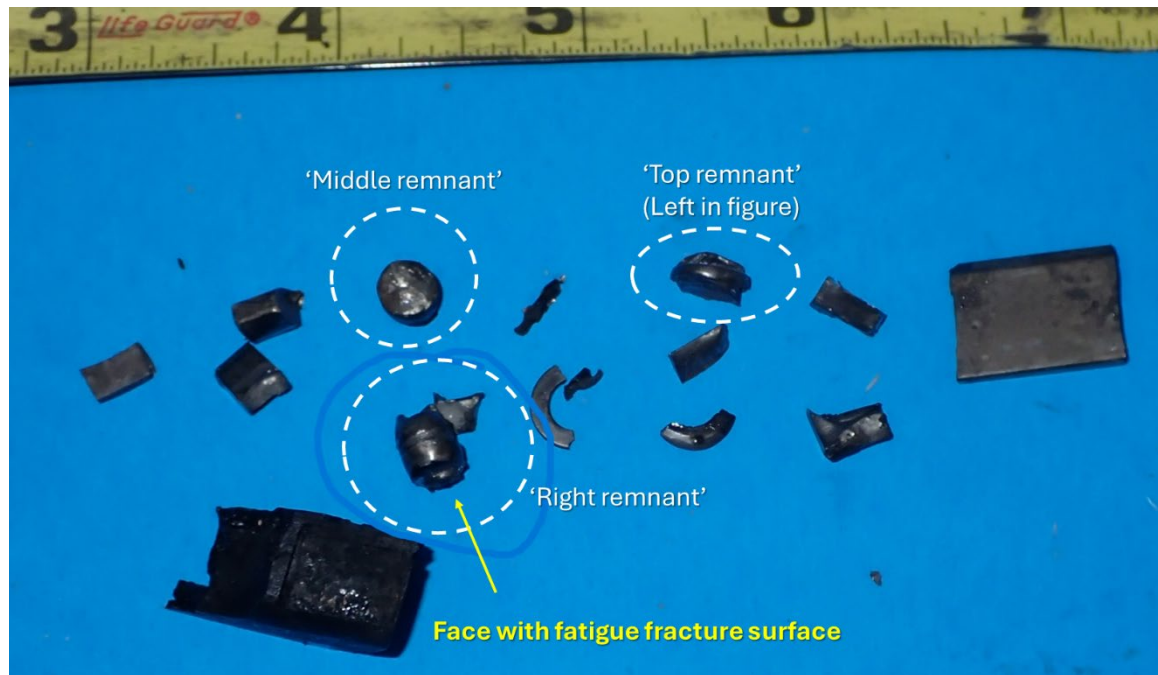
**Photograph 21 - NTSB Digital Photograph. Annotated photograph depicting pieces of Impulse Coupling Rivet Found in Oil Sump**
