ERA24FA069

## INVESTIGATION PHOTOGRAPHS

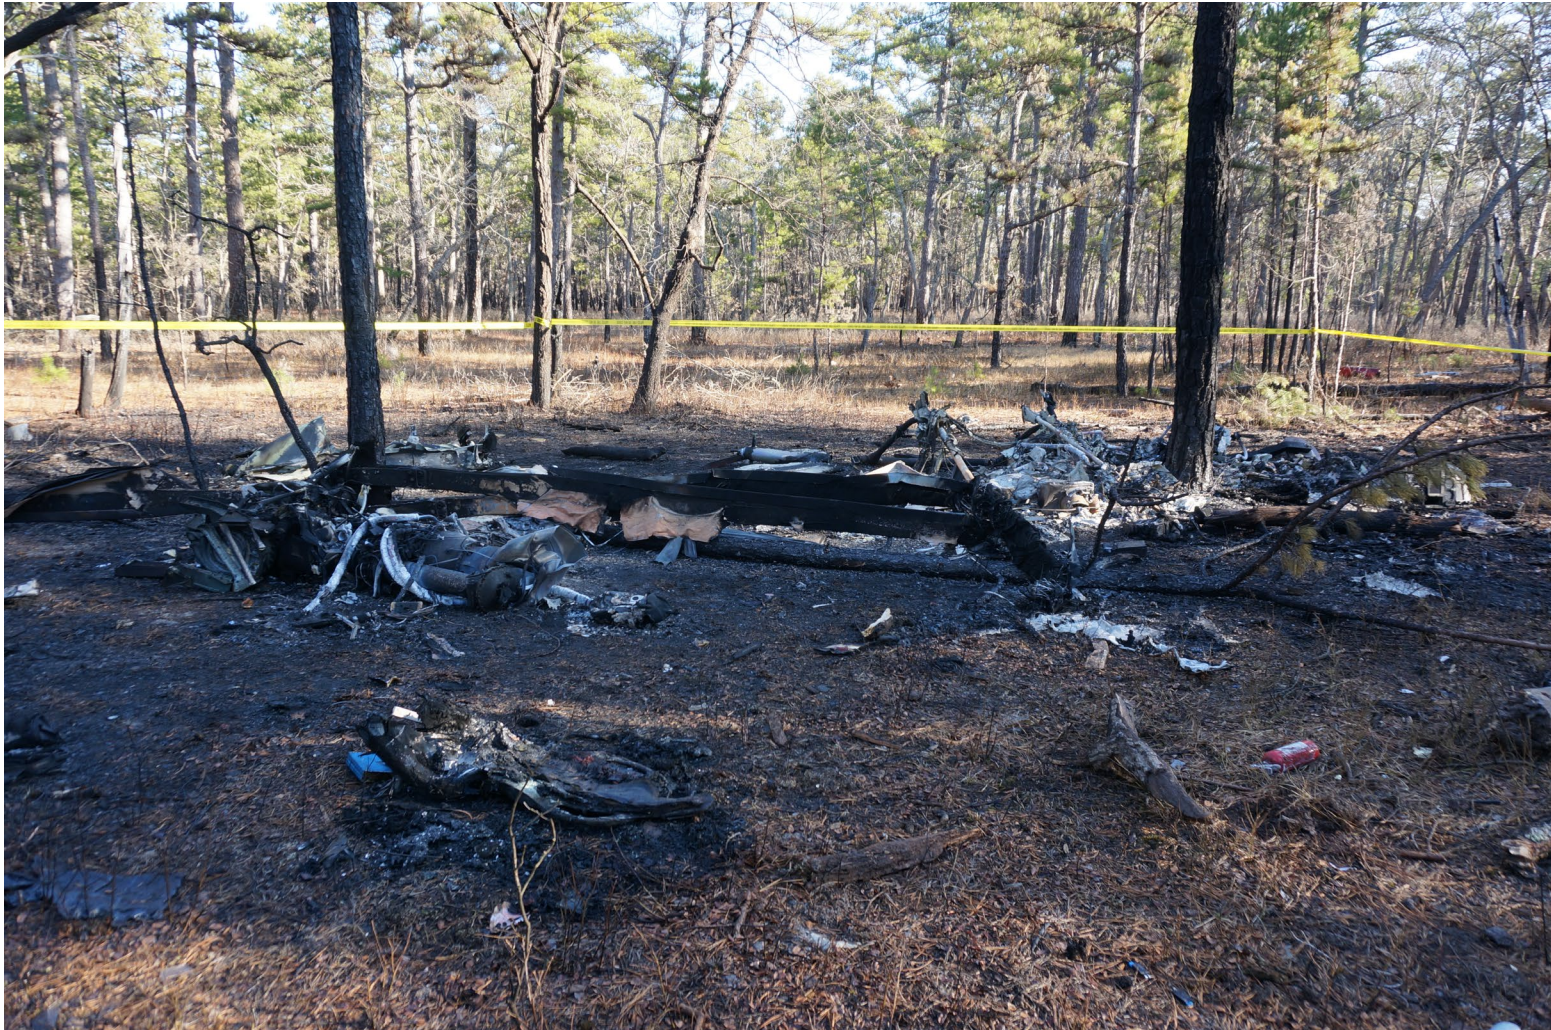
**Photograph 1 - Main Wreckage**

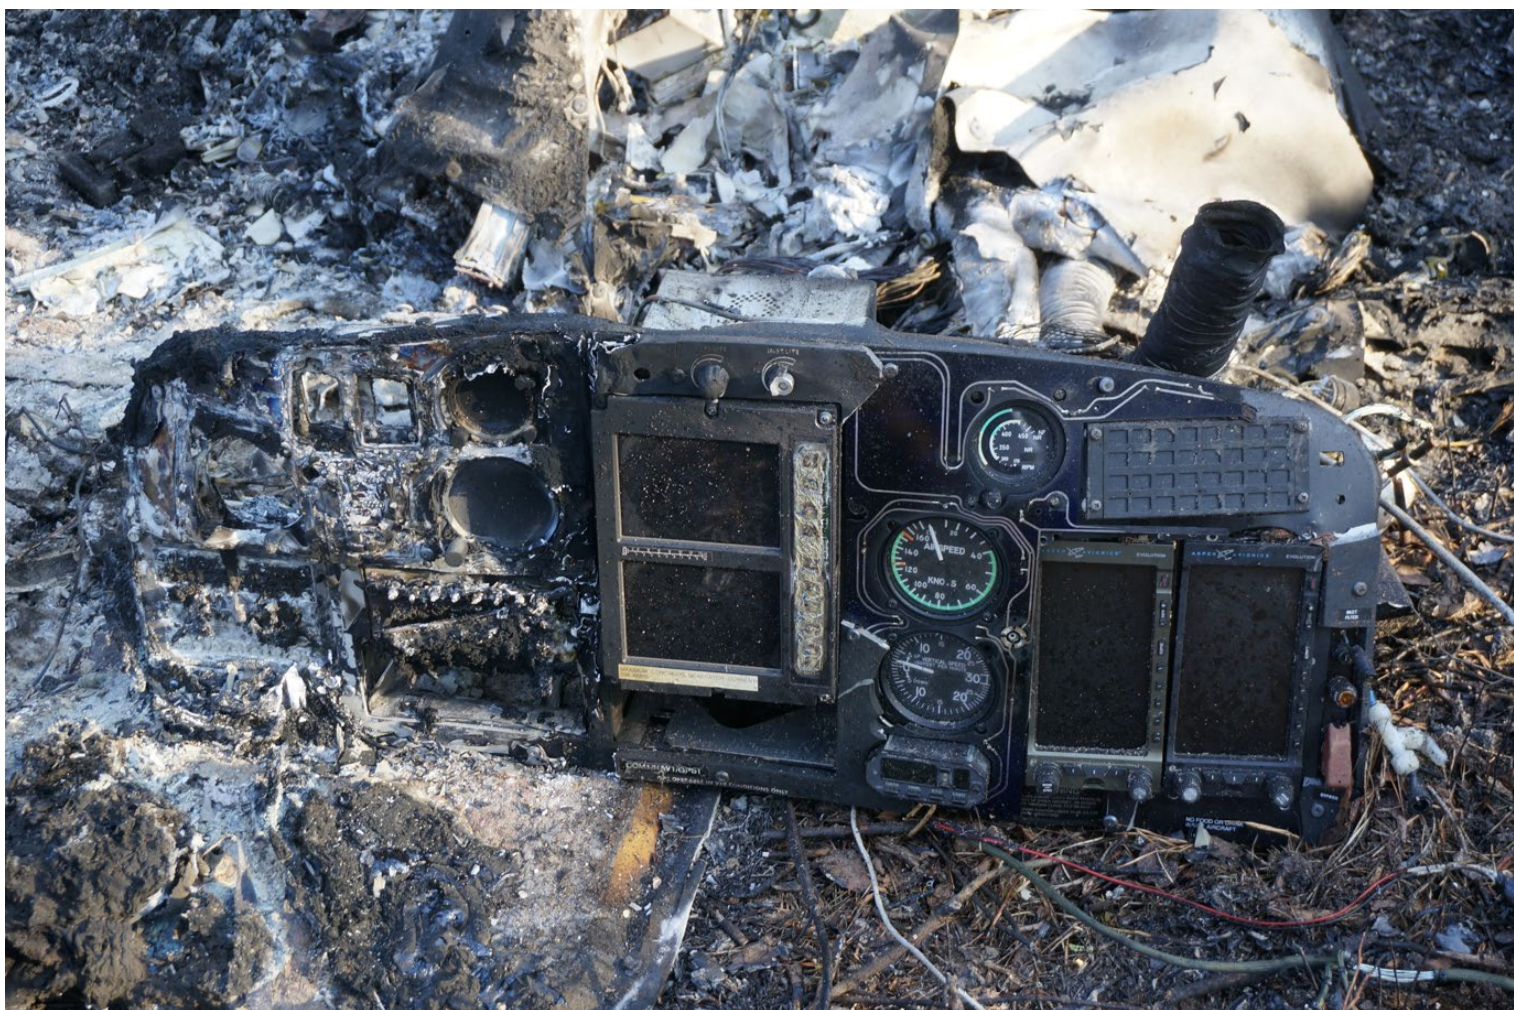
**Photograph 2 - Instrument Panel**

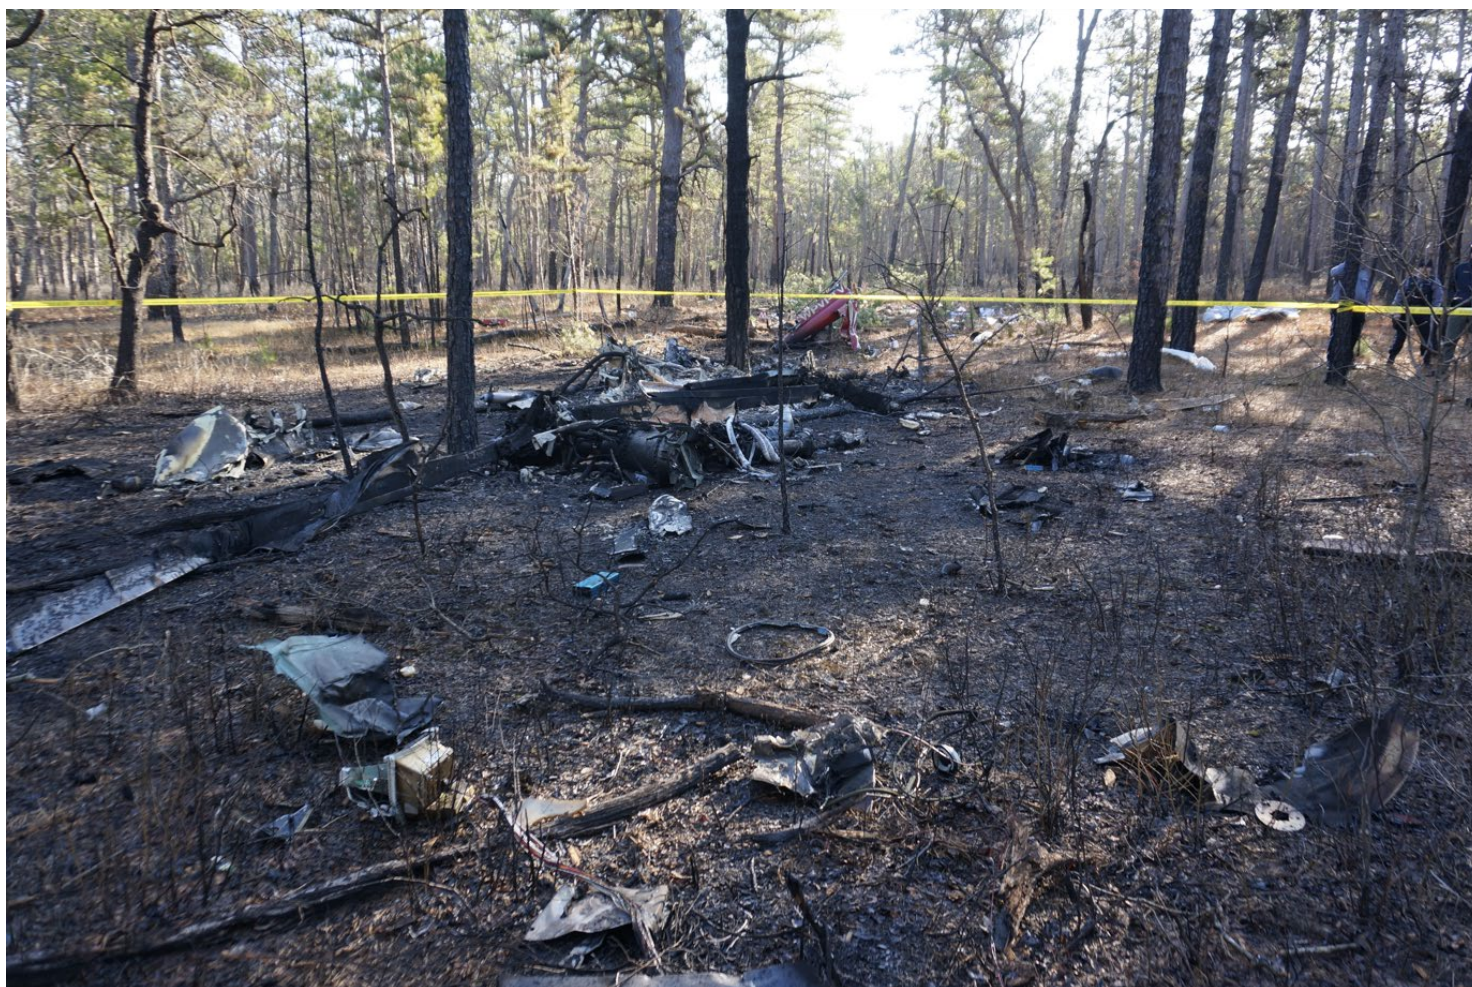
**Photograph 3 - Wreckage Path**

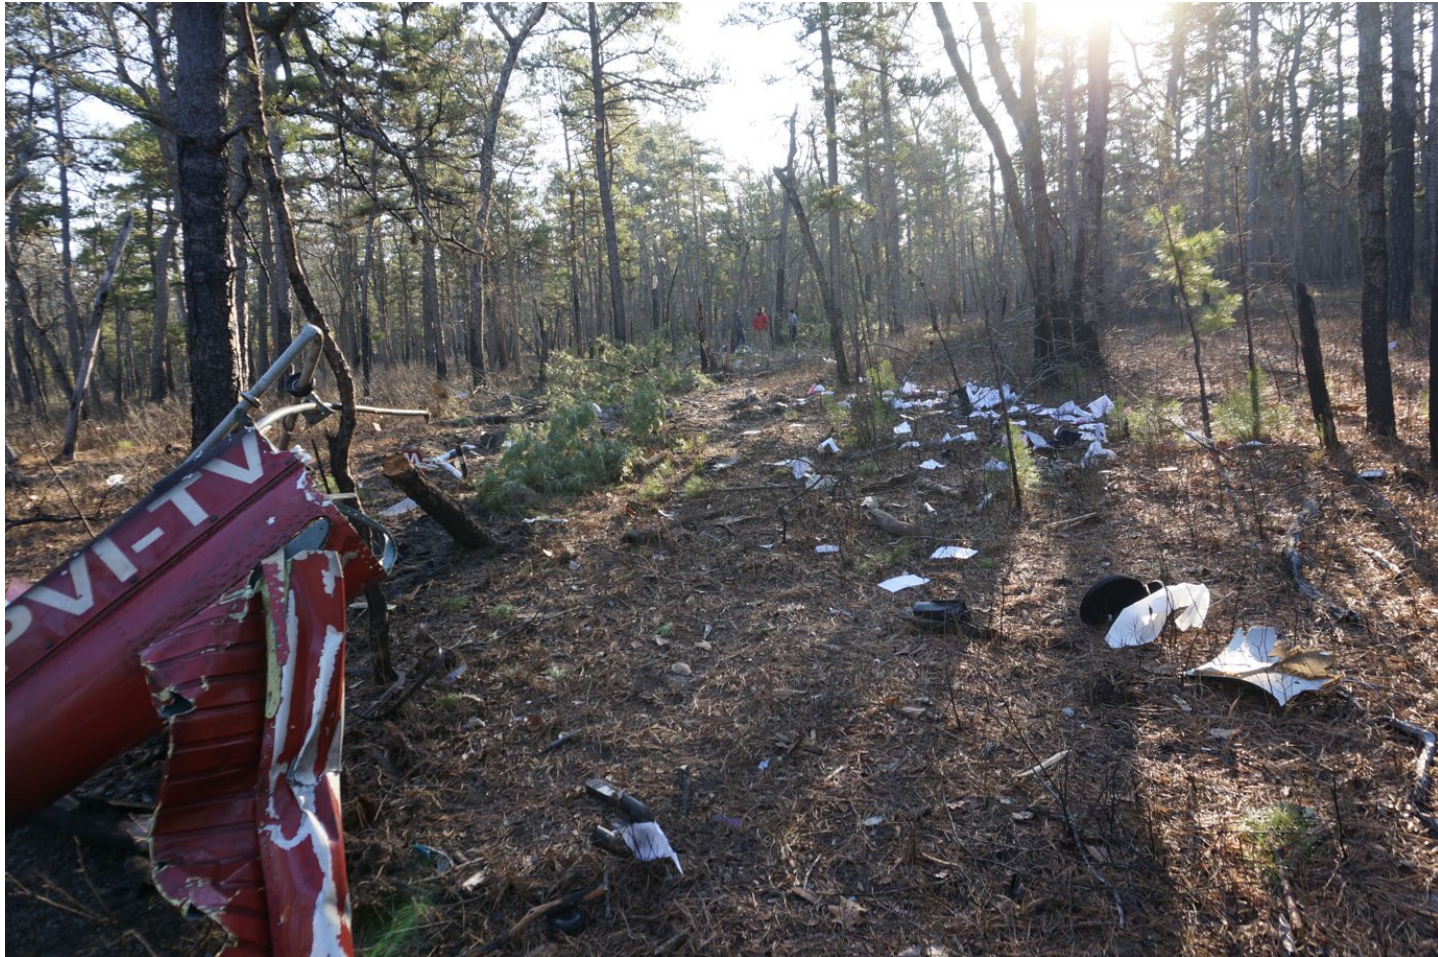
**Photograph 4 - Wreckage Path**

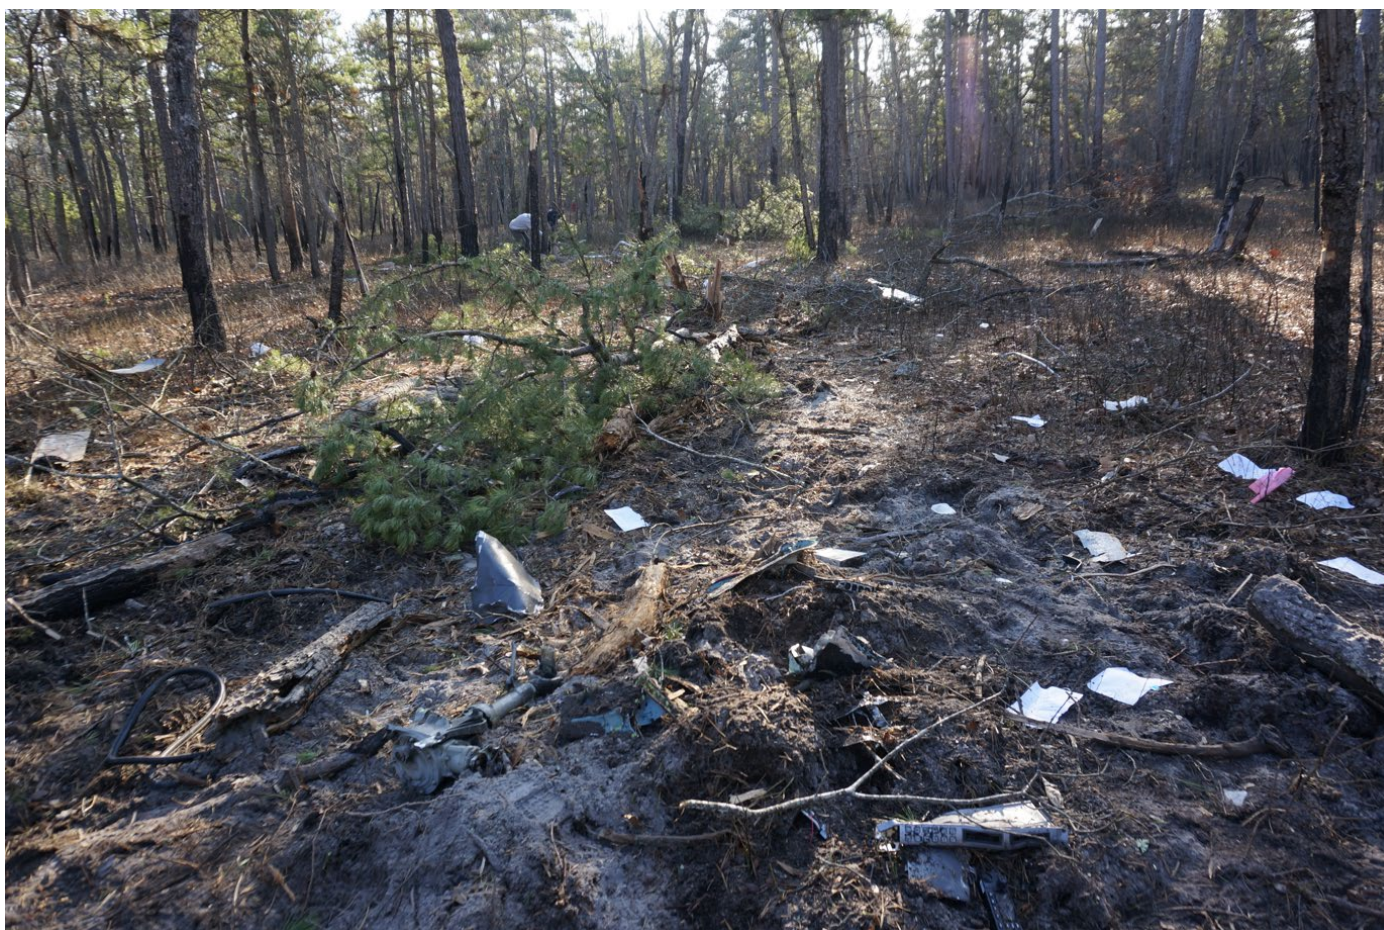
**Photograph 5 - Wreckage Path**

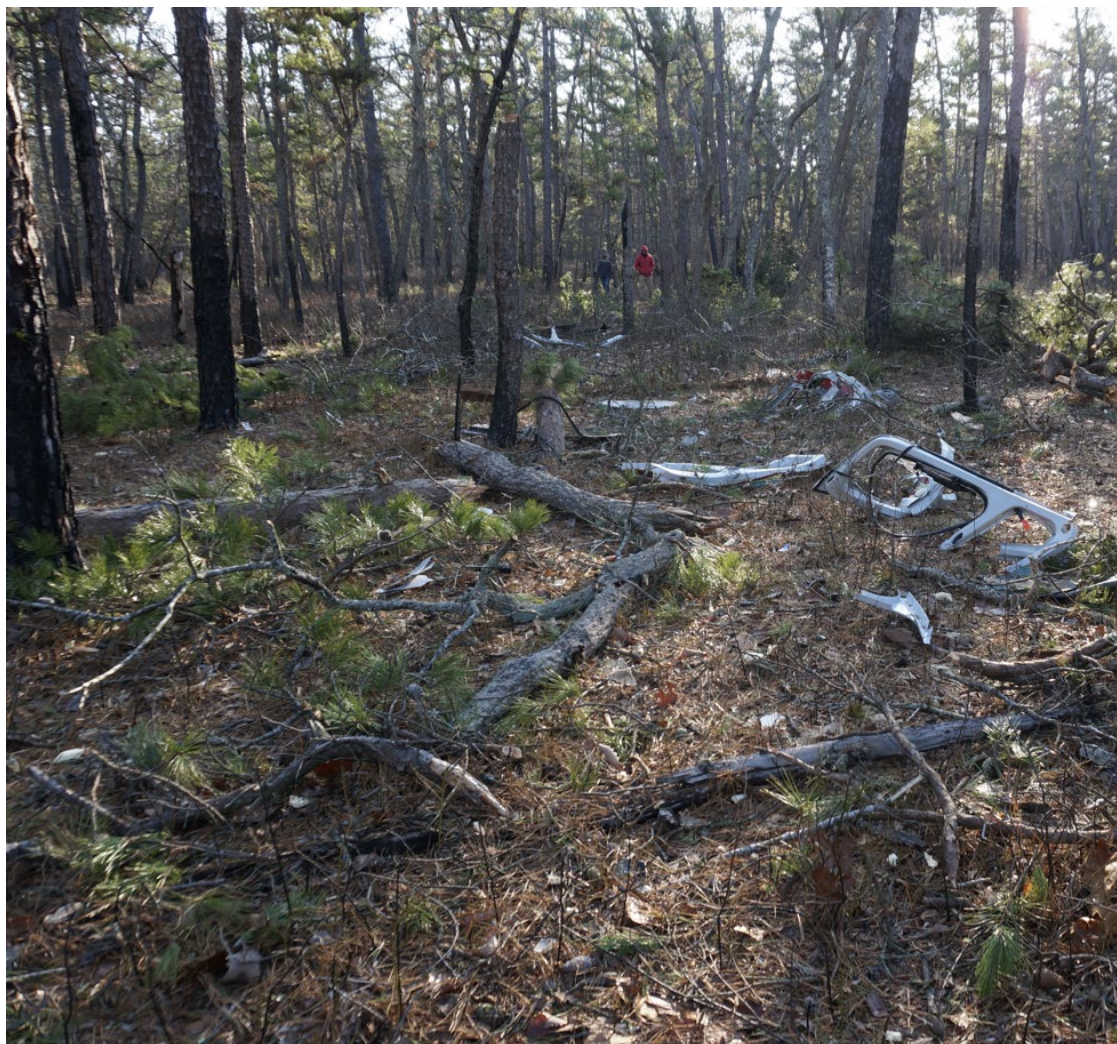
**Photograph 6 - Doors and Sections of Cabin Interior Liners**

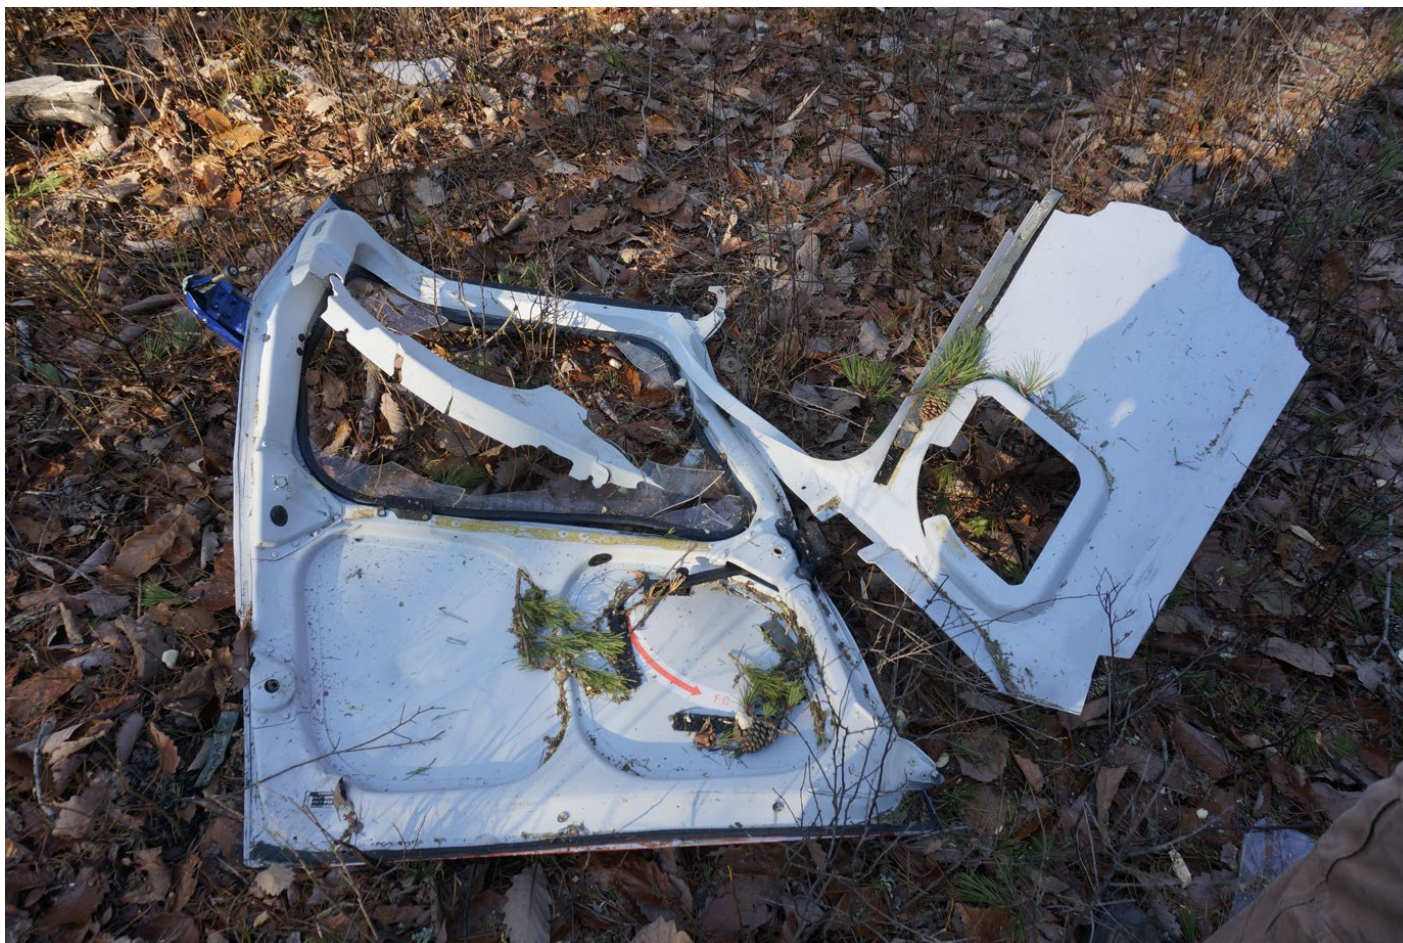
**Photograph 7 - Portions of Cabin Door**

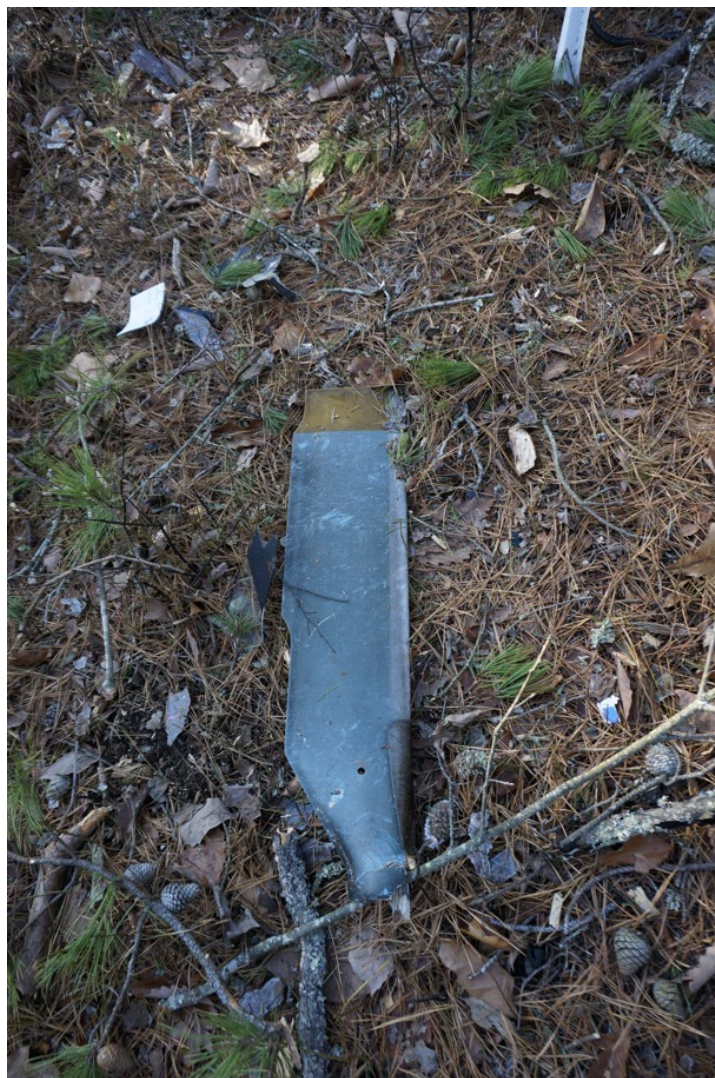
**Photograph 8 - Tail Rotor Blade**

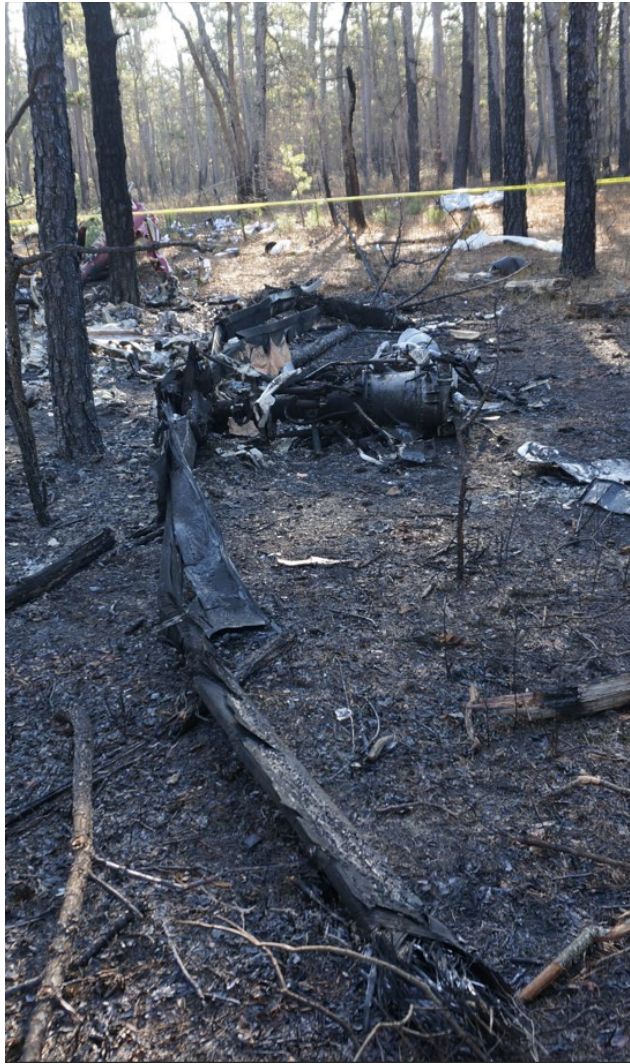
**Photograph 9 - Engine, Transmission, and Remains of Main Rotor Blades**

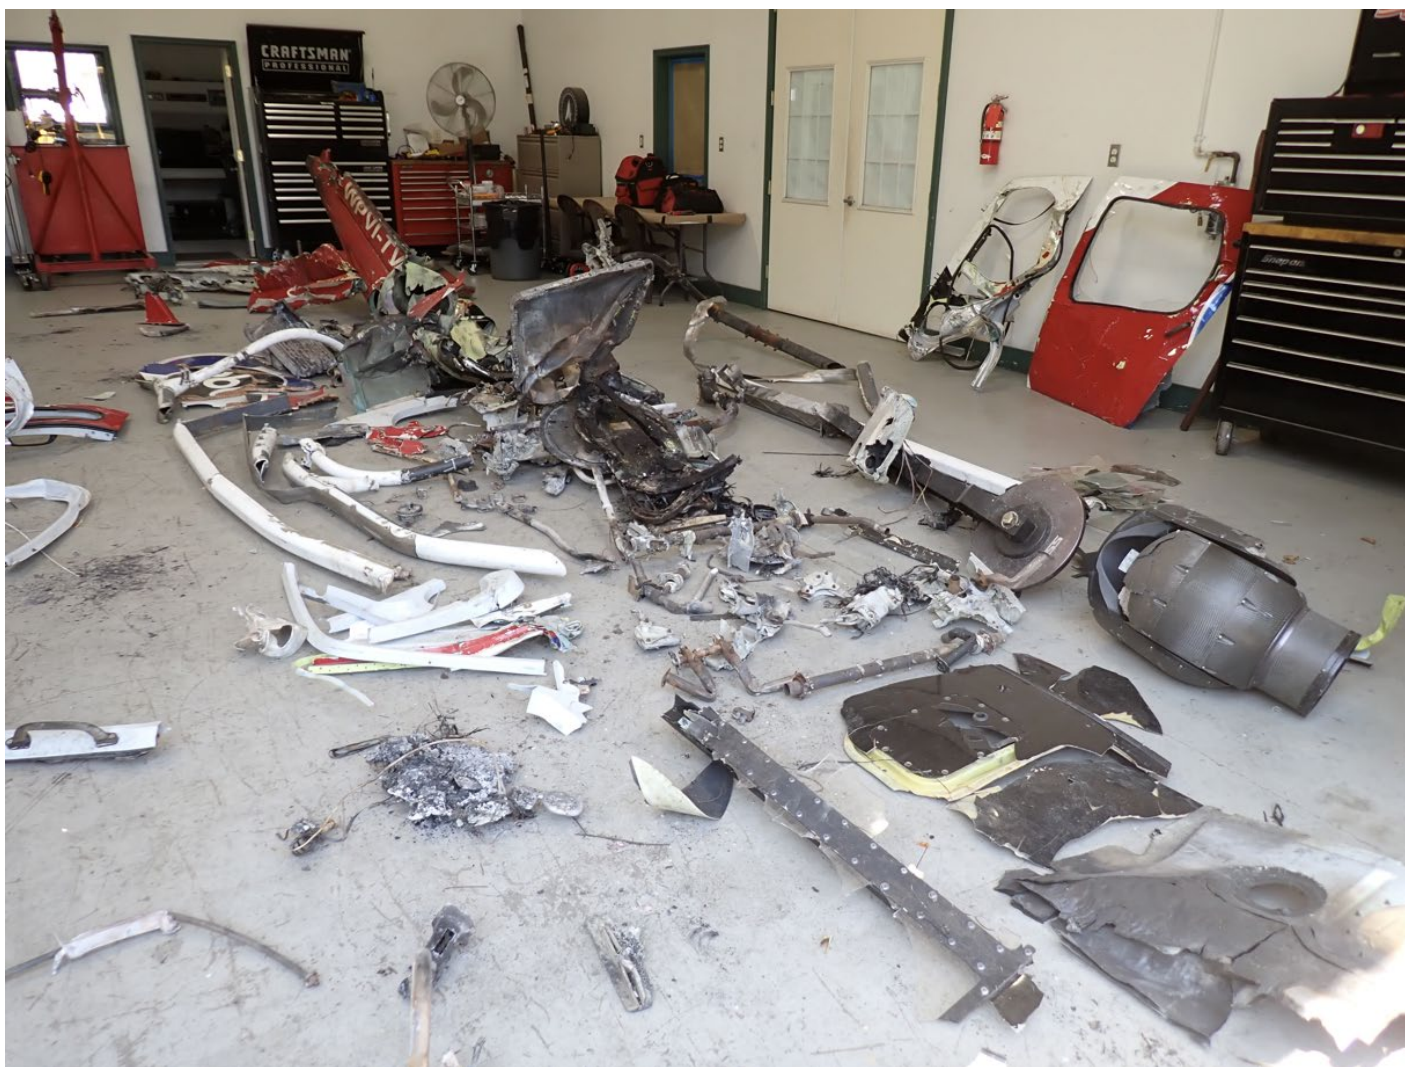
**Photograph 10 - Remains of Airframe after Recovery**

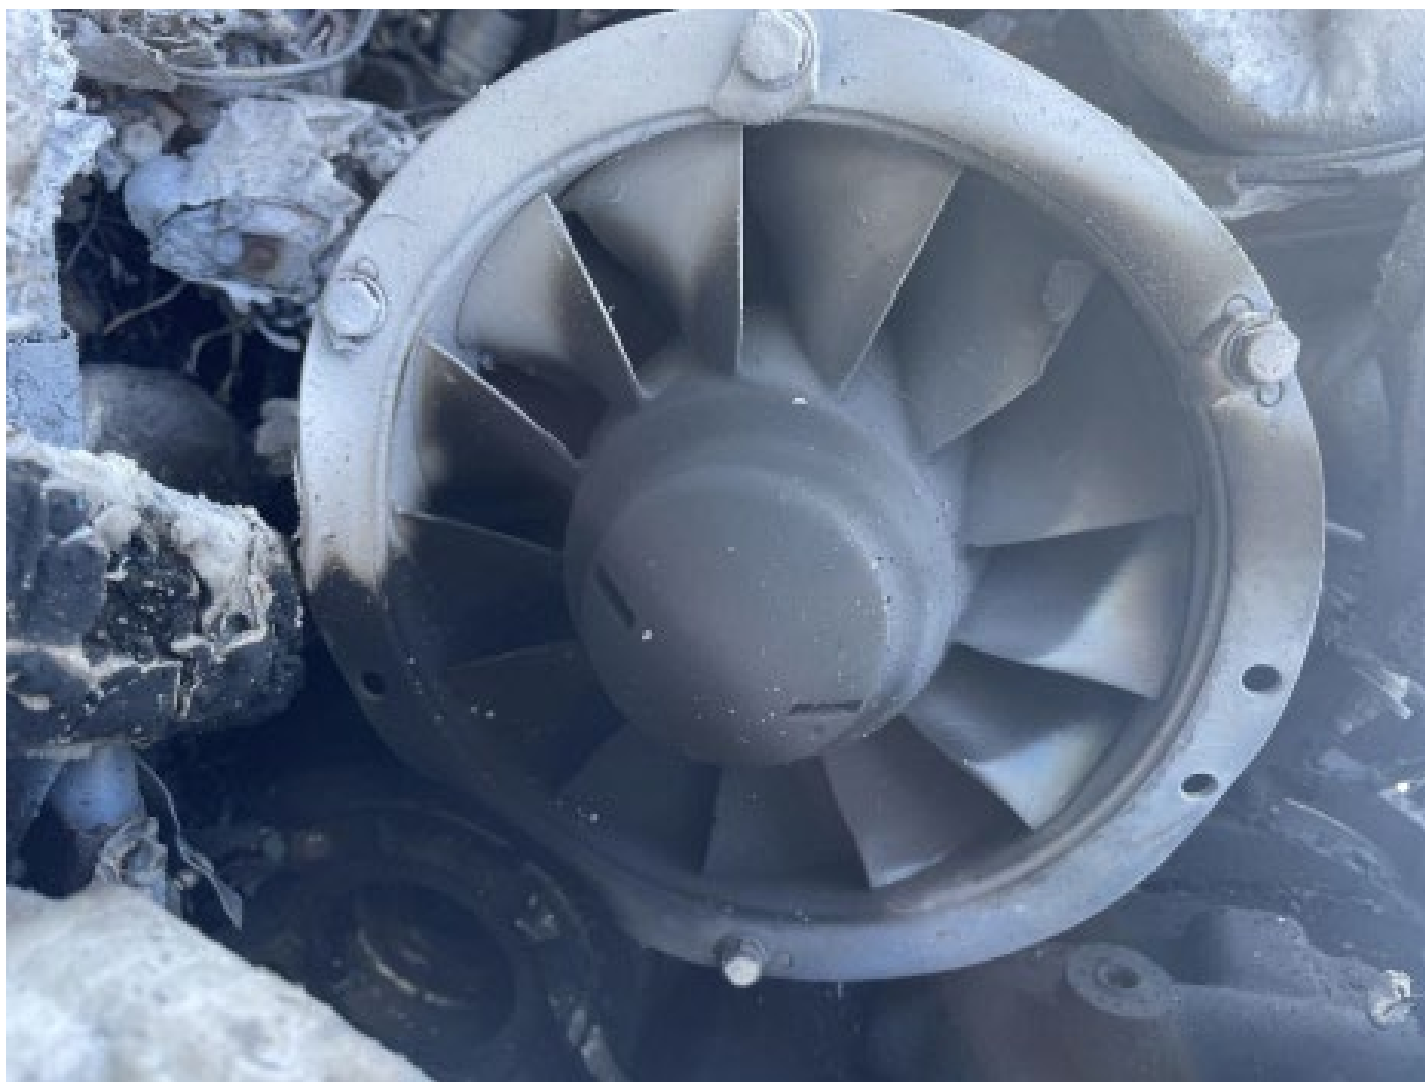
**Photograph 11 - Axial Compressor (Courtesy of Safran)**

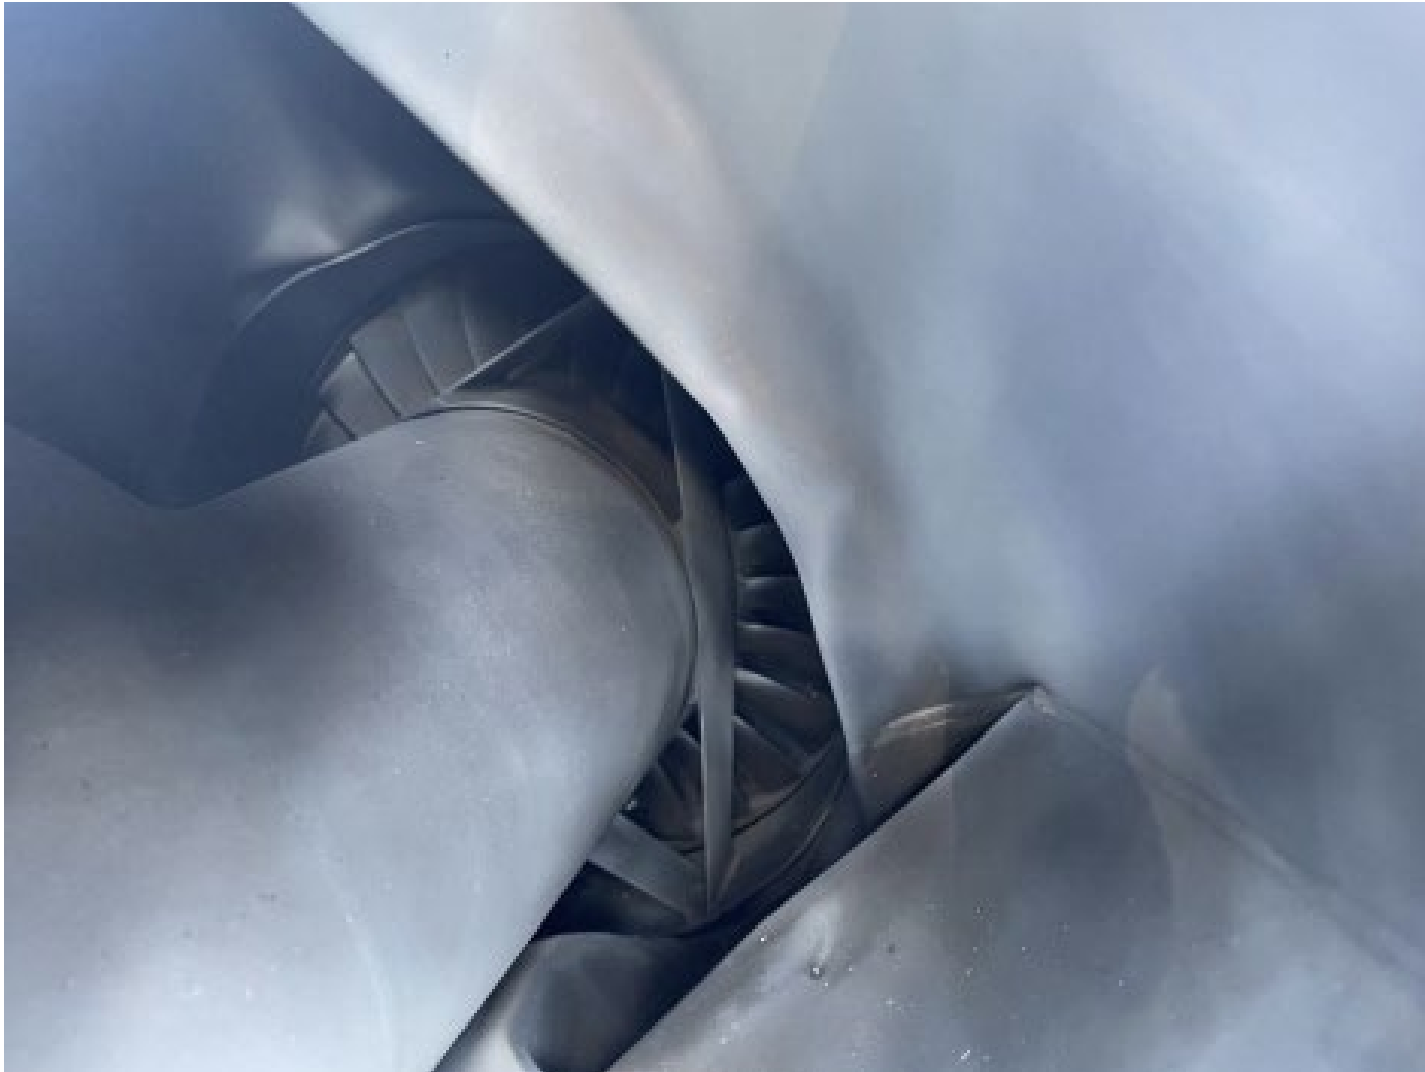
**Photograph 12 - Power Turbine (Courtesy of Safran)**

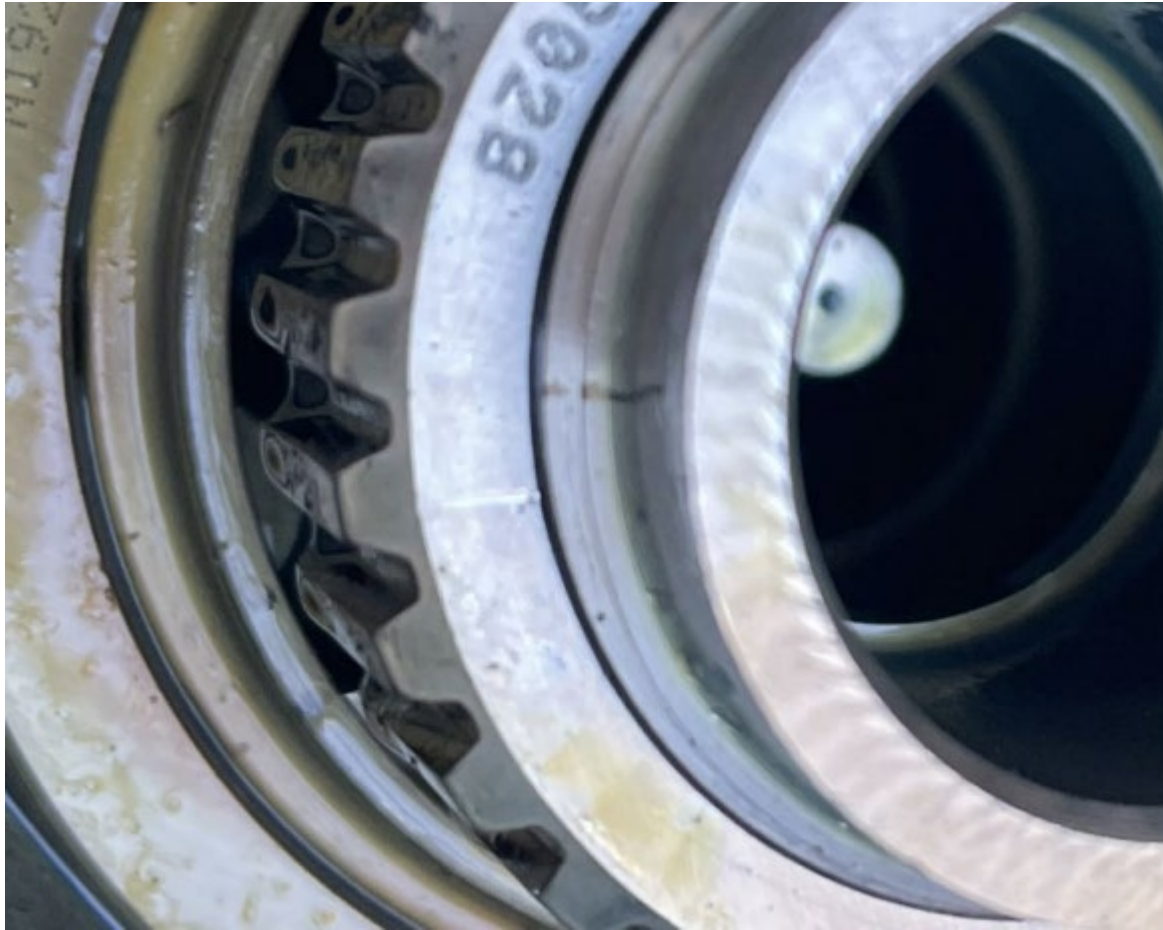
**Photograph 13 - Input Pinion Slippage Mark Misalignment (Courtesy of Safran)**
