# National Transportation Safety Board

ERA24FA075

Group Chair's Factual Report

Location: Miami, Florida  
Date: December 27, 2023  
Time: 1300 eastern standard time  
Helicopter: MD Helicopters 369E, registration N757TB

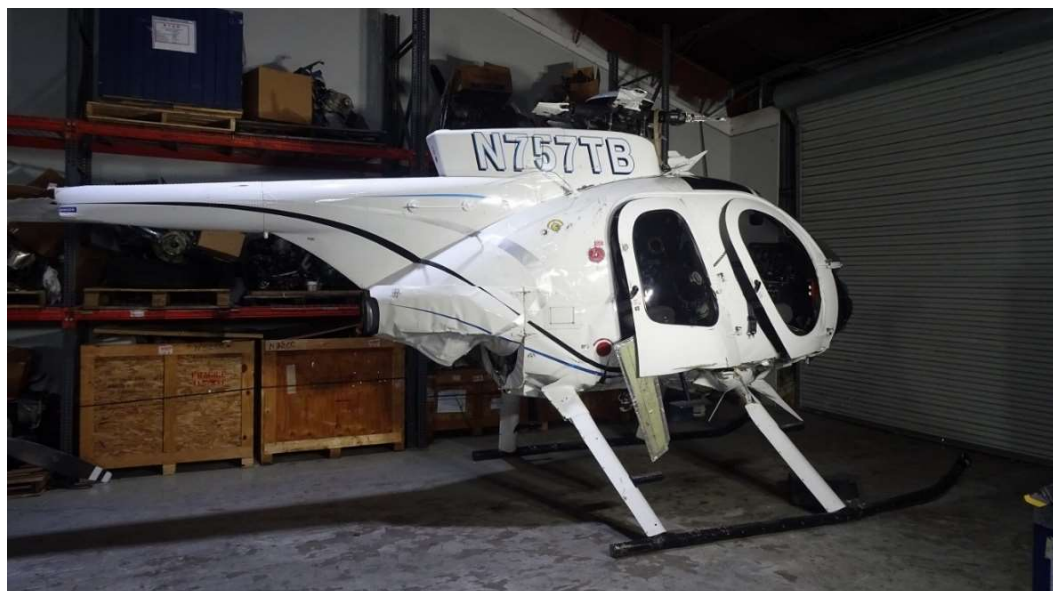
The main fuselage was whole but exhibited inward crushing on its belly (**Figure 1**). The aft portion of the tail boom containing the tail rotor and T-tail stabilizer (empennage) was fractured and separated about 57 inches aft of the tail boom-to-main fuselage attachment and about 25 inches forward of the tail rotor gearbox attachment (**Figure 2**). The tail boom fracture and deformation were to the right and exhibited signatures consistent with main rotor blade contact (**Figure 3**). The landing gear remained installed and did not exhibit significant deformation or splaying. The engine inlet screen exhibited no evidence of blockages.

**Figure 1.** The recovered helicopter.

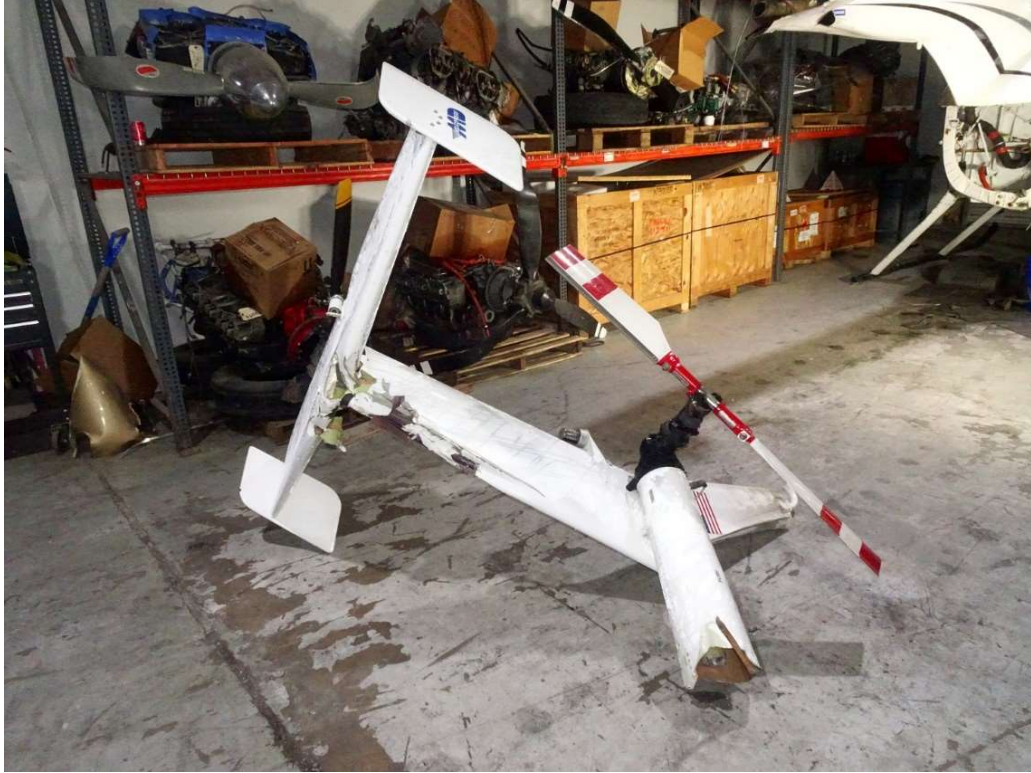
**Figure 2.** The recovered empennage wreckage.

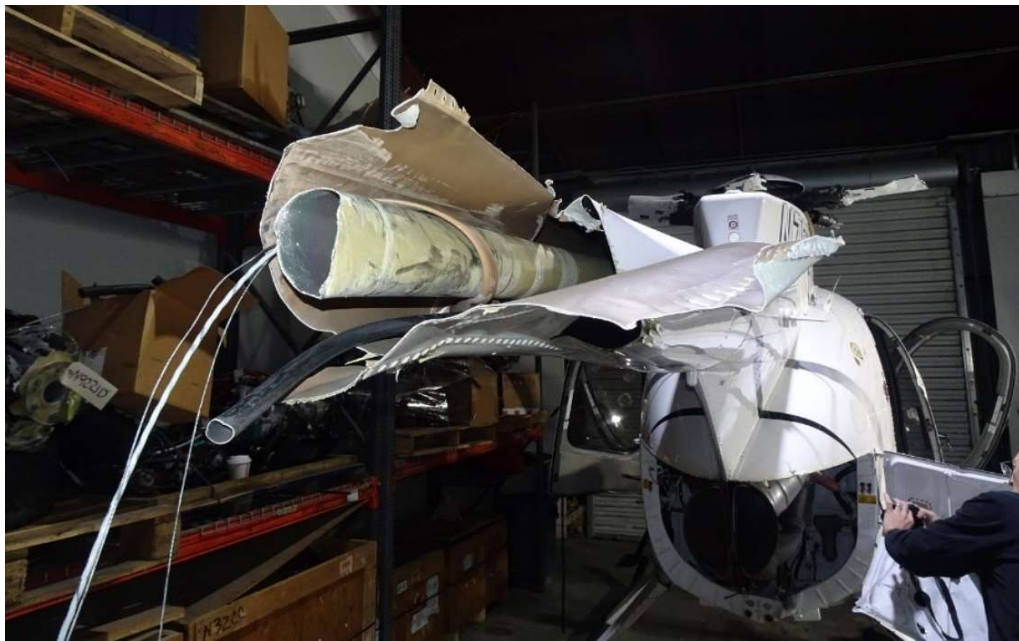
**Figure 3.** The fractured tail boom, tail rotor drive shaft, and tail rotor control tube.

The tail rotor drive shaft was fractured at the location of the tail boom fracture. Rotation of the tail rotor drive shaft resulted in a corresponding rotation of the main rotor, confirming continuity of tail rotor drive from the main transmission, with no evidence of binding.

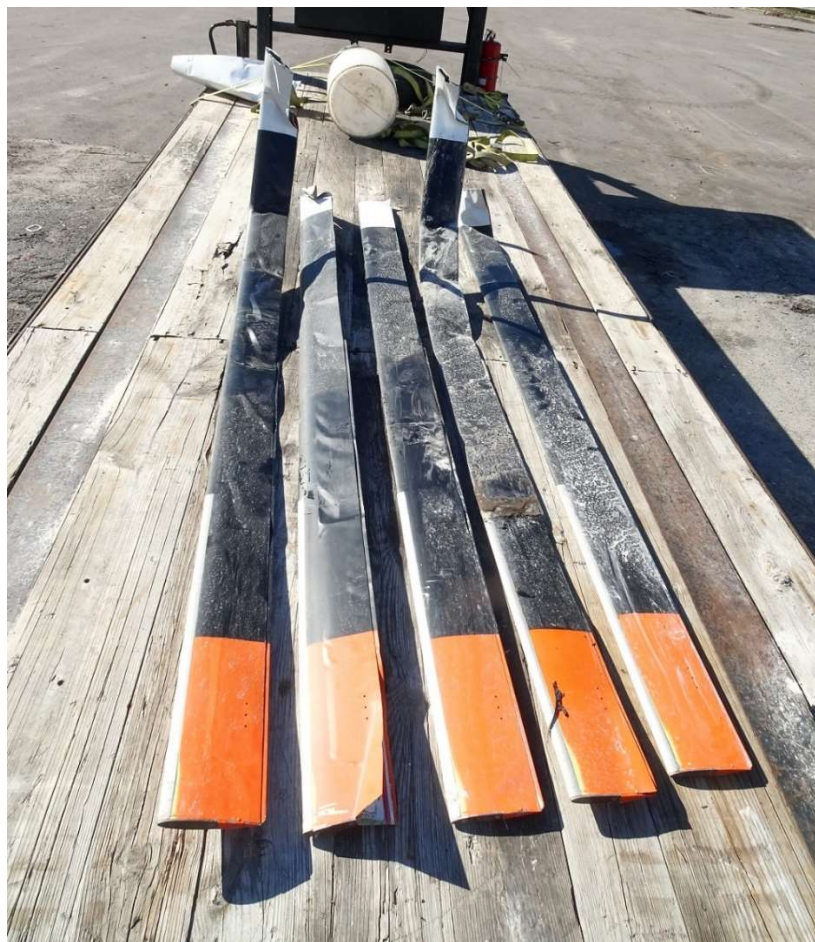
The main rotor and main transmission remained installed on the helicopter. All main rotor head components remained installed with no evidence of separation or fractures. The main rotor blades were cut near their root ends to facilitate recovery of the wreckage. The main rotor blades did not exhibit fragmentation and all were full-length (**Figure 4**). The main rotor blades exhibited chordwise deformation, with two blades exhibiting significant chordwise and downward deformation near their root ends. At the trailing edge of one blade, the upper and lower skins had splayed open at the tip end.

**Figure 4.** The main rotor blades.

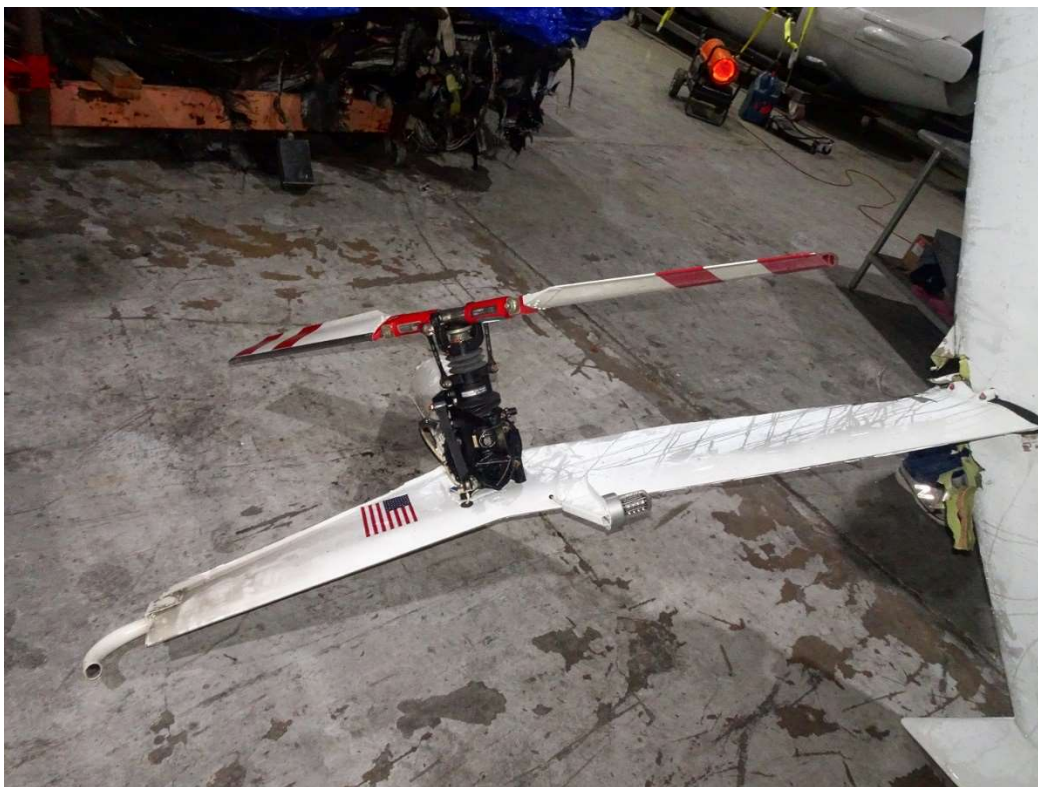
The tail rotor gearbox remained installed on the aft end of the tail boom, the latter of which was fractured and separated from the main wreckage (**Figure 5**). The tail rotor blades remained installed on the tail rotor hub and did not exhibit anomalous damage other than damage due to submersion in the canal. Rotation of the tail rotor resulted in a corresponding rotation of the tail rotor drive shaft that remained within the [separated] empennage.

**Figure 5.** The tail rotor gearbox and tail rotor.

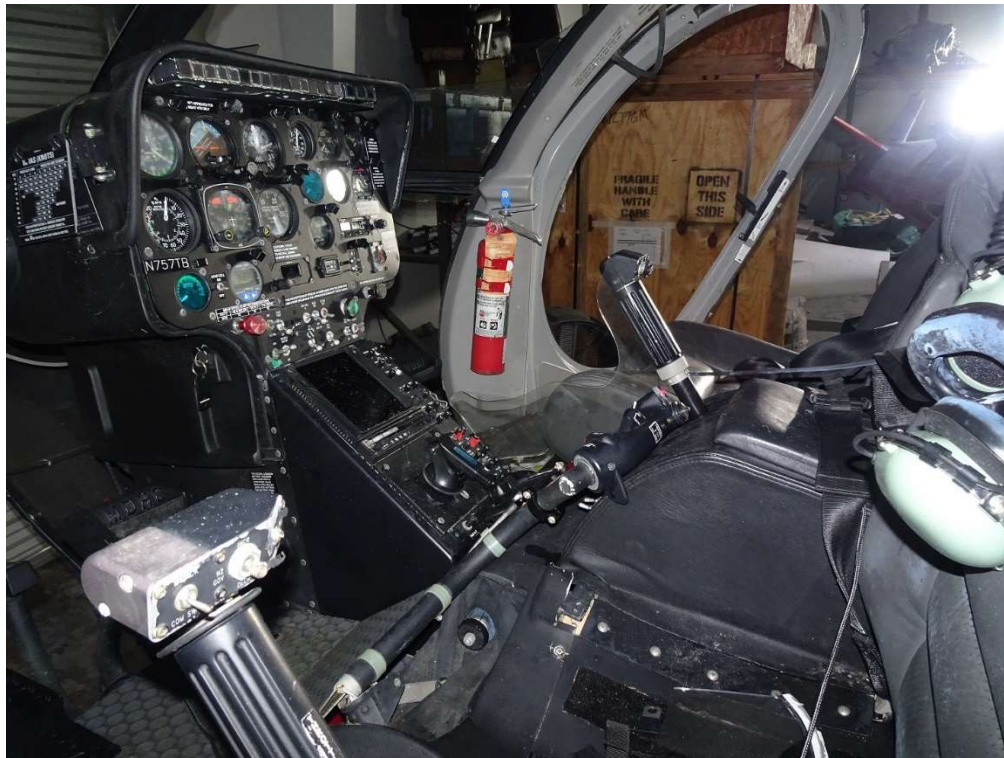
The helicopter was equipped with dual flight controls (**Figure 6**). Both left side and right side pedal sets and collective controls remained installed and intact. Both left side and right side cyclic control sticks were fractured near their base, but the base remained installed on the cyclic control tubes. Both left and right cyclic control sticks remained partially attached via their wiring.

**Figure 6.** The cockpit control installation.

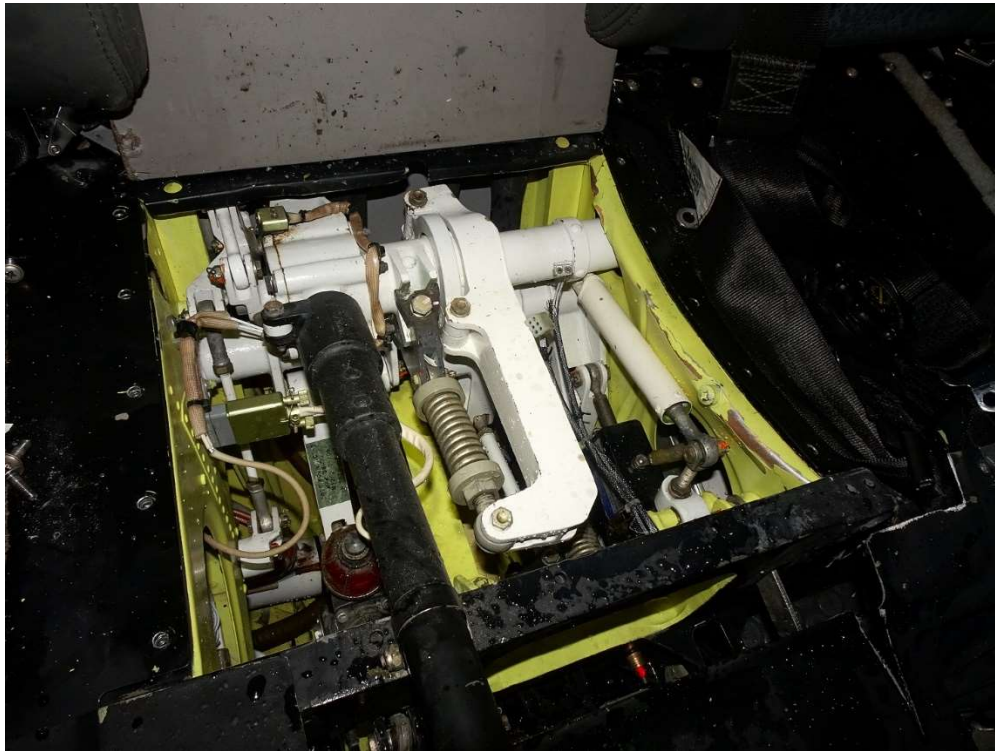
Movement of the left collective control resulted in a corresponding movement of both the right collective control as well as the main rotor blades, confirming continuity of the collective control system (**Figure 7**). Movement of the collective

resulted in the collective balance spring pushing the collective control either in the full up (if moving upward) or full down (if moving downward) positions.

**Figure 7.** A portion of the cockpit flight control bellcranks and balance springs.

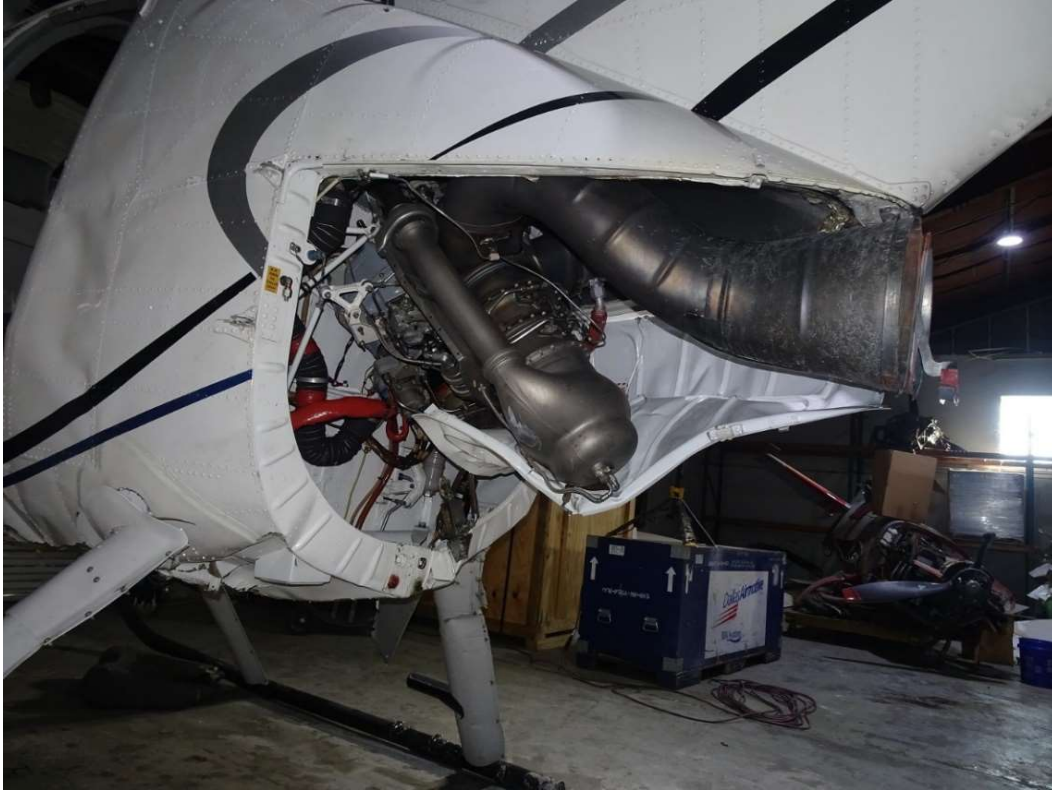
The engine remained installed on the airframe (**Figure 8**). The left engine mount had a fracture at its rod end threads near the lower airframe mount. The remaining engine mounts were not fractured. The engine fuel control unit (FCU) power indicator was pointing to 90°, it's maximum setting (**Figure 9**). The engine power turbine governor (PTG) indicator was pointing between 80-90%. Continuity of control between the collective-mounted twist grip and the FCU was confirmed, but movement of the twist grip was restricted due to crushing of the airframe that impinged on the control cable. Continuity of control between the collective control and the input drive arm of the PTG was confirmed.

**Figure 8.** The engine installed on the airframe.

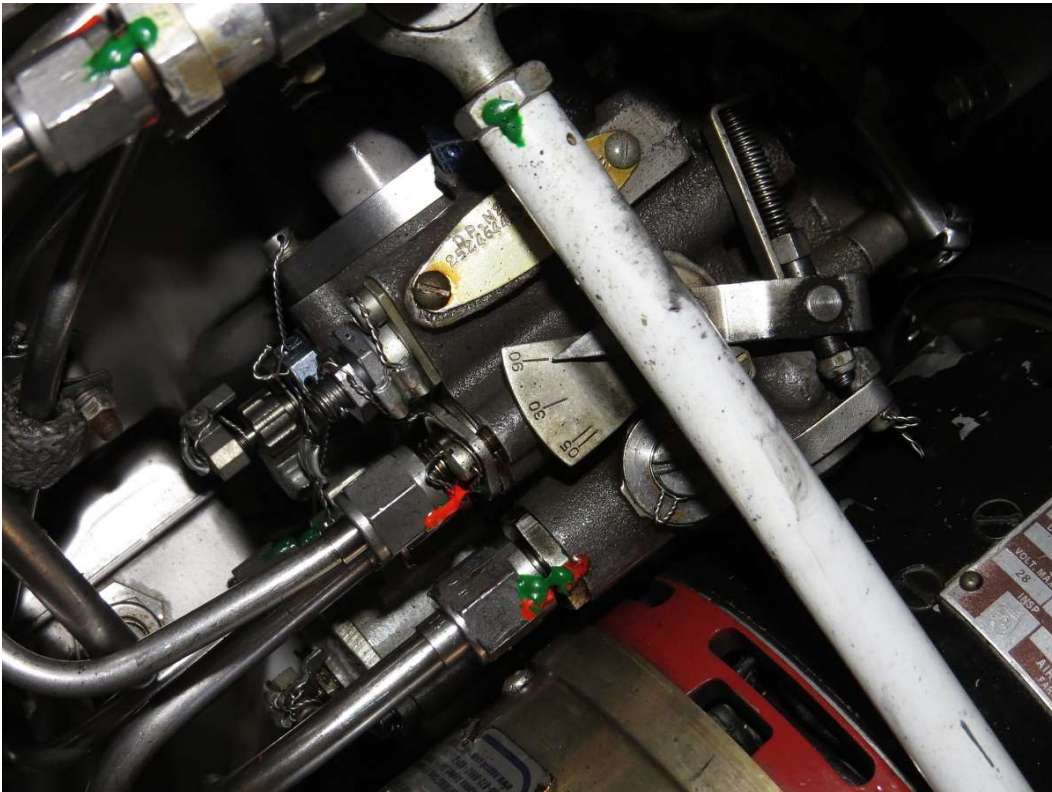
**Figure 9.** The engine FCU indicator showing 90°.

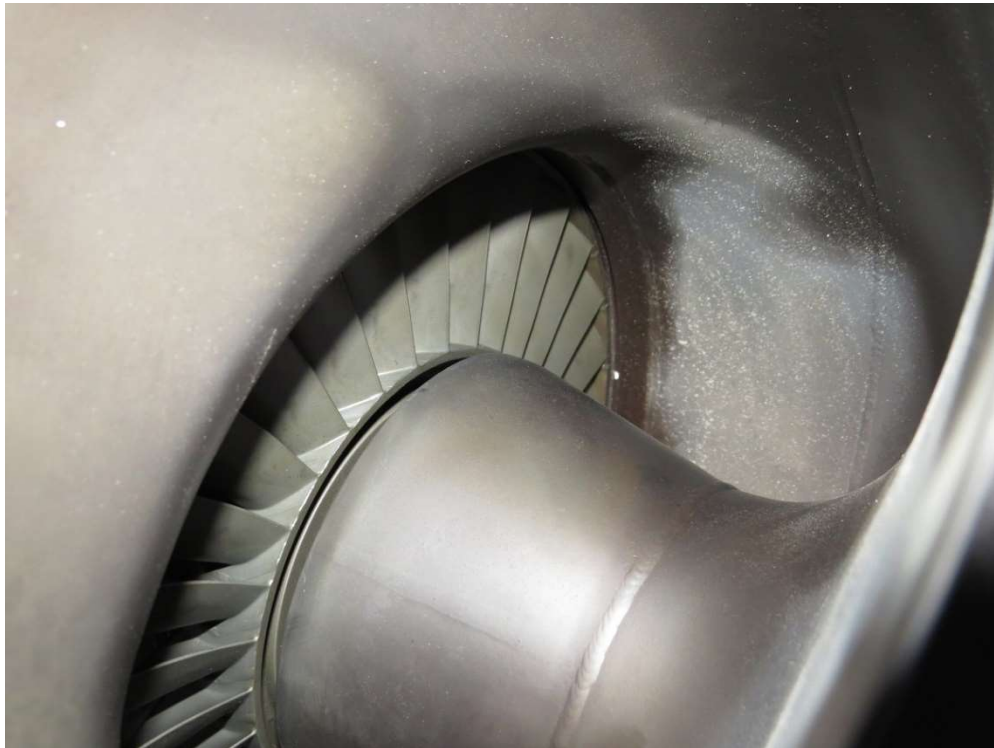
The engine was removed from the airframe to facilitate further examination. The engine fuel filter bowl was removed and the filter element showed no evidence of debris or clogging. Remnant fuel was present in the fuel filter bowl. The engine fuel pump was removed and its driveshaft splines exhibited no anomalous damage. Rotation of the fuel pump driveshaft resulted in pumping out of residual fuel within the fuel pump. Viewing the fourth stage power turbine from the engine exhaust revealed no evidence of anomalous damage or deformation of the power turbine blades (**Figure 10**).

**Figure 11.** The fourth stage power turbine. (Image courtesy of Rolls-Royce)

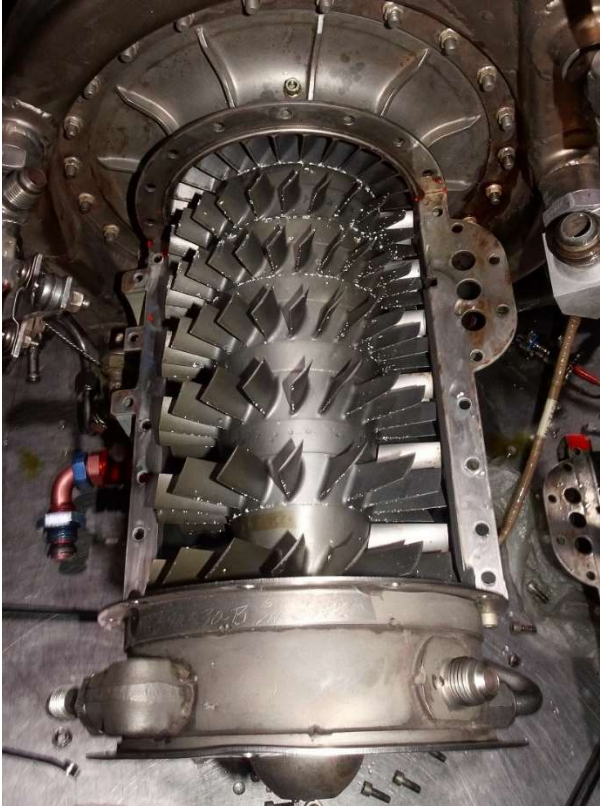
The upper compressor case half was removed to facilitate inspection of the compressor rotor. The blades of all axial compressor blisks were present and did not exhibit anomalous damage or deformation (**Figure 11**). Salt crystals were present on the blade surfaces. The stator vanes on the compressor case half that was removed were all present and exhibited no anomalous damage or deformation (**Figure 12**). Removal of the fuel control and the power turbine governor showed no evidence of binding of those drive shafts.

**Figure 11.** The axial compressor blades after removal of a compressor case half.

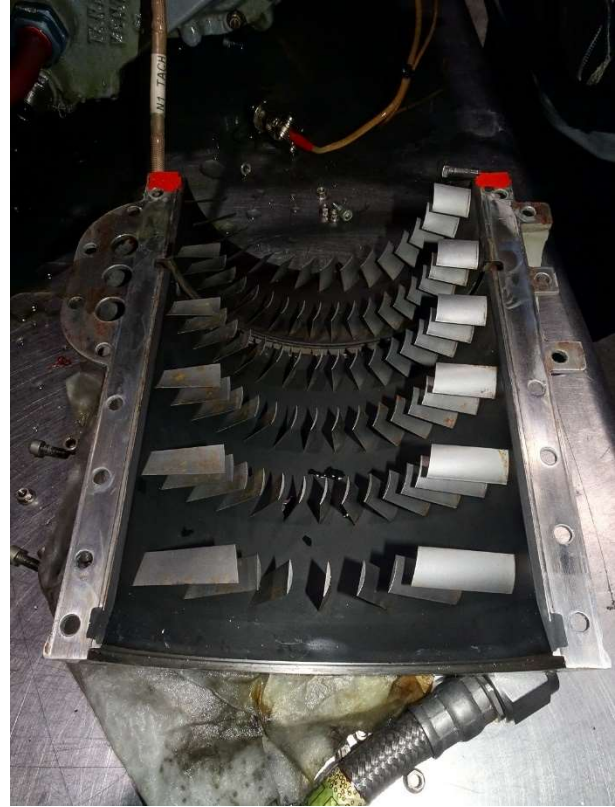
**Figure 12.** The stators of the removed compressor case half.
