# National Transportation Safety Board

ERA24FA077

## WRECKAGE EXAMINATION

Location: Marienville, Pennsylvania  
Date: December 29, 2023  
Time: 2157 EST  
Airplane: N7628Y, Piper PA-30

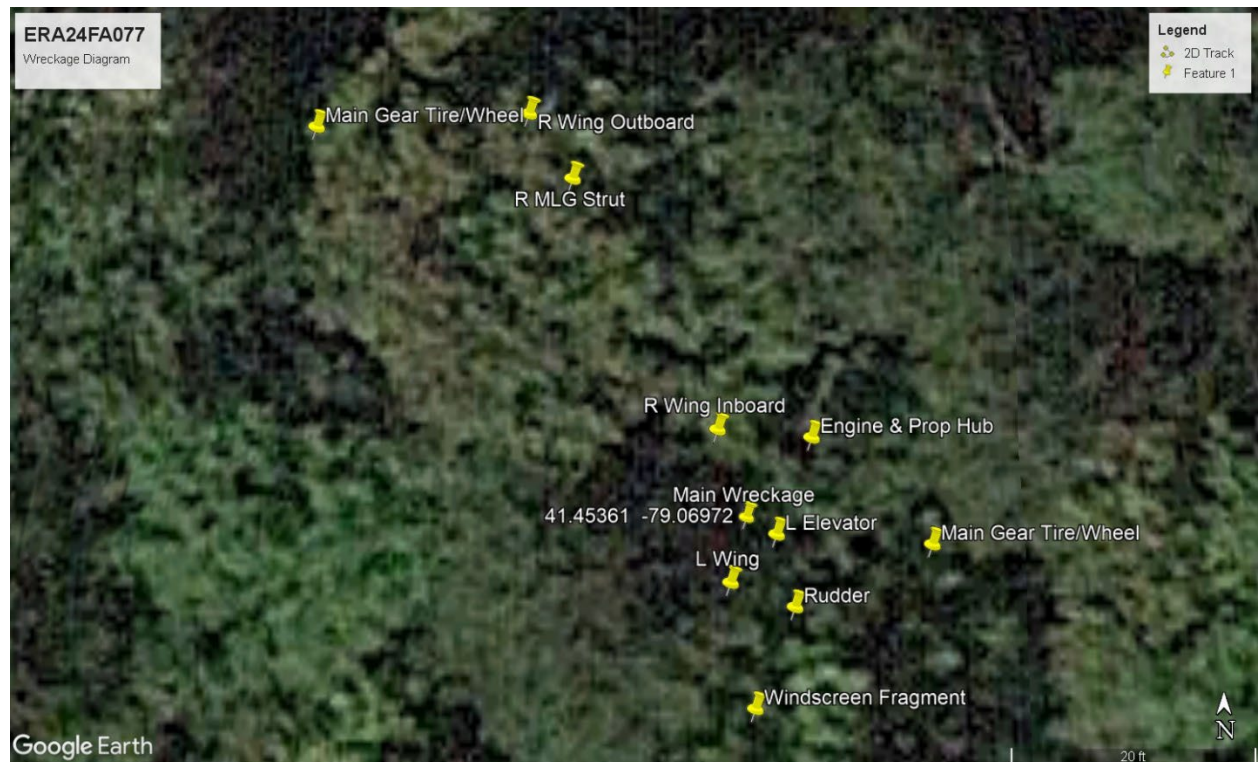
Figure 1 - Wreckage Diagram

The airplane crashed on wooded terrain inside the confines of the Allegheny National Forest at coordinates 41.45361, -79.06972 (see Figure 1). The initial impact point was the top of a 70-foot-tall tall hardwood tree, and the airplane

continued at a 60° descent angle until the main wreckage lodged in another hardwood tree.

The magnetic heading from the initial tree strike to the main wreckage was 140°, and the fuselage was found oriented on a heading of 320°.

The entire wreckage path was about 65 ft long and about 25 ft wide.
