# National Transportation Safety Board

ERA24FA078

## **SOUND SPECTRUM**

Location: Mooresville, North Carolina  
Date: December 31, 2023  
Time: 12:13 eastern standard time (EST)  
Aircraft: Piper Aircraft PA46R-350T, N539MA

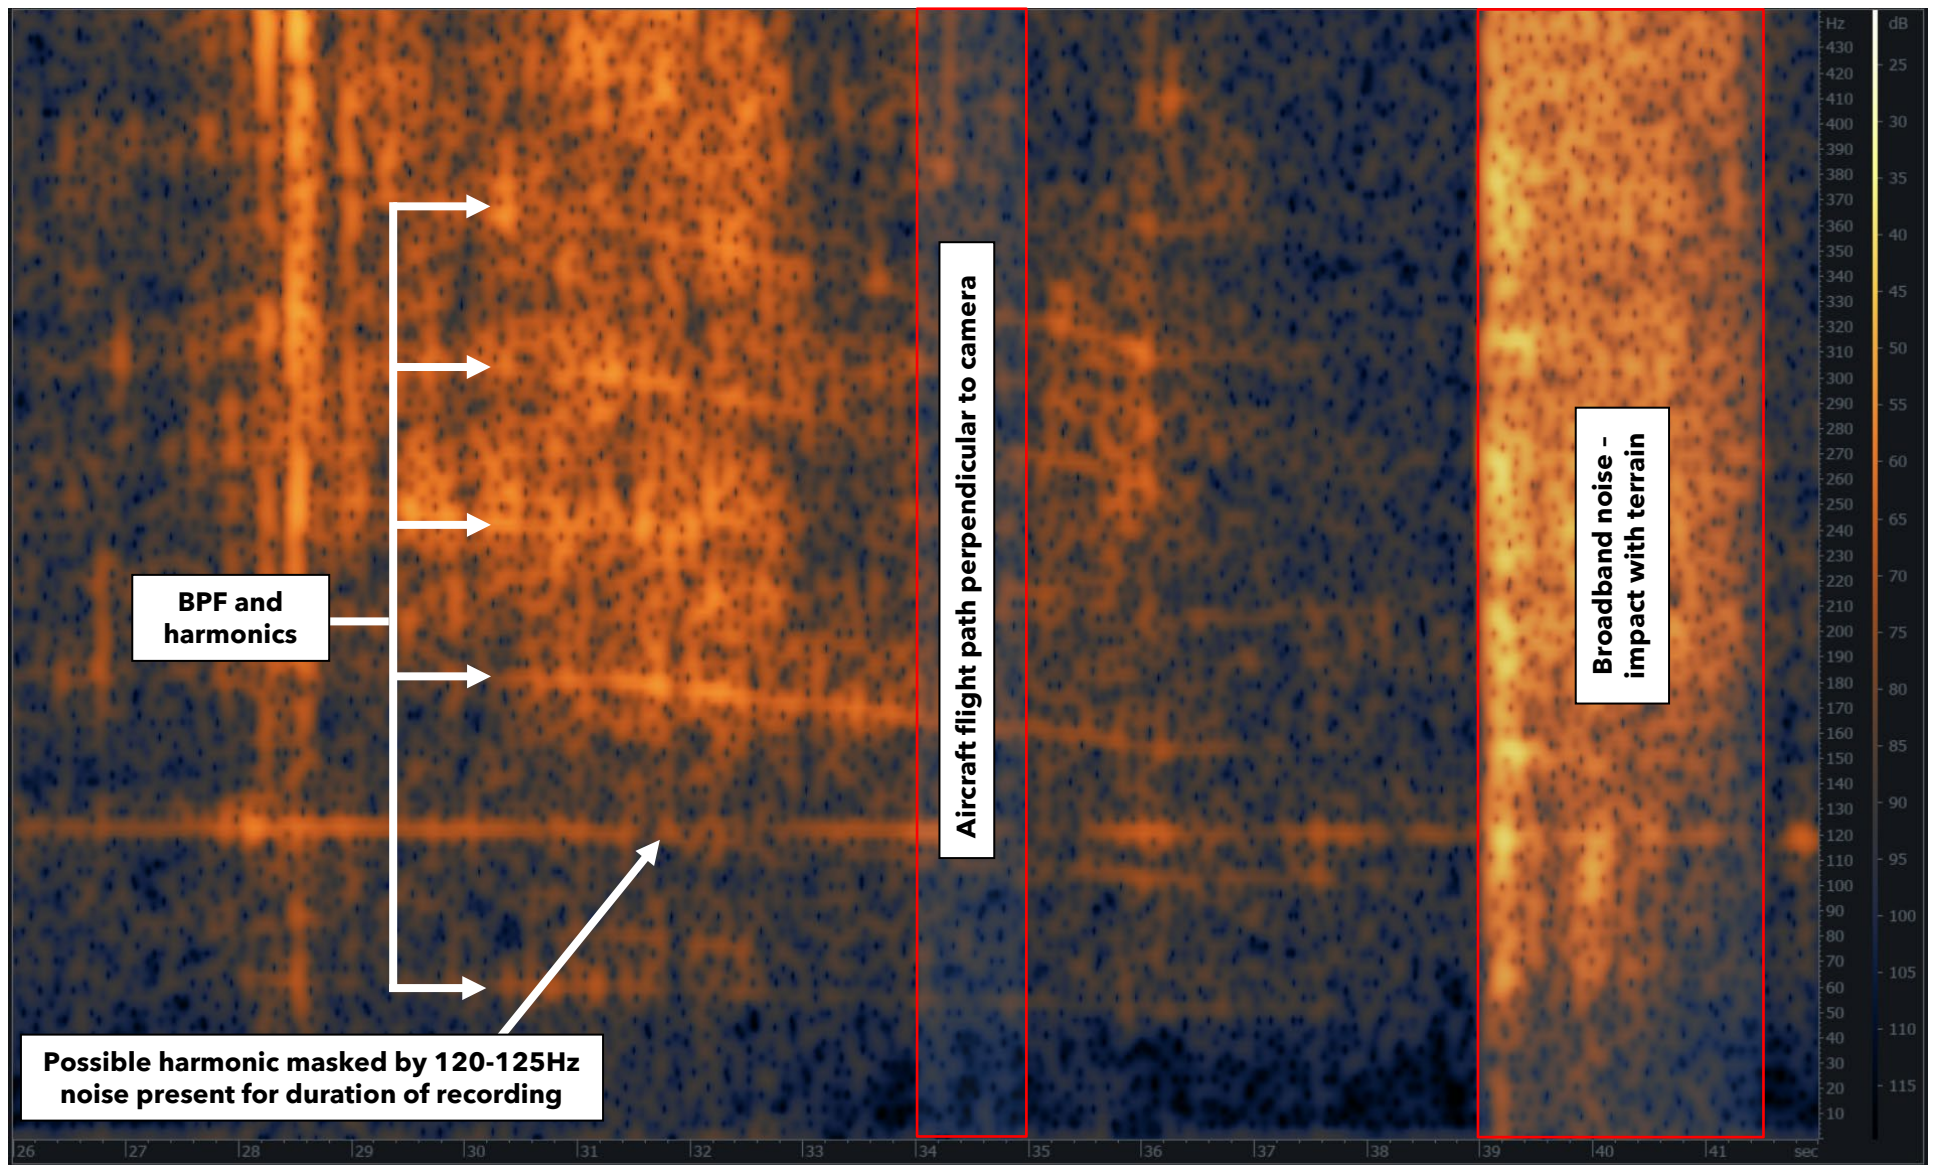
A spectrogram was generated, as shown in Figure 2, showing the frequency content of the sound from the camera and how it changed over time from 12:13:40 EST to 12:13:56 EST (00:26 to 00:42 video elapsed time). The x-axis represents time in elapsed seconds of the video and the y-axis represents sound frequency in Hertz (Hz). The color represents sound intensity, with black being the lowest intensity sound and orange being the highest intensity.

Overall, the BPF signal-to-noise (SNR) ratio was low as there were two people in the foreground of the video speaking and playing outside. Additionally, there was a 120-125Hz band of noise present throughout the entirety of the recording. Nonetheless, there appeared to be visible lines of BPF, and its harmonics present in the spectrogram as annotated in Figure 2. Also note the gradual downward slope of the lines of BPF and harmonics as time passes, which suggests that the influence of the Doppler effect was present. Broadband noise consistent with the aircraft's impact with terrain was also visible starting at 12:13:53 EST (00:39 video elapsed time).

**Figure 2.** Spectrogram of audio from 12:13:40 EST to 12:13:56 EST (00:26 to 00:42 video elapsed time).

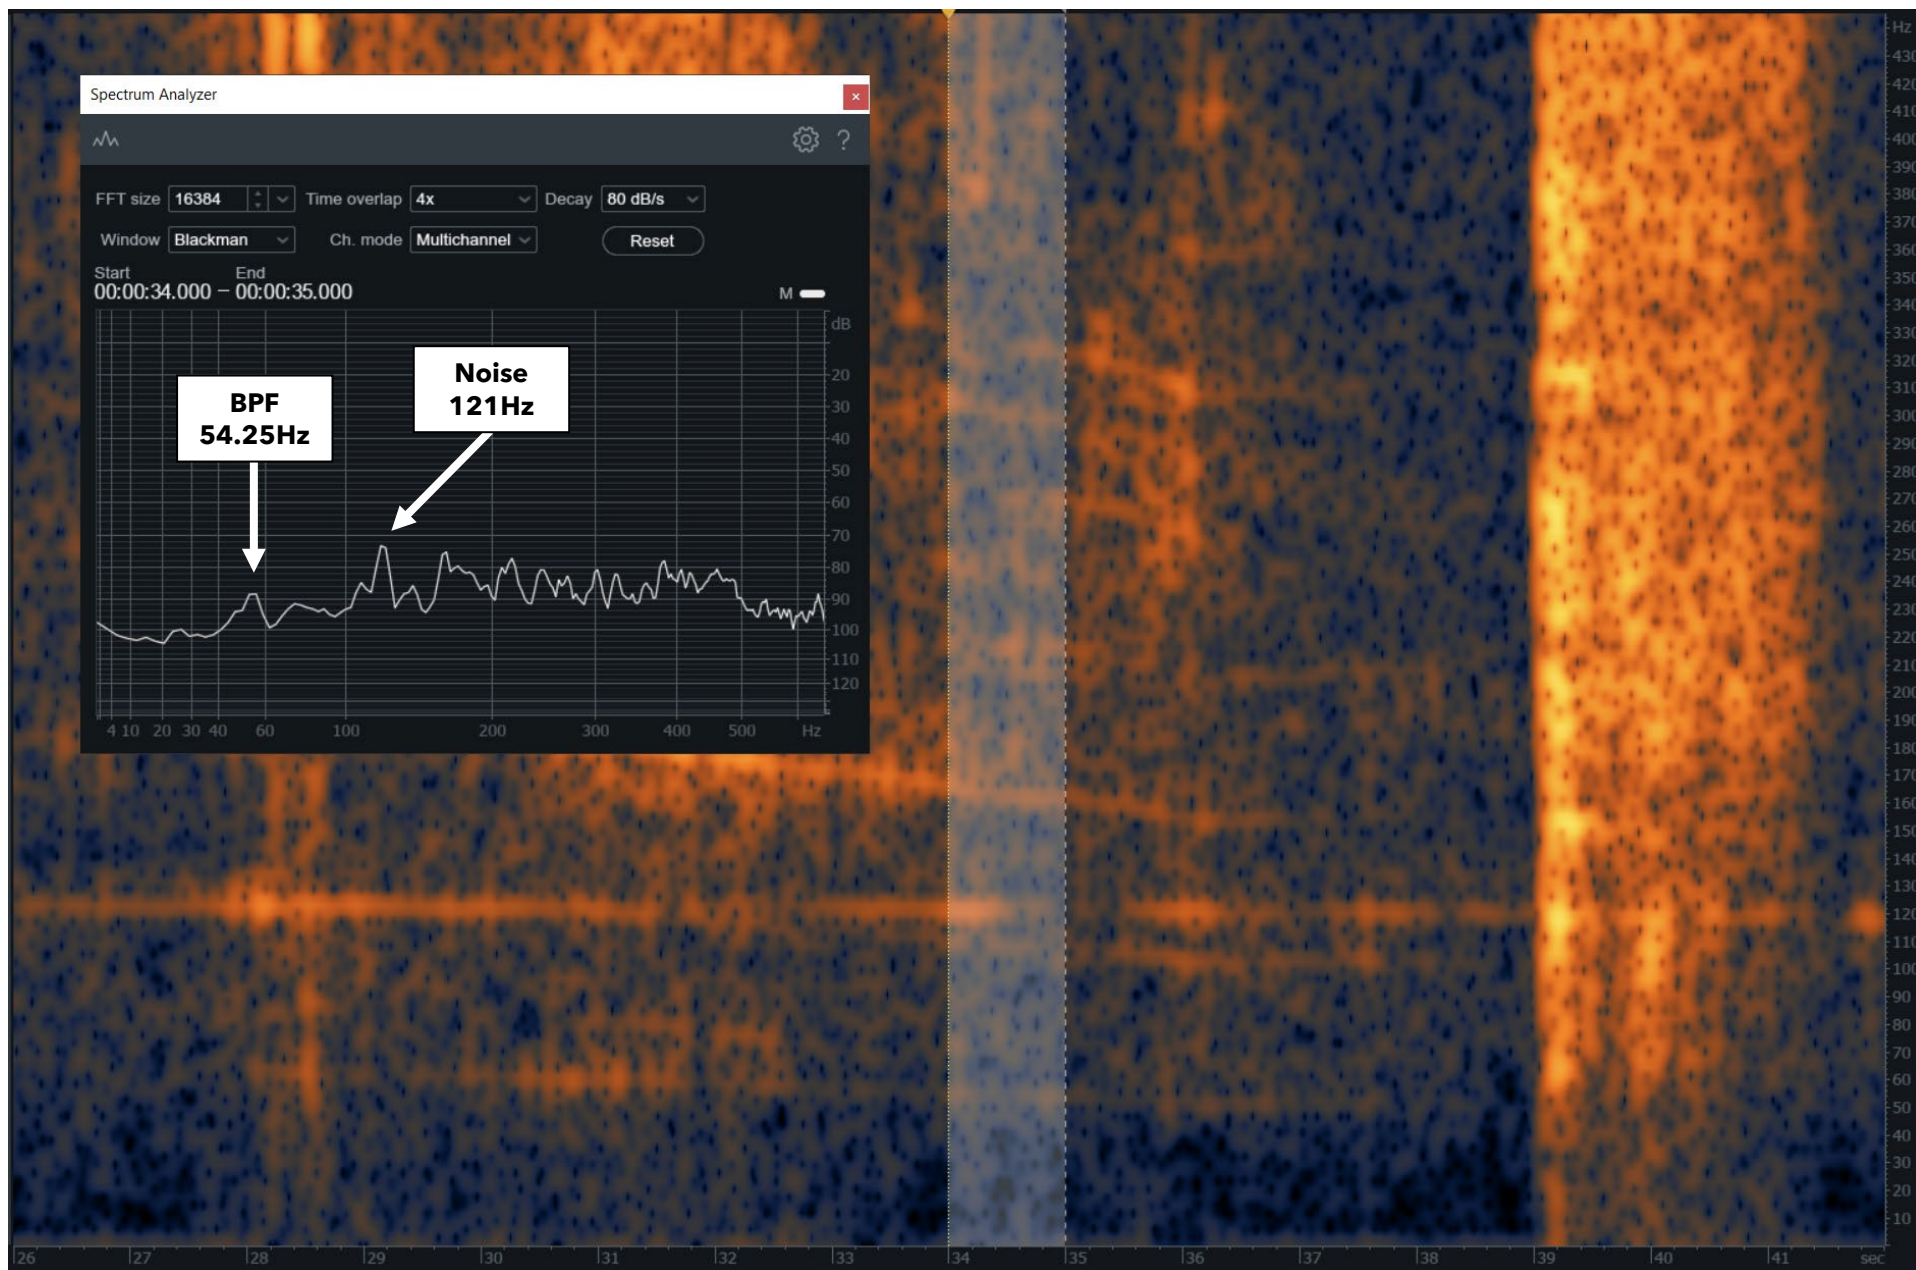
the influence of the Doppler effect could be ignored.<sup>3</sup> A Fast Fourier Transform (FFT) generated for this second, as shown in Figure 3, indicated a fundamental BPF of about 54.25Hz. Using equation 1, this fundamental frequency corresponds to an engine speed of about 1100 RPM during that time.

knots is about 1100-1350 RPM, which is consistent with the RPM value calculated using the BPF in equation 1.

**Figure 3.** FFT of audio from 12:13:45 to 12:13:46 EST (00:34 to 00:35 video elapsed time).

The sound emitted by an aircraft that was captured on a camera at a private residence near the wreckage site was used for estimating the speed of the aircraft's engine prior to impact with terrain. The calculated engine RPM before the aircraft impacted terrain appeared to be consistent with the propeller windmilling at or near 1100 RPM, which is below the engine's published maximum continuous power setting of 2500 RPM.
