**To:** Lynn Spencer, NTSB Investigator In Charge

**From:** Thomas Justice, Engineering Manager, Champion Aerospace

**Date:** September 12, 2024

**Subject:** N539MA Investigation – Magnetos and Spark Plugs

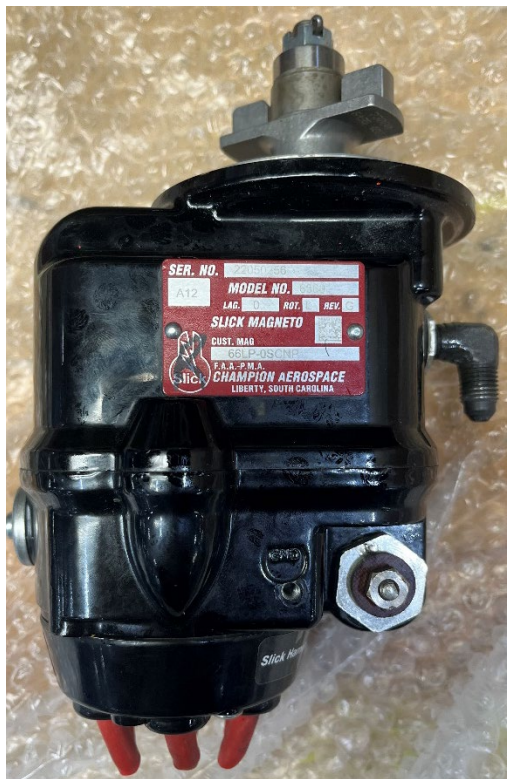
Figure 1. Magneto SN 22050256 (R) Model# 6360

The magnetos were both removed from the box and bubble wrap and set on the work bench for visual examination. Nothing abnormal was noted on either magneto. The harness cap was still installed but the wires had been cut. In order to test the magnetos on the bench test, the harness cap had to be removed and the drive coupling had to be removed as well.

Both magnetos were installed on the Champion magneto tester, used for testing all new parts against new part performance requirements before leaving the facility. Both magnetos **passed** this test against new part specifications. No further investigation or testing was performed.

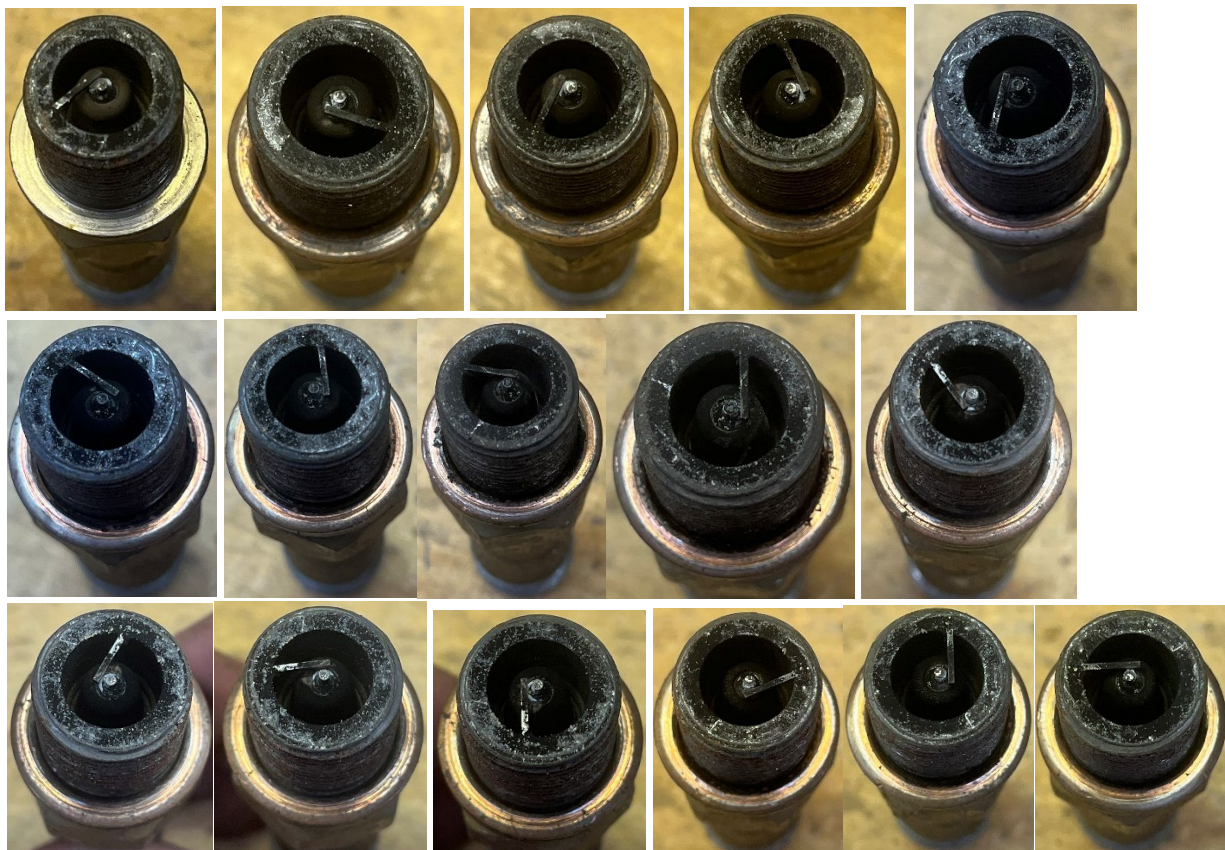
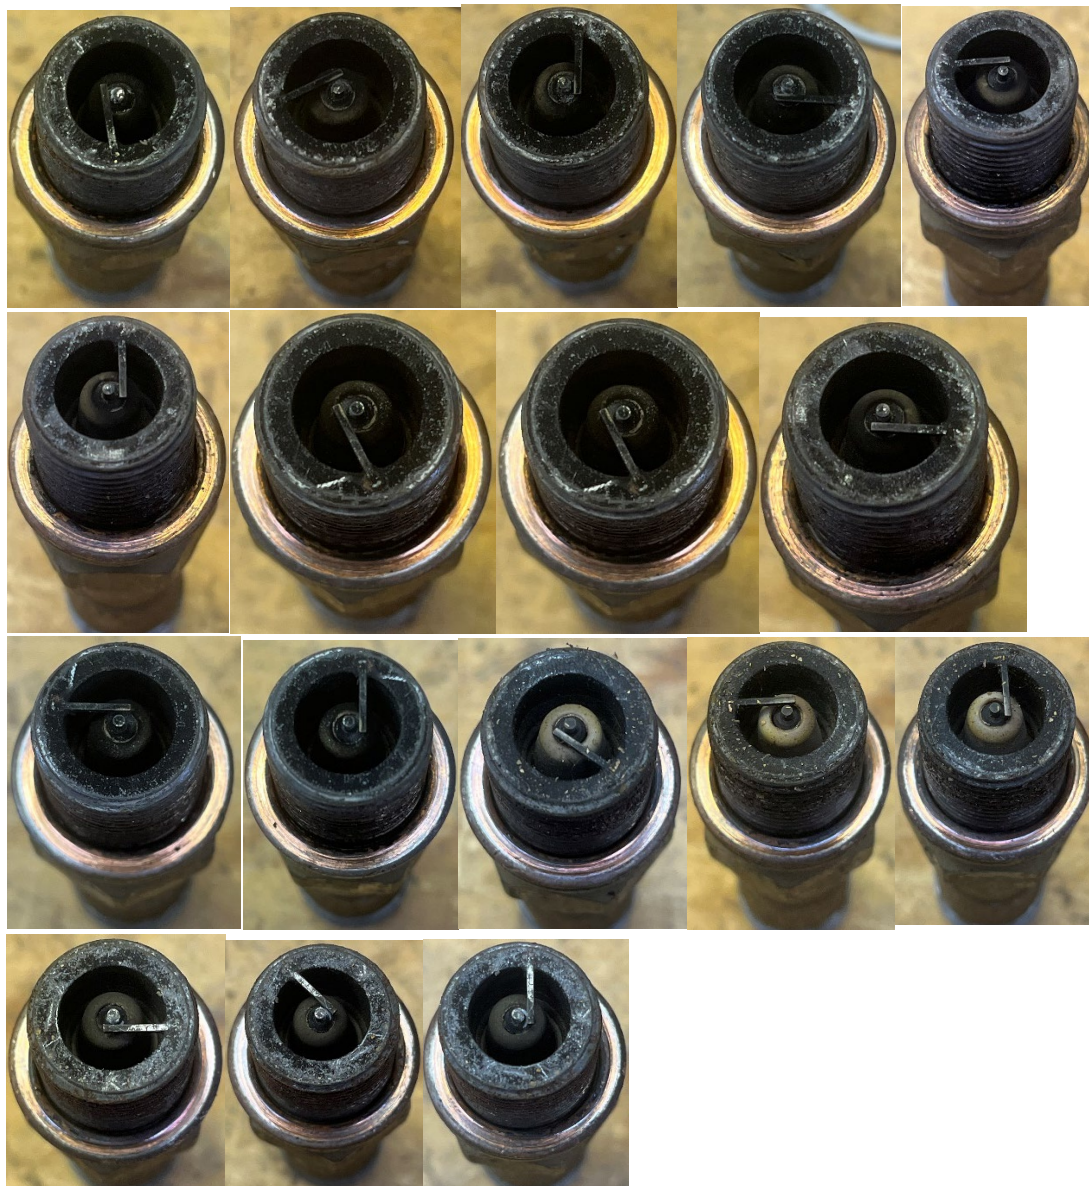
**Figure 3. Spark Plugs**

All twelve (12) spark plugs were provided and intact. The spark plugs showed signs of heavy carbon fouling and were not cleaned prior to testing. All but one spark plug had the gasket already attached. They were not labeled for cylinder location, however the NTSB report does have a picture of the spark plugs labeled for their respective installation position.

All twelve spark plugs were tested on a Champion Spark Plug tester. All twelve spark plugs produced a spark using that tester.

As shown in the photos below, the spark plugs were very dirty (note, multiple pictures per spark plug). The substance on the firing ends was “ashy” in nature. Additionally, there was a white substance on some of the electrodes of the spark plugs. The origin and nature of this substance is unknown. The substance did not cause an adverse effect on the ability of the plugs to produce a spark.
