# National Transportation Safety Board

ERA24FA078

## **AIRFRAME AND ENGINE EXAMINATION**

N539MA, PA46R-350T

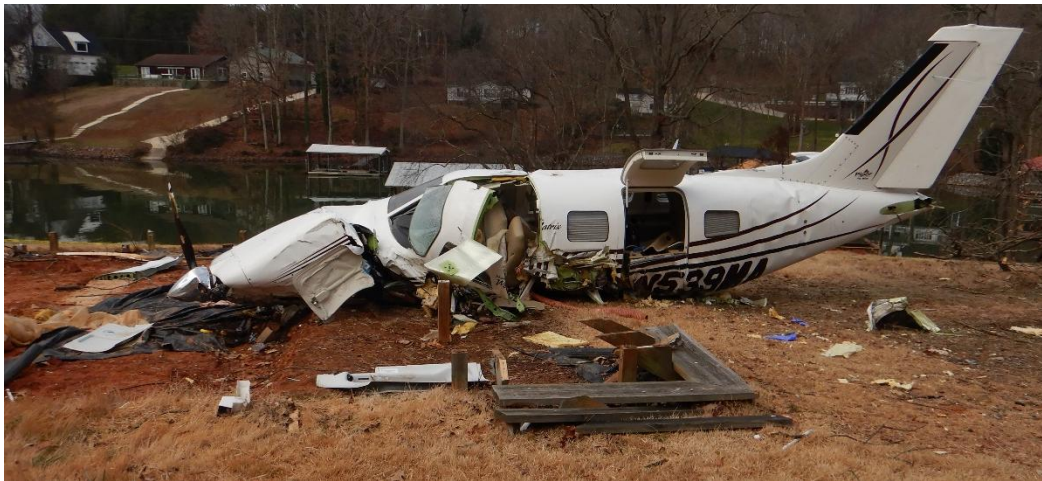
The airplane as first observed was upright in the vacant lot about 58 ft from the base of the impacted trees. The fuselage, right wing, and most of the empennage were intact. A portion of the upper fuselage and windscreen of the cockpit was cut to facilitate recovery of the pilot. The left wing was fractured and resting inverted on top of the

right wing. The left horizontal stabilizer (minus the elevator) was located in front of the cockpit, and the left elevator remained in a tree. The right wing remained attached by the aft wing attachment, and the main spar was fractured at the wing root. The left wing spar was fractured at the wing root. The engine remained attached to the fuselage at the engine mount. One propeller blade came to rest at the base of the impacted trees and a second propeller blade came to rest about 25 ft to the right of the fuselage. The third blade remained attached to propeller hub.

**Photo 6 - Wreckage as viewed from left side.**

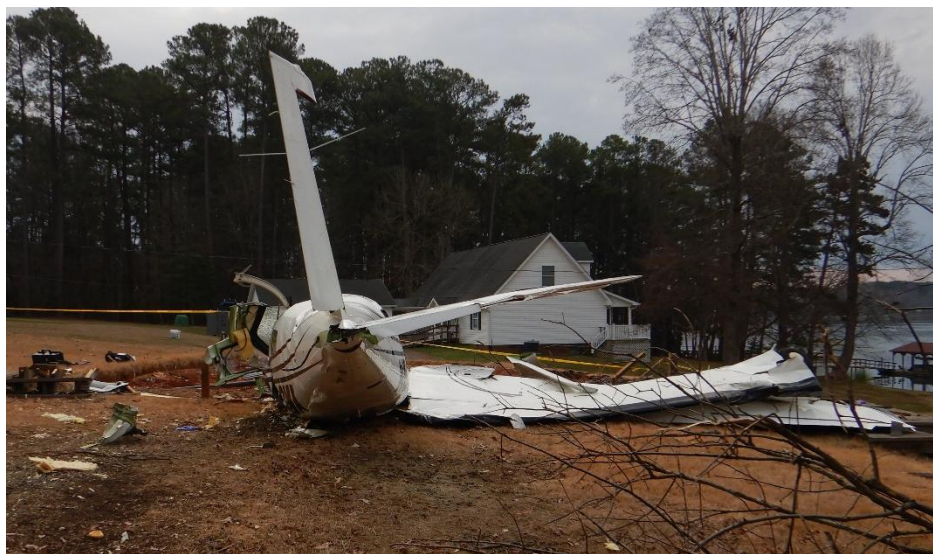
**Photo 7 - Wreckage as viewed from rear.**

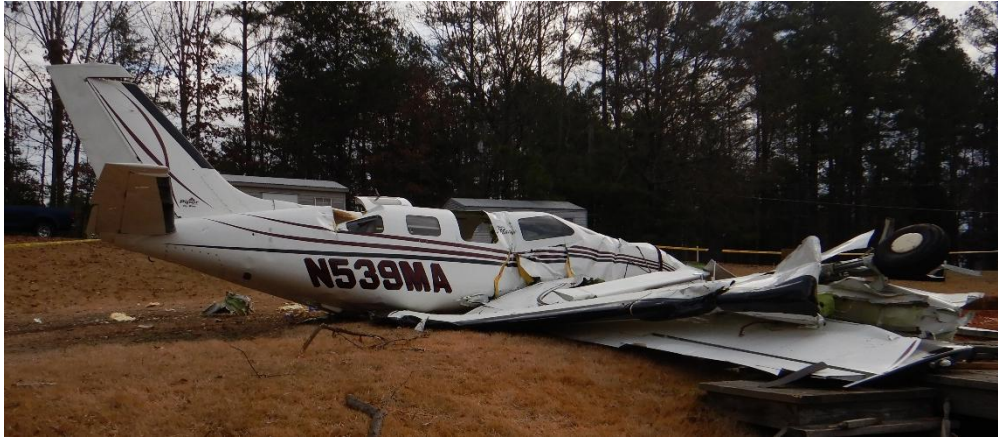
**Photo 8 - Wreckage as viewed from right side.**

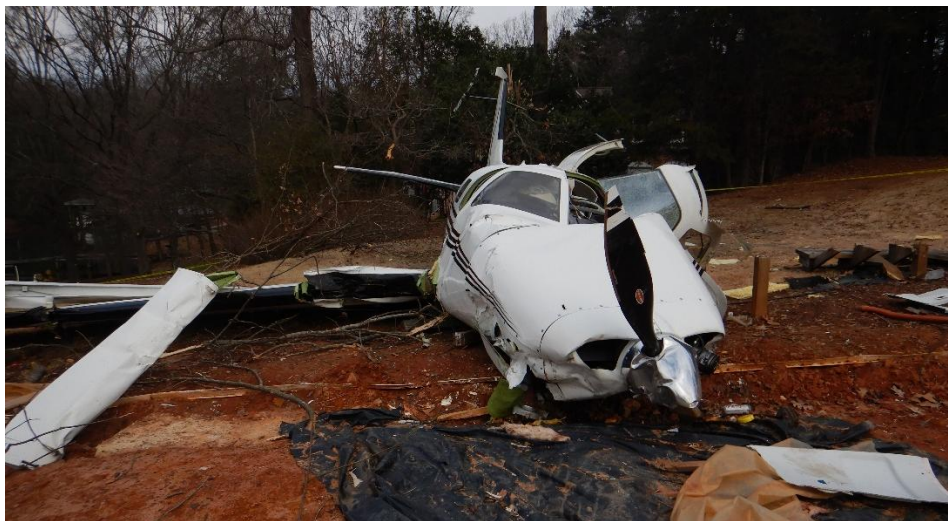
**Photo 9 - Wreckage as viewed from front.**

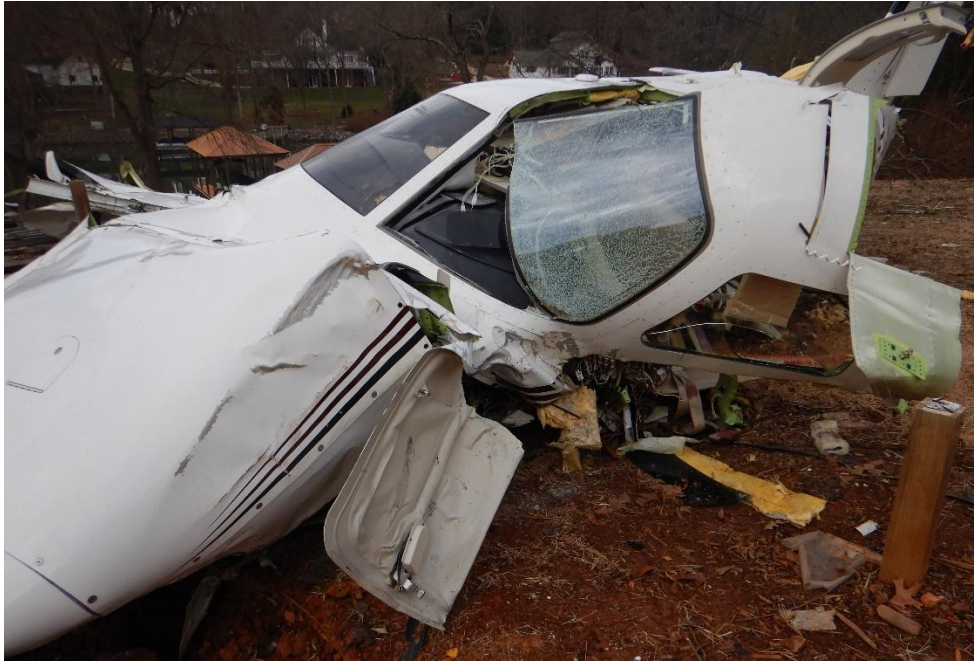
**Photo 10 - Close-up view of crushing to lower front left cockpit area.**

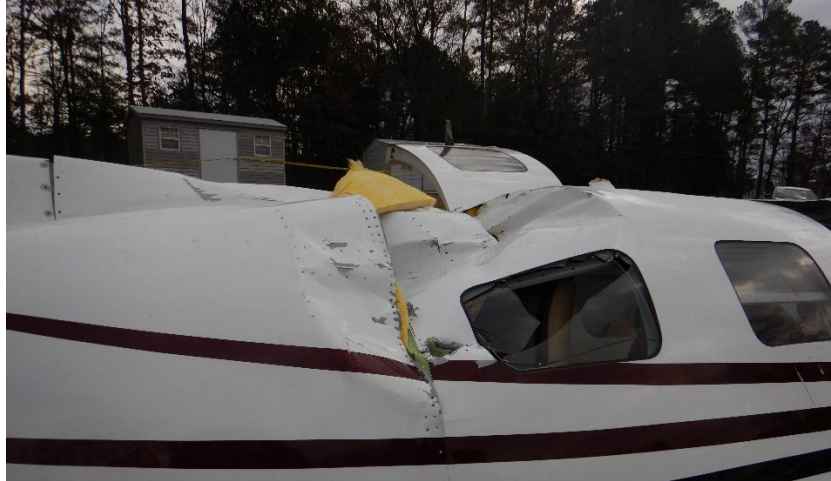
The fuselage was resting upright and was canted slightly to the left side. The left front side of the airplane had been cut by emergency personnel to facilitate removal of the pilot. The firewall displayed downward bending. The engine was canted down and to the left. The nose baggage area displayed compression damage and was crushed aft. The left side of the fuselage was torn open at the wing root and displayed compression damage. The right side of the fuselage displayed compression damage. The cabin roof displayed a localized area of compression damage near aft portion of the cabin.

**Photo 11 - Close-up of upper fuselage damage.**

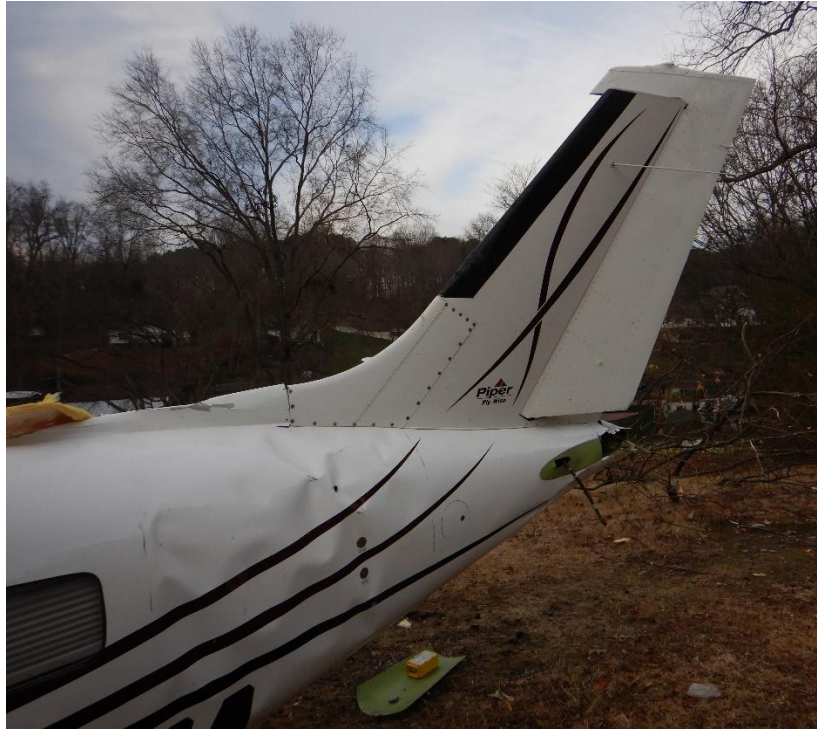
The left side of the horizontal stabilizer separated from the airframe at the inboard end. It displayed compression damage about 12 inches inboard from the tip that was about 18 inches wide. The left side of the elevator separated from the horizontal stabilizer. The left side of the elevator was bent aft 22 inches from the tip. The left side of the elevator trim surface remained attached to the elevator at the hinges. The right side of the horizontal stabilizer remained attached to the empennage. The right side of the elevator remained attached to the stabilizer at the hinges. The right side of the elevator trim surface remained attached to the elevator. The elevator control cables remained attached to the elevator sector in the empennage. The elevator trim control cables remained attached to the elevator trim actuator. The elevator actuator rod was observed with 1 inch of threaded rod showing on the forward end, equating to a near neutral position. Movement of the elevator and elevator trim cables from the empennage by hand revealed that the cables were bound in the forward cabin floor area due to deformation in that location. Some sound could be heard in the forward cabin floor during this effort. No movement of the control column was noted during this manipulation.

The vertical stabilizer remained attached to the empennage and revealed leading edge damage. The rudder remained attached to the vertical stabilizer at all hinges. The rudder displayed minor damage. The rudder control cables remained attached to the rudder horn on both sides in the empennage. The rudder cables were moved by hand and sound could be heard in the forward cabin floor location. Damage to the forward cabin floor precluded movement to the rudder pedals. No movement of the rudder pedals was noted during the hand manipulation.

**Photo 12 - Empennage with fractured left horizontal stabilizer.**

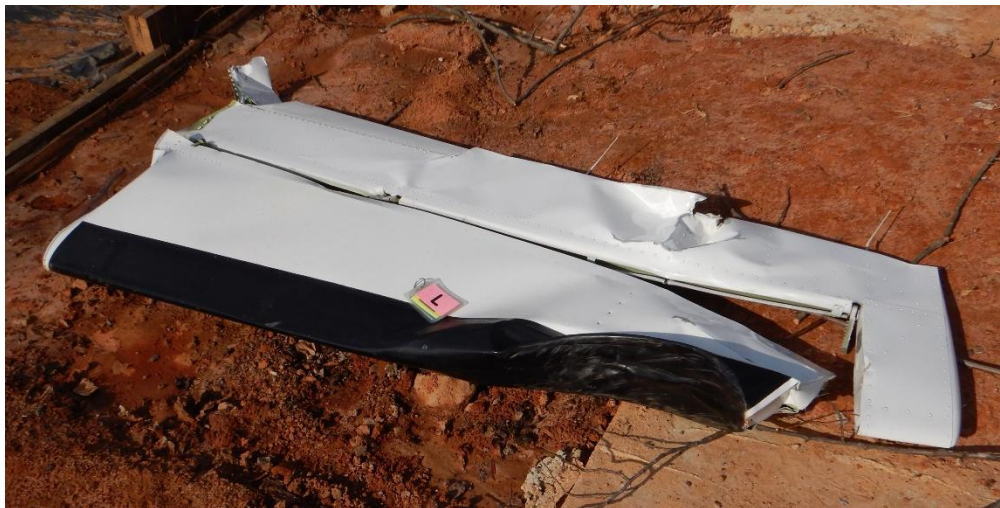
**Photo 13 - Left horizontal stabilizer with elevator after elevator recovery from tree.**

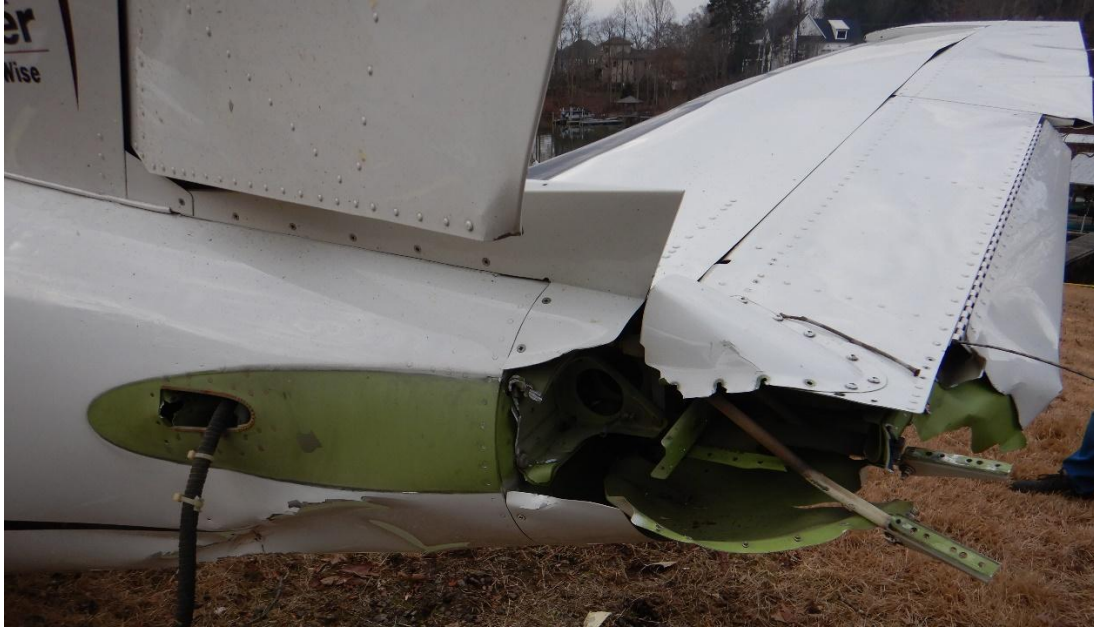
**Photo 14 - View of right horizontal stabilizer from fracture area.**

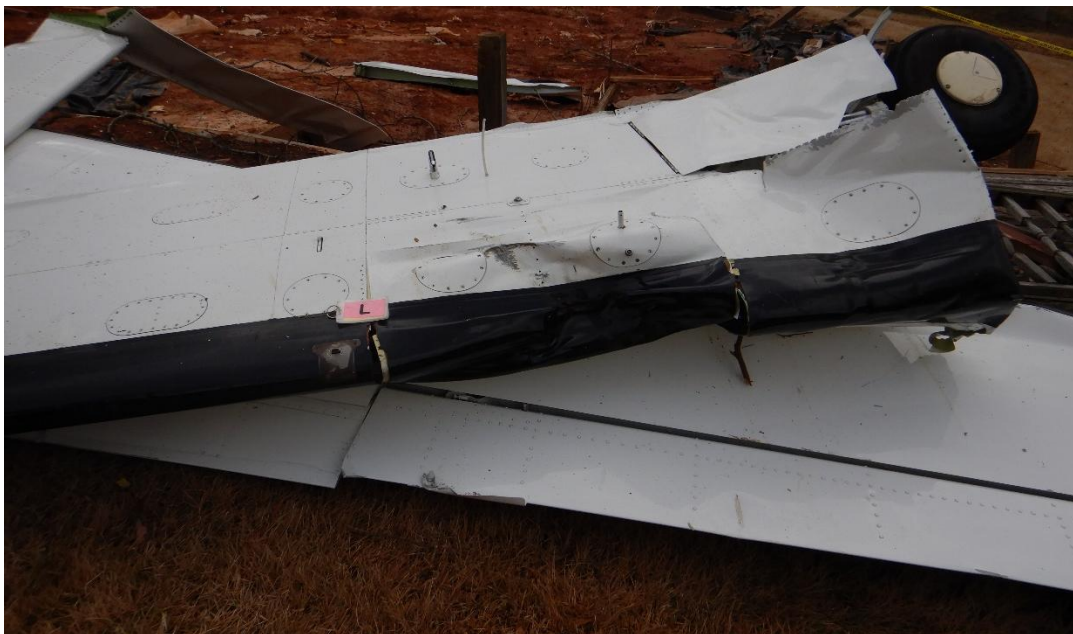
The left wing was fractured from the fuselage at the wing root at the main wing spar and aft wing attachment. Damage consistent with tree impact was observed on the wing's leading edge about 60 inches outboard of the wing root, and the leading edge from the wing root displayed aft compression and deformation. The flap displayed impact damage and remained attached to the wing by the outboard hinge only. The flap was torn mid-span from the wing root. The aileron remained attached to the wing at all hinges. The aileron cables both remained attached to the aileron sector. The aileron control rod from the sector to the aileron remained attached. Both aileron cables were separated at the wing root. The separated ends displayed fraying and unraveling consistent with overload separation. The left main landing gear was found retracted, with the gear door slightly open. The pitot tube remained attached to the wing. The lift detector remained attached to the wing and was not damaged. The fuel cap was found secured at the fuel filler port. Blue fuel was observed to be leaking from the fuel vent during the investigation. The wing spoiler was found in the retracted position.

**Photo 15 - Inverted left wing as found on right wing.**

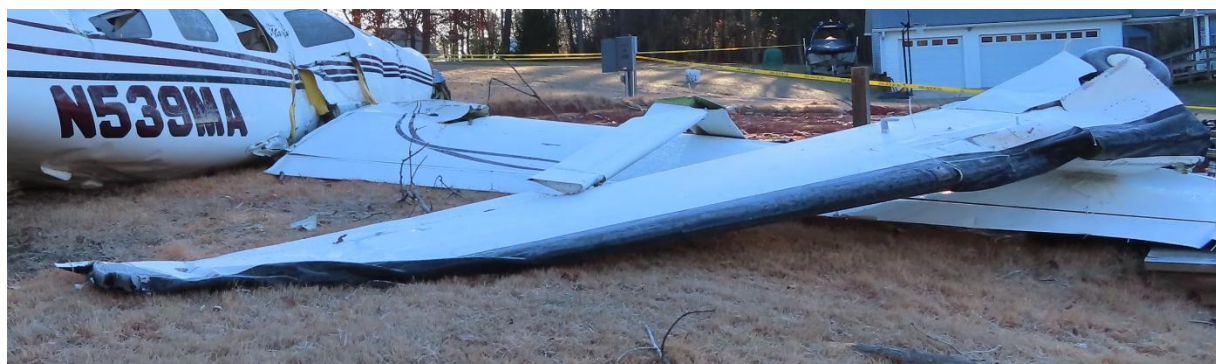
**Photo 16 - View of inverted left wing once partially removed from right wing.**

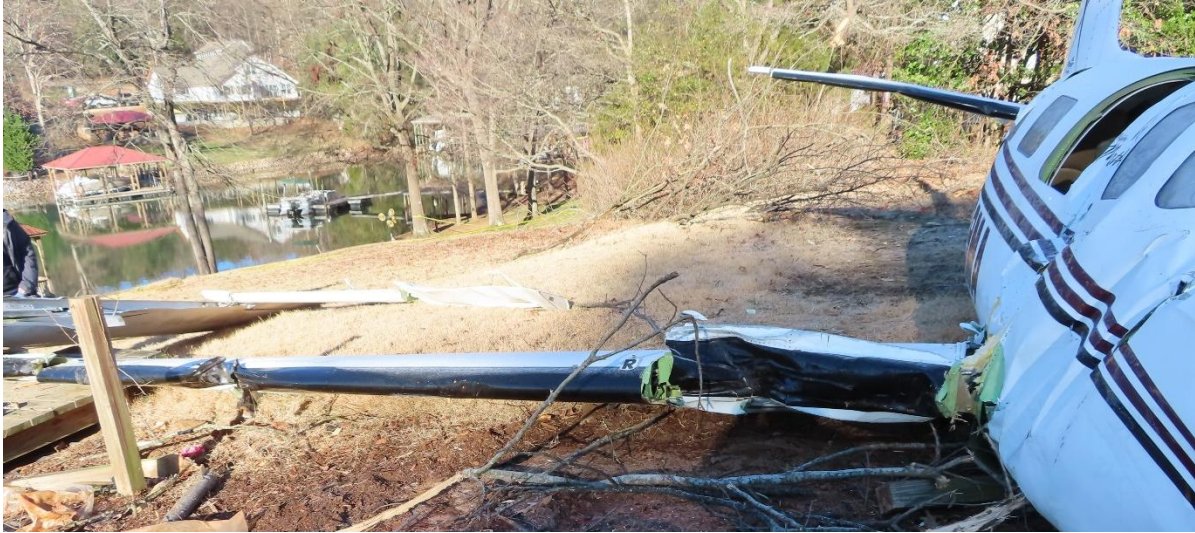
The right wing main spar was completely fractured and the wing remained attached to the airframe at the aft wing attachment. The wing displayed compression damage consistent with tree impact about 30 inches outboard of the wing root that was about 24 inches wide. The main landing gear was found in the retracted position. The pitot tube remained attached to the wing and was undamaged. The fuel cap was intact and secured at the filler port. Some fuel was present in the fuel tank. The spoiler was in the retracted position.

**Photo 17 - View of right wing with left wing removed.**

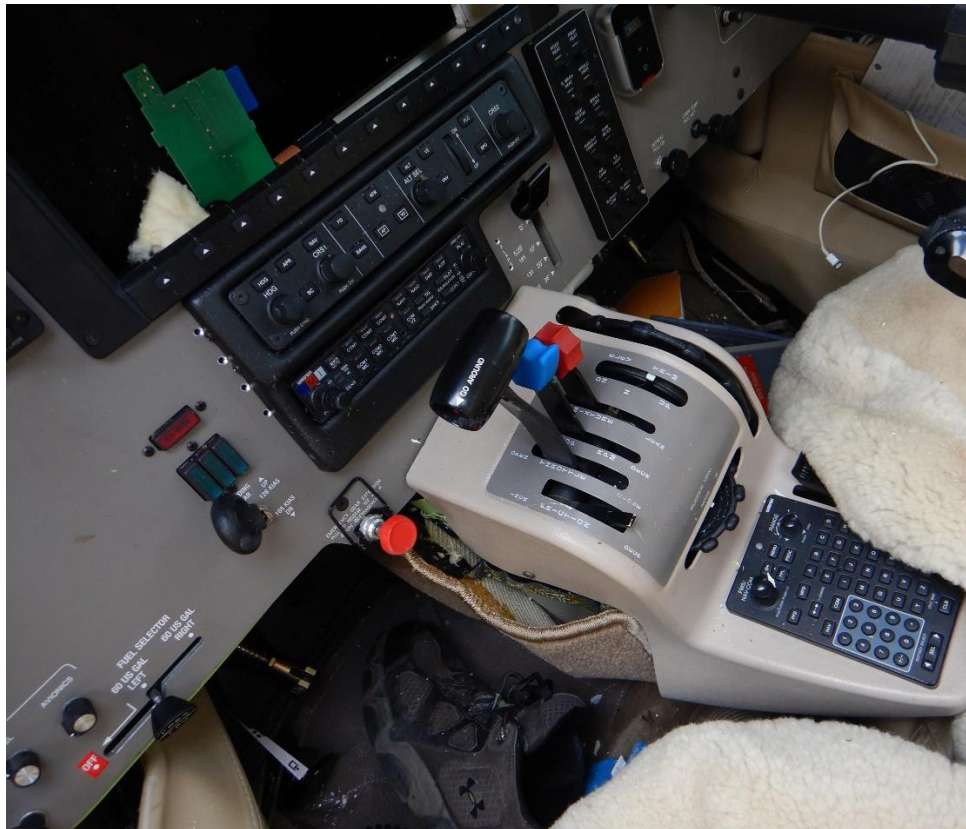
Throttle - Full forward

Propeller - Full forward (the propeller governor linkage was intact and was found in the fine pitch position at the governor)

Mixture - Full forward position

**Photo 19 - Throttle control quadrant with all levers full forward.**

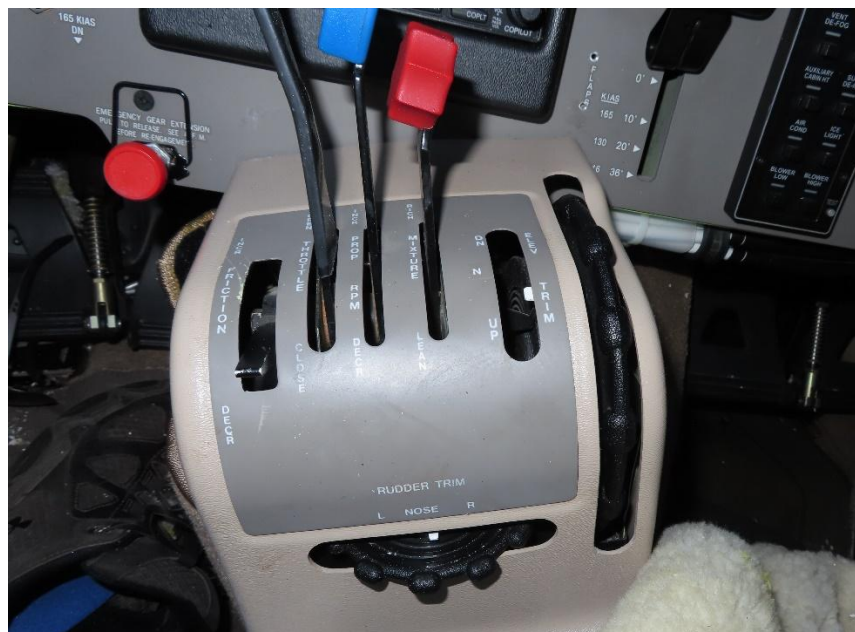
Flaps - Retracted

**Photo 20 - Throttle quadrant and flap selector set to zero.**

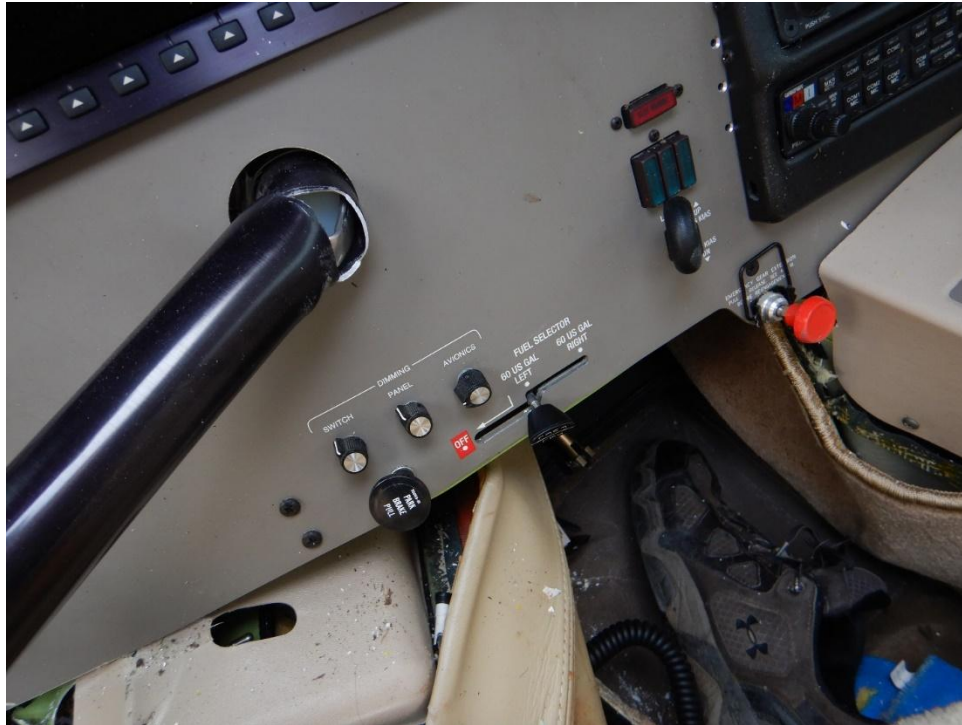
Fuel selector - left tank position

**Photo 21 - Fractured pilot control column and fuel selector.**

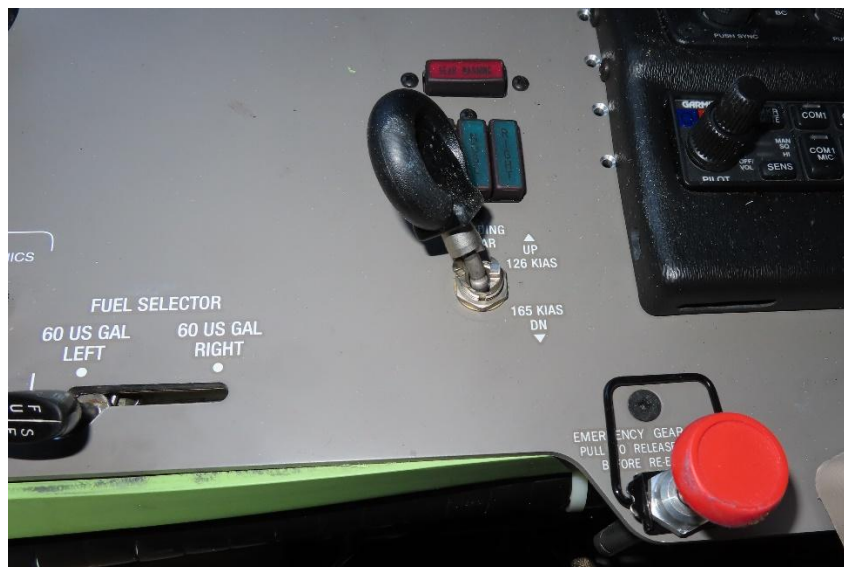
Landing gear lever - Bent and in the gear retracted position

**Photo 22 - Close-up view of landing gear selector in UP position.**

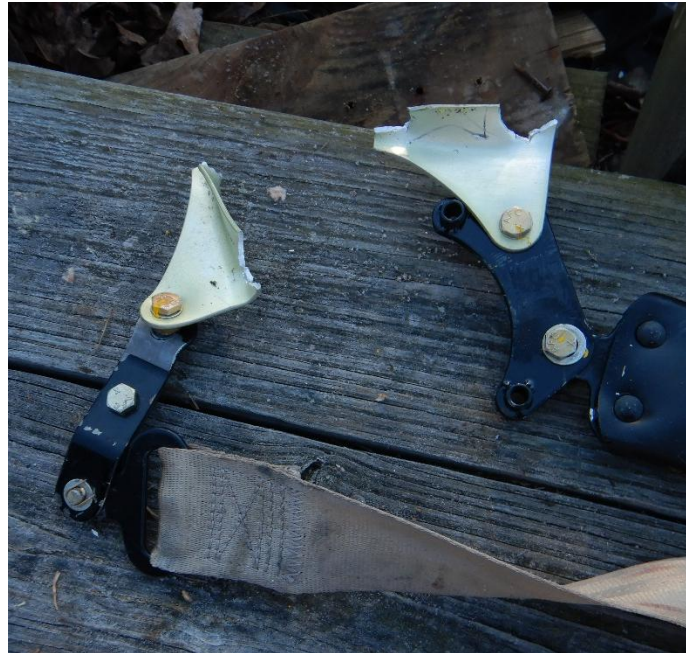
The left front pilot seat (occupied) remained partially attached to the mounting rails. The seat frame was bent to the left. Impact damage and bending of the cabin floor at the seat rails was noted. The outboard and inboard lap belt anchors separated from their floor mounts. Both anchors revealed deformation consistent with overload. The shoulder harness had been cut by emergency personnel to facilitate extraction of the

**Photo 23 - Fractured pilot seatbelt anchors.**

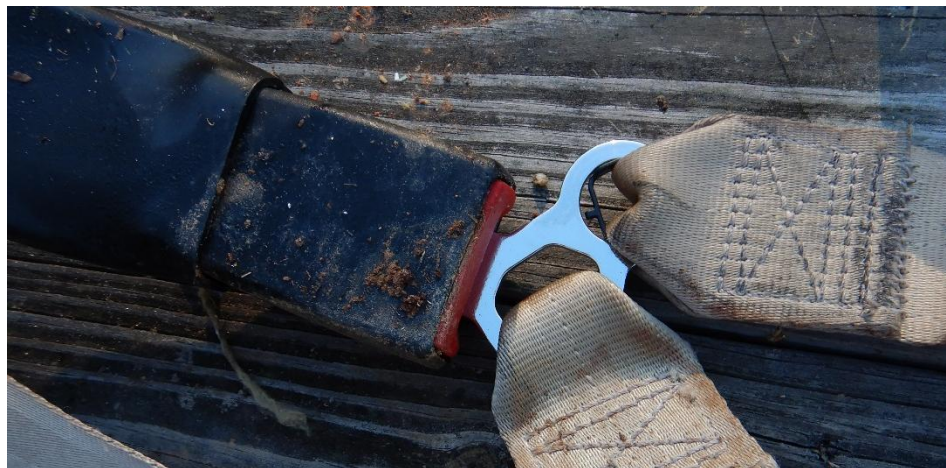
**Photo 24 - Pilot seatbelt still fastened to buckle.**

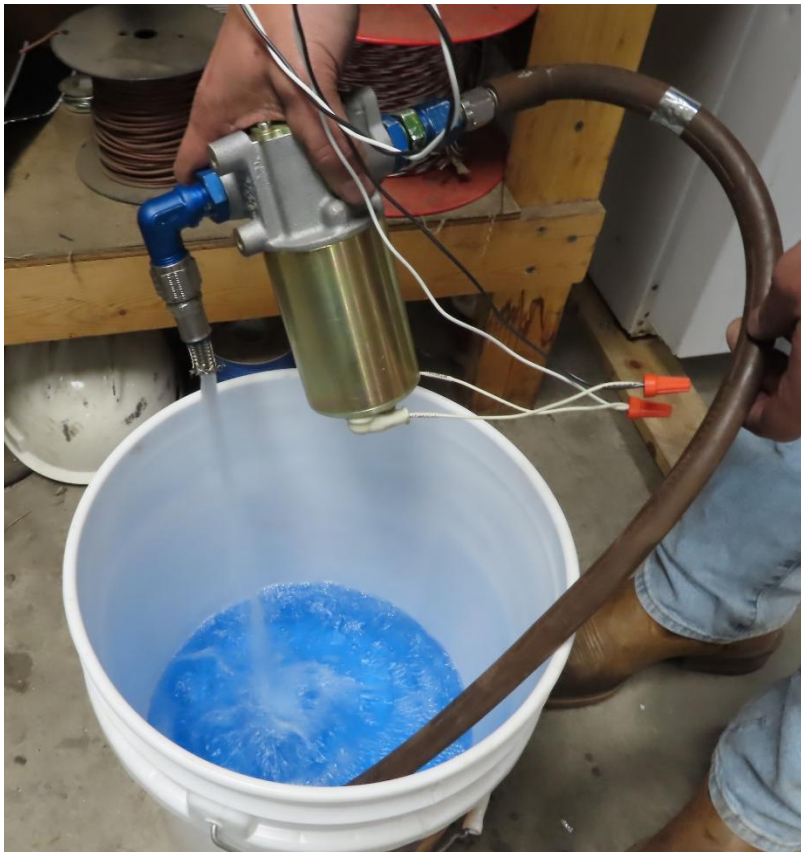
**Photo 25 - Emergency fuel pump tested using 100LL fuel and 24 volt power source.**

The pump operated normally and pumped fuel successfully. The fuel strainer contained about 3 drops of fuel. The fuel strainer was opened, and the interior screen appeared clean.

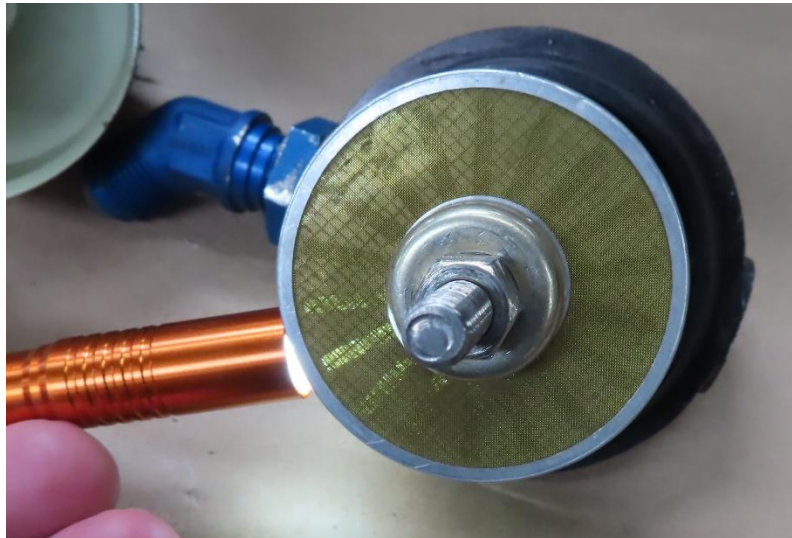
**Photo 26 - Fuel strainer fuel screen.**

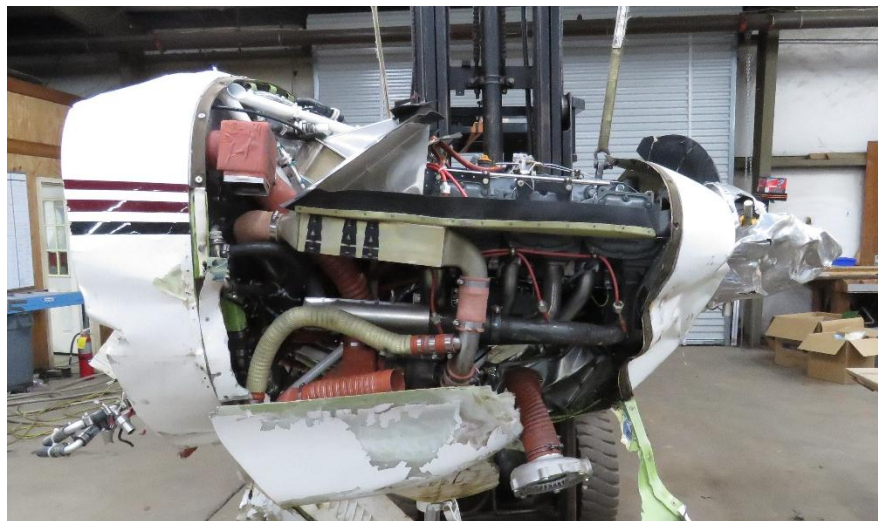
At first view at the recovery company, the Lycoming TIO-540-AE2A engine had been separated from the fuselage and hoisted in the air with straps. The engine was visually inspected prior to the examination. The engine exhibited signs of crush damage on the forward bottom portion of the engine. The intake scat tubing on the left side turbo was intact but showed signs of crush damage. The engine cowling and airframe baffling were removed to facilitate further examination of the engine.

**Photo 27 - Hoisted engine before examination.**

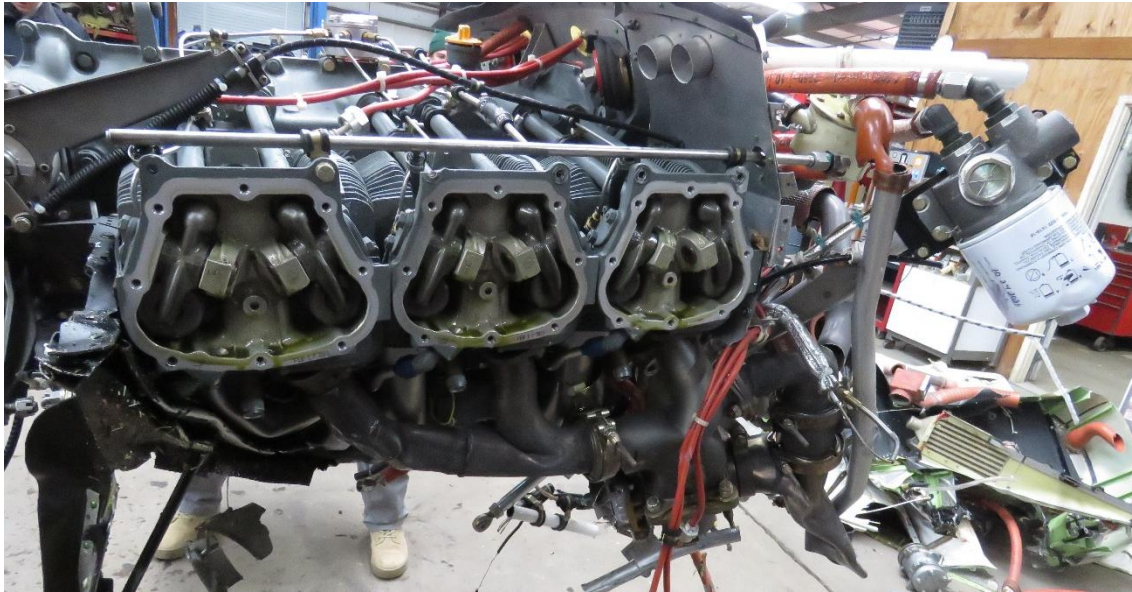
**Photo 28 - Cylinder Nos. 2, 4 and 6 with rocker covers removed.**

No impact damage was observed from the starter ring gear noted on starter assembly. Engine rotated by hand smoothly through multiple 360-degree rotations. Finger compressions were good on all six cylinders. Performed borescope inspection of each cylinder, no anomalies noted. Removed rocker box covers and verified exhaust and intake valves moved equal distance on all six cylinders. Performed internal timing check IAW SSP-475, found crankshaft to camshaft timing correct. Idler gears observed through magneto mounting points, and while rotating the engine, no discrepancies were noted with teeth or movement of gears. The top sparkplugs were removed and showed signs of heavy carbon on the sparkplug ends. Valvetrain continuity was observed throughout the engine. The cylinders were borescope, and no anomalies were noted within the cylinders.

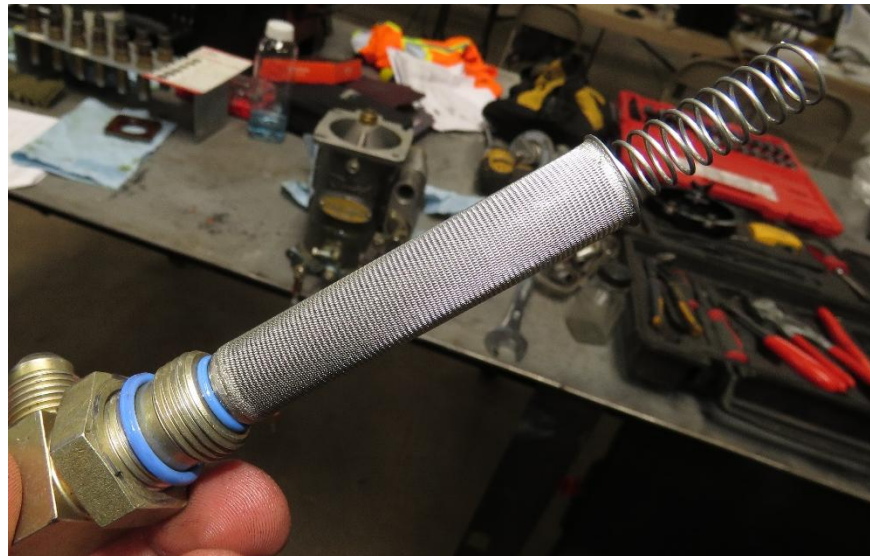
The throttle and mixture linkages of the fuel servo, a Precision model RSA-10ED1, S/N: 70007902, remained attached to the fuel servo and could be manipulated from stop to stop by moving the throttle and mixture controls at the throttle quadrant. The fuel servo was intact and undamaged. Upon removal, fluid consistent with aviation gasoline was observed coming from the inlet to the servo fitting and from the fuel pressure sensor fitting. The throttle plate moved appropriately when the throttle arm was actuated. The fuel servo screen was removed and inspected, with no contamination noted.

**Photo 29 - The fuel servo screen was unobstructed.**

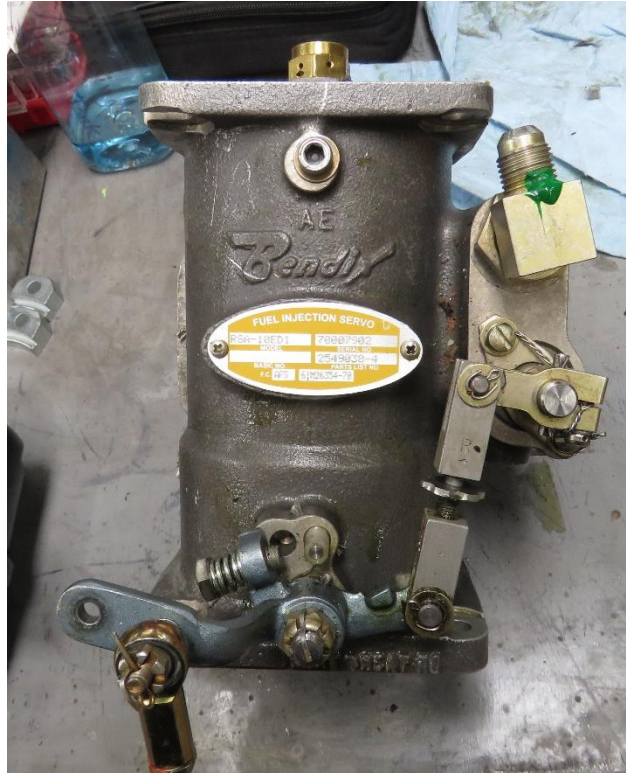
**Photo 30 - Fuel injector servo**

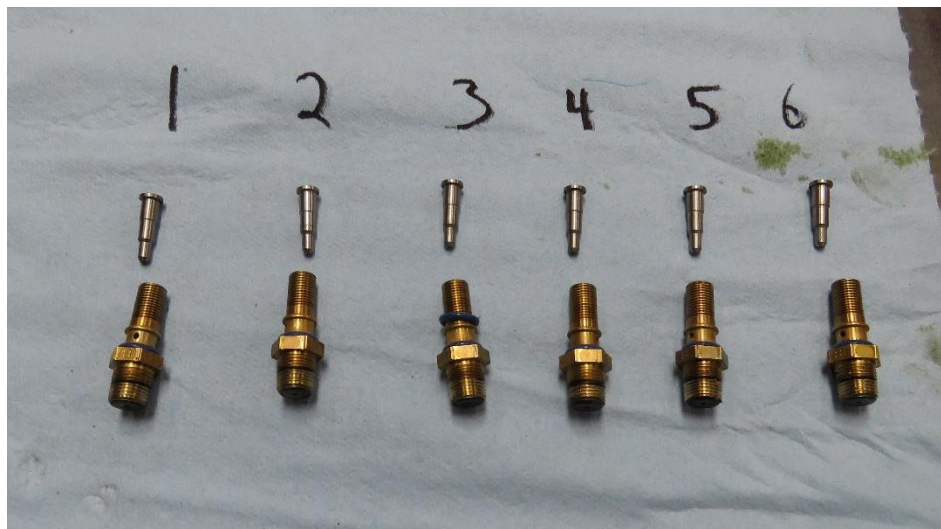
The fuel line to the fuel distribution manifold contained a few drops of fuel. The fuel line fittings to the fuel distribution manifold and to all six injector nozzles were found secure. The manifold was opened for examination and revealed an intact and pliable rubber diaphragm. A few drops of fuel were found in the fuel distribution manifold. All six fuel injector nozzles were found clean and open. The fuel injection nozzles were removed and inspected, with no blockage or abnormal condition noted with the nozzles.

**Photo 31 - Fuel injectors**

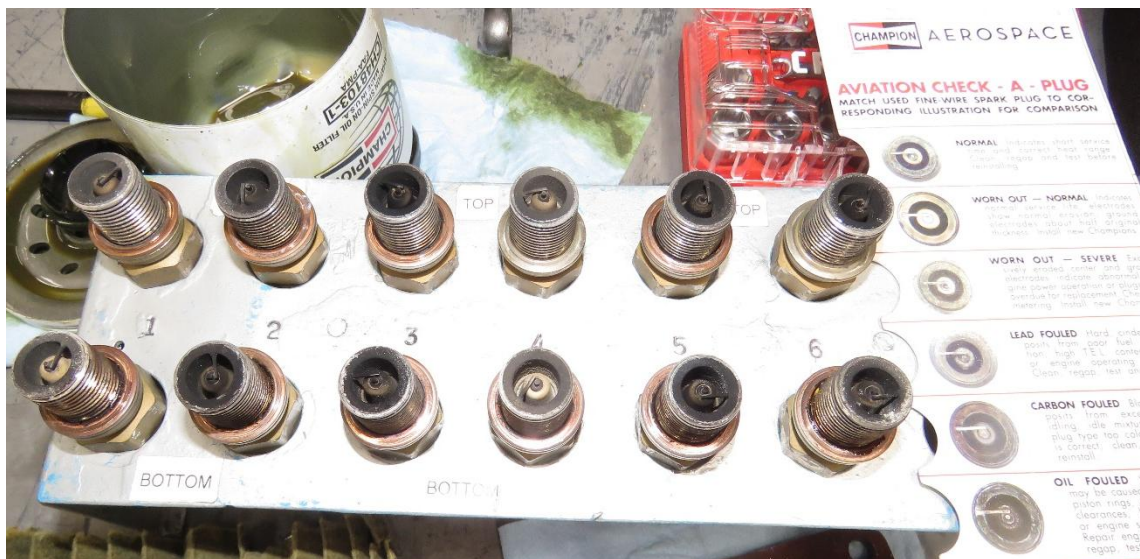
All 12 spark plugs were carbon fouled and displayed dark black soot consistent with operation of the engine with an overly rich mixture.

**Photo 32 - The spark plugs were carbon fouled.**

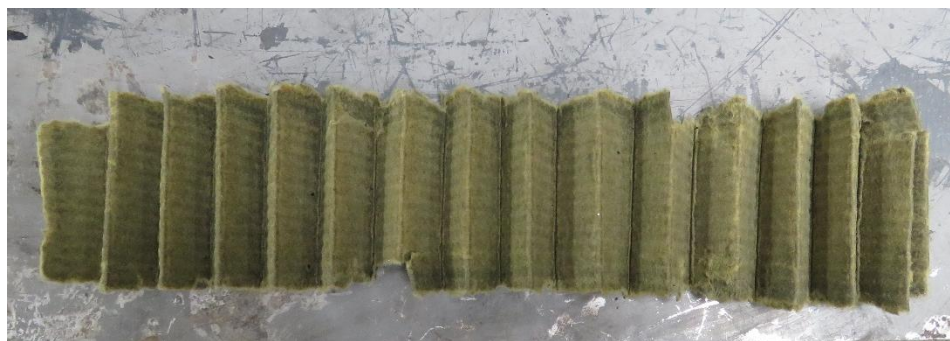
The oil suction screen was removed and free from contamination. The oil filter paper element was removed and examined with no contamination noted. The oil filter was dated October 24, 2023.

**Photo 33 - Oil filter element free from debris.**

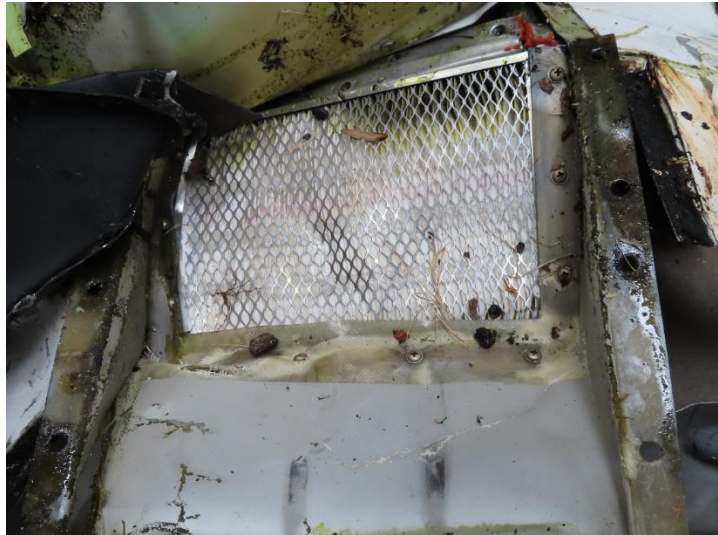
The airframe air filter was deformed by impact forces. The filter element was found clean.

**Photo 34 - Air induction filter.**

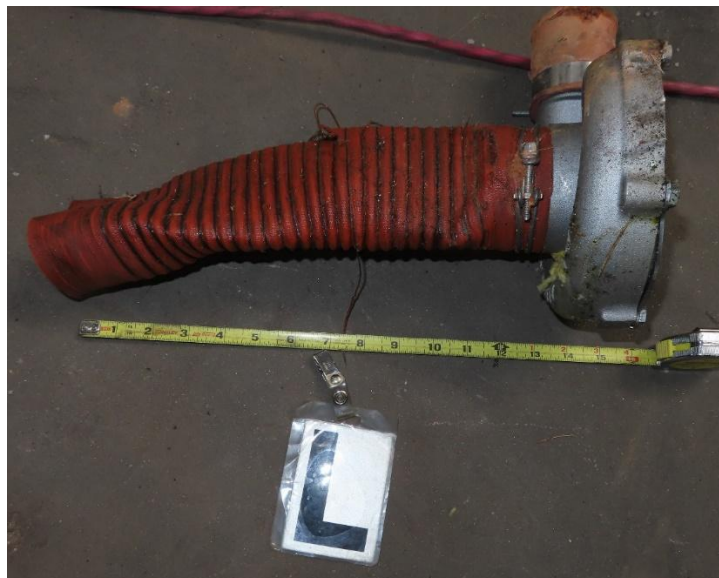
The scat tubing from the air filter to each compressor wheel of the turbocharger displayed damage consistent with impact and was partially collapsed due to deformation of the interior wire of the tubing.

**Photo 35 - Left side scat tubing from induction airbox to the left turbocharger compressor section.**

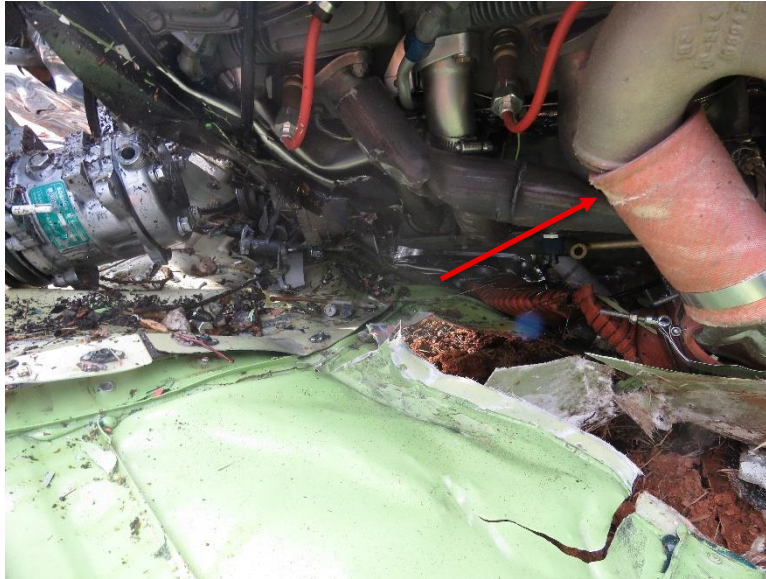
**Photo 36 - Left side intercooler hose with missing clamp, with arrow pointing to clamp location  
(Photo Source: Lycoming Engines)**

The induction hose that connects to the left side intercooler was missing the clamp, and the hose was displaced from the intercooler. The clamp was not observed during the examination.

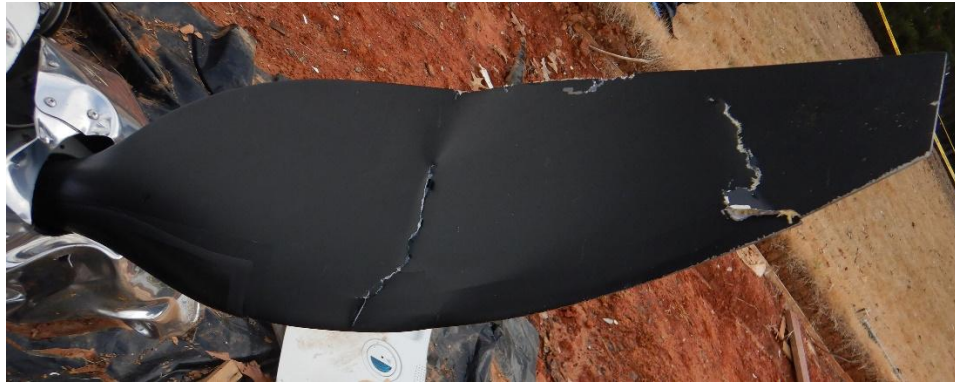
The Hartzell composite propellers were examined. One blade remained attached to the propeller hub and displayed chordwise tears. Two blades separated from the hub

at the root ends. One blade was fractured. The blades were free from chordwise abrasion, twisting or bending. No leading edge damage was observed on any of the propeller blades.

**Photo 37 - One propeller blade remained attached to the propeller hub.**

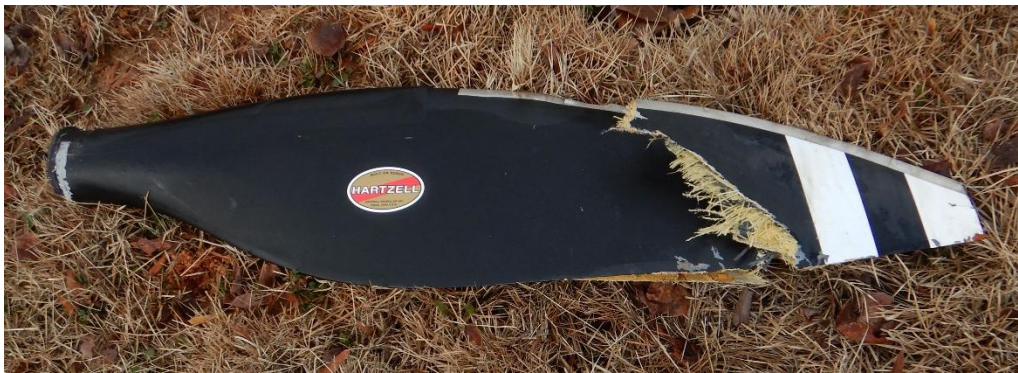
**Photo 38 - Propeller blade separated from the propeller hub and fractured.**

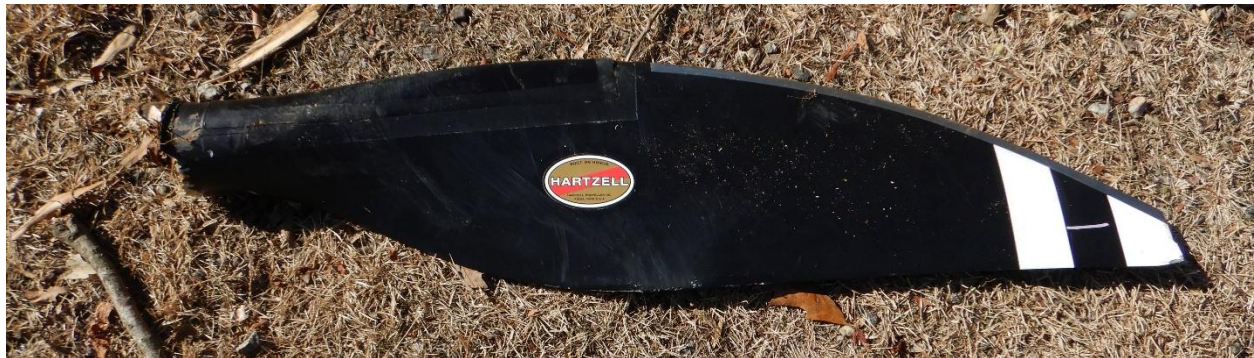
**Photo 39 - Propeller blade separated from the propeller hub and intact.**
