Air Safety Office  
Parker Hannifin Corporation  
Parker Aerospace

**Subject:** Fuel Pump Examination NTSB ERA24FA078, Piper PA46R-350T, Mooresville, NC

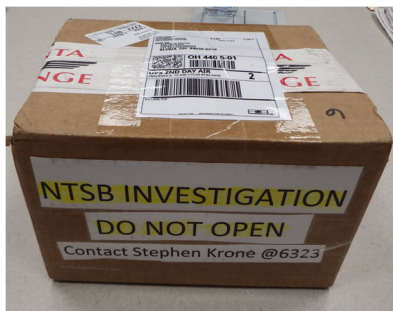
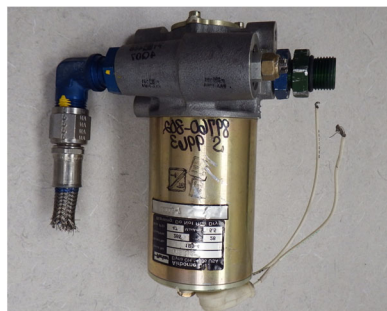
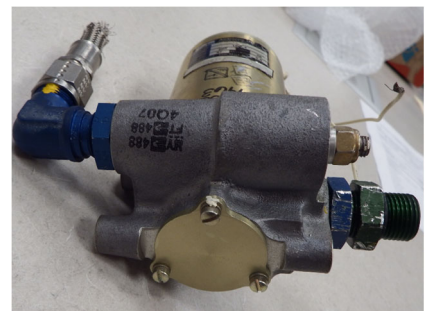
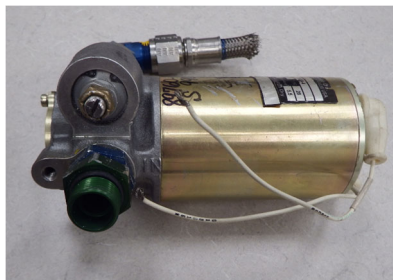
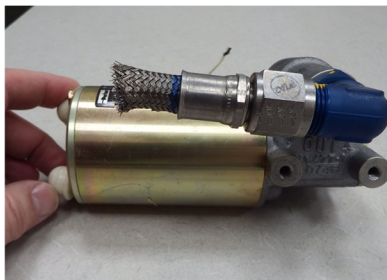
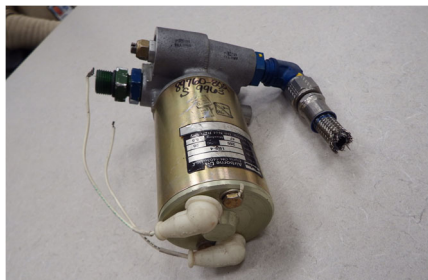
The package was shipped to the FSD Elyria facility by the NTSB and remained unopened until the day of the examination. The cardboard box contained one electric fuel pump, Model 1B9-4 Serial No. 11BE32. The serial number corresponds to a manufacture date of 2009.

The pump was removed from the packaging and photographed.

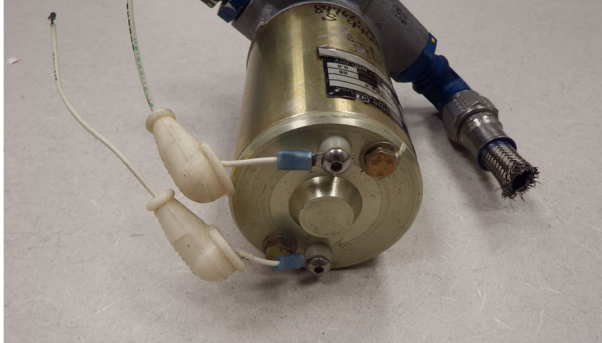
The insulating boots were pulled back to expose the electrical connections. The connections were tight.

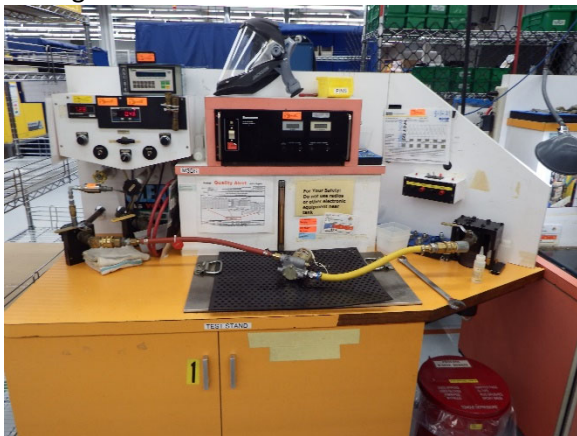
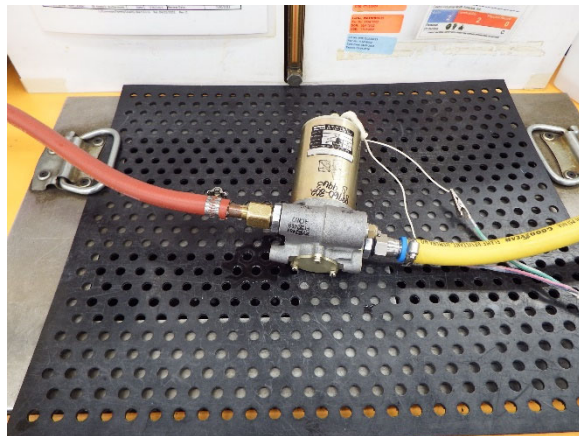
The aircraft fittings and hose were removed, and the pump was connected to the production ATP test stand to measure performance. The pump met the flow and pressure ATP requirements. The measured pressure and current is typical of new pump ATP measurements. No leakage was observed during this testing.

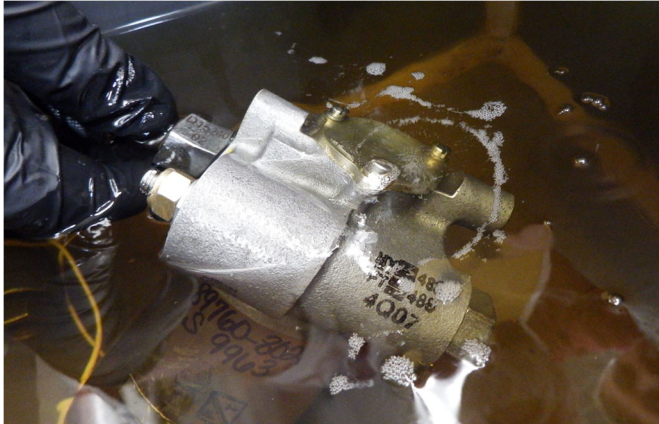
Next the pump was “hydrotested” for leakage per the ATP. For this test, the pump discharge port is capped, and air pressure is applied to the inlet port with the pump submerged in test fluid. Some air leakage was evident around the pump end cap.

There was some air leakage from the pump end cap during the ATP hydrotest, which was performed after the pump functional test. The hydrotest is a proof pressure test performed at elevated pressure with air to maximize leak detection around housing or motor seals or through casting walls. No cuts, scratches, or imperfections were observed in the housing bore and end cap O-ring groove, or the O-ring itself. O-rings swell when exposed to aviation fuel and typically shrink again after extended time without fuel exposure.

It is not unexpected that there was some minor leakage from a test designed for a new production in a pump that has been fielded for 15 years. Still, the fuel pump operated normally, meeting ATP requirements for flow and pressure. No fluid leakage was observed from the end cap while testing pump performance on the test bench using calibrating fluid (Stoddard solvent).

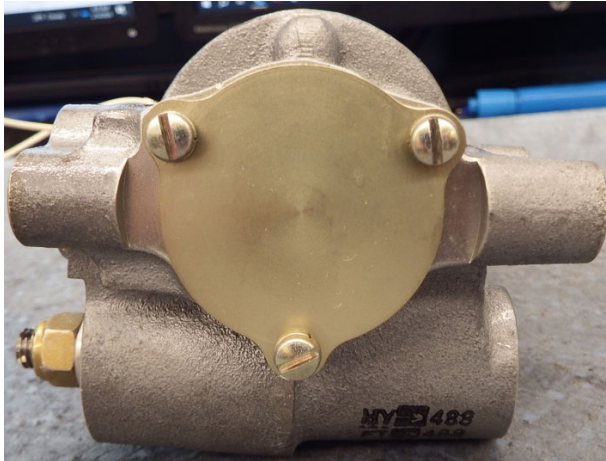
Before re-torquing

The three screws holding the end cap appeared to be tight and the split lock washers were fully compressed. Per the pump assembly drawing, the torque for the three screws is 14 to 17 in-lbs. There was no rotation when the three screws were tightened, using a torque wrench that was set to 14 in-lbs.

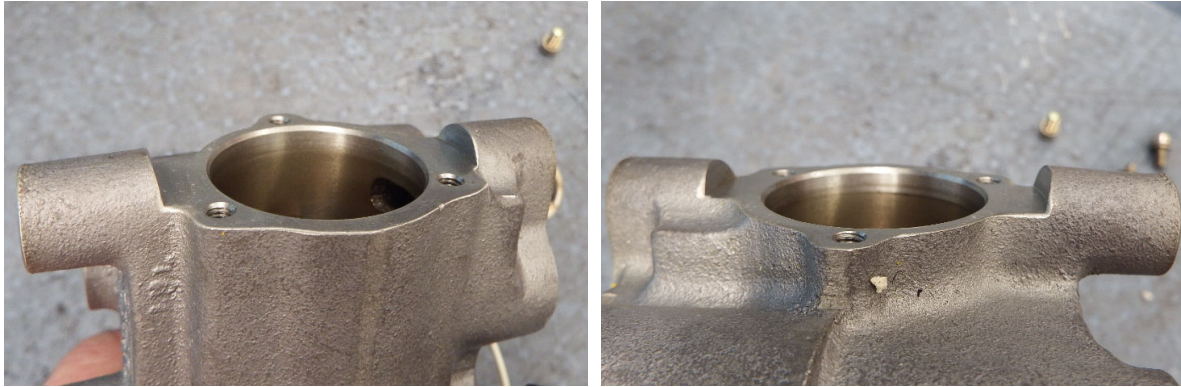
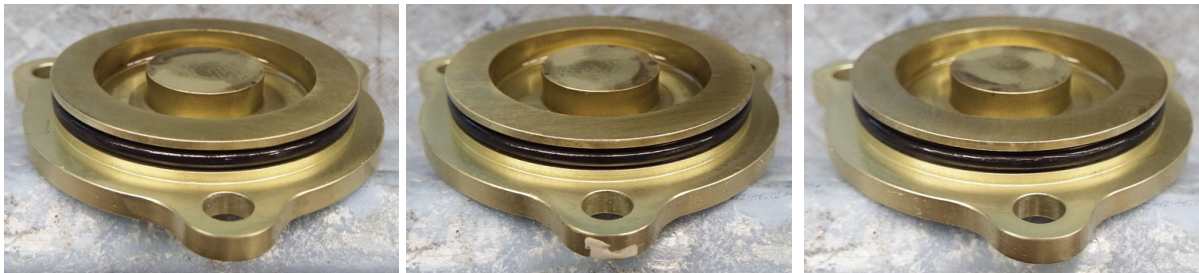
The end cap was removed for further examination. The pump housing inside bore was smooth without any scratches or dents. The O-ring was not cut or torn, and there were no obvious imperfections when examined under magnification.

The O-ring was removed from the end cap for inspection. The O-ring ID also was not cut or torn, and there were no imperfections when examined under magnification. There were no scratches or imperfection in the end cap O-ring groove.
