ERA24FA078

## INVESTIGATION PHOTOGRAPHS

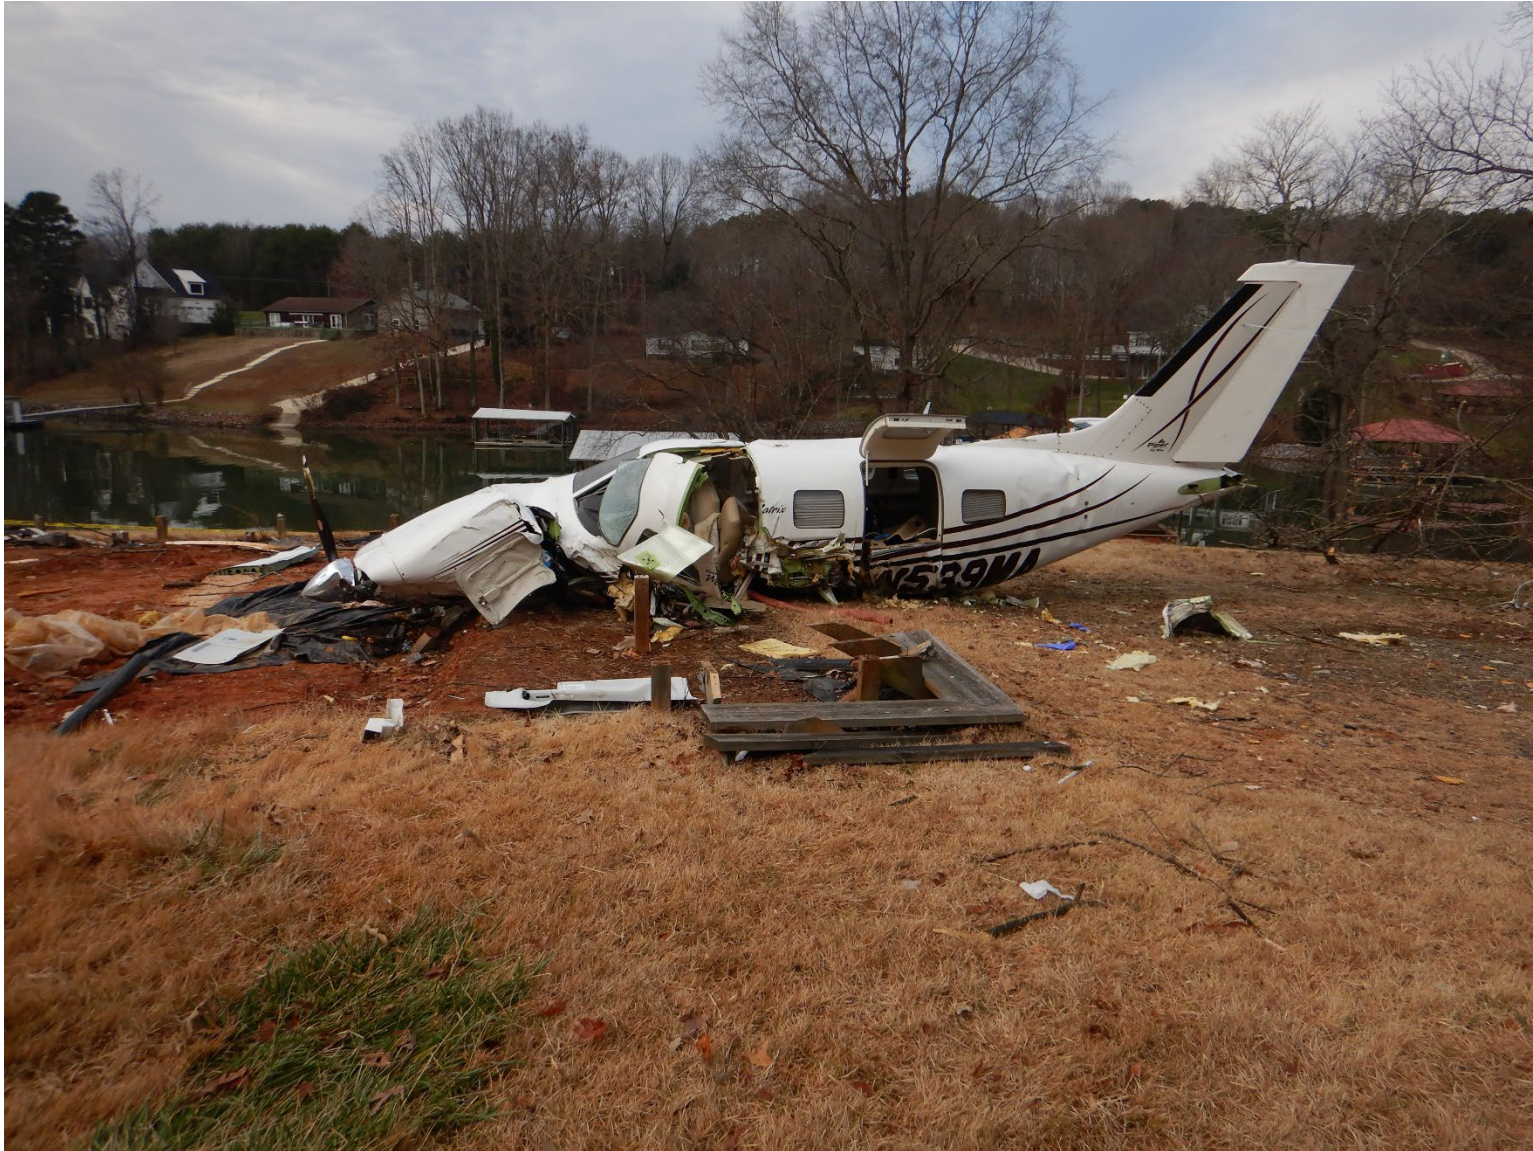
**Photograph 1 – Airplane overview at accident site**

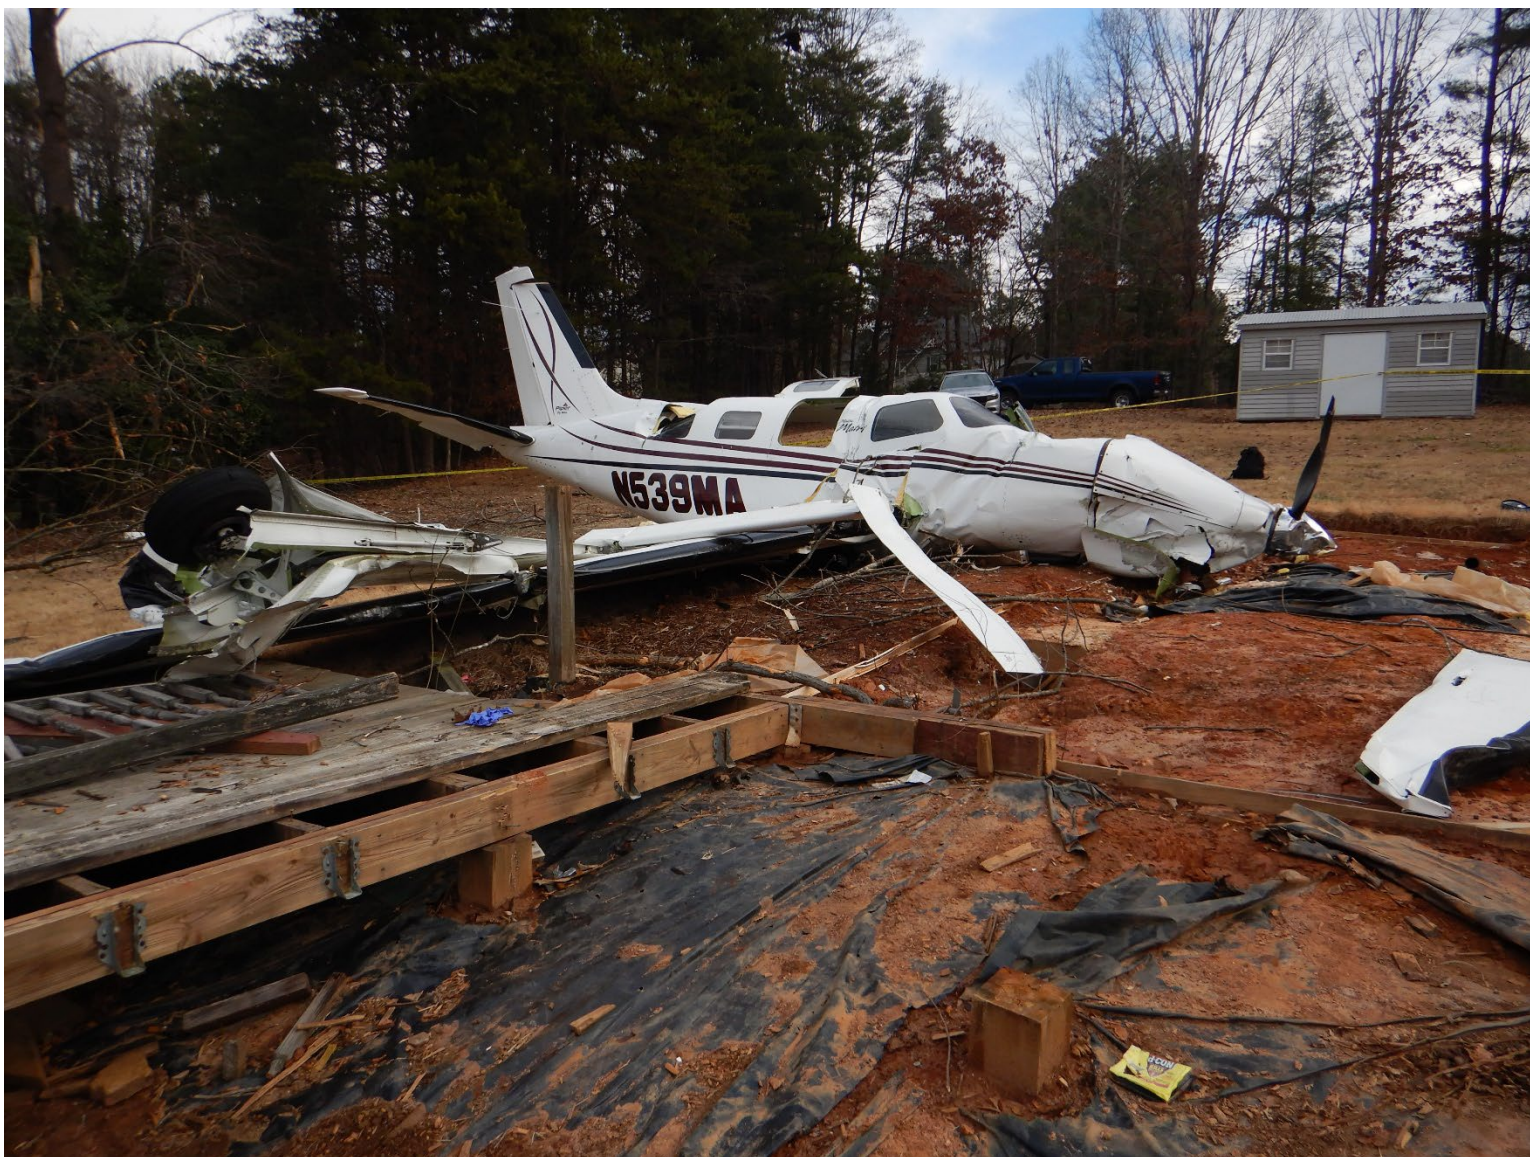
**Photograph 2 – Airplane overview at accident site**

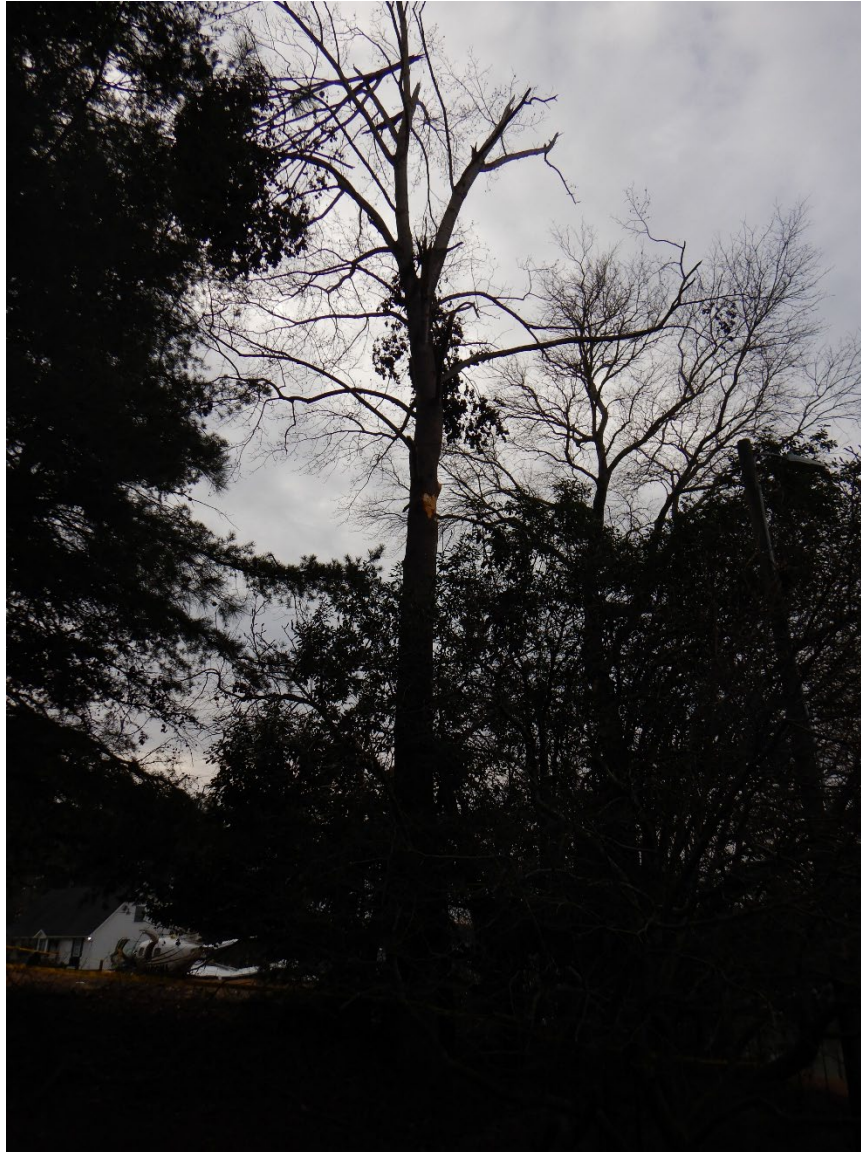
**Photograph 3 – Tree impact at accident site**

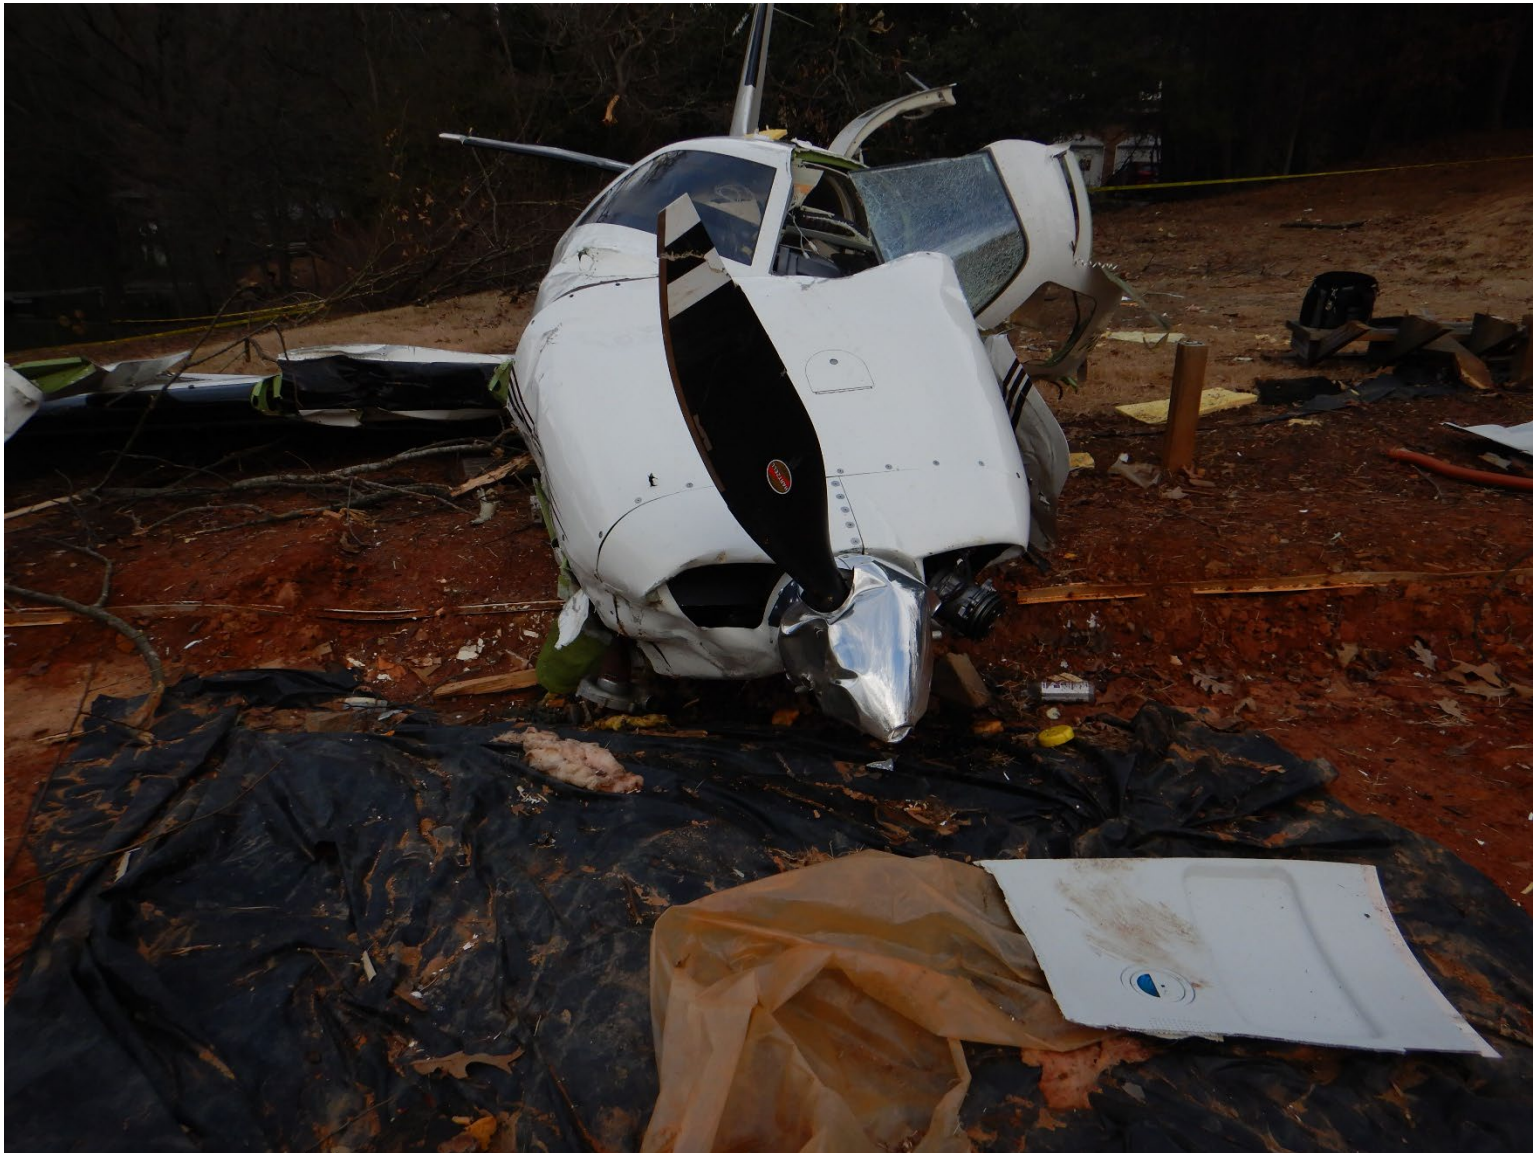
**Photograph 4 – Airplane overview at accident site**

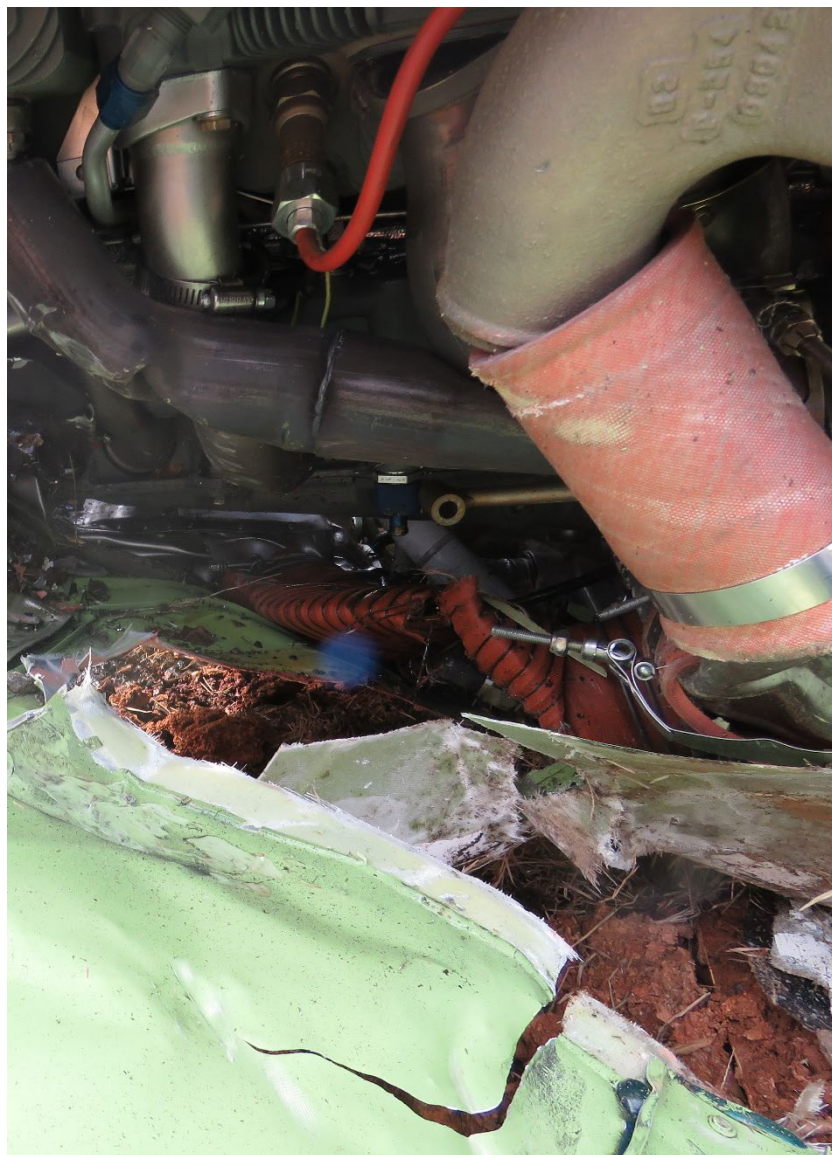
**Photograph 5 – Induction tube with missing clamp**
