ERA24FA088

## INVESTIGATION PHOTOGRAPHS

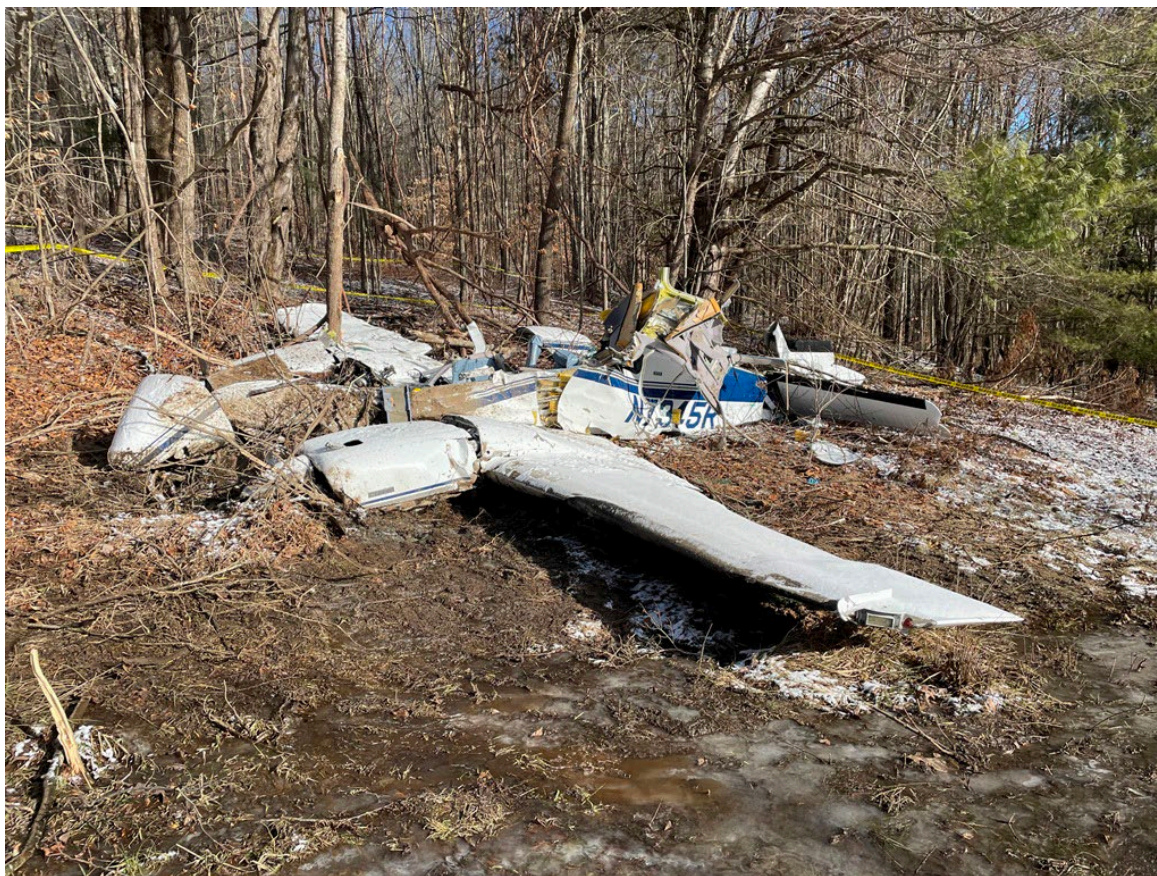
**Photograph 1 - Front Left View of Airplane at Accident Site**

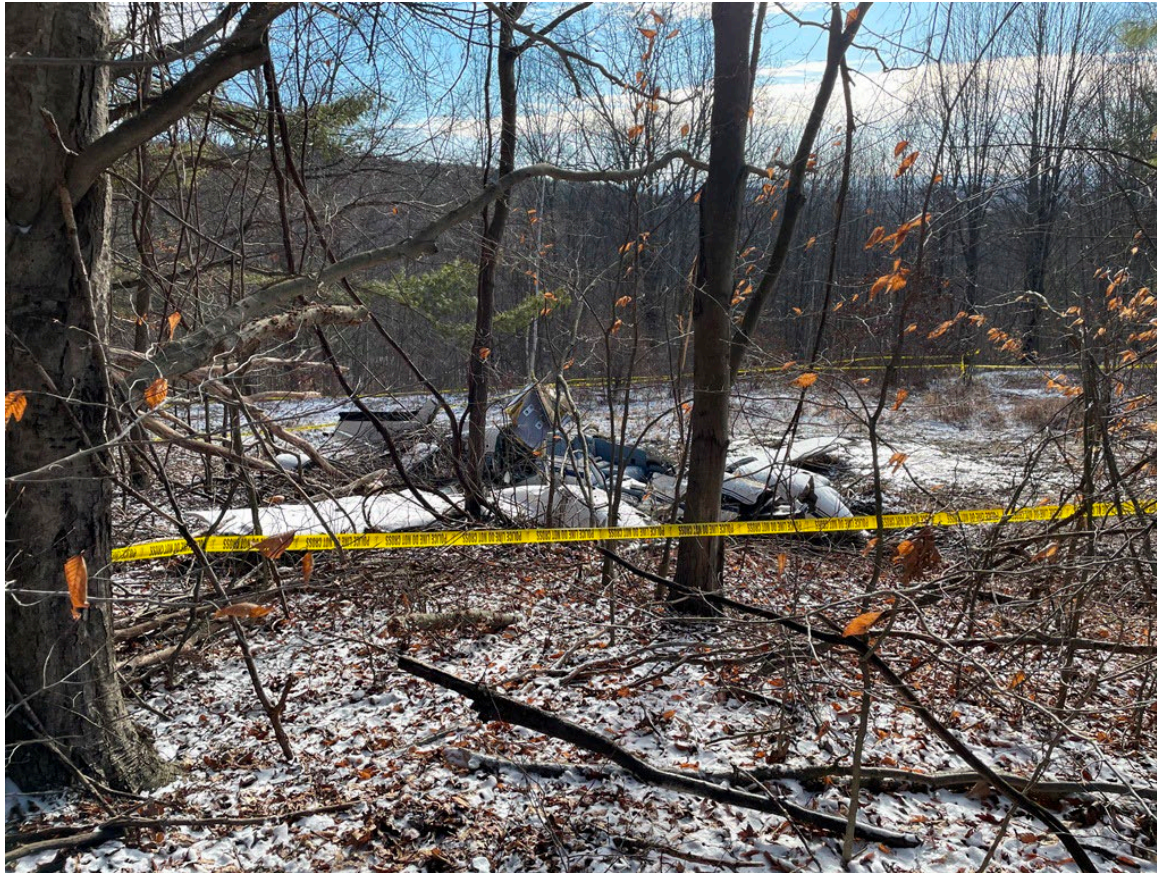
**Photograph 2 - Right Front View of Airplane at Accident Site**

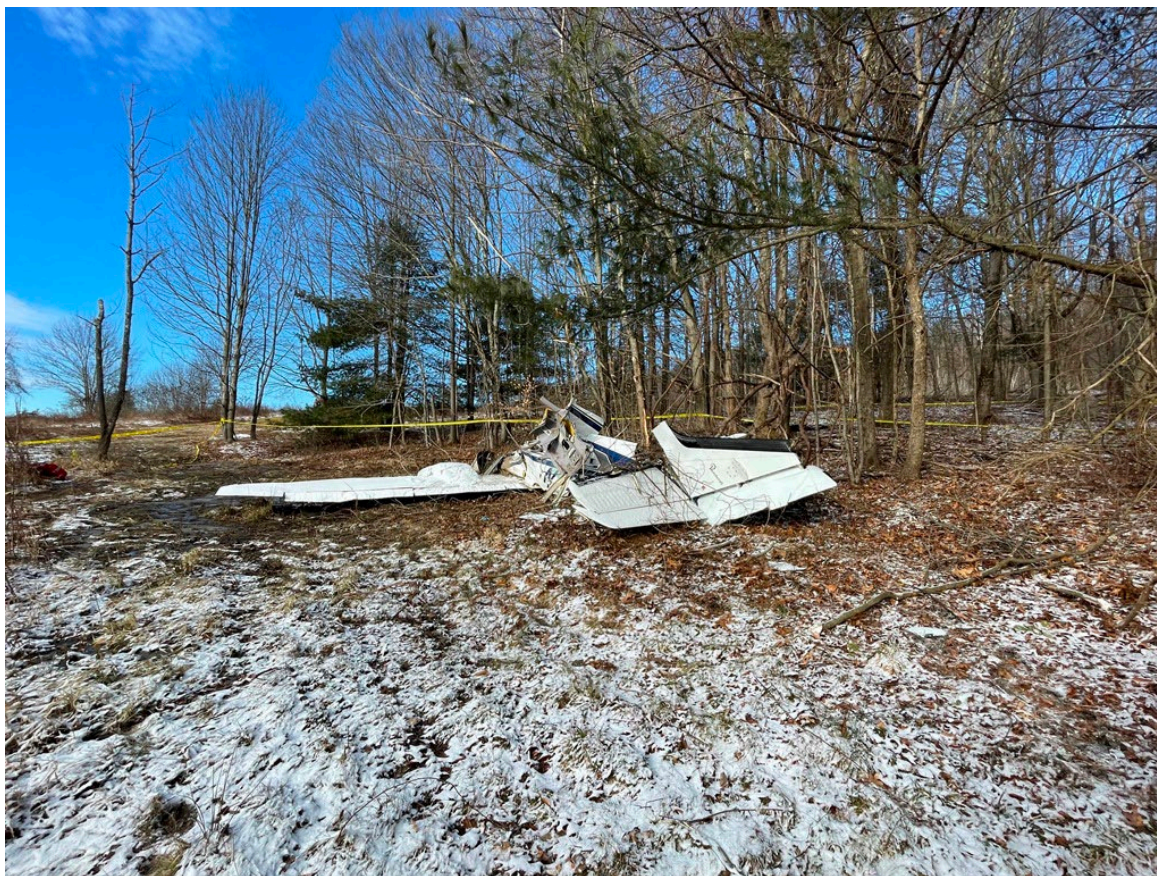
**Photograph 3 - Rear View of Airplane at Accident Site**

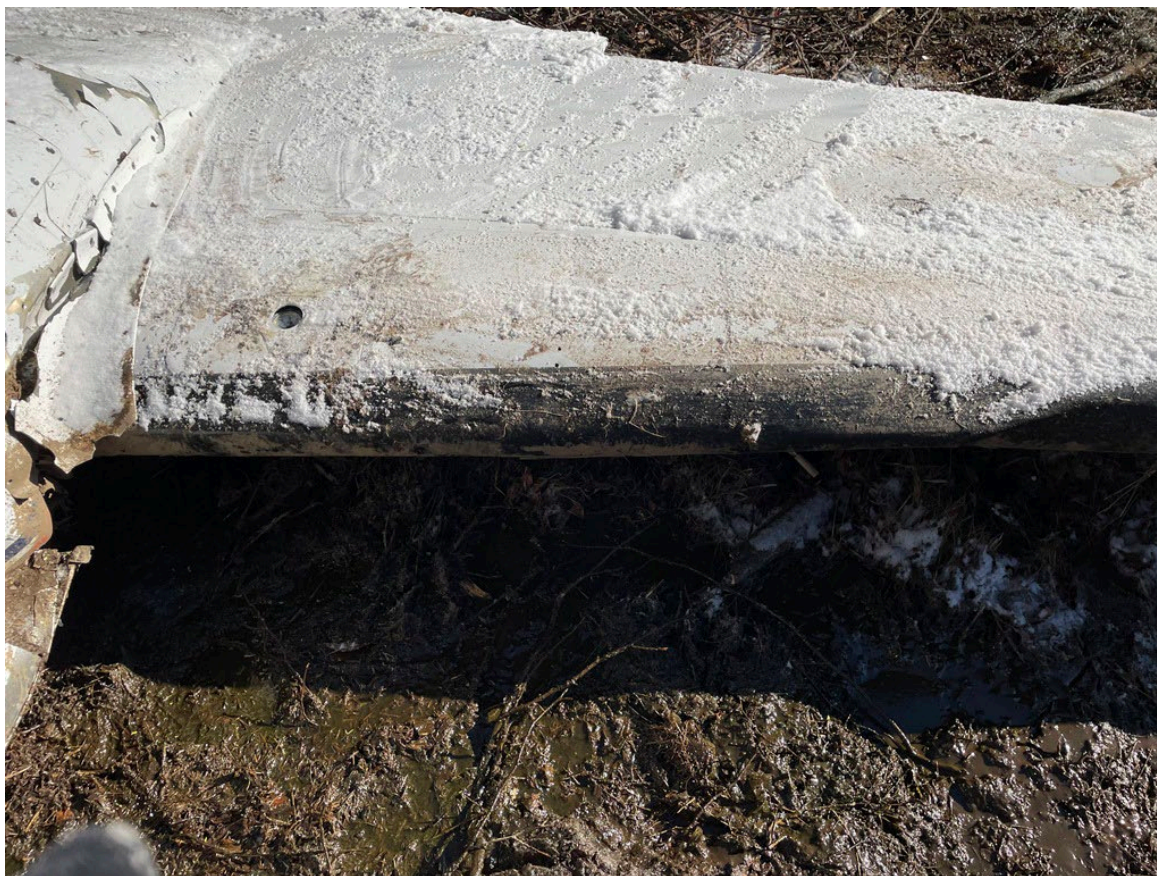
**Photograph 4 - Ice on Leading Edge of Left Wing (outboard)**

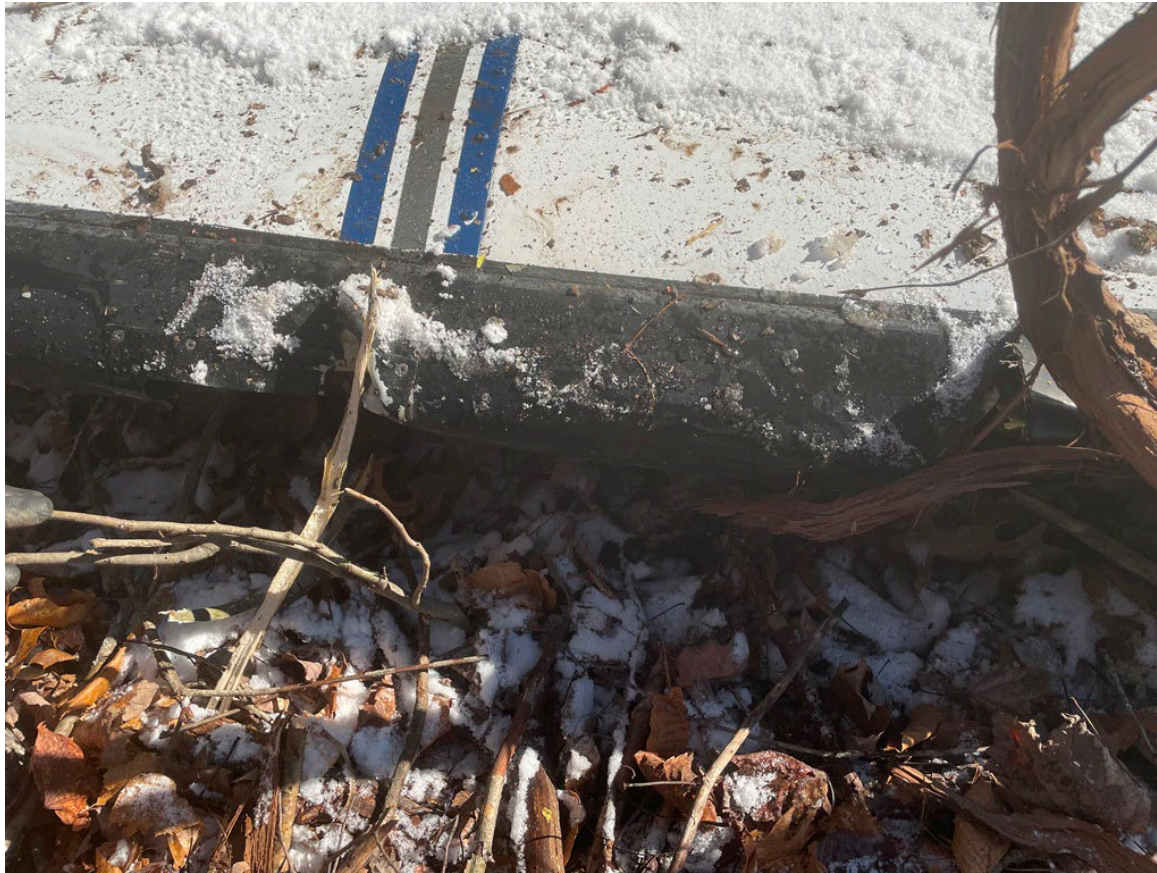
**Photograph 5 - Ice on Leading Edge of Right Wing (outboard)**

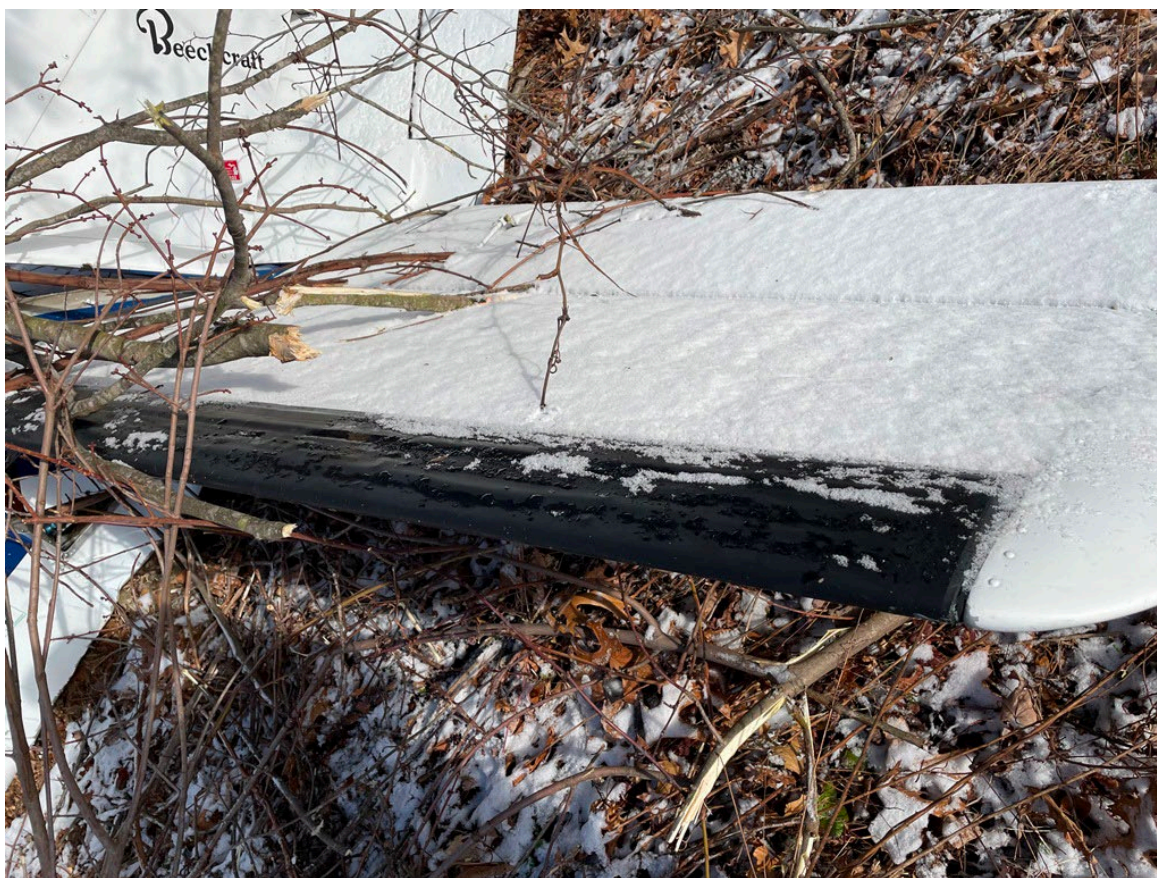
**Photograph 6 - Ice on Leading Edge of Left Horizontal Stabilizer**

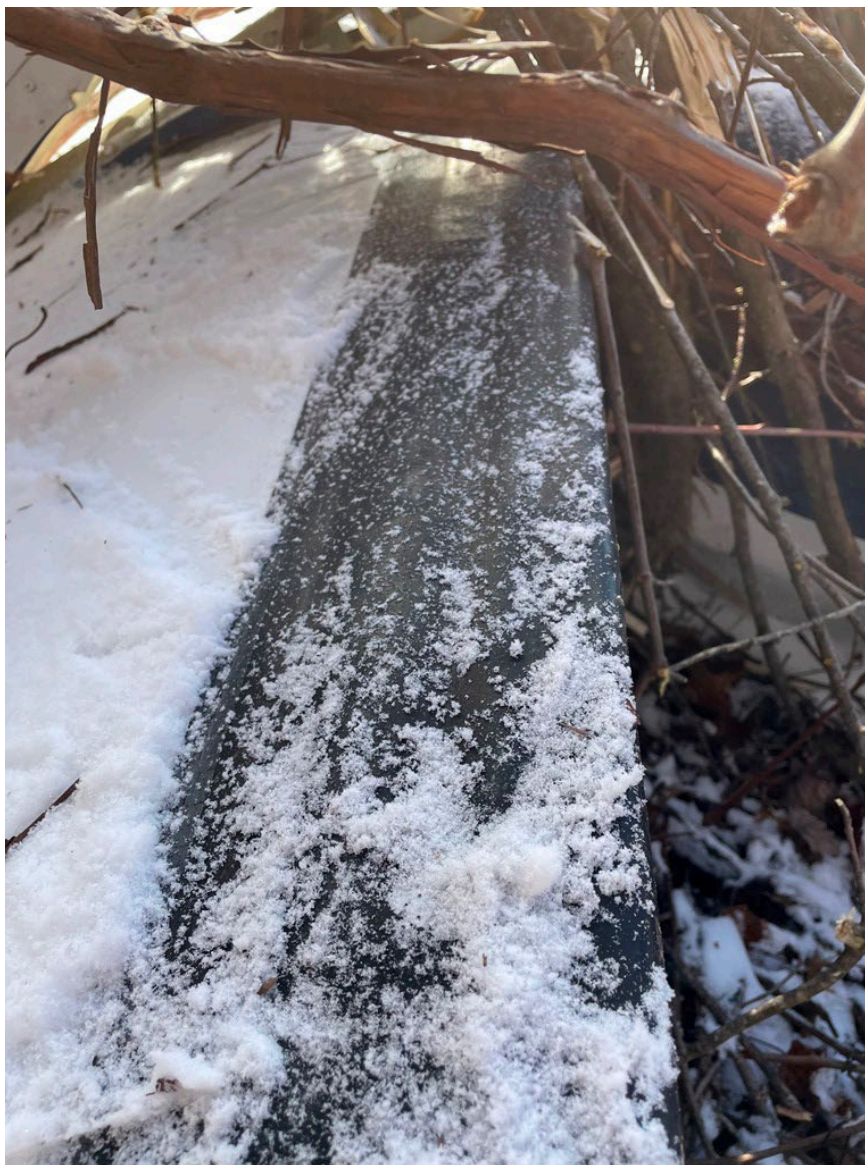
**Photograph 7 - Ice on Leading Edge of Right Horizontal Stabilizer**
