# National Transportation Safety Board

ERA24FA096

## **WRECKAGE EXAMINATION**

Location: Weston, FL  
Date: January 23, 2024  
Time: 1844 EST  
2344 UTC  
Airplane: N737VC; Cessna 172-N

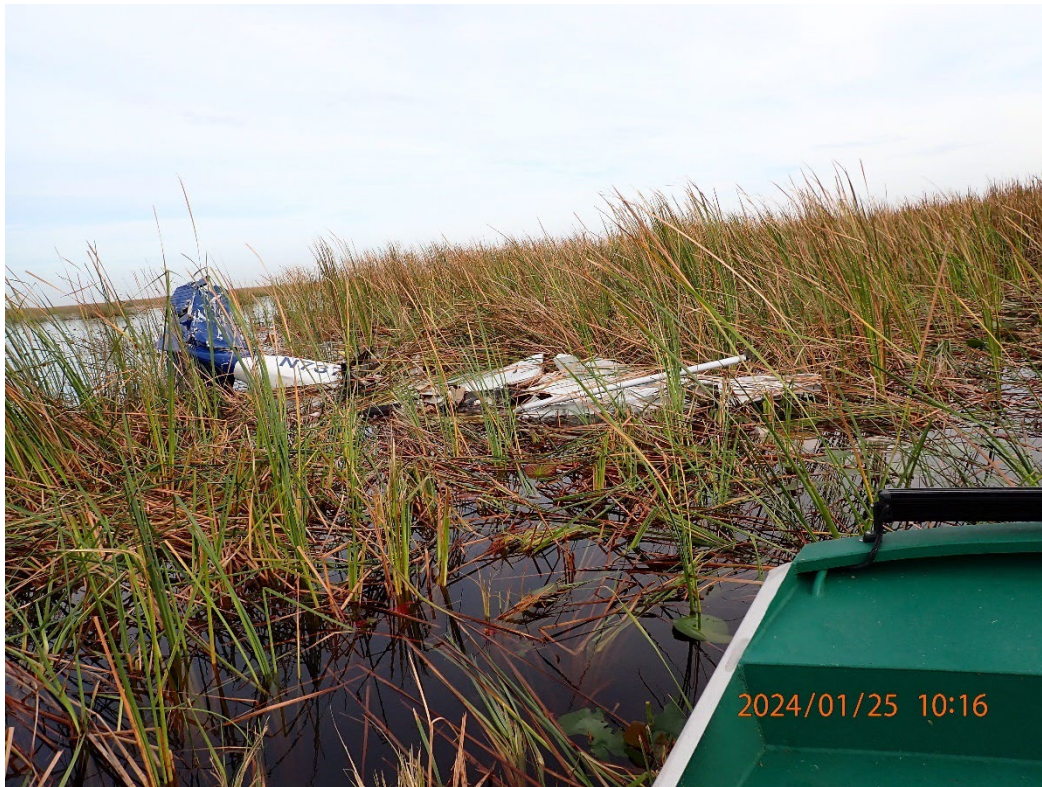
The airplane came to rest in a swamp/marsh area near Weston, FL. The debris path was about 100 yards in length and was oriented on about a 010° magnetic heading. The first piece in the debris path was the nose wheel which had been impact separated from the nose landing gear strut and was about 100 yards from the main wreckage. The nose landing gear was in the vicinity of the nose wheel and had been impact separated from the firewall at all attachment points. The left -wing was impact separated from the fuselage and was located about 50 yards from the main wreckage. The main wreckage came to rest on a heading of about 130° magnetic, and in an area of about 4 ft of water. There was a postaccident fire which consumed portions of the fuselage and right wing. The instrument panel, firewall and engine remained attached

**Photo 1: View of the main wreckage.**

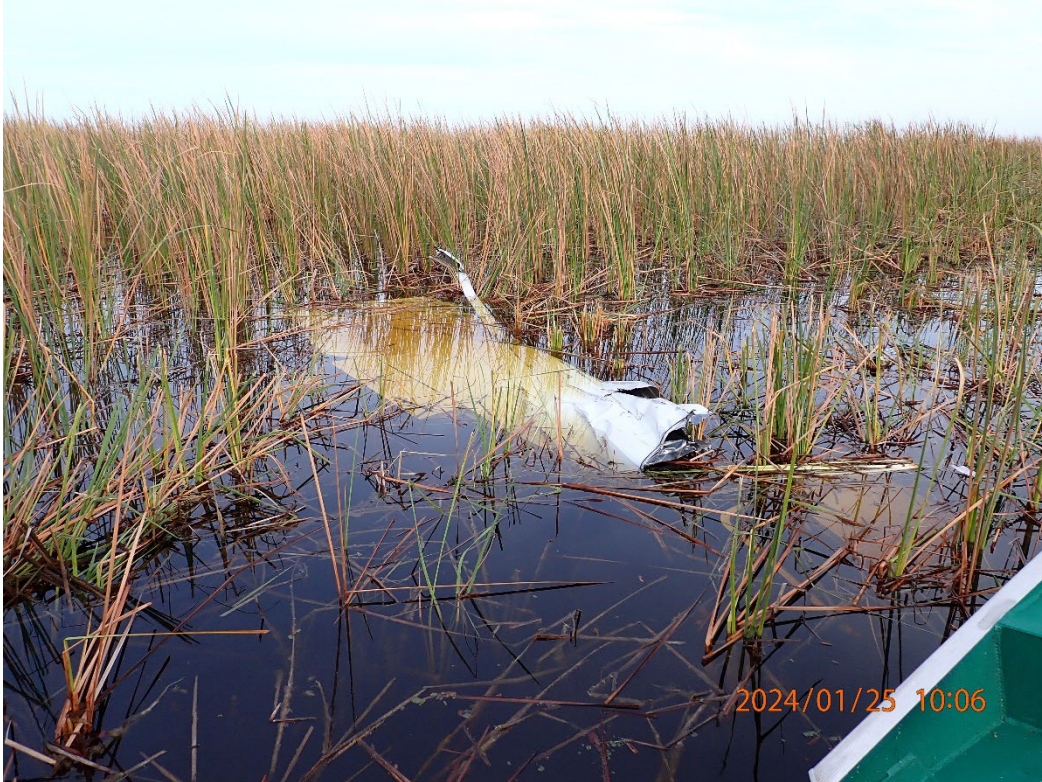
**Photo 2: View of the impact separated left wing.**

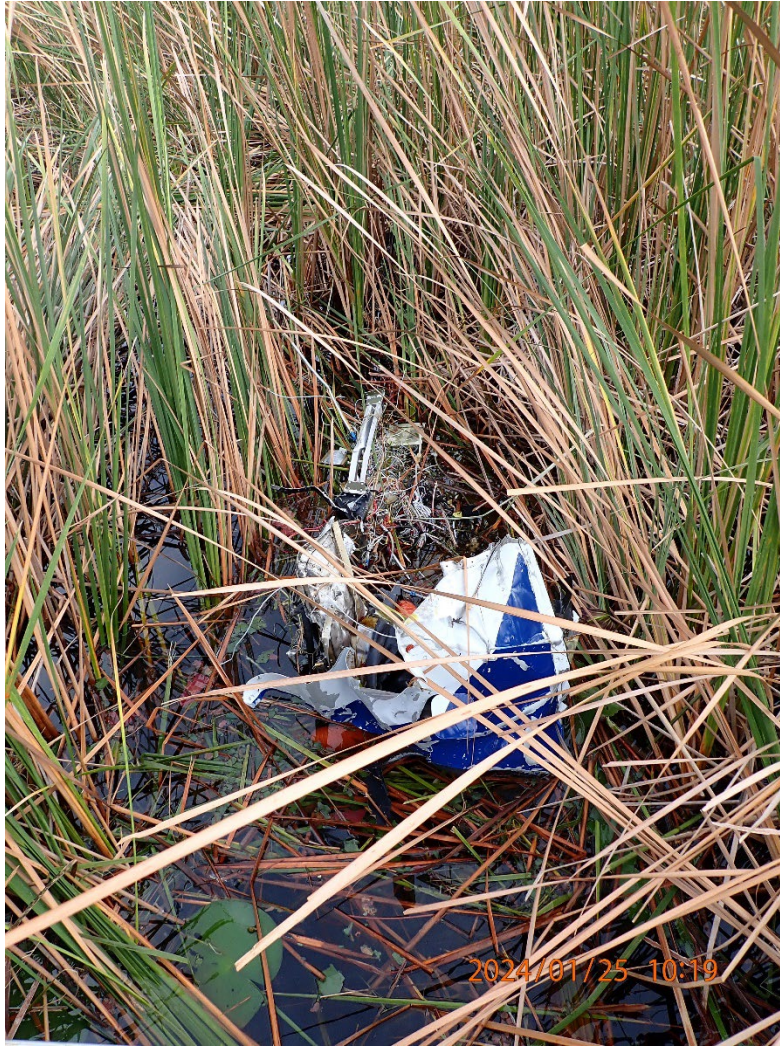
to each other and were impact separated from the main wreckage. They were found about 25 ft from the main wreckage.

**Photo 3: View of the instrument panel impact separated from the fuselage.**

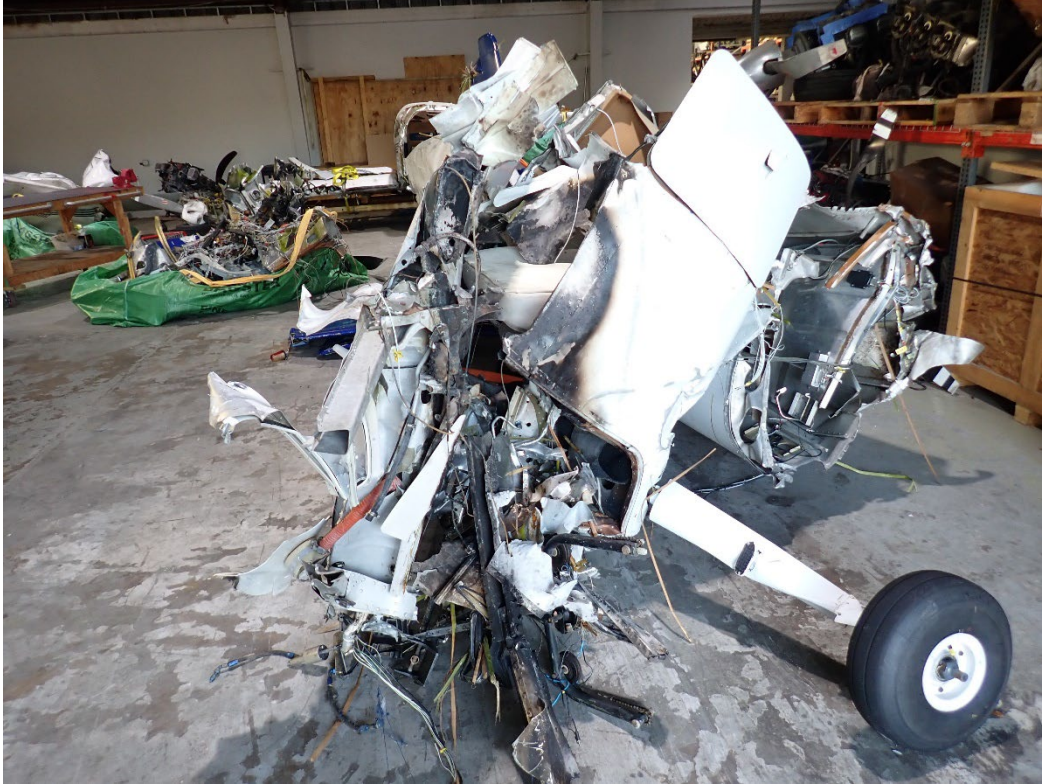
The fuselage was impact separated into multiple pieces. The instrument panel and firewall were impact separated at the windshield bottom attachment. Both doors, the roof, both skylights, rear window, and the floor were impact separated into multiple sections.

**Photo 4: View of the largest section of fuselage. (Textron Aviation Photo)**

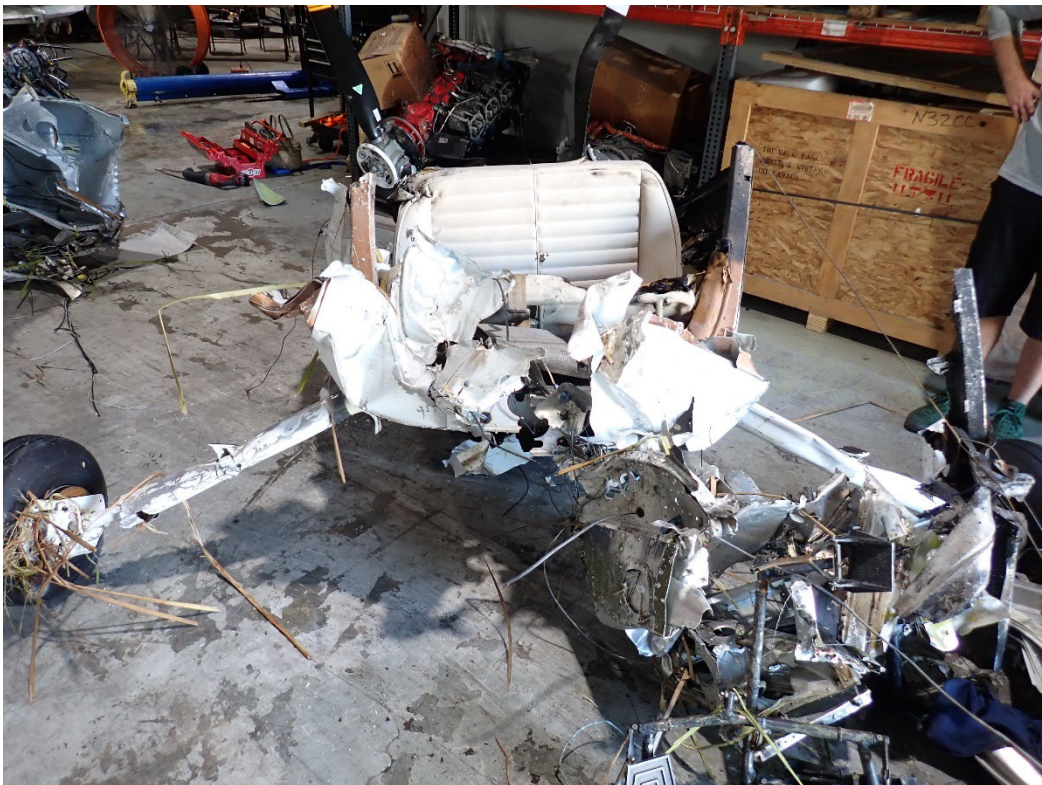
**Photo 5: View of the fuselage wreckage. (Textron Aviation Photo)**

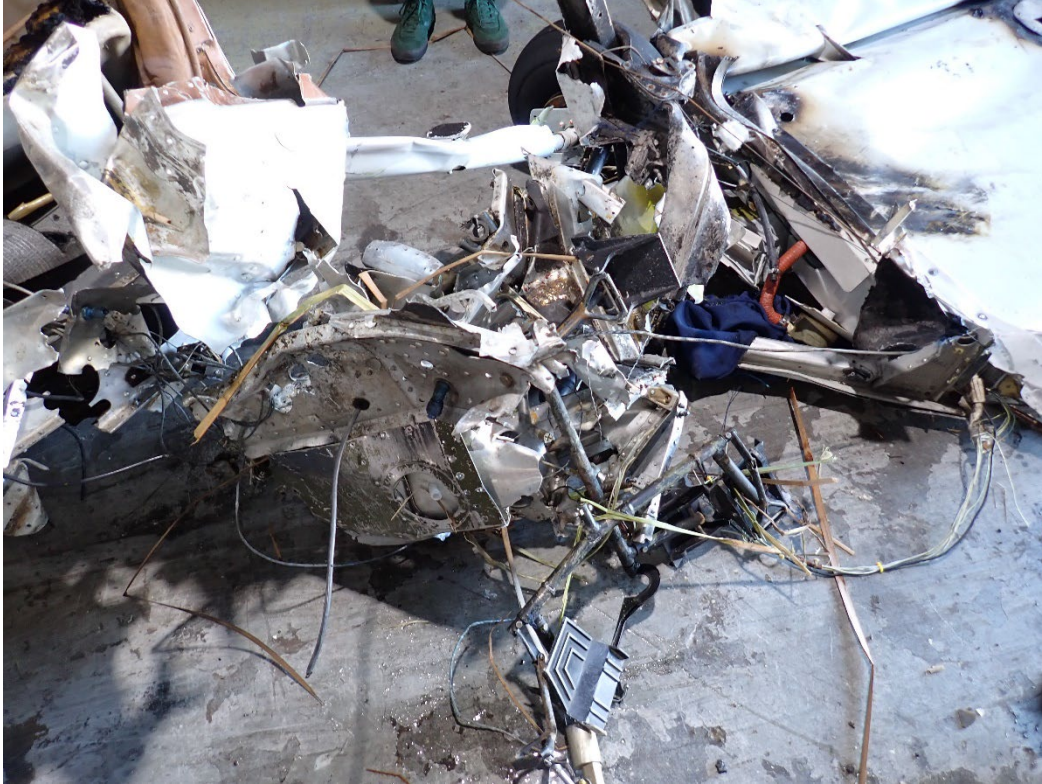
**Photo 6: View of the forward fuselage. (Textron Aviation Photo)**

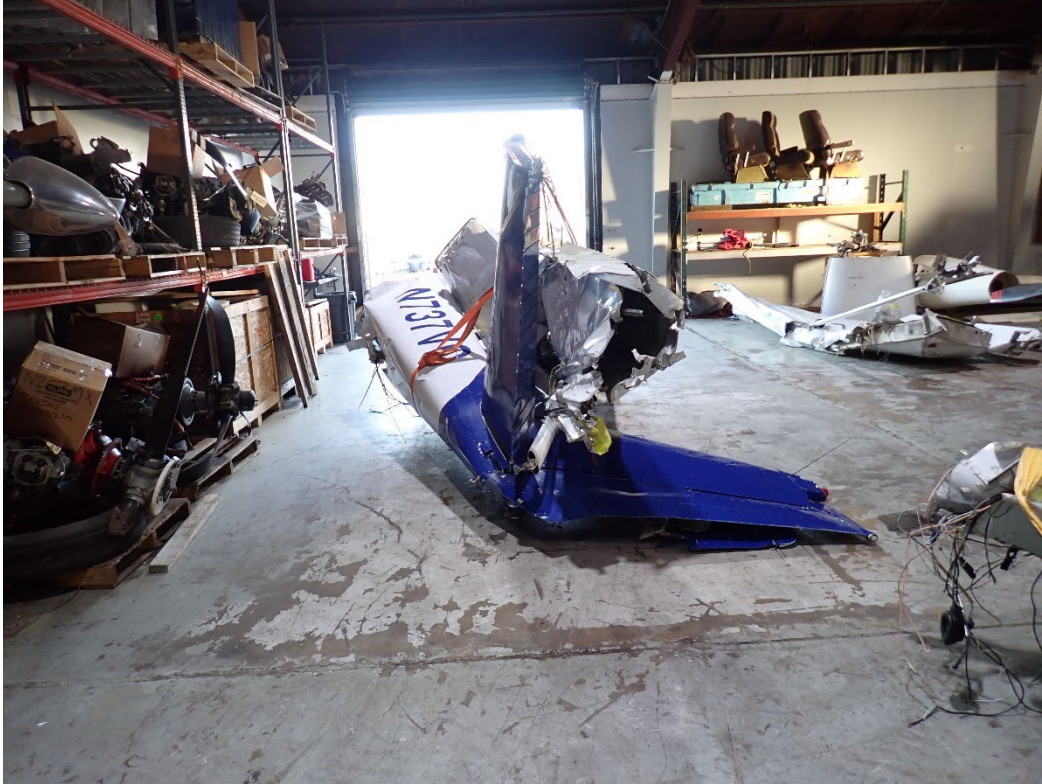
The empennage was held onto the fuselage only by control cables. Control continuity of the elevator, elevator trim, and rudder were confirmed from the flight control surfaces to the controls in the cockpit through impact fractures and cuts made for recovery. The left horizontal stabilizer was undamaged, and the left elevator remained attached at all attachment points and was impact fractured down at the tip. The right horizontal stabilizer exhibited impact damage and was bent up about 80°. The right elevator exhibited impact damage and remained attached at the outboard attachment point; the inboard 45 inches were impact separated and recovered. The elevator trim tab remained attached to the recovered section of the right elevator. When measured the elevator trim tab actuator showed a trim of 15° tab up. The vertical stabilizer and rudder exhibited impact damage and remained attached at all attachment points.

**Photo 7: View of the empennage as first viewed at the recovery facility. (Textron Aviation Photo)**

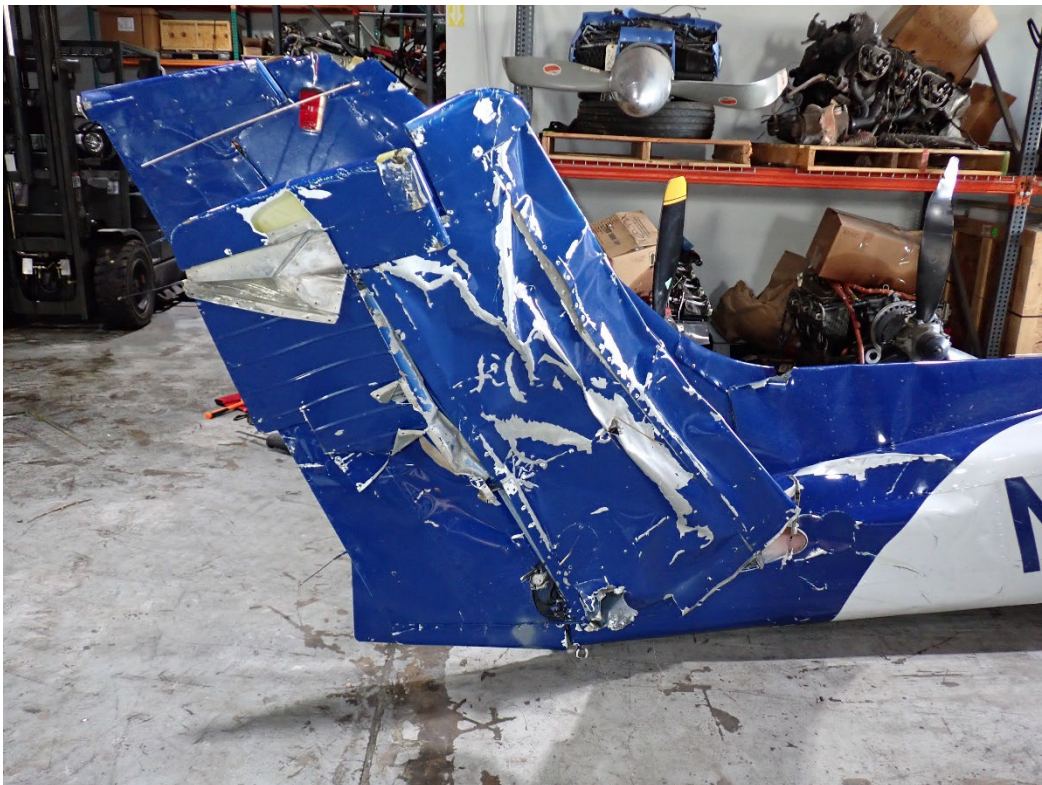
**Photo 8: View of the right side of the empennage. (Textron Aviation Photo)**

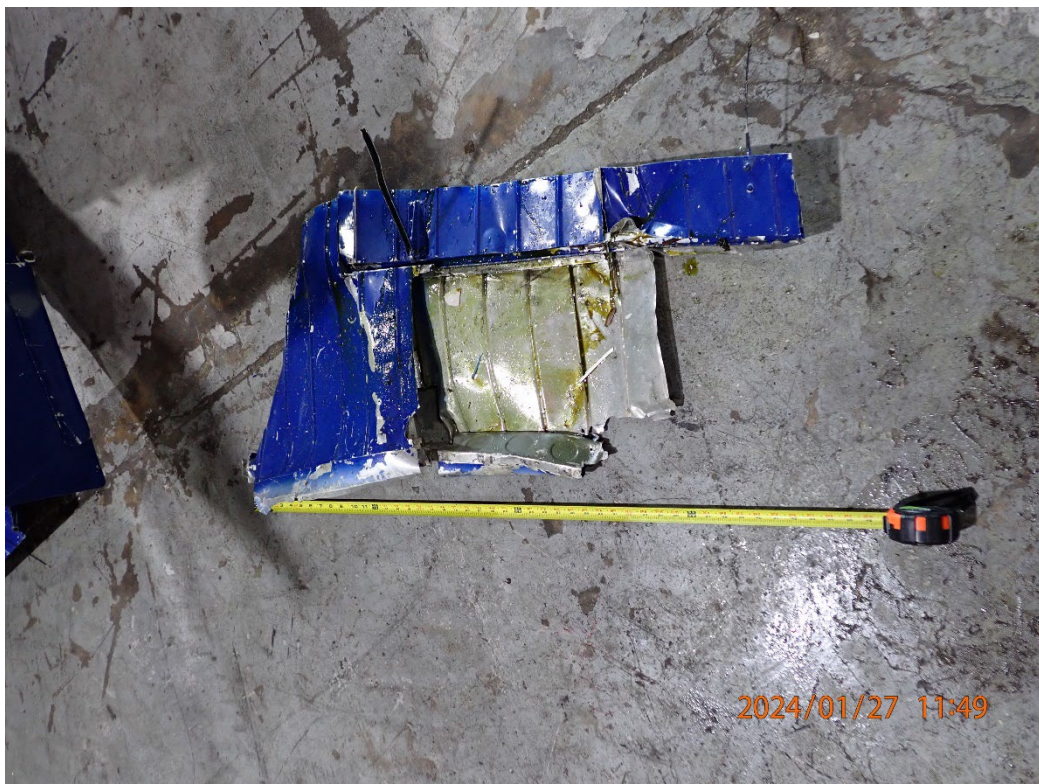
**Photo 9: View of the impact separated portion of the right elevator and the elevator trim tab.**

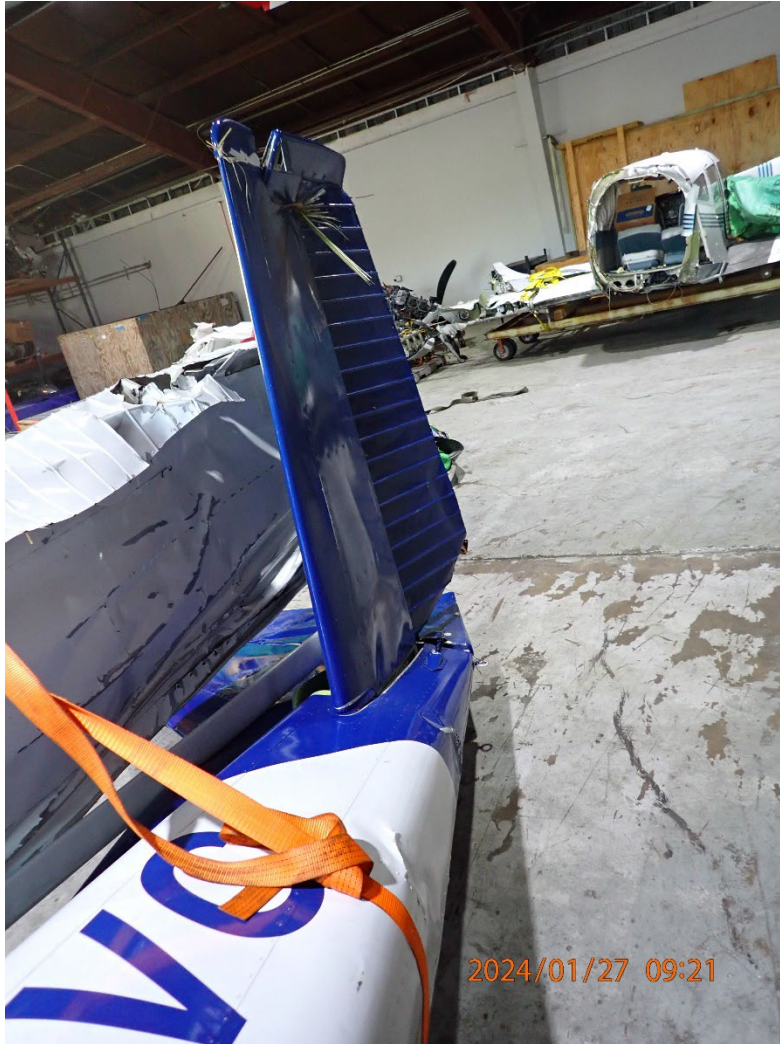
**Photo 10: View of the left horizontal stabilizer and elevator.**

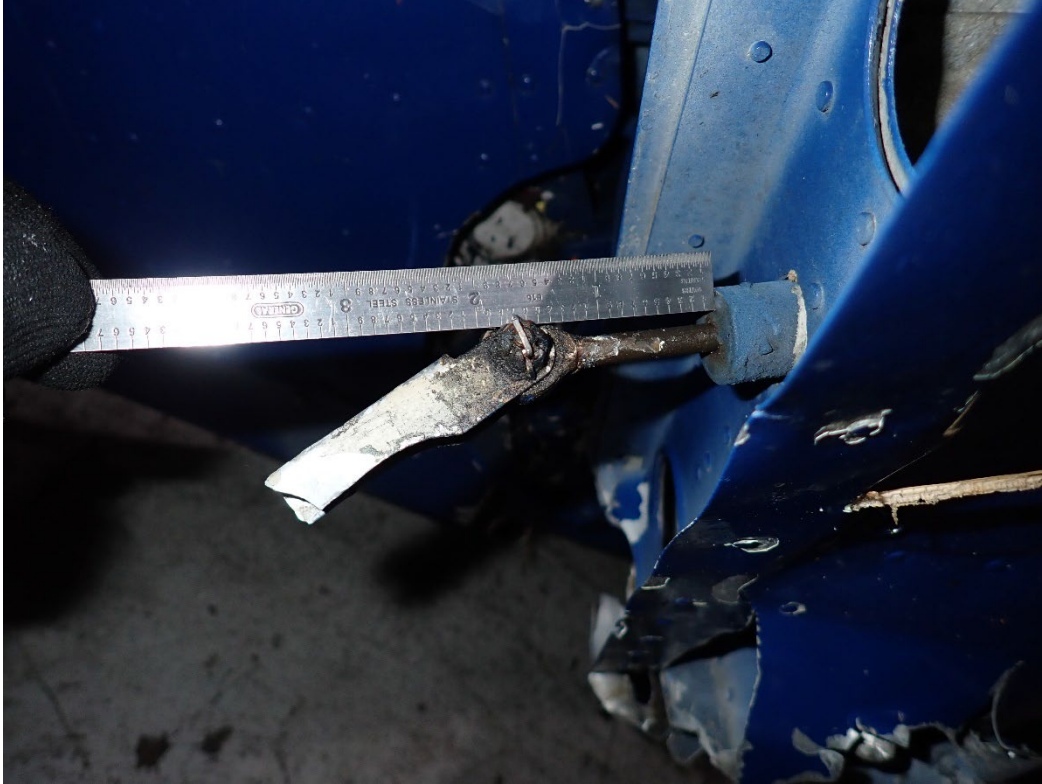
**Photo 11: View of the elevator trim actuator with scale. (Textron Aviation Photo)**

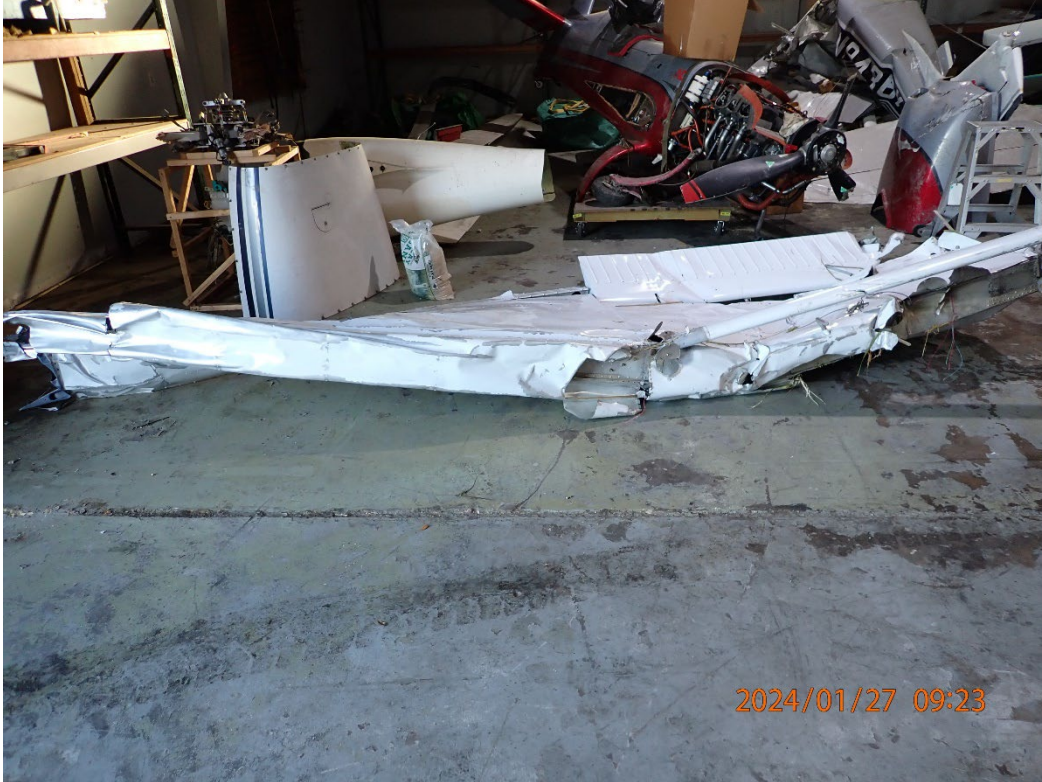
The left wing was impact separated from the fuselage. The left wing tip was impact separated and was not recovered. The leading edge was impact crushed aft, from the upper strut attachment point outboard to the end of the wing and was twisted. The inboard portion of the wing was twisted downward from the strut inward about 30°. The wing strut had about a 2 inch cut along with multiple strike marks about 31 inches from the end of the wing strut fairing near the wing attach point. The left flap remained attached to the wing at all attachment points and the flap drive cable exhibited tensile overload. The inboard 56 inches of the left aileron remained attached to the wing. A 21 inch section of the left aileron was impact separated and recovered the remainder of the left aileron was not recovered. Control continuity of the left aileron was confirmed from the flight control surface to the flight control in the cockpit through multiple overload fractures.

**Photo 12: View of the left wing leading edge as first viewed at the recovery facility.**

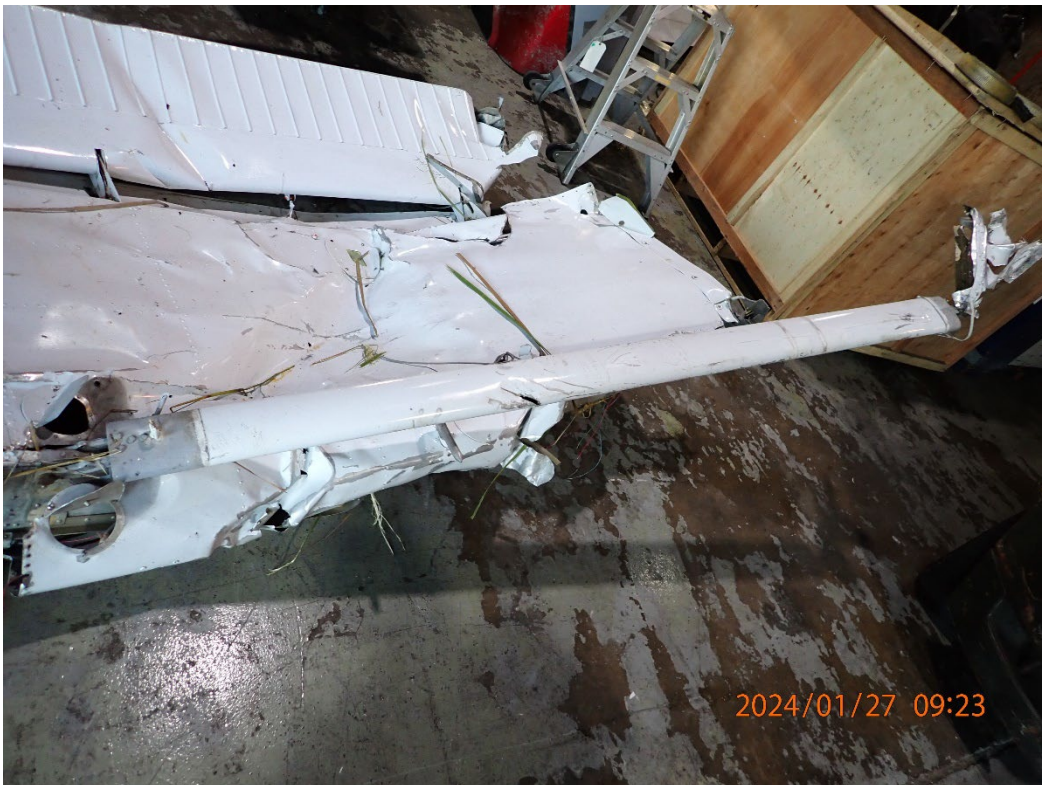
**Photo 13: View of the left wing strut.**

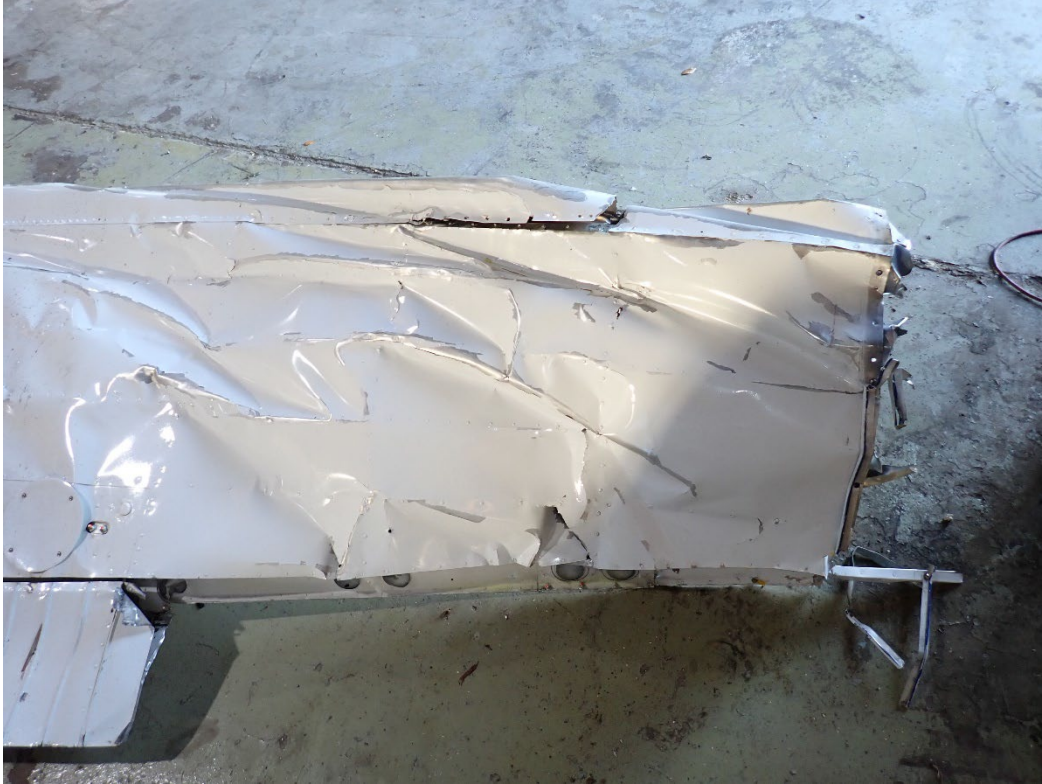
**Photo 14: View of the left wing tip. (Textron Aviation Photo)**

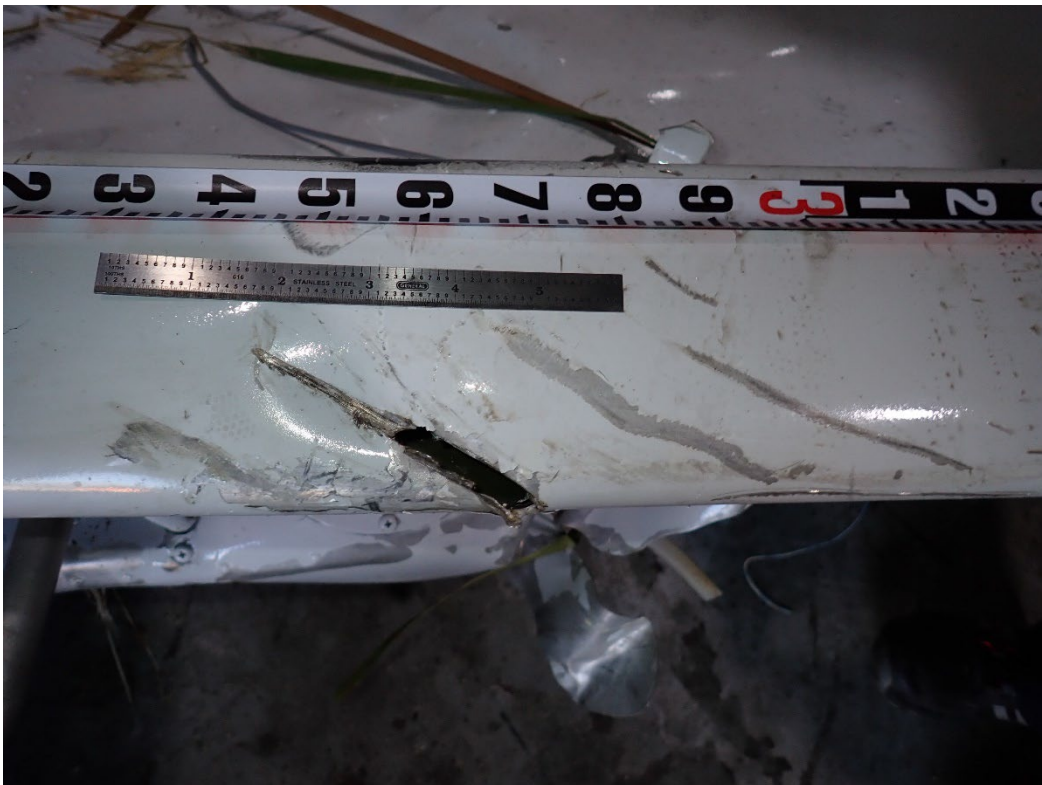
**Photo 15: View of the cut and witness marks on the left wing strut. (Textron Aviation Photo)**

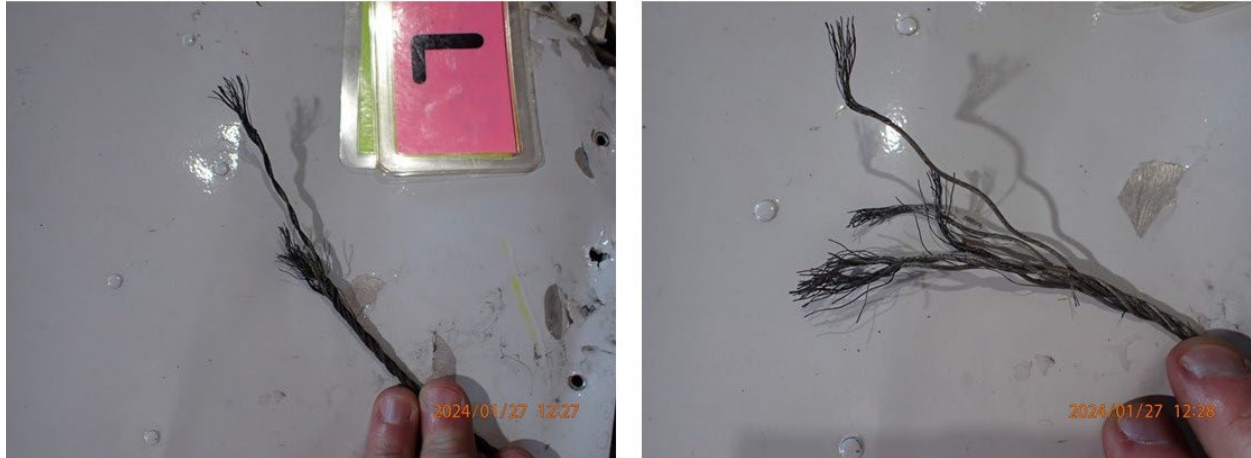
**Photo 16: View of left wing control cables.**

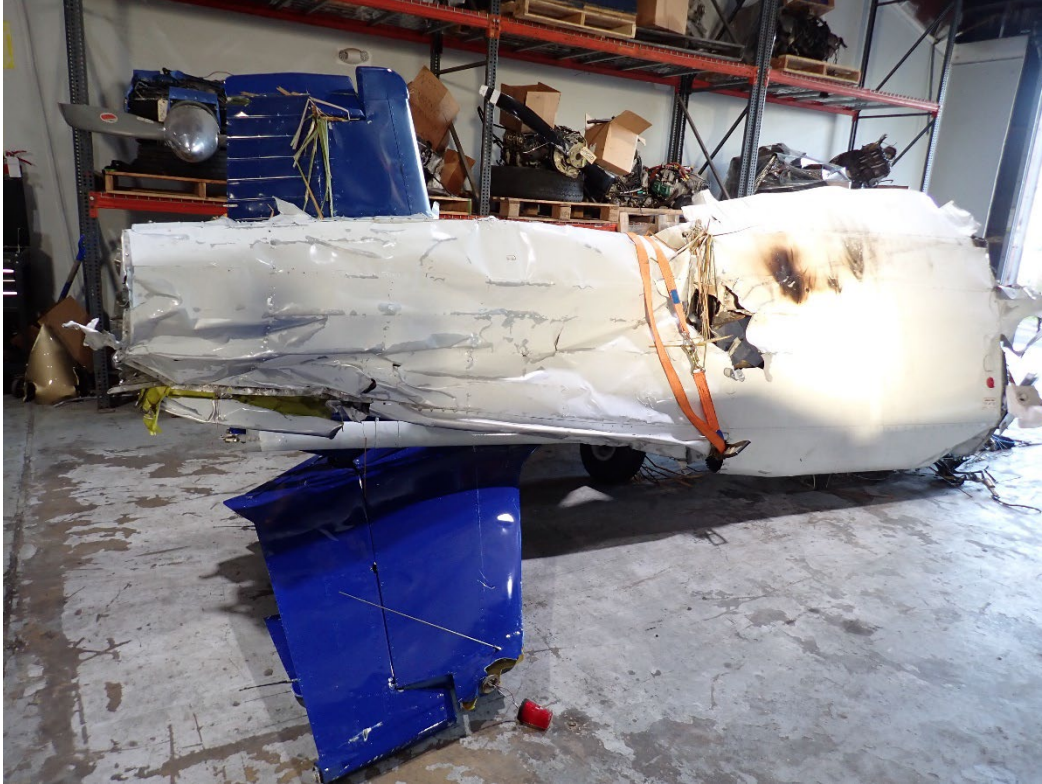
The right wing remained attached to the main wreckage through the right aileron direct control cable. The wing tip was impact separated and not recovered. The leading edge was impact crushed aft from the upper strut attachment point outboard to the wing tip. The right flap remained attached at all attachment points. The flap motor was impact separated from the mount and found inside the wing. The flap actuator was measured and was found to be consistent with a flaps UP position. The right aileron remained attached to the wing at all attachment points. Control continuity of the right aileron was confirmed from the flight control surface to the flight control in the cockpit through multiple overload fractures. The aileron balance cable exhibited tensile overload.

**Photo 17: View of the right wing as first viewed at the recovery facility. (Textron Aviation Photo)**

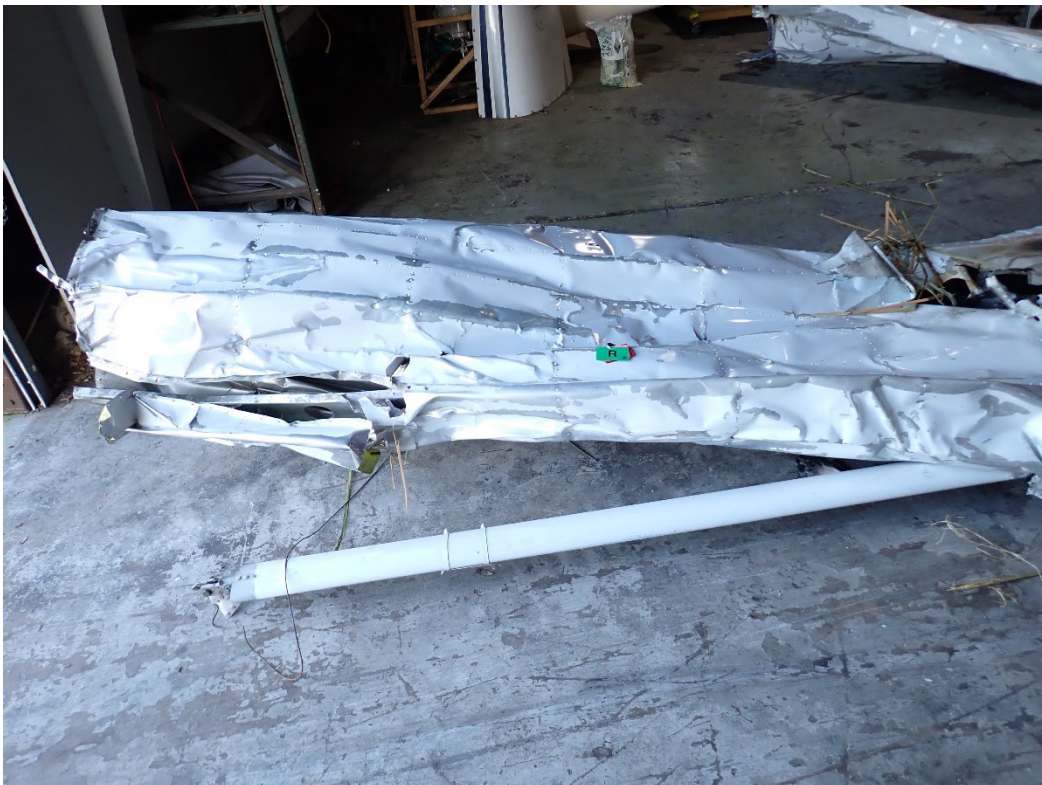
**Photo 18: View of right wing tip. (Textron Aviation Photo)**

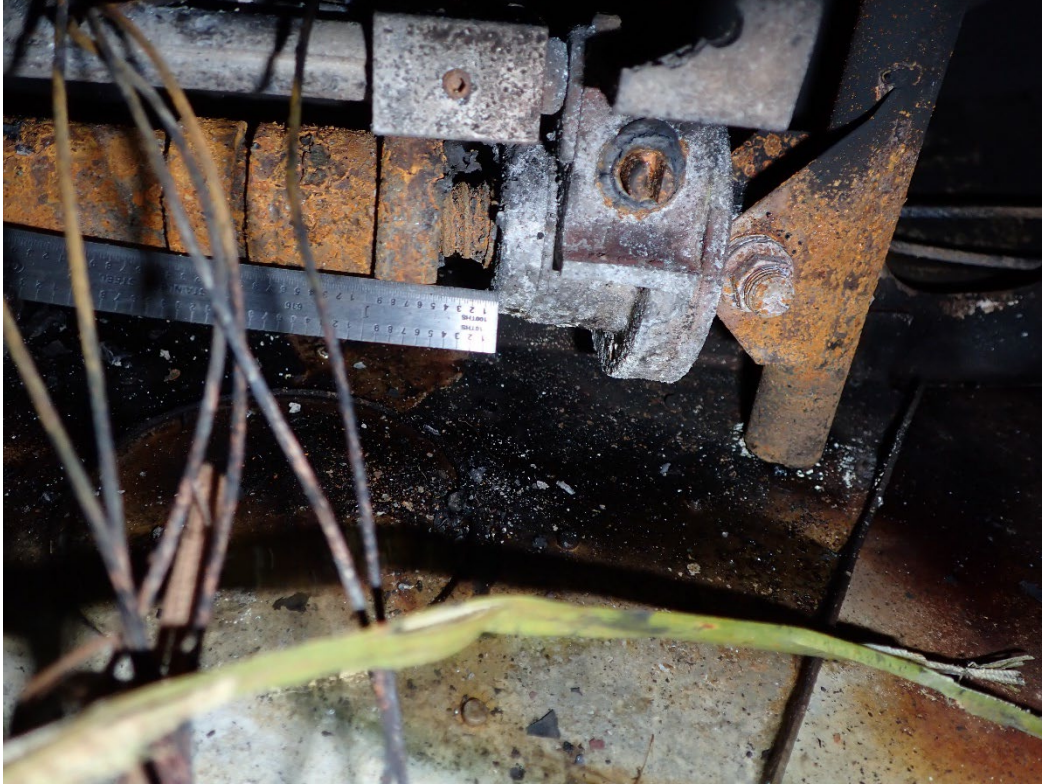
**Photo 19: View of the flap actuator with scale. (Textron Aviation Photo)**

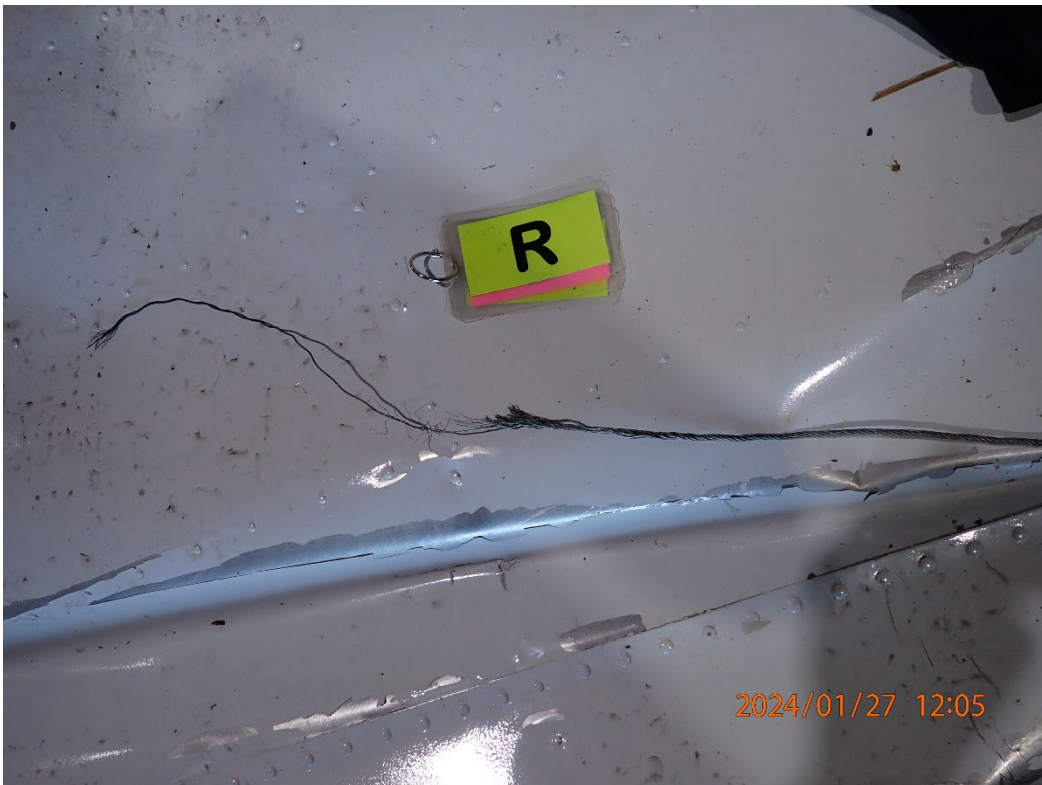
**Photo 20: View of right aileron balance cable.**

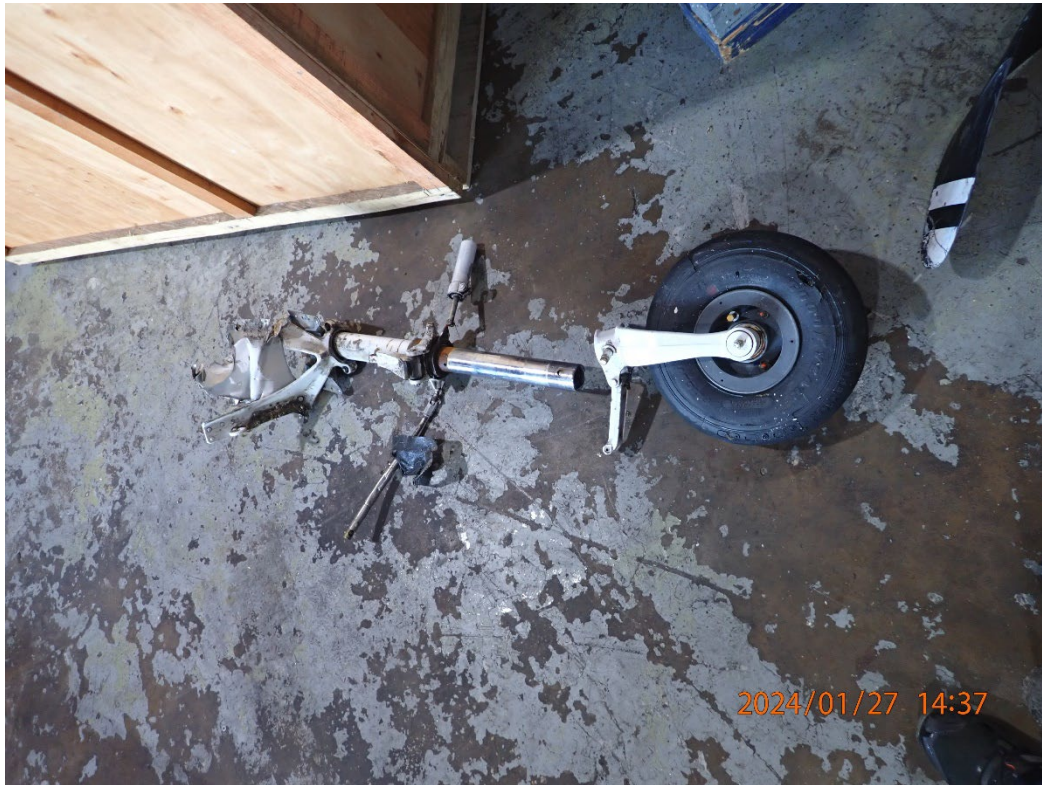
The nose landing gear strut was impact separated from the firewall. The nose wheel was impact separated from the nose strut. The main landing gear remained attached at all attachment points.

**Photo 21: View of the nose landing gear.**

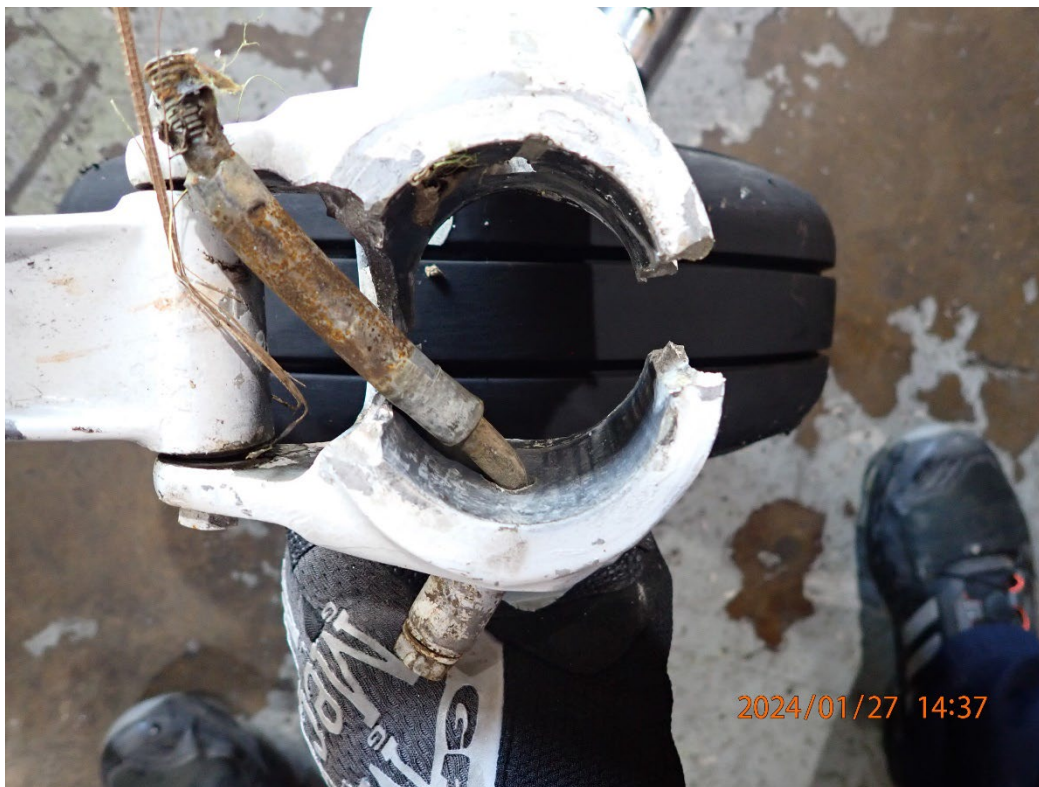
**Photo 22: View of the nose wheel fork.**

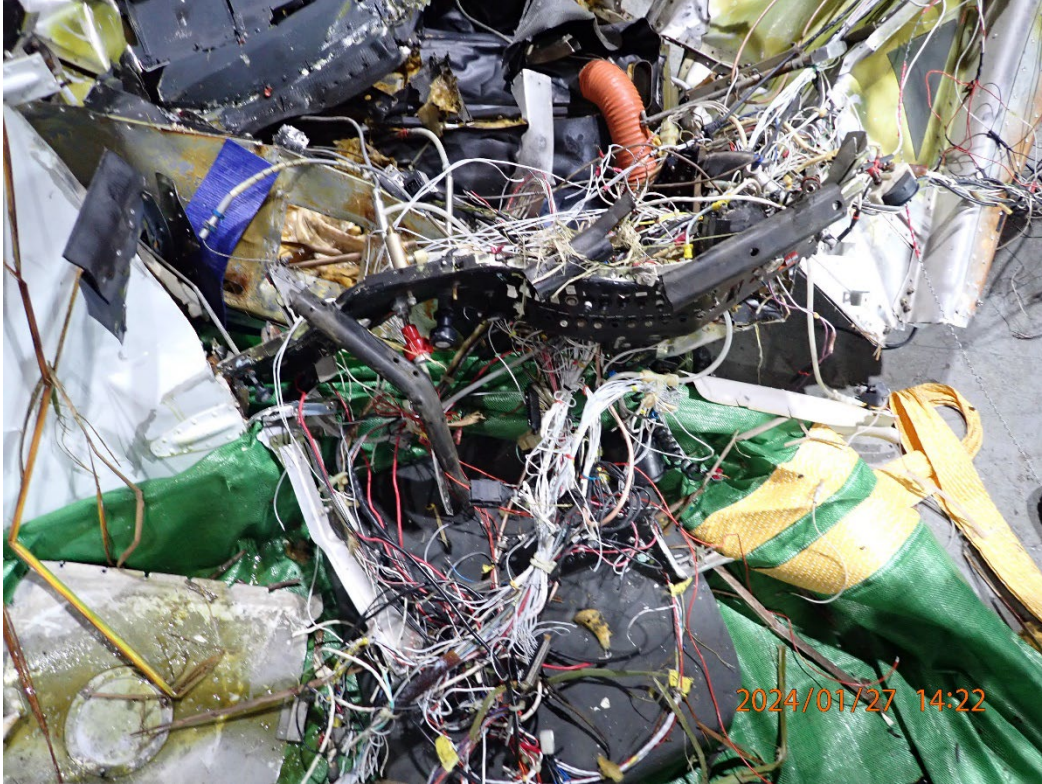
The cockpit area was impact damaged and in multiple pieces. The only instrument that remained attached was the tachometer. The recovered switches were in the following positions:

**Photo 23: View of the instrument panel.**

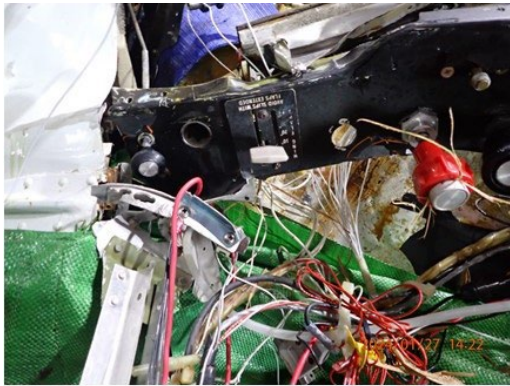
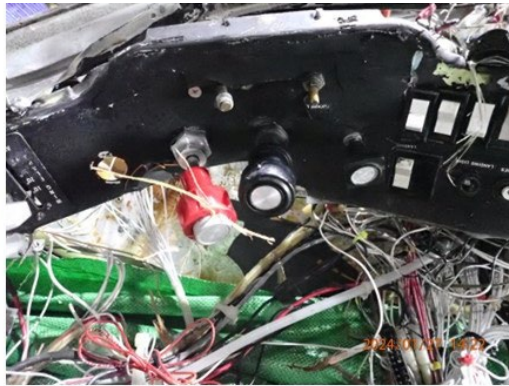
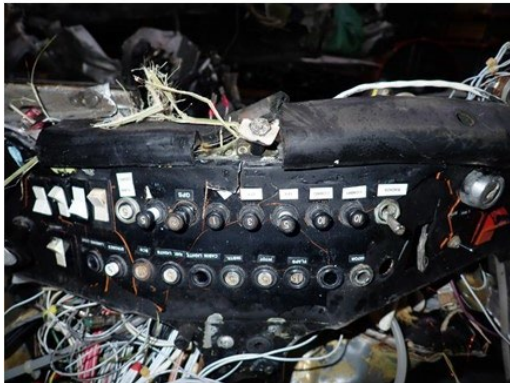
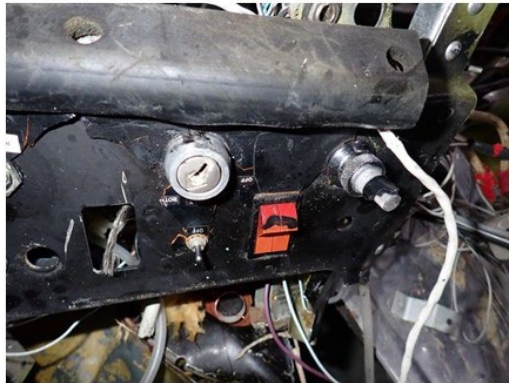
- Master Switch - ON
- Landing Light - ON
- Radios - UP

- TPX
- GPS
- Unknown 5 amp circuit breaker
- HSI
- Unknown 5 amp circuit breaker

**Photo 24: View of cockpit switches and circuit breakers.**

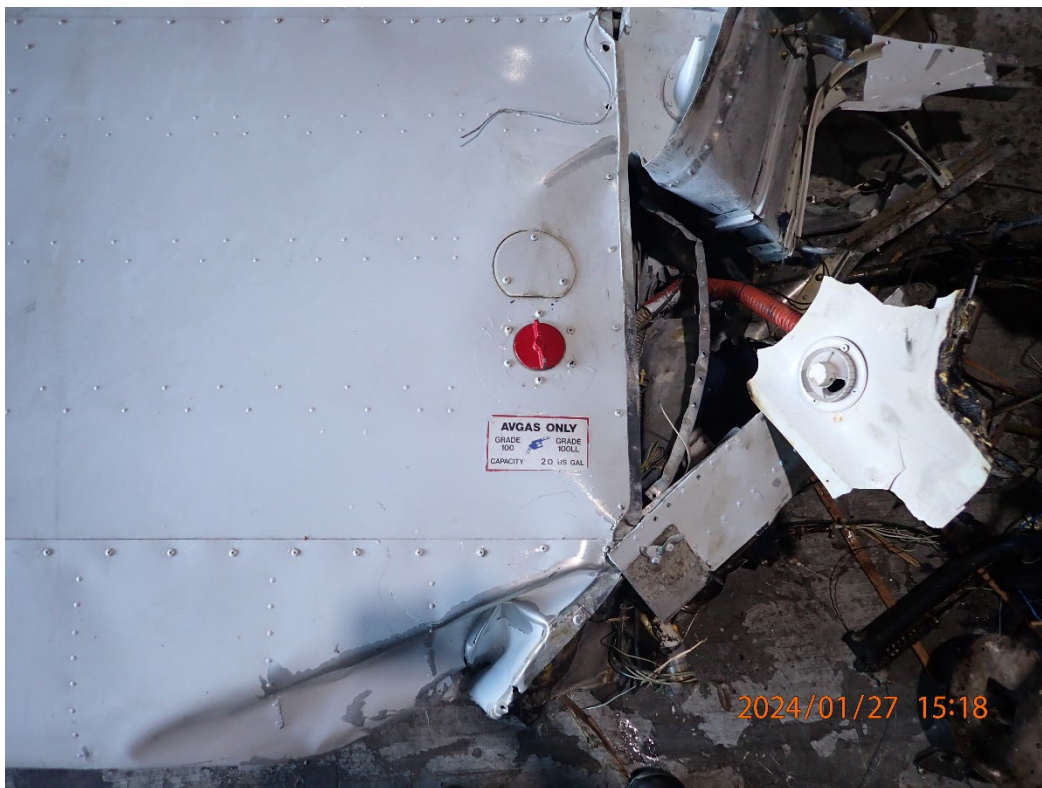
Both wing fuel tanks were ruptured, and the right wing was damaged by postaccident fire. Both wing fuel caps were secured in place and were undamaged. The fuel selector handle and control arm were recovered, and the position could not be determined. The fuel selector valve was impact separated and not recovered.

**Photo 25: View of the right wing fuel cap.**

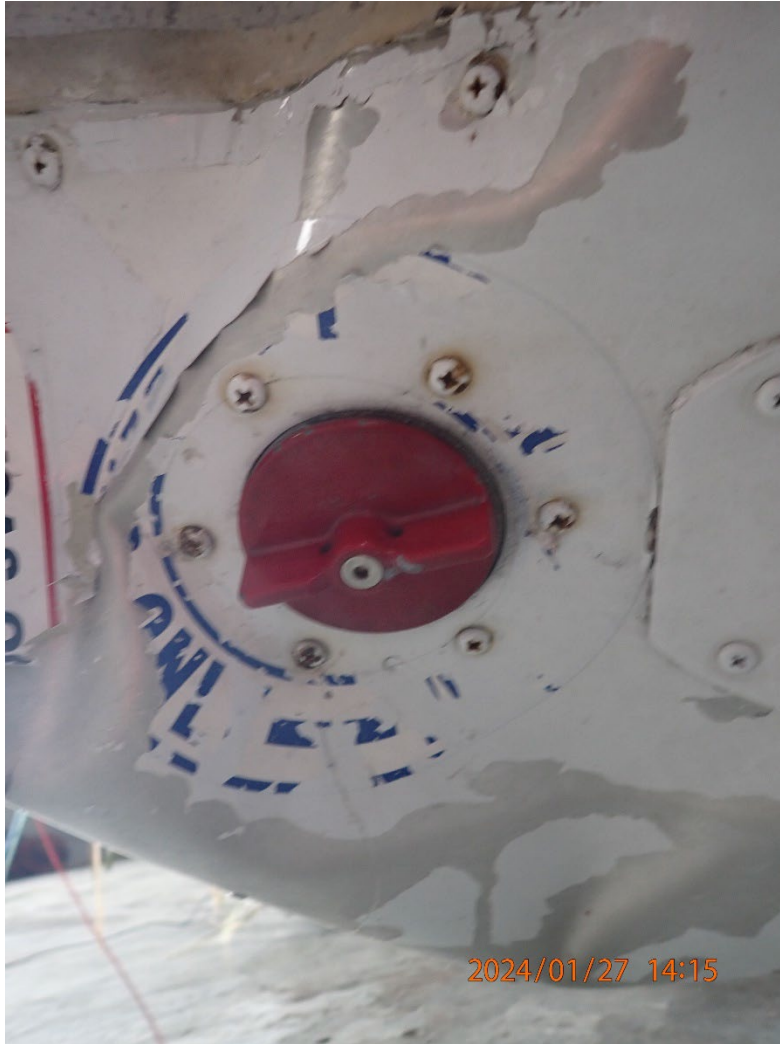
**Photo 26: View of the left wing fuel cap.**
