# National Transportation Safety Board

ERA24FA096

## **WRECKAGE EXAMINATION**

Location: Weston, FL  
Date: January 23, 2024  
Time: 1844 EST  
2344 UTC  
Airplane: N737VC; Cessna 172-N

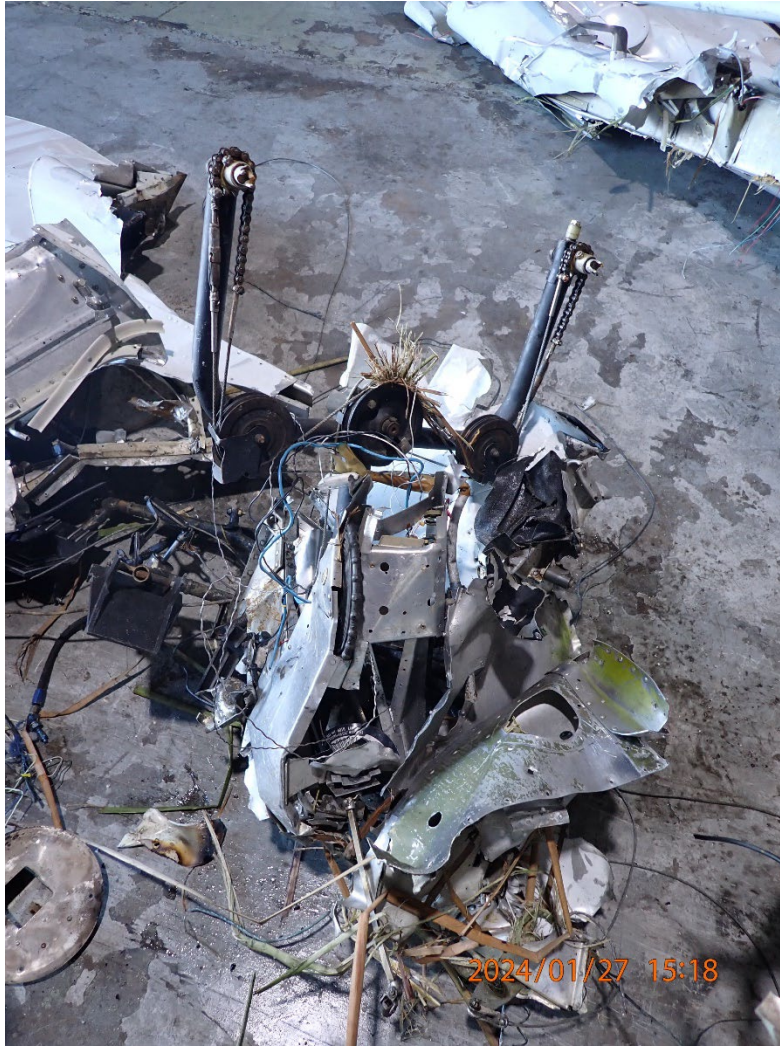
**Photo 27: View of the control yoke and pedestal.**

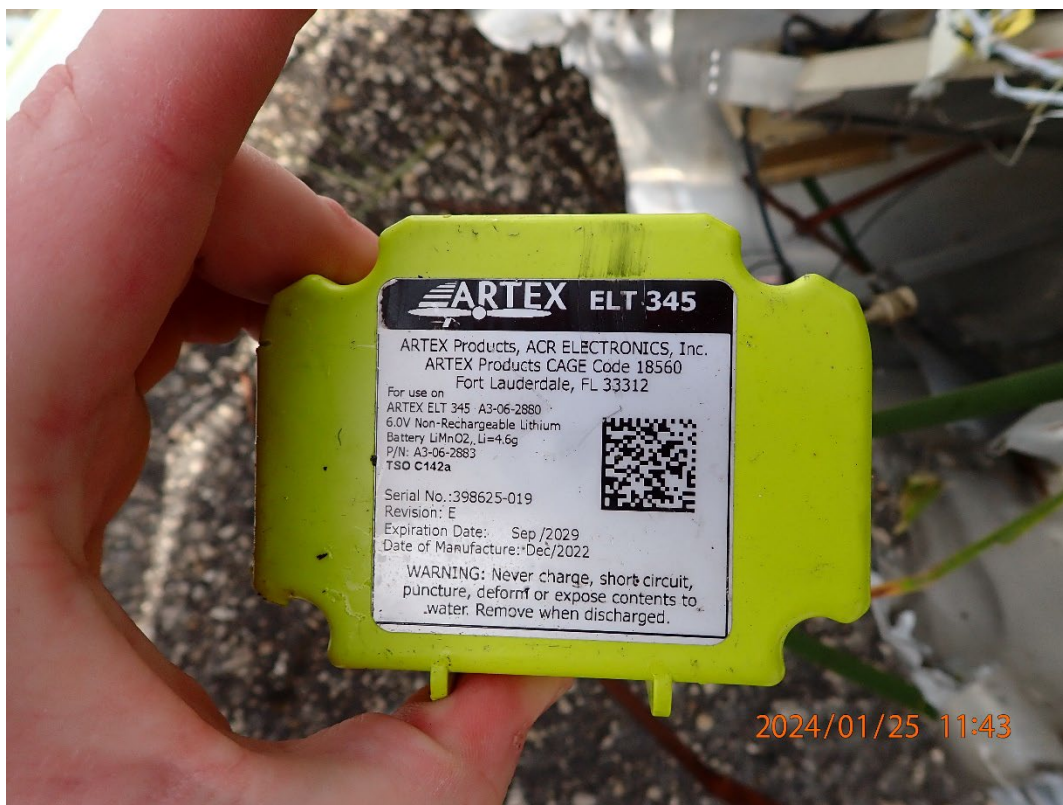
An ELT was installed on the airplane and was turned off by the initial Federal Aviation Administration Inspector on-scene. The ELT was manufactured in December 2022, and expired in September 2029.

**Photo 28: View of the ELT.**

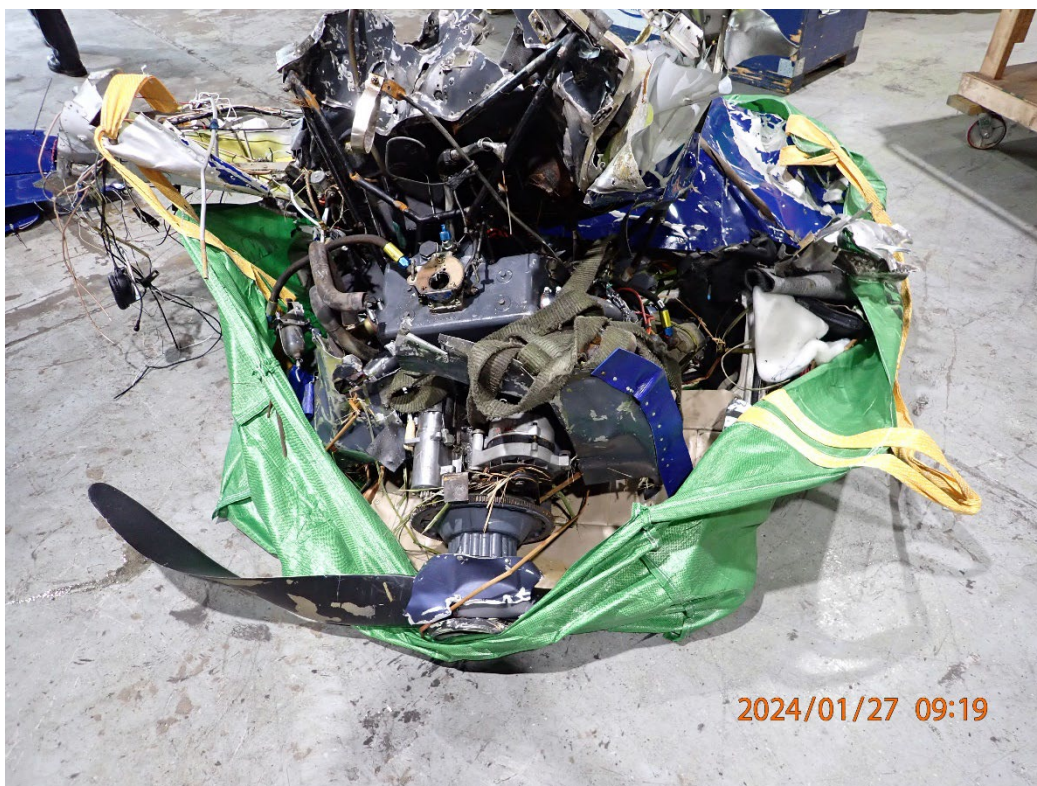
The engine model was a Lycoming O-320-H2AD, serial number L-3361-76. The last inspection was a 100 hour inspection performed on January 20, 2024, and noted an engine total time of 1958.8 hours and a time since major overhaul of 388.3 hours. The engine remained attached to the engine mount at 3 of the 4 attachment points, the lower right engine mount tubes were impact separated. The alternator and starter remained attached to the front of the engine at all attachment points. The alternator belt remained attached and under tension, organic debris was observed on the alternator pulley when the alternator belt was removed. The top spark plugs, and rocker box covers were removed to facilitate rotation attempts. The No. 2 intake push rod was impact damaged and was removed to facilitate crankshaft rotation. Compression and suction were confirmed on all cylinders using the thumb method when the crankshaft was rotated through 720° of rotation by hand using a tool in an accessory drive pad. Valvetrain continuity was confirmed when the crankshaft was rotated through 720° of rotation by hand using a tool in an accessory drive pad.

**Photo 29: Engine as first viewed at the recovery facility.**

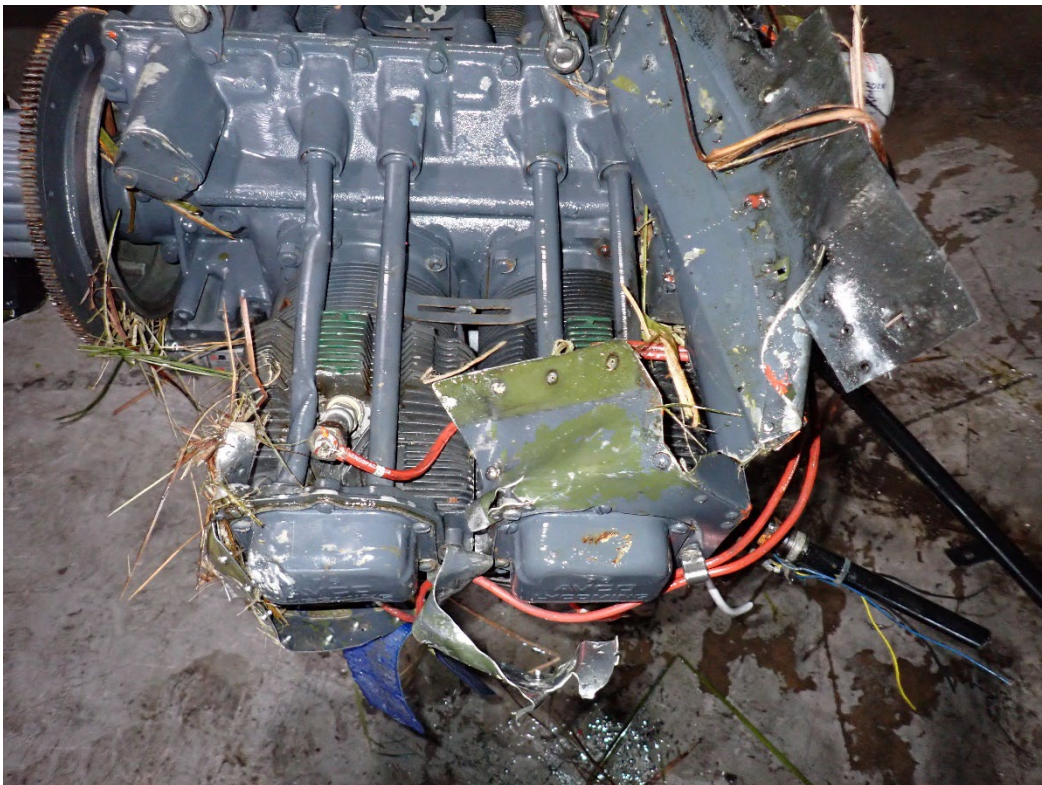
**Photo 32: View of damage to the No. 2 intake pushrod. (Textron Aviation Photo)**

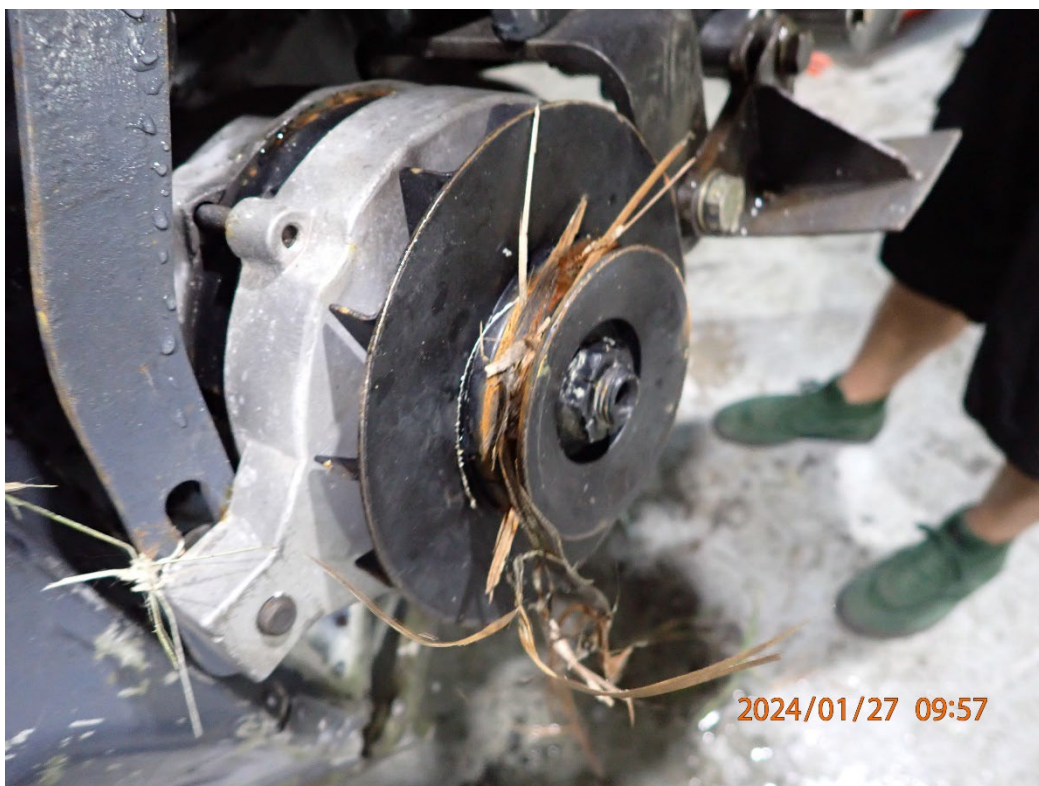
**Photo 33: View of organic debris in the alternator pulley.**

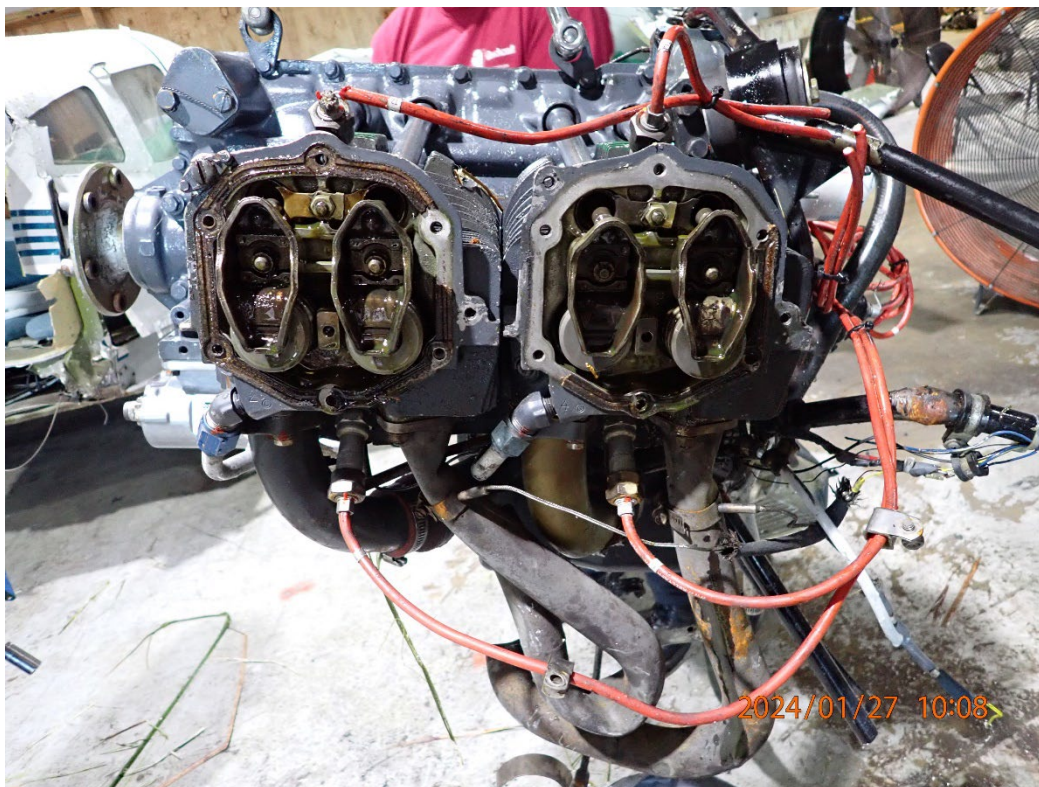
The induction system was impact separated from the engine. The exhaust stacks remained attached to the cylinder heads and exhibited impact damage. The muffler was impact separated.

**Photo 34: View of damage to the Nos. 2 & 4 exhaust.**

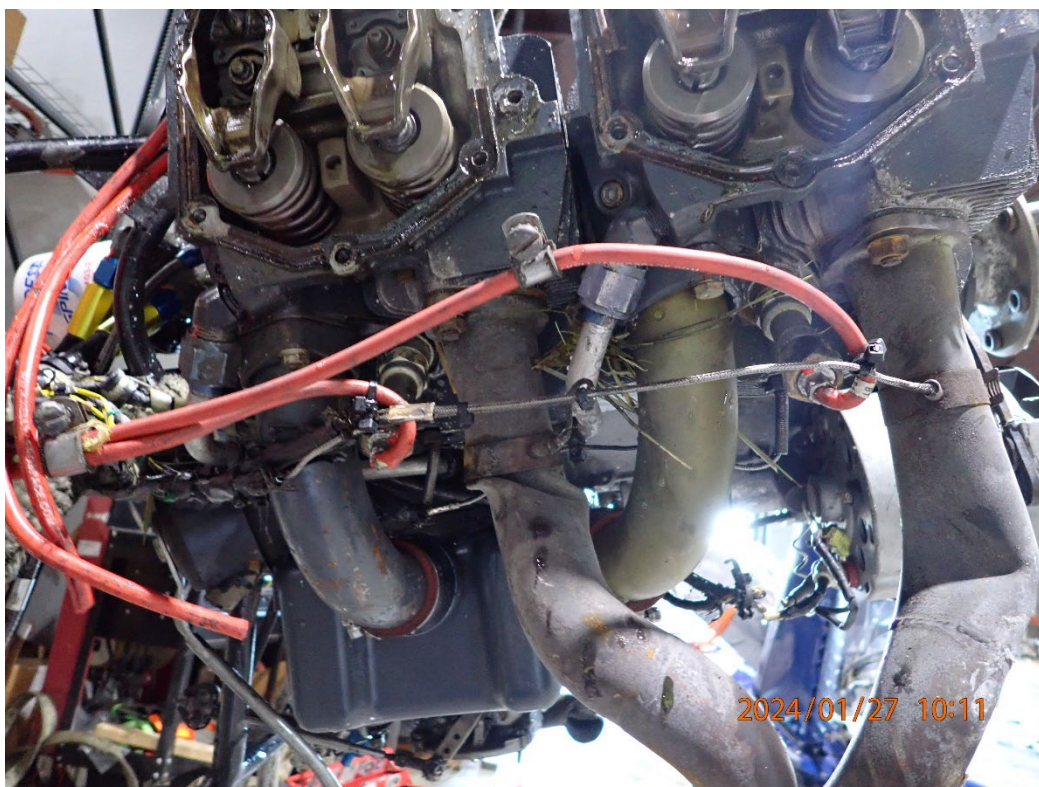
**Photo 35: View of damage to the Nos. 1 & 3 exhaust.**

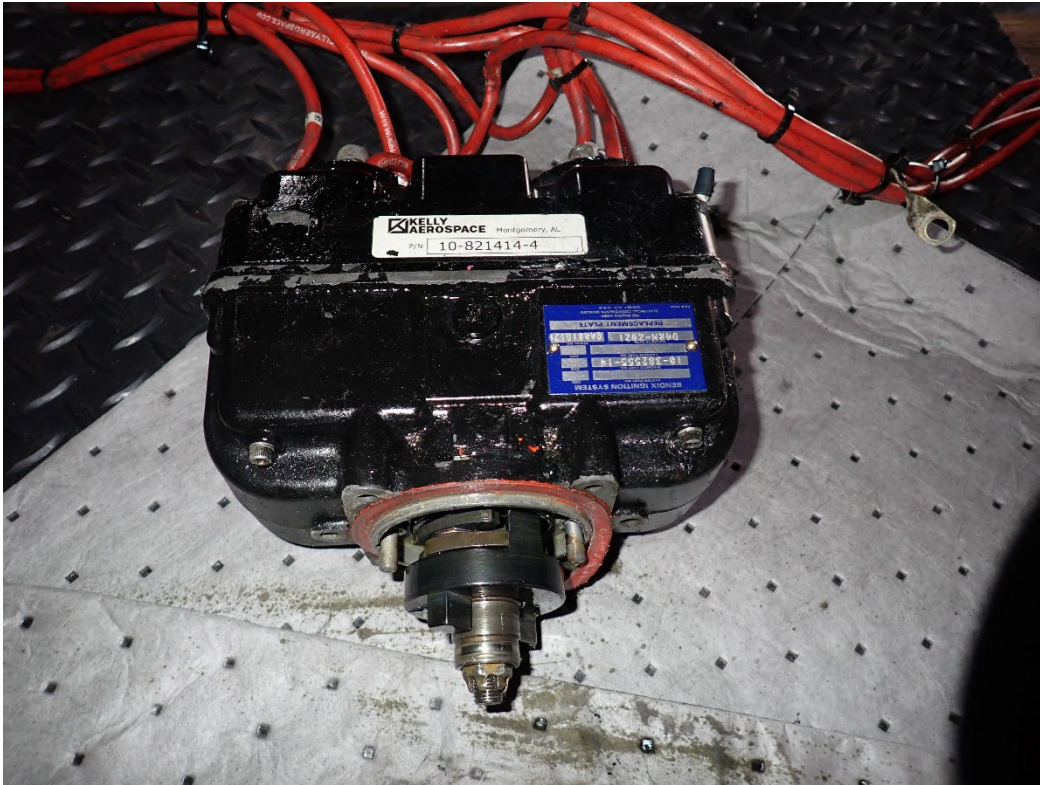
A single drive dual magneto remained installed on the accessory case of the engine at all attachment points. Both magnetos sparked on all leads when the drive gear was rotated using an electric drill. The impulse couplings snapped as expected.

**Photo 36: View of the single drive dual magneto. (Textron Aviation Photo)**

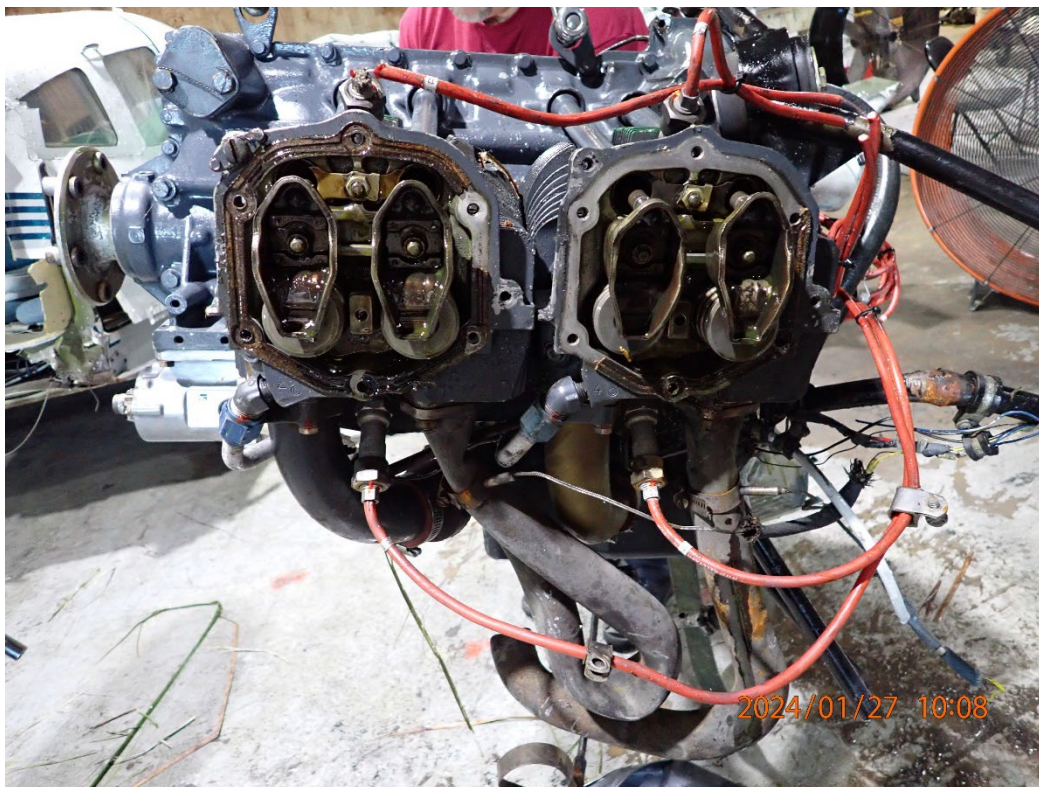
**Photo 37: View of damage to the No. 2 top spark plug lead.**

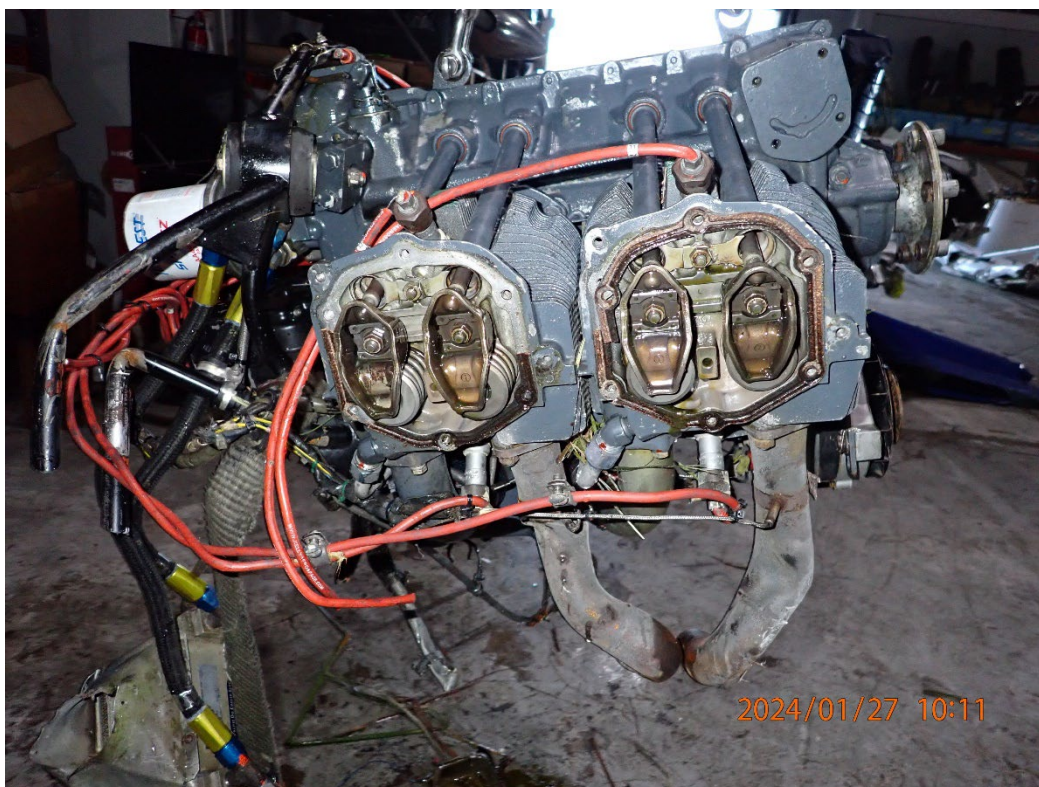
**Photo 38: View of damage to the No. 3 top spark plug lead.**

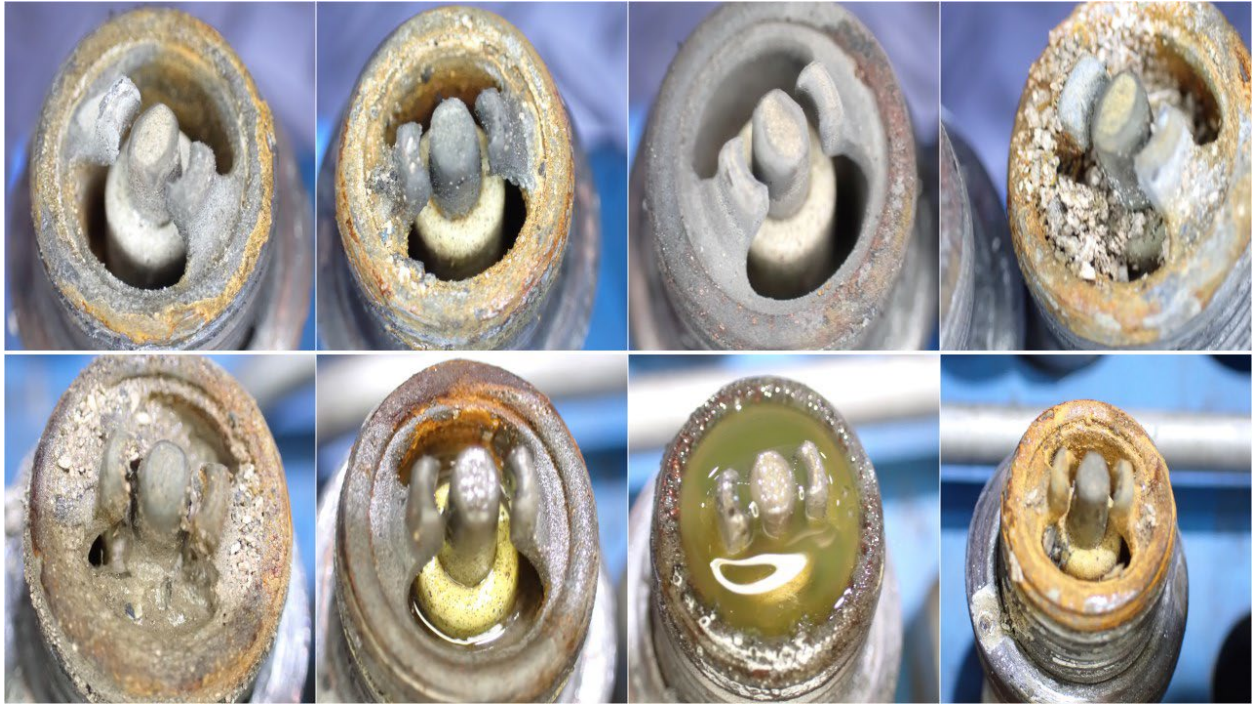
All top and bottom spark plugs were secure in the cylinder heads and the leads remained secured to the plugs. The Nos. 2 and 3 top spark plug leads exhibited impact damage. The spark plugs were removed and examined using the Champion Aviation AV-27 Check-A-Plug chart. All spark plugs were visually consistent with worn out - severe.

**Photo 39: View of top and bottom spark plugs. (Textron Aviation Photos)**

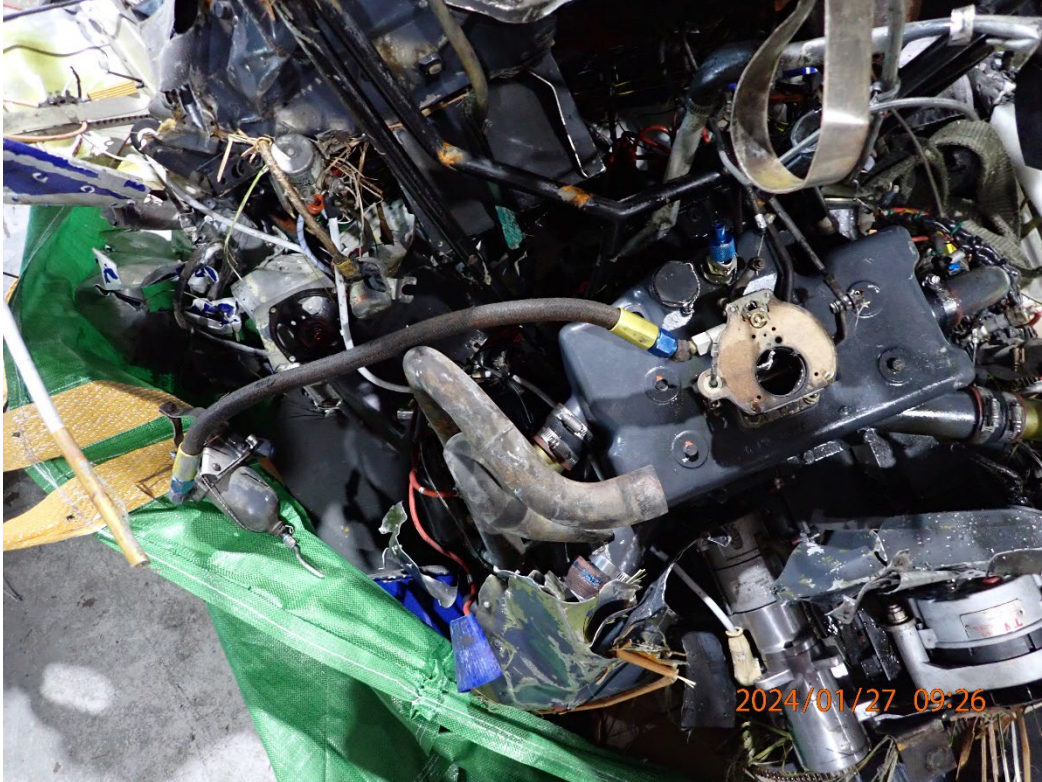
The fuel strainer remained attached to the engine through the fuel lines and was impact separated from the firewall. The strainer bowl was fractured, and minimal organic debris was observed on the strainer screen. The fuel line to the carburetor remained attached to the engine. The carburetor fuel bowl and float assembly were impact separated. The carburetor fuel screen was removed and examined and contained slight organic debris. The throttle and mixture control cables remained attached to the carburetor and were continuous to the controls in the cockpit. The carburetor heat control remained secured in the cockpit and the control cable was impact separated on the engine side of the firewall.

**Photo 40: Fuel strainer and carburetor as first viewed at the recovery facility.**

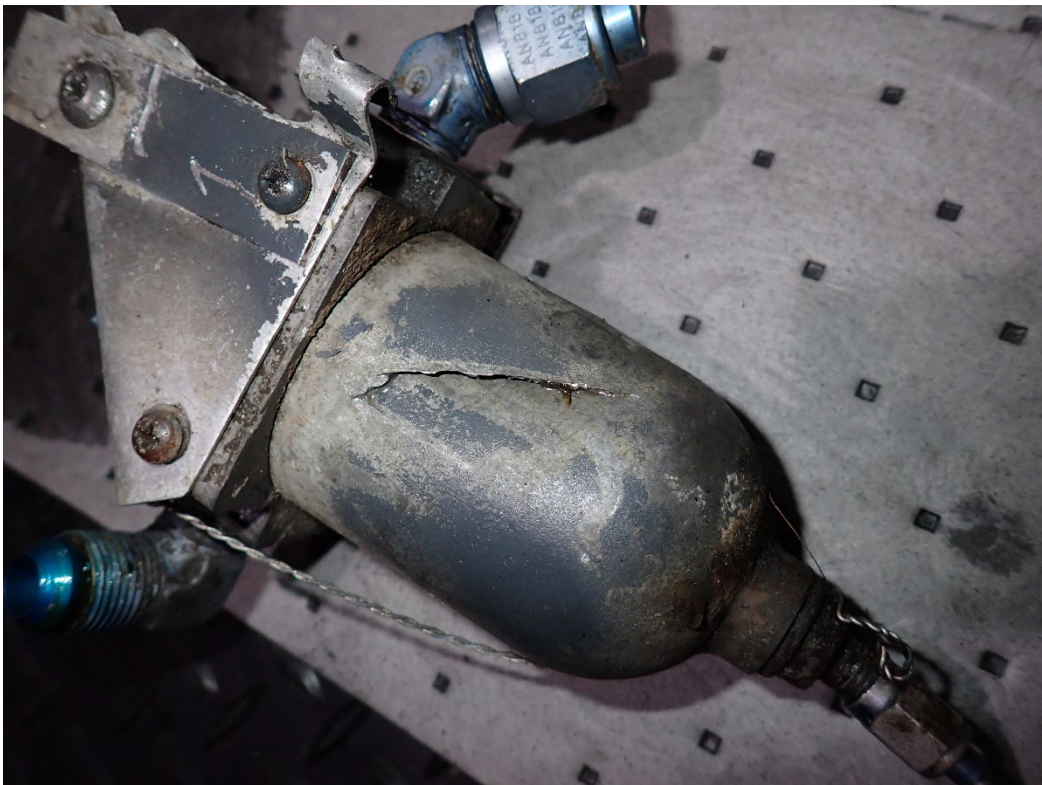
**Photo 41: View of fuel strainer bowl. (Textron Aviation Photo)**

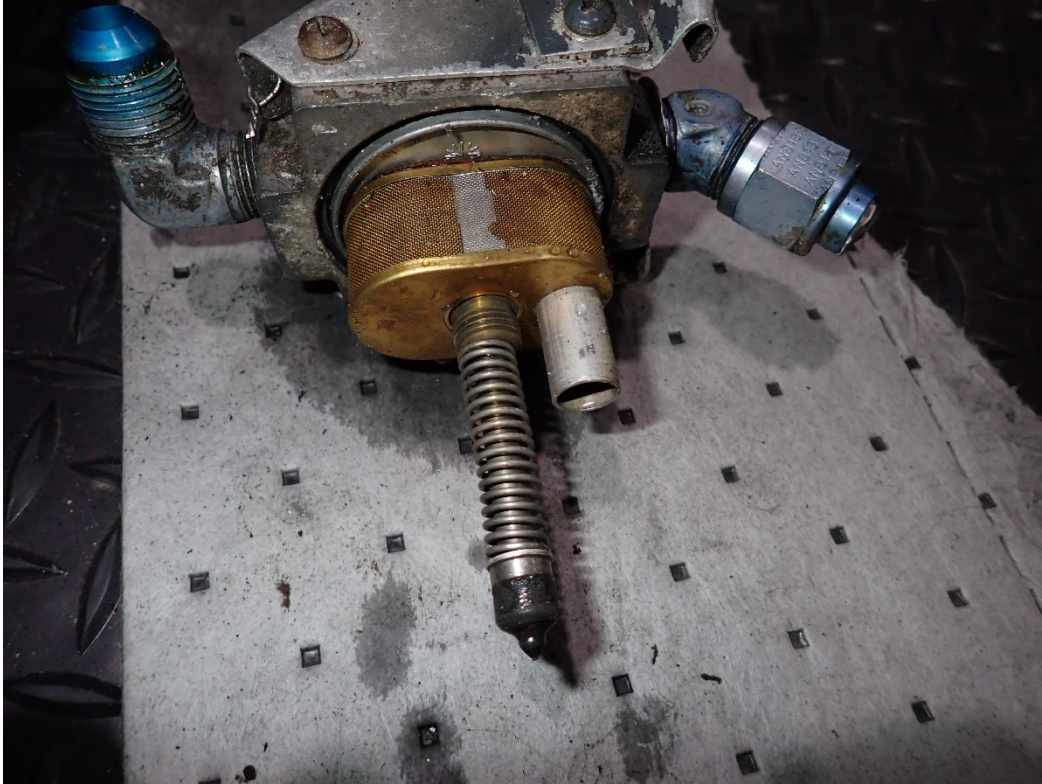
**Photo 42: View of the fuel strainer screen. (Textron Aviation Photo)**

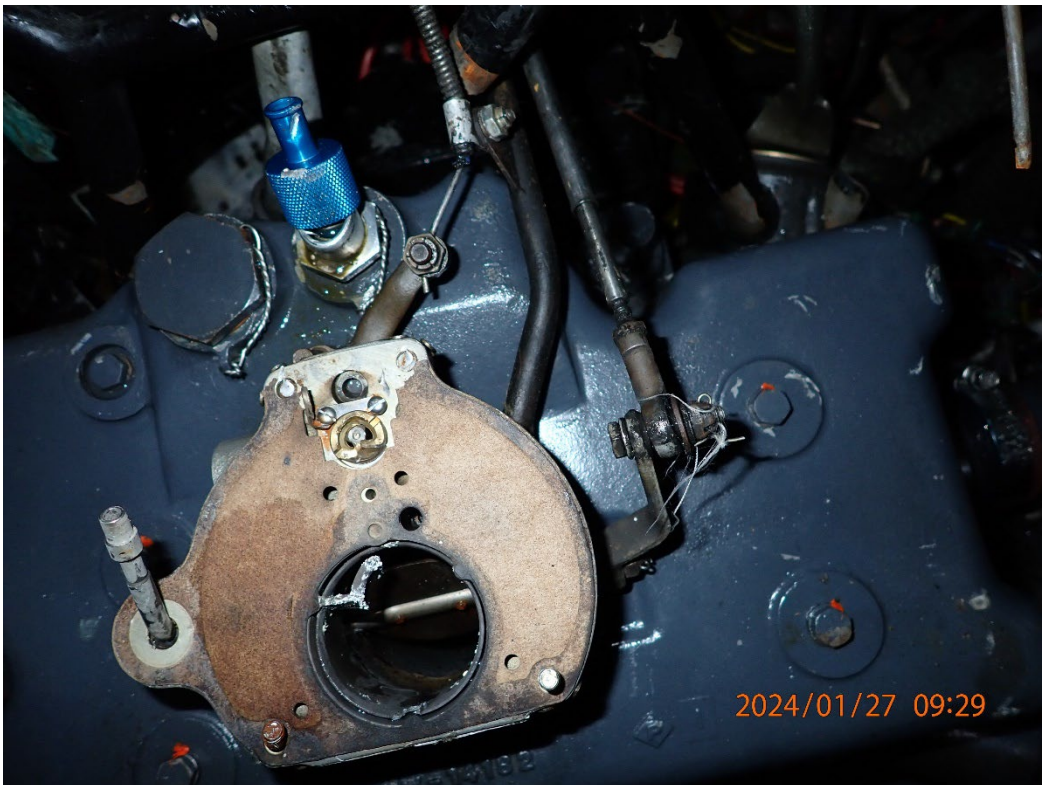
**Photo 43: View of throttle and mixture controls attached to the carburetor.**

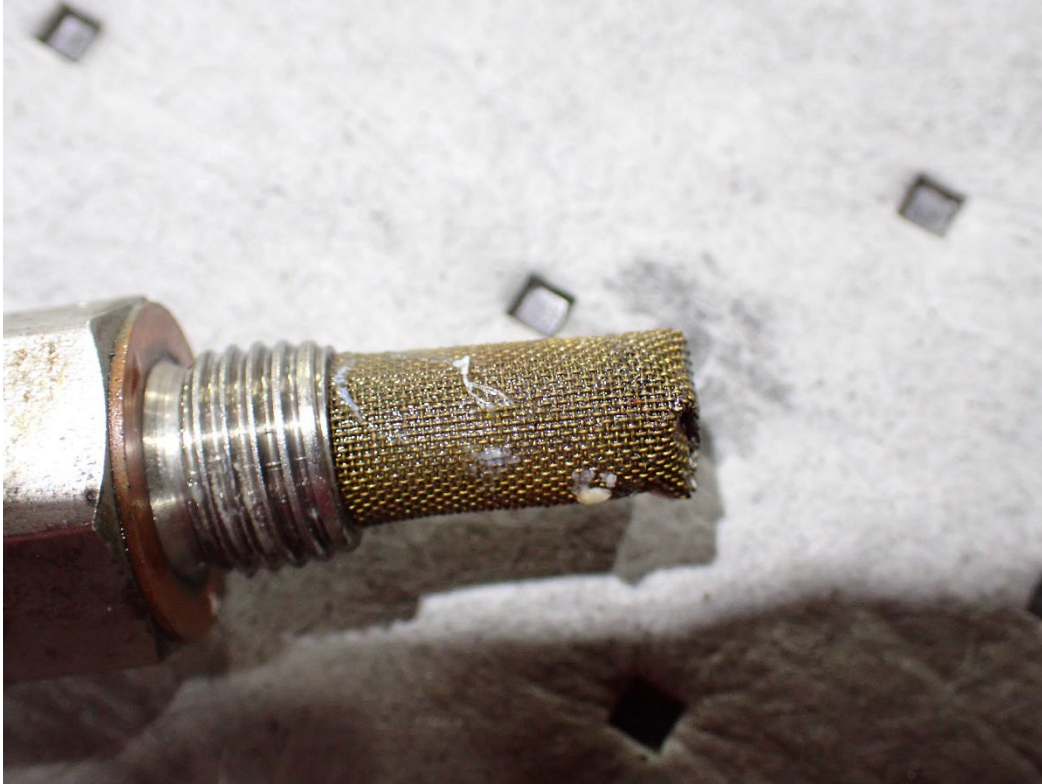
**Photo 44: View of carburetor fuel screen. (Textron Aviation Photo)**

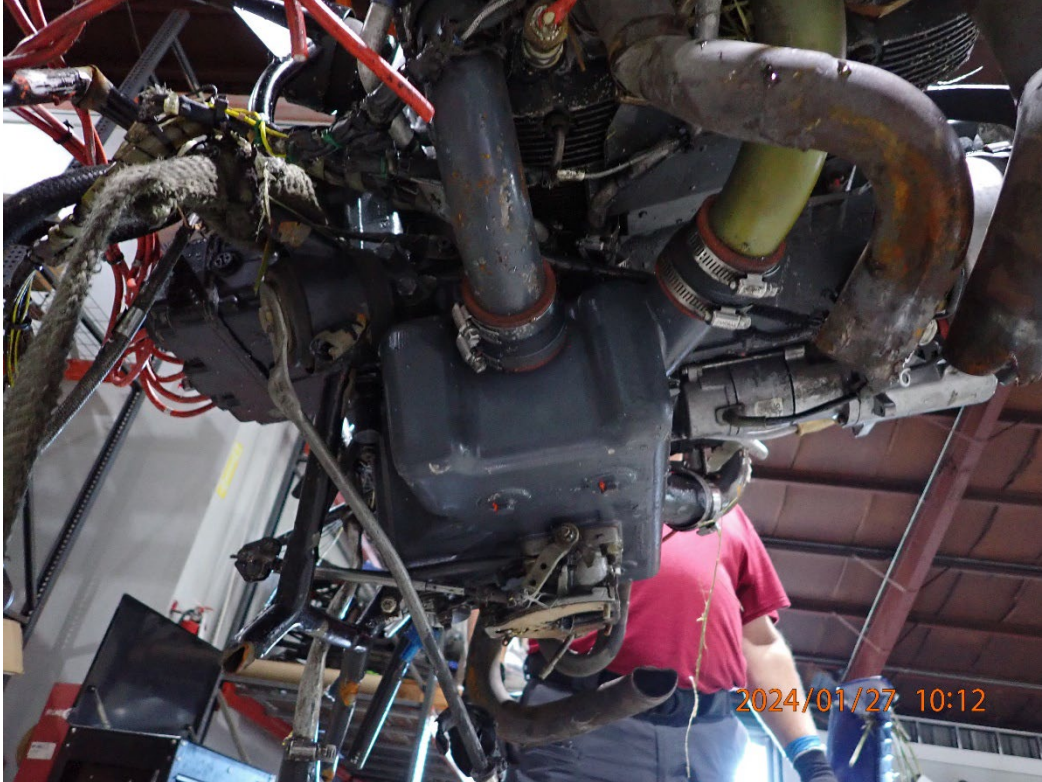
The oil sump remained attached to the bottom of the engine and was undamaged. The oil pump and filter remained attached to the engine accessory case at all attachment points. The oil filler tube and dip stick were impact separated and not recovered. The oil pump pumped oil out when the crankshaft was rotated by hand with a tool inserted into an accessory drive pad. The oil filter was dated January 20, 2024, and was removed and cut open for examination. No debris was observed on the oil filter pleats. The oil cooler remained attached to the engine through the oil hoses.

**Photo 45: View of undamaged oil sump.**

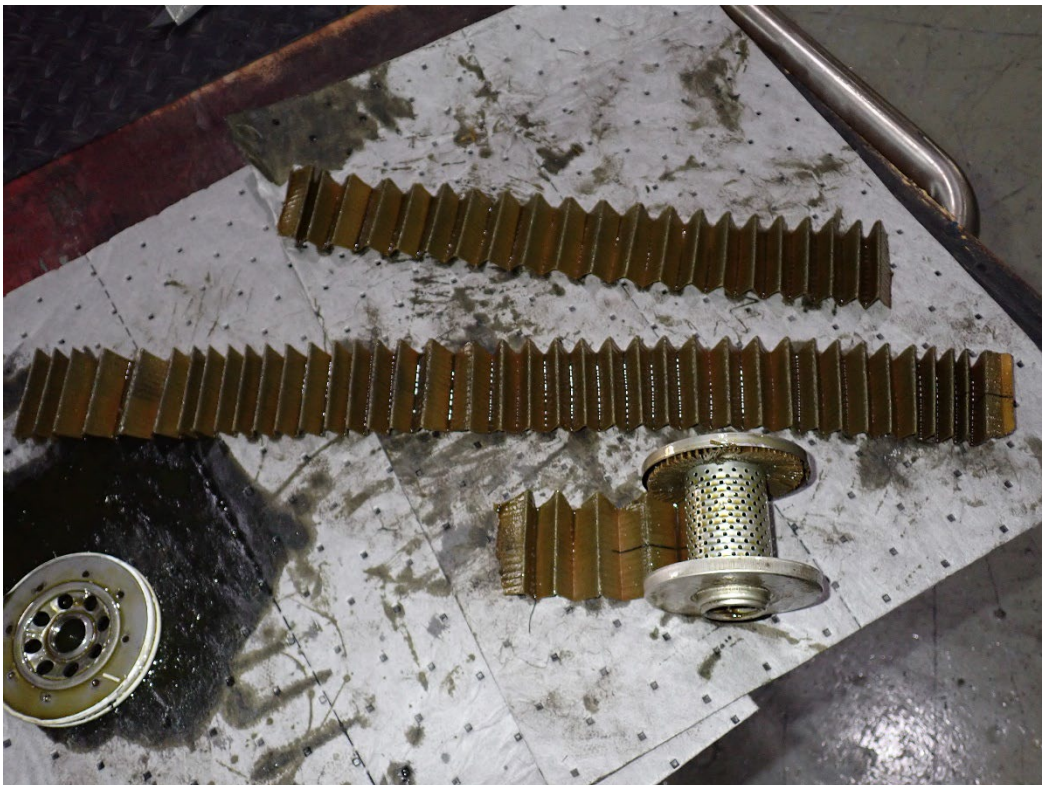
**Photo 46: View of oil filter pleats. (Textron Aviation Photo)**

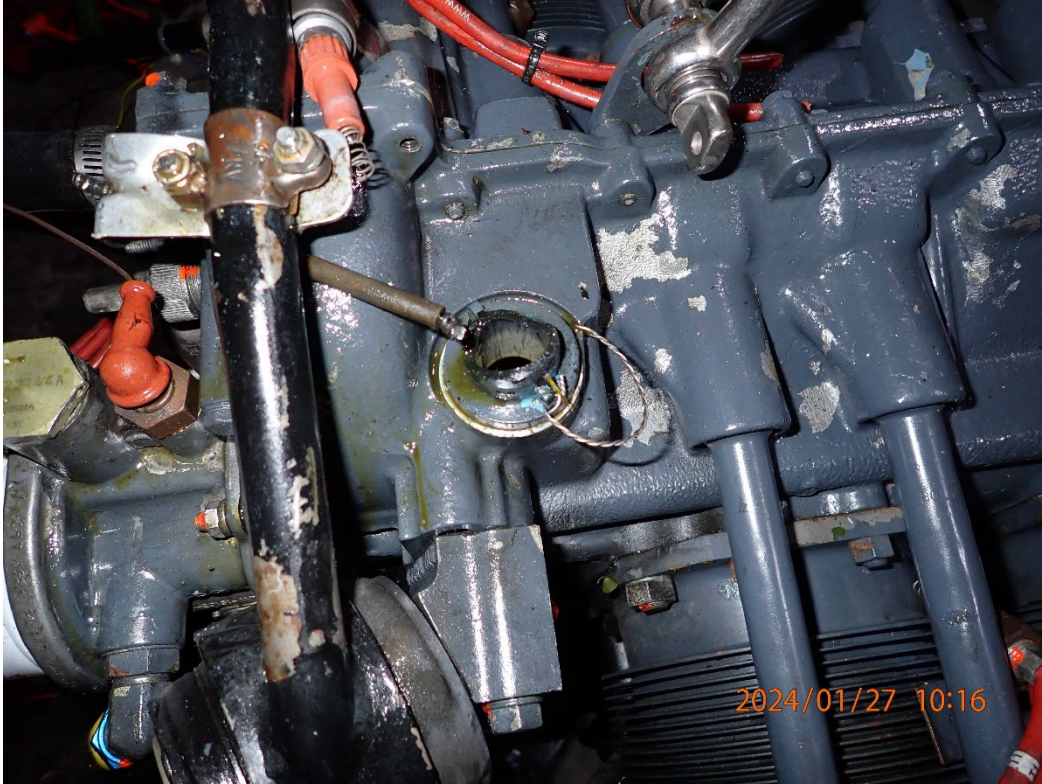
**Photo 47: Impact separated oil filler tube and dipstick.**

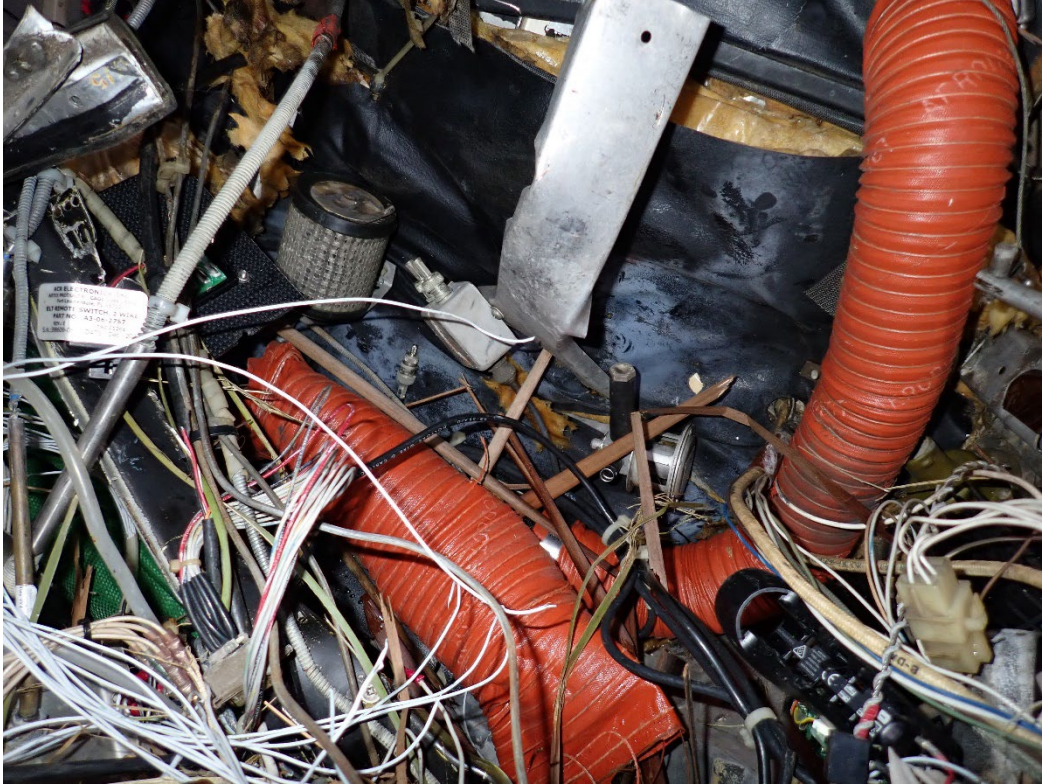
There was no vacuum pump installed on the engine. The vacuum filter and relief valve remained attached to the firewall.

**Photo 48: View of vacuum filter and relief valve. (Textron Aviation Photo)**

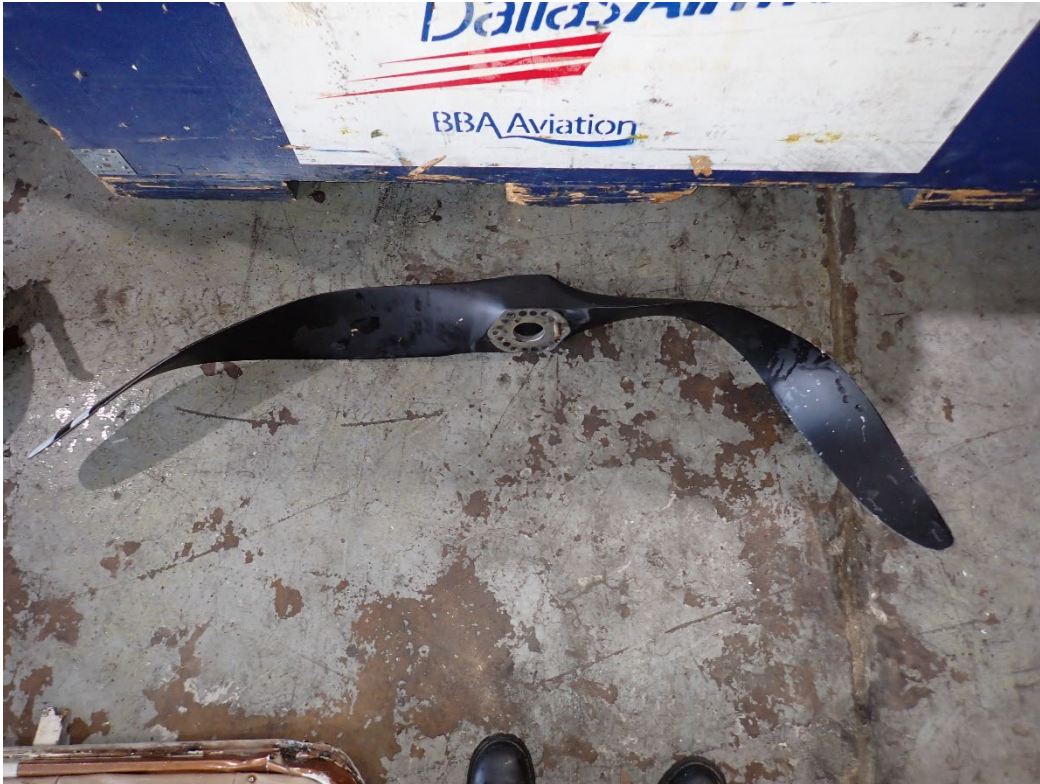
The airplane was equipped with a McCauley 1C160/DTM7557M1 fixed pitch, 75 inch propeller. The propeller remained attached to the crankshaft flange at all attachment points. The propeller was removed, and the propeller blades were arbitrarily labeled A and B to facilitate examination. Blade A was bent aft at the midspan about 30°. The blade exhibited chordwise scratching, trailing edge gouging, and white and blue paint transfer. Blade B was bent aft about a third of the length outboard from the hub about 90°. The blade exhibited chordwise scratching, tip polishing and blue and white paint transfer.

**Photo 49: Overview of propeller. (Textron Aviation Photo)**

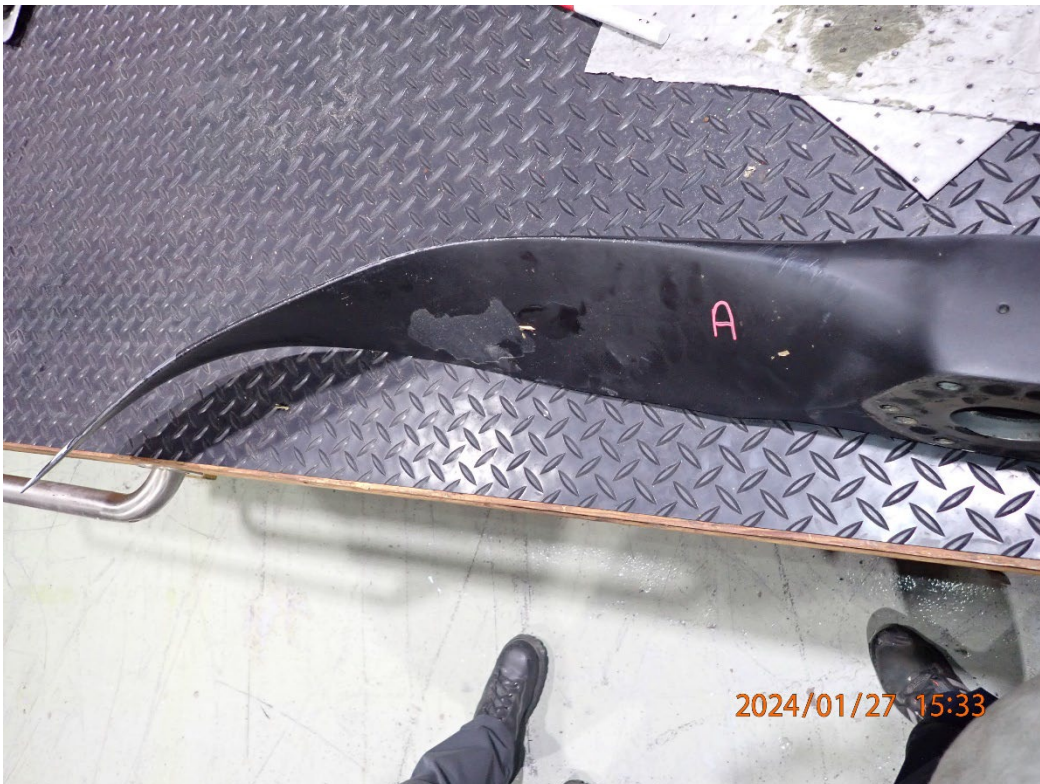
**Photo 50: Overview of blade A.**

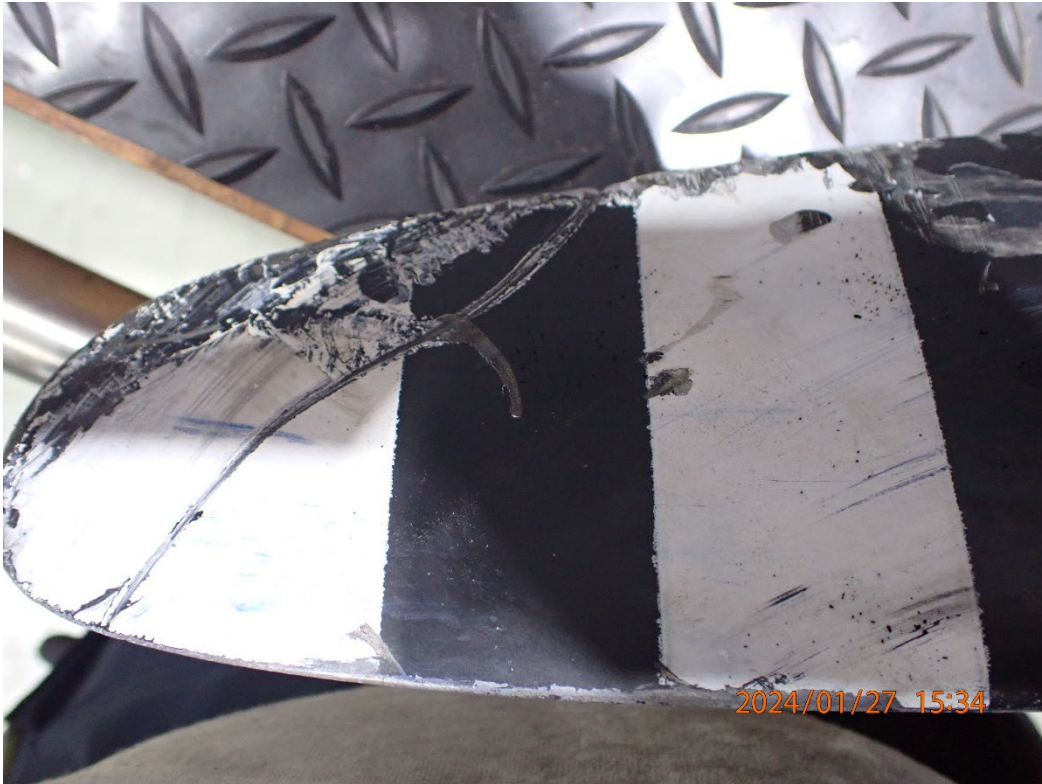
**Photo 51: Tip of blade A.**

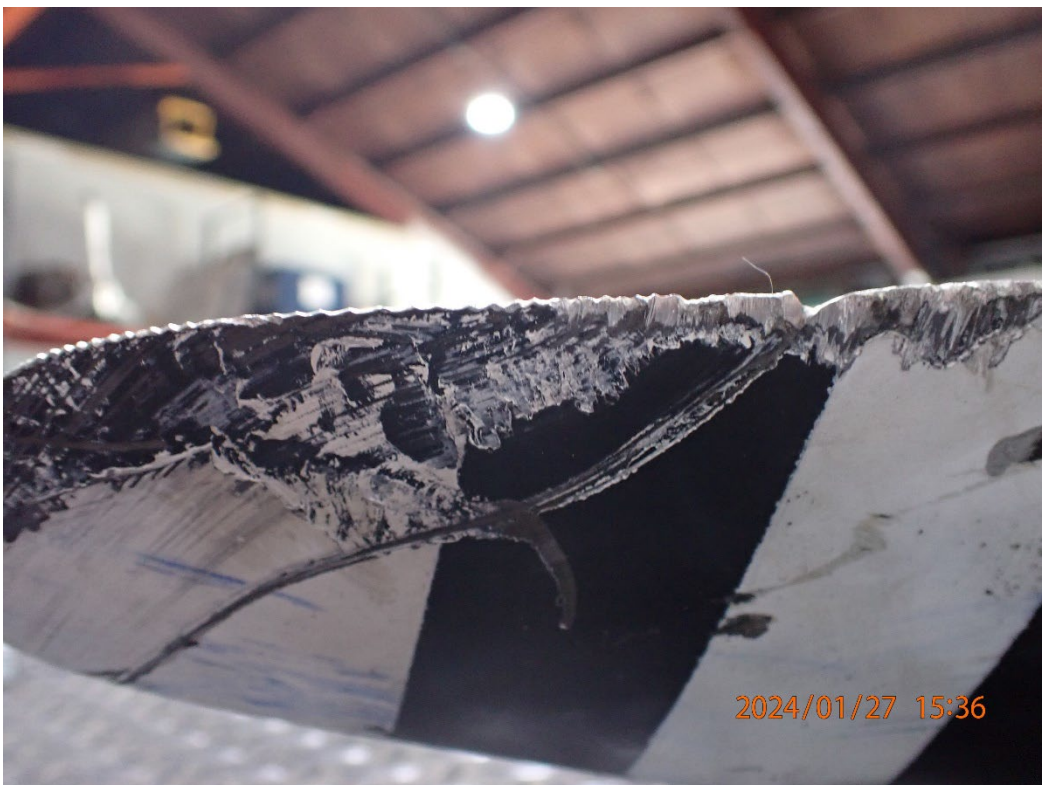
**Photo 52: Trailing edge of blade A.**

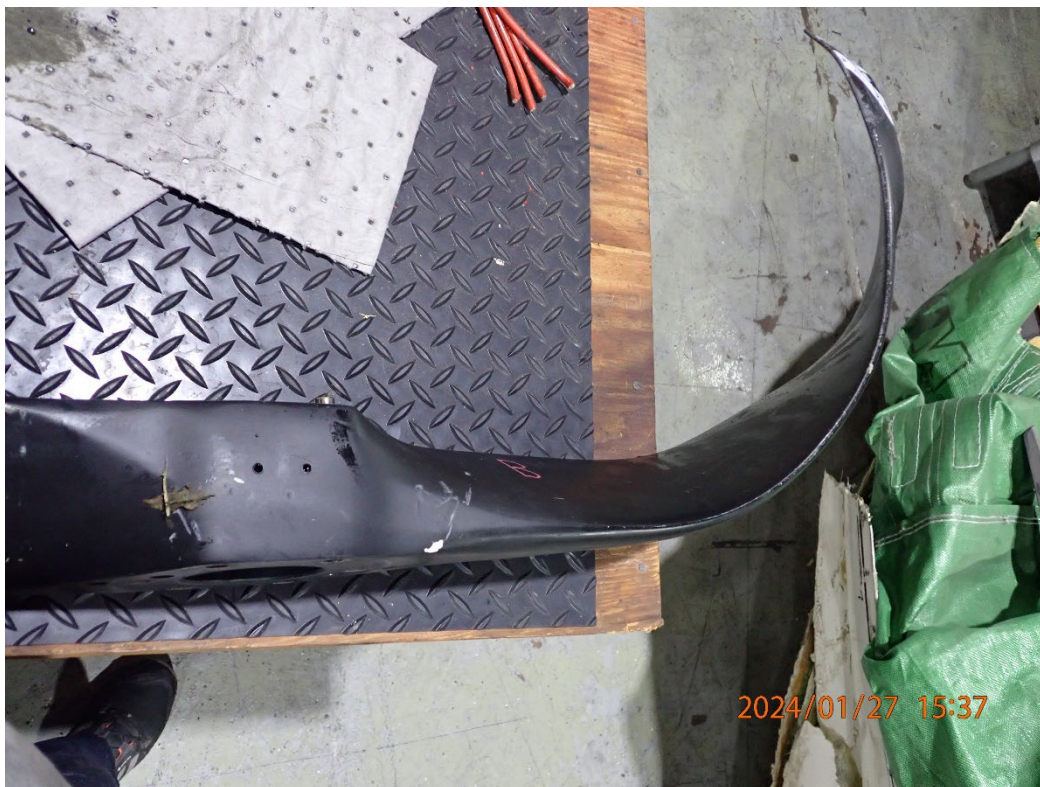
**Photo 53: Overview of blade B.**

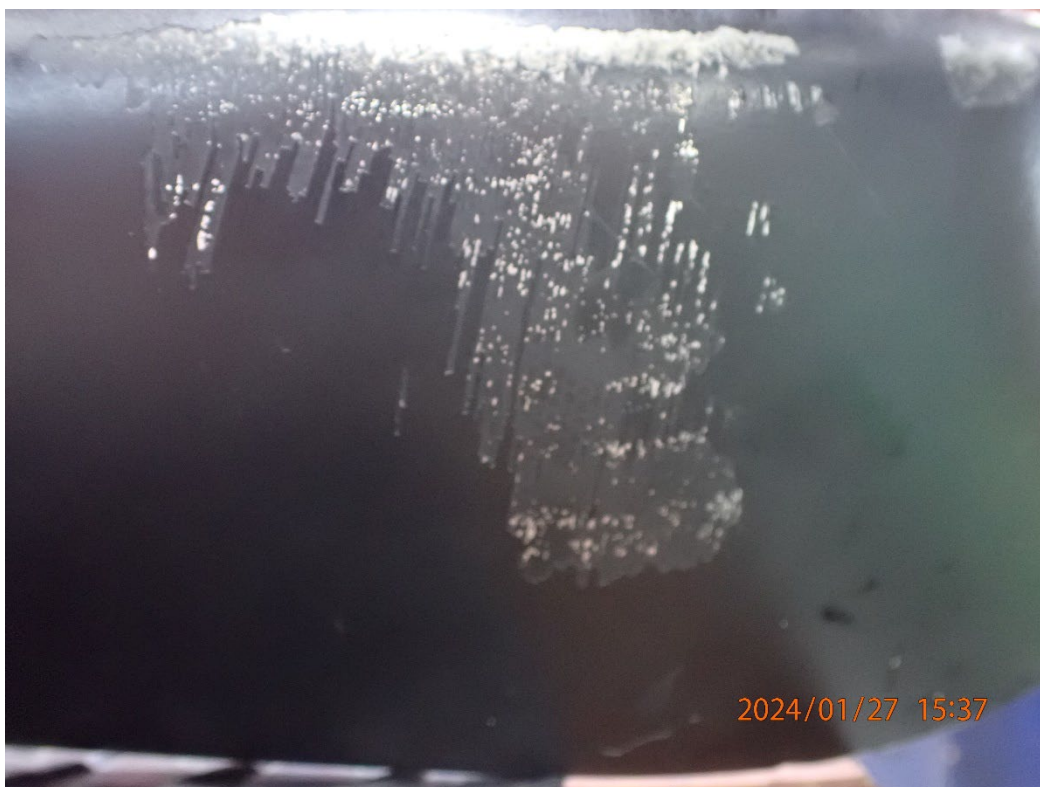
**Photo 54: Chordwise scratching on blade B.**
